DONAL ANDERSON ARCHITECT MRIAI

Registered Architect , Architect Accredited in Conservation , Measured building Surveys

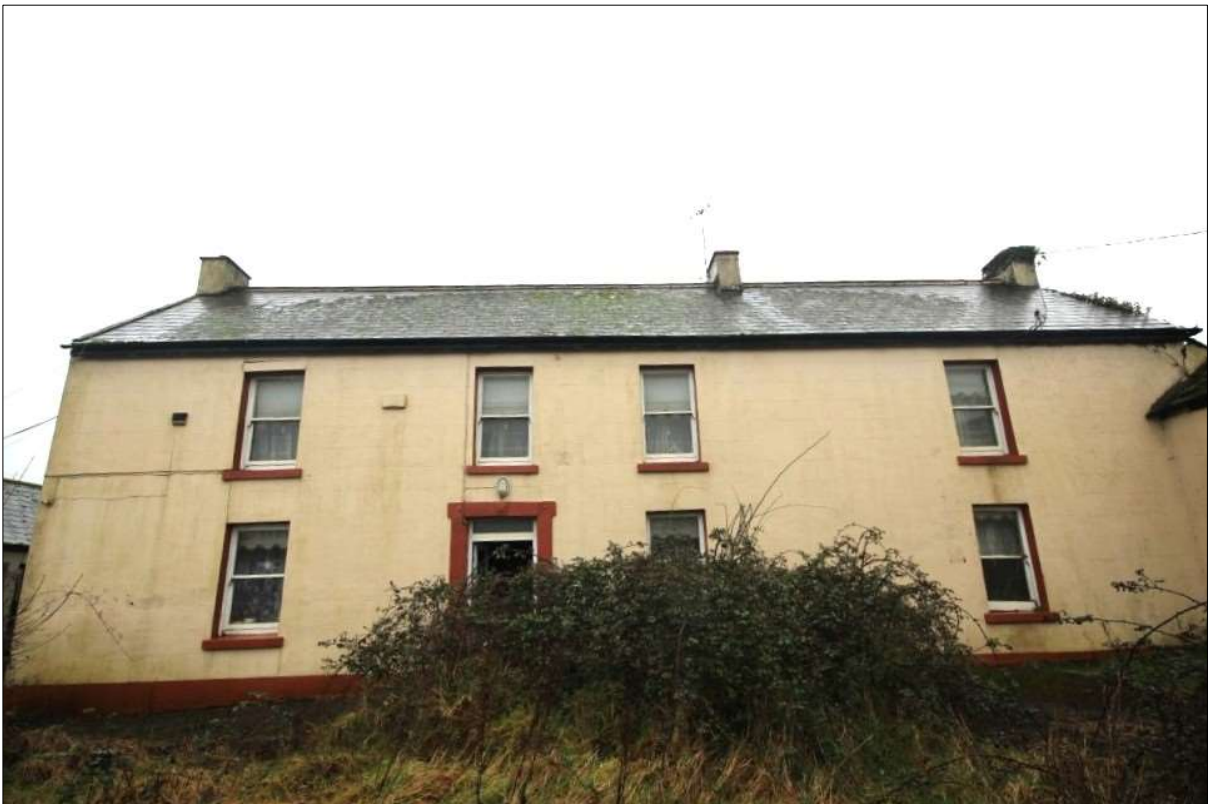
Plate 5: Front (eastern) elevation of Building A-Note window head to lhs first floor window cracked and dislovcated.

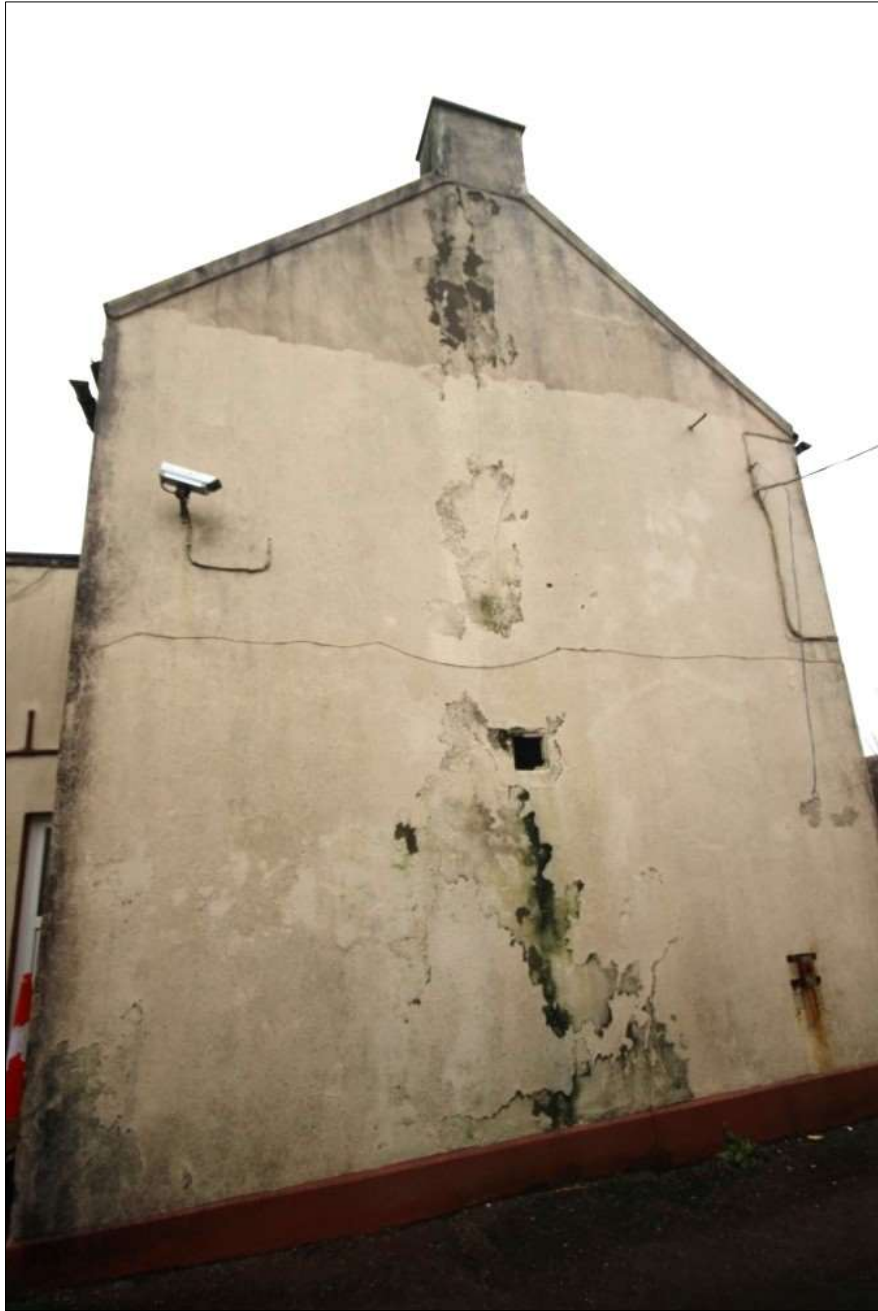
Plate 6: Southern elevation of Building A Main house gable

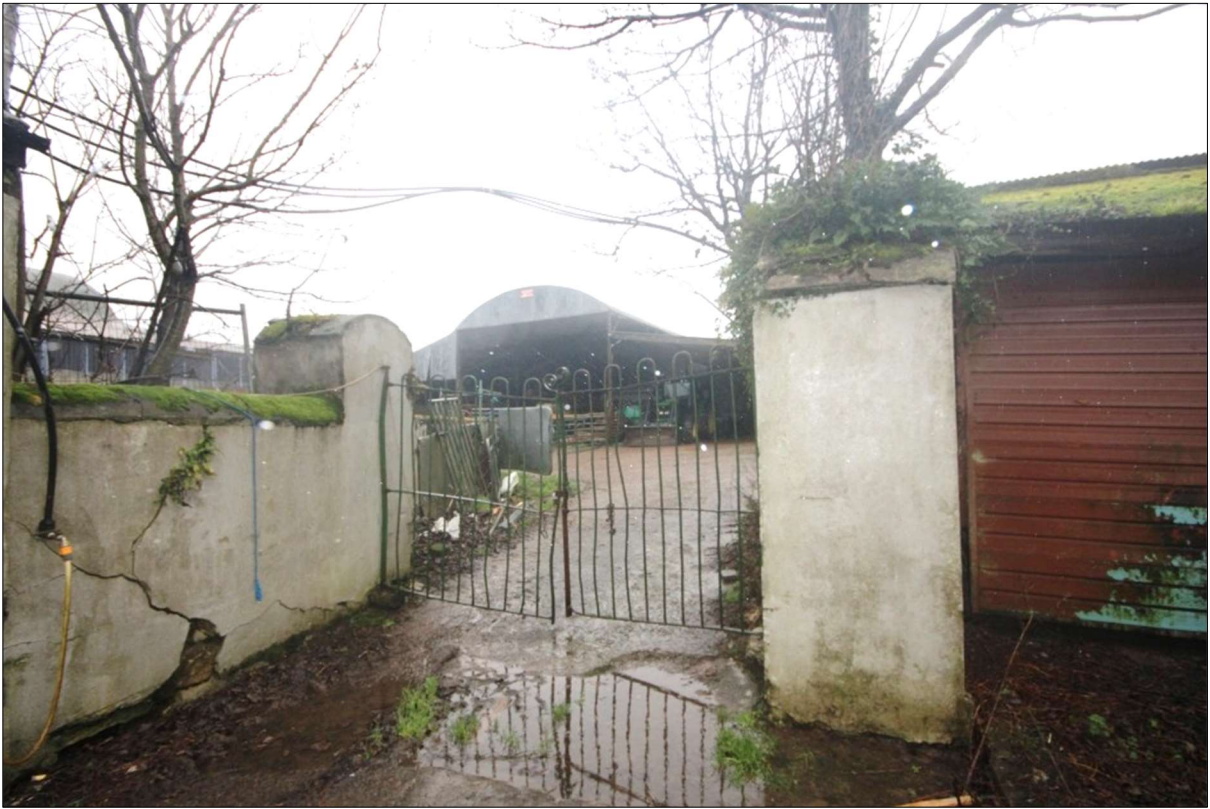
Plate 10: Piers and gateway to rear farmyard to be repaired and made useable.

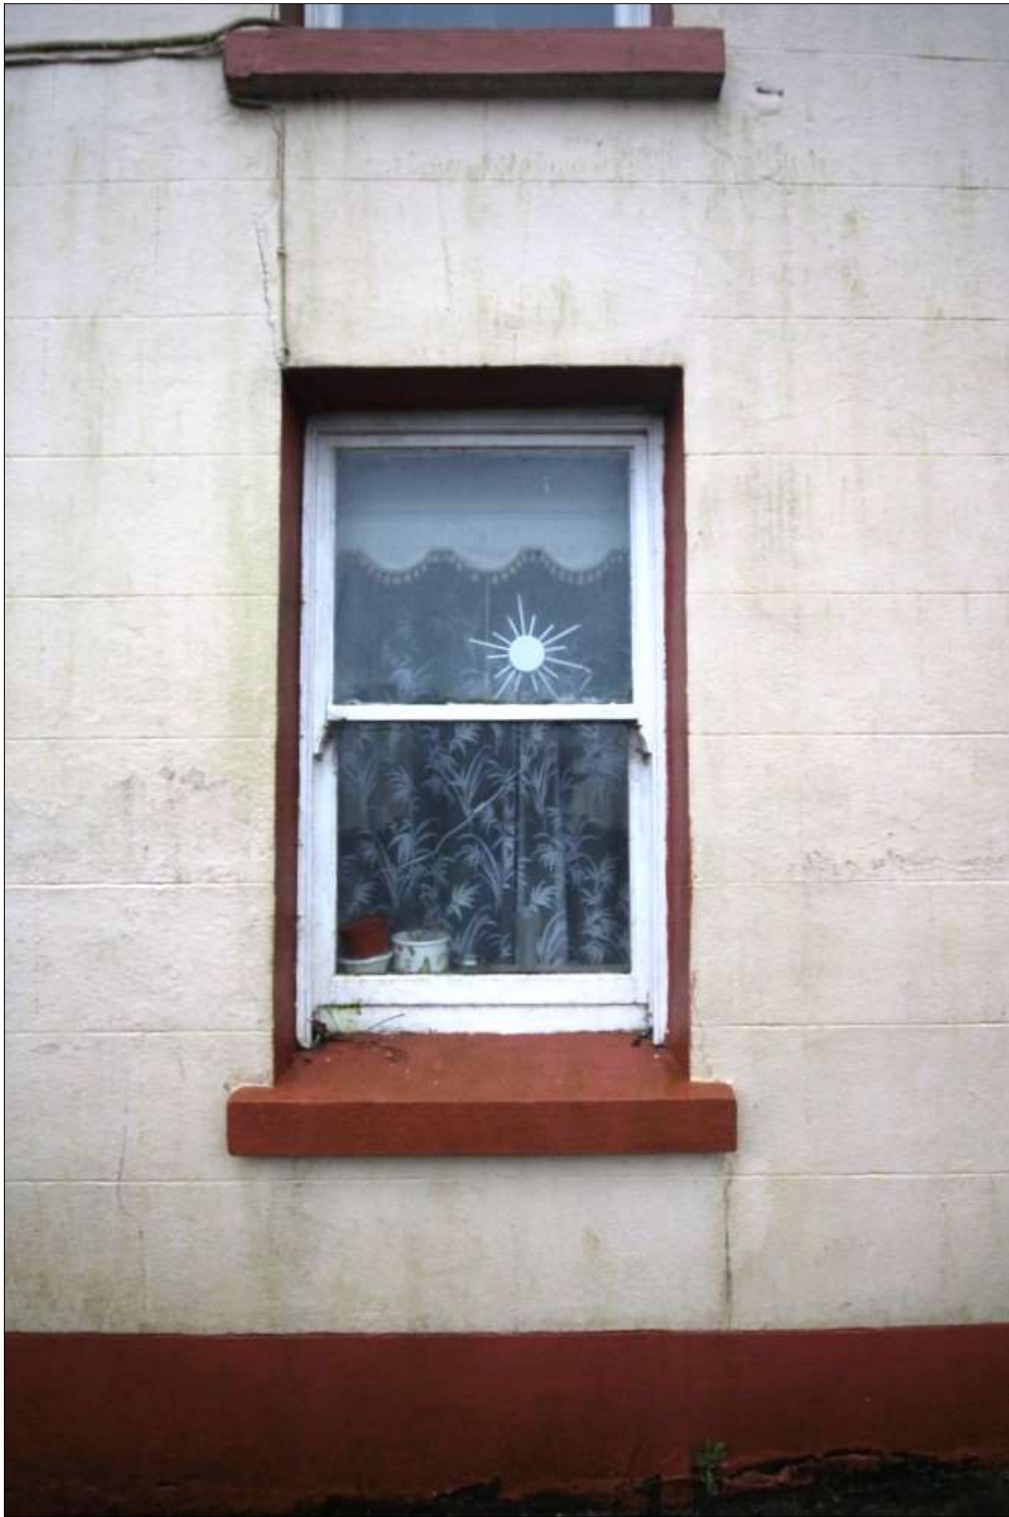
Plate 11: Replacement window detail to front elevation-note sash have been replaced at some time in the last 40 years and are a more square and fresher profile.. Cills are cast concrete

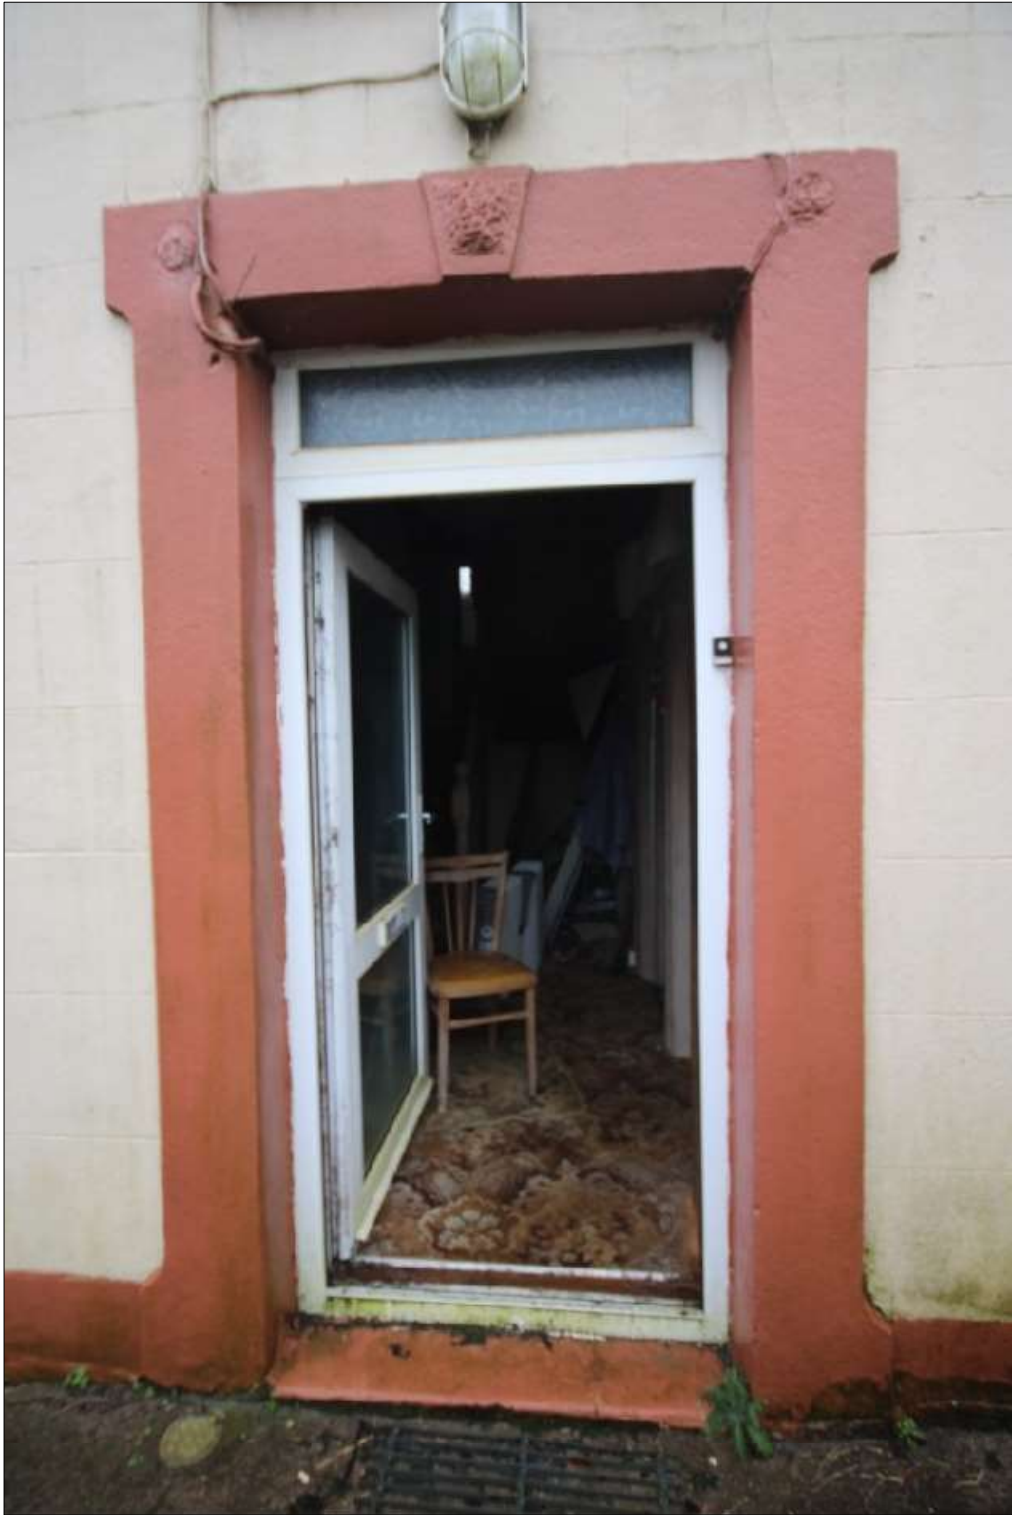
Plate 12: Replacement aluminium front door with rendered detail to be retained.

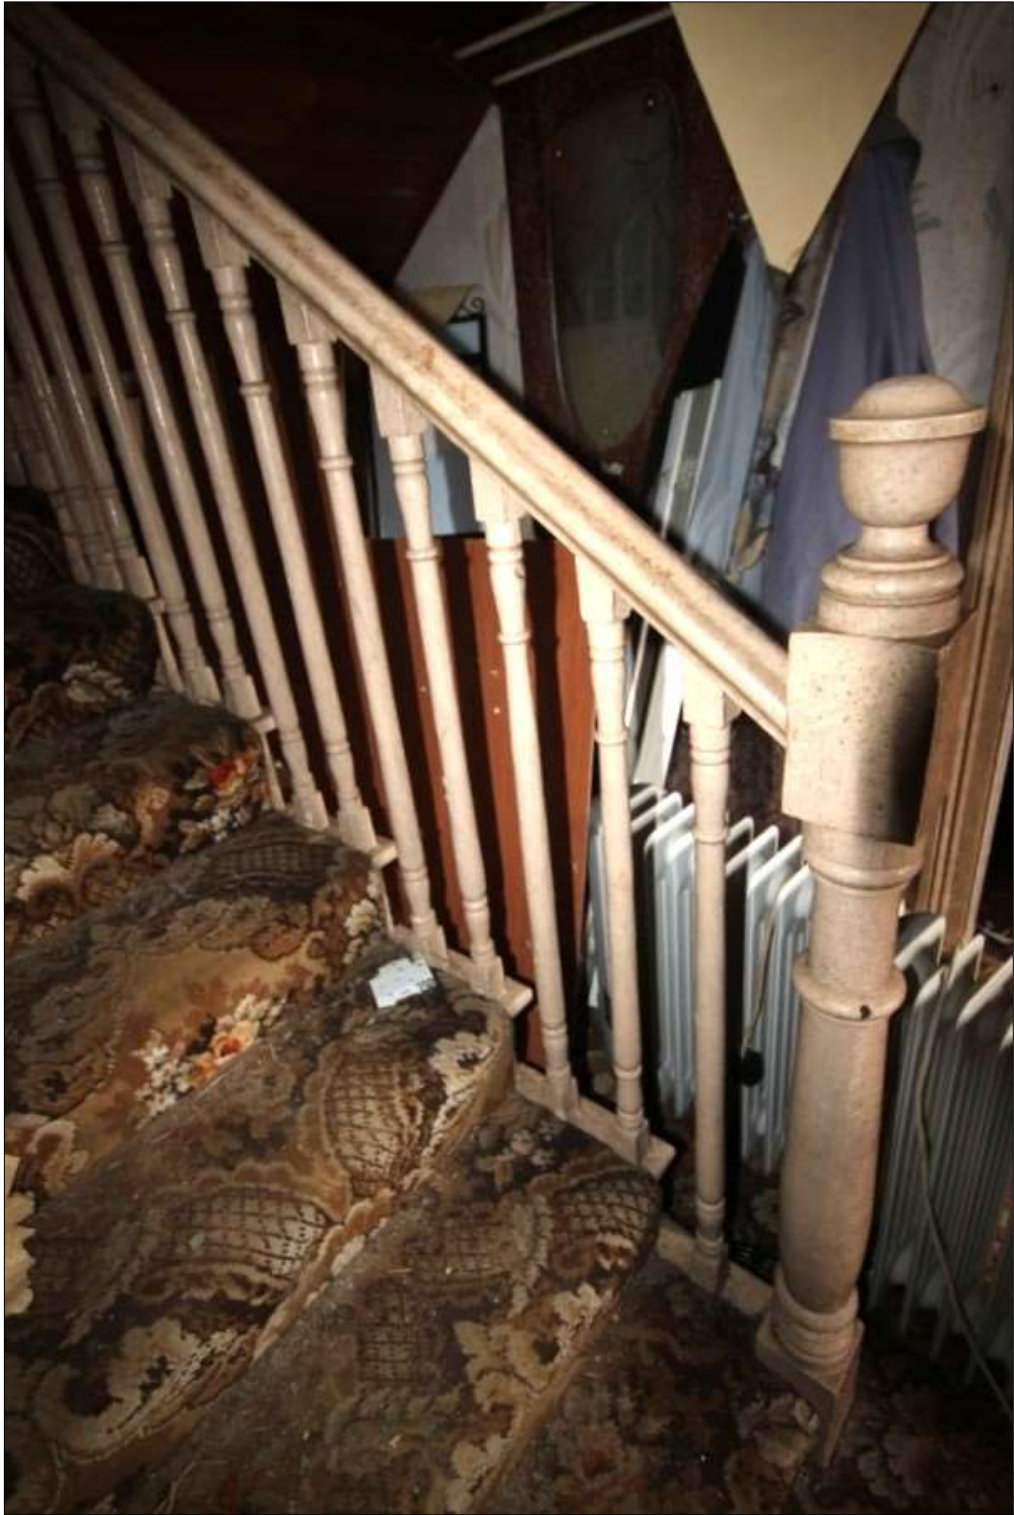
Plate 13: Staircase detail in main entrance hall A-GF01

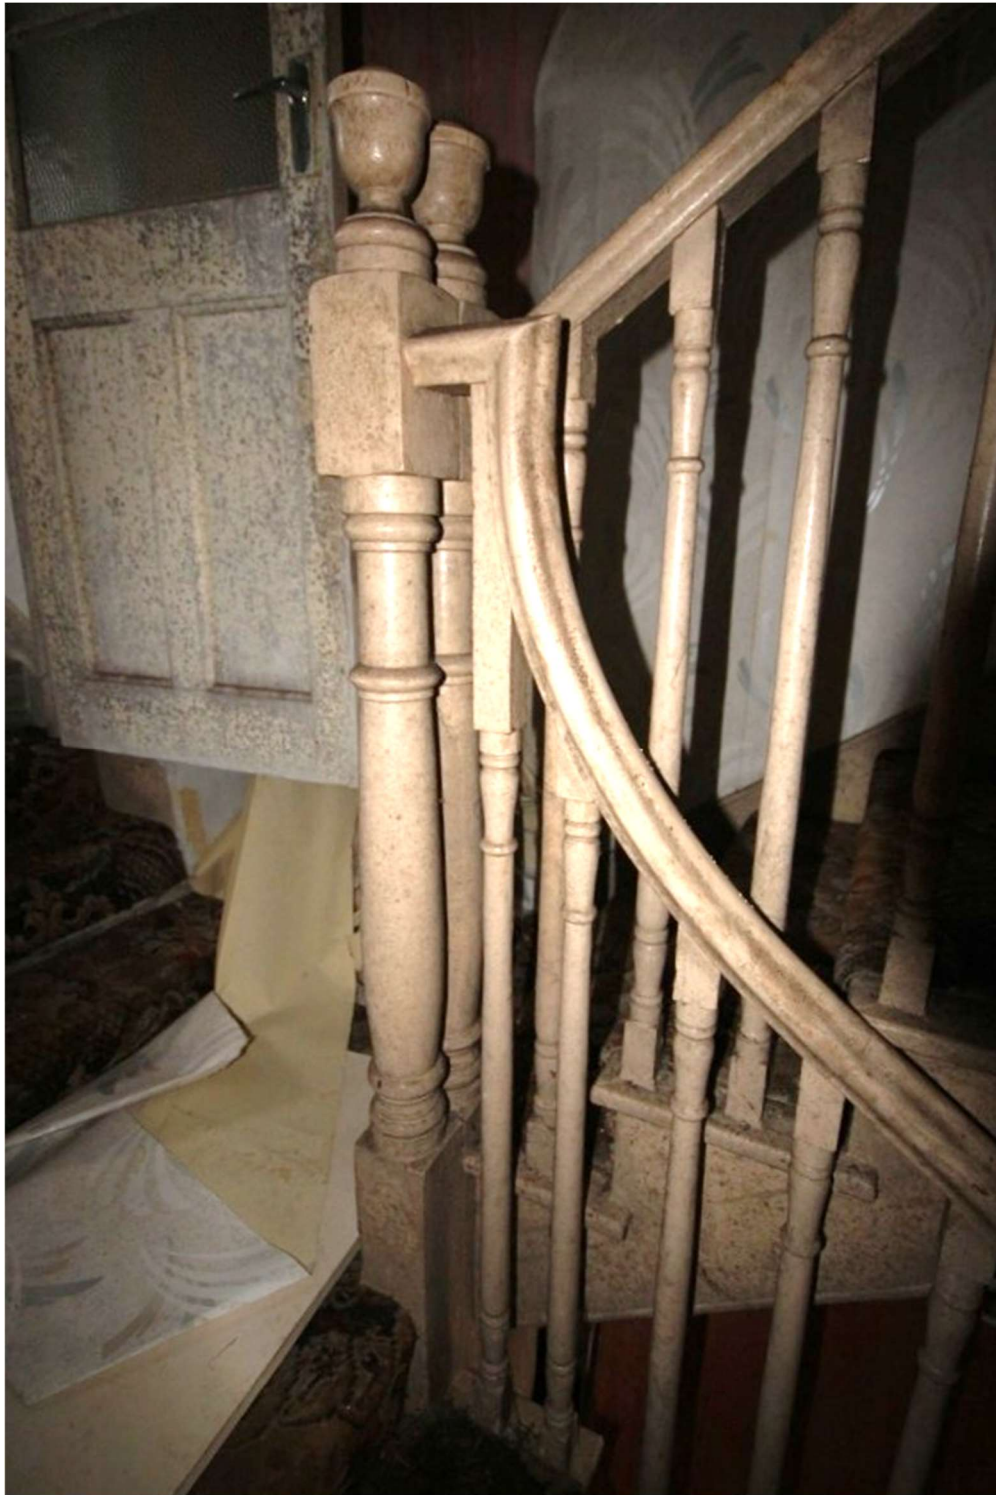
Plate 22: Ramped handrail and double newel to staircase on half landing. Stairs in good condition except mid landing collapsing most likely due to wood worm on supports. No access was made to inspect underneath.

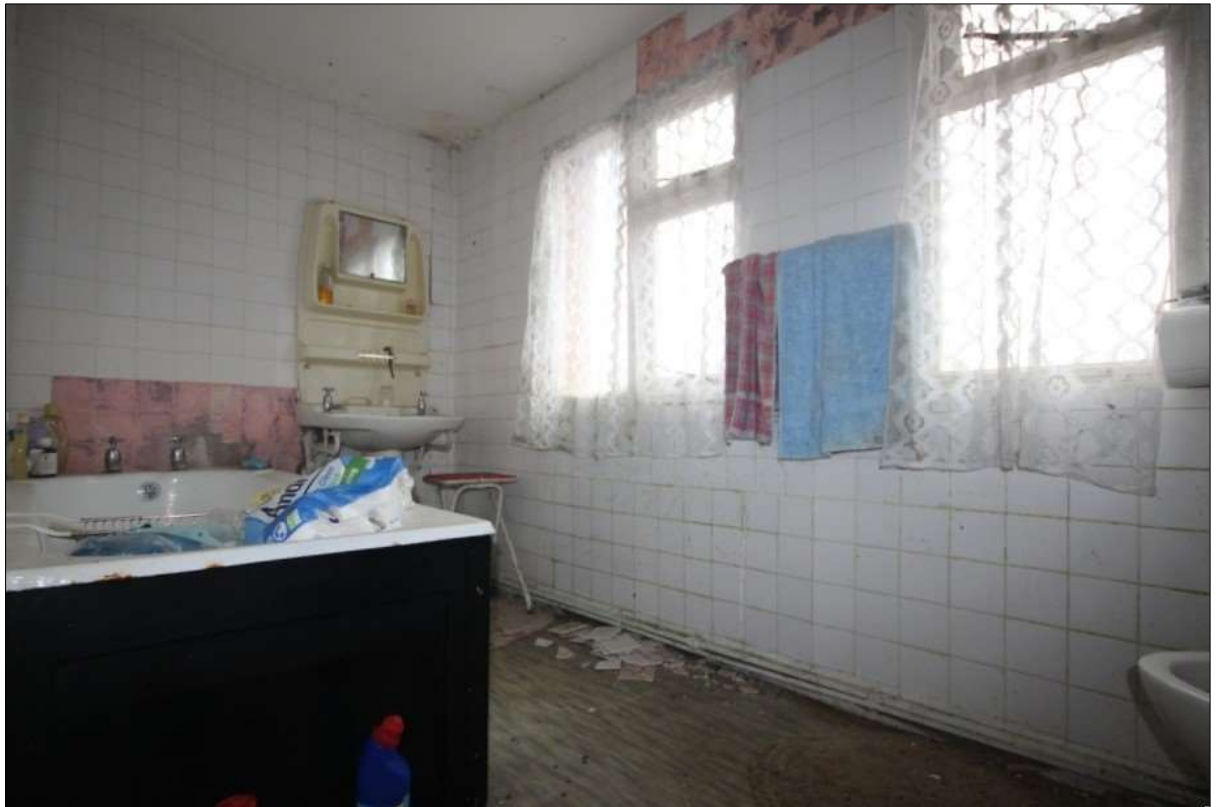
Plate 23: First-floor bathroom in later extension to rear A-FF06. Note this is a modern space in blockwork and a flat roof to be modernised off the mid landing to the main house.

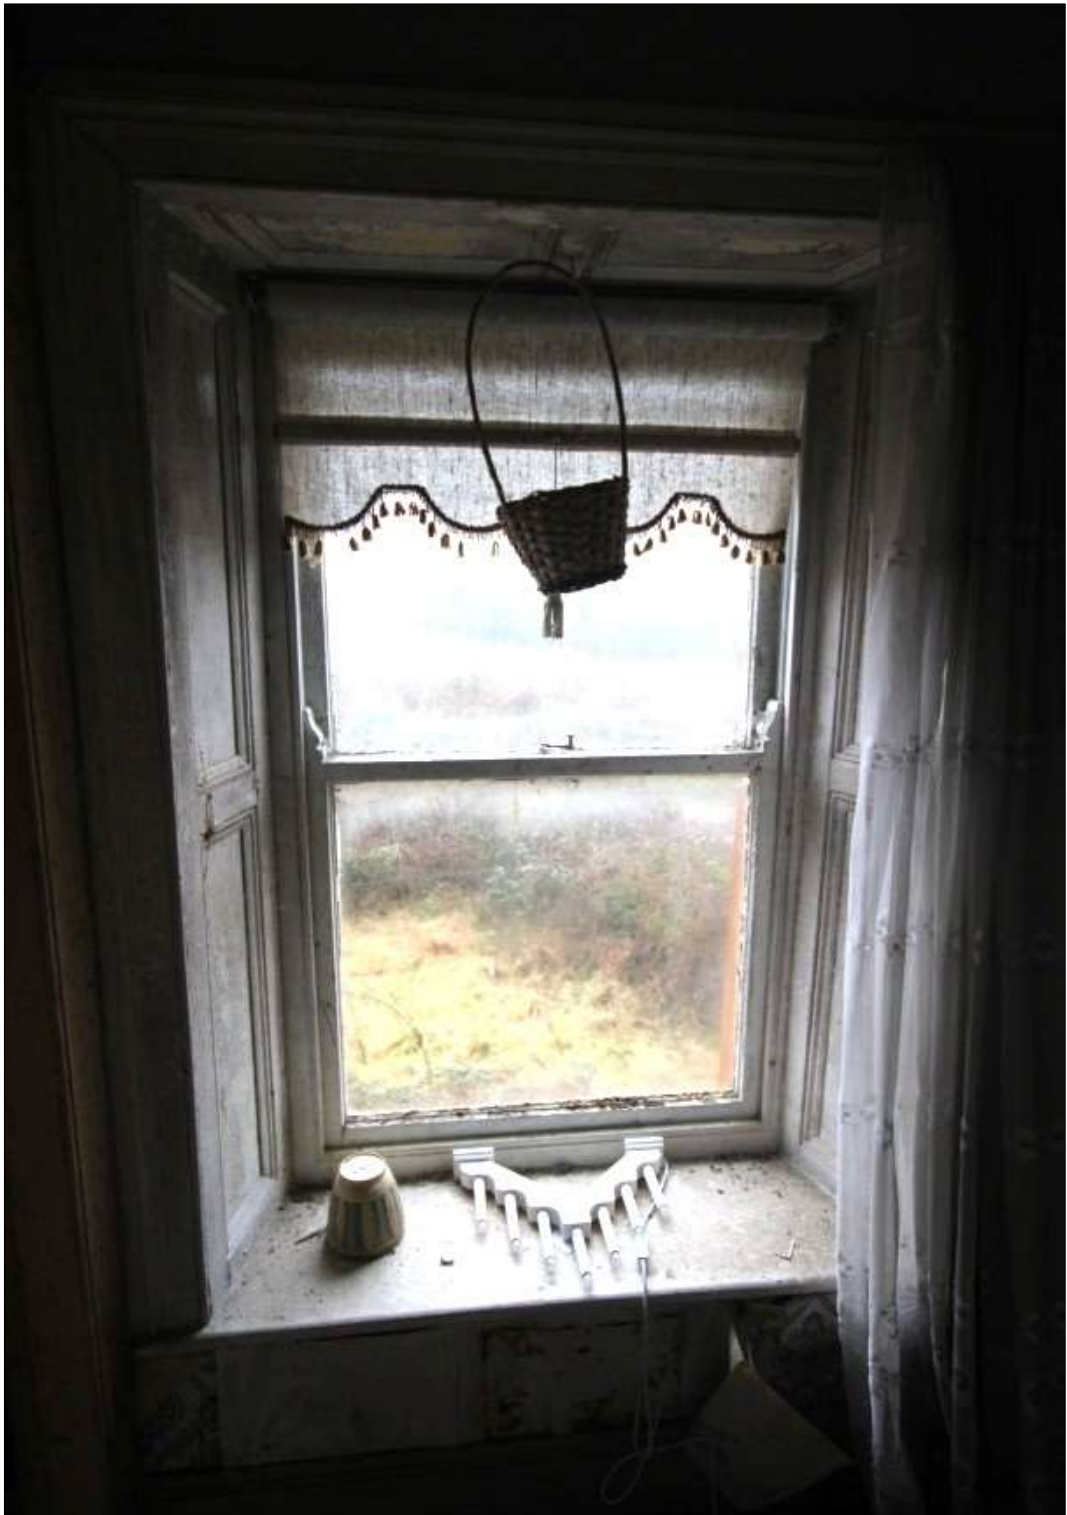
Plate 26: Replacement landing window to front on first-floor landing A-FF01. Note the main frame looks original . the sashes have been replaced. Alos the panelling is the only remaining sample of what may have been present to all windows.

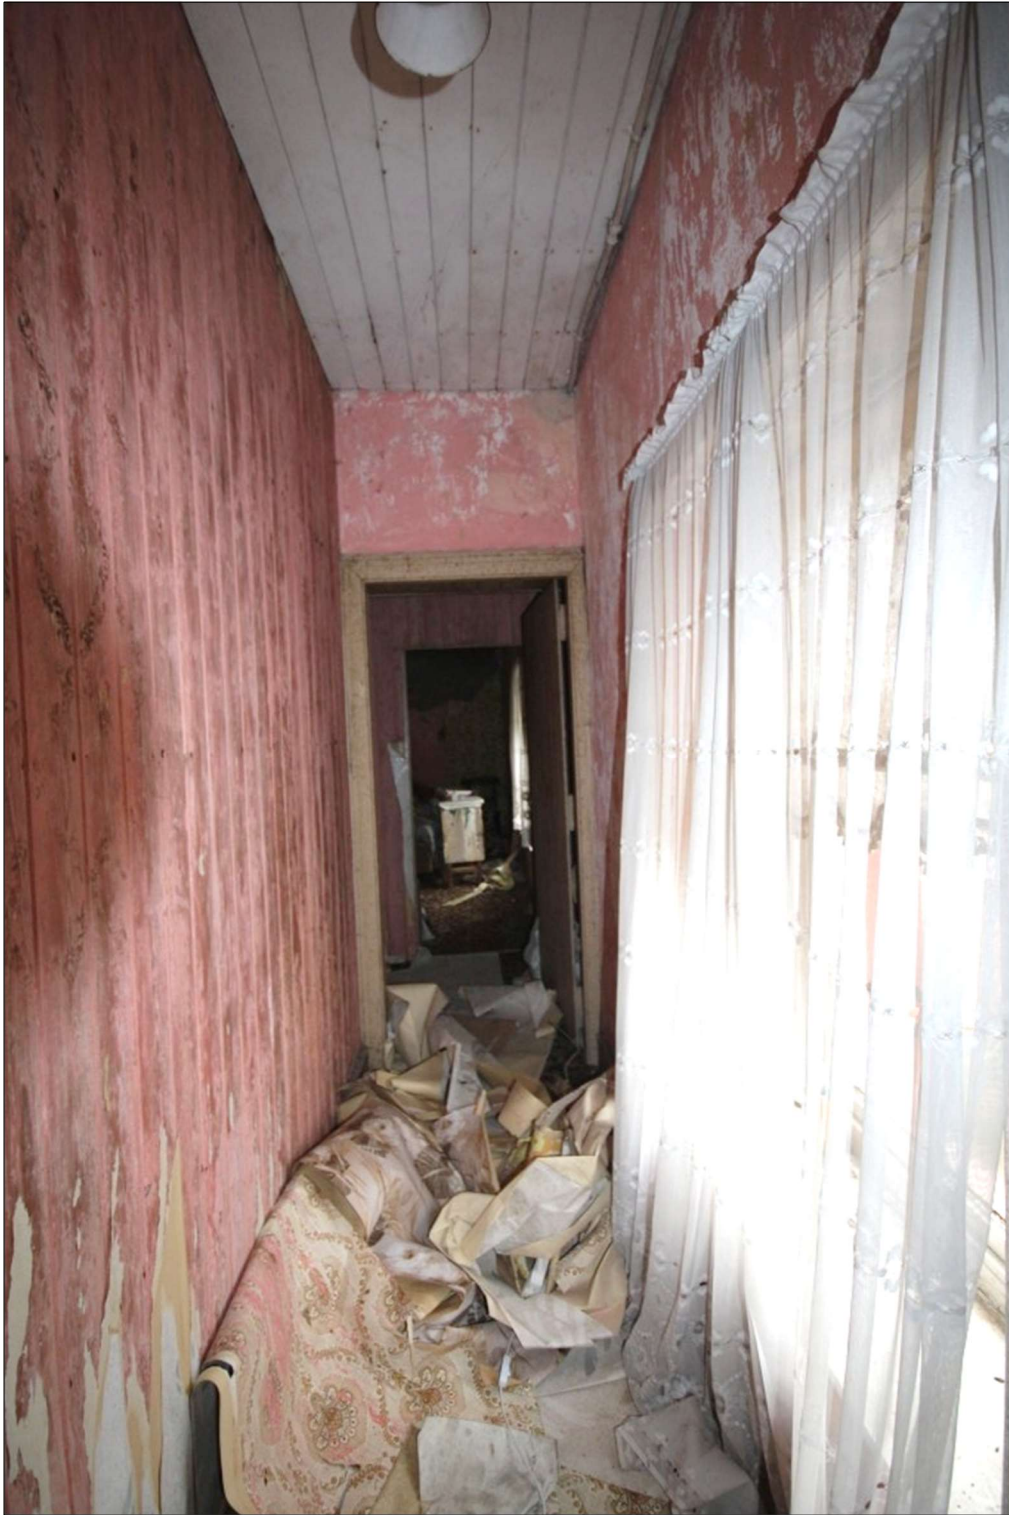
Plate 27: First-floor short lobbied landing A-FF02 looking to A-FF03. Note timber stud partition to LHS and window behind curtain

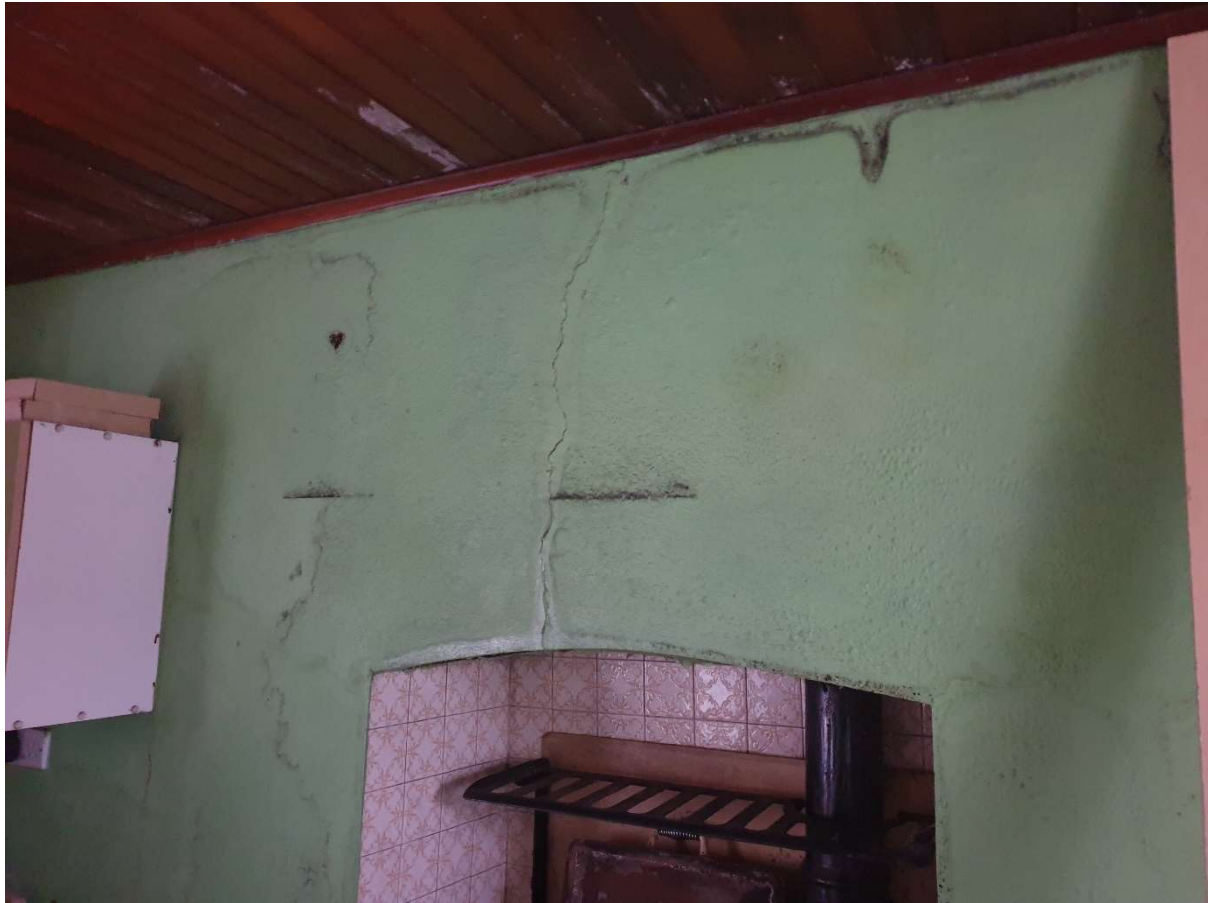
Plate 36: *Detail of crack to gable to kitchen.*

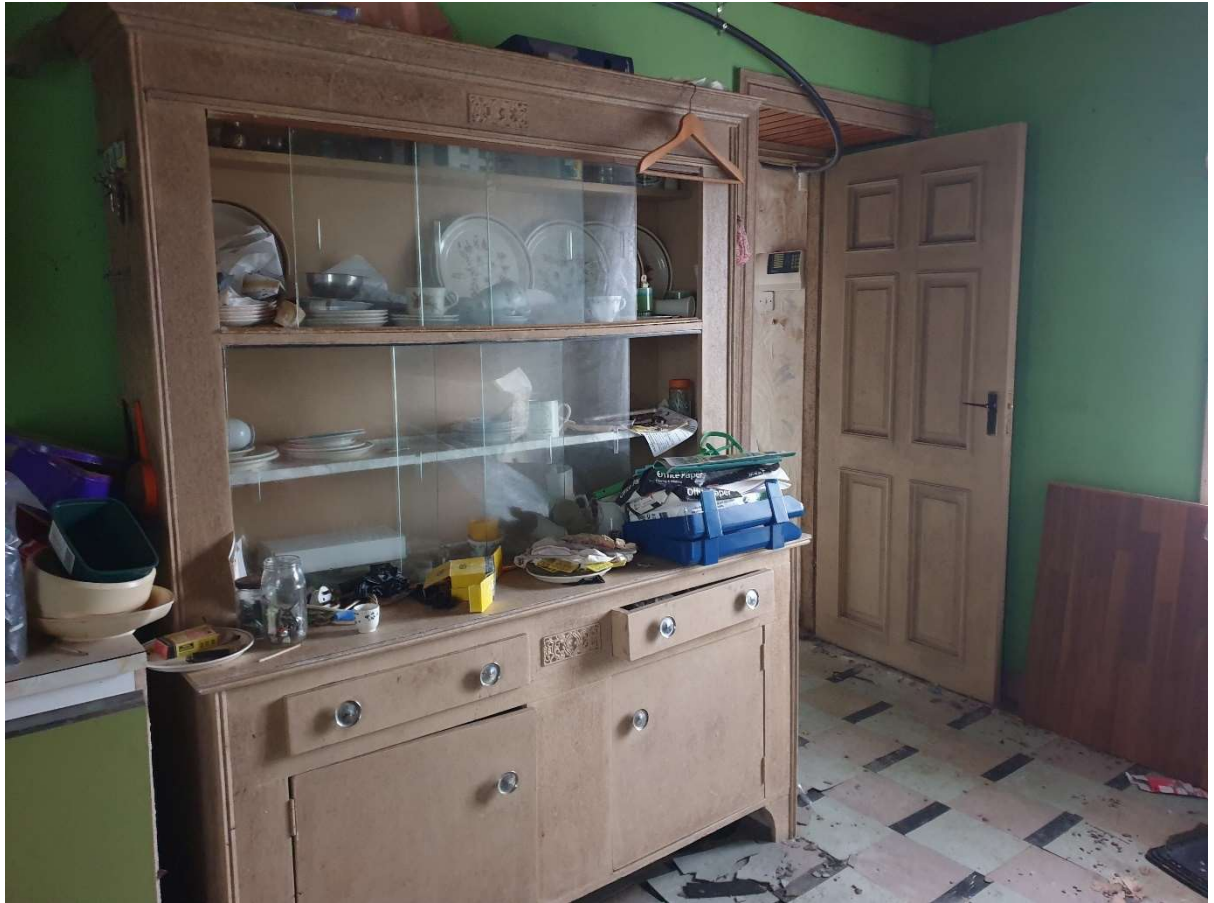
Plate 37: Detail of dresser to kitchen: Ideally should be kept and repurposed .

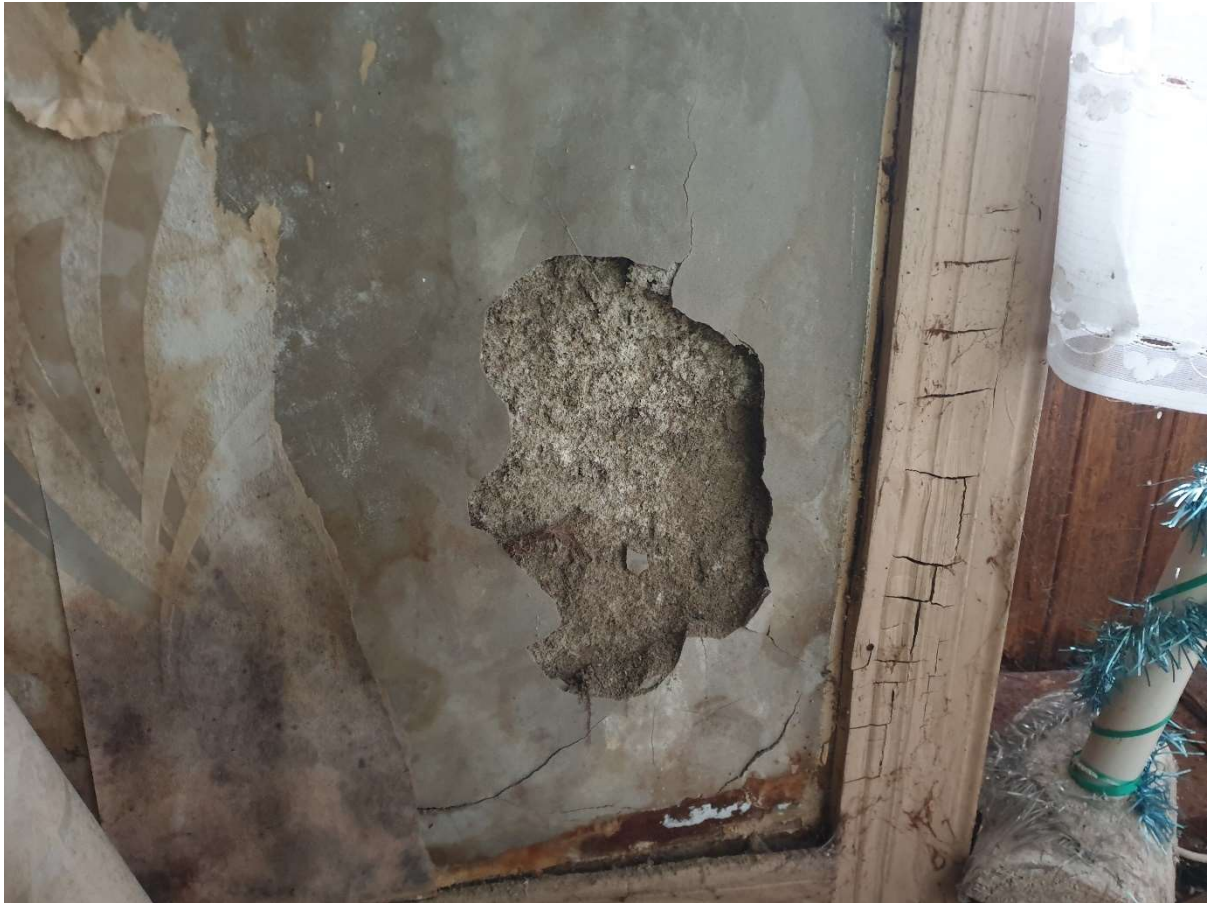
Plate 40: Detail of cubic rot and gypsum delaminating plaster to external wall.

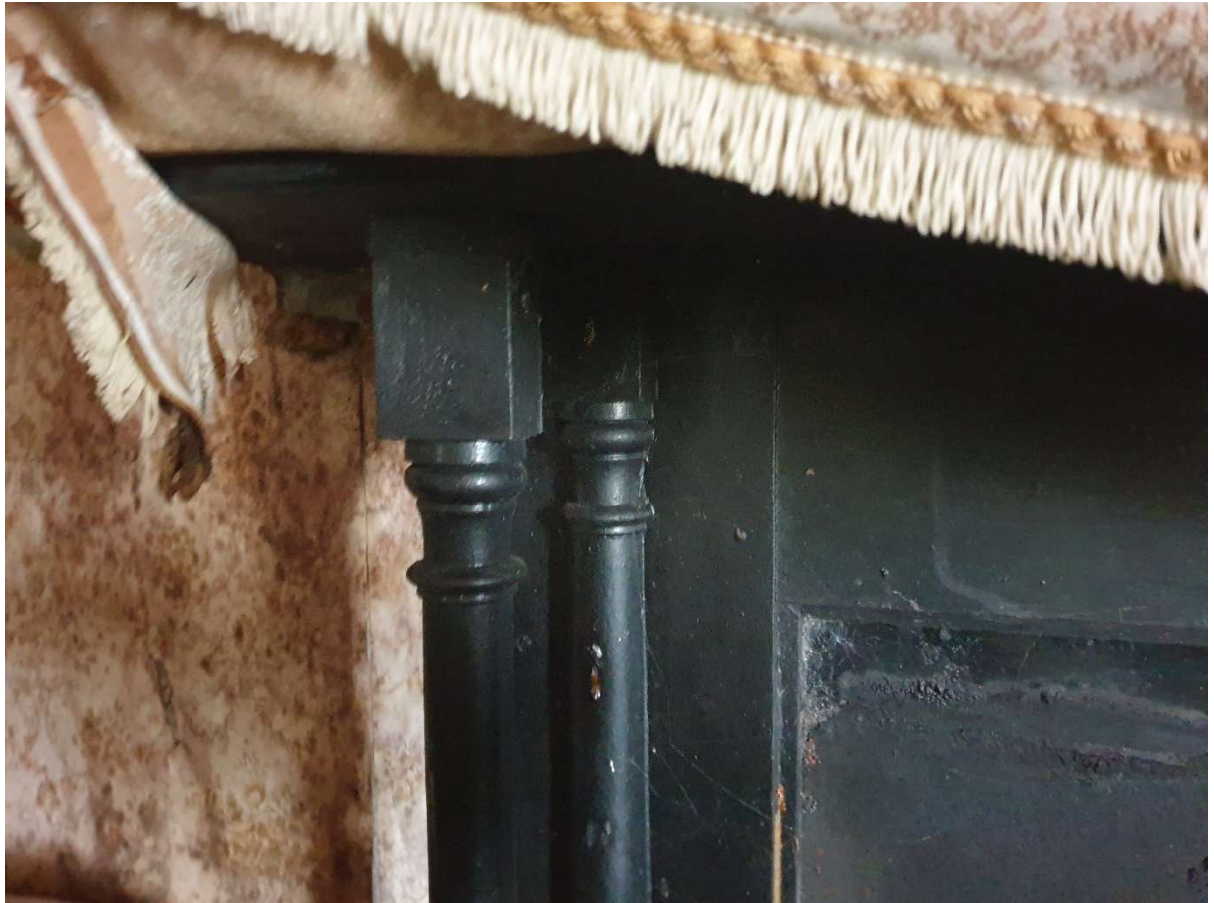
Plate 41: *Detail of engaged and free standing timber support columns to fire surround to Living room.*

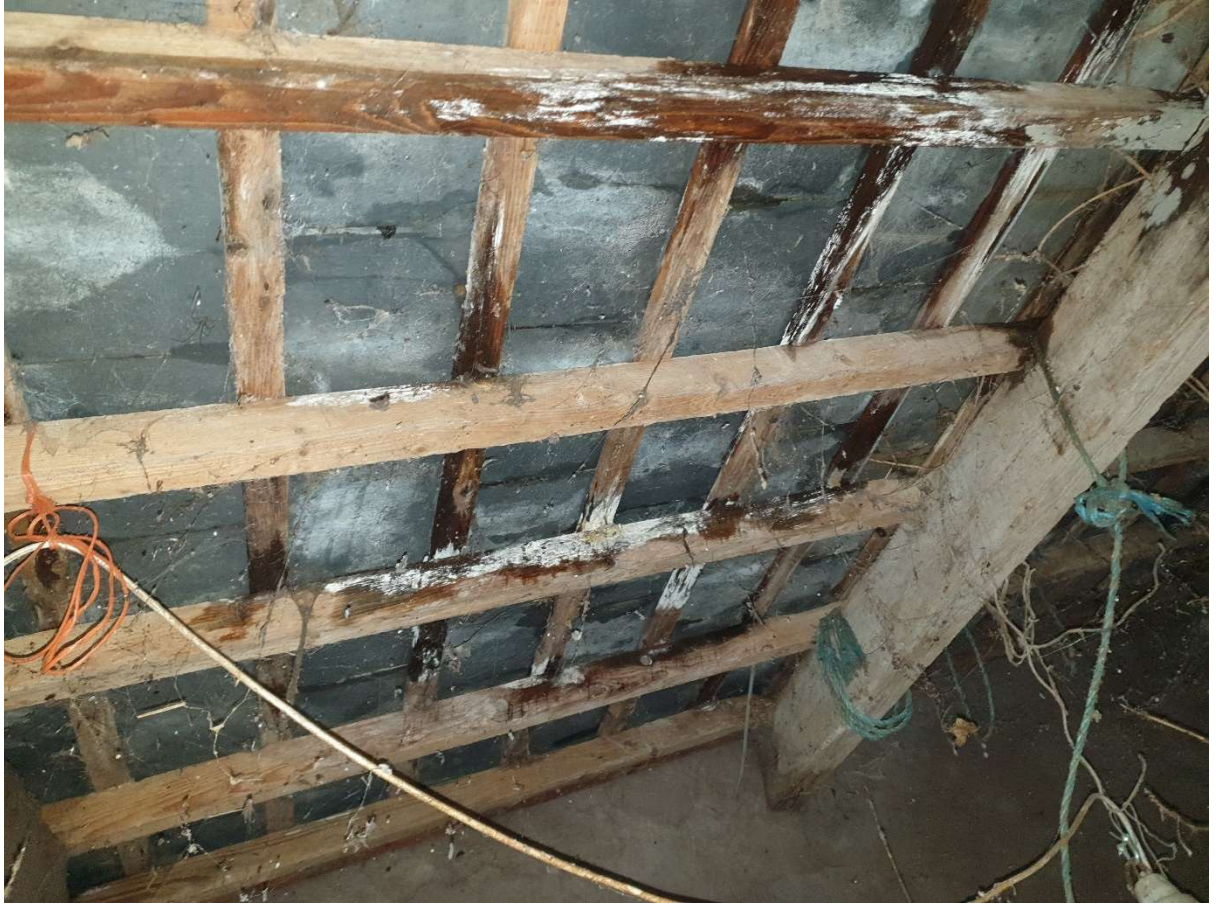
Plate 56: View of rotting and water damaged roof structure to Building C

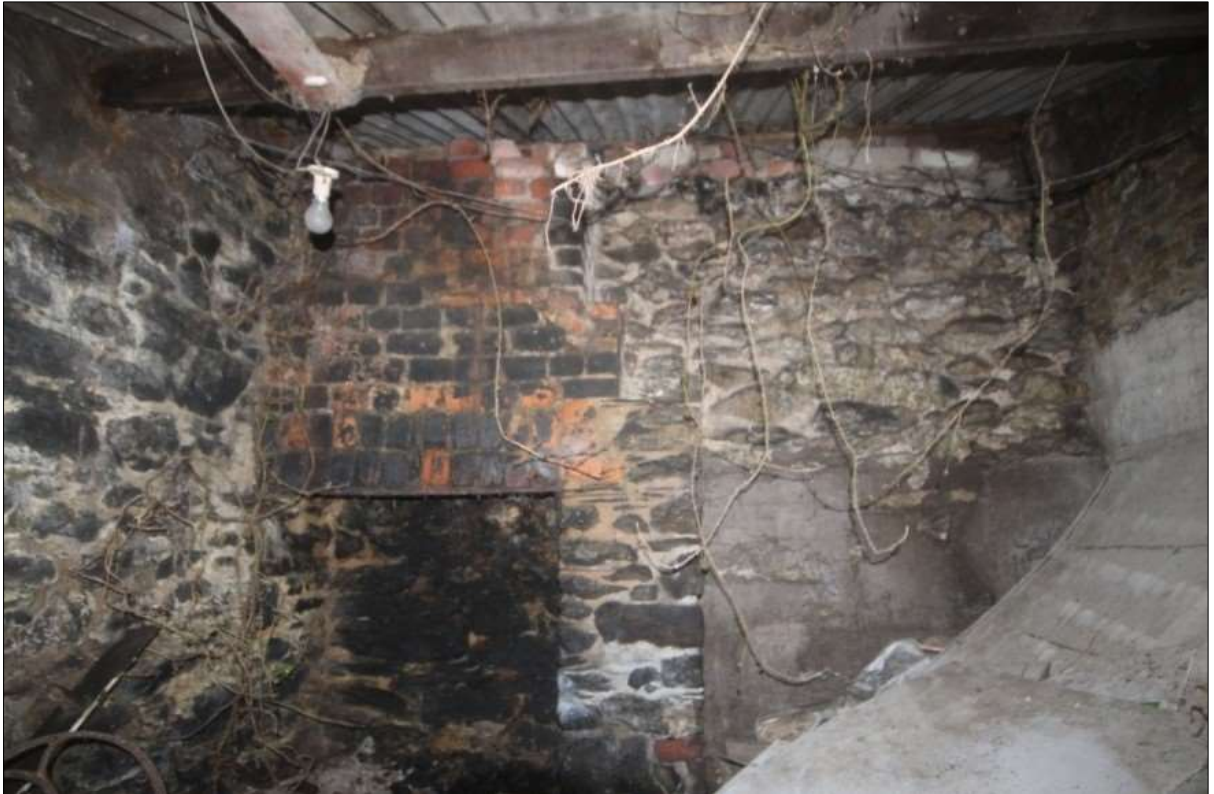
Plate 57: Fireplace in northern bay of Building C
