FLORENCE M. HURLEY

**Descriptive and photographic report**  
**on**  
**Ballynahinch Tower House**  
**and adjoining structure**  
**with mortar analysis**

**Ballynahinch,**  
**Recess,**  
**Connemara,**  
**Co. Galway**

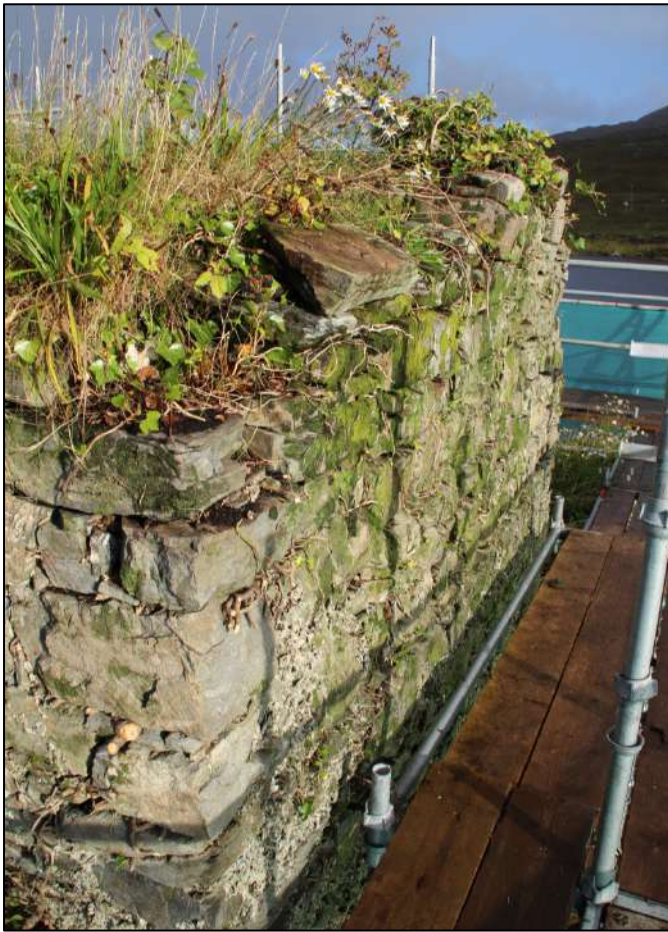
**Pl. 1** Top of tower house, eastern side.

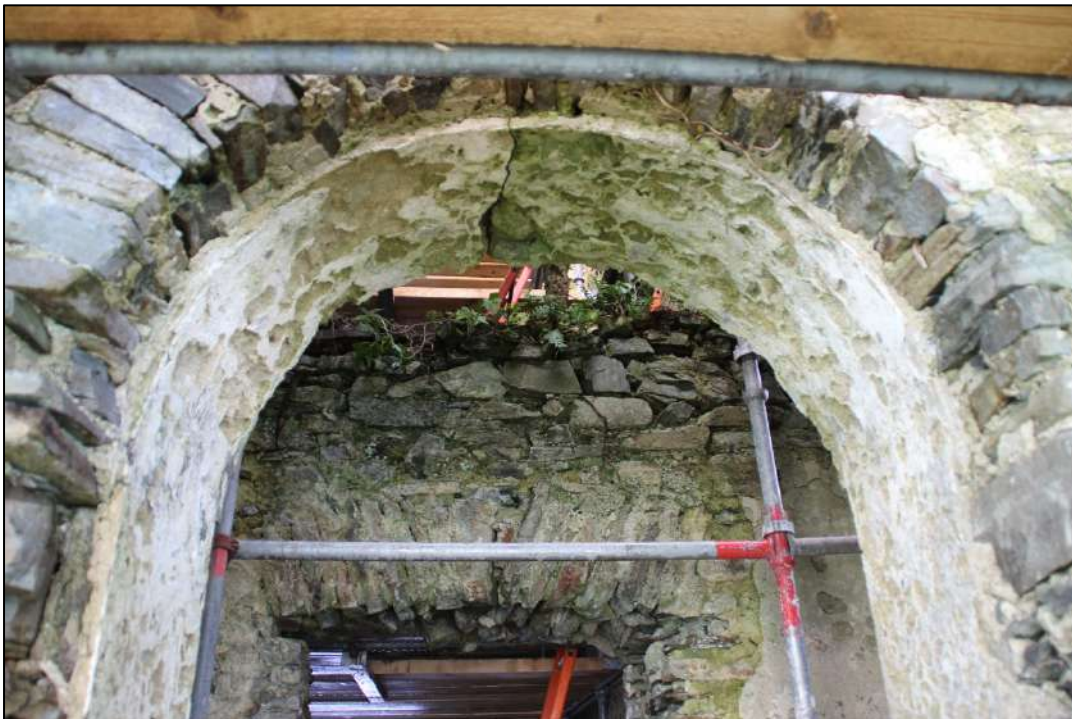
**Pl. 3** Arched top of main doorway.

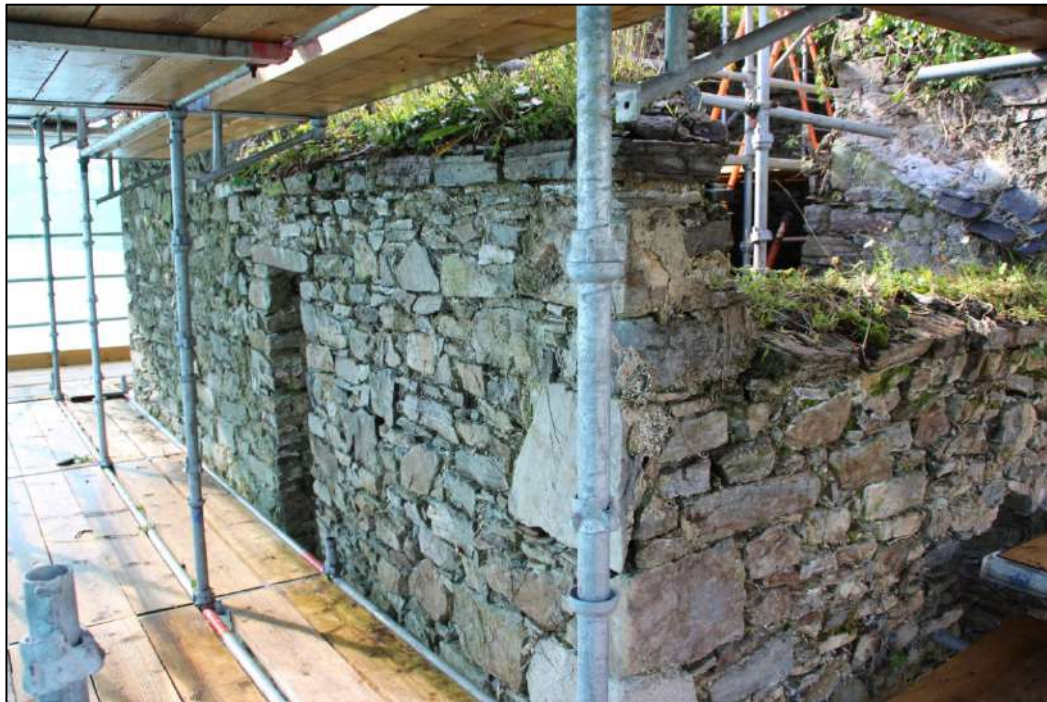
**Pl. 10** Eastern elevation, first floor level.

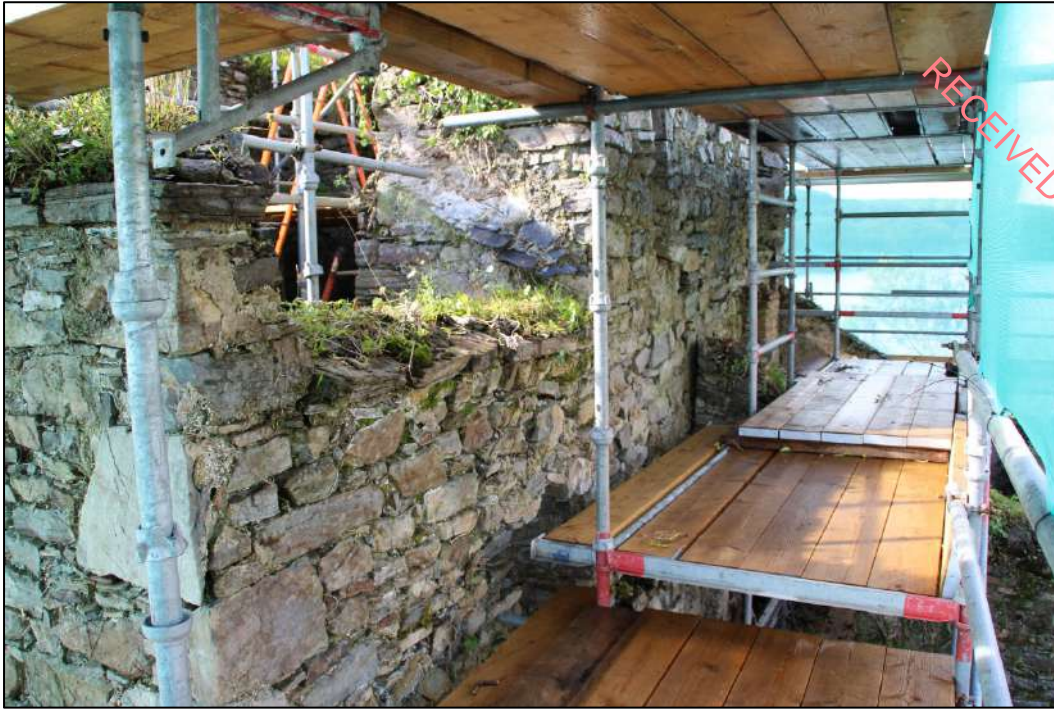
**Pl. 13** The northern face of the tower house. The masonry on the left is all from the later rebuilding. Note the cornice at the top of the walls on left and the possible roof line or weatherslating at centre.

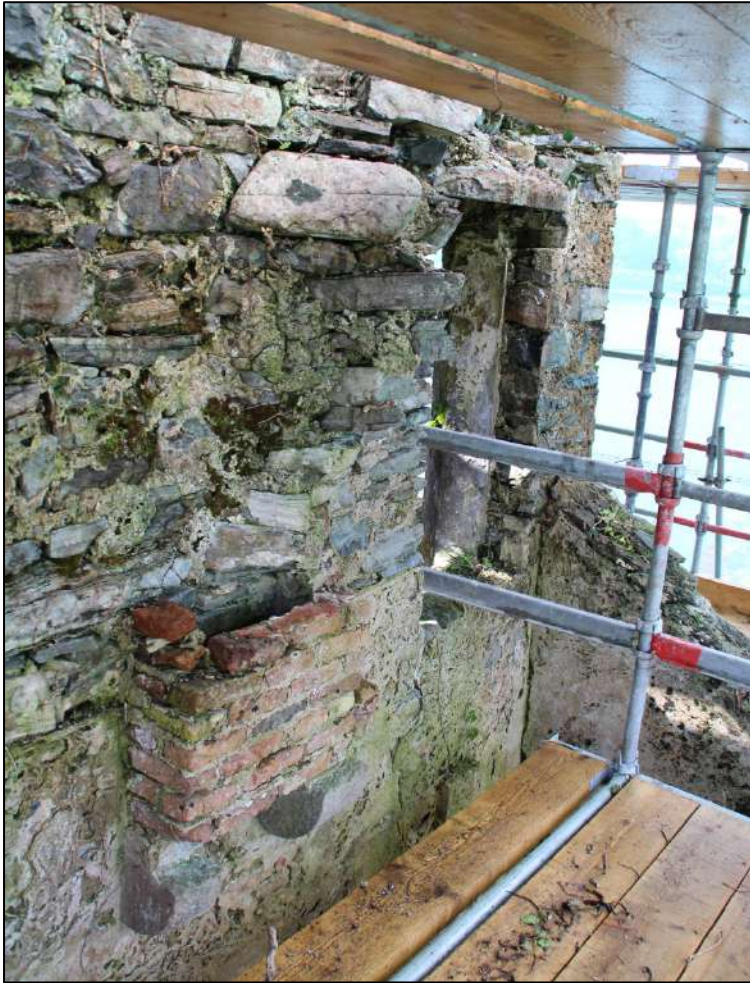
**Pl. 17** The window is one of the two in the 'oriel' chamber. Much of the elaborate stone hood has disappeared. The brick chimney-like feature rests on two corbels. It is not have any connection to a flue and is not a chimney or waste chute.

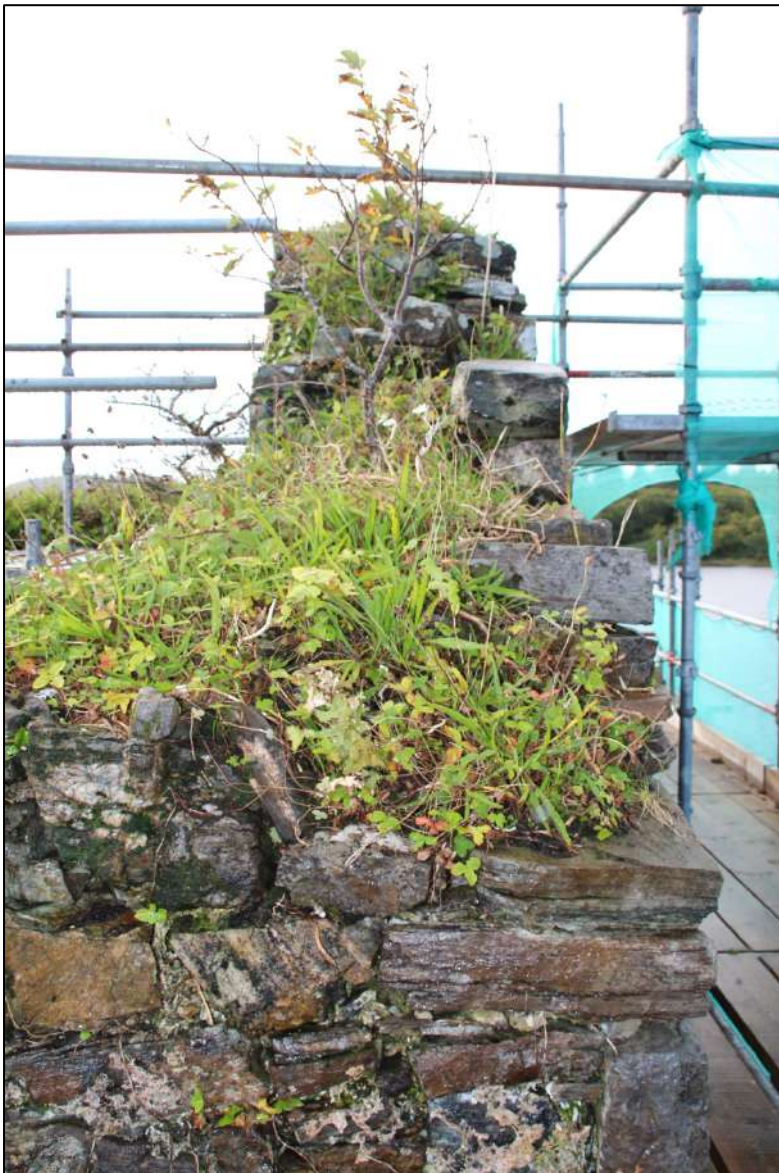
**Pl. 20** The northern side of the western gable prior to final trimming of vegetation.

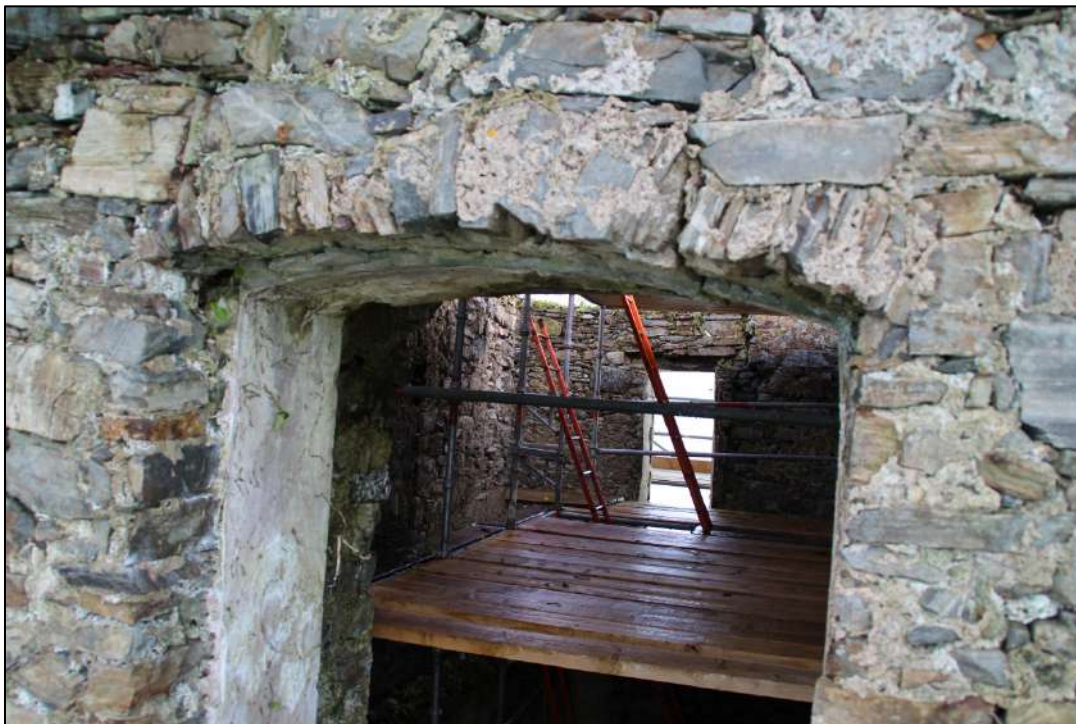
**Pl. 22** The head of the large window on the western side of the first floor. This later held a wooden sash window.

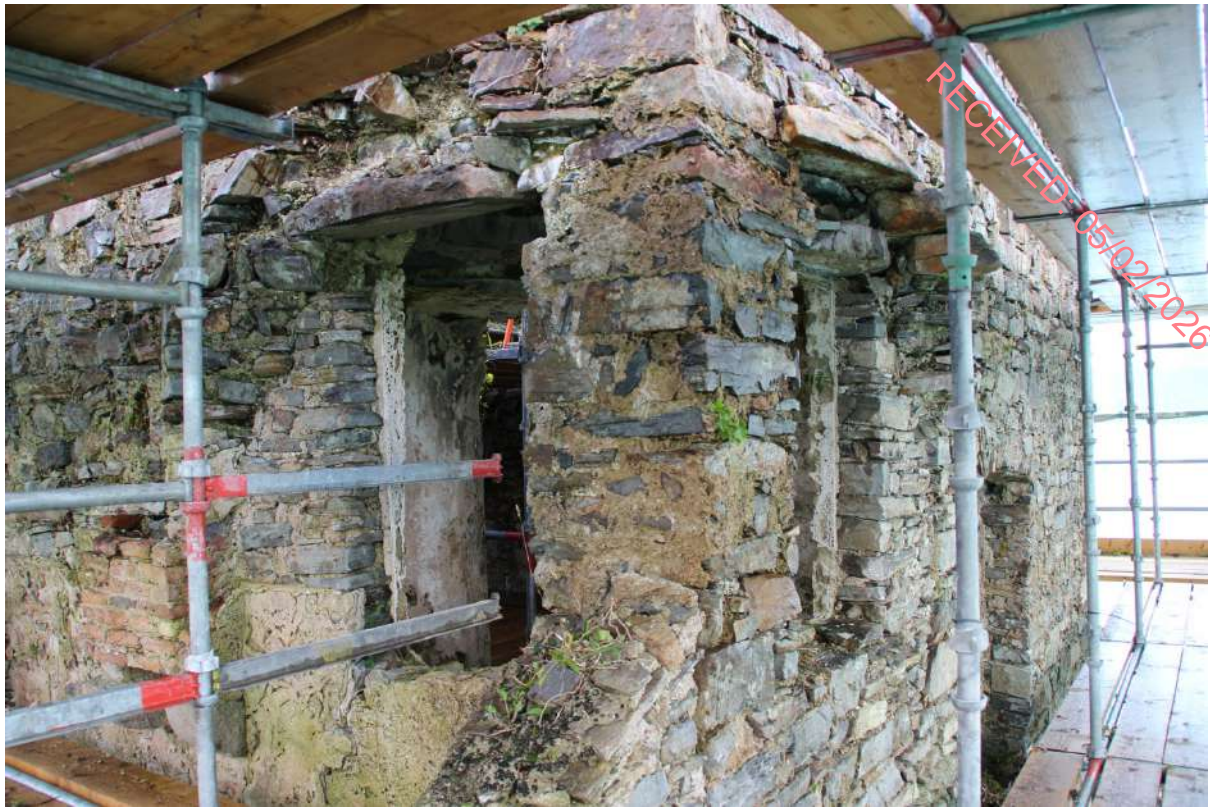
**PI. 23** The two windows in the 'oriel' chamber. When intact and viewed from a distance they would have looked imposing, giving the impression of a single larger feature.

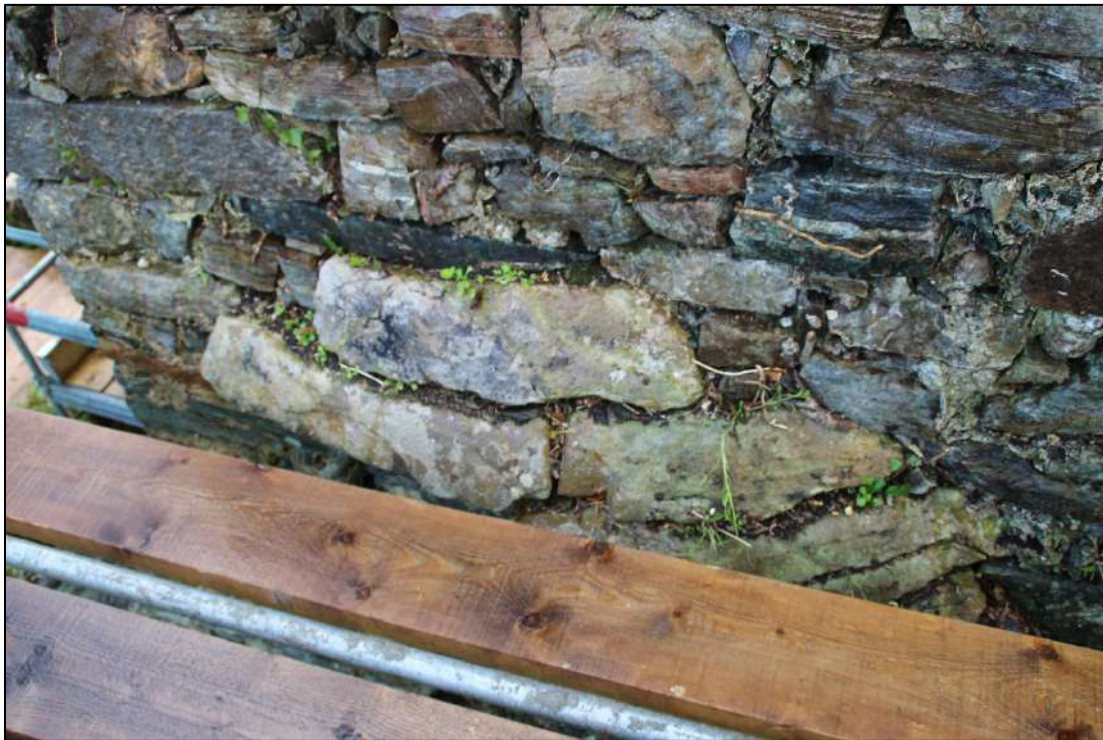
**PI. 24** The hood over the window on the north-western corner is the most intact.

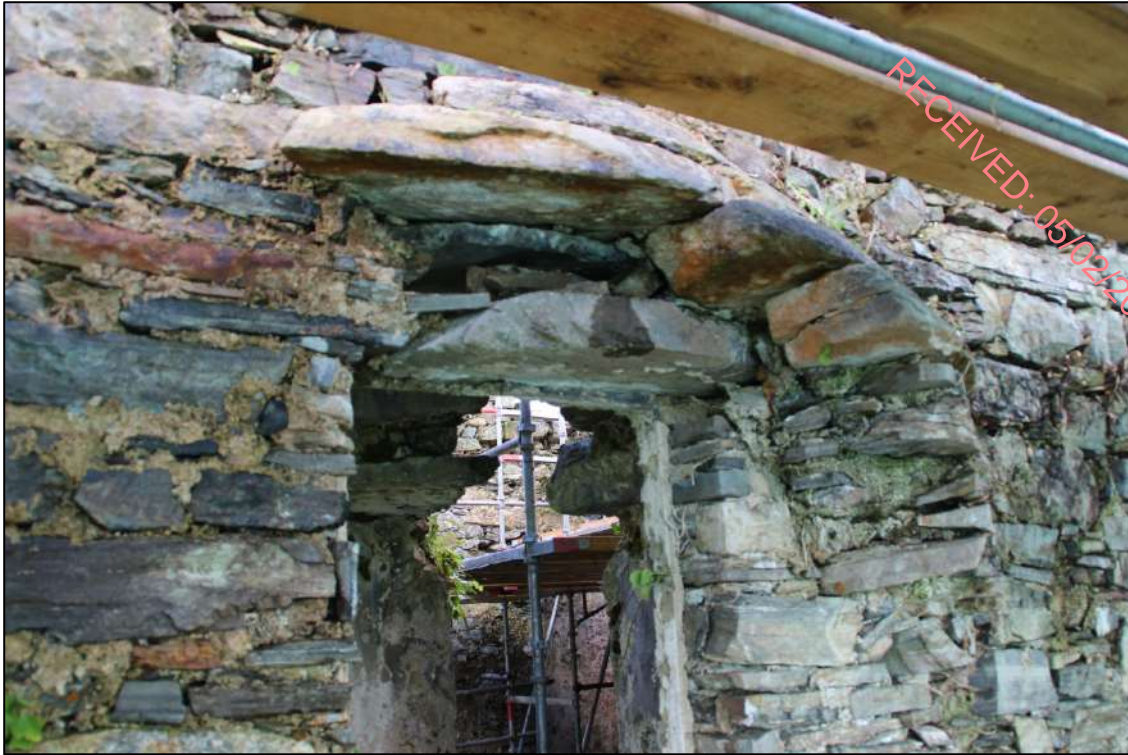
**Pl. 25** Another view of the same hood. The unusual narrowing 'tail' still survives here.

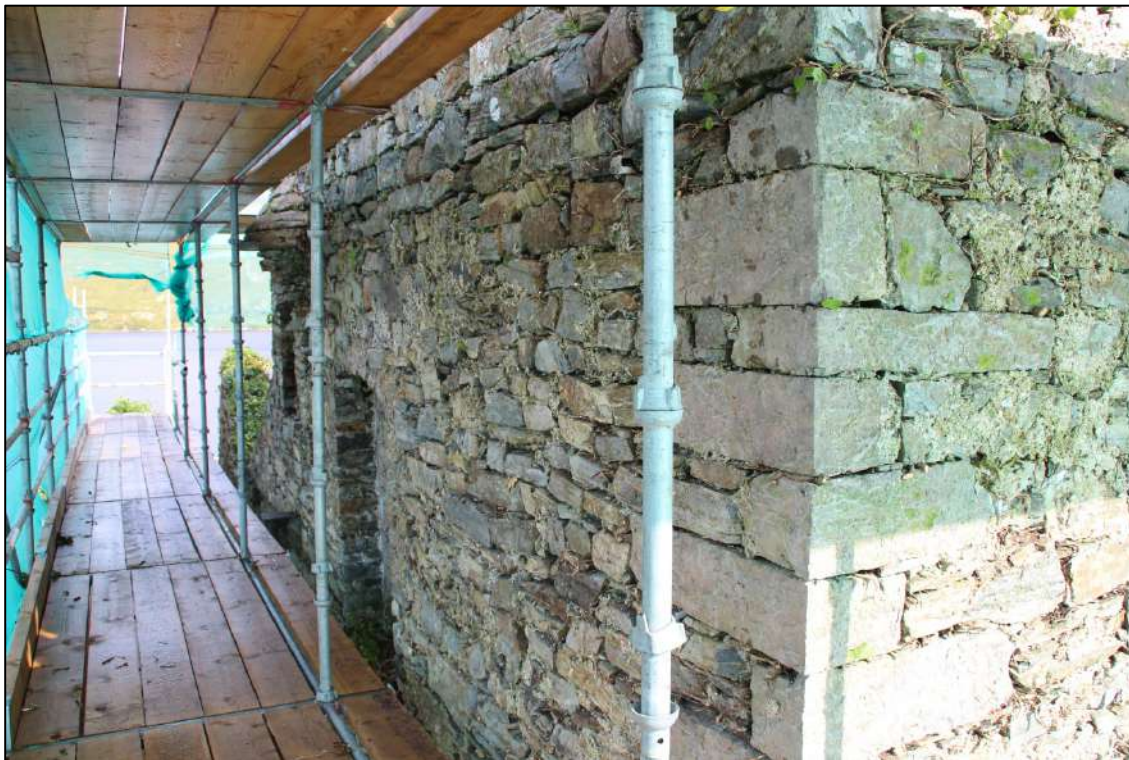
**PI. 30** The western elevation at first floor level.

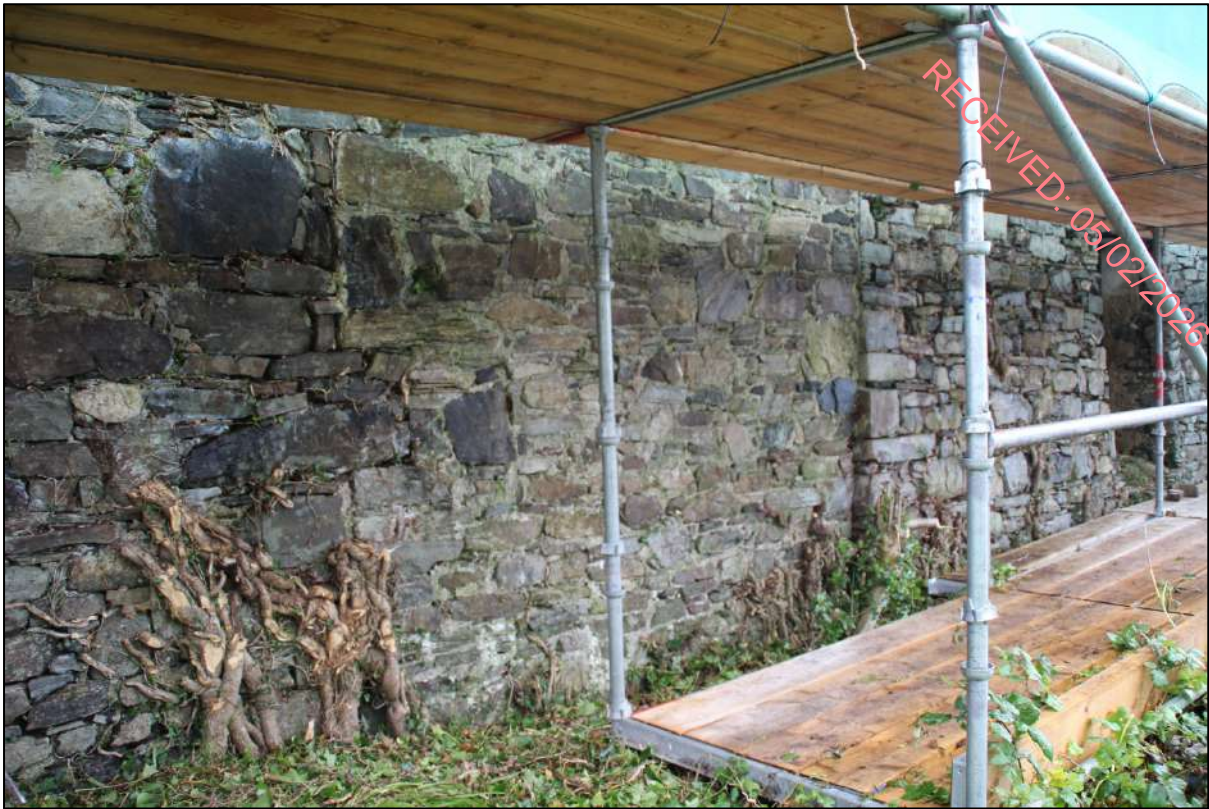
**Pl. 31** The clear difference in the masonry of the central part of the wall marks the location of the first kiln erected on the site, kiln 1. The tower house is on the right and kiln 2 on the left.

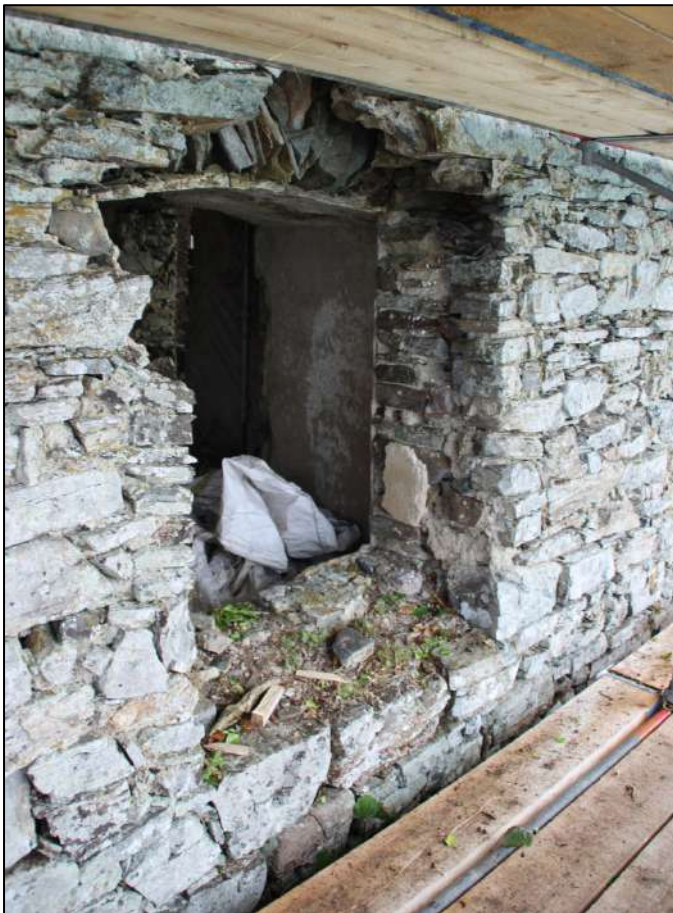
Directly below this window and just above the surface level of the water was an opening or rather where several facing stones had come loose. This was noted in previous site work but due to the presence of the scaffolding is not accessible and was not recorded in this survey. A base batter is present on this side as well as on the eastern and western sides.

**Pl. 32** This is the ground floor window on the southern side of the tower house. The collapse of the masonry head has resulted in a small hole appearing in the floor of the garderobe passageway.

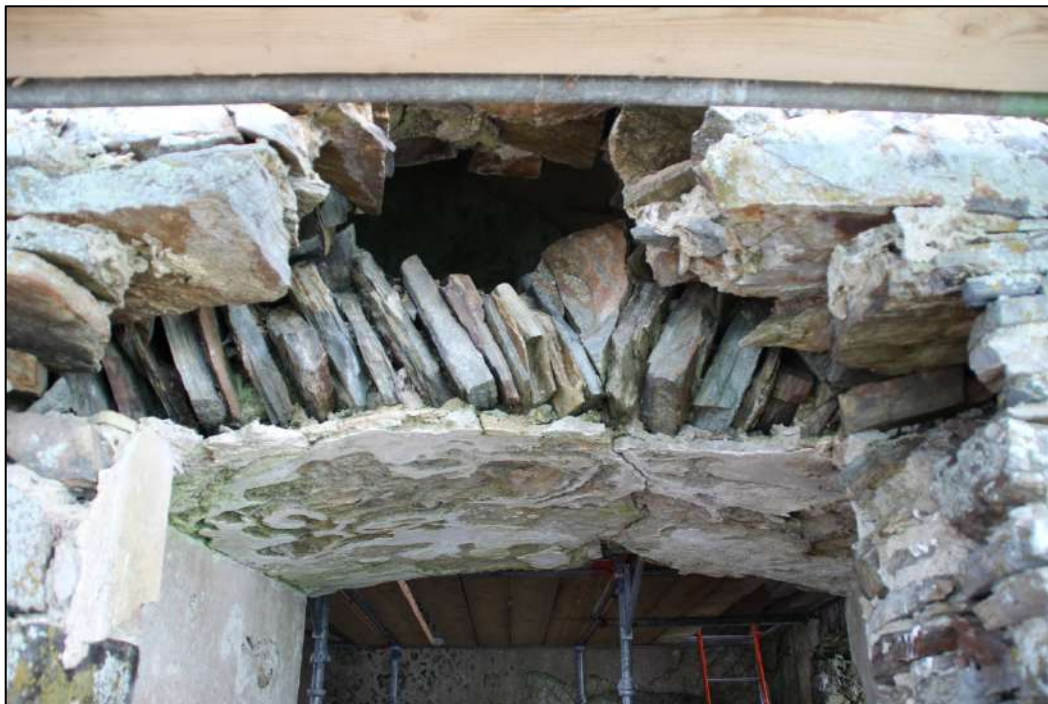
**Pl. 34** The hole over the window head. Very little mortar is present.

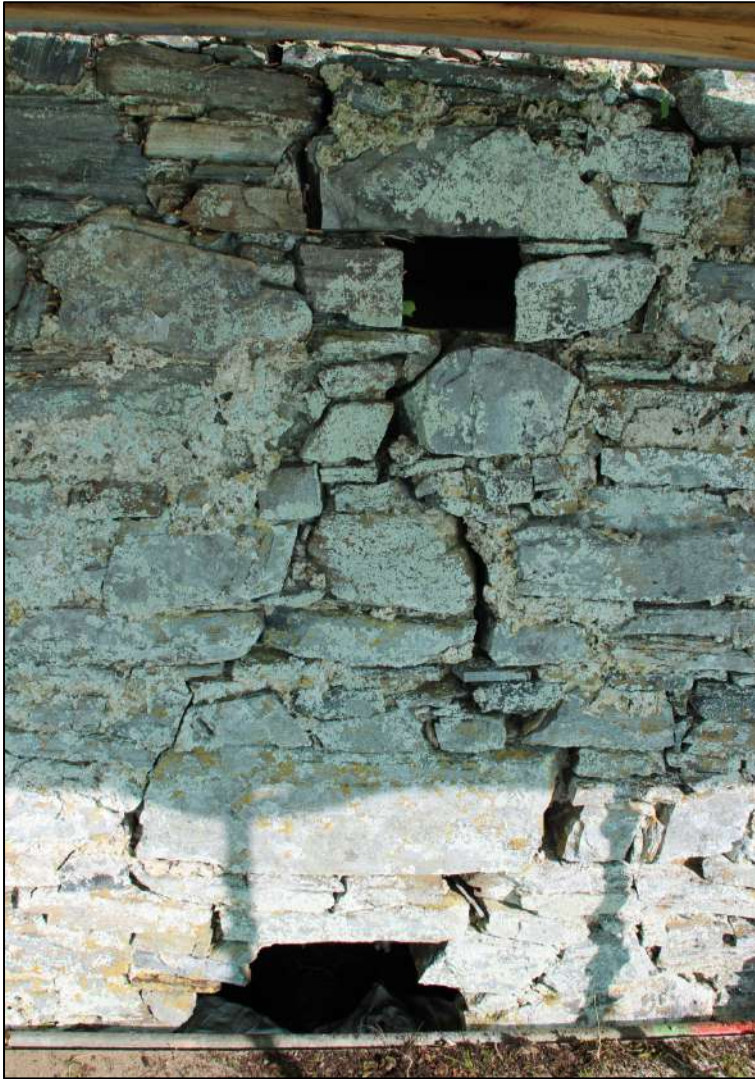
**Pl. 37** The lower opening is where the masonry over the window head has collapsed. The small opening at the higher level is the window in the garderobe passageway. Note the cracks.

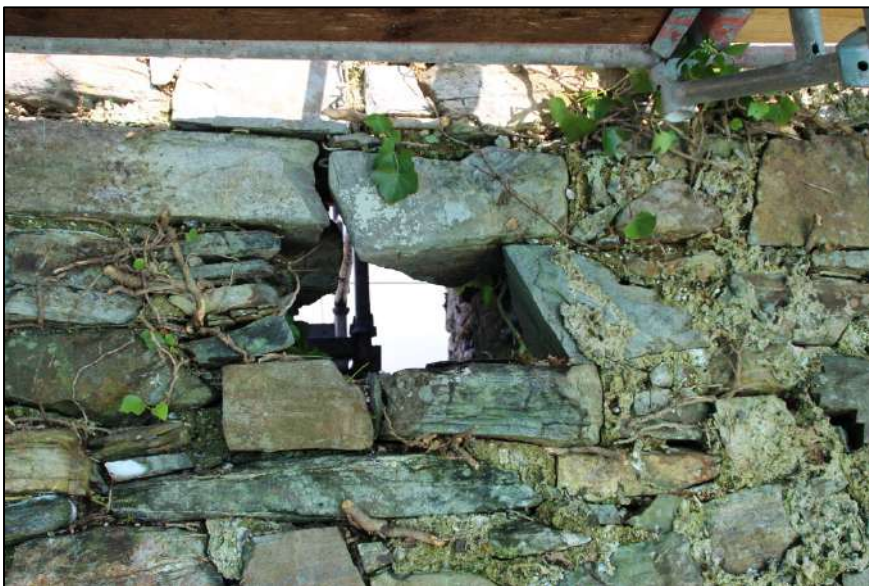
**Pl. 38** This irregular opening belongs to a rectangular window high on the stairwell. It is larger internally.

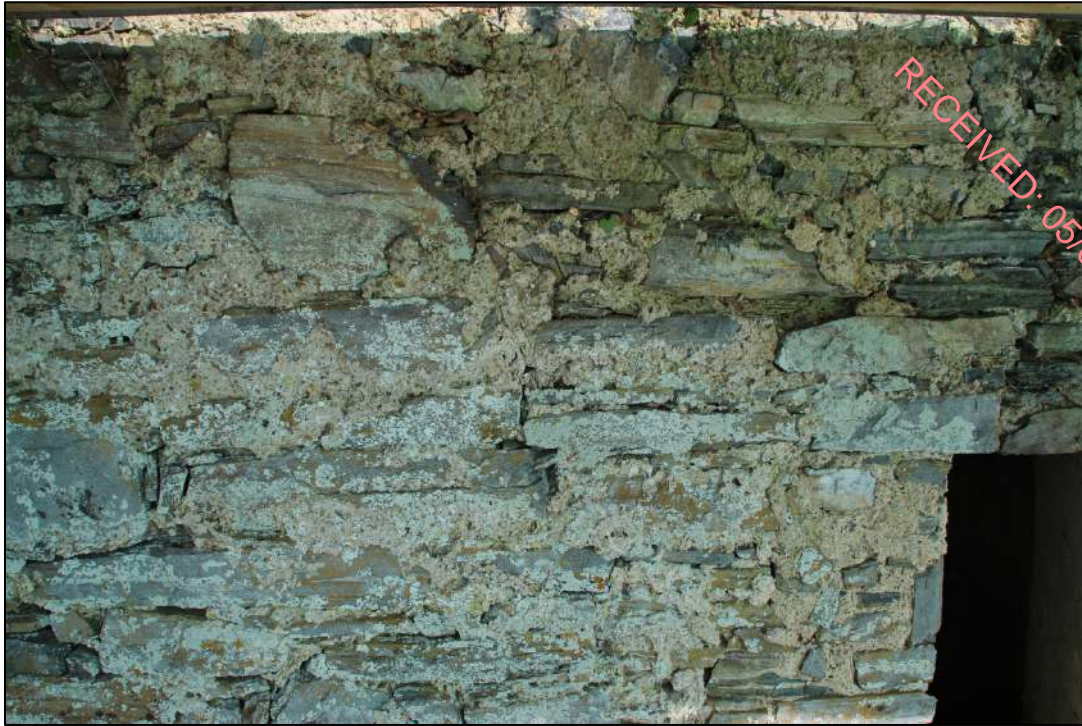
**Pl. 41** Remnants of the mortar finish by the stairs window, southern elevation.

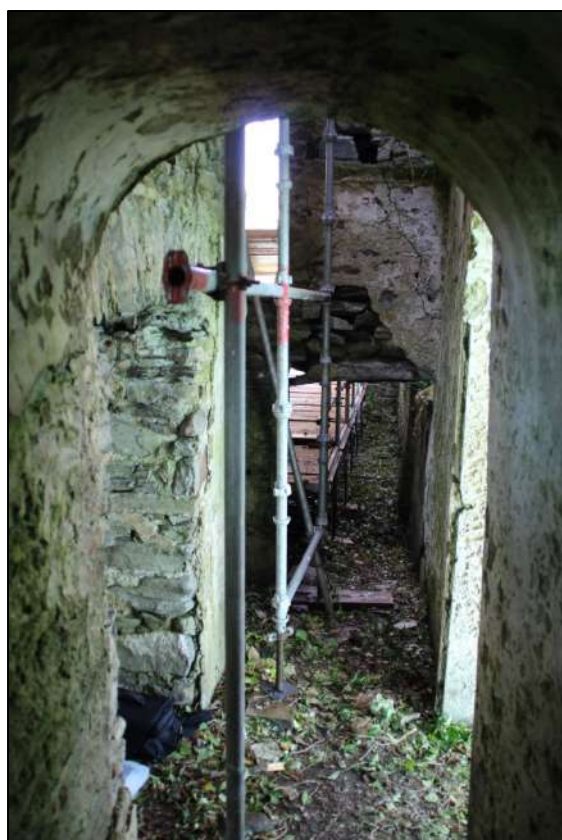
**Pl. 43** The entrance lobby looking northwards.

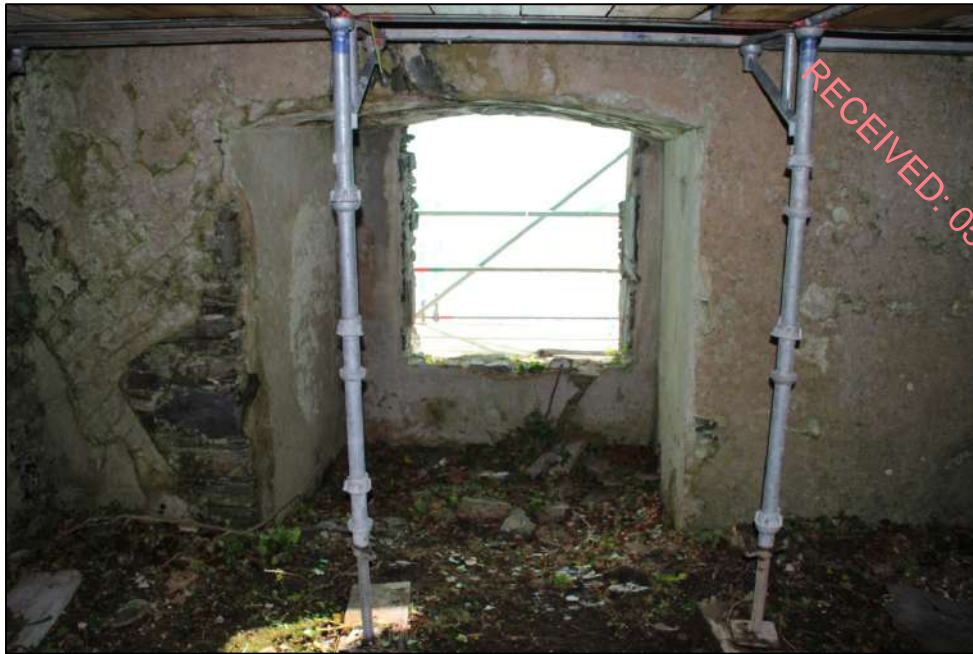
**Pl. 48** The interior of the southern window embrasure, ground floor.

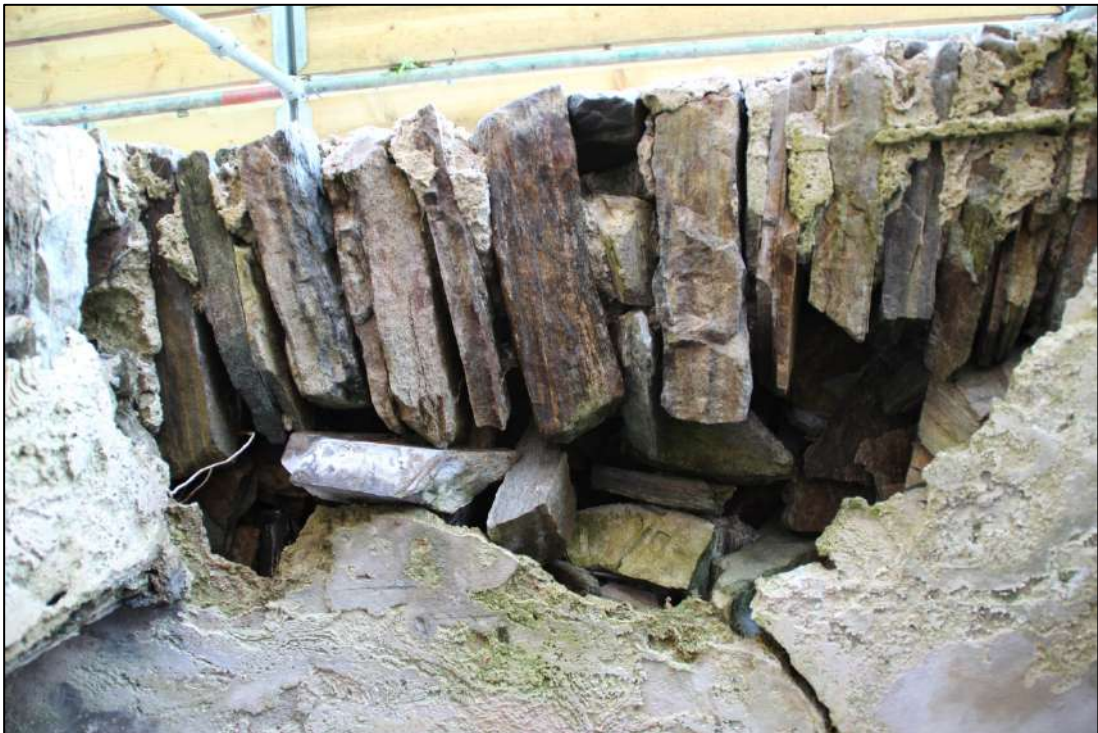
**Pl. 49** The underside of the window head, western window, ground floor. This has lost much of its mortar bonding.

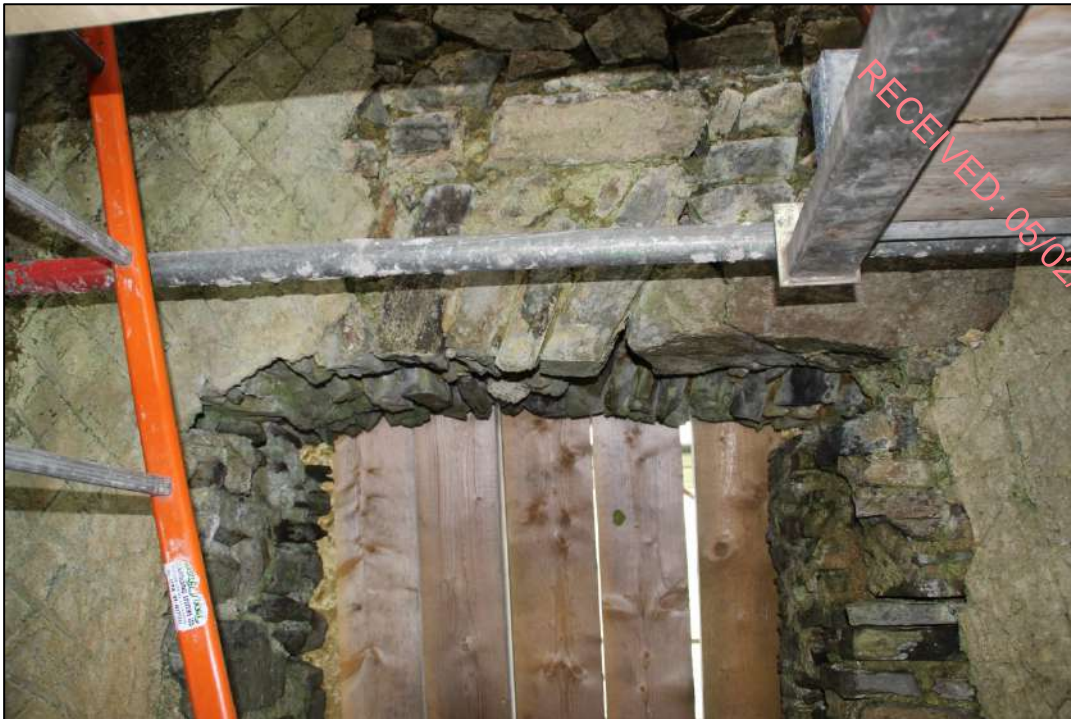
**Pl. 50** The doorway leading to the entrance lobby from the main chamber of the ground floor.

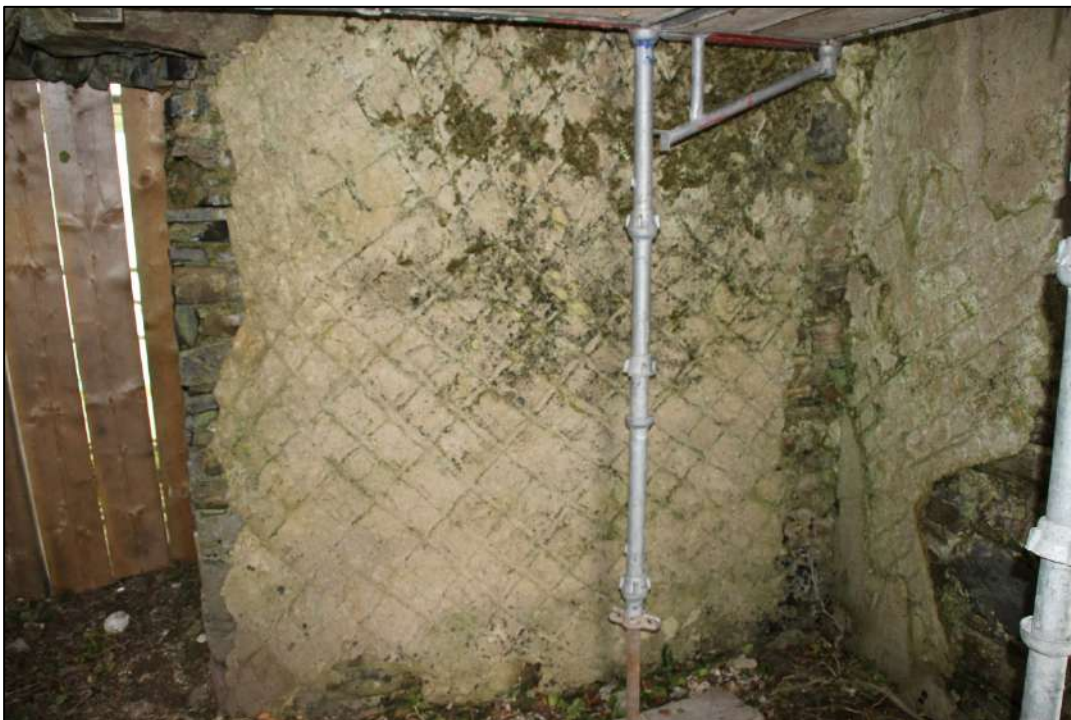
**Pl. 51** Much of the plaster coat has fallen off the eastern and southern walls of the main room of the ground floor revealing a prominent scratch coat.

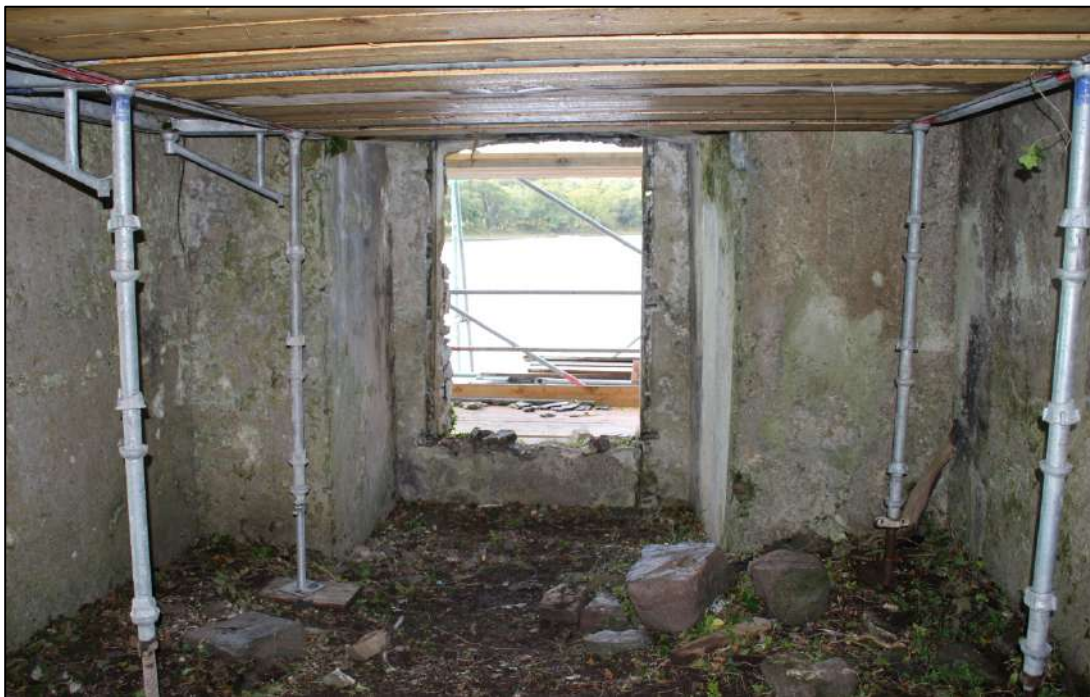
**Pl. 53** The western window embrasure. Impressions of the wickerwork centring for the head of the embrasure survives in each upper corner.

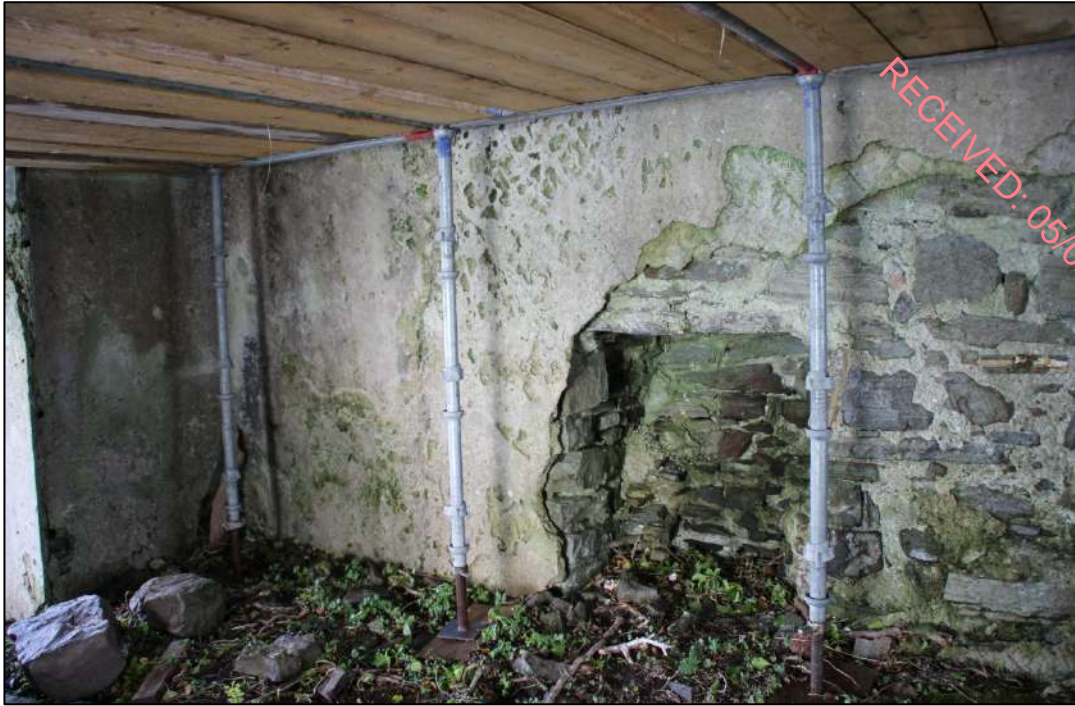
**Pl. 56** The fireplace in the northern wall of the main chamber of the tower house.

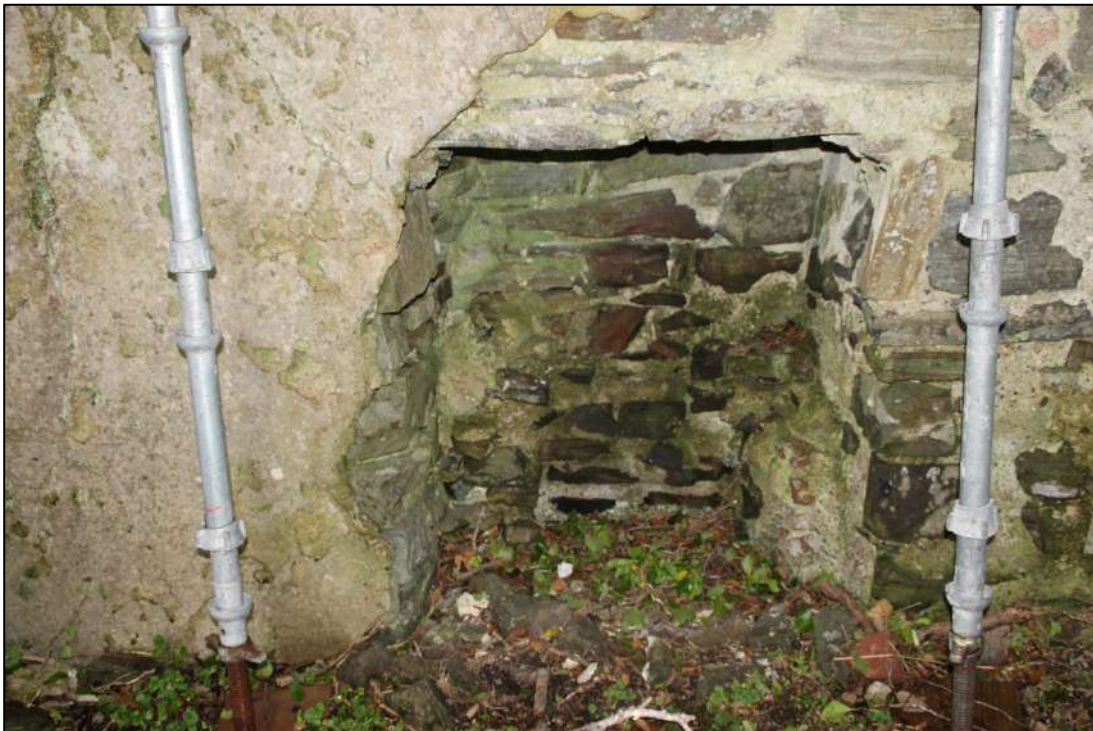
**Pl. 57** Close up of the fireplace. Note the two voussoirs of the arch that spanned the feature.

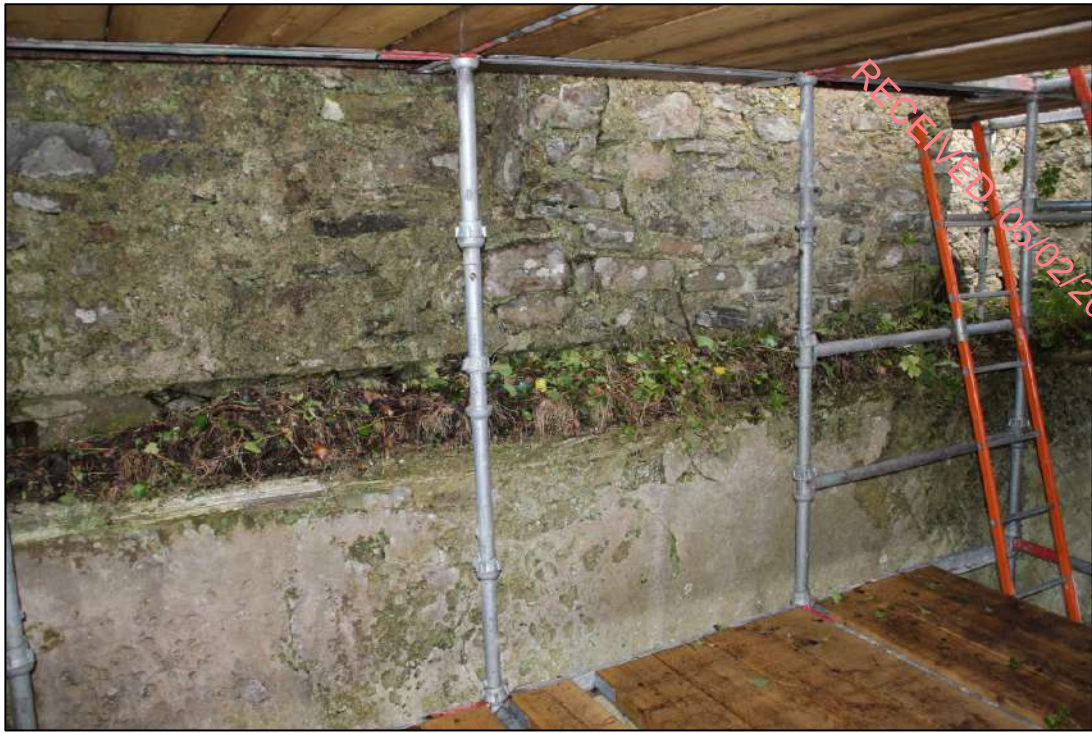
**Pl. 58** The ceiling level is marked by the lower edge of the band crossing the centre of the photograph. This is where a shallow lip held the joists of the floor. A small part of the decorative moulding can be seen on the left. It has collapsed in the middle and right of the picture.

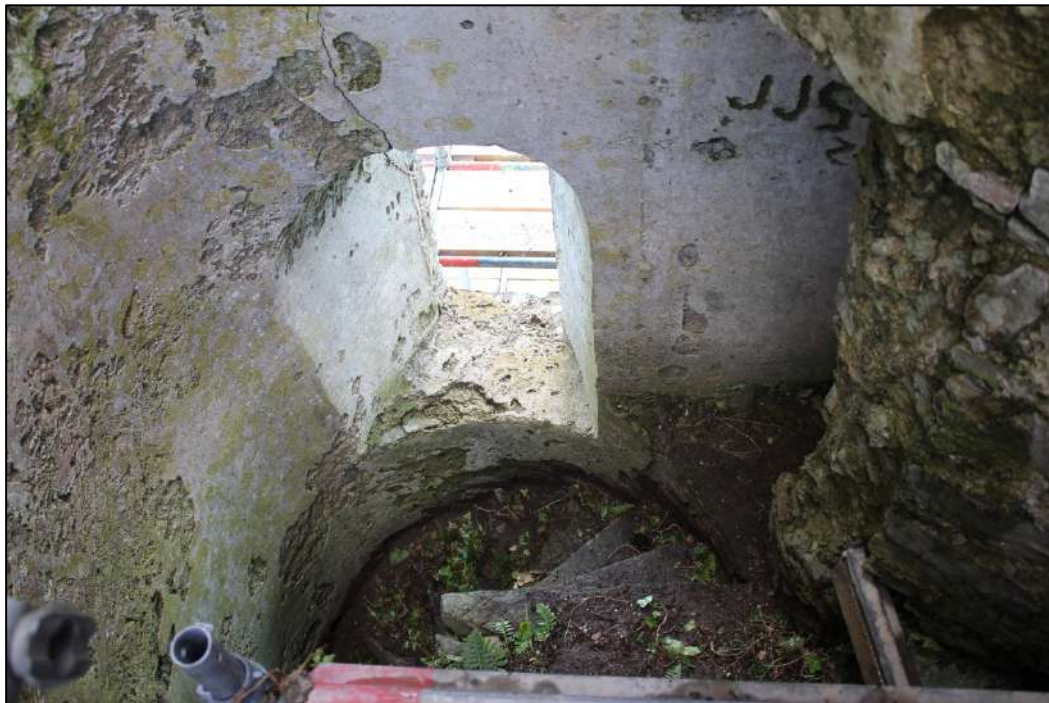
**Pl. 61** View of the stairs, the splayed window opening, the garderobe passageway (on centre right) and the entrance to the main room of the first floor (on lower right).

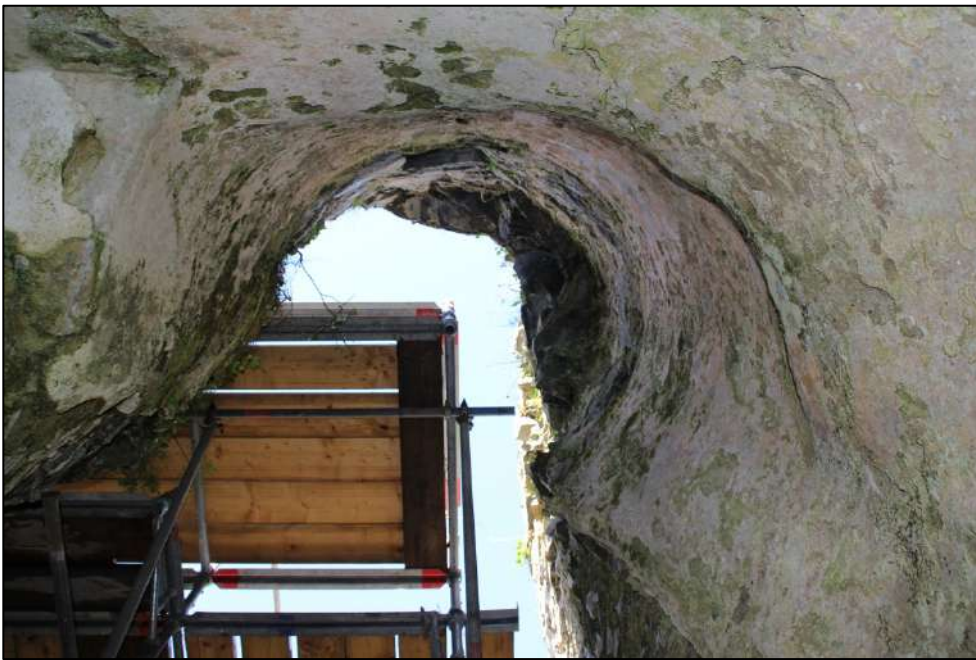
**Pl. 63** Looking upwards at the stairwell from the highest remaining steps. It is likely that more were originally present, either in stone or wood. Note the good condition of the plaster finish.

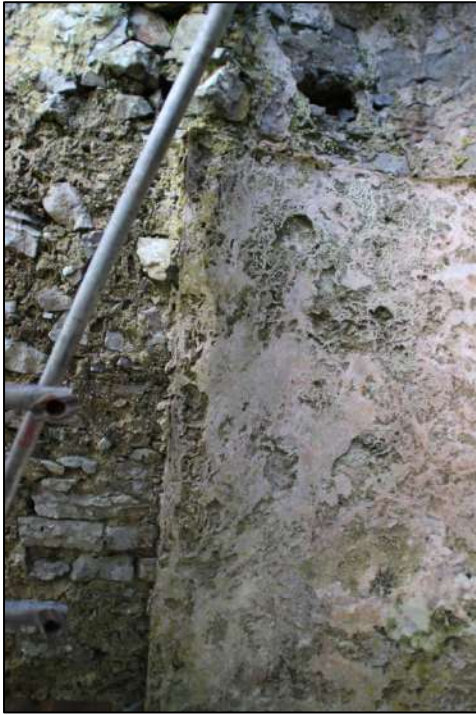
**Pl. 64** The clear division between the plastered stairwell and the first floor lobby on the left. The lobby may have had some form of panelling as a wall covering.
