FLORENCE M. HURLEY

**Descriptive and photographic report**  
**on**  
**Ballynahinch Tower House**  
**and adjoining structure**  
**with mortar analysis**

**Ballynahinch,**  
**Recess,**  
**Connemara,**  
**Co. Galway**

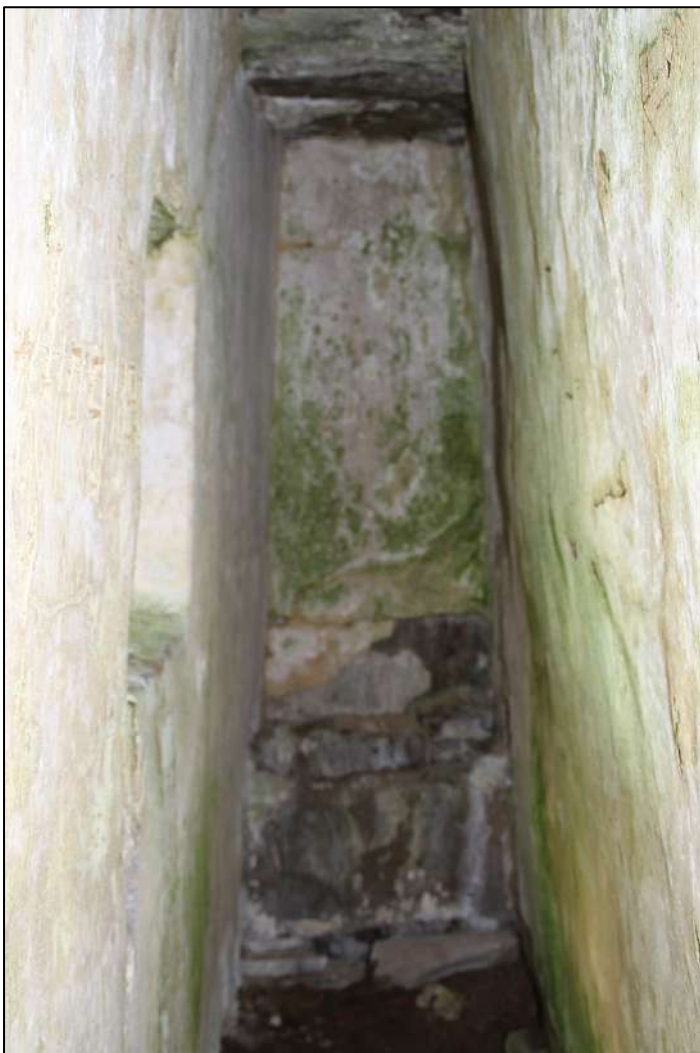
**Pl. 68** The latrine.

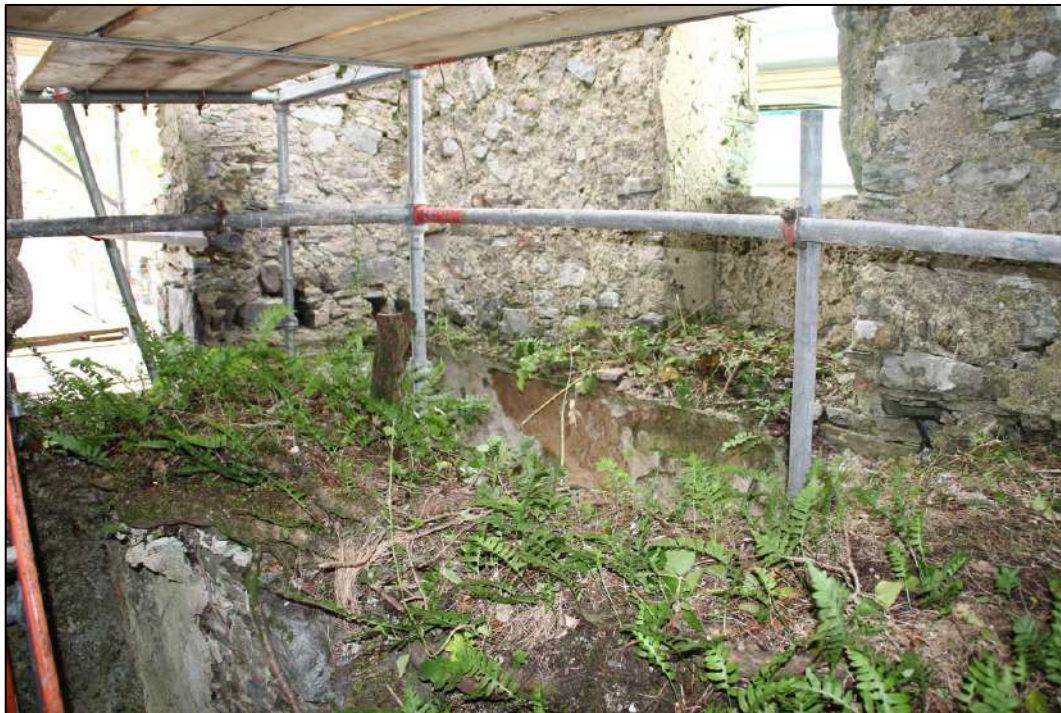
**Pl. 73** The location of the first floor lobby. It is presumed that there was some form of partition separating this from the main room at this level.

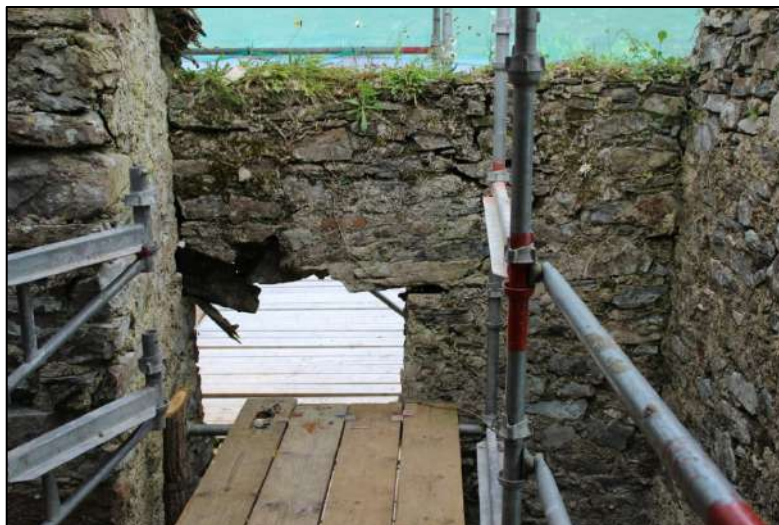
**Pl. 78** The wall forming the north-east corner, a later construction now in poor repair

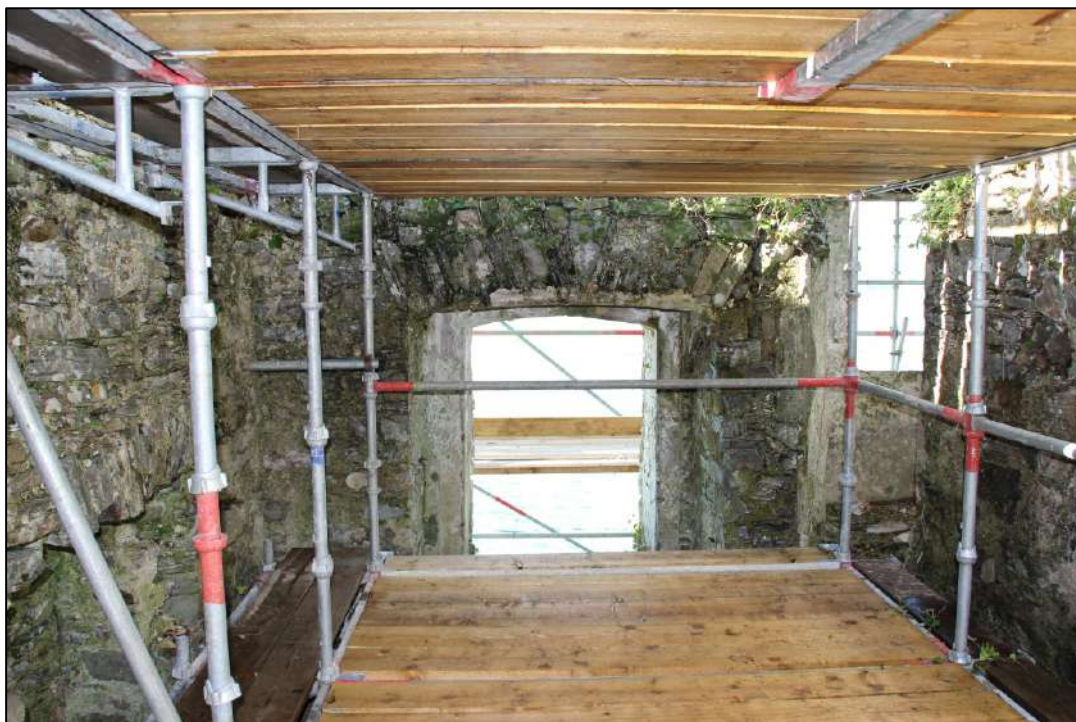
**PI. 79** The first floor chamber looking west. Note the 'oriel' chamber on right.

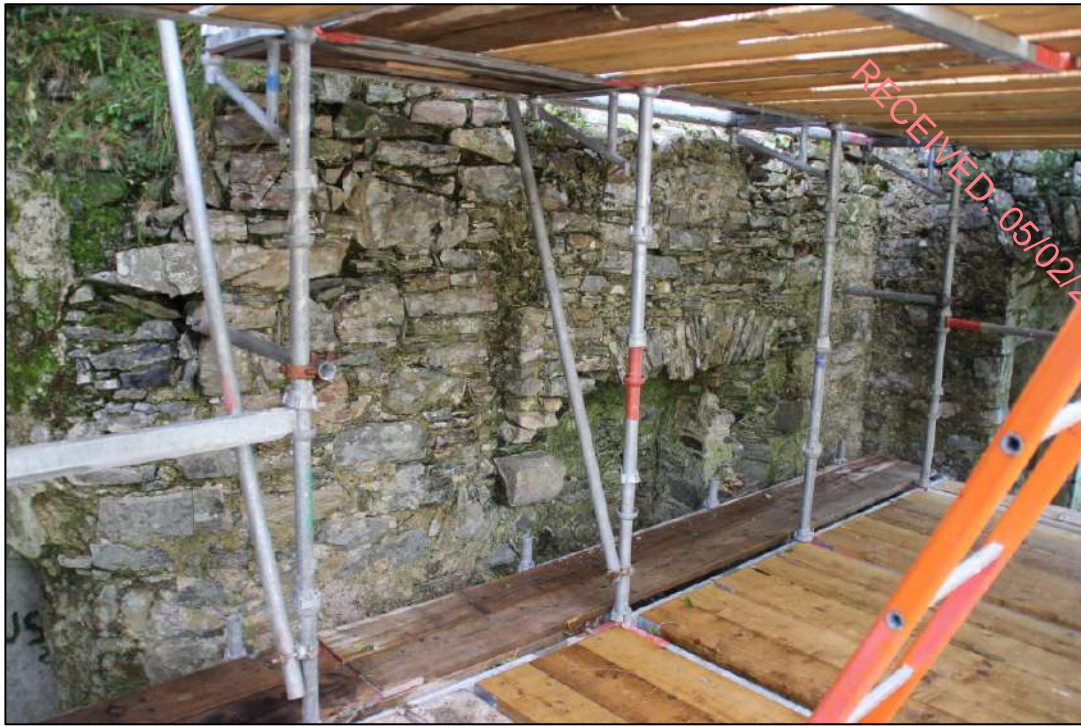
**Pl. 80** The southern wall of the first floor.

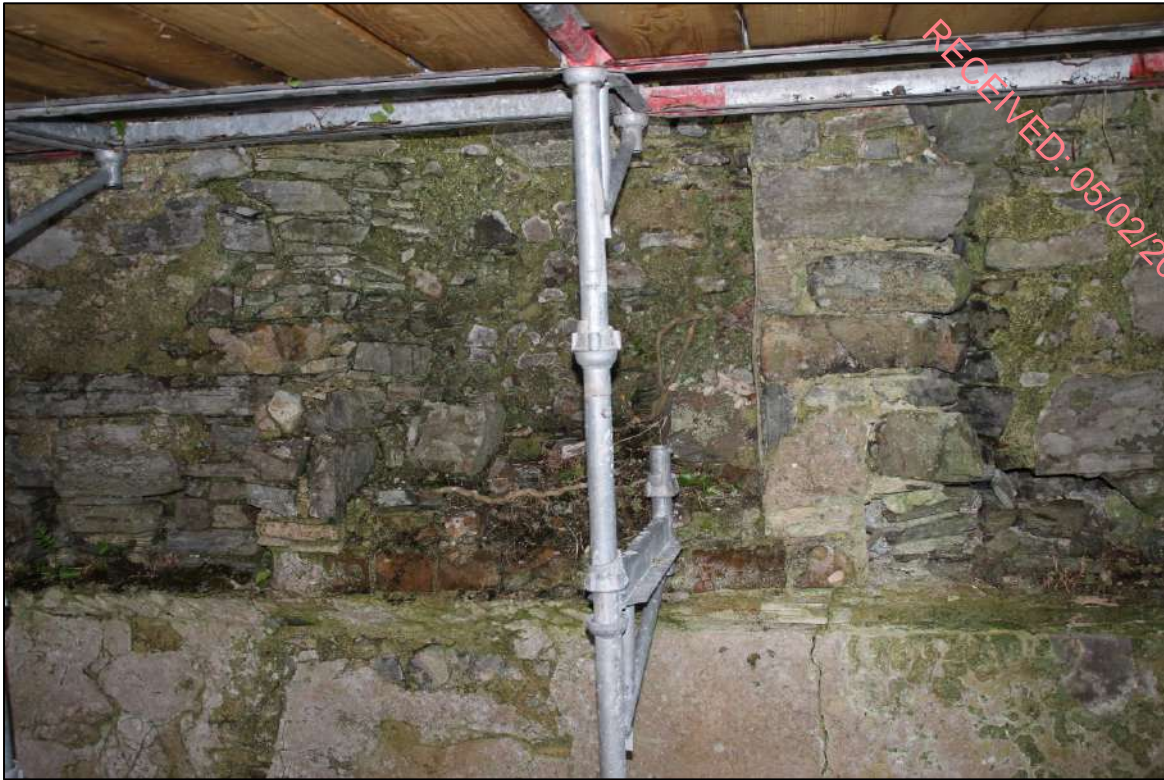
**Pl. 82** Base of fireplace. Note the bricks in the base of the hearth.

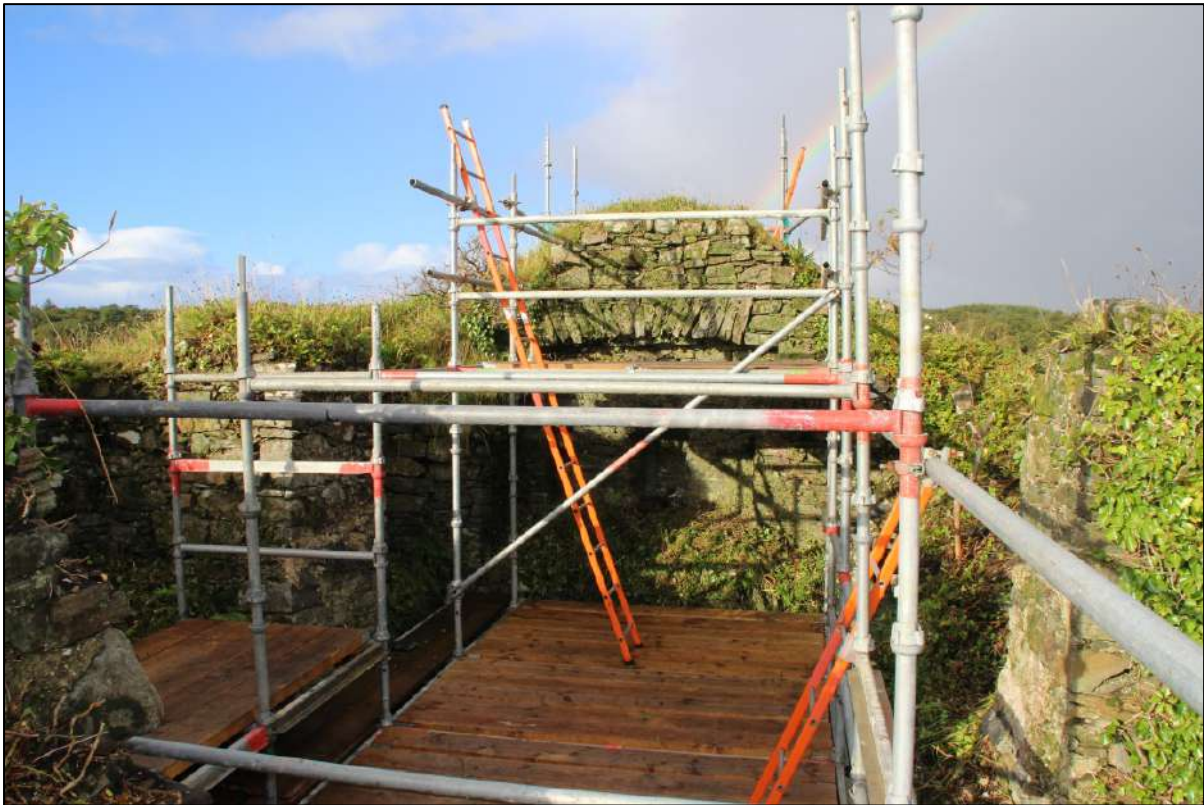
**Pl. 95** The second floor of the tower house looking west.

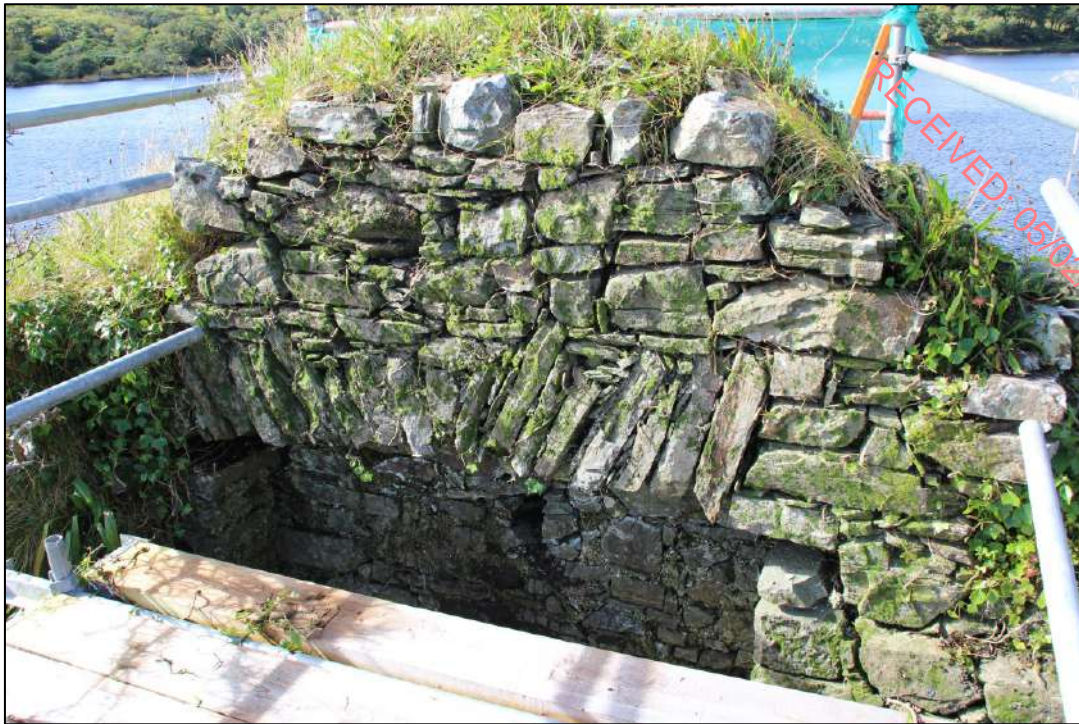
**Pl. 96** The upper part of the western gable showing the flat-headed arch over the window embrasure. A timber lintel supported the arch.

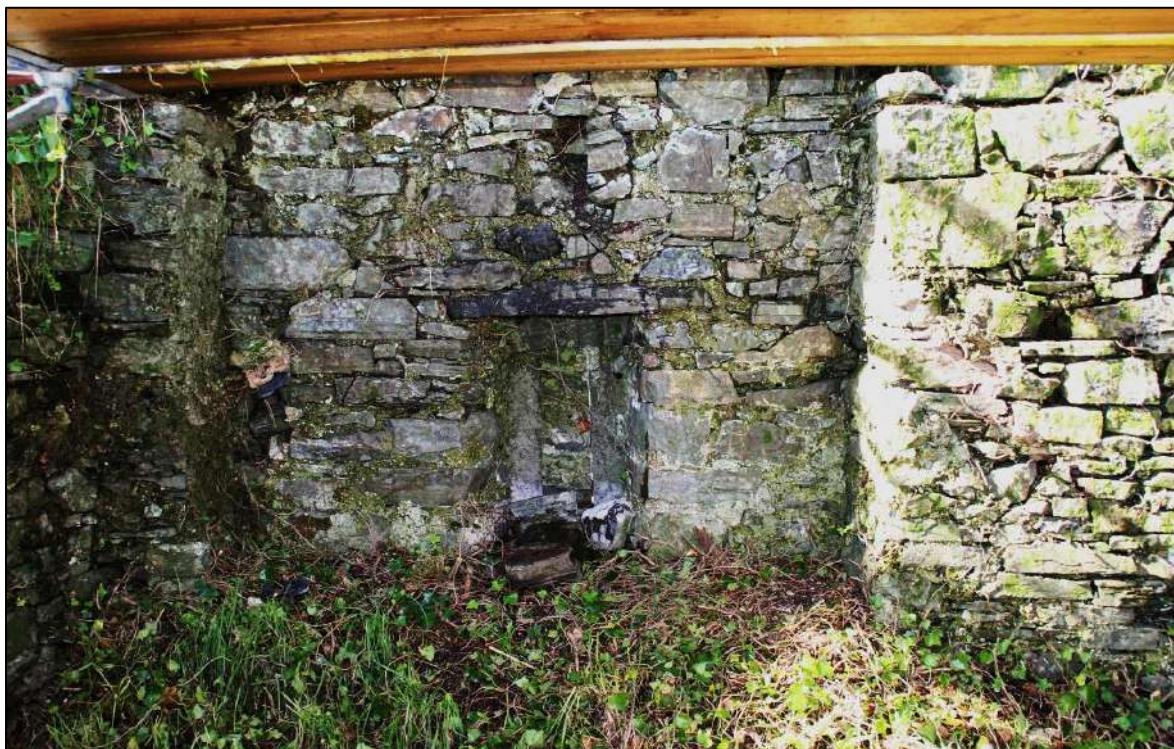
**Pl. 97** The window embrasure on the western wall of the second floor. The window ope is blocked. There is a slot for a timber just above the window. Slight traces of a plaster scar are present on the northern (right hand) side of the embrasure. This extends from the slot downwards towards the inside of the northern and southern walls. It is very intermittent.

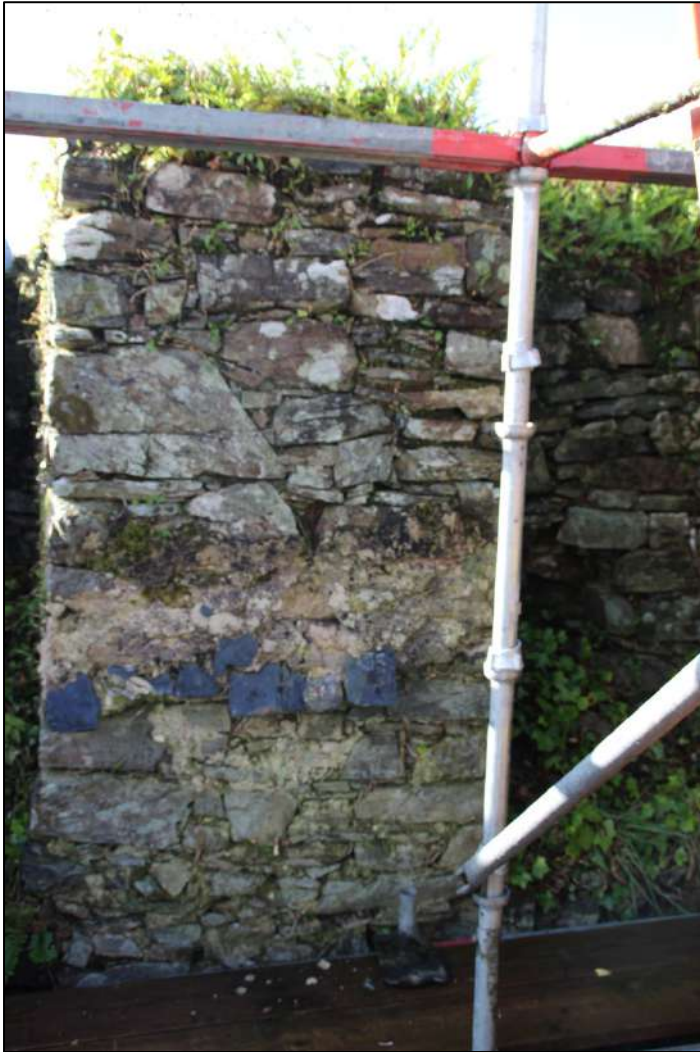
**Pl. 98** The chimney breast on the southern wall of the second floor. Visible is a line of slates bonded to the chimney with mortar. These are laid sloping towards the interior. Note the different weathering above and below the slates.

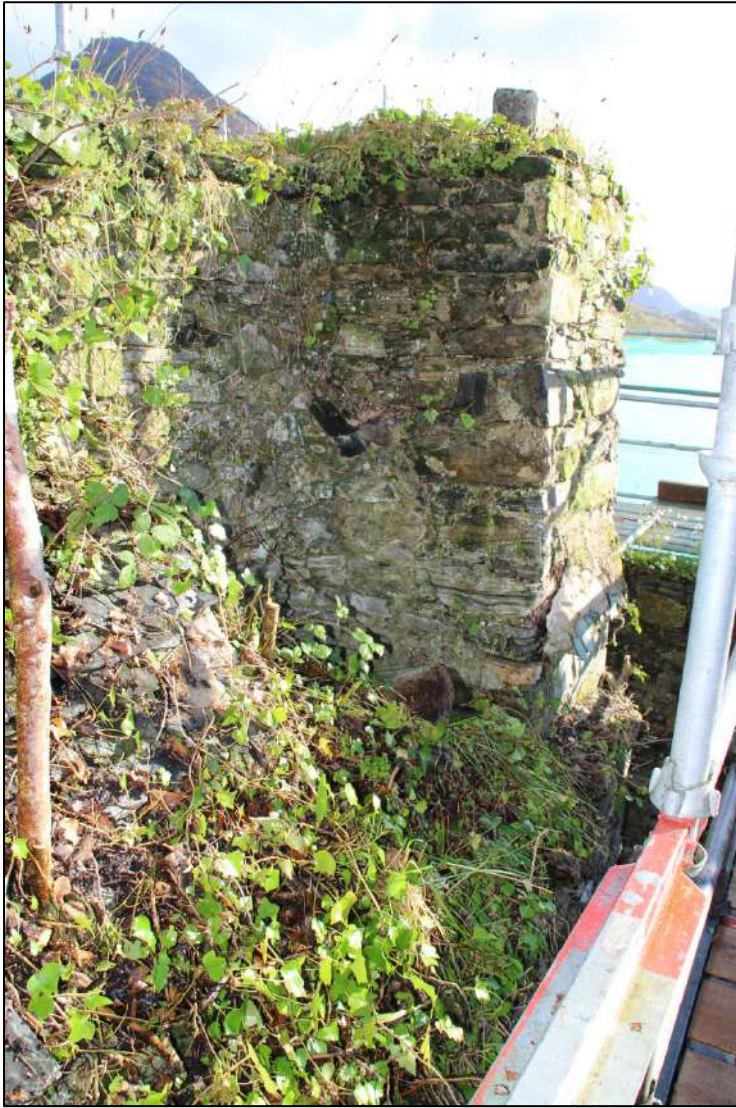
**Pl. 99** The chimney breast on the northern side of the second floor. This too has a line of slates (on centre right of photograph) laid in the same manner as those on the southern chimney breast. Visible in the left foreground is part of the large weatherslated panel on the north-western corner of this level.

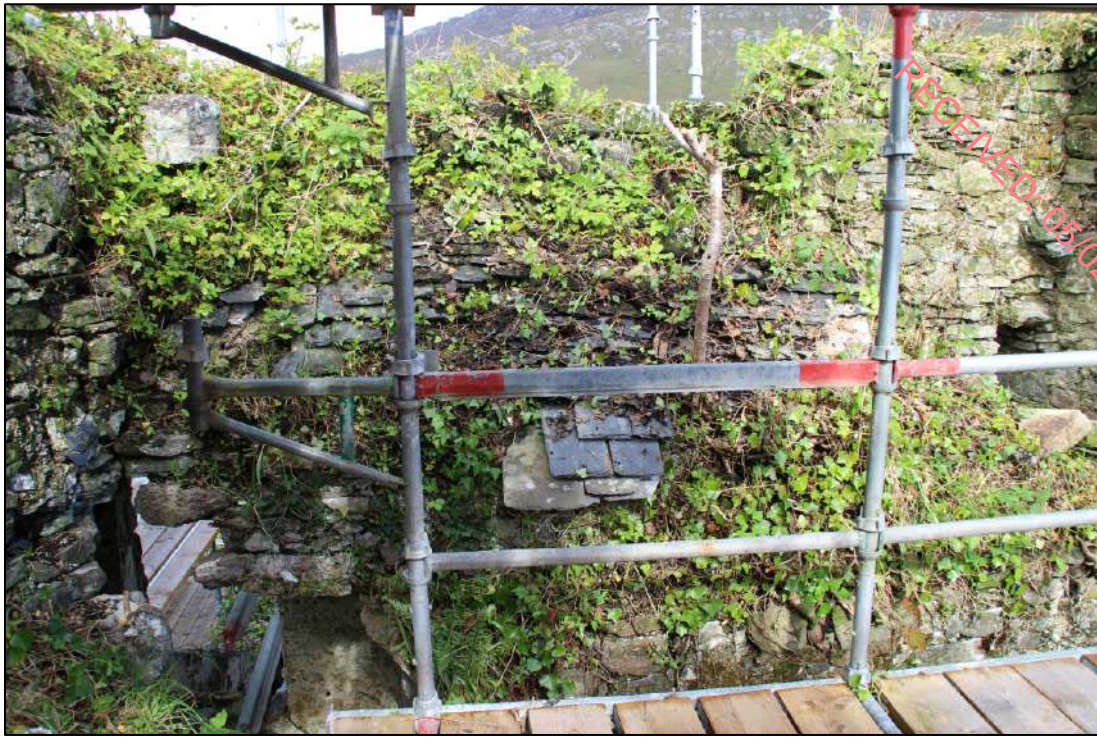
**Pl. 100** The weatherslated panel in the north-western corner of the second floor. This is laid sloping towards the interior of the building. The opening in the masonry on the left exposes the 'oriel' chamber.

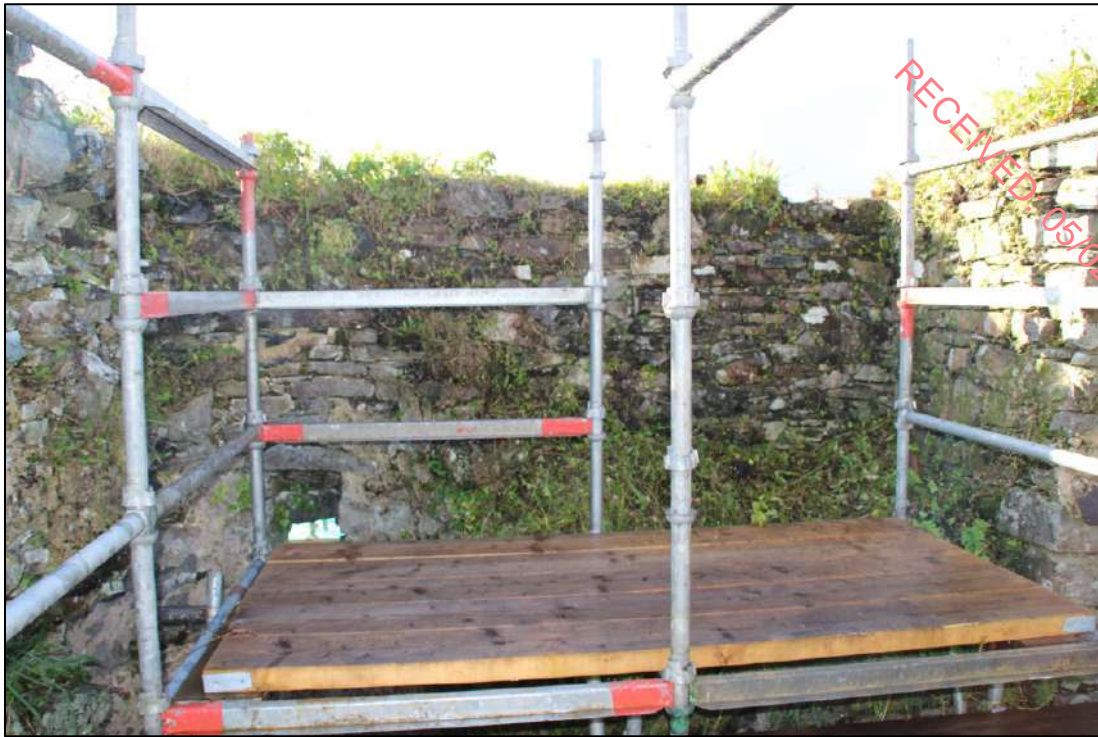
**Pl. 102** View of the second floor looking east. The irregular masonry on the centre right of the photograph marks the location of the roof cap of the stairwell.

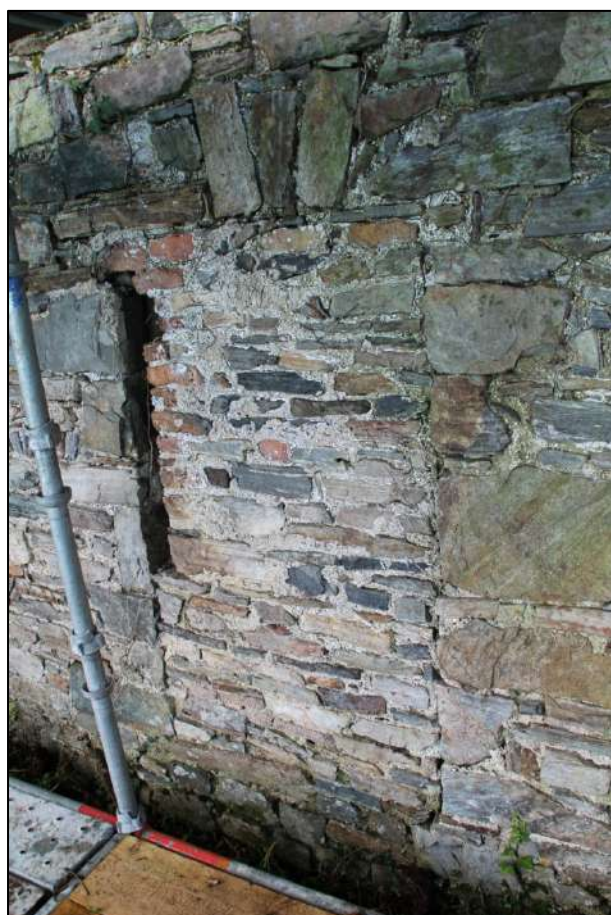
**Pl. 104** Blocked doorway converted into a slit opening on the eastern side of the ground floor of the industrial building. Note the use of brick in the infill.

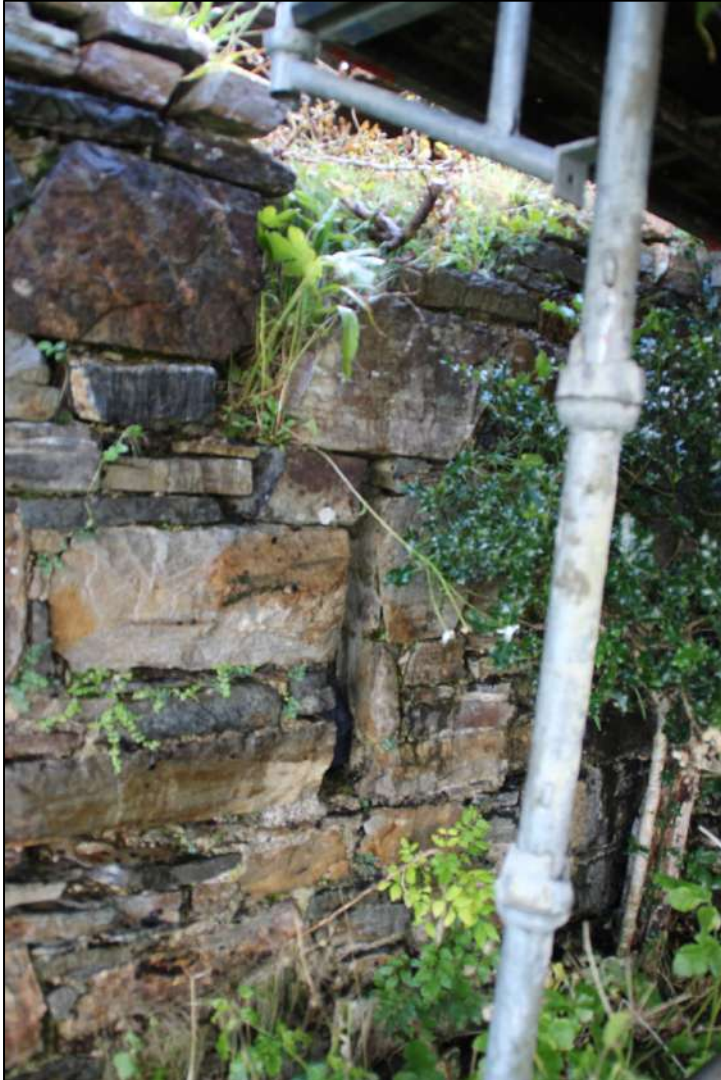
**Pl. 113** The slit window on the western side of the large room of the industrial building.

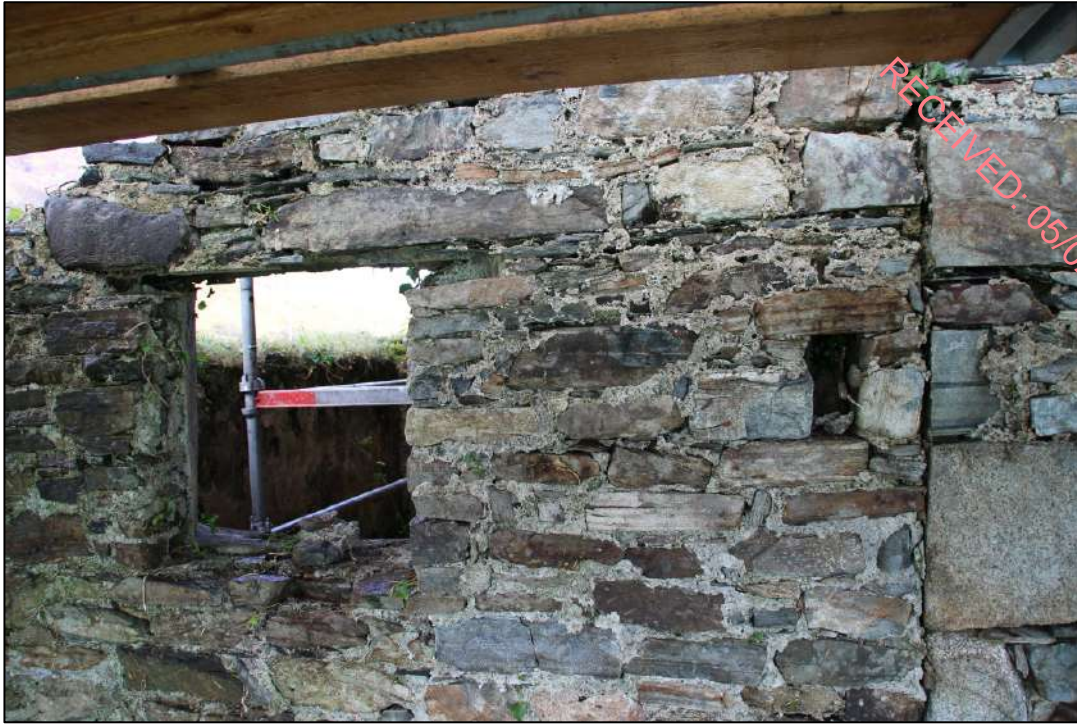
**Pl. 116** The window of the first floor room over kiln 1, the first kiln on the site. The wall on the far right of the photograph is that of the tower house. The rectangular slot may be a putlog hole with another possibly present on the left hand side of the window, out of picture.

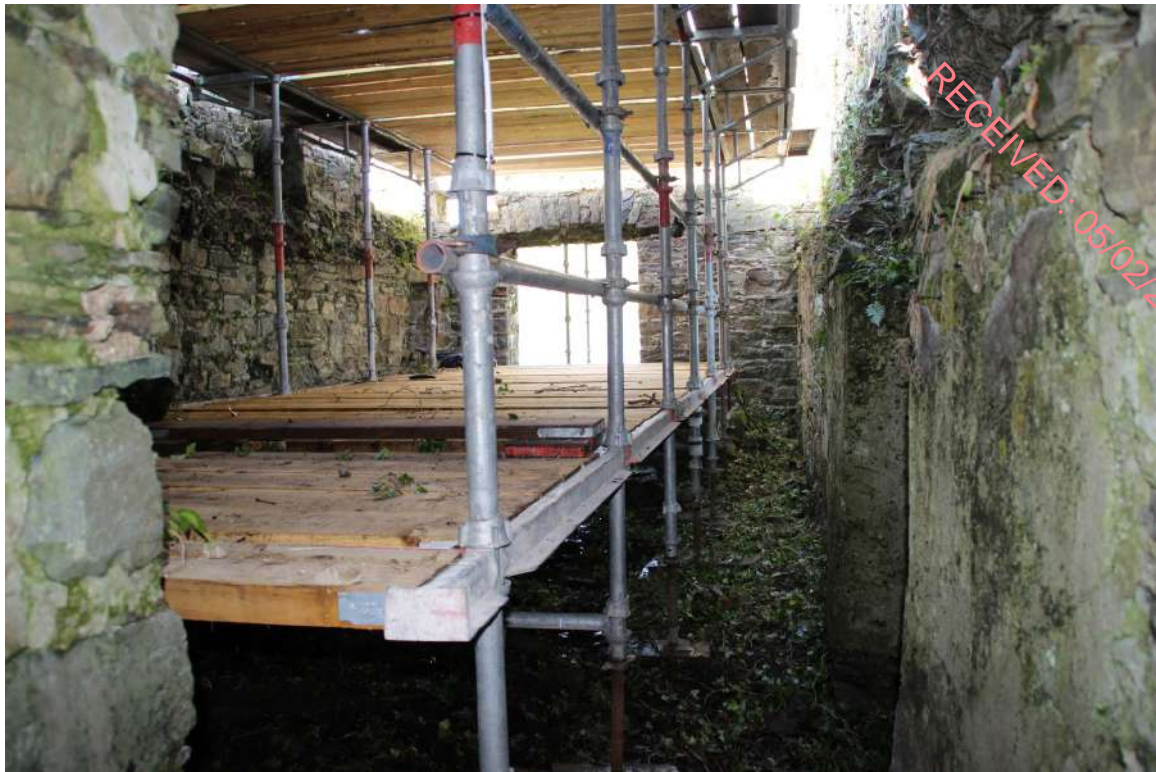
**Pl. 117** View looking north of the large (eastern) room of the industrial building. This is from the doorway connecting to the entrance lobby of the tower house.

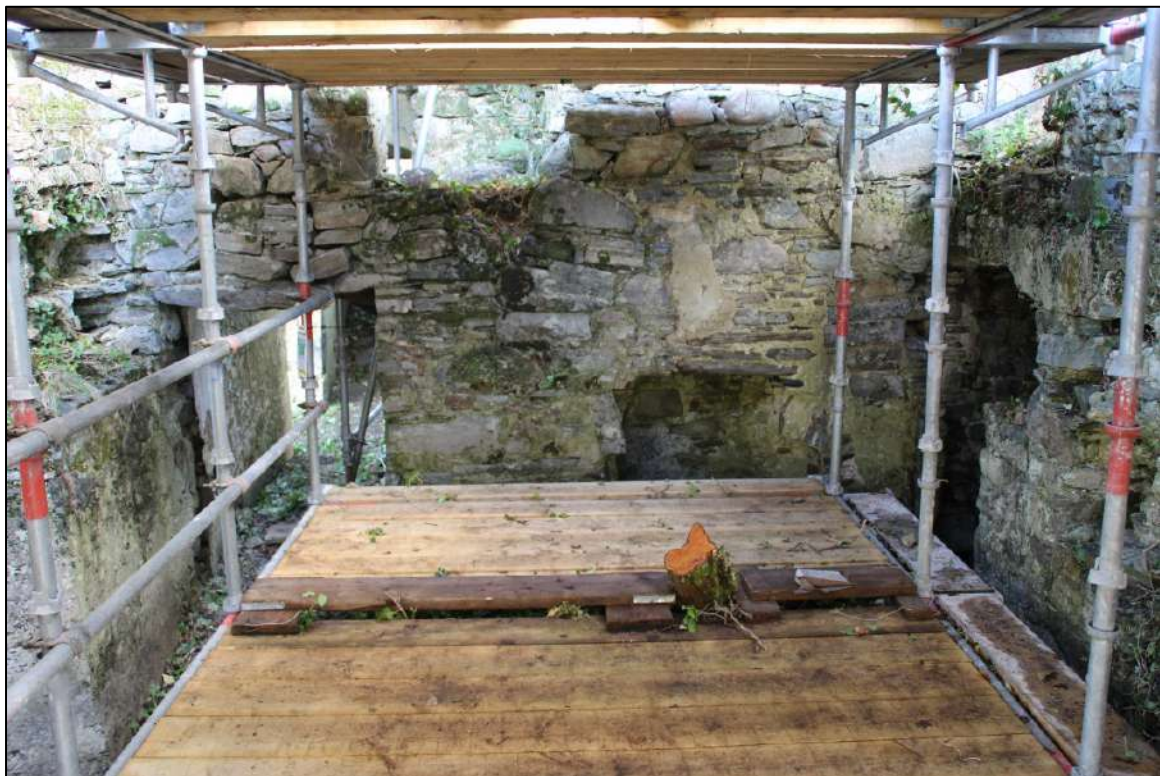
**Pl. 118** View of the southern end of the large (eastern) room of the industrial building. The doorway on the left leads into the tower house lobby, that on the right leads to kiln 1. The fireplace just right of centre appears to be inserted. The doorway in the top of the photograph is part of the later rebuilding of the north-eastern corner of the tower house.

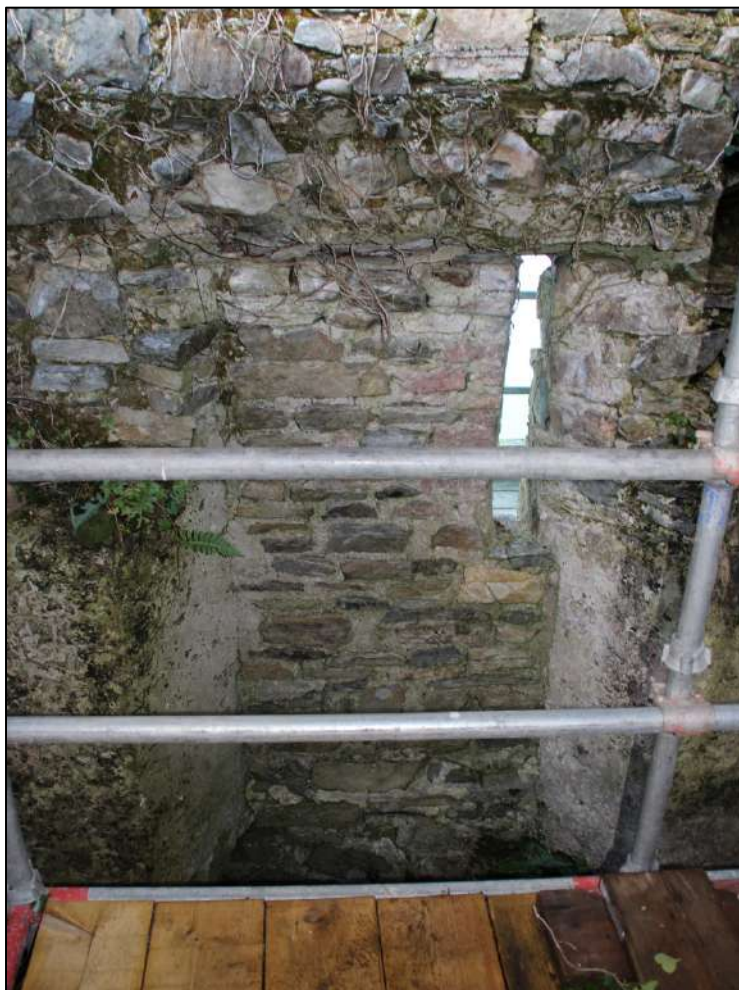
**Pl. 120** The interior of the blocked doorway on the eastern wall of the southern end of the large room of the industrial building. This was adapted as a slit window.

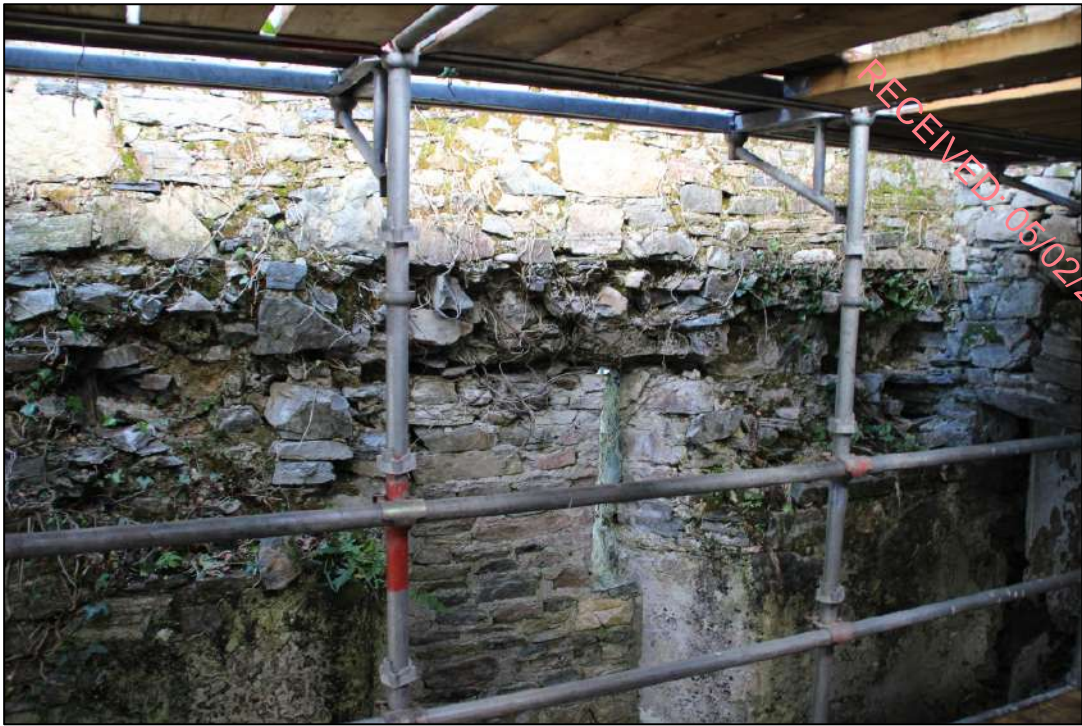
**Pl. 122** Scar of the floor/ceiling line of the large room of the industrial building.

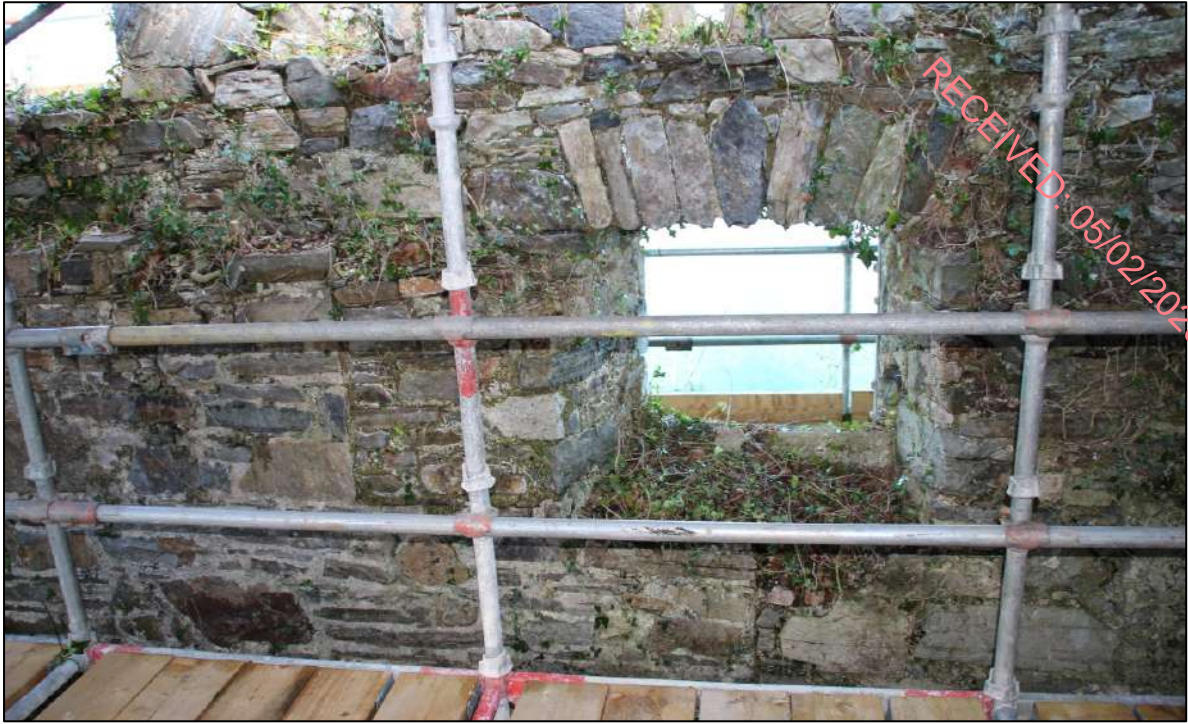
**Pl. 124** Inner side of the eastern elevation of the industrial building, ground floor. The infilled masonry area on the left is where a slit window was constructed but changed in favour of the larger window opening.

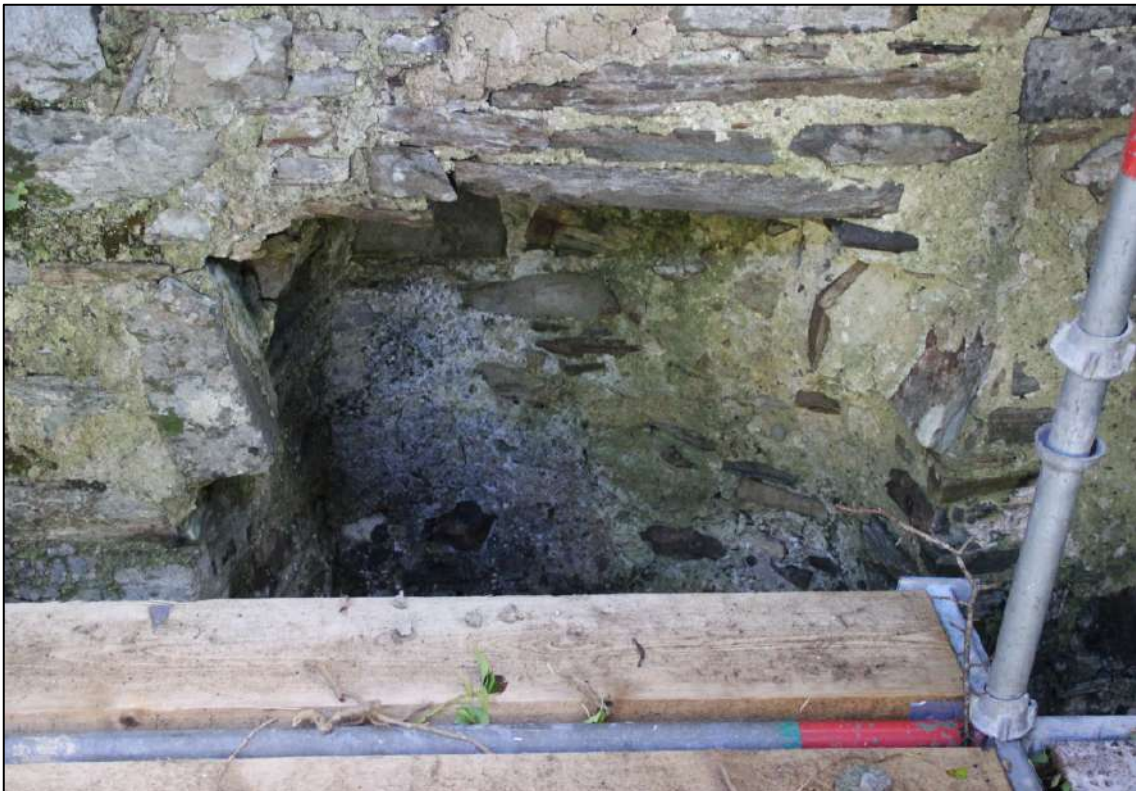
**Pl. 125** The fireplace on the exterior of the northern wall of the tower house. This is in the large room of the industrial building. A single rough stone voussoir can be seen on either side of the top of the feature. Note how the right hand side of the fireplace is shallower in depth than the other side, giving an uneven appearance.

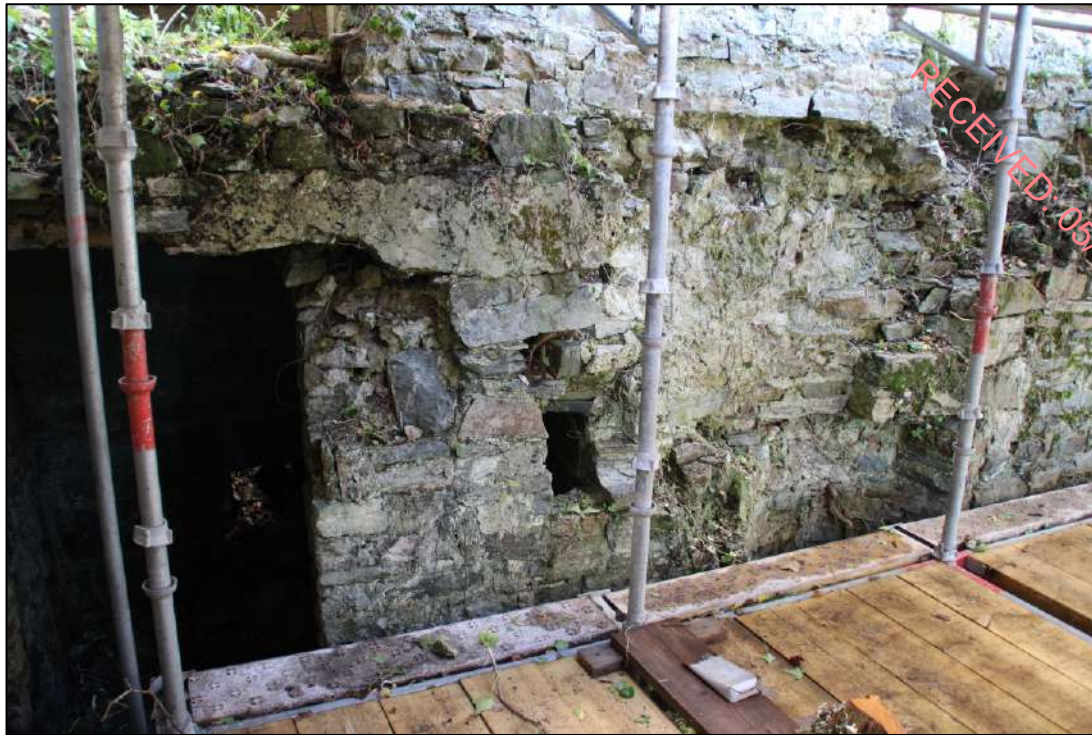
**Pl. 126** The south-western side of the large room of the industrial building. The doorway leads to kiln 1. Immediately right of the ope at the centre of the photograph is a shallow fireplace.

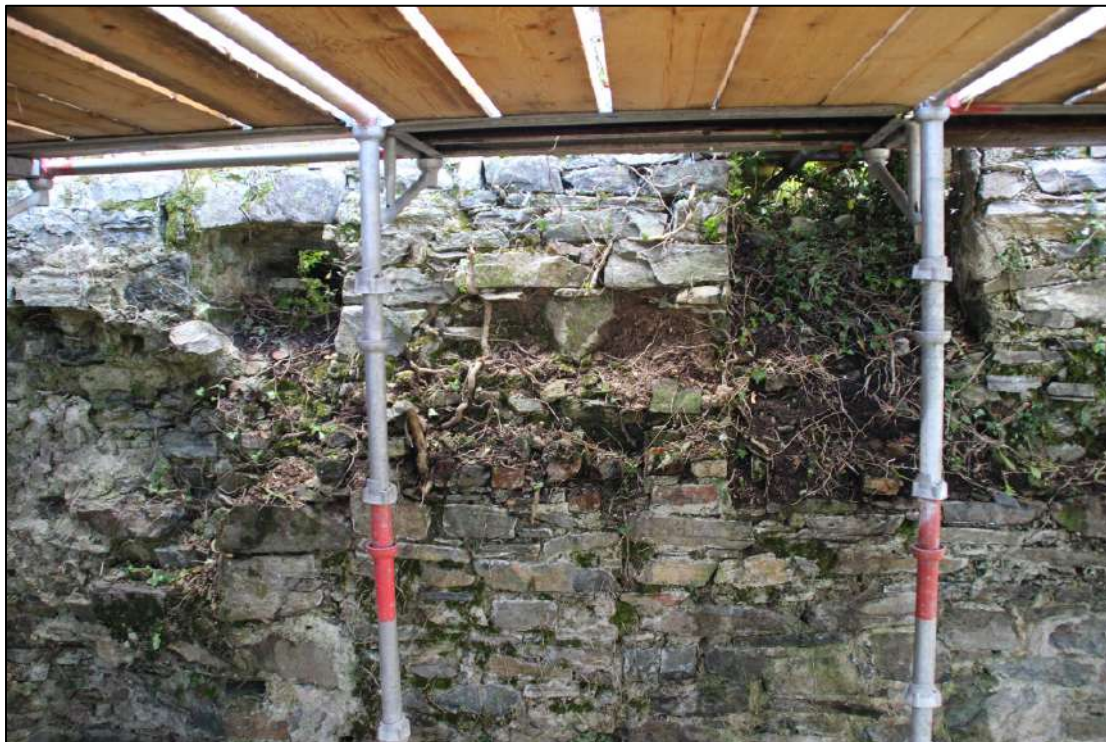
**Pl. 127** The large opening on the upper right is the doorway leading to the room over kiln 2. On the upper left is a small opening (vent?) into the same area. The fireplace can be seen in the lower left. The vertical break in the masonry in the bottom centre of the photograph may be the remains of a (slit?) window that was blocked when kiln 2 was constructed.

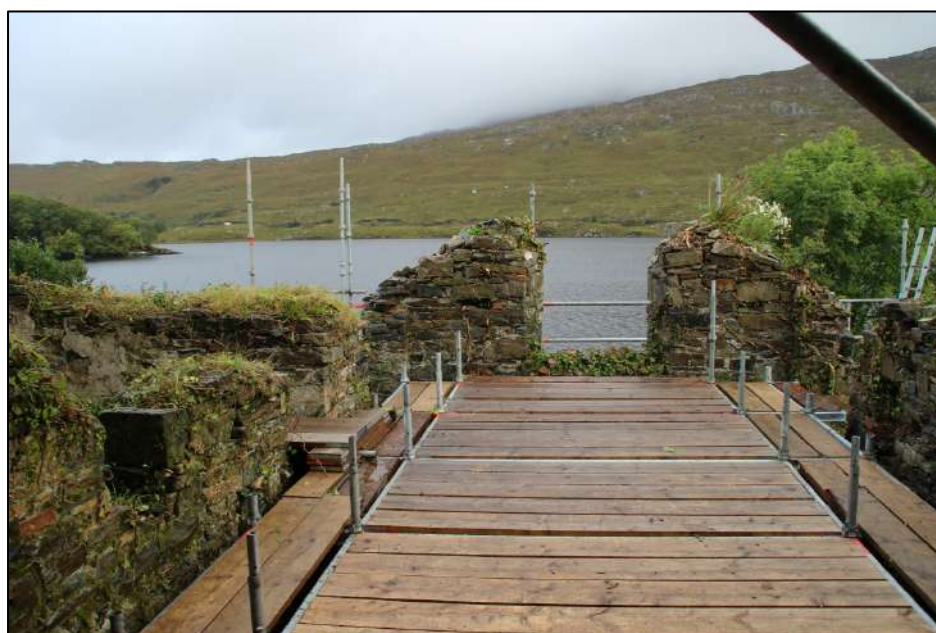
**Pl. 128** The view of the first floor of the industrial building looking north. Note the collapsed top of the gable.

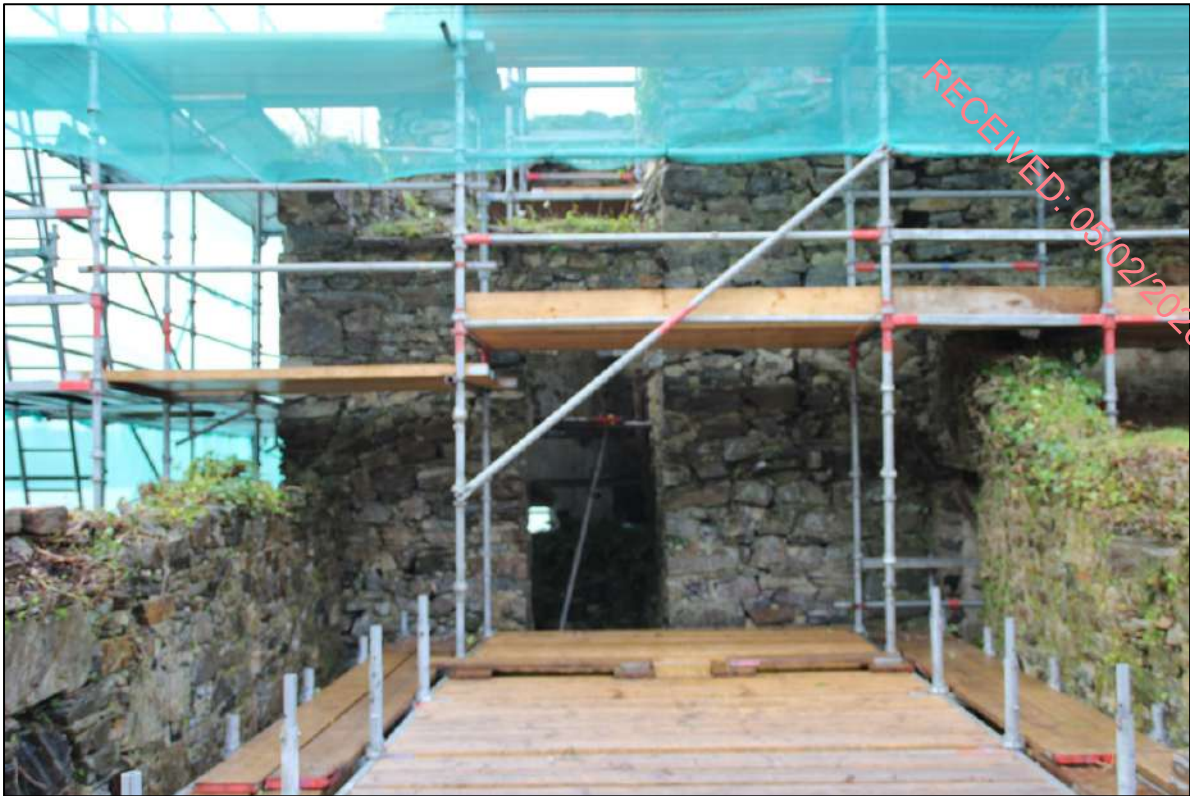
**Pl. 129** The southern end of the first floor. The doorway leads to the first floor lobby of the tower house. All of the north-eastern (left hand side of the doorway) corner has been rebuilt. Note the mortar scar running from the tops of the walls of left and right to just over the doorway.

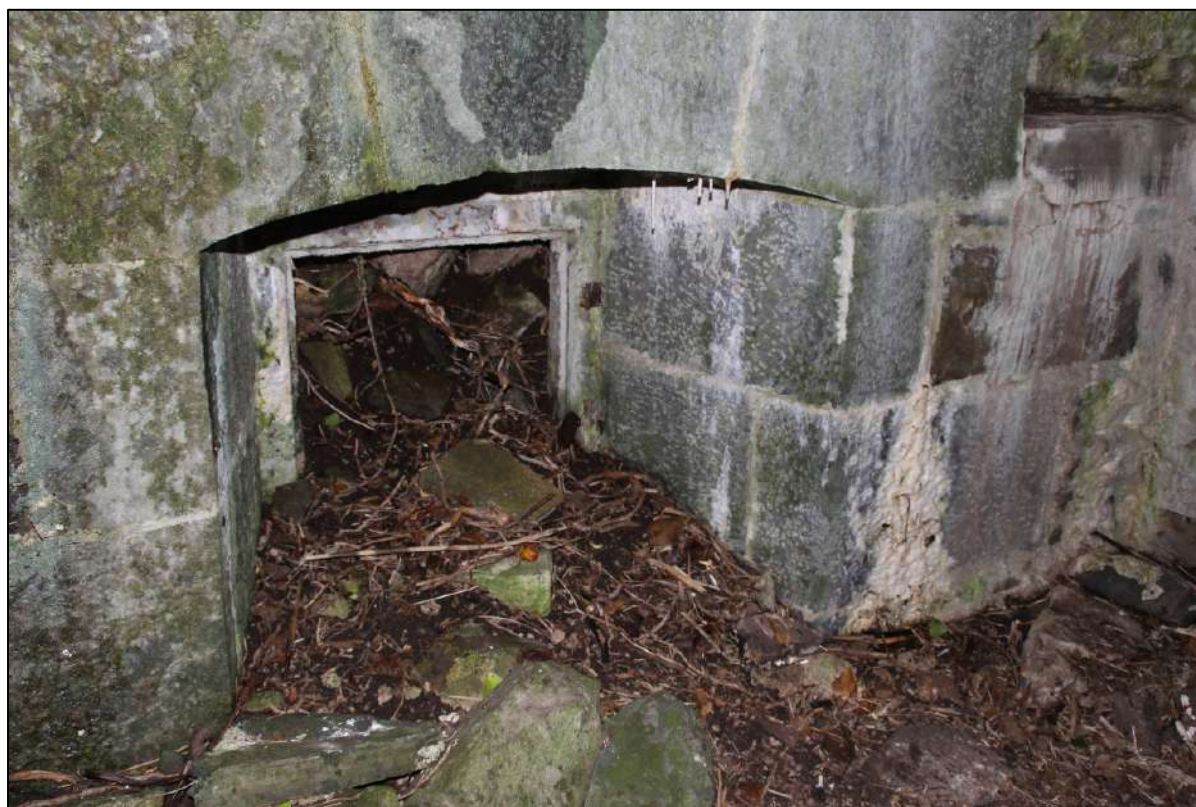
**Pl. 130** Kiln 1 looking at the drawing hole. Two iron hinges are present on the right hand side of the inner doorway. The poking hole in inner part of the kiln is full of debris. The quality of the masonry here is excellent. At the top right can be seen the access opening to the back of the kiln.
