FLORENCE M. HURLEY

**Descriptive and photographic report**  
**on**  
**Ballynahinch Tower House**  
**and adjoining structure**  
**with mortar analysis**

**Ballynahinch,**  
**Recess,**  
**Connemara,**  
**Co. Galway**

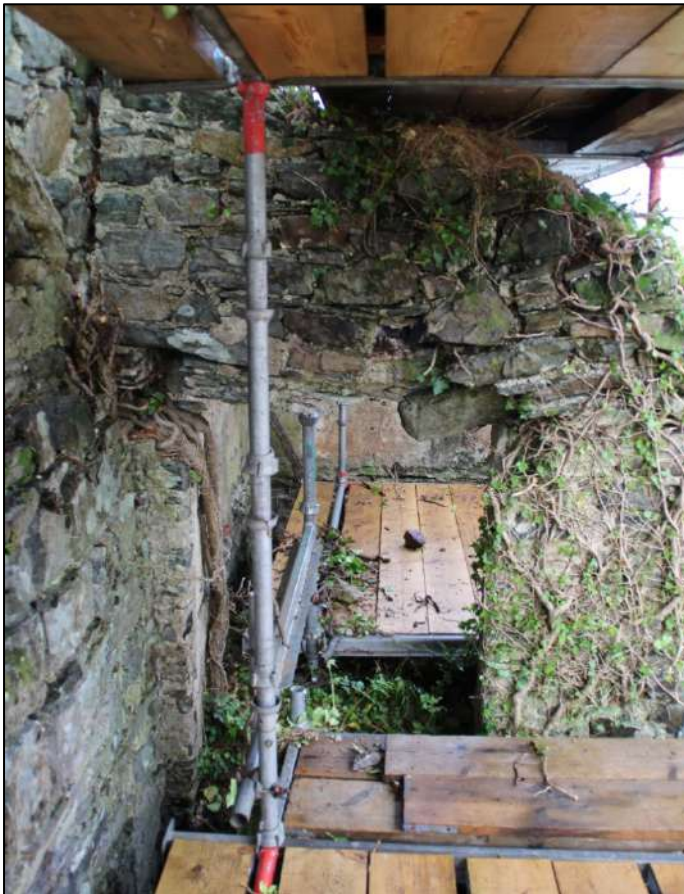
**PI. 136** The doorway at first floor level leading into the room over kiln 1. Note how poorly it is bonded to the north wall of the tower house and the poor condition of the wall and window head.

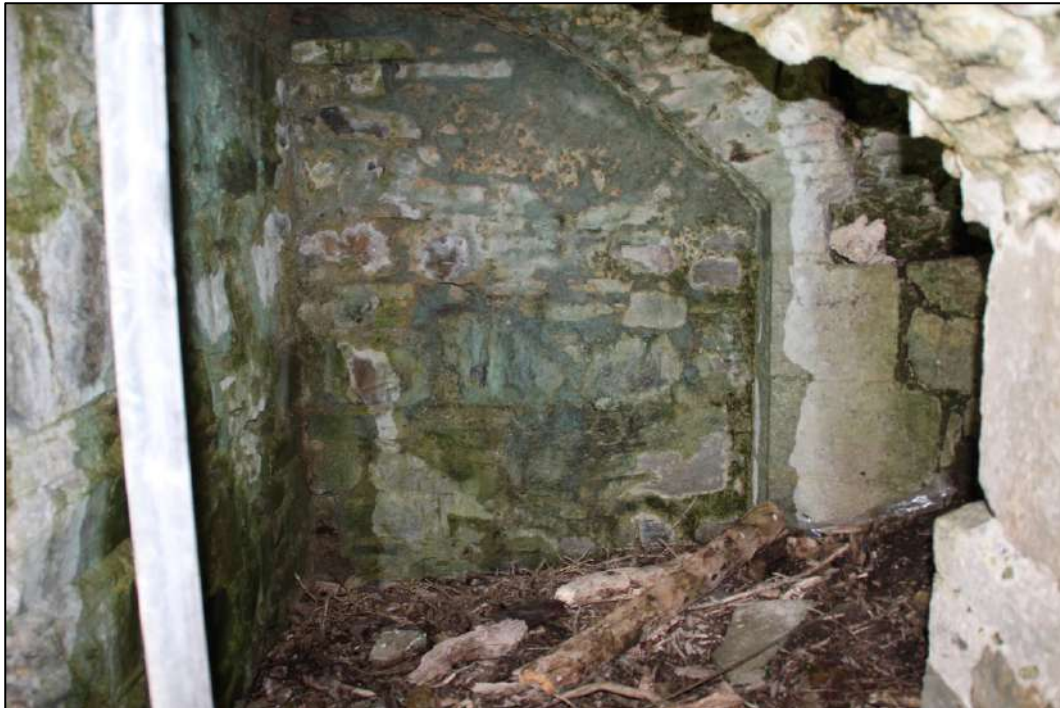
**Pl. 138** The interior of kiln 2 looking east. The drawing hole of the kiln is on the right. This structure is a later addition to the industrial complex on the island.

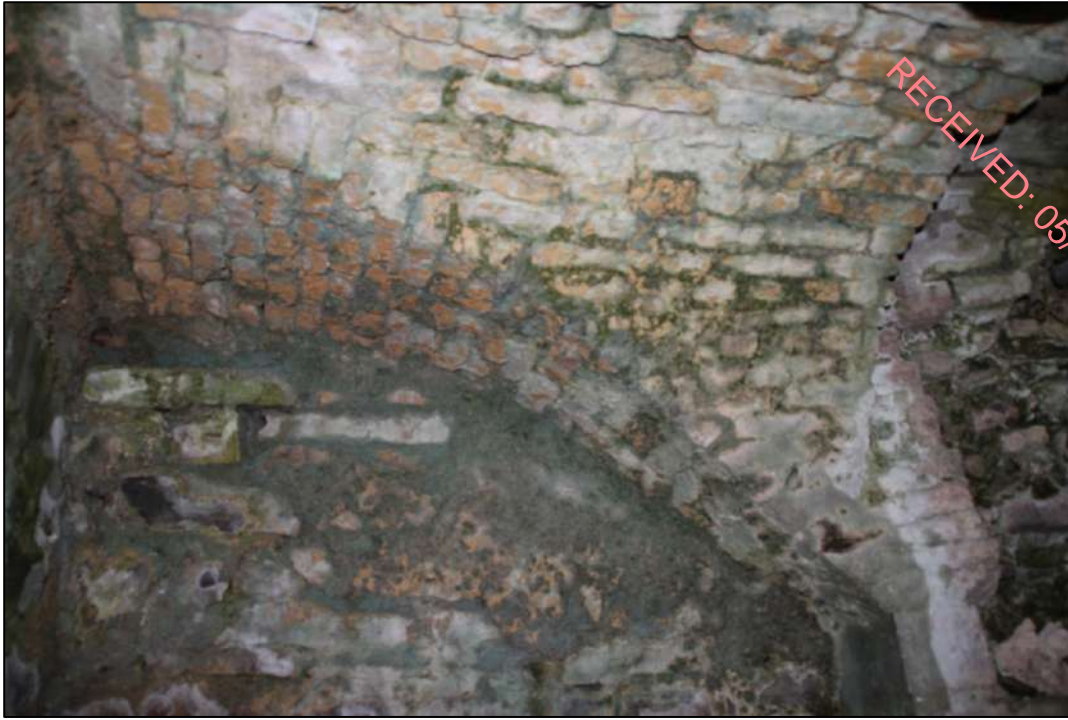
**Pl. 139** The brick groin vaulting in kiln 2.

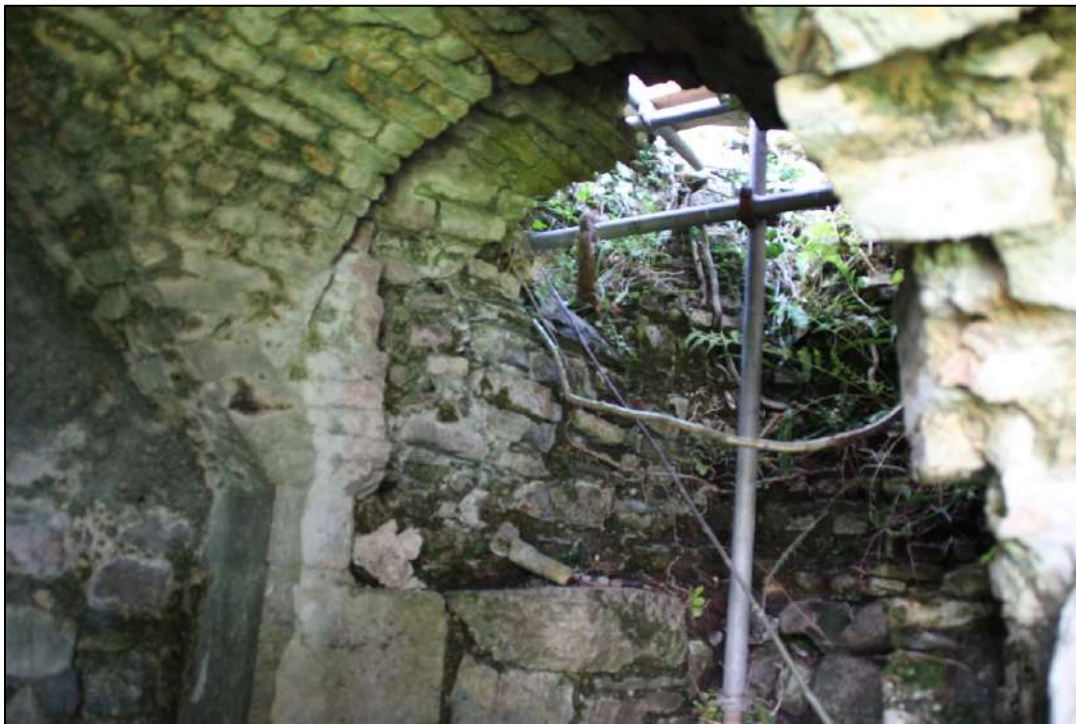
**Pl. 140** The upper part of the drawing hole arch has collapsed. This was built of brick with ashlar masonry used for the lower part.

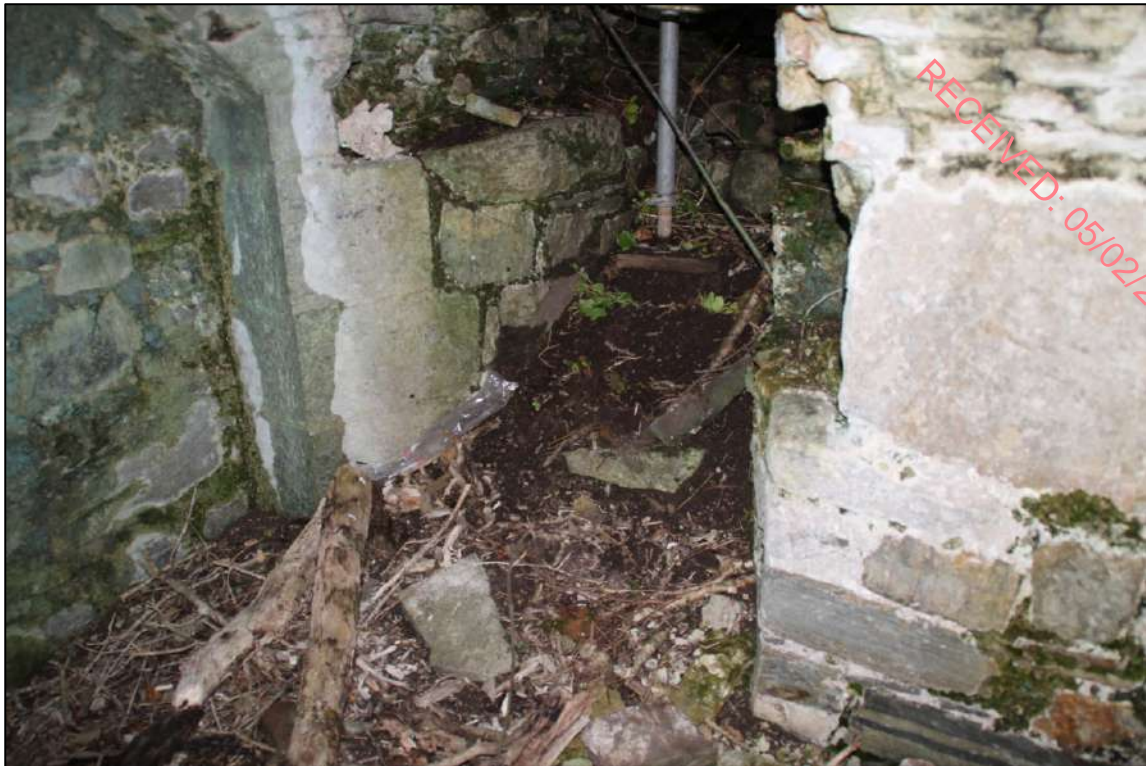
**Pl. 141** The lower part of the drawing hole of kiln 2.

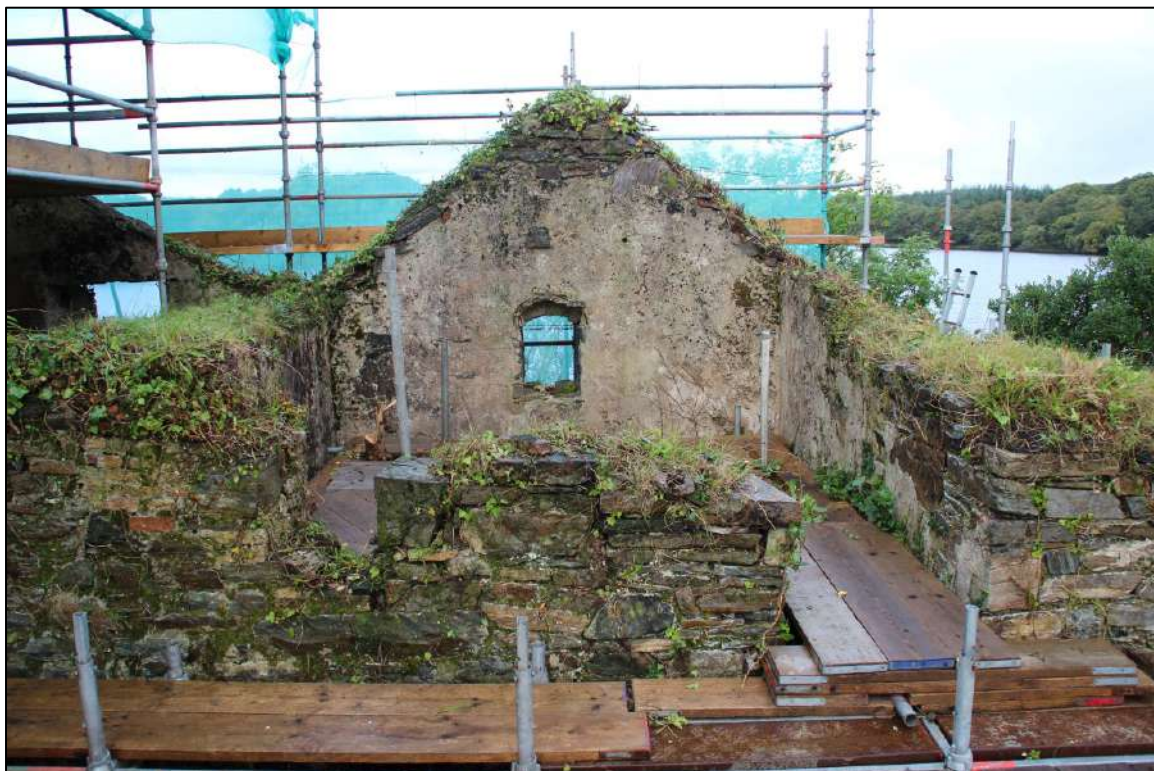
**Pl. 142** The first floor room over kiln 2. The doorway is on the right. Like in the first floor room of kiln 1, this is also plastered internally.

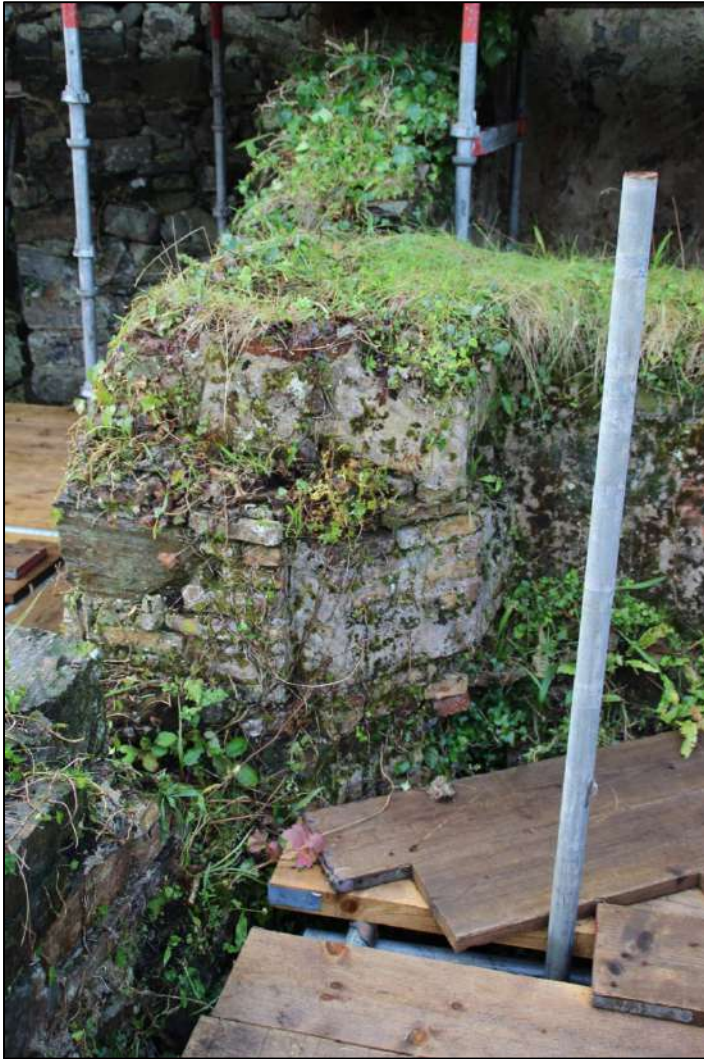
**PI. 143** The chimney in the south-eastern corner of kiln 2. This is built of handmade brick.

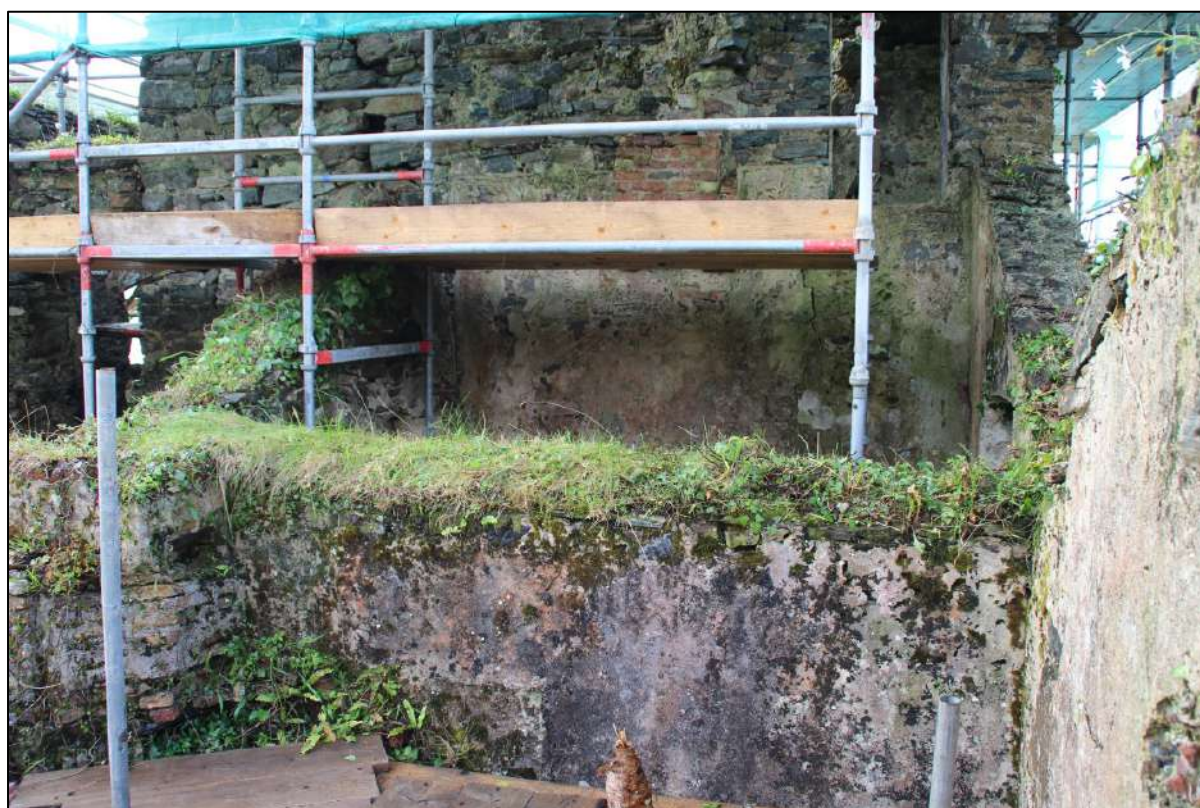
**Pl. 145** The gabled single pitch form of the roof over kiln 1 can be seen here. The manner in which the roof crosses the lower part of the northern 'oriel' window on upper right is unusual as no trace of any blocking material is present.

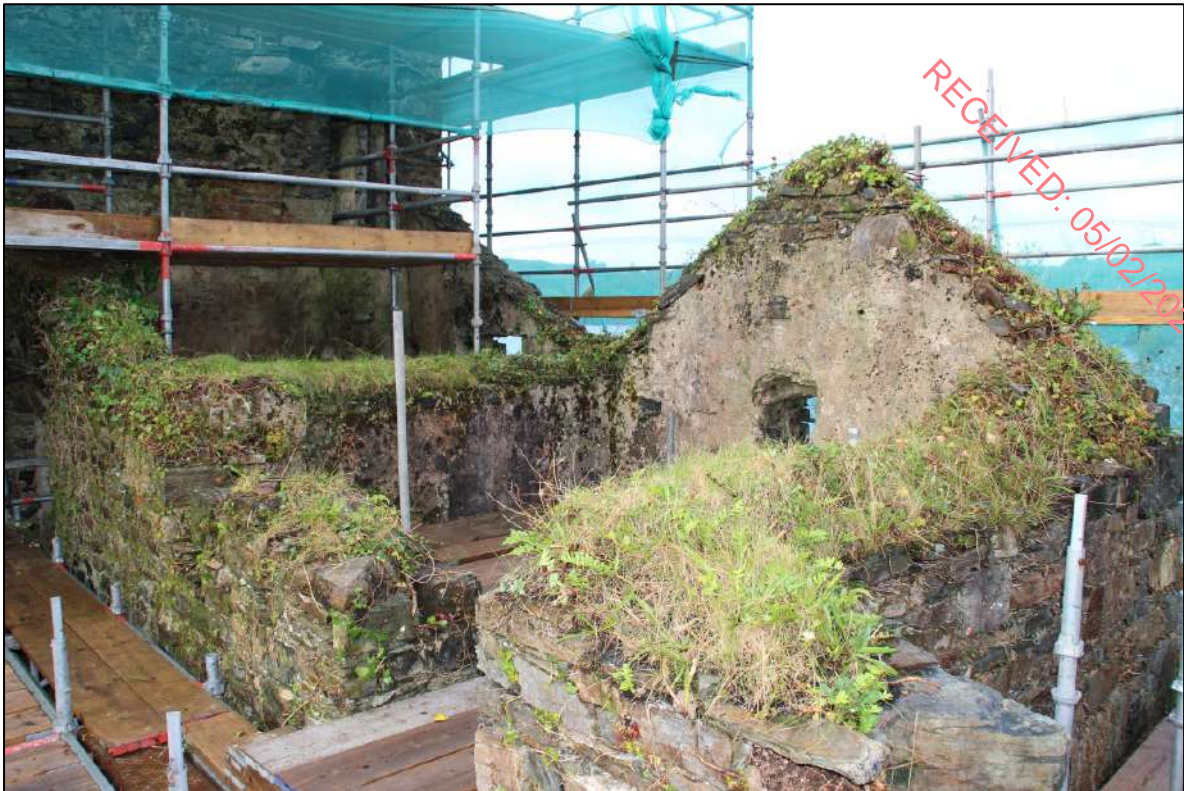
**Pl. 146** The gabled form of the roof over kiln 2 can be seen here.

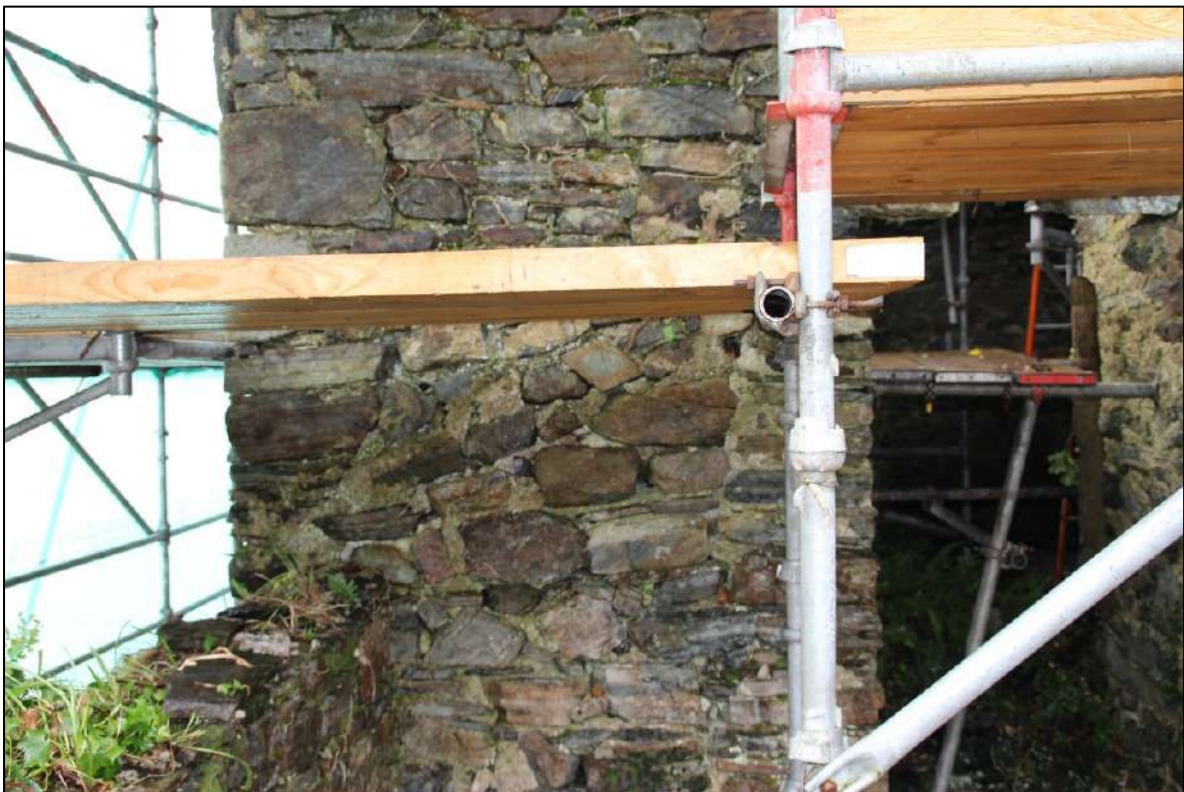
**Pl. 146** Mortar scar evident running from the top of the wall on the left towards the top set of scaffolding planks. This marks the position of the roof over the large room of the industrial building.
