Descriptive and photographic report
on
Ballynahinch Tower House
decorative plasterwork

Ballynahinch,
Recess,
Connemara,
Co. Galway

CLIENT : Yelsea Ltd.,
c/o de Blacam and Meagher Architects,
4 St. Catherine's Lane West,
Dublin 4.

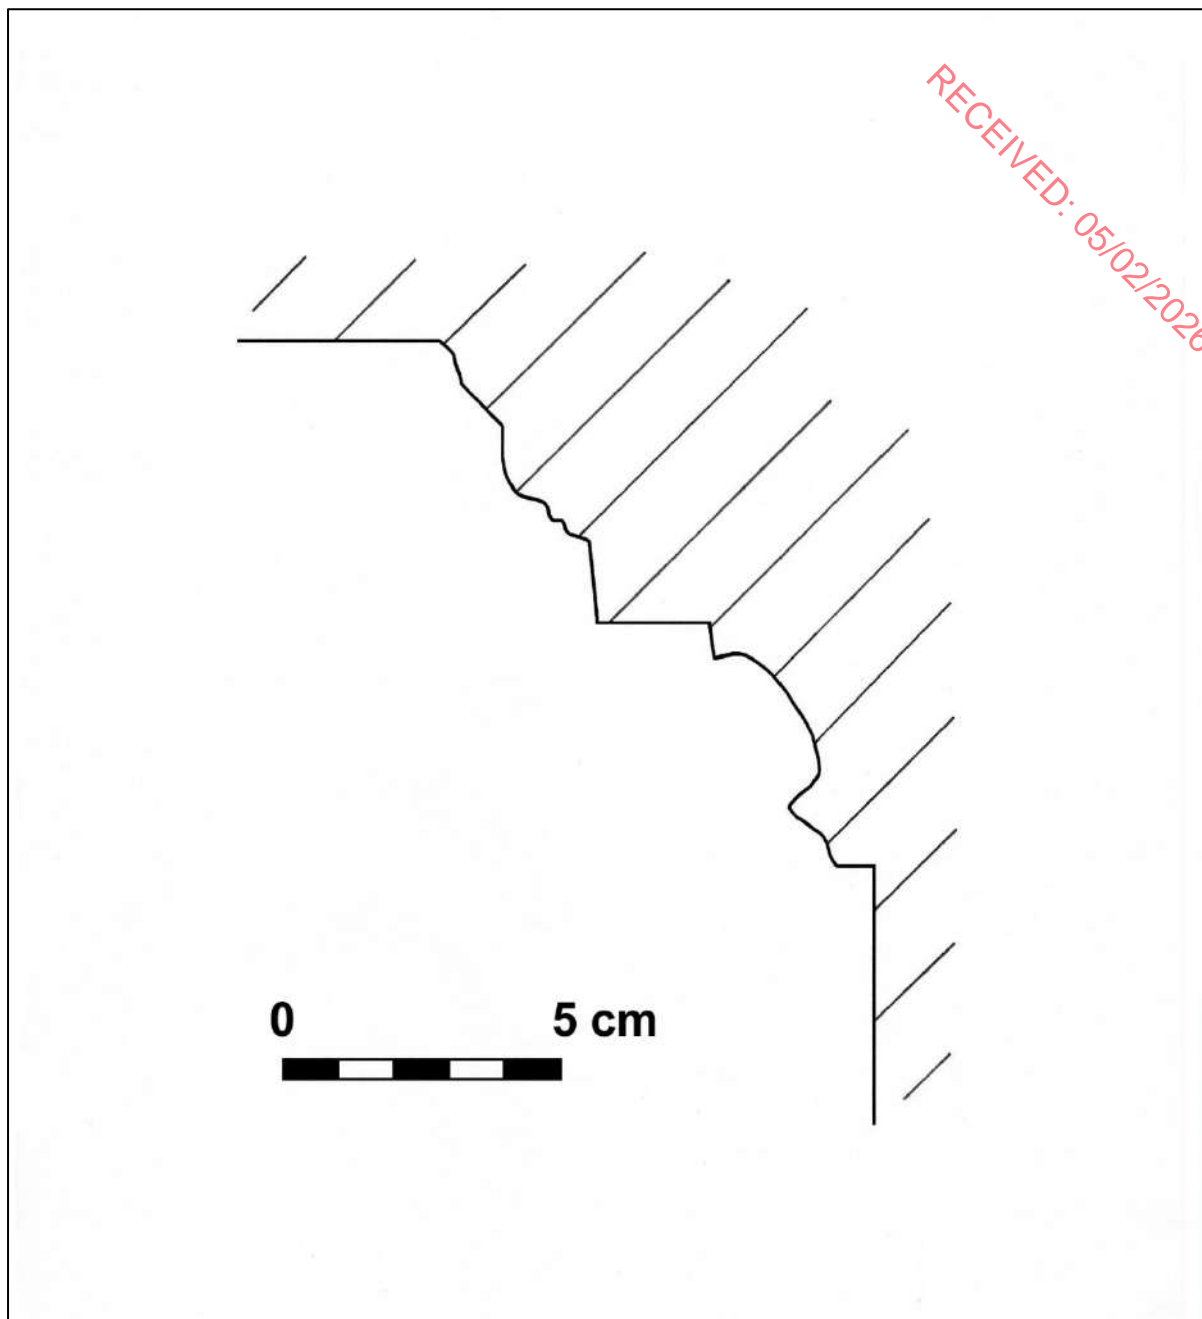
The moulding where most complete (**Fig. 1**) has a projection of 80mm and a drop of 94mm, the face measuring 125mm. The elements of the coving consist of (from the base) an astragal, with a cavetto moulding above with a corona separating the cavetto from another astragal. The upper astragal is not as prominent as the lower one.

The coving is best preserved in the north-east corner of the lobby despite some light vegetation growing on top of it. The general condition of the wall plaster here is poor. Much of this is attributable to the large voids within the wall allowing moisture penetration resulting in the collapse of a large area of plaster and the bulging of some of the remaining plaster. Only the lower part of the moulding survives on the northern wall. On the eastern wall the coving has disappeared completely over the main doorway and to the south of this feature.

Fig. 1 Section through coving moulding, eastern wall of entrance lobby.

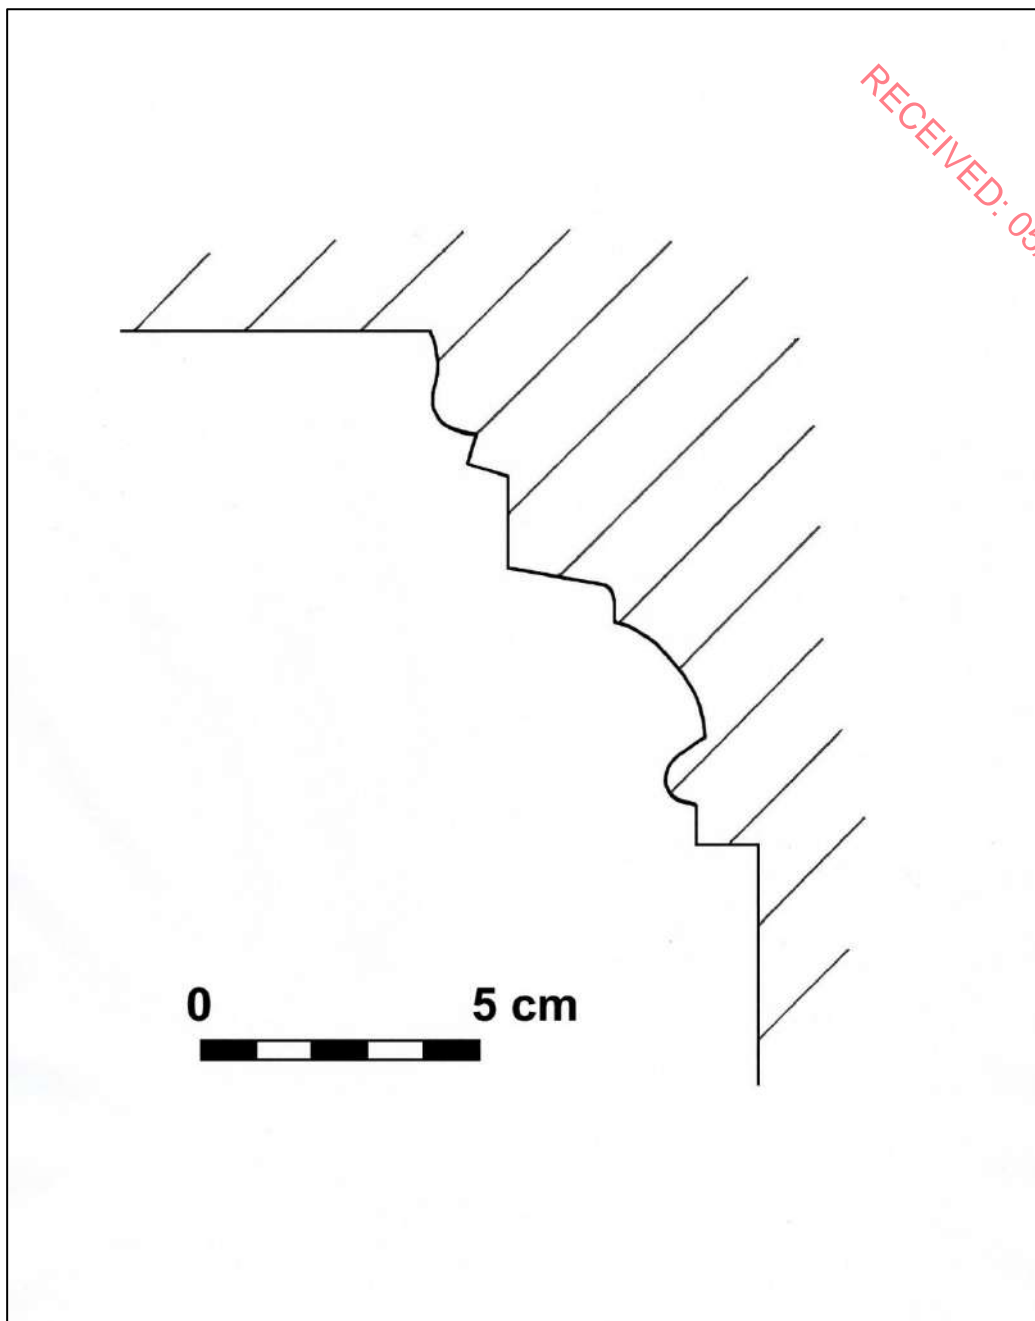
The detail of the moulding is identical to that found in the lobby (**Fig. 2**) with only minor differences in the sharpness of the moulding; the elements of it are exactly the same. The ceiling here was formed by timber joists running in a north-south direction. These presumably supported a lath and plaster ceiling.

Fig. 2 Section through coving moulding, northern wall of ground floor chamber.

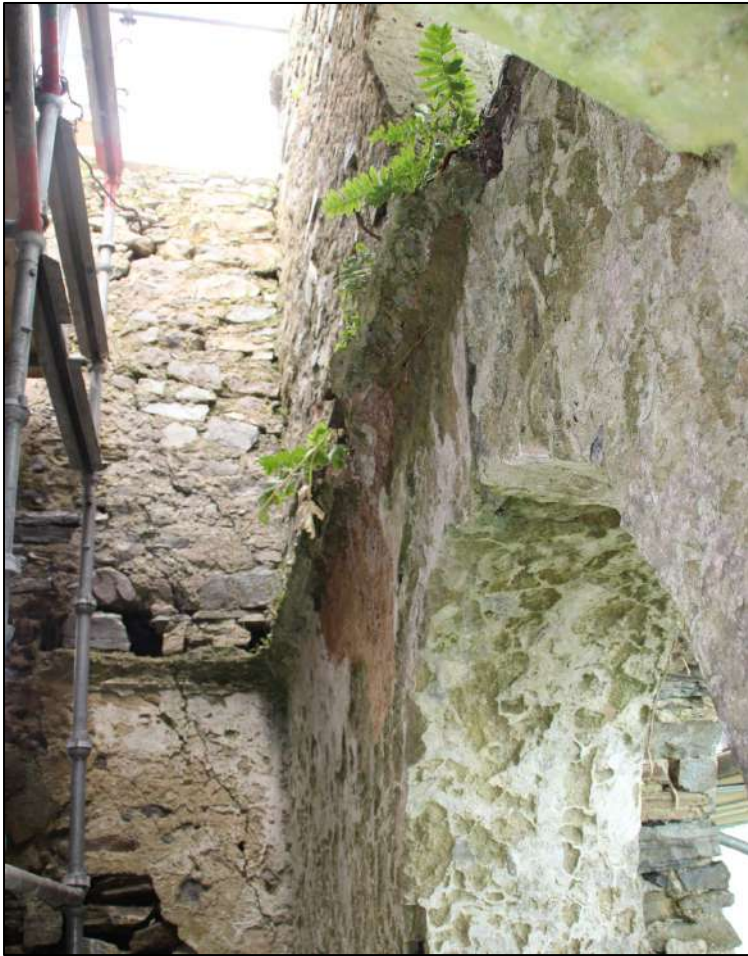
PL. 1 View of entrance lobby decorative coving looking north.

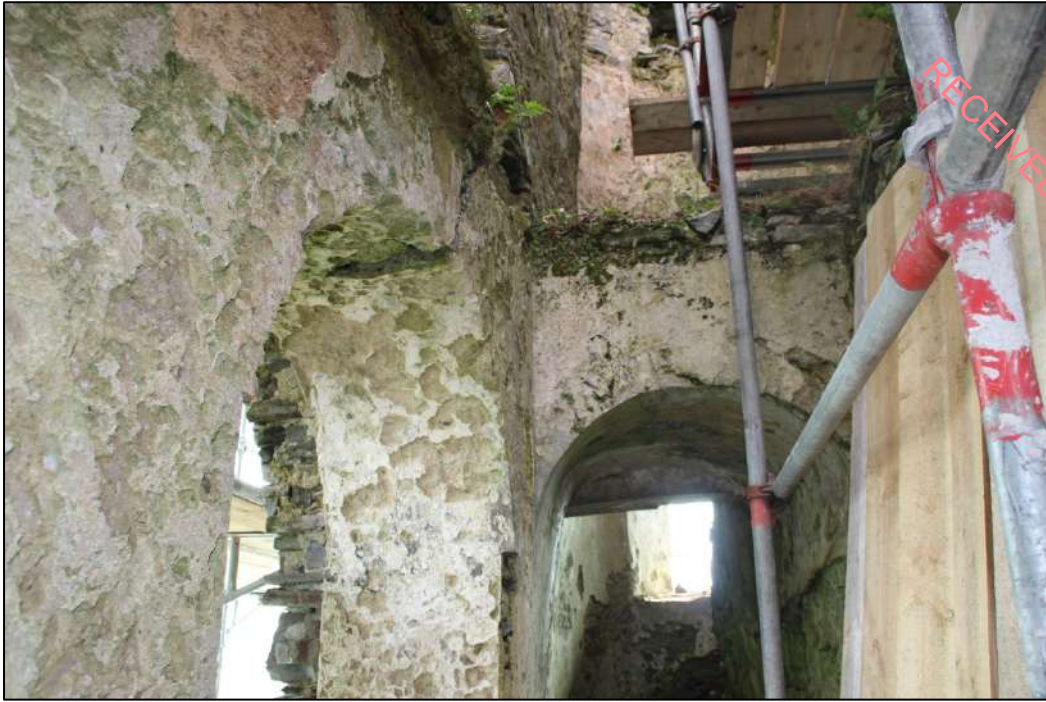
Pl. 2 Entrance lobby looking south. Coving has disappeared from wall over stairwell.

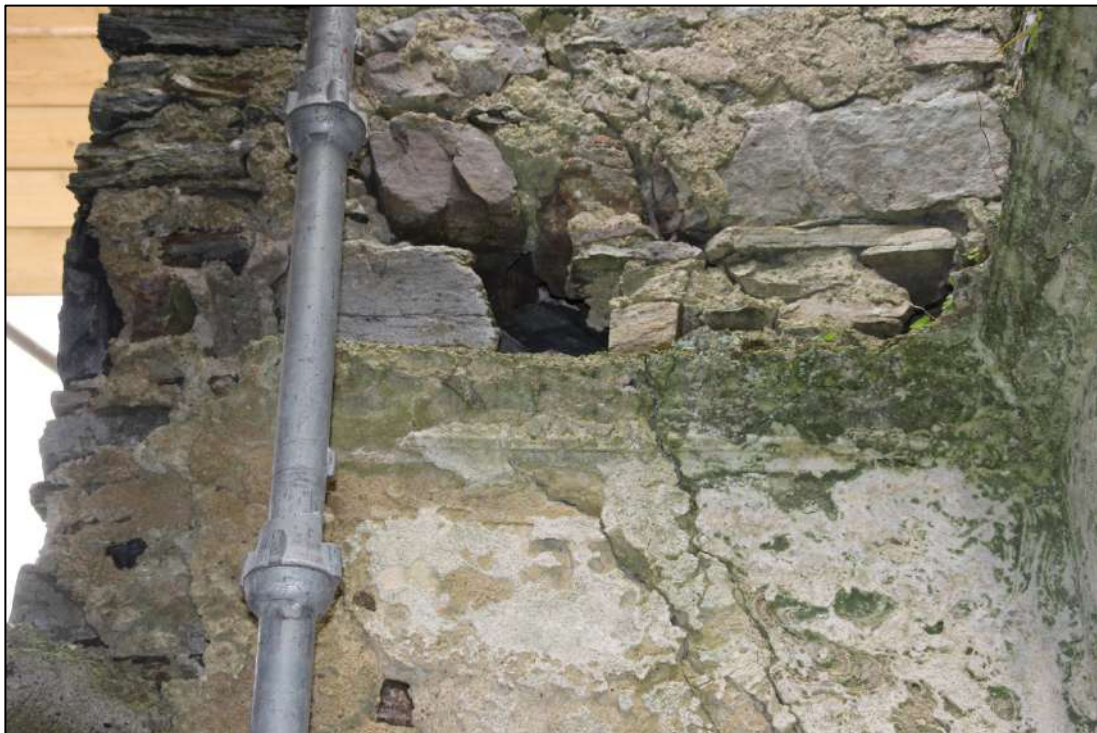
Pl. 3 Detail of coving on interior of northern wall of the entrance lobby.

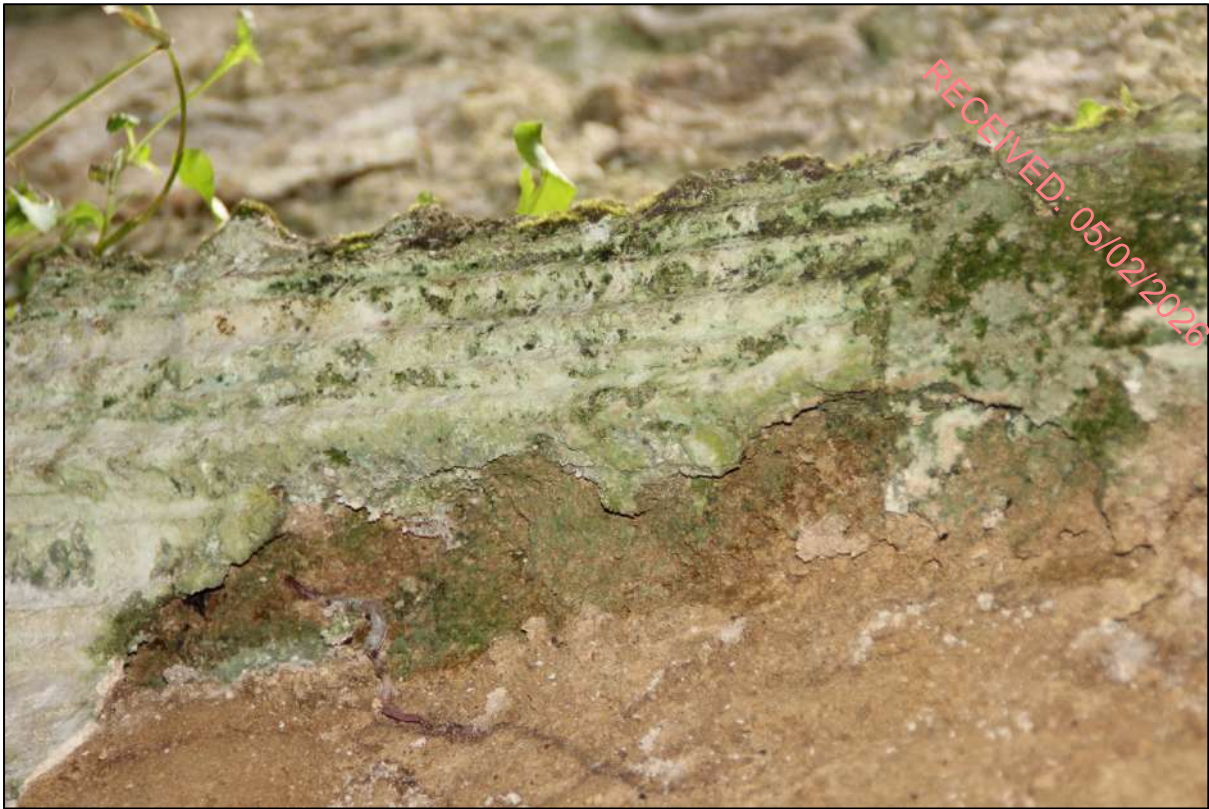
Pl. 4 Detail of coving on interior of eastern wall, entrance lobby. Note deterioration on right.

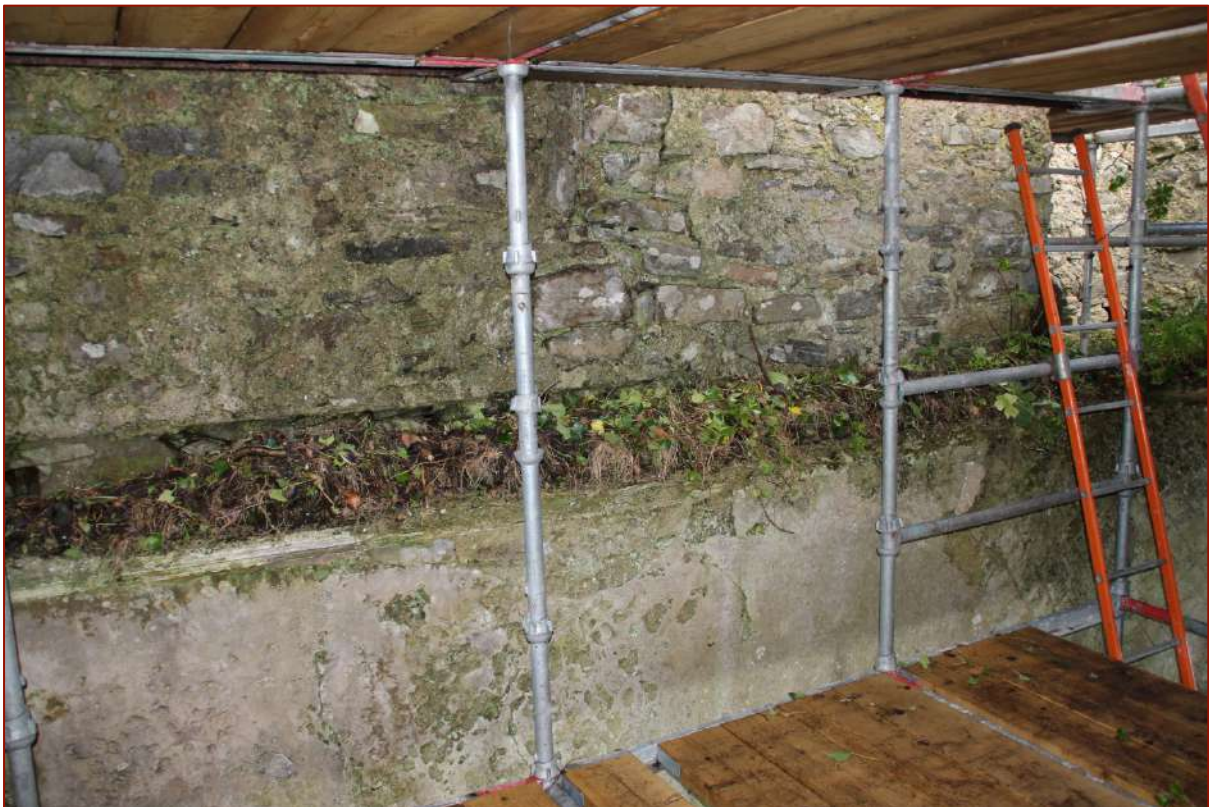
Pl. 5 The coving on the north wall of the main chamber of the ground floor. The band of vegetation across the centre marks the position of the ceiling of the ground floor and floor of the first floor. Only the portion on the western side (on left) survives to any extent.

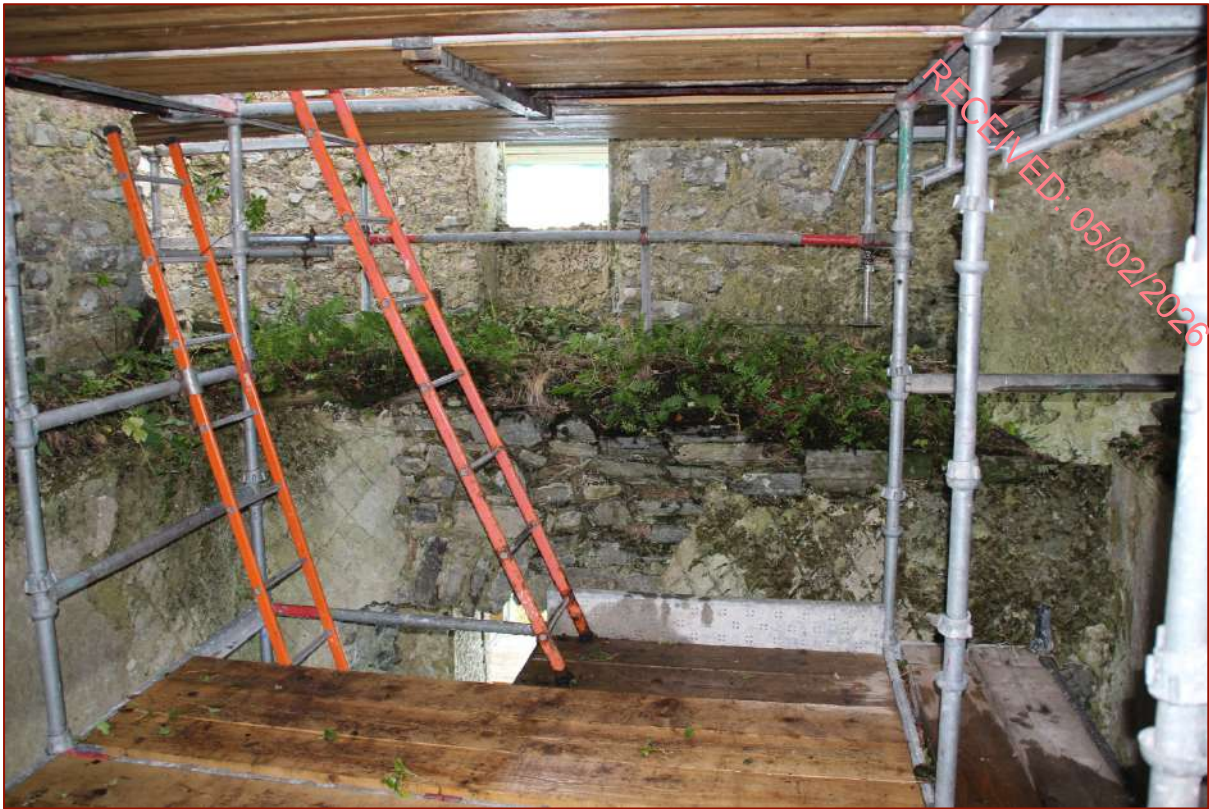
Pl. 6 The eastern end of the ground floor chamber. There may have been a partition wall where the vegetation is growing. No coving survives below that level. The stairs is on right.

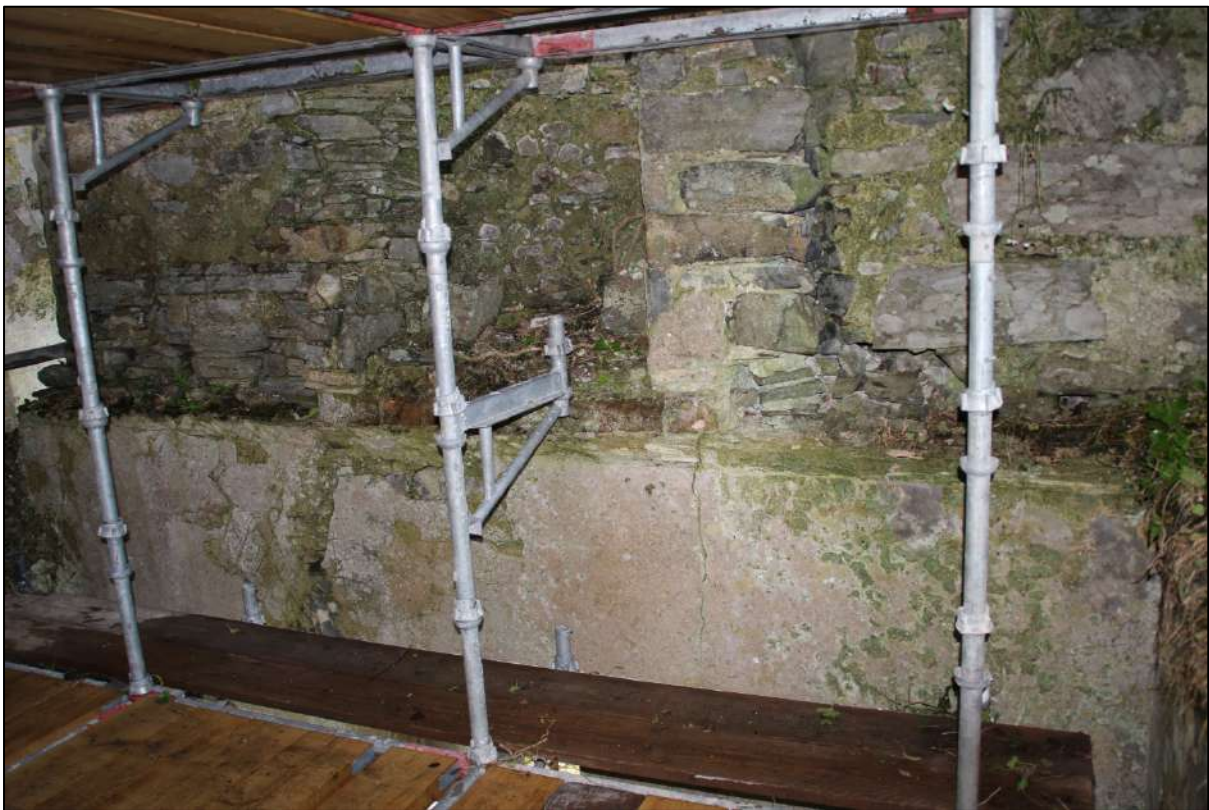
Pl. 7 The interior of the southern wall. The vertical masonry is infilling of the western side of the fireplace. The coving survives on the extreme right with the scratch coat evident elsewhere.

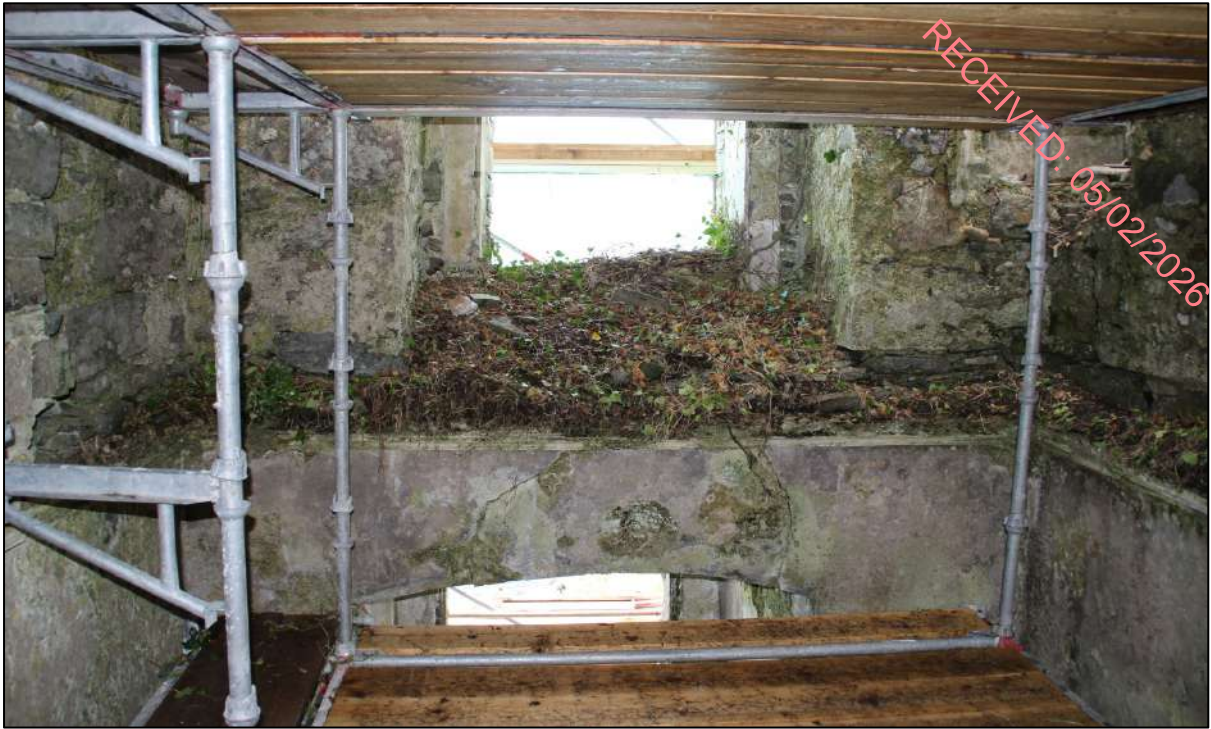
Pl. 8 The western side of the ground floor chamber. The coving on either side of the window survives in reasonable condition.

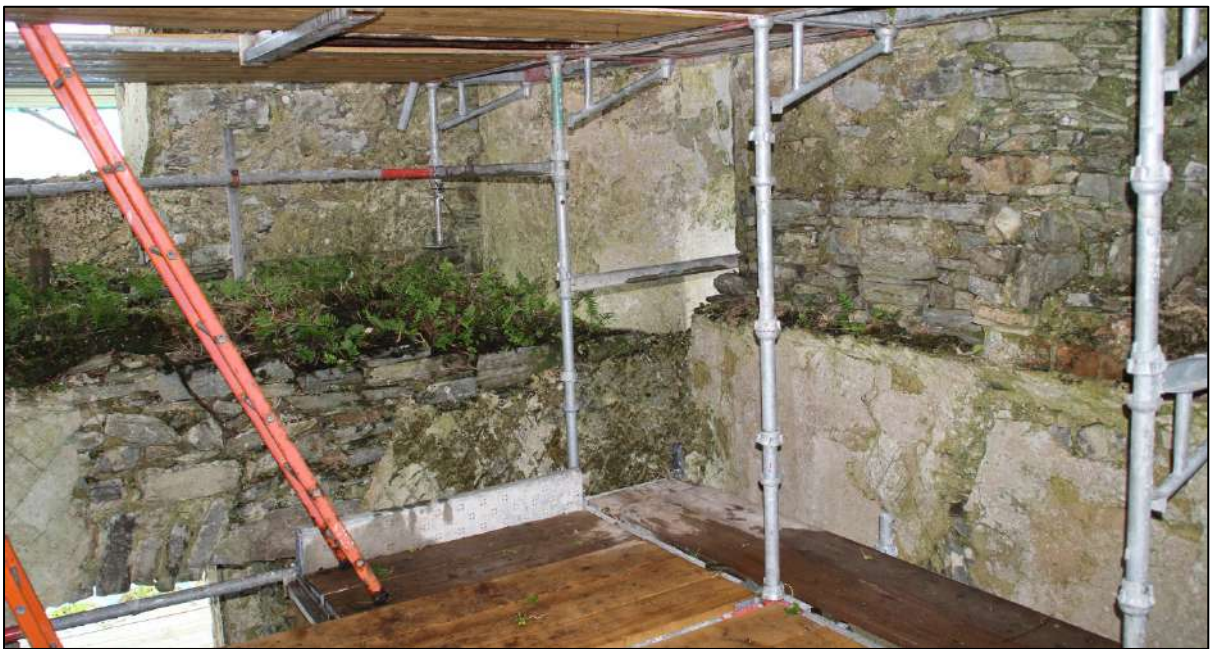
Pl. 9 Detail of south-east corner of the ground floor. The plaster line at right marks the level of the ceiling.

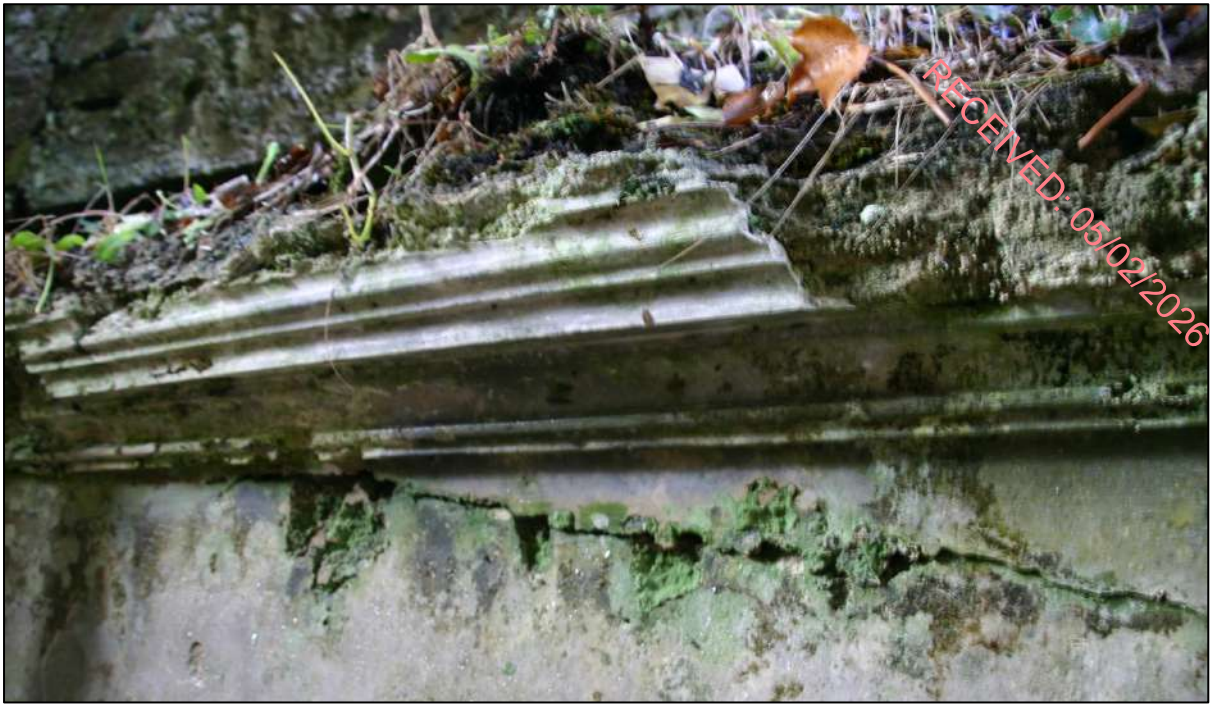
The continued existence of the moulded coving is problematical given its poor condition and the ingress of water into the ruined structure. This may be alleviated to a limited degree if coping is placed on the walls but this is more likely to slow the deterioration rather than stop it. The rebate that supported the timbers of the first floor acts as a vegetation and water trap and as this is directly over the moulding it has caused much damage. Clearance of the vegetation from this area might be of short term help.

Pl. 10 Detail of the moulding on the northern wall, north-west side. Vegetation accumulates on the lip where the floor joists sat, this eventually leads to a deterioration of the plasterwork.

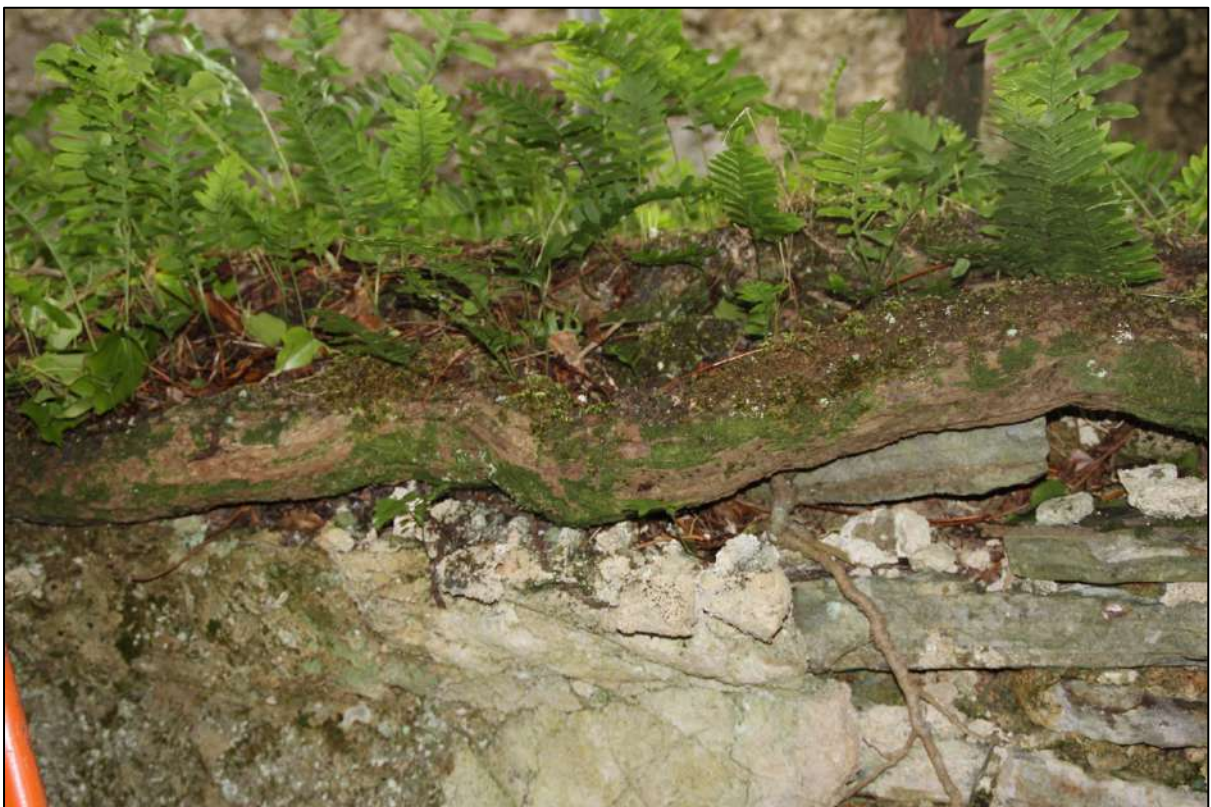
Pl. 11 Part of a tree trunk on top of the internal wall which separates the entrance lobby from the main chamber on the ground floor. The scratch coat base for the coving can be seen directly below the tree in the centre of the picture.

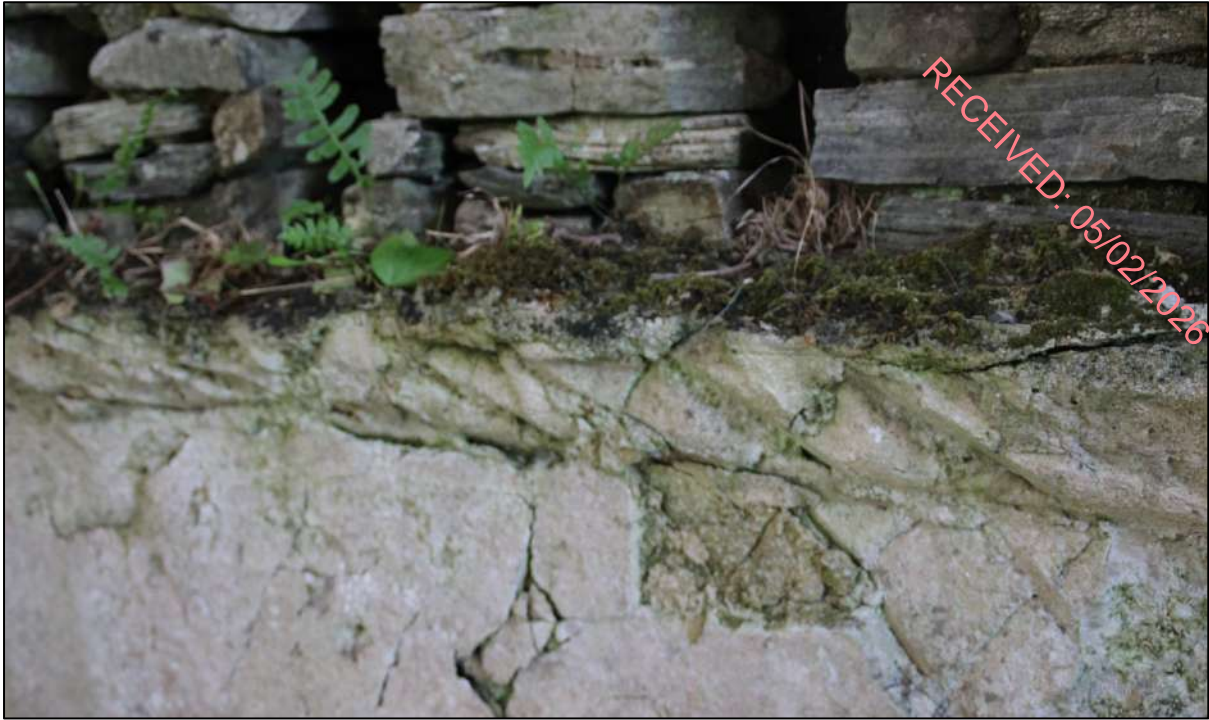
Pl. 12 Detail of the scratch coat band applied to give support to the decorative moulding. This is deeply scored to allow the plaster to grip. Southern wall, ground floor.

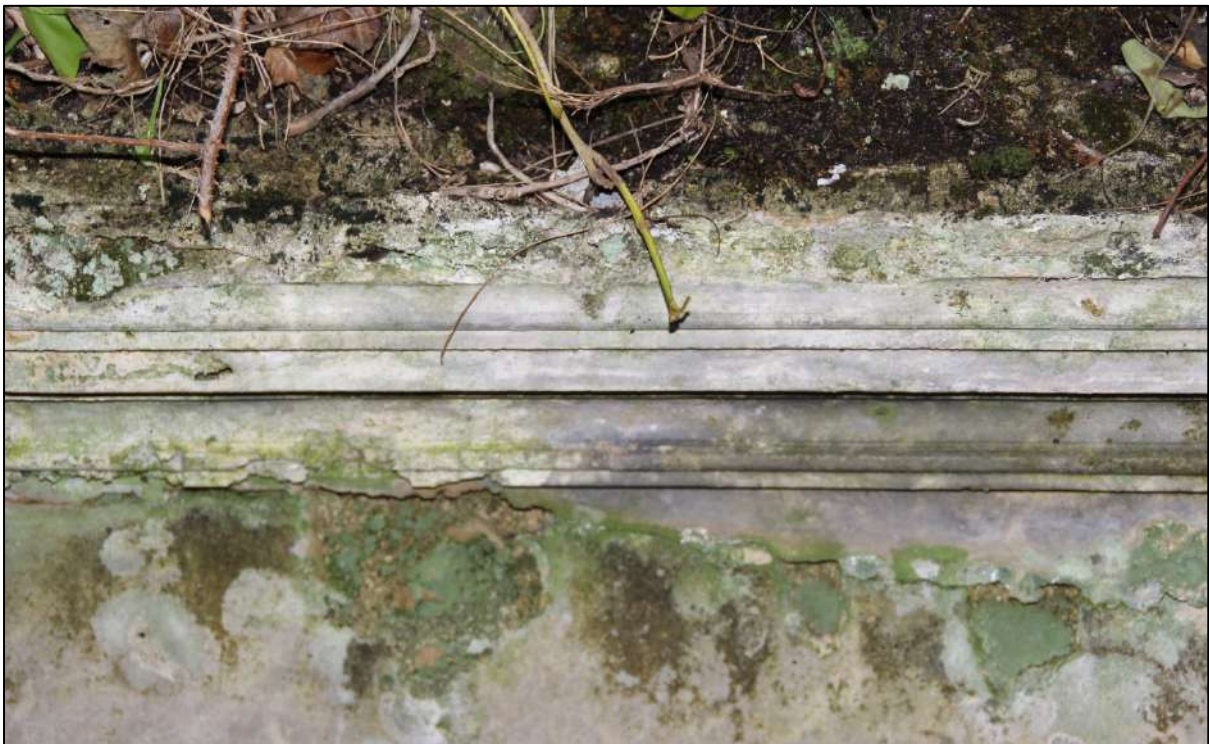
Pl. 13 Detail of the moulding on the northern wall, north-western corner. This is one of the best surviving sections.

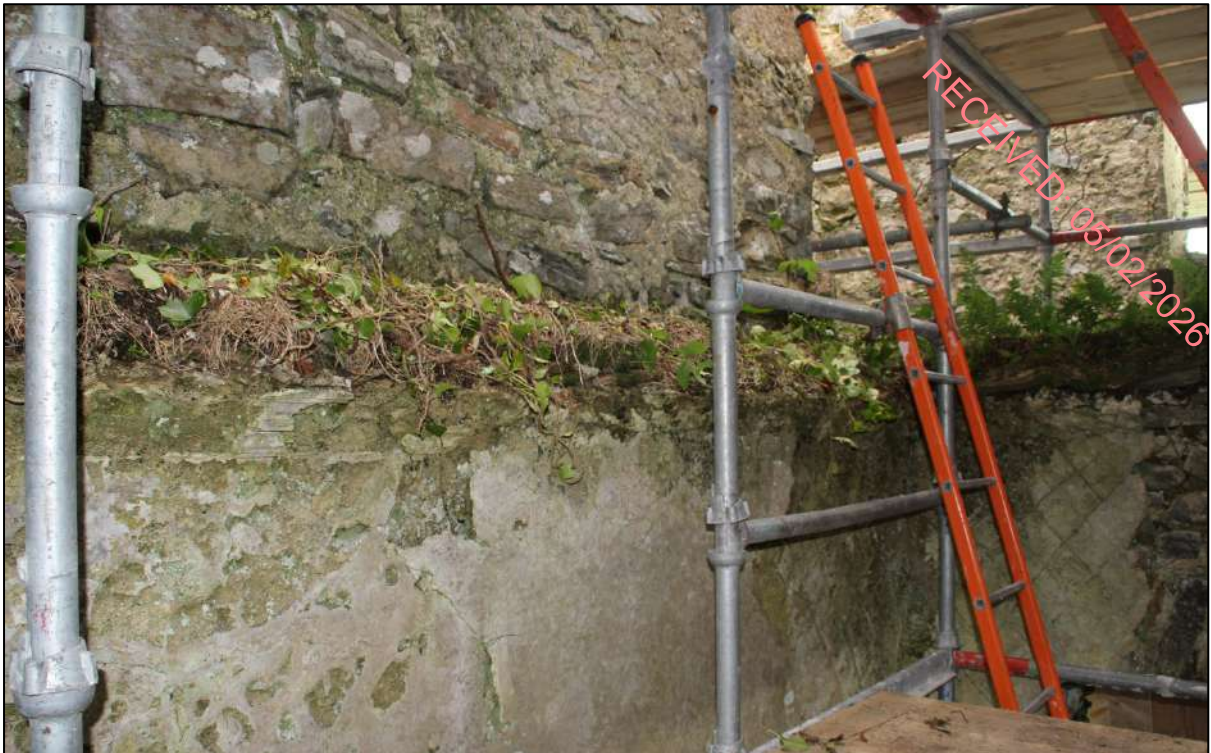
Pl. 14 The moulding on the northern wall of the ground floor chamber. Most of this is in poor condition.

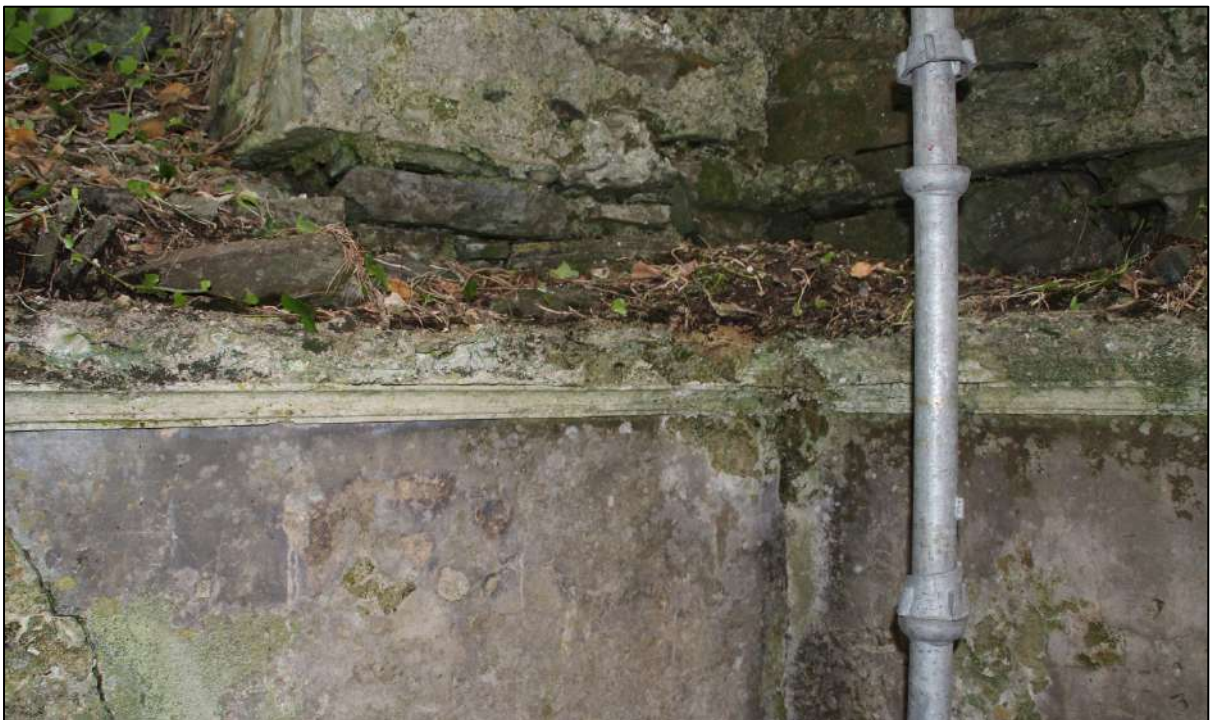
Pl. 15 Moulding detail in the north-west corner of the ground floor chamber. Note how the upper part of the moulding has fallen away.

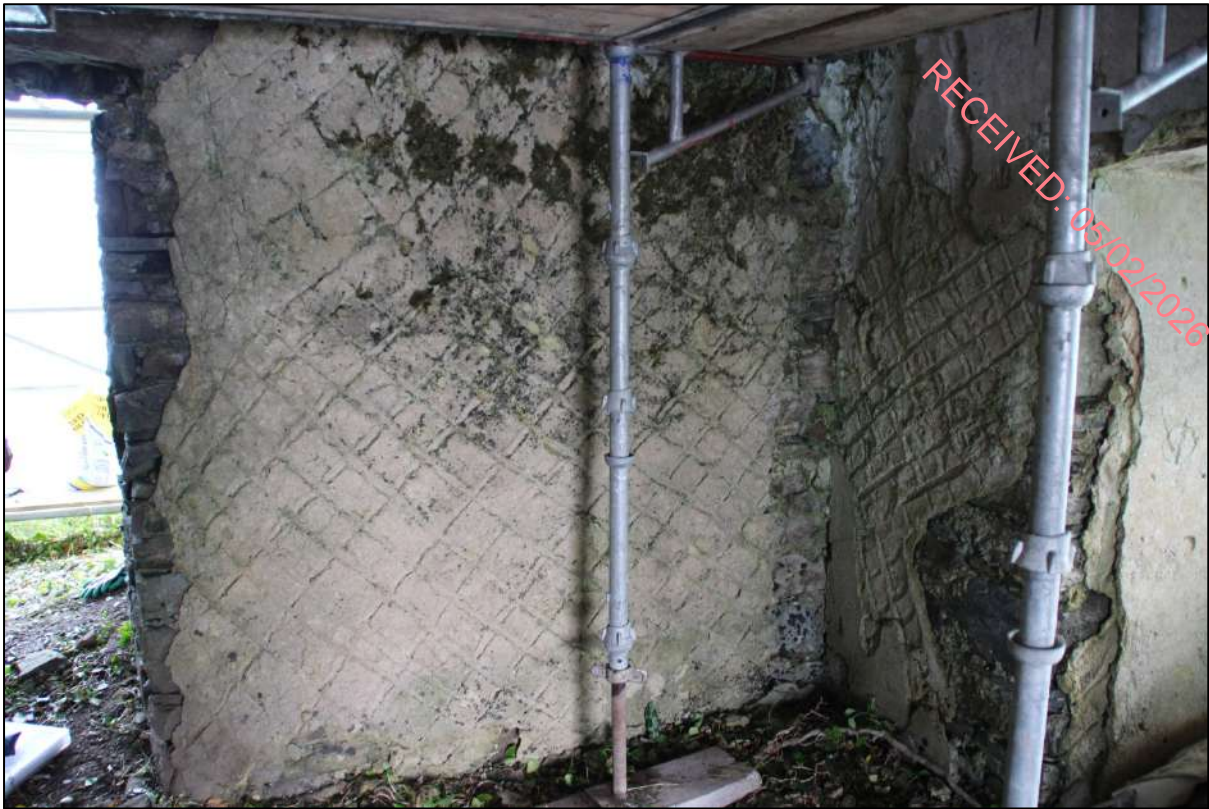
Pl. 16 The scratch coat that lay under the plaster top coat exposed, this finish can be seen on the southern window embrasure on the far right. East face of internal wall of tower house.

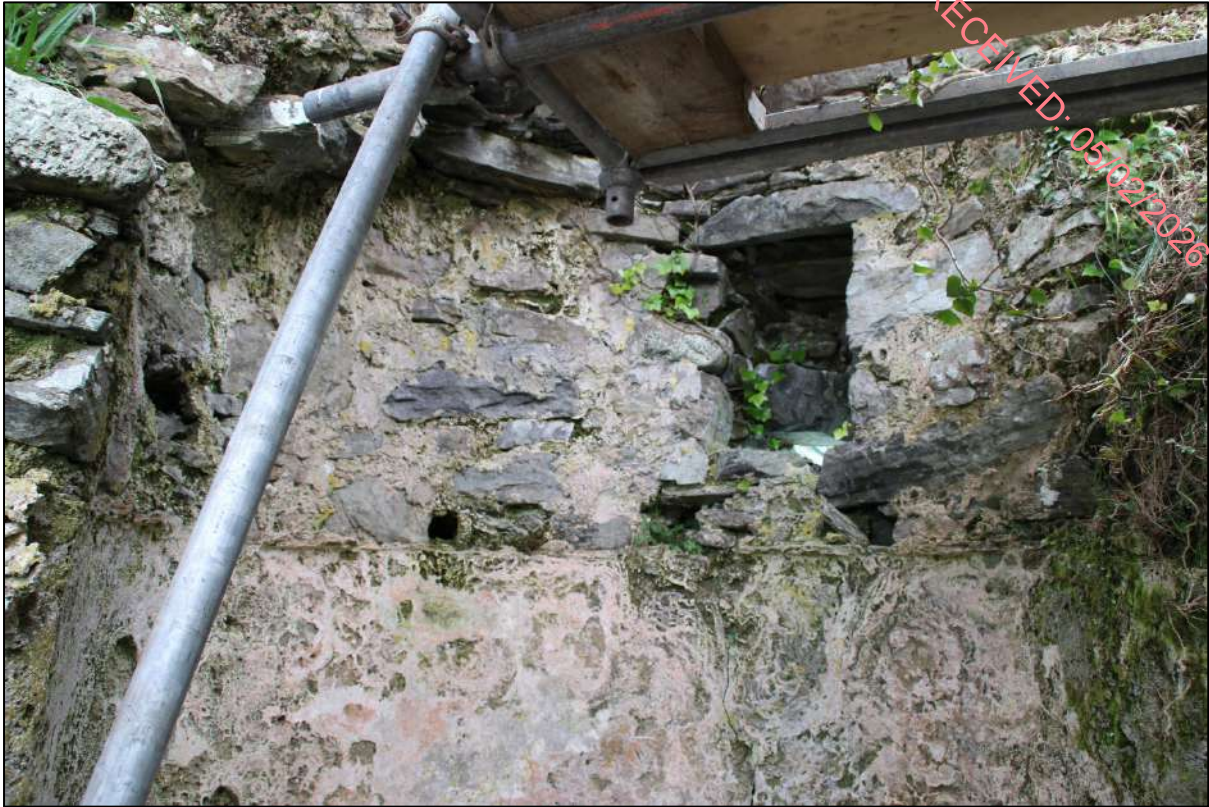
Pl. 18 The upper part of the stairwell. Note the plaster coat on the lower part of the photograph. The small holes held the timbers that supported the ceiling. The small opening is likely to be associated with the late-medieval occupation of the tower house.

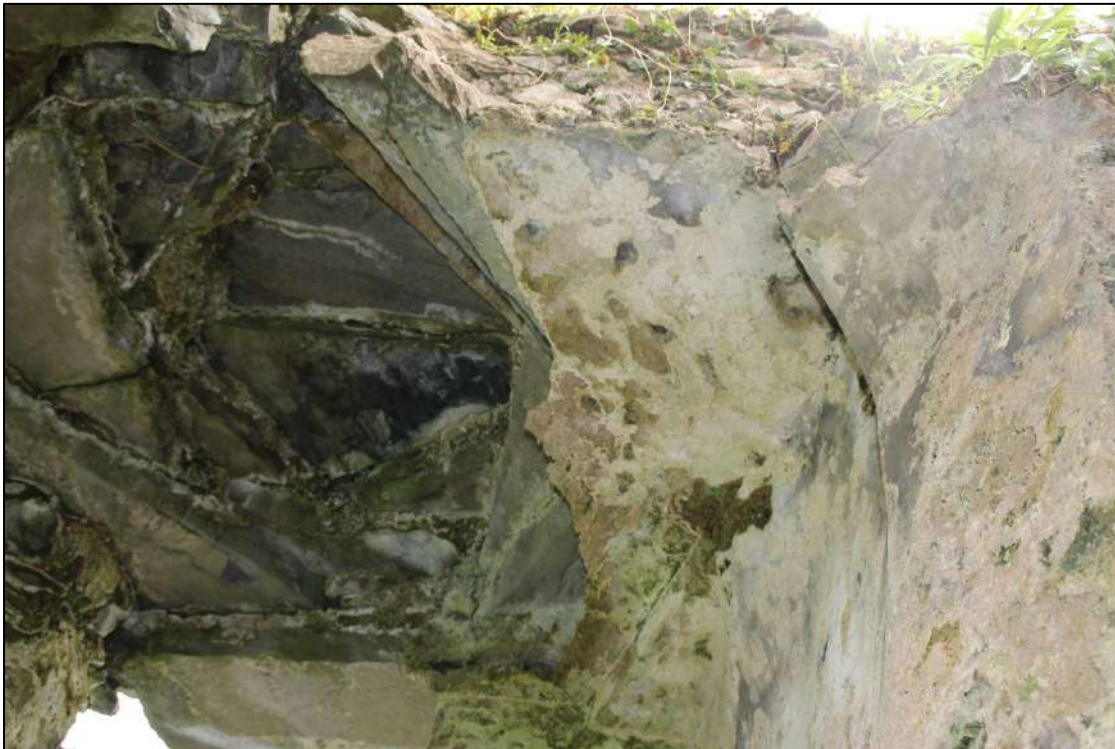
Pl. 19 The roof of the room containing the oriel window. This was entered through a doorway with an arched head, the remains of which are visible on right. There was a flat

plaster ceiling, the remnants of which can be seen in the centre of the photograph. This was supported by a timber at the base of the corbelling.

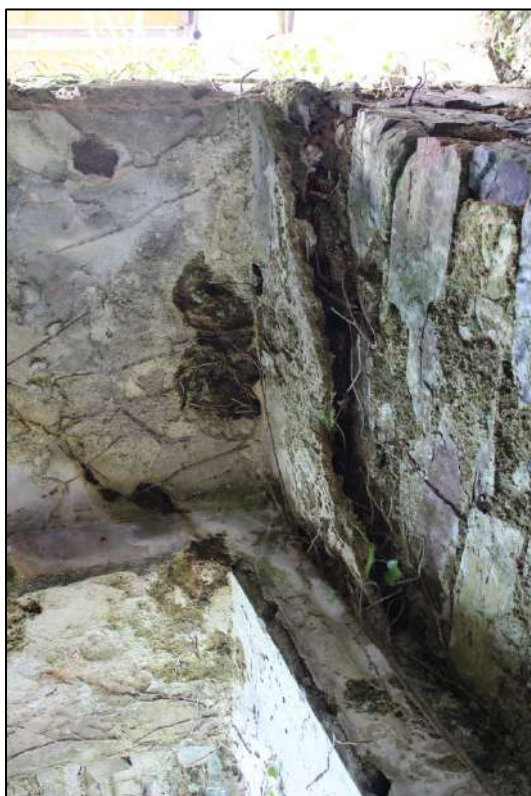
PI. 20 While there are very scant remains of any plaster on the walls of the first floor chamber, it is present on northern side and top of the western window embrasure.

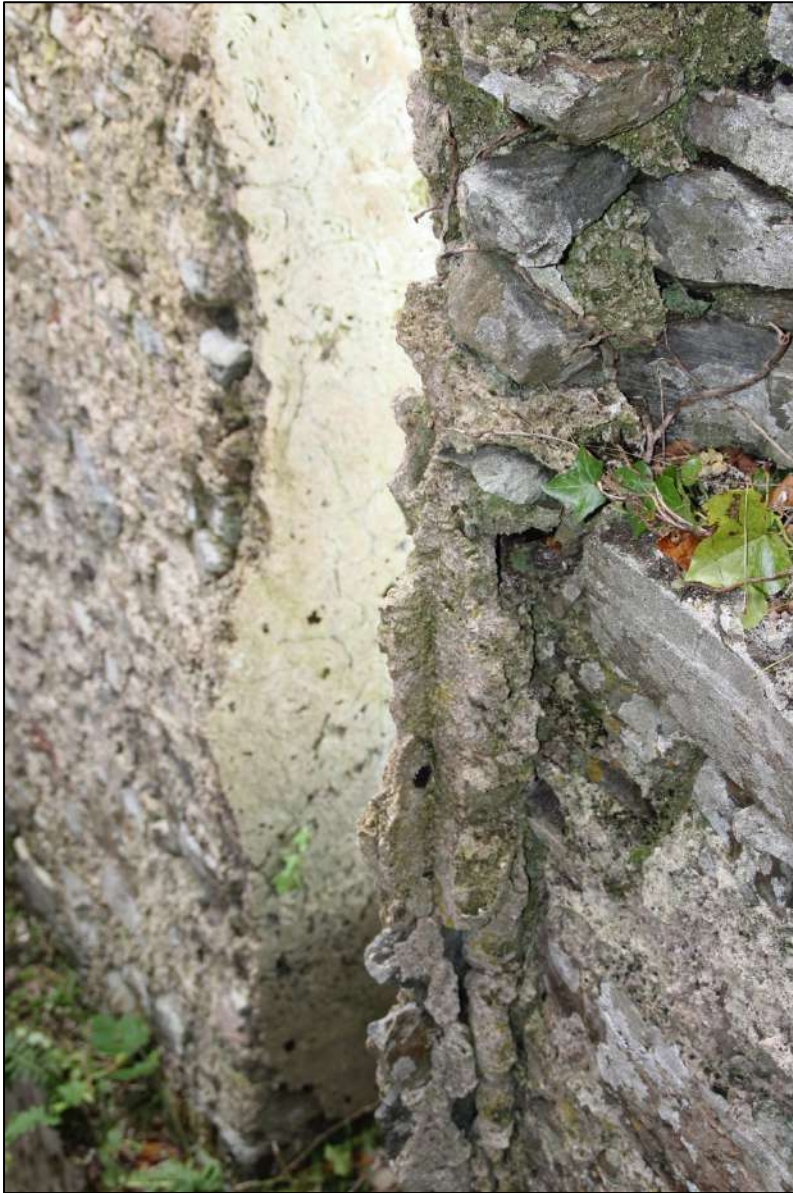
Pl. 21 Impression of a timber upright in the plaster on the southern side of the eastern window at first floor level. The wall on the left of the window is thinner, having been rebuilt.

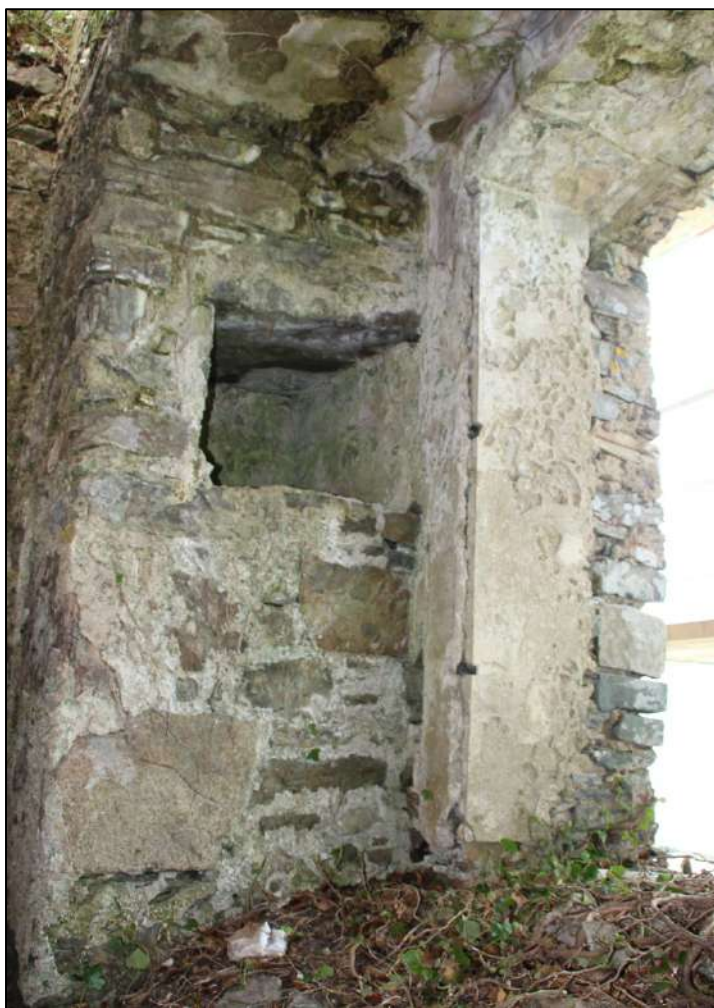
Pl. 22 Southern side of western window embrasure, first floor. Note the impression of a timber corner bead on the inner side of the reveal. The holes on the edge mark where timber plugs were used to attach the beading to the stonework.
