Descriptive and photographic report
on
Ballynahinch Tower House
decorative plasterwork

Ballynahinch,
Recess,
Connemara,
Co. Galway

CLIENT : Yelsea Ltd.,
c/o de Blacam and Meagher Architects,
4 St. Catherine's Lane West,
Dublin 4.

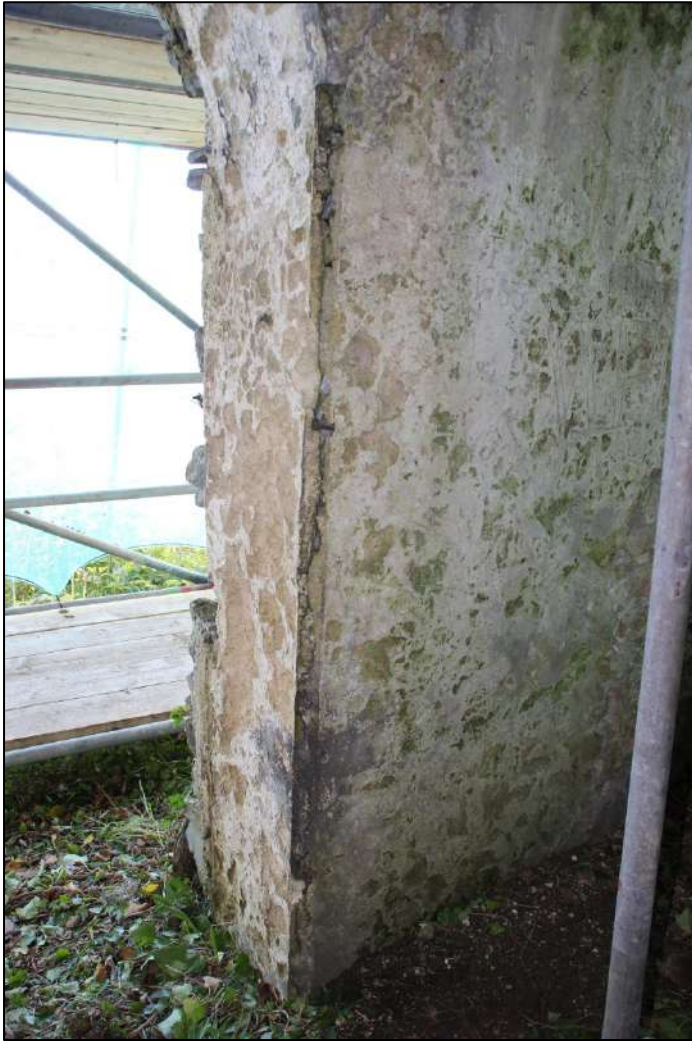
Pl. 23 This is the southern side of the main entrance where the impression of the corner beading can be seen.

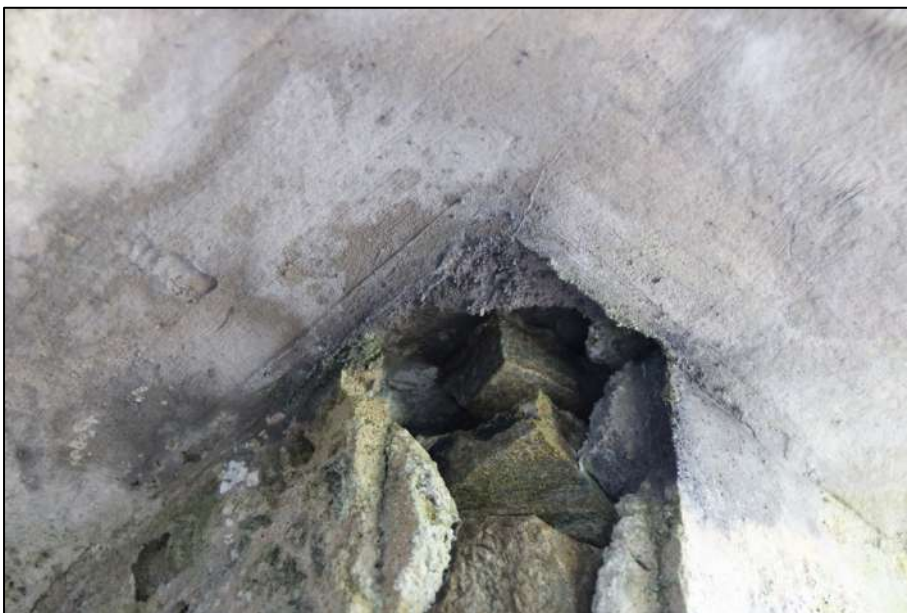
Pl. 24 Detail of corner beading, south side of western window embrasure, ground floor.

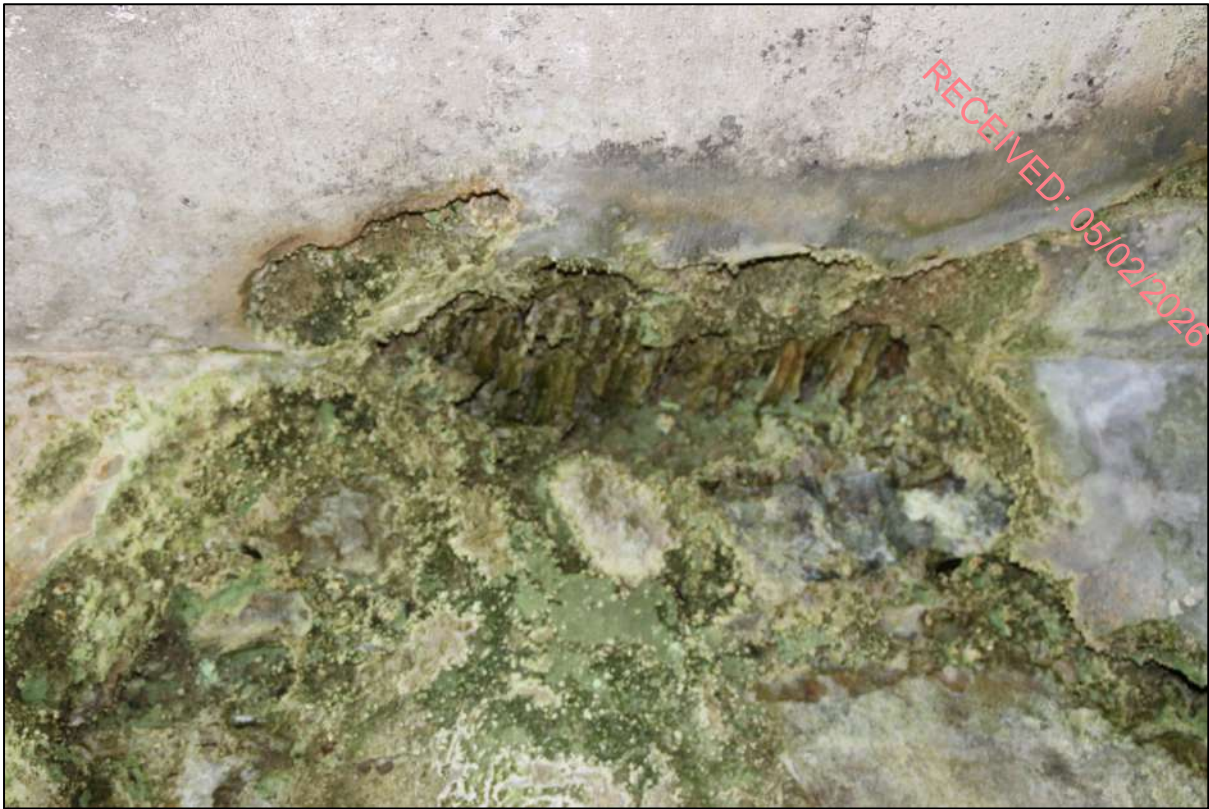
The only other evidence to be gleaned from examining the plasterwork is the impression of wickerwork centring over the western window embrasure on the ground floor. This is only present in two areas, on opposite sides of the embrasure with the larger, clearer piece on the northern side. This measures 340mm in length by 110mm in width. The other piece is less distinct and is covered by mould. It measures 210mm long by 80mm wide.

Pl. 25 Impression of wickerwork centring for head of embrasure, northern side of western window. This is the best example of this technique visible in the tower house. All examples occur in embrasures.

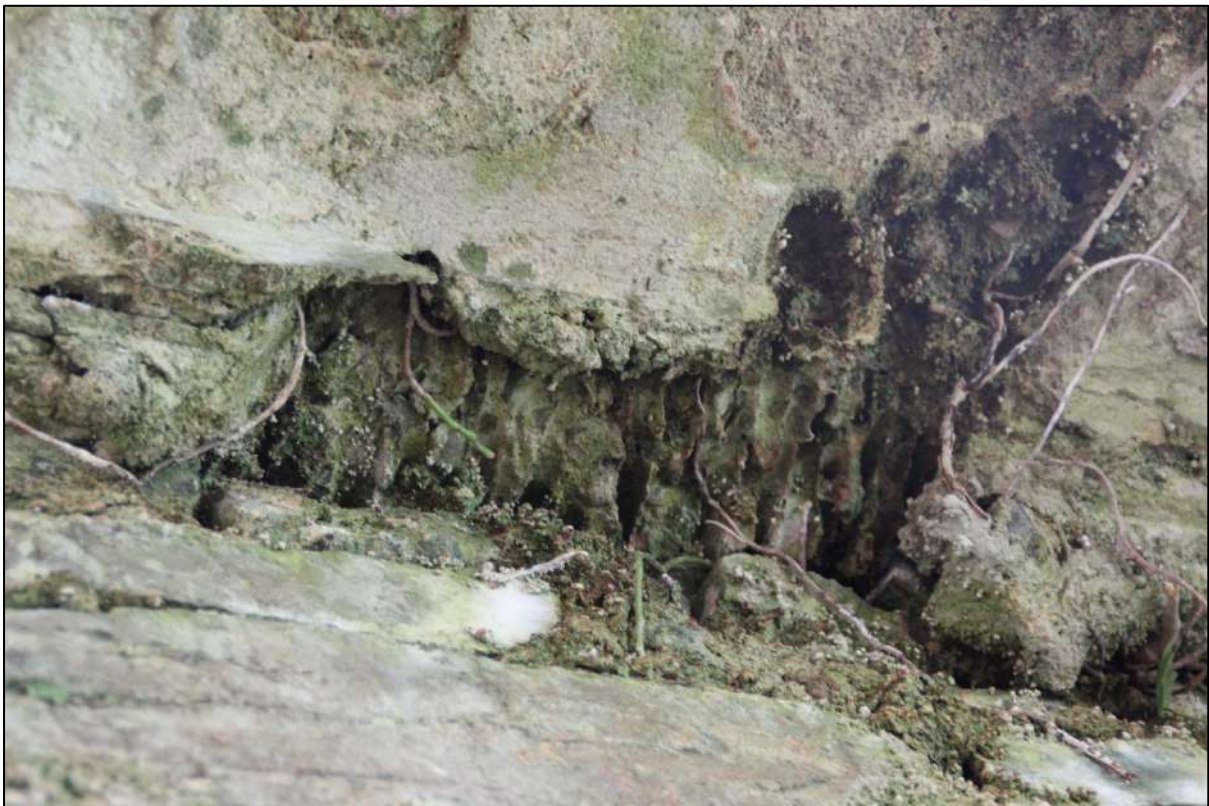
Another small area where wickerwork centring was located is on the southern side of the intrados of the western window embrasure on the first floor. This measured 270mm by 170mm.

Pl. 26 Another example of the preservation of the impression of wickerwork centring for the window embrasure, in this case the southern side of the western window, first floor.

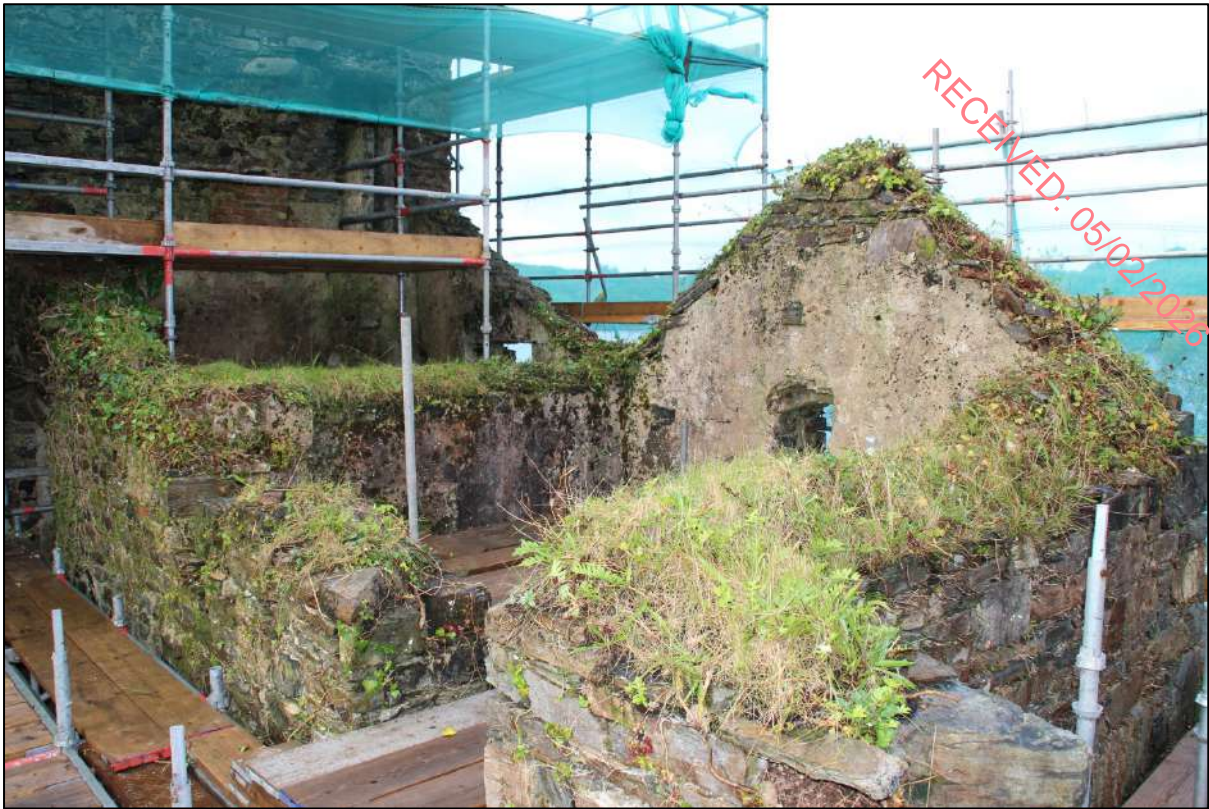
Pl. 27 Plastered surfaces visible in the attic space over the northern kiln, foreground, and the southern kiln, in the background.

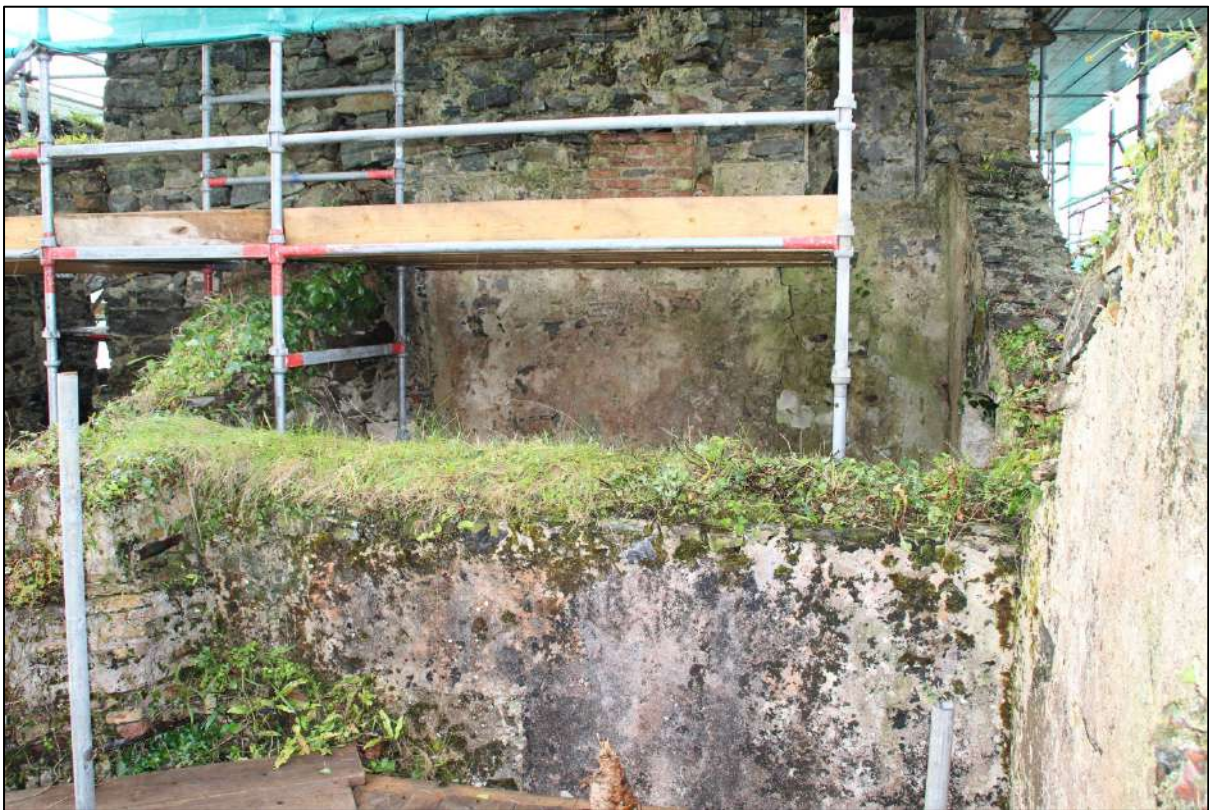
Pl. 28 Another view of the plastered walls of the attic spaces of the two kilns.
