**Conservation Report and  
Architectural Impact Assessment  
For  
Planning Application for Proposed Extension and Alterations to  
Aghadoe House, Knoppoge, Aghadoe  
Killarney, Co. Kerry  
For  
NOMIS AMO Ltd**

Mary O'Connell  
B.Sc. B. Arch. MRIAI  
RIAI Grade II Accredited Conservation Architect

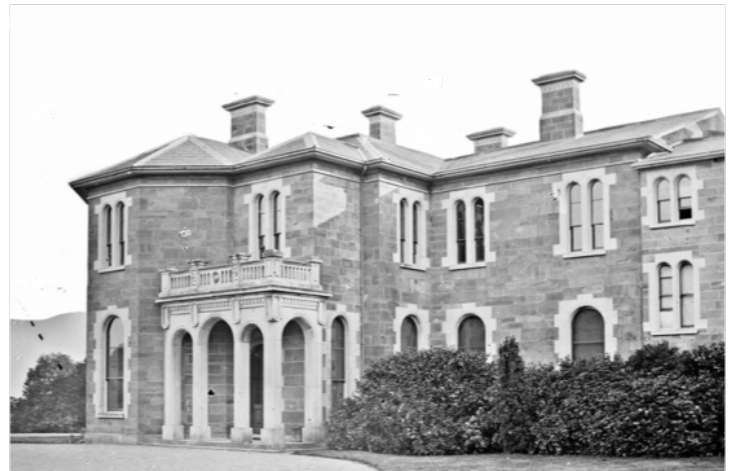
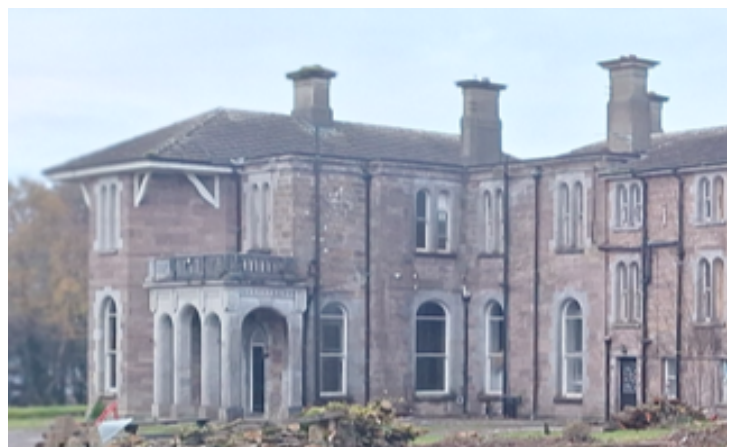
The Triple-arch arcade to the entrance porch (with some structural cracking) with limestone balustrade detailing overhead, along with timber one-over-one pane sliding sash windows and a nine-panel door with fanlight.

Comparison of the entrance portico elevation

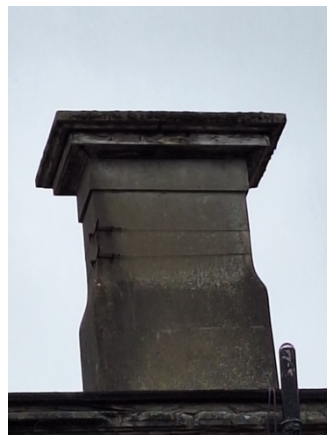
Currently the remaining chimneys h a cementitious render applied and a in poor condition with leaks eviden the attic areas (refer to Appendix 2 Timber Condition Survey)

Existing rendered chimney

- suitable repairs to the chimneys and associated flashings including removal of the cementitious plaster, examination and repair of brickwork (replacement of perished bricks), necessary repairs to flues and lining, inspection of existing cappings and where concrete cappings, replacement with limestone cappings to match original details.
- repairs to the existing roof and suspended floor timbers as per timber condition report recommendations,
- repairs to the older timber sash windows and replacement of any damaged timber lintels or timber supports to later concrete lintels,

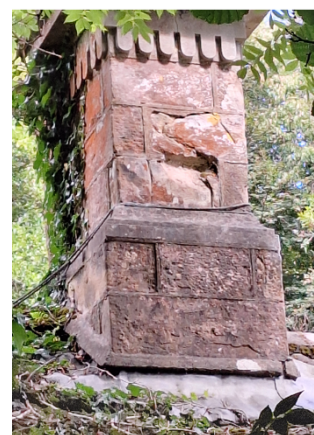
As a reference the chimney to the g lodge (in poor condition) retains th detail.

Existing Chimney to Gate lodge

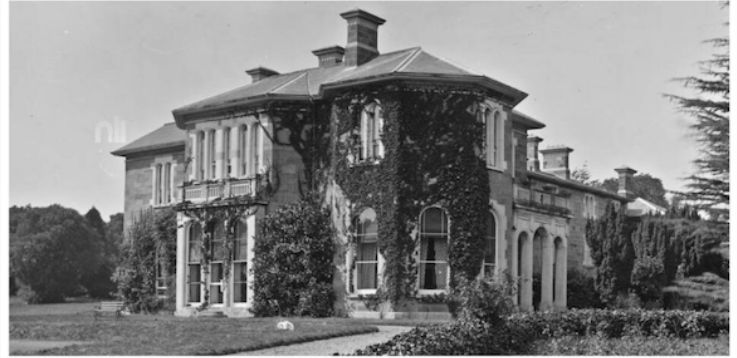
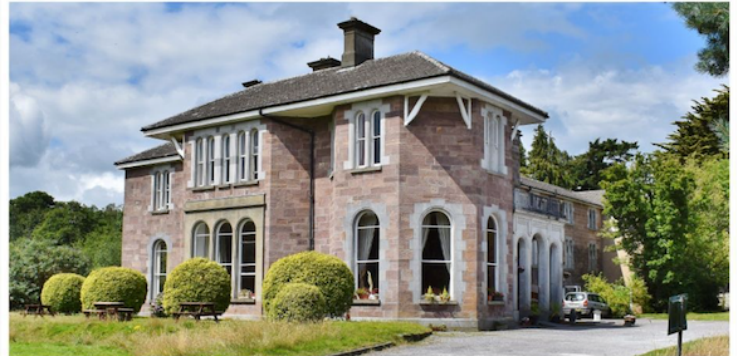
- Originally there was an intricate natural slate roof with hipped details corresponding with the external wall plan on the northeast and south east elevations to the main 2 storey wing.  
This was replaced with a simpler rectangular shaped concrete tiled roof with deep overhangs to the octagonal plan.
- There were originally feature gables with stone plinths to the Southwest Elevation that have been replaced with a simpler hipped roof detail
- The roof to the main staircase had a pitched slate roof with stone plinth detailing – this has been replaced with a flat roof with parapet detail.

Comparison of the south east elevations

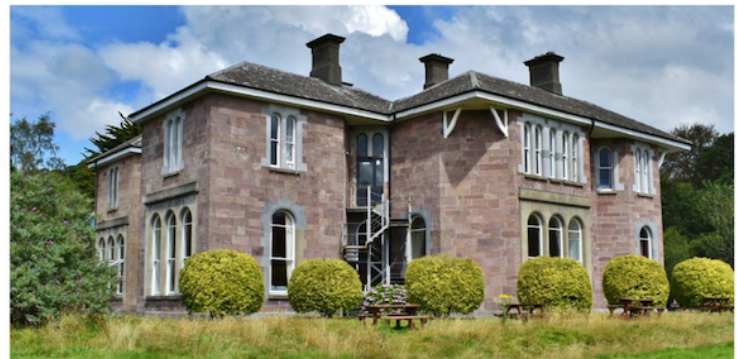
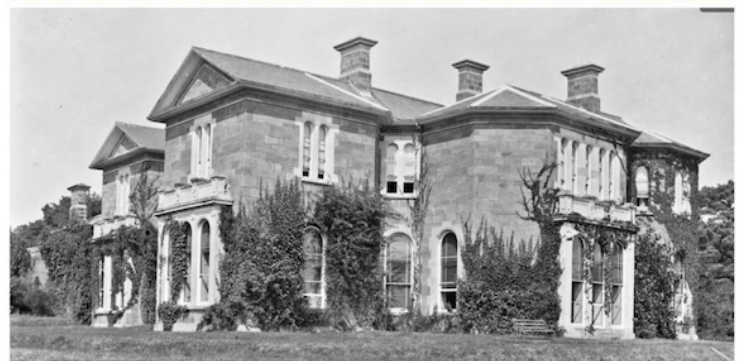
Comparison of the south west elevations

- The ground floor 3 bay window features to the southeast and southwest elevation originally projected beyond the main building with a limestone clad surround and stone balustrade detail similar to the entrance portico. It is assumed there were replaced after the 1922 fire a replica concrete surround within the depth of the existing external all.

It is proposed to reintroduce the original fenestration design with door arrangement to the bay window to the southwest elevation along with the reintroduction of a limestone surround in lieu of the replacement concrete surrounds as per the documented evidence of the Lawrence Photos of 1885-1914.
