Structural Report on Roof Timbers at Aghadoe House, Aghadoe, Co.Kerry

Date of Report: 10th September 2025
Clients: Simon Gallivan
Date of Survey: 4th March 2025
Report By: **Adrian Sheehan, Consulting Engineer M.I.E.I.**
Reeks Consulting Engineers Ltd.,
Rock Road,
Killarney,
Co. Kerry.

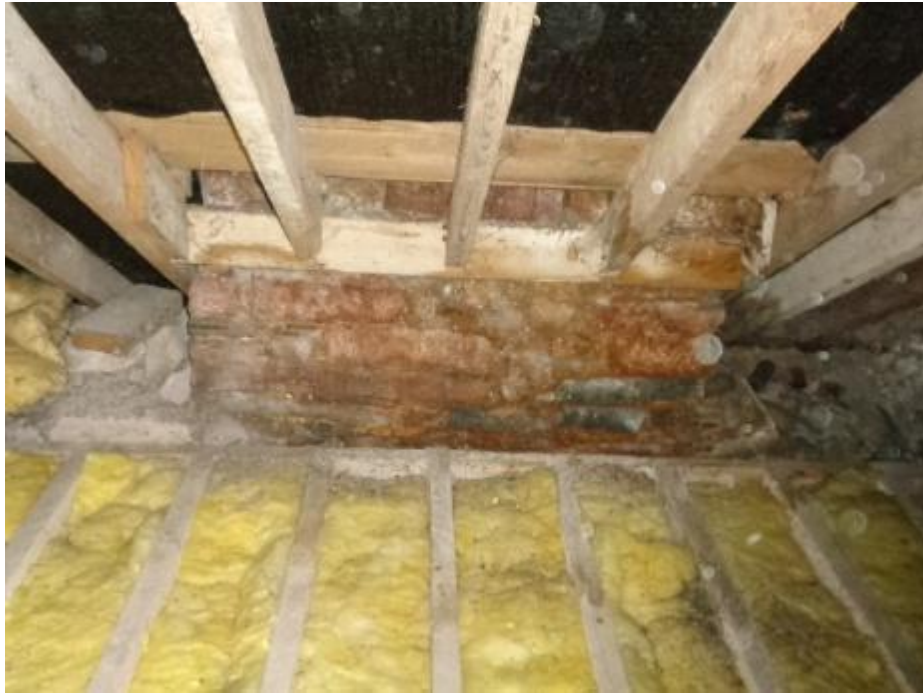
1)

- In assessing the condition of the roof, we noted that the chimneys which are a red brick chimney are completely porous, and this was having a detrimental effect to the timbers which surround same. These timbers will need to be removed in their entirety. (Pictures 1-3).

Photos 1, 2 & 3 show water egress from the chimneys. This has affected the timbers in these areas which will need complete replacement

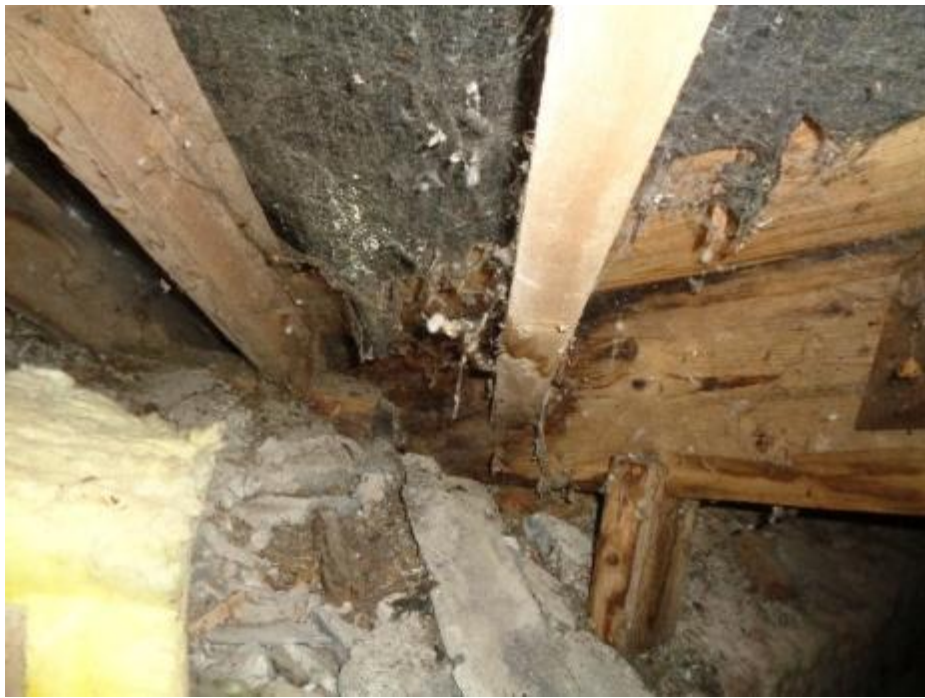
4)

Photos 4-8 show a selection of photos of the valleys and hip which have excessive water egress. This will require complete replacement in the effected areas. This is very prominent in the areas which require complete replacement

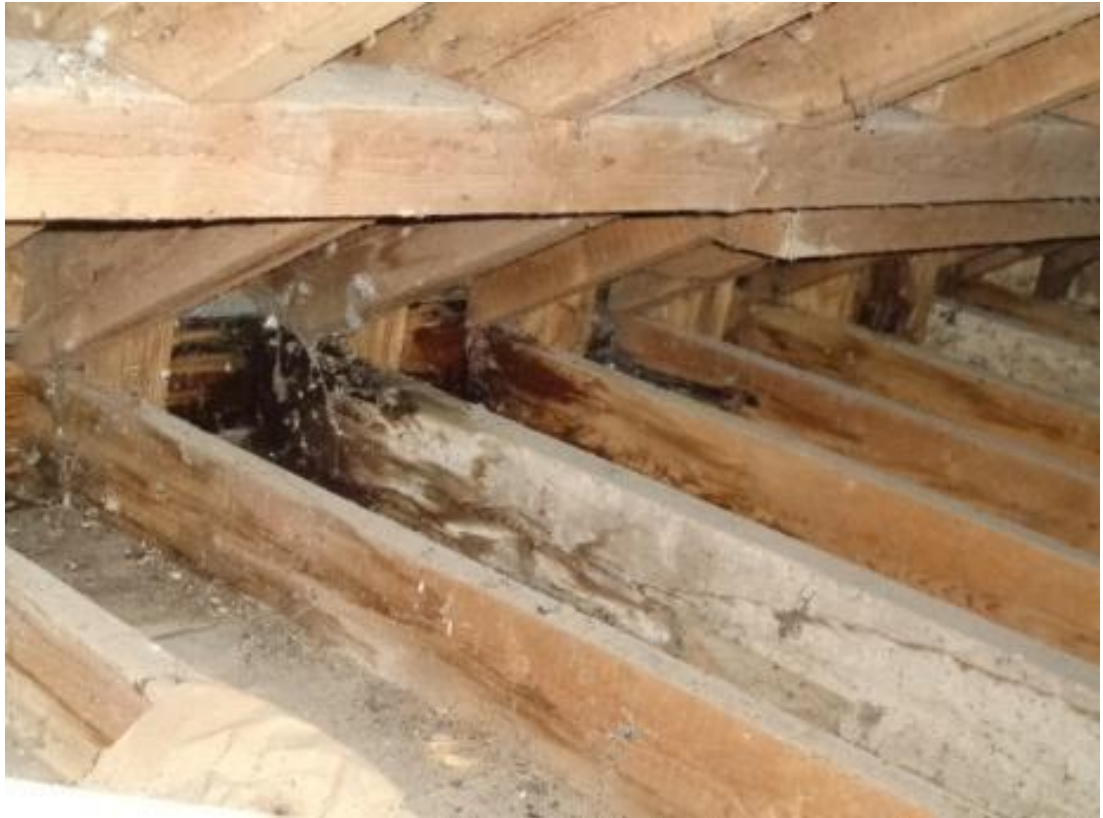
9)

- These particular sections have the majority of the hips and valleys all of which have timber defects as a result of water egress.
- As per photos 9&10, these sections of roofs are also affected at the edges of the rafters & ceiling joists, all of which will need replacing.
- There are timber defects at the wall plate also.

Photos 9&10 show ends of rafters and joists in the section to be replaced which are affected by wet rot. and will require replacement.

A lot of the cause of valleys leaking has been lack of maintenance. The rotting of the fascia & soffits has continued to the rafters & joists as shown in photos 9 & 10.

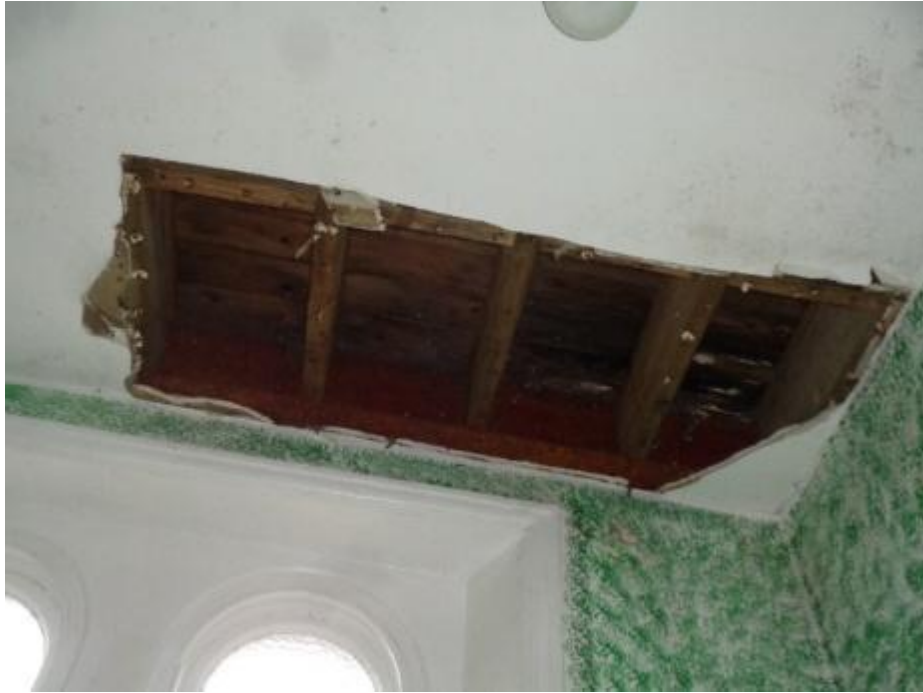
13)

- With regards to the flat roof sections, these have completely failed from a weathering point of view, but more so a structural point of view. This failure is now a major issue in the building. The timbers are rotten and will need immediate attention to prevent water entering the building causing damage to internal joinery such as stairs and walls.

The flat roof sections have completely failed and require complete replacement. This is common for flat roofs in any case.
