2 INTRODUCTION

Ecology Research and Solutions have undertaken extensive bat surveys on a private dwelling in Aghadoe, House, Knoppoge, Aghadoe, Killarney, Co. Kerry. The building is a protected structure. It is listed in the Kerry County Development Plan 2022-2028 Record of Protected Structures (RPS) under the reference number 2130661. The building has recently changed ownership, with the new owners to seeking to carry out conservation and renovation works on the building, in order to make it their family home. Along with extensive internal works and demolitions, there are planned upgrades and rebuilds to the many roofs of the building, to rectify that damage that has occurred over the years due to a lack of maintenance.

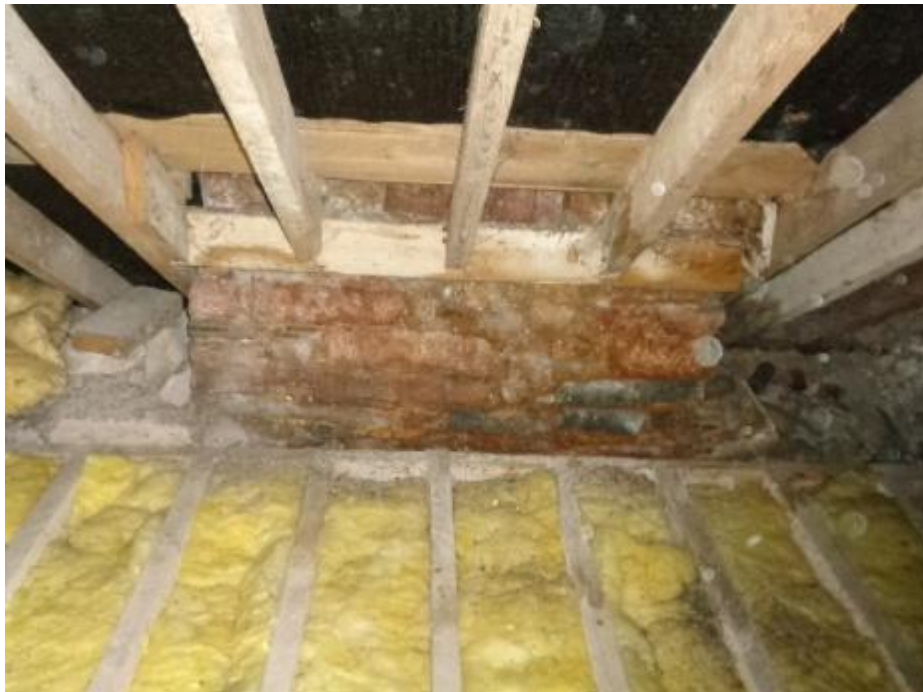
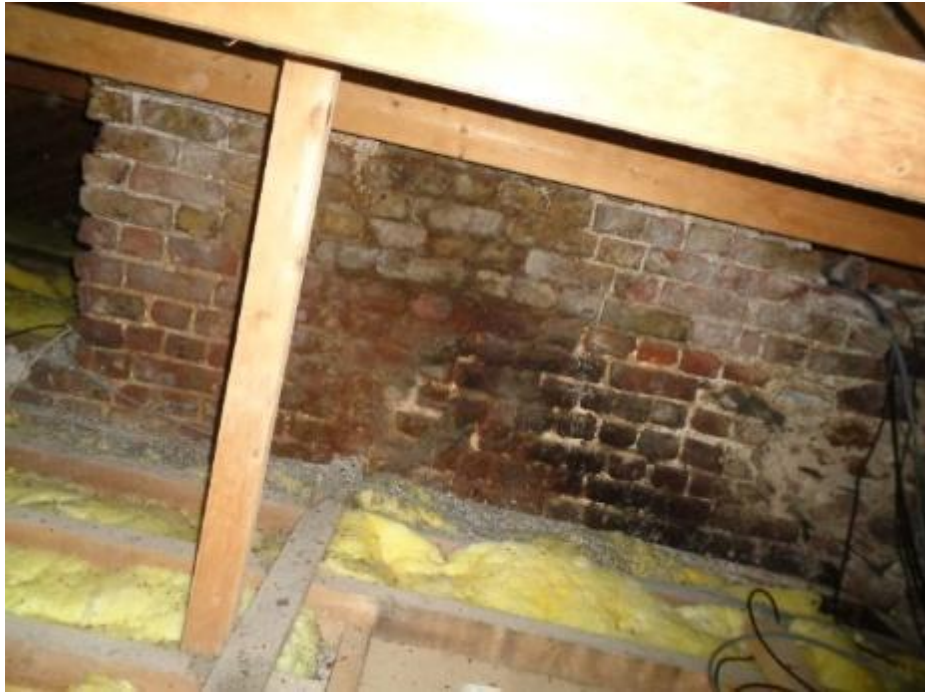
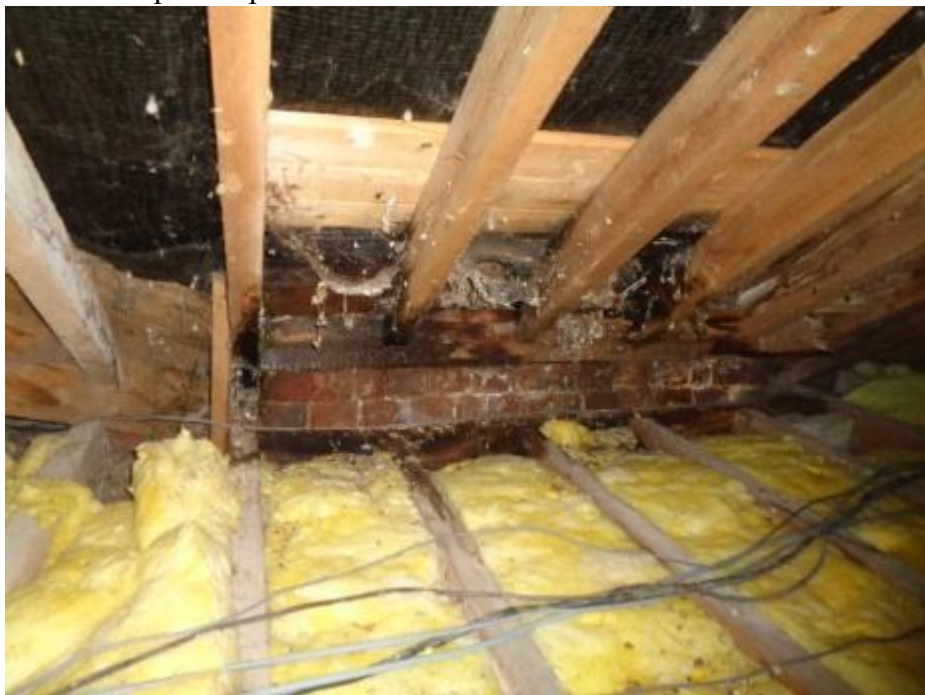
Photos 1, 2 & 3 show water egress from the chimneys. This has affected the timbers in these areas which will need complete replacement

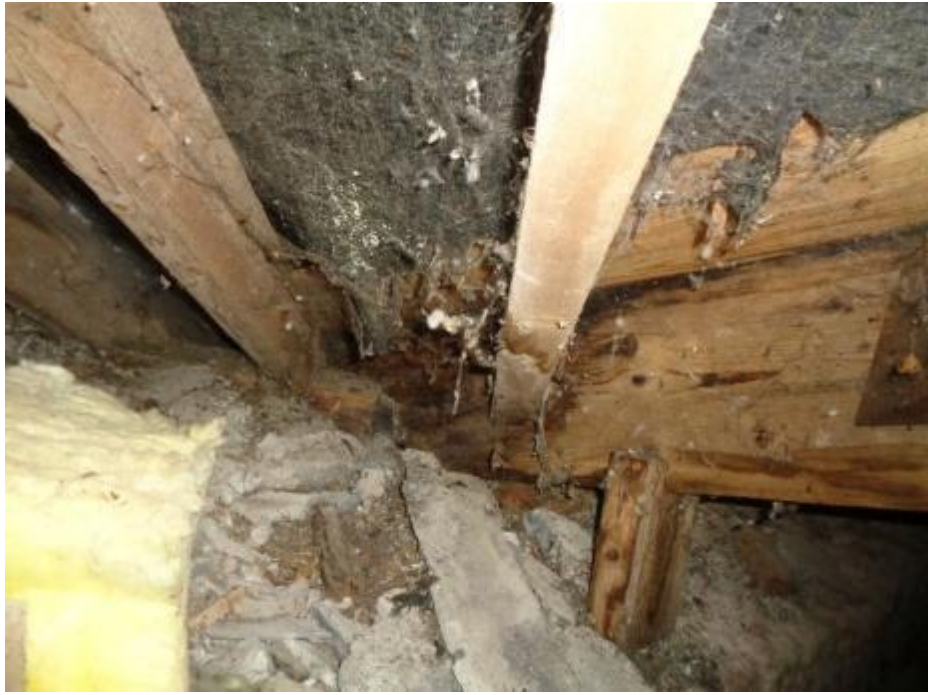
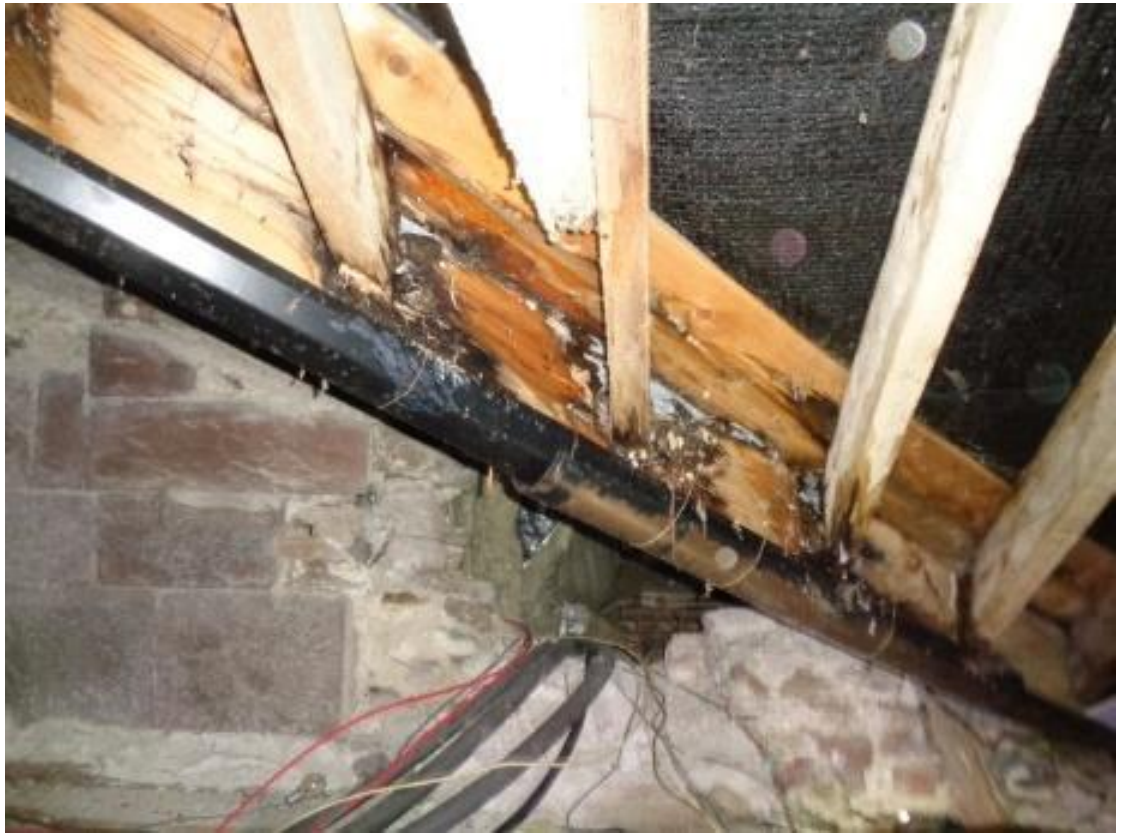
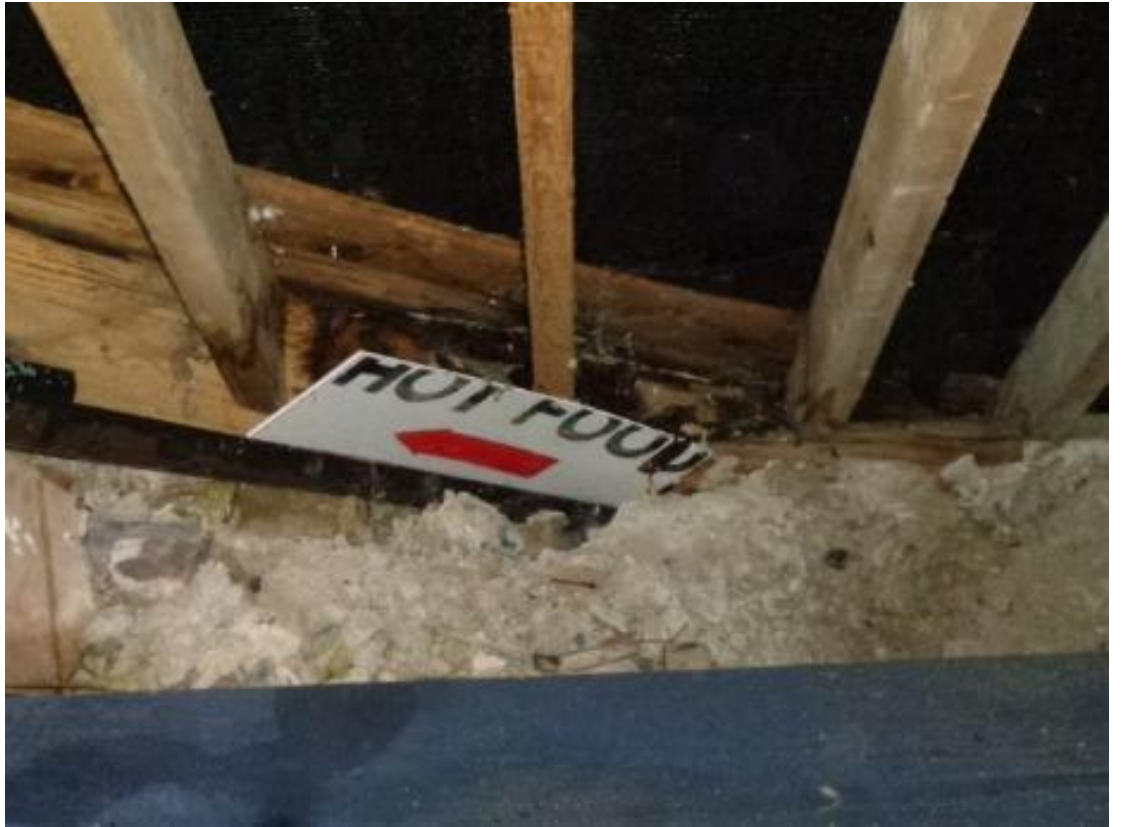
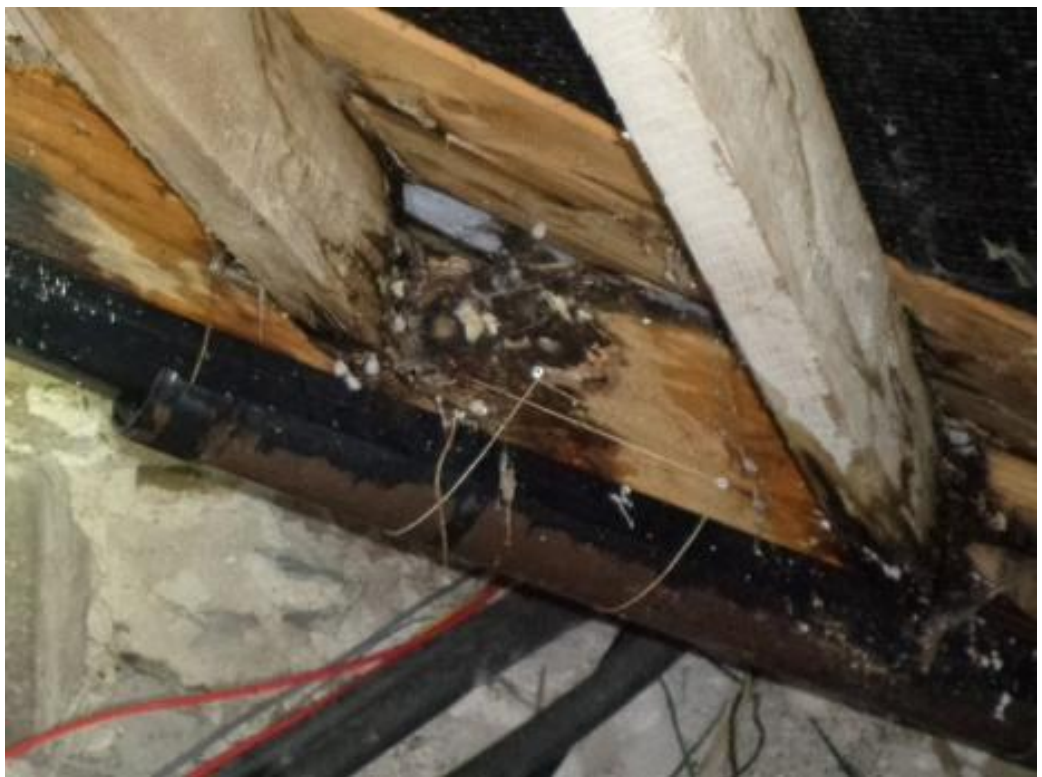
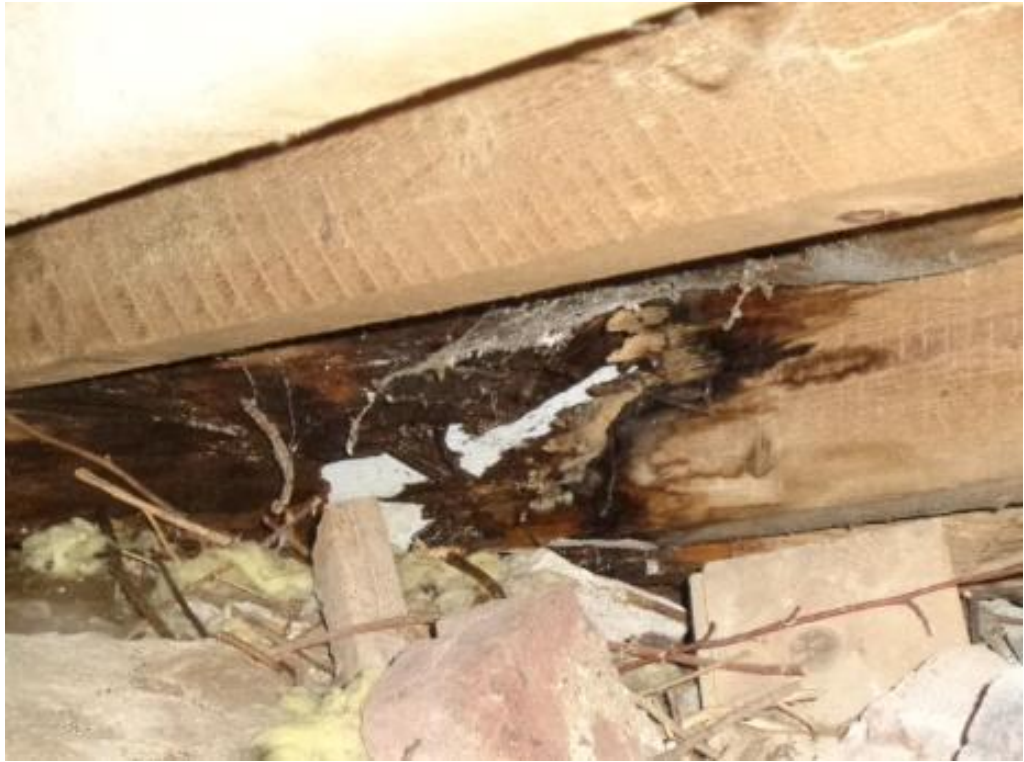
Photos 4-8 show a selection of photos of the valleys and hip which have excessive water egress. This will require complete replacement in the affected areas. This is very prominent in the areas which require complete replacement.

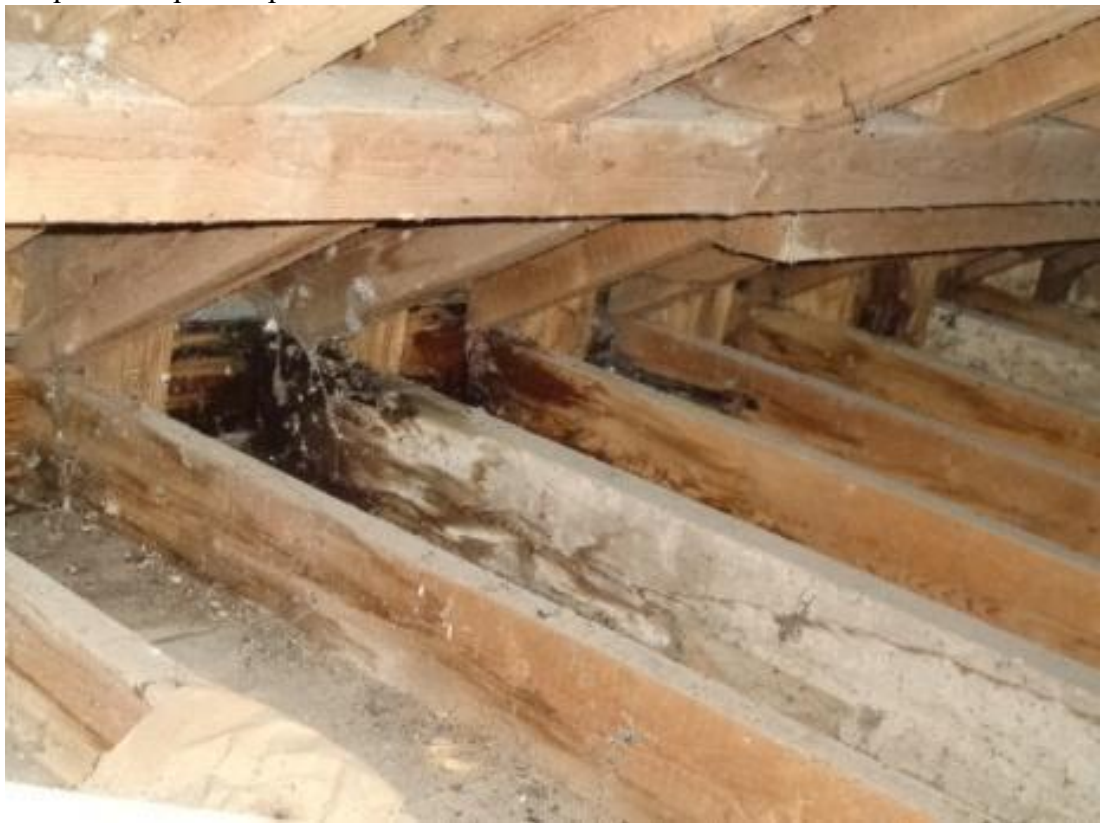
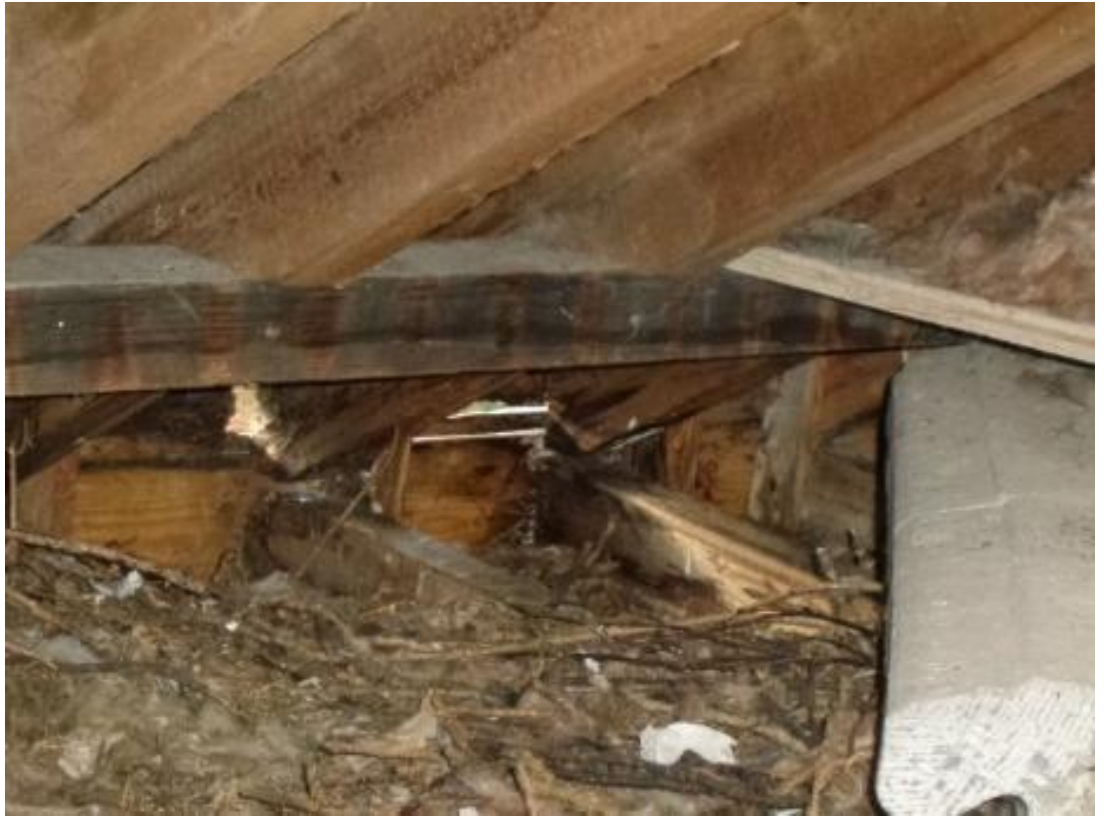
Photos 9&10 show ends of rafters and joists in the section to be replaced which are affected by wet rot. and will require replacement.

A lot of the cause of valleys leaking has been lack of maintenance. The rotting of the fascia & soffits has continued to the rafters & joists as shown in photos 9 & 10.

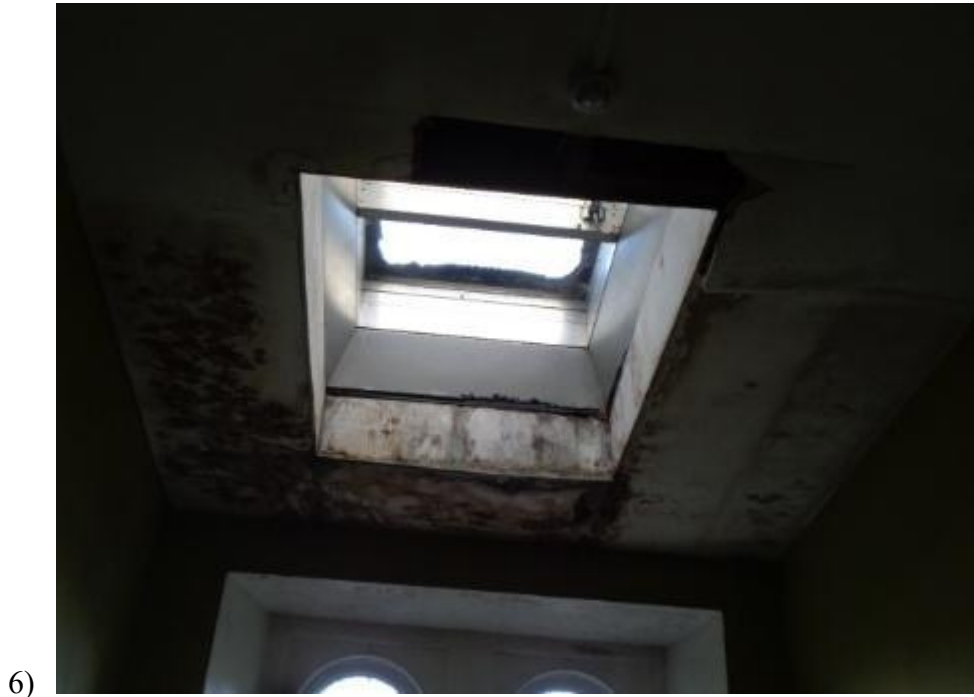
The flat roof sections have completely failed and requires complete replacement. This is common for flat roofs in any case.

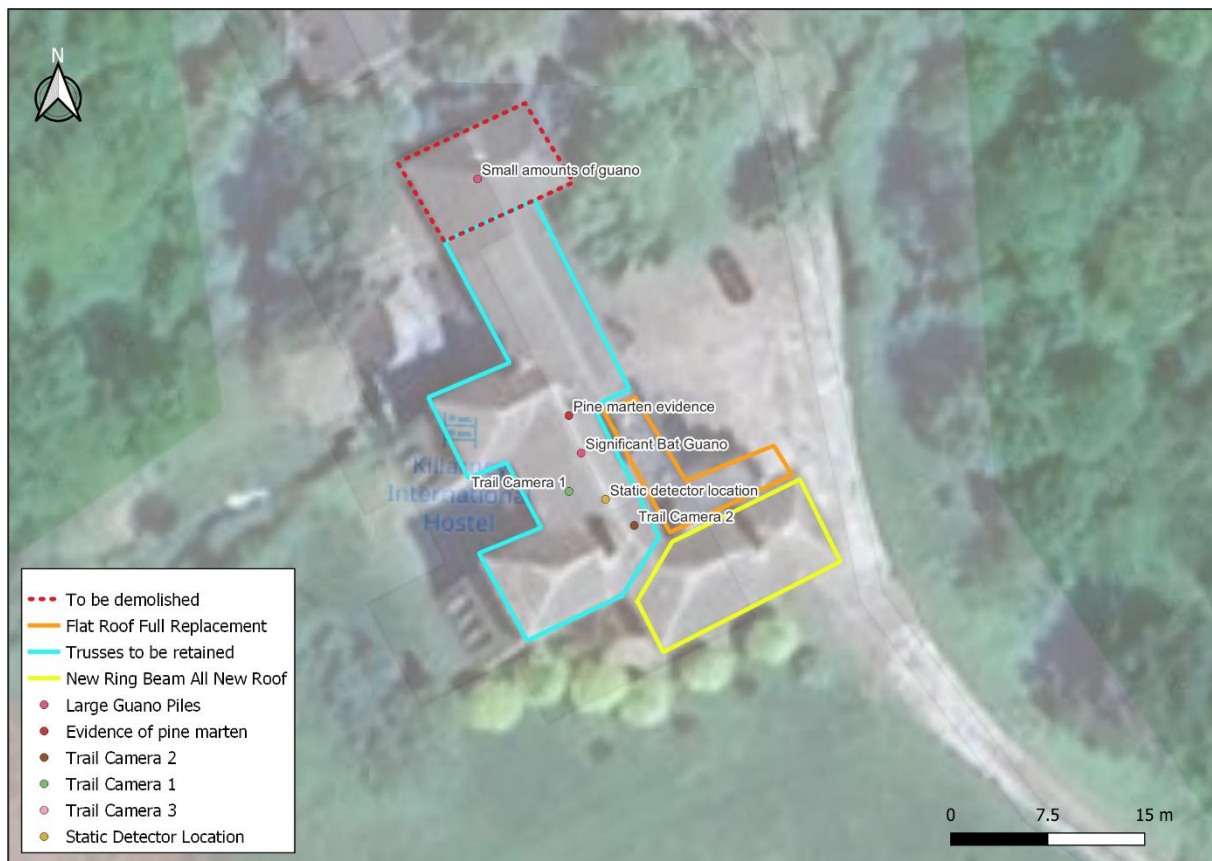
Figure 4. Location of bat droppings found, and positions of detection equipment.

- Leisler's bat (*N. leisleri*)
- **Manual search:** Moderate accumulations of droppings found in the southern attic of an added extension (highlighted in blue in figure 4), smaller quantities in the northern attic of added extension (highlighted in red-dash in figure 4). Droppings varied in age, with some fresh, indicating recent use. No evidence of roosting in the Lodge or Gate Lodge.

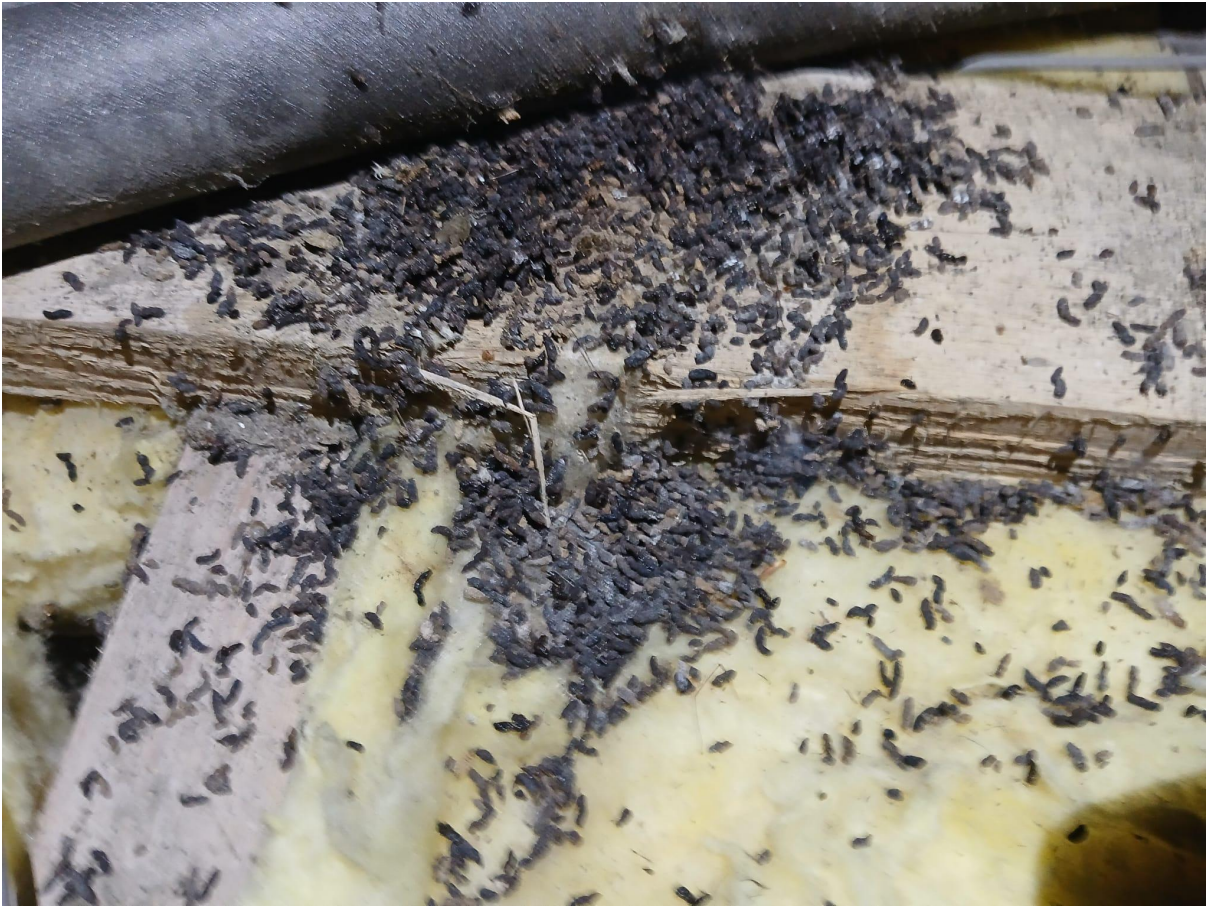
Figure 5. Significant piles of bat droppings.

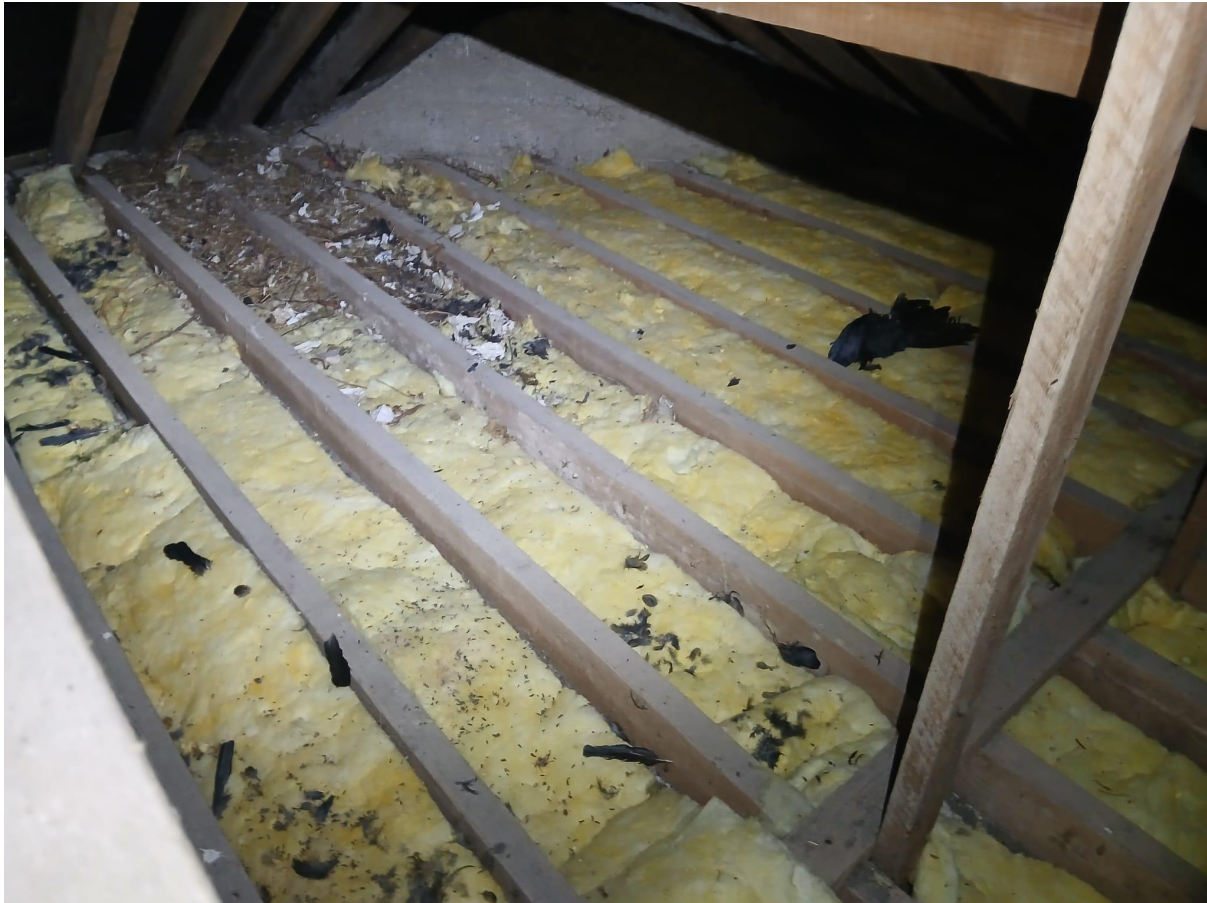
- **Other species:** Pine marten (*Martes martes*) evidence found in the attic (scat, bones, crow remains). Predation pressure may explain limited bat presence despite suitable conditions.

Figure 6. Evidence of pine martin. Crow feathers and scat were found.

Surveys found evidence of pine marten in the attic. The planned works will close the large openings currently allowing pine marten access, reducing predation pressure and making the roost environment safer and more attractive to bats in the long term.
