TEICNIUIL-PRIORY CONSULTING ENGINEERS Ltd

Photographic Schedule

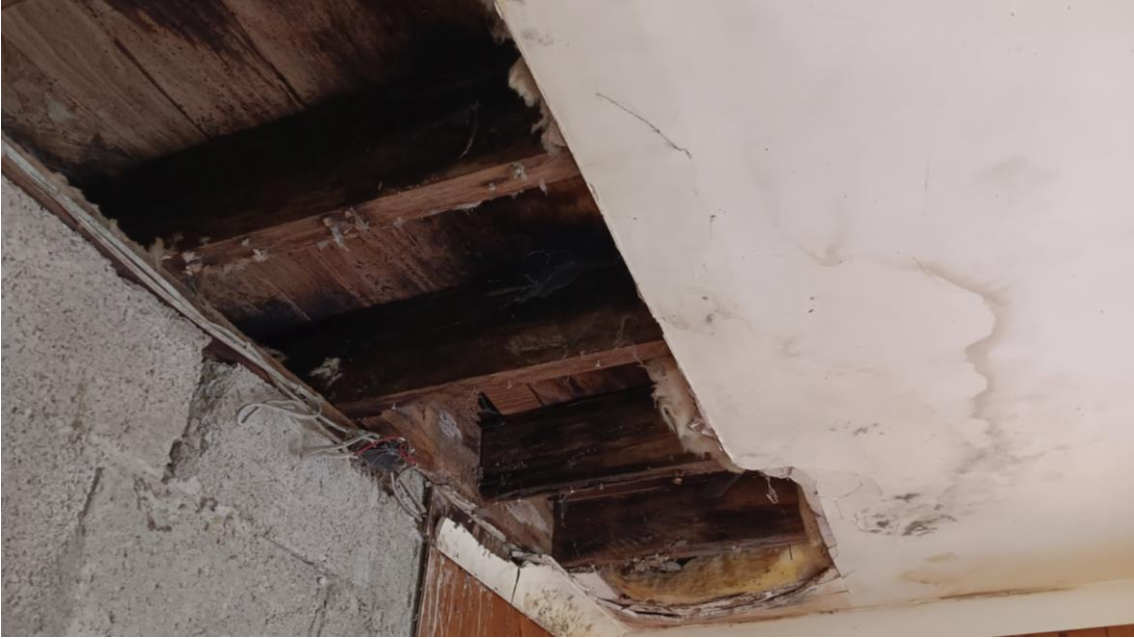
Photo 1 – Rotten timber joists (within flat roof) - incorrect and inadequate bearing – signs of wet rot (cuboidal cracking) and fungal growth – joists visibly wet. Irreparable Structural damage to joists.

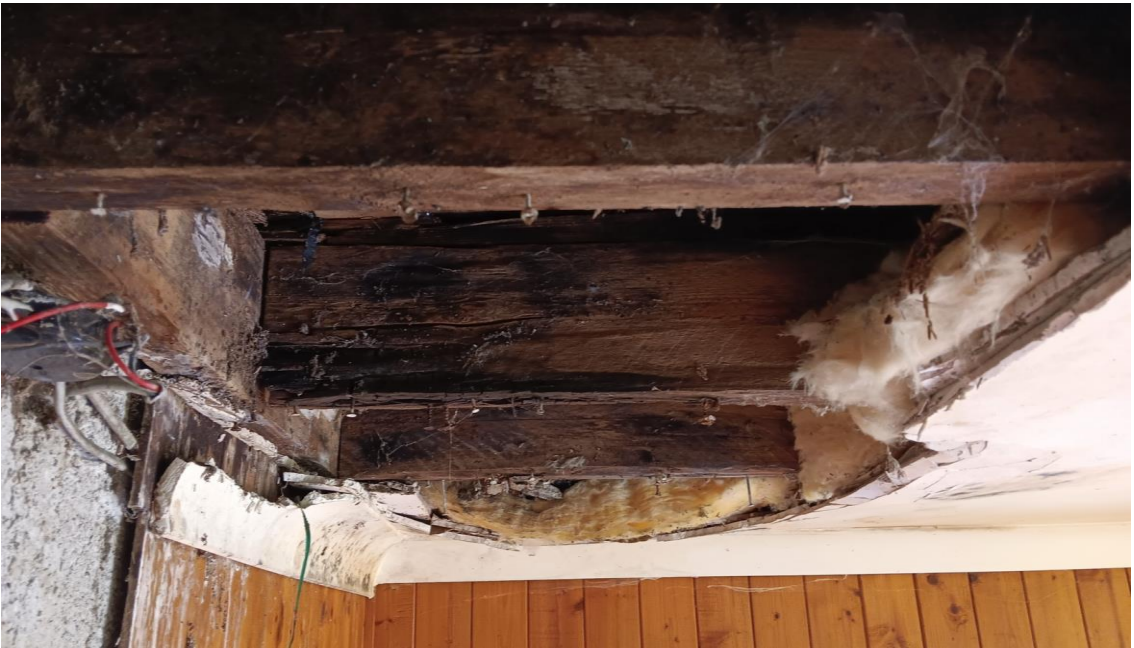
Photo 2 – flat roof over hall. Rotten / wet timber joists – inadequate fixing of joists to trimmer joist.

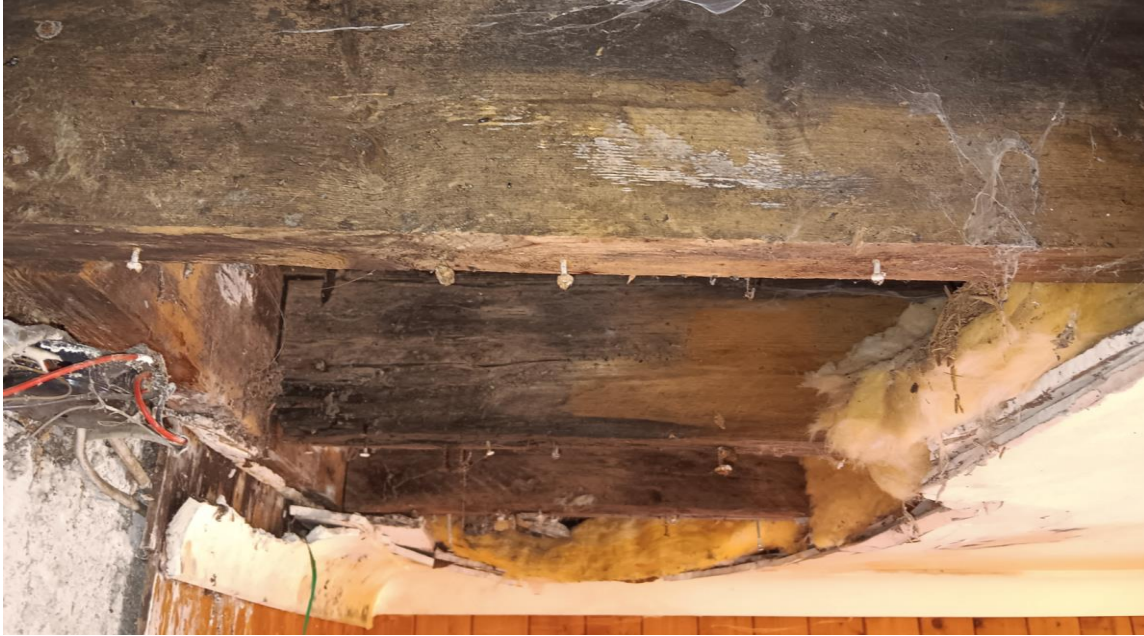
Photo 3 – ‘White rot’ visible on joists. Incorrect fixing to trimmer joist – Structural cracking noted and joists now structurally defective.

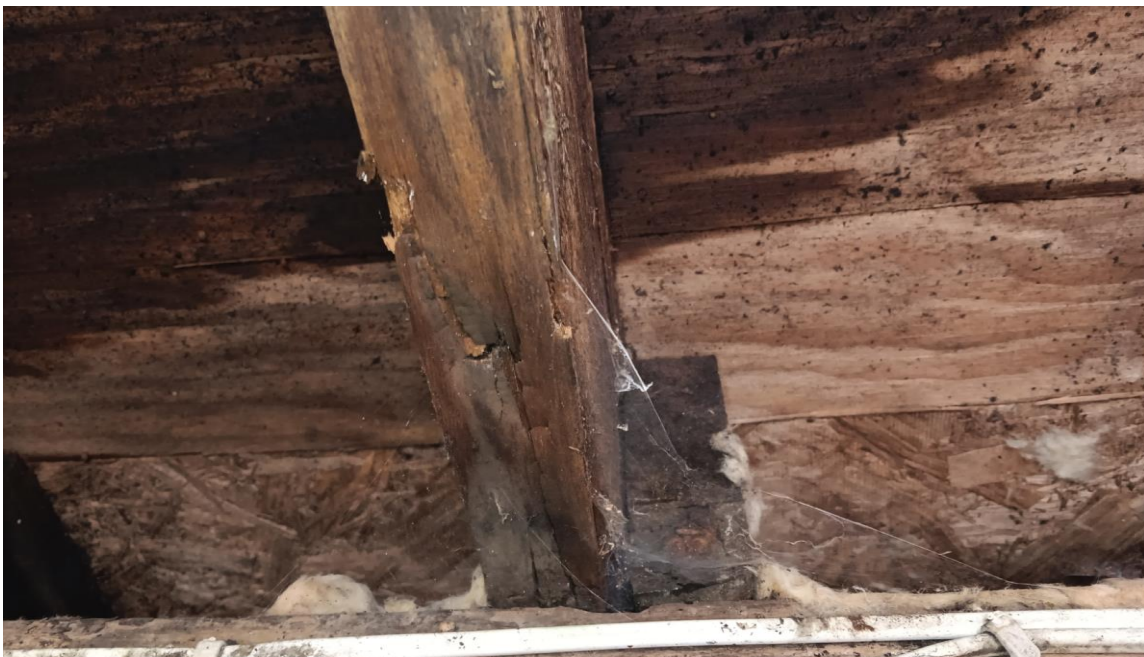
Photo 4 – Rotten and failed flat roof joist. Timber ‘split’ and degraded throughout. Wet rot visible

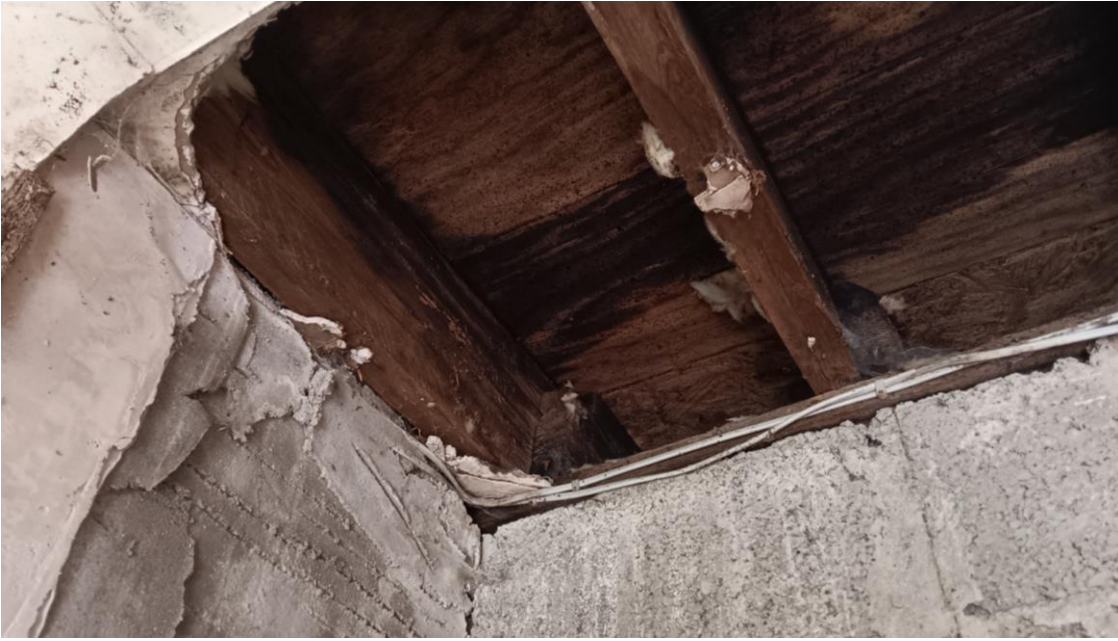
Photo 5 – Visible damp on underside of roof deck – general overall fail of flat roof.

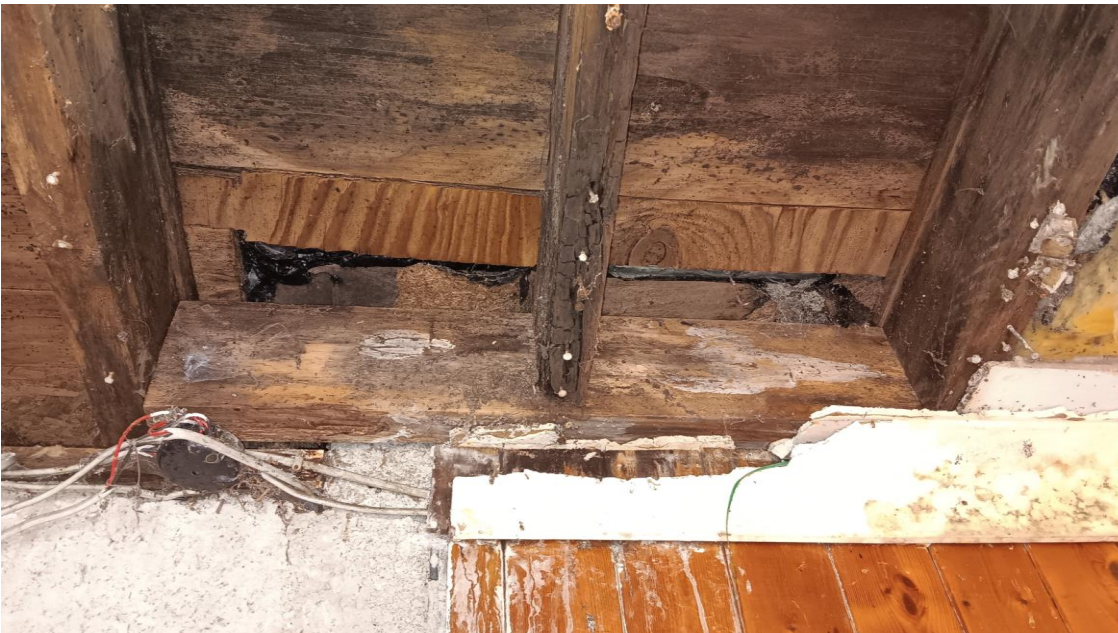
Photo 6 – Rotten flat roof joists – cuboidal fractures present – visible 'white rot' and severe timber degradation noted. Severe damp penetrating through structural roof deck.

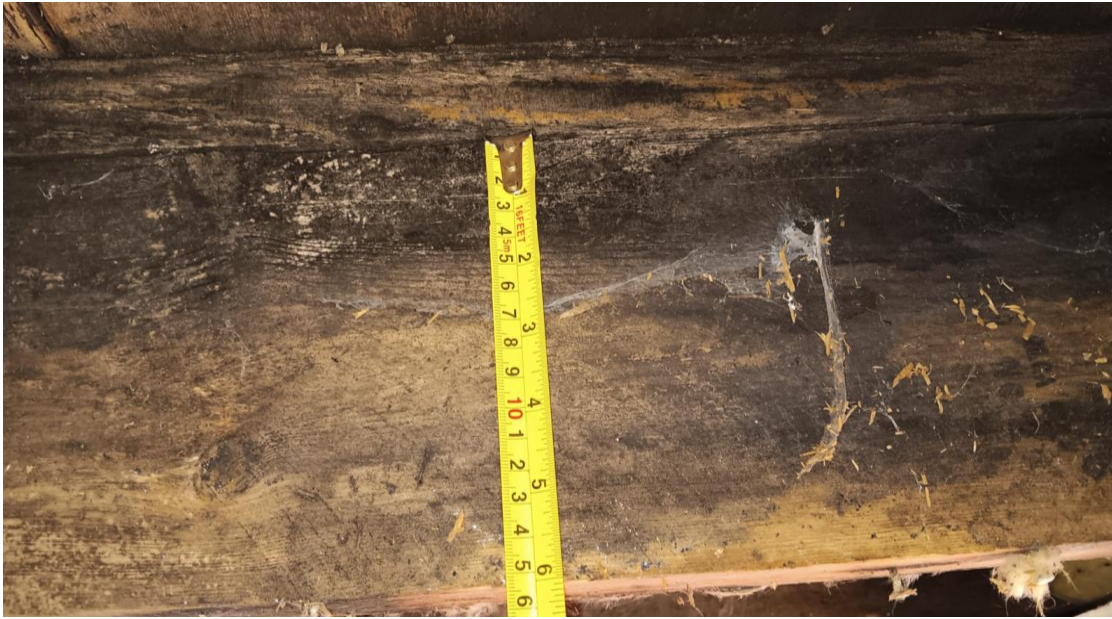
Photo 7 – Depth of flat roof joists measures 150mm – undersized for flat roof loads given required span. Structural inadequate.

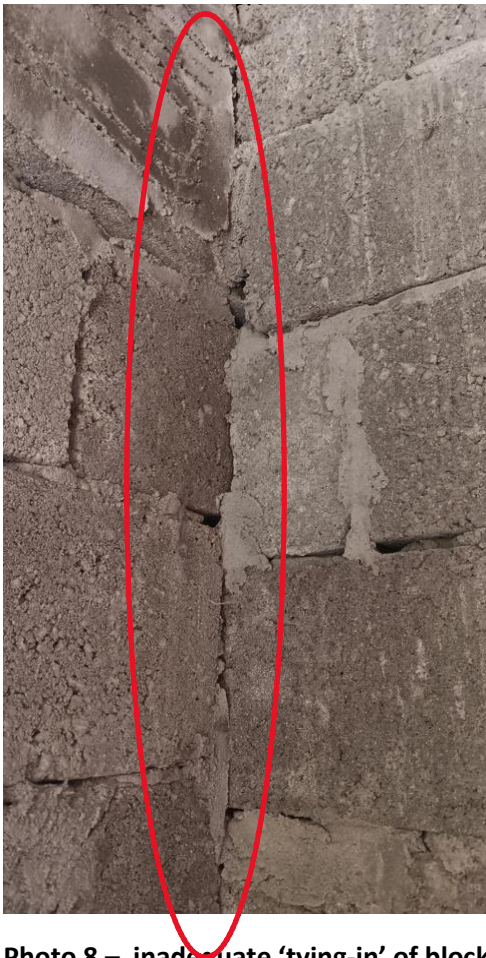
Photo 8 – inadequate 'tying-in' of blockwork – no 'keying in' of blocks, and no ties at wall junction. Poor bed and perpend mortar joints.

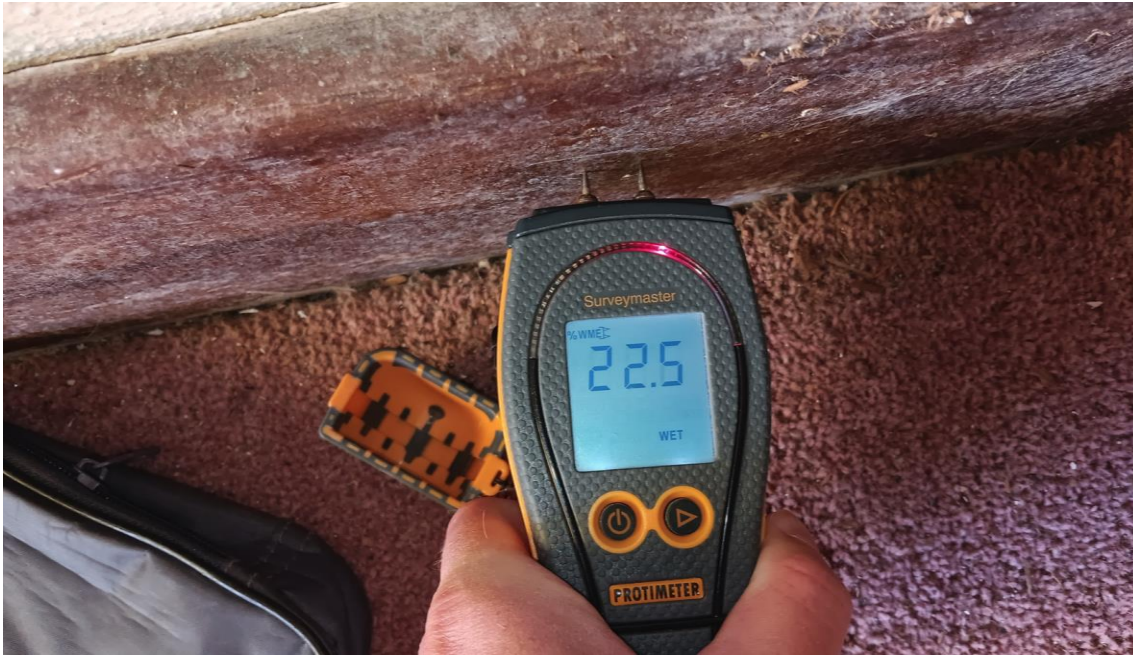
Photo 9 – Skirting board reading as 'damp' (MC – 22.5%) due to damp wall / floor

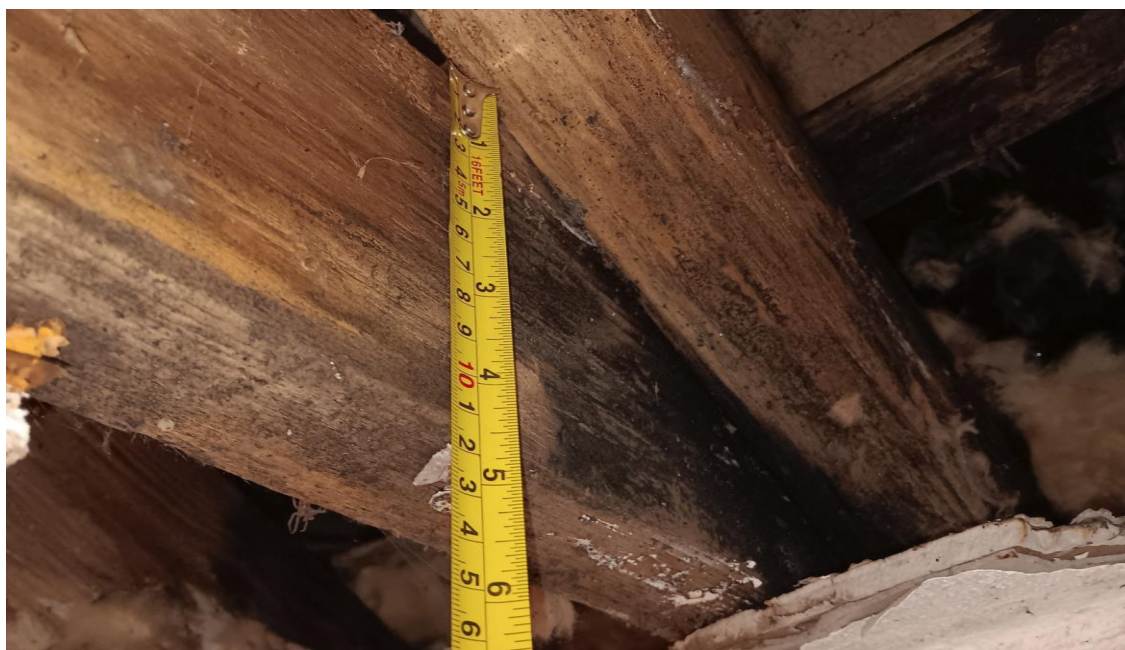
Photo 11 – Ceiling Joist (in pitched roof) lounge 2 , measures 110mm. Undersized given span. Substantial damp and timber damage at wall junction, on wall plate. Wet rot / timber damage visible

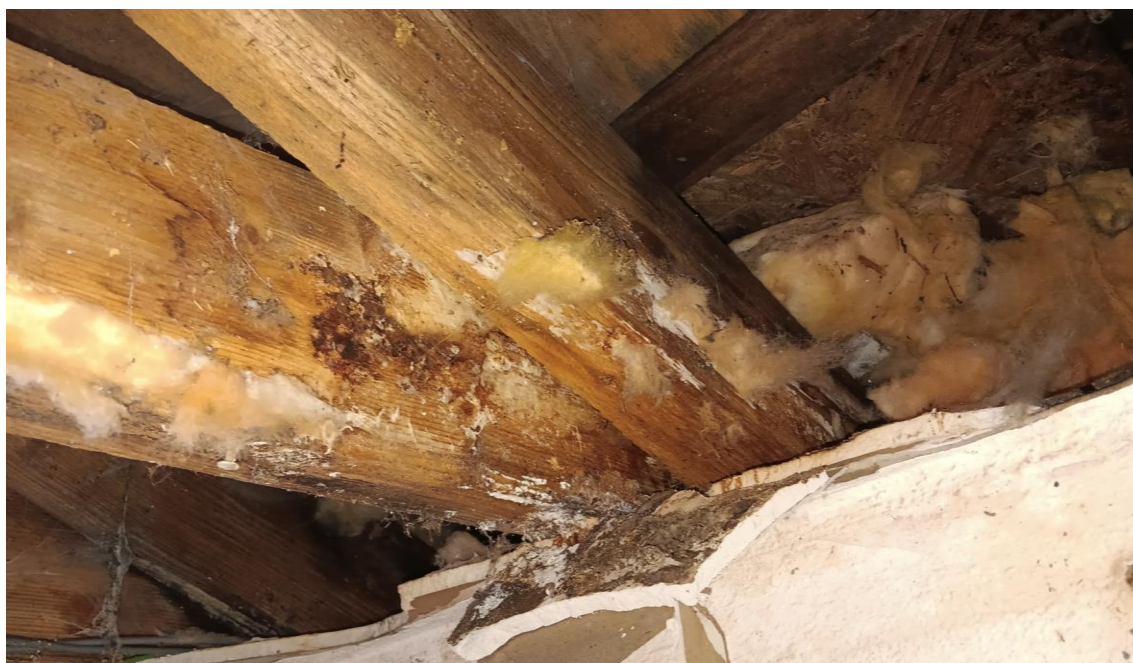
Photo 12 – Ceiling Joists (in pitched roof) lounge 2 , presents fungal growth. Ends of timber (joist and rafter) are rotten / severely damp.

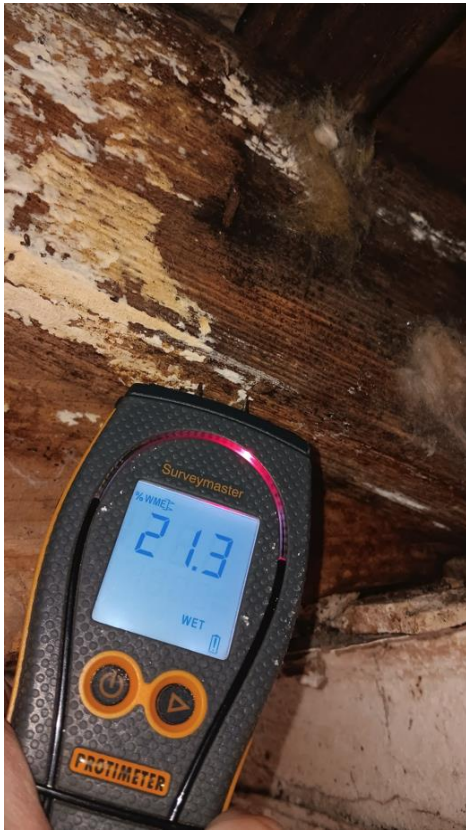
Photo 14 – Timber rafters rotten – MC = 21.3% (damp) white rot present. Timbers irreparable.

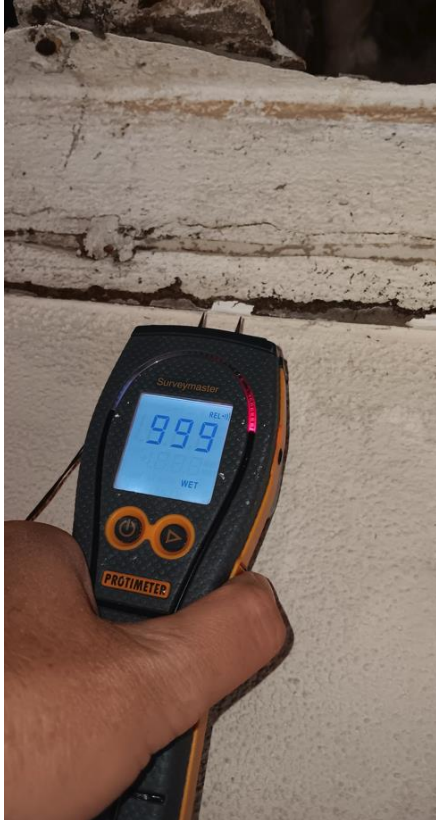
Photo 15– Wall under wall plate – ‘saturated’ (MC index = 999)

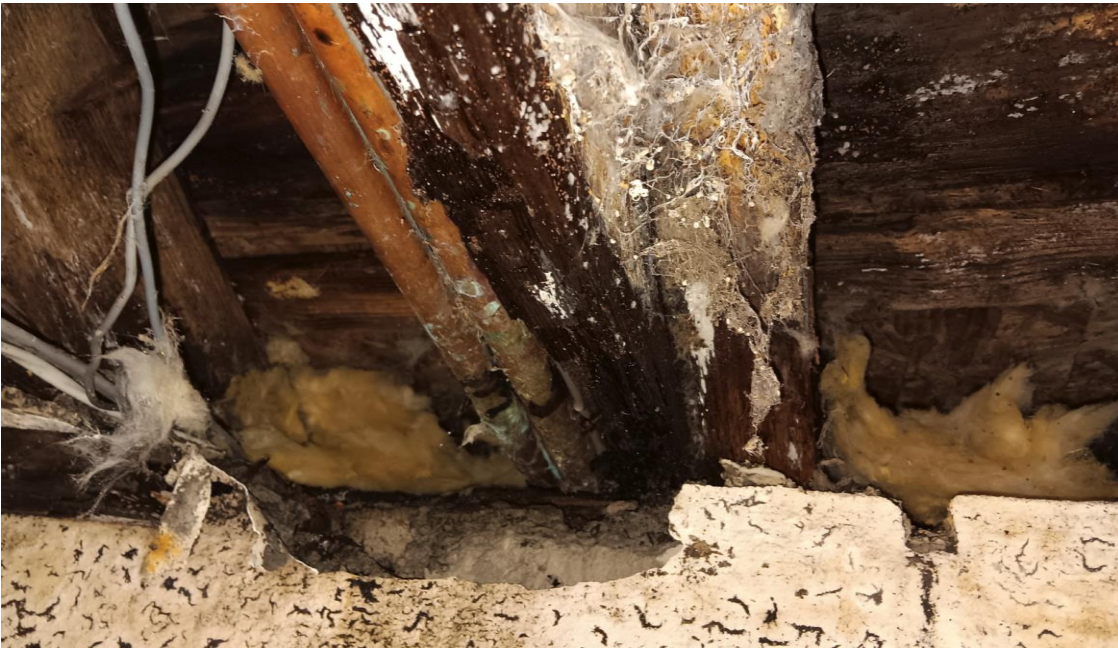
Photo 16– Severe degradation of timber joists and rafter – easily ‘crumbled’ by hand on timber surface– fungal growth clearly present.

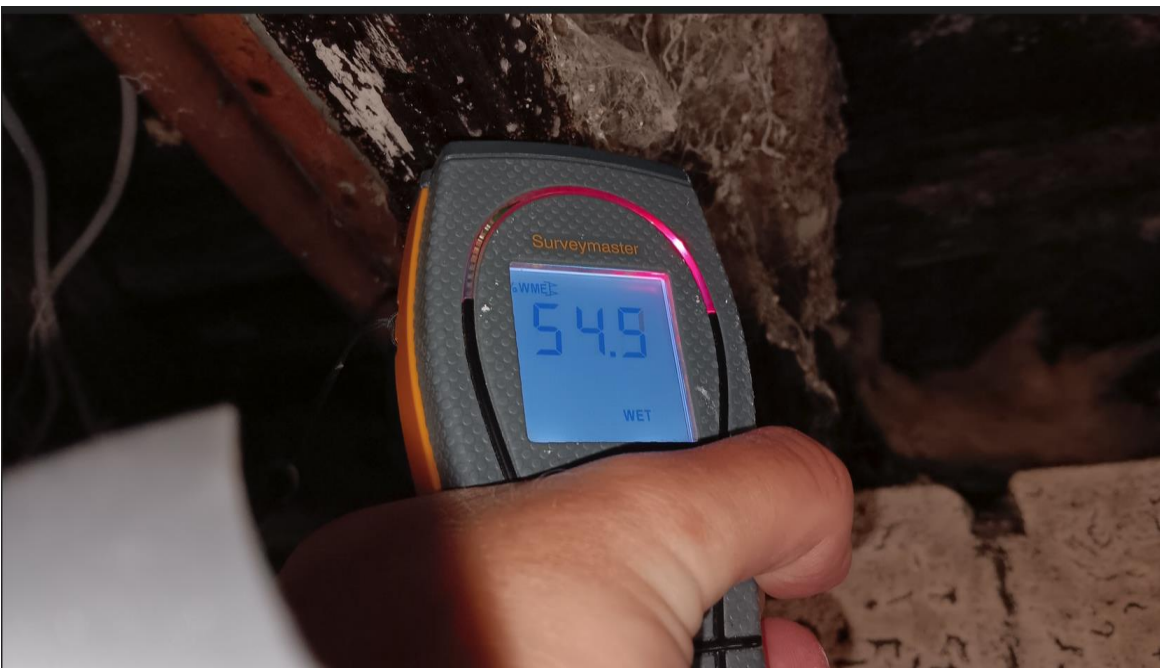
Photo 17– Moisture Content (MC) of timber joist = 54.5% - severely wet.

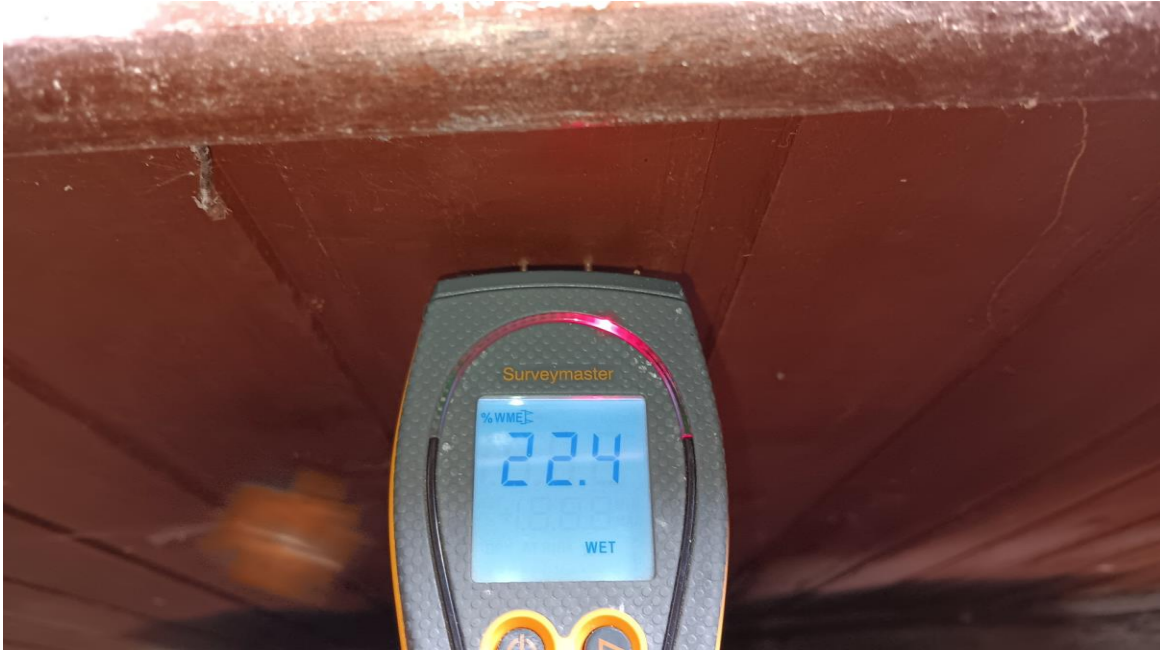
Photo 18– Moisture Content (MC) of timber cladding adjacent wall = 22.4% - damp. Indicates damp wall structure behind cladding.

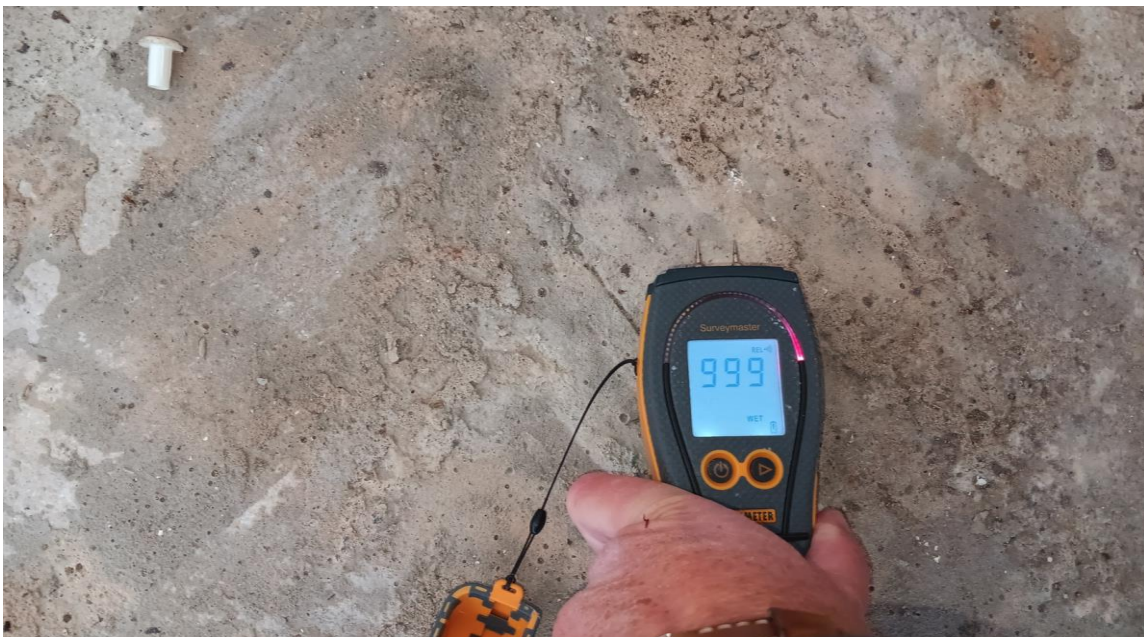
Photo 19– Moisture Content index (MC) of floor (lounge 2) = 999 (ie 'saturated').

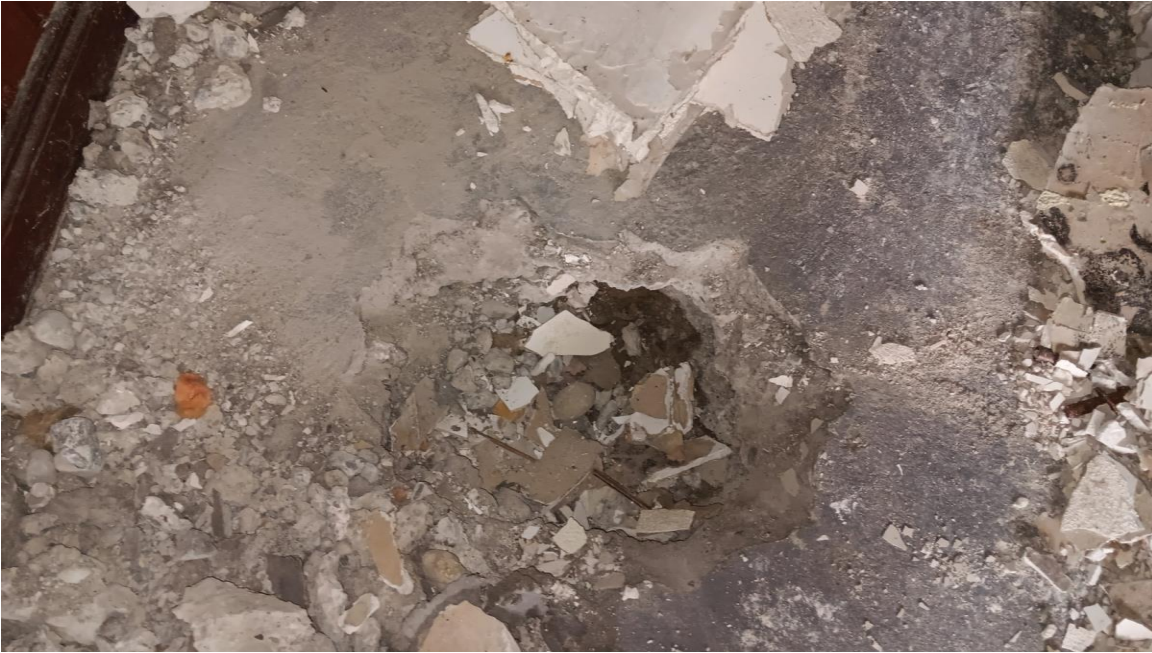
Photo 20– No damp proof membrane within floor (lounge 2) . Floor easily ‘broken out’ - Weak concrete, not suitable as structural slab.

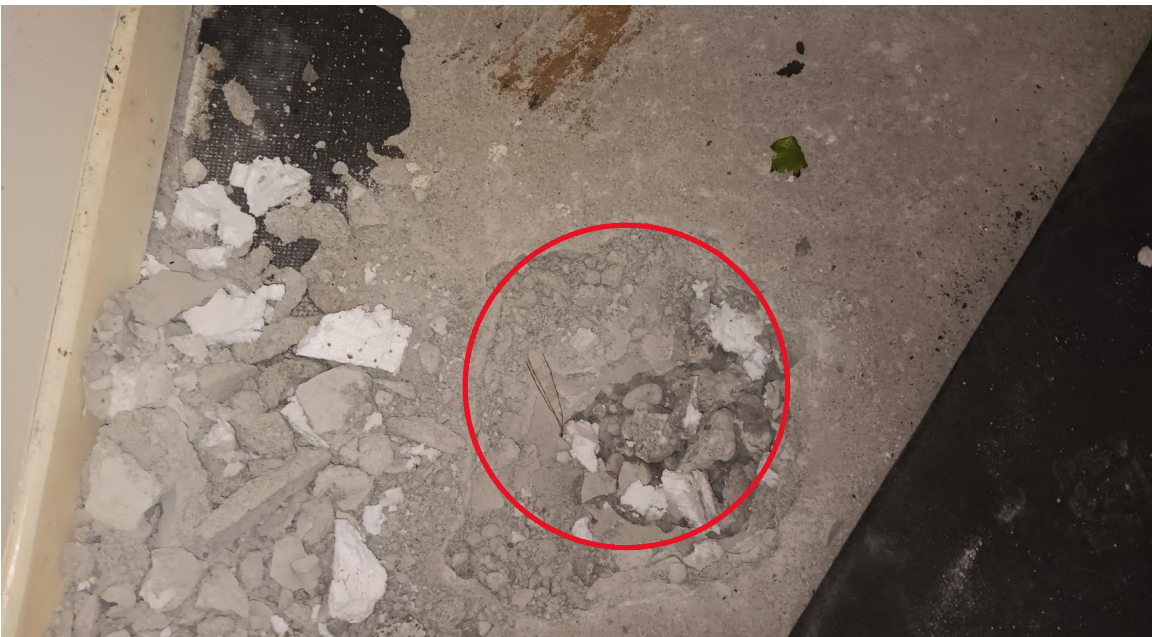
Photo 21– No damp proof membrane within floor (lounge 2) . Weak concrete presents

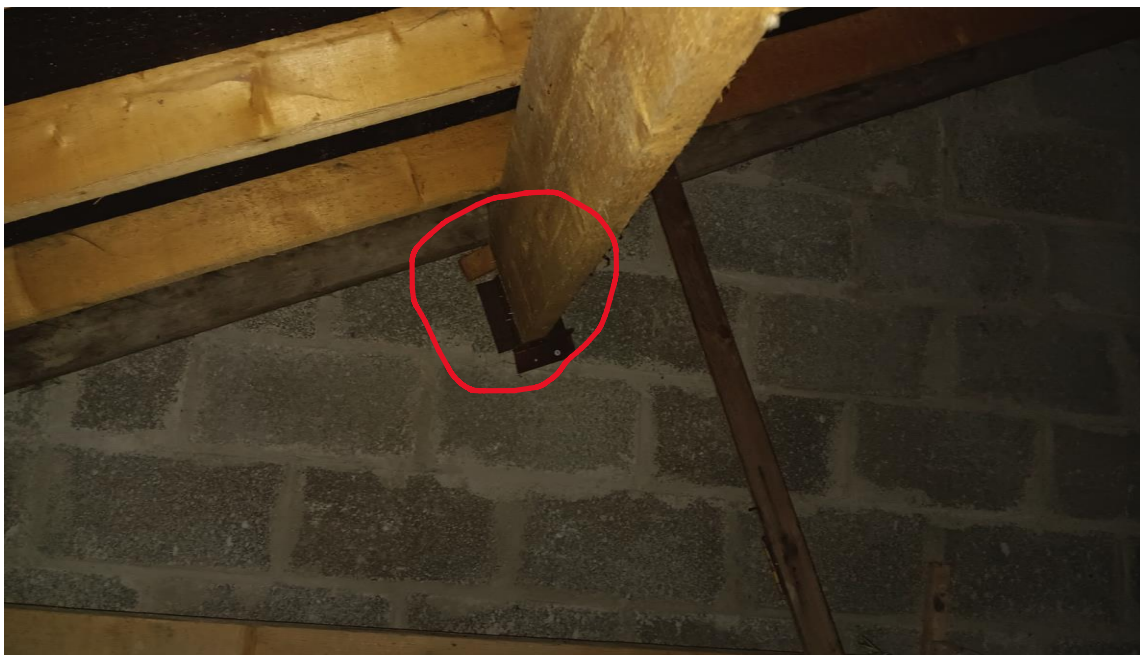
Photo 23– Structurally inadequate purlin fixing to gable wall. No 'birdsmouth' joint in raft-purlin connection.

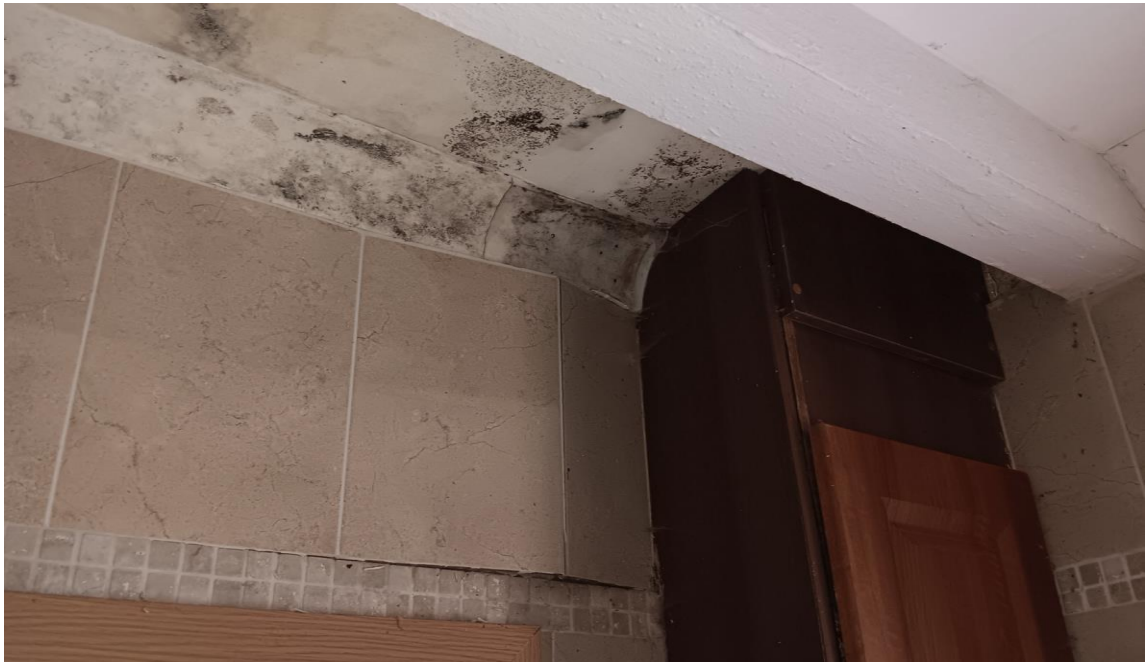
Photo 24 -severe mould growth on ceiling , due to defective roof. Severly damp walls present

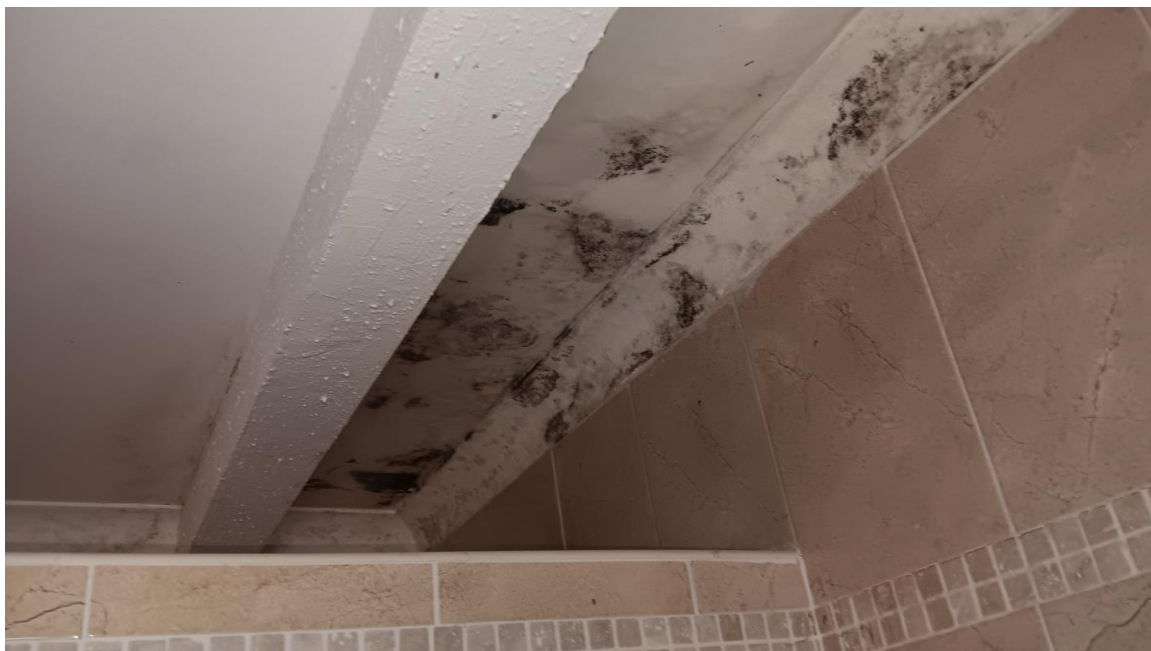
Photo 25 -severe mould growth on ceiling – due to defective roof. Severly damp walls present - black mould on ceiling due to damp.

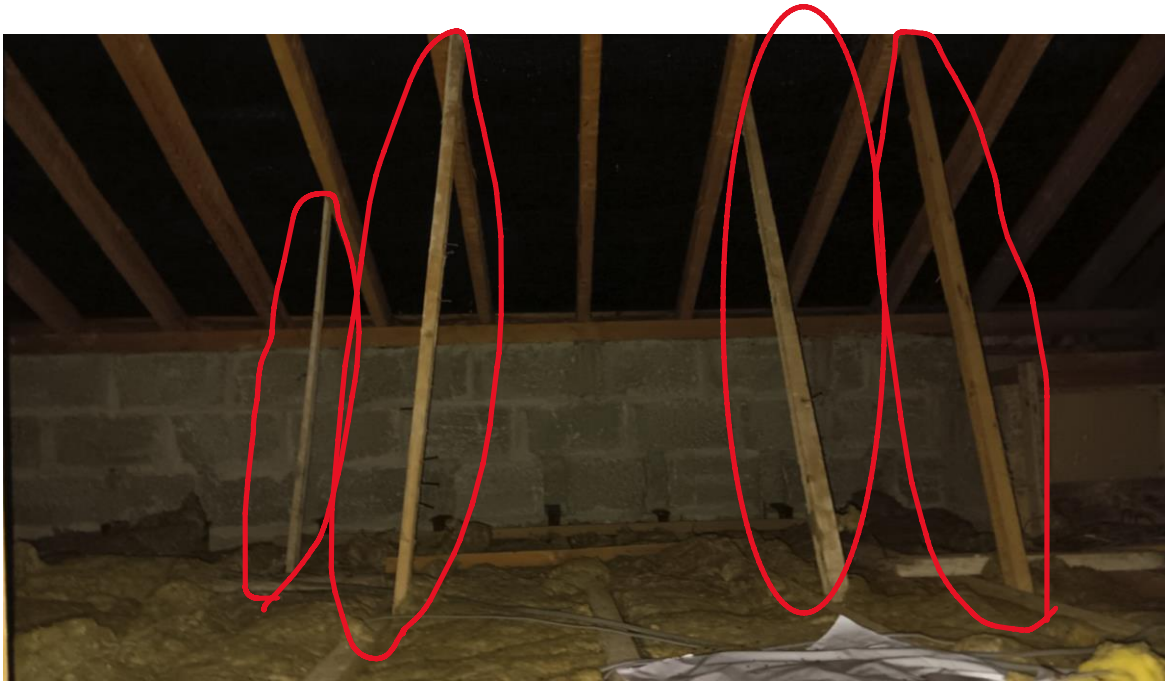
Photo 26– Struts provided to support roof (struts measure 50mm x 50mm and 100mm x 50) totally structurally inadequate to support roof. Bowing observed on rafters. Overall sagging noted externally on this roof (see photo no 30) due to inadequate structural support. No ‘holding down’ straps present. Overall roof is structurally weak.

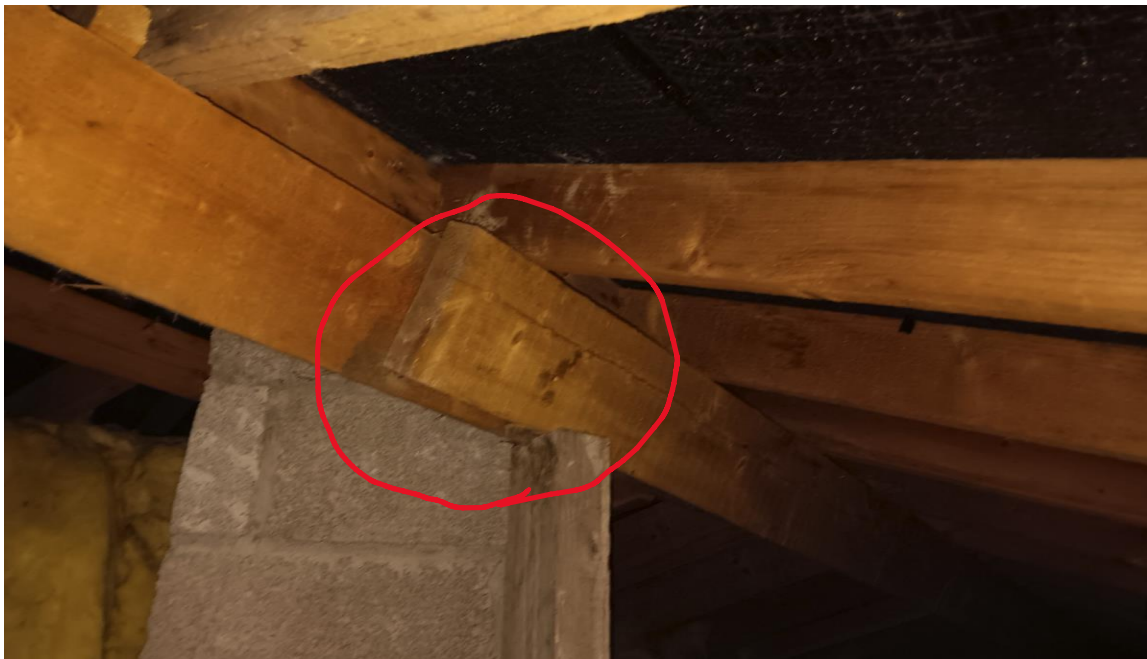
Photo 27– 2no purlins (measuring 75x255 and 63x225 respectively) spanning over entire length of pitched roof with 1No central support (total purlin span = c12m ie approx 6m span per purlin) this is wholly structurally inadequate. Purlin supports to be max 2.4m spacing. Central strut support is inadequate, no fixing of purlins to each other exists (ie splice joint not present). White rot noted on rafters due to damp / lack of attic ventilation. Structural design of roof is required – roof to be replaced

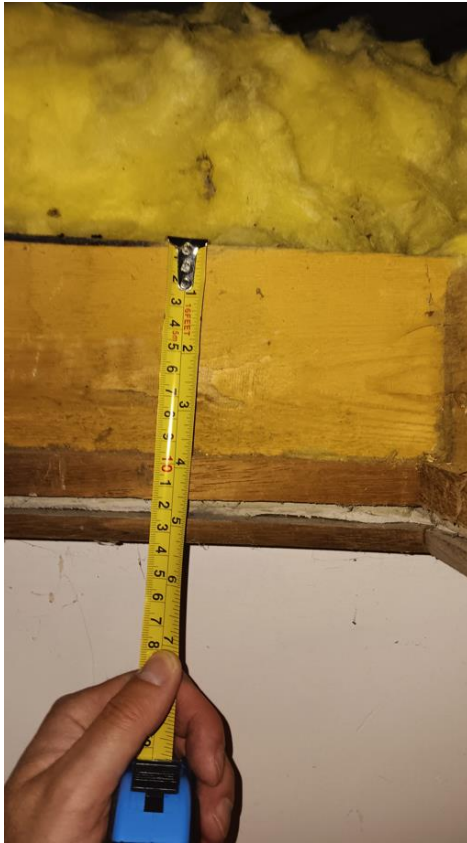
Photo 28 Thickness of ceiling joist = 100mm. inadequate for any pulin loading.

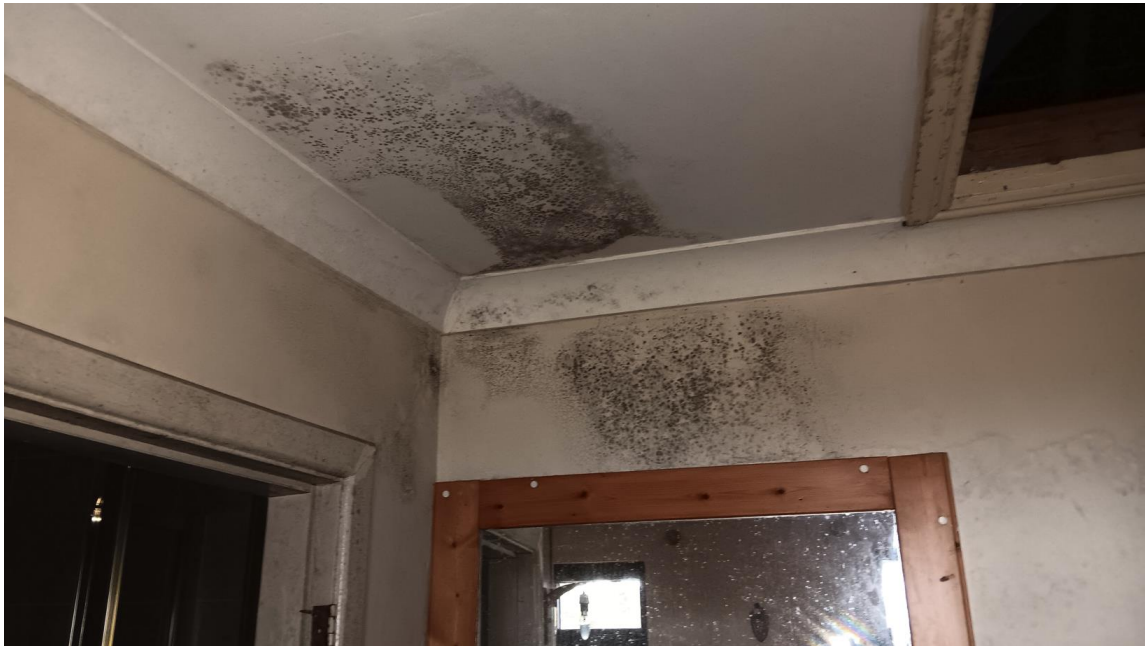
Photo 29 Black mould growth on ceiling due to structurally defective and leaking roof.

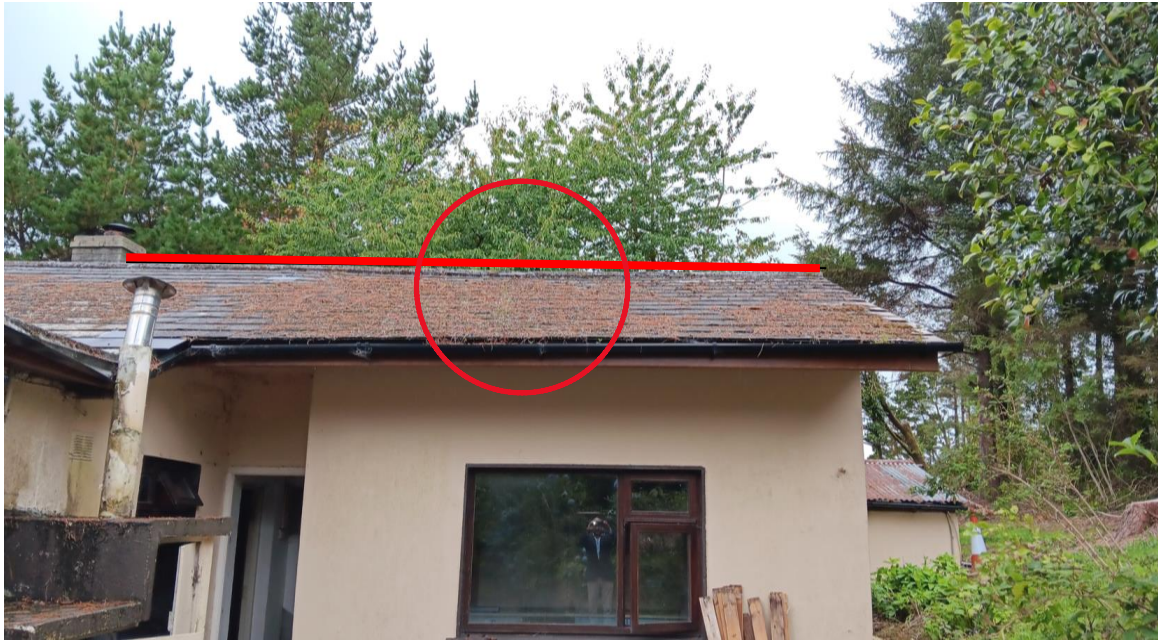
Photo 30 'bow' in roof, due to inadequate structural roof support (see photo no 26).

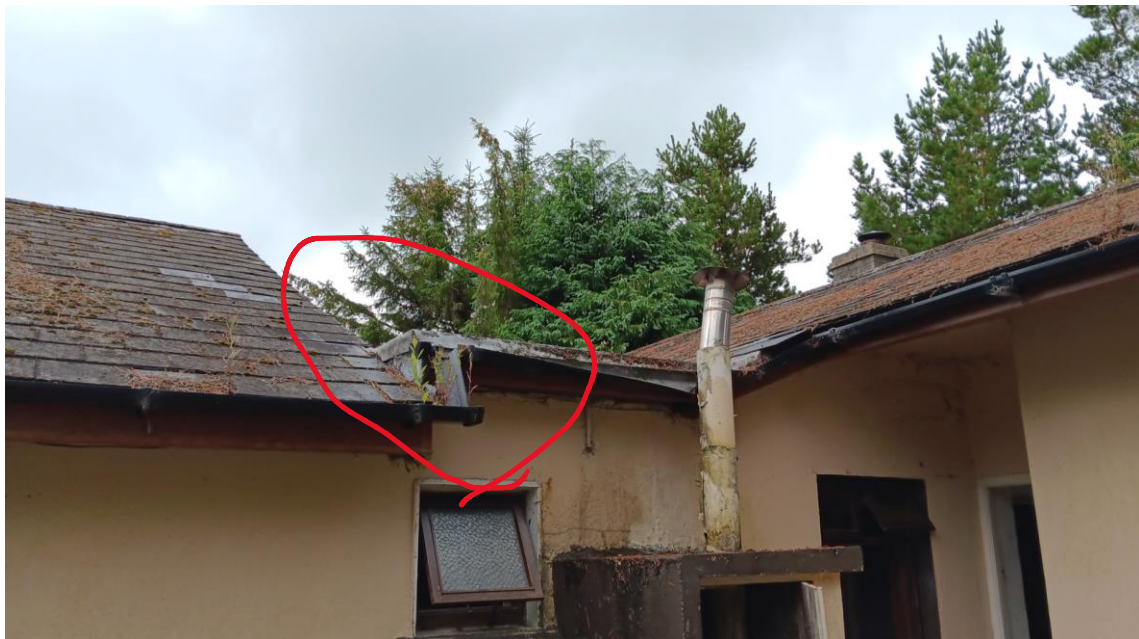
Photo 31 – roof tiles at 'end of life' Note: the probability of asbestos containing material, within the tile is high. Loose /missing tiles exist, and overall defective roof covering. Structurally damaged vertical flue pipe (probably storm damage), water ingress at flat roof within ensuite, due to failed flashing construction. Damp wall behind boiler enclosure penetrating to internal rooms. Note: asbestos flue sleeve around stainless steel flue.

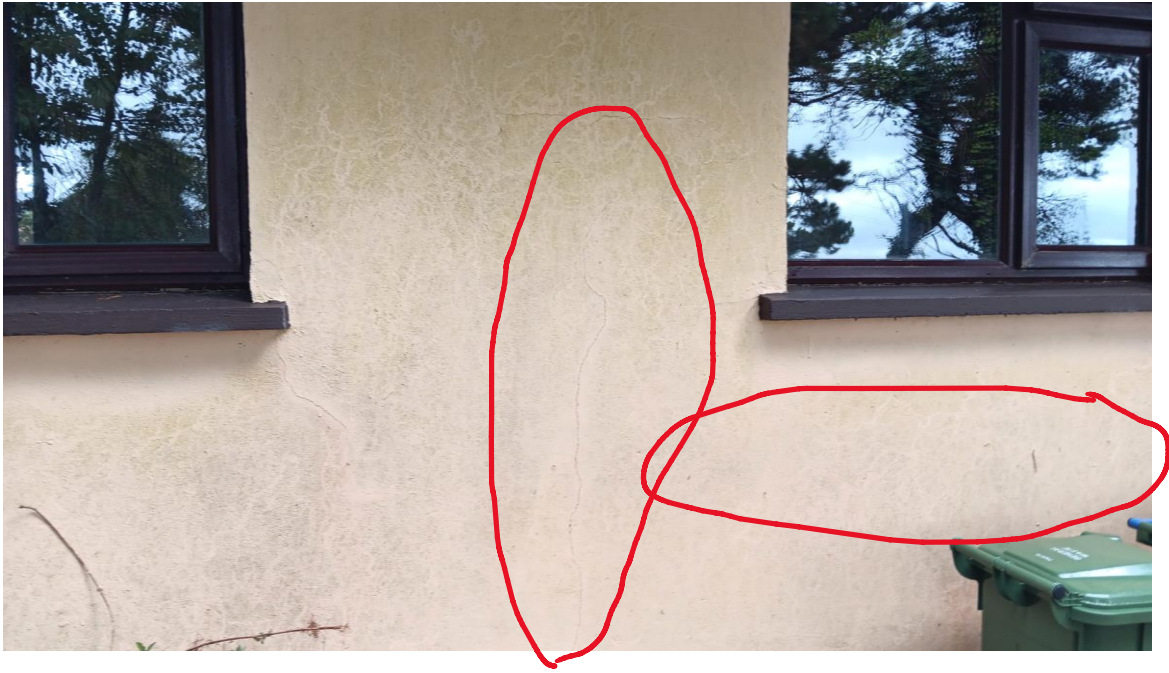
Photo 32 Slight cracking in wall (vertical and horizontal)

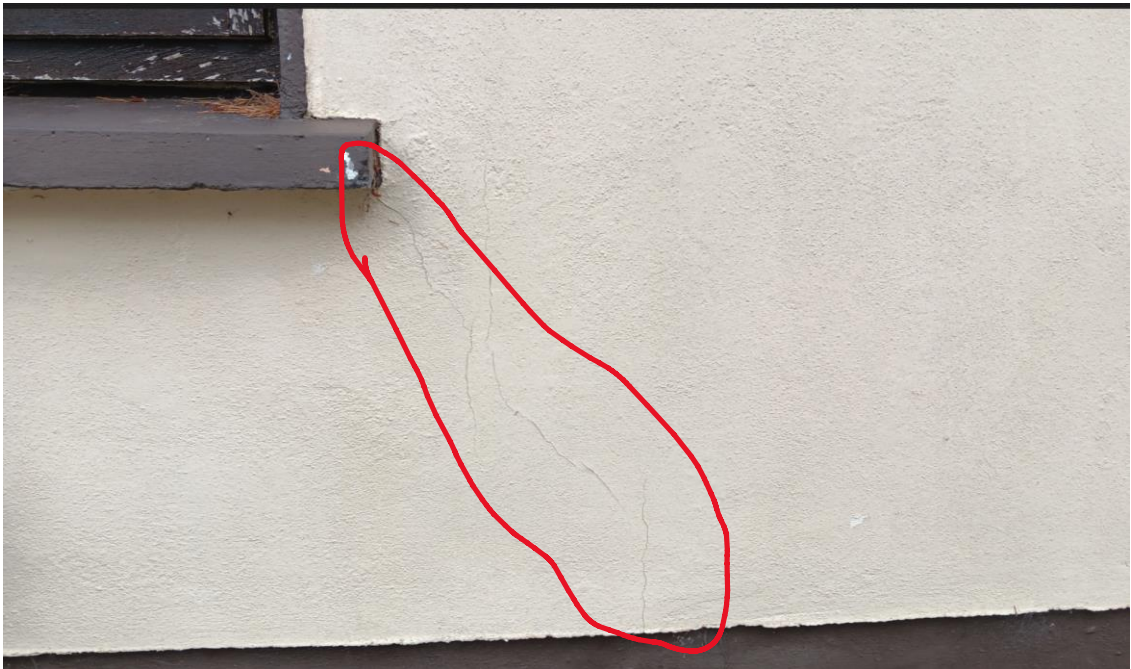
Photo 33 Slight diagonal cracking in wall

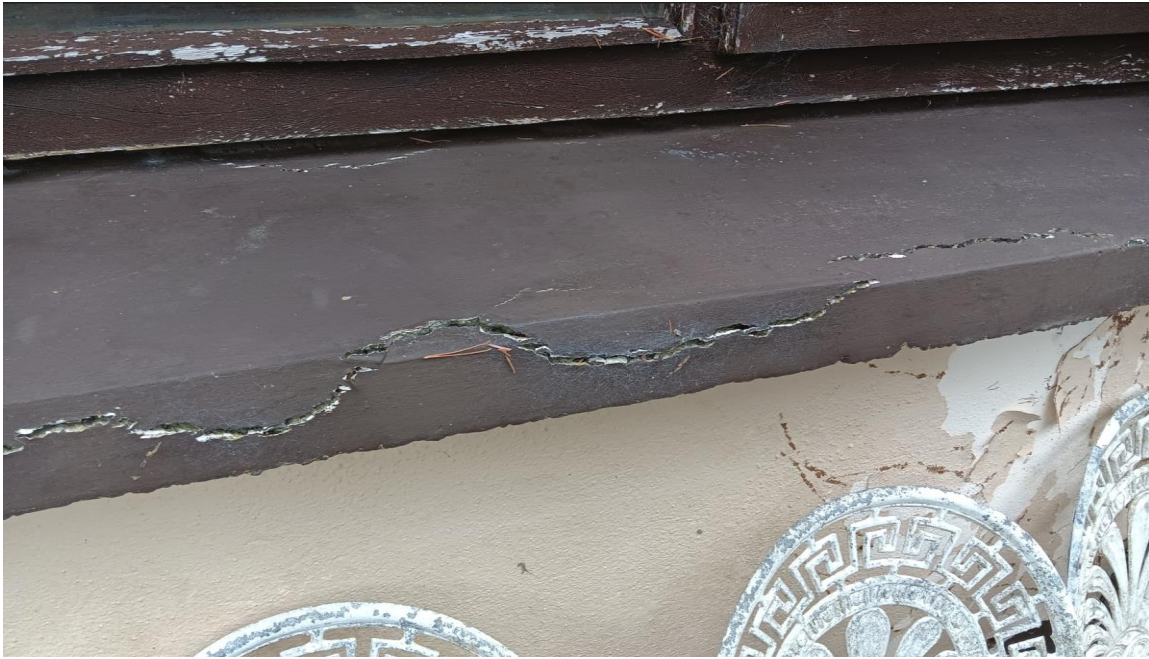
Photo 34 damage to window cill spalling / cracking – to be rectified.
