TEICNIUIL-PRIORY CONSULTING ENGINEERS Ltd

Photographic Schedule

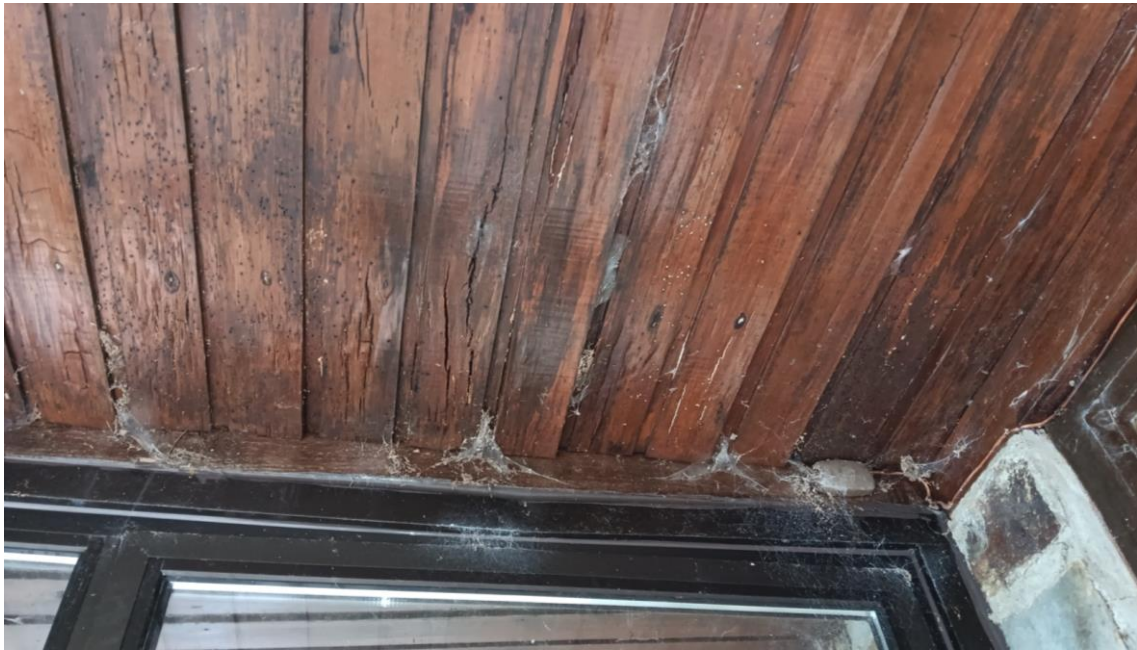
Photo 35 – rotten timber cladding over porch, due to defective roof, at front door.

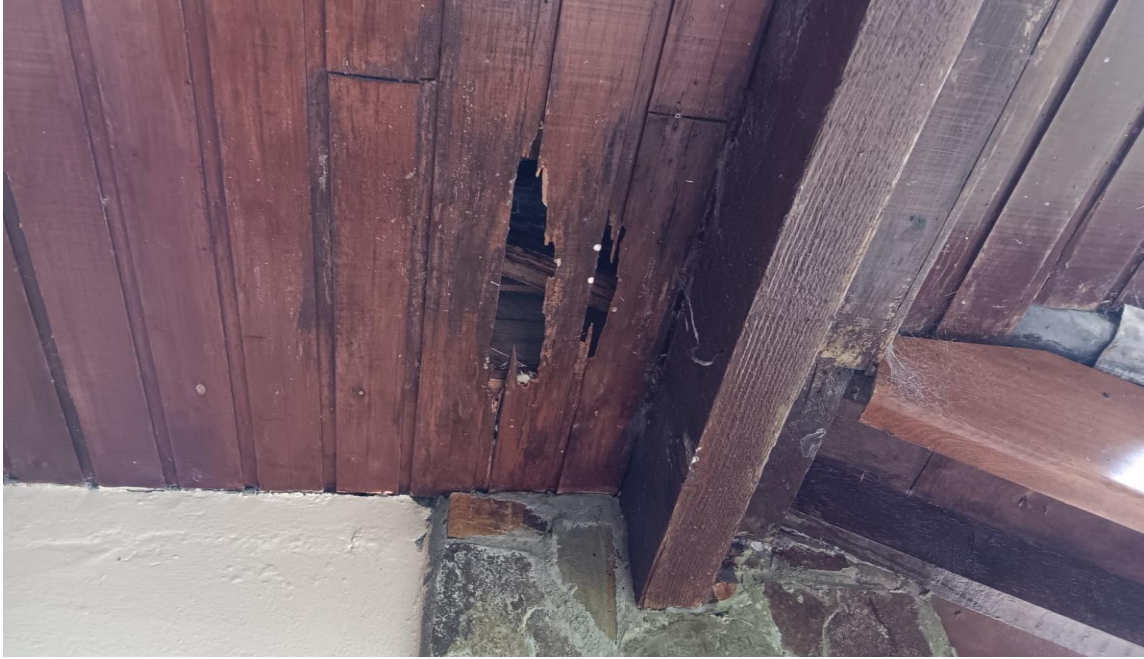
Photo 36 – timber cladding rotten – rafters visible through hole in cladding – rafters also rotten and structurally defective.

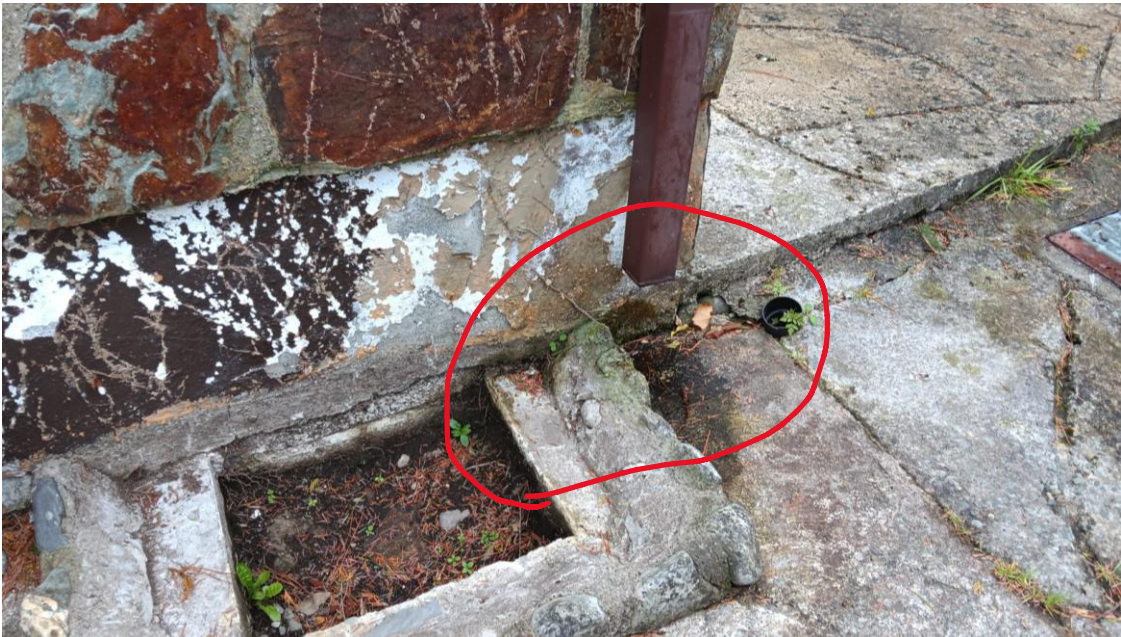
Photo 37 – off-set rainwater outlet pipe from gully – may cause foundation subsidence over time – to be rectified.

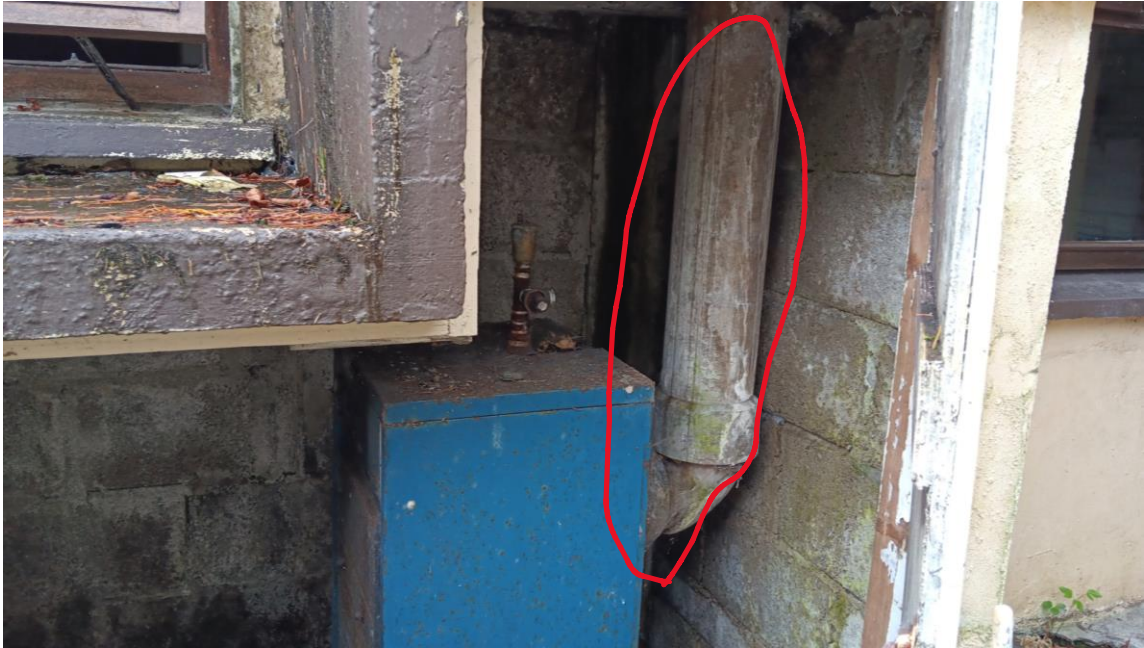
Photo 38 – asbestos sleeve from boiler – specialist removal. Note: boiler considered perished.

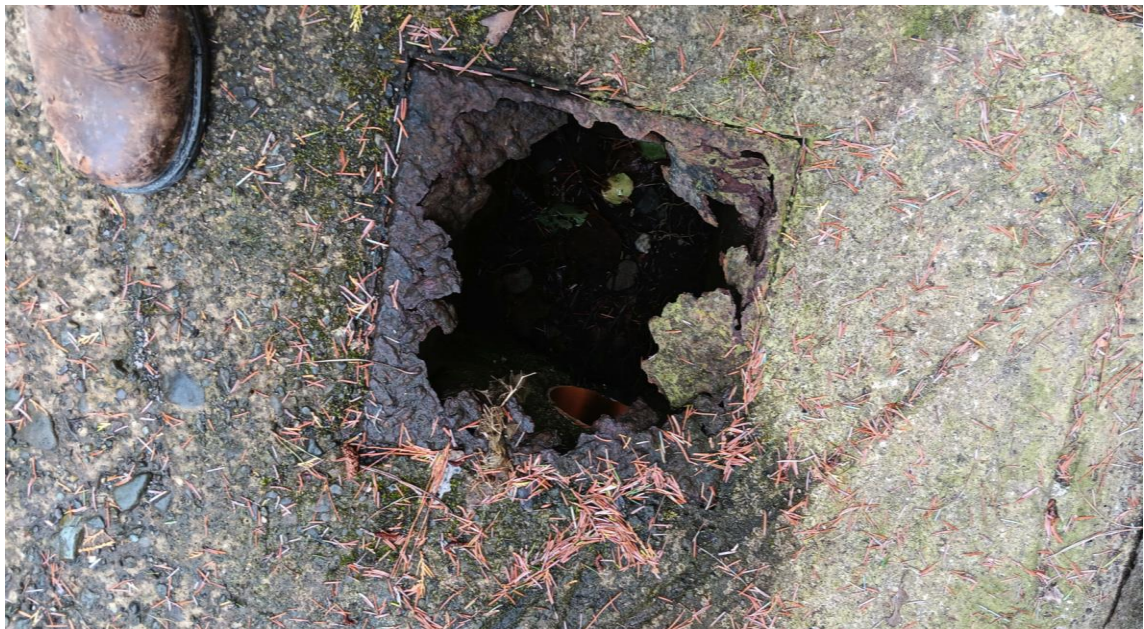
Photo 39 – severe structural damage to drainage cover and frame. Cover completely disintegrated. Substantial health hazard presents.

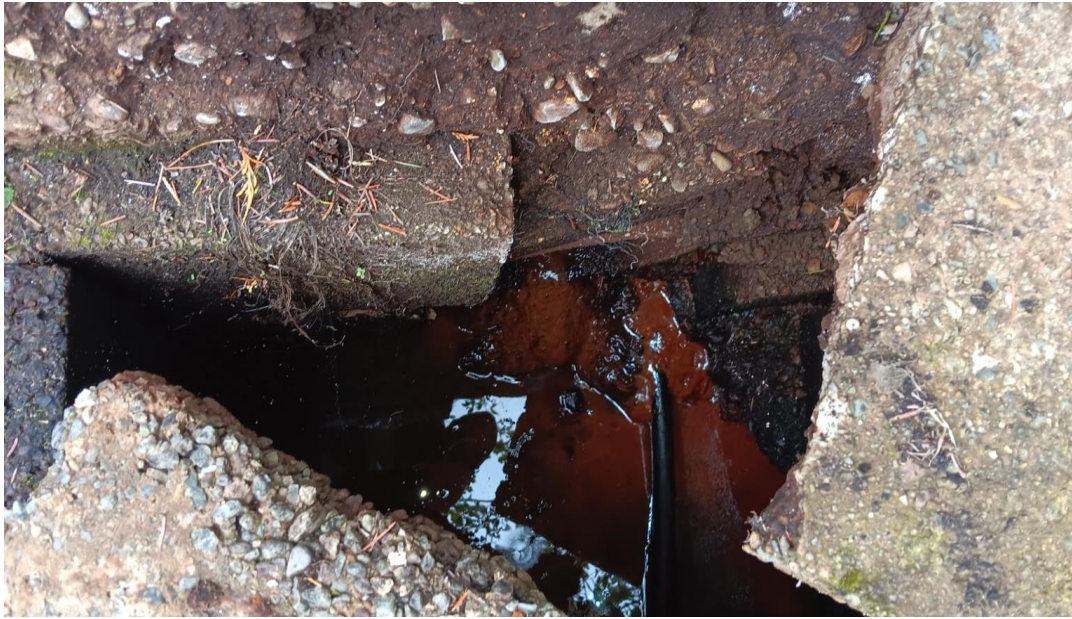
Photo 40 – Severe structural damage to concrete inspection drainage manhole

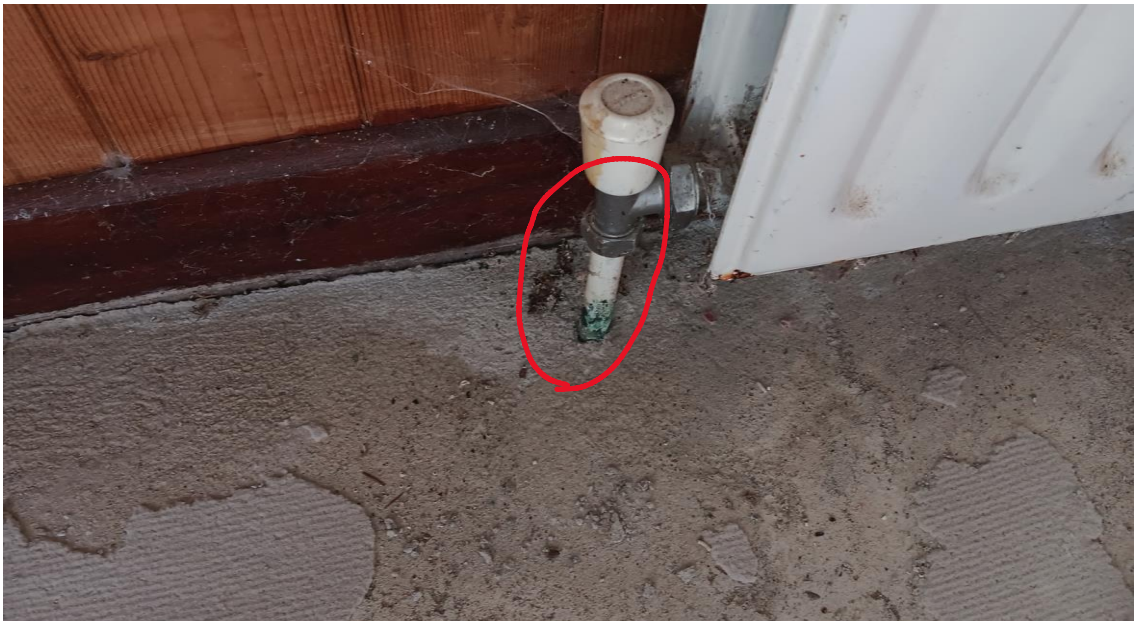
Photo 41 – signs of corrosion at copper pipe. House approx 50 years old – typical age for copper radiator pipes to leak (pitting corrosion)

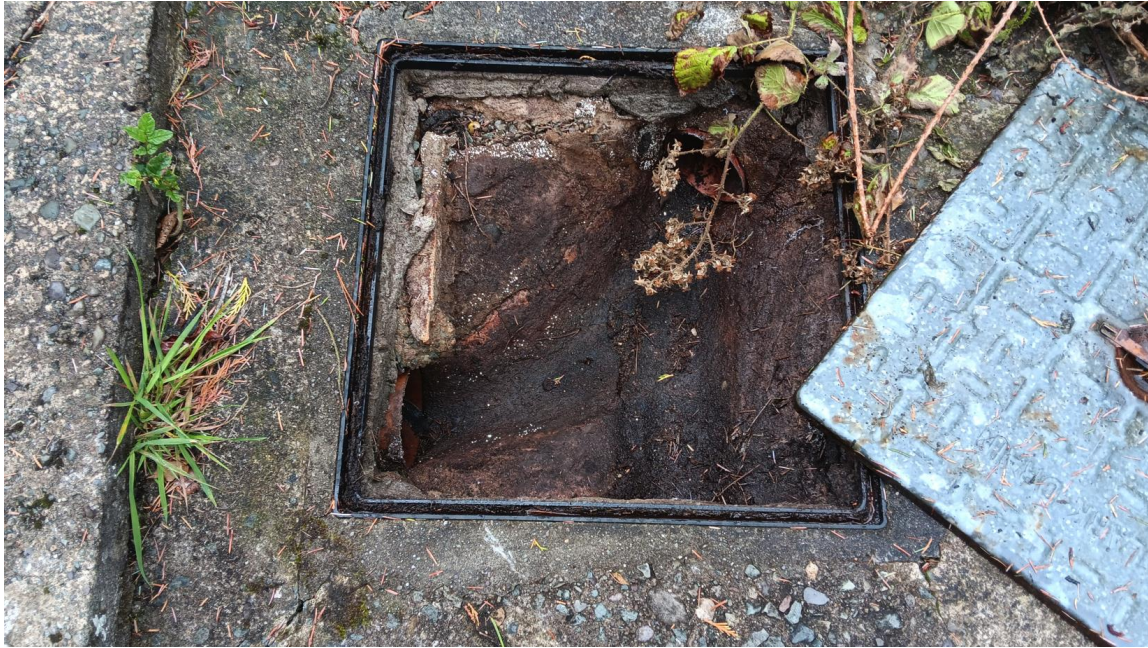
Photo 42 Drainage manhole inadequate - too shallow, structural integrity fail, very poor construction detail and presents health hazard.

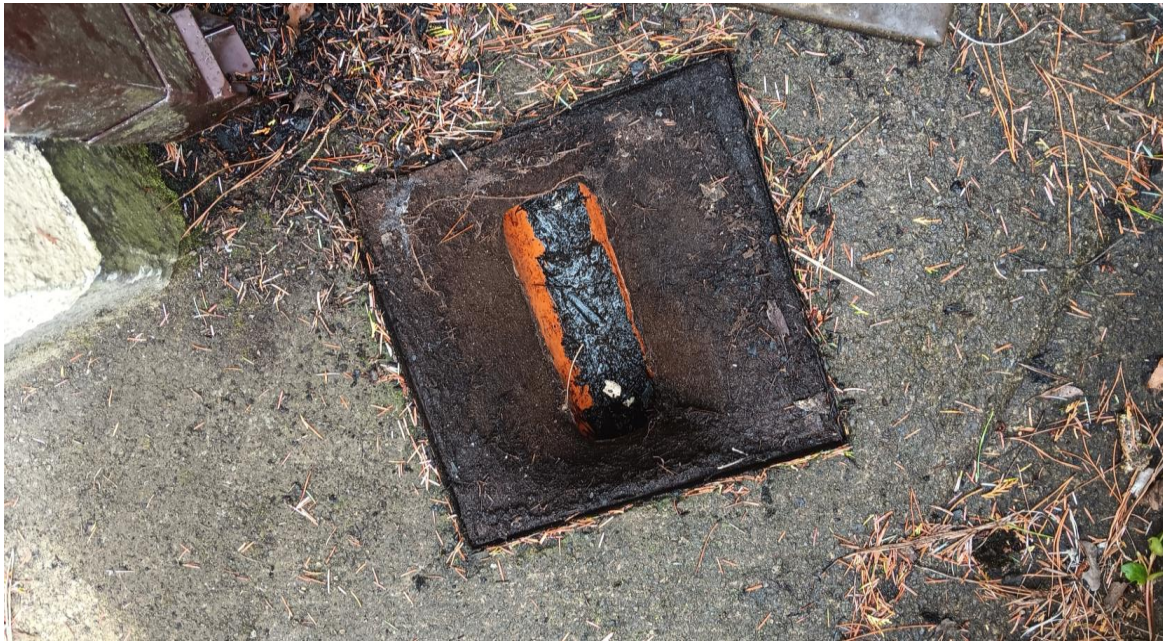
Photo 43 Drainage manhole inadequate - Very poor Construction detail. Block drains, requires replacement.

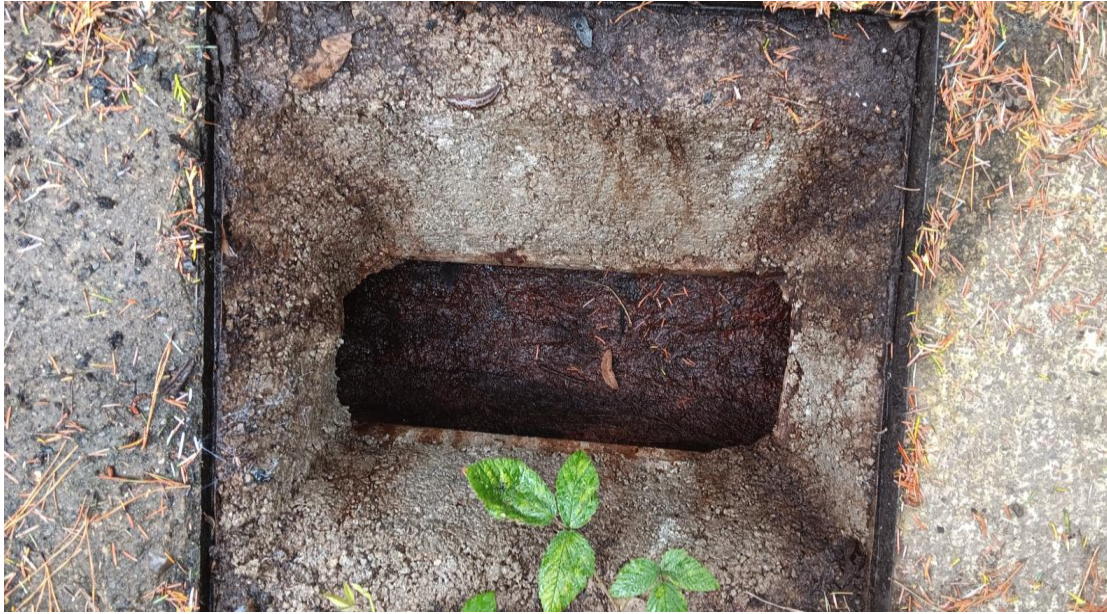
Photo 44 Drainage manhole inadequate - Very poor Construction detail. Cover and frame structurally failed.

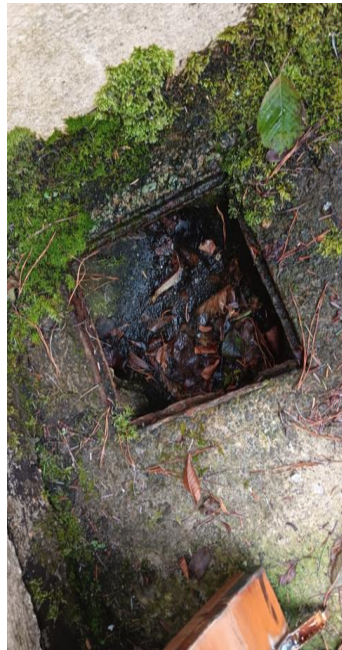
Photo 45 Drainage manhole inadequate - Stuctural fail of sides of manhole, cover and fame. Very poor Construction detail – requires replacement.

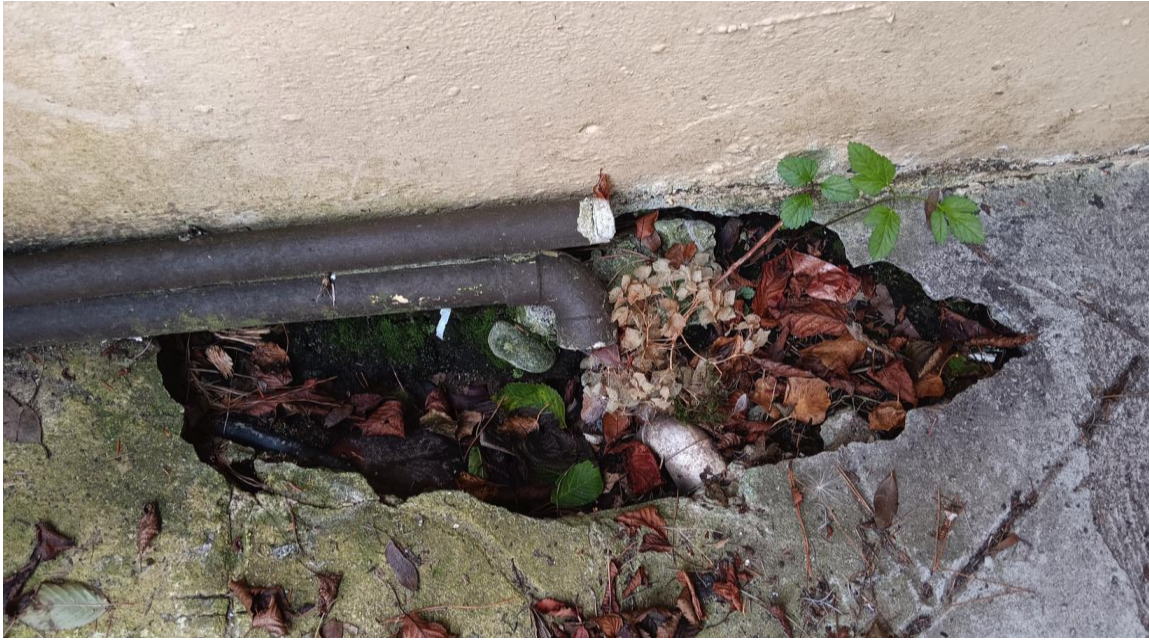
Photo 46 Drainage gully inadequate - Very poor construction detail, and arrangement contrary to Building Regulations

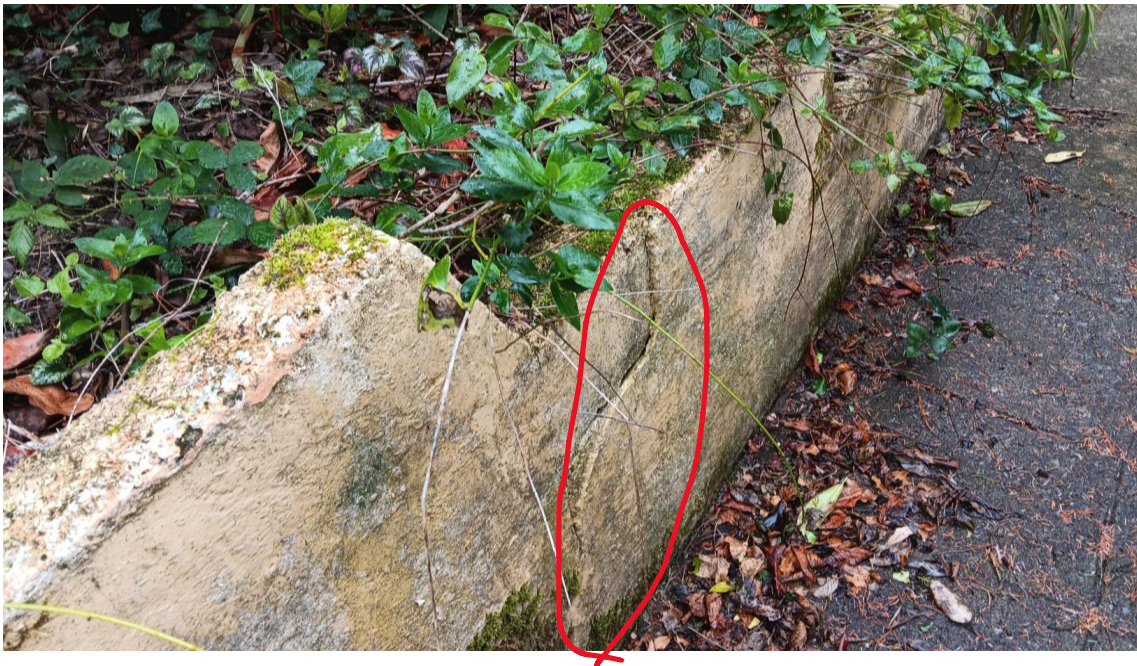
Photo 47 Structural failure of retaining wall – Structural crack presents (c.20mm wide) wall not vertical and is 'leaning', no 'weep' holes in wall. Land drainage absent.

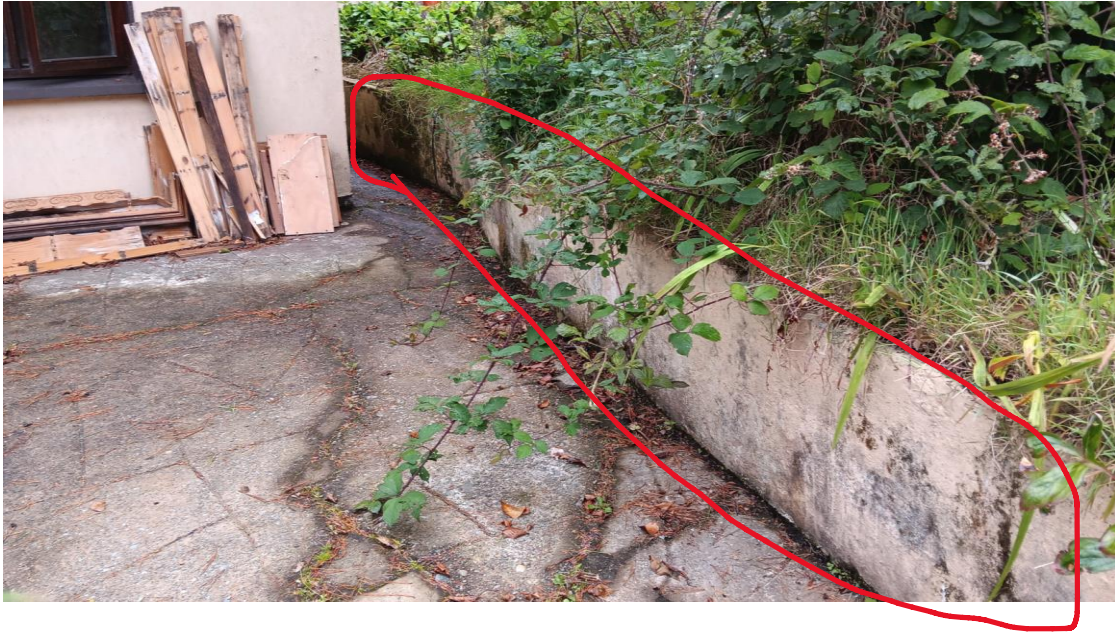
Photo 48 Structural failure of retaining wall – wall severely ‘leaning’ (approx 100mm displacement from vertical)

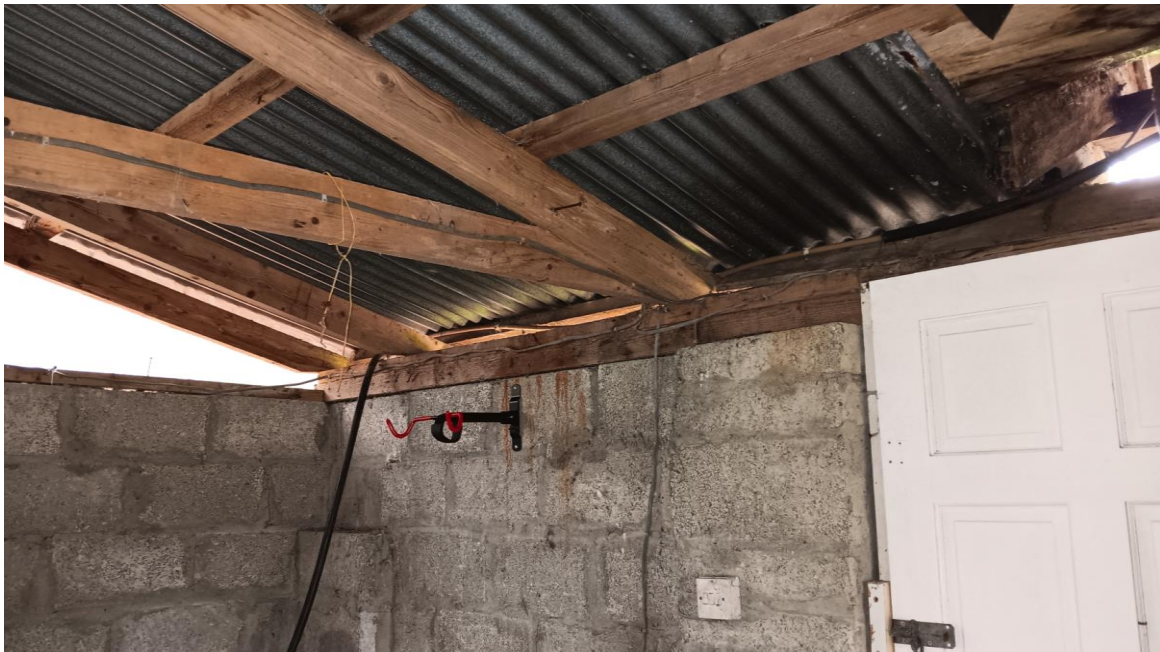
Photo 49 Structural inadequacy of garage roof; Purlins undersized, insufficient rafters, rot presenting at wall plate, no ‘holding down’ straps present – Entire garage roof to be replaced. (note: all electrical wiring, sockets etc are not IP rated, for semi- exposed /damp area, and should be replaced – all wiring to current IEE standards).

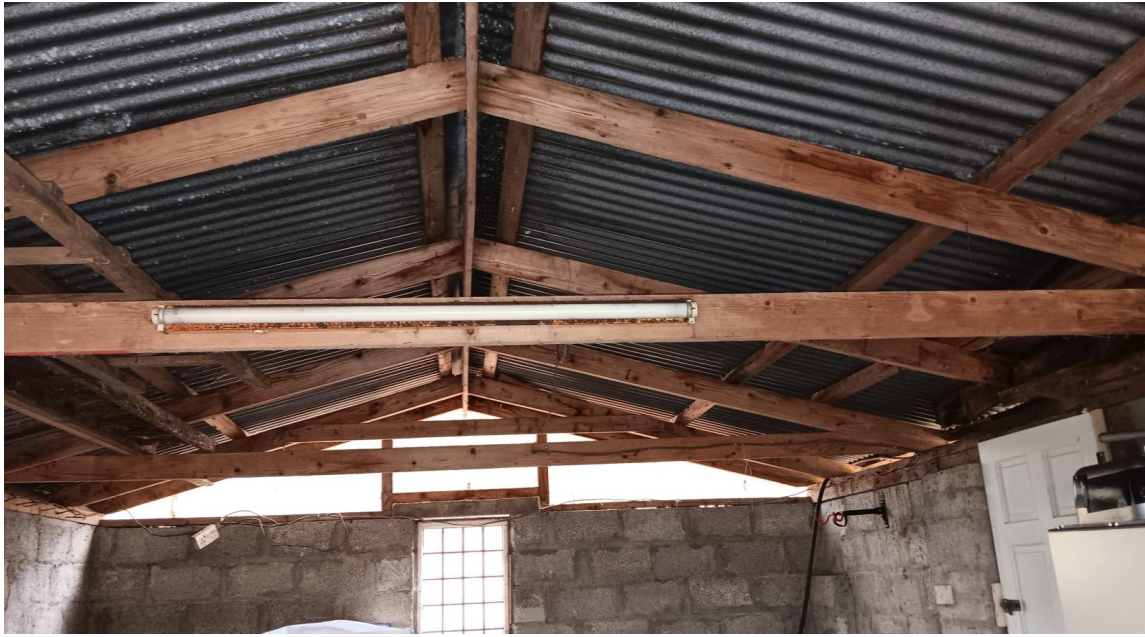
Photo 50 Structural inadequacy of garage roof; Purlins undersized, insufficient rafters, rot presenting at wall plate, no 'holding down' straps present – Entire garage roof to be replaced.

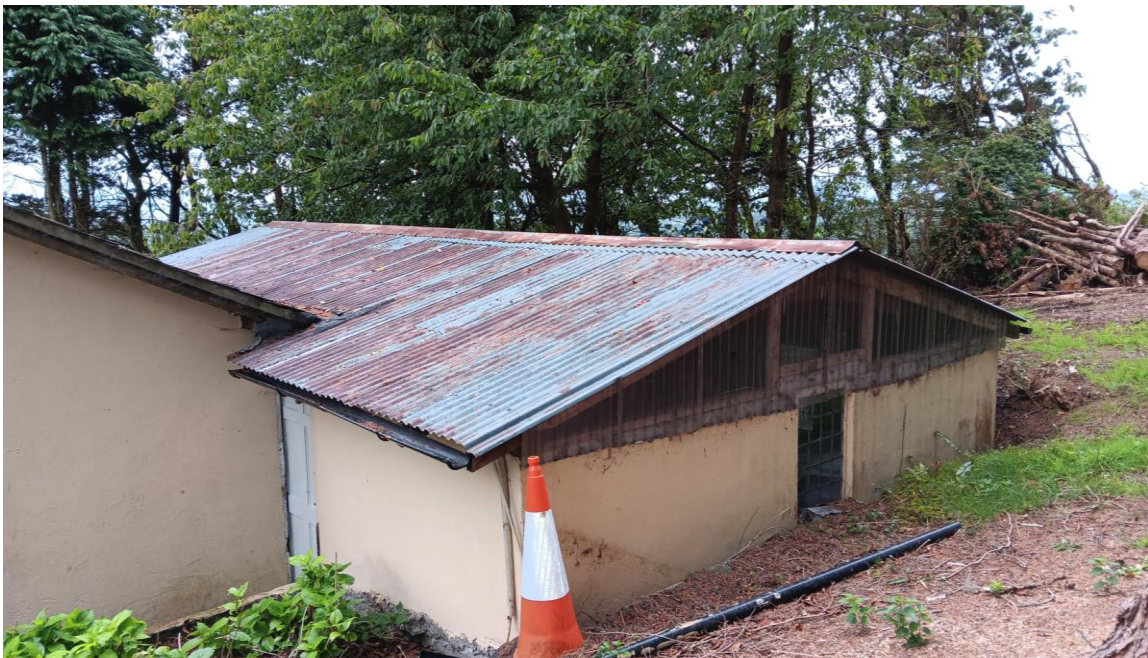
Photo 51 Overview of rear of garage – roof structurally inadequate. rear gable wall potentially acting as a retaining wall – current wall not adequate as a retaining wall. (see photo 52)

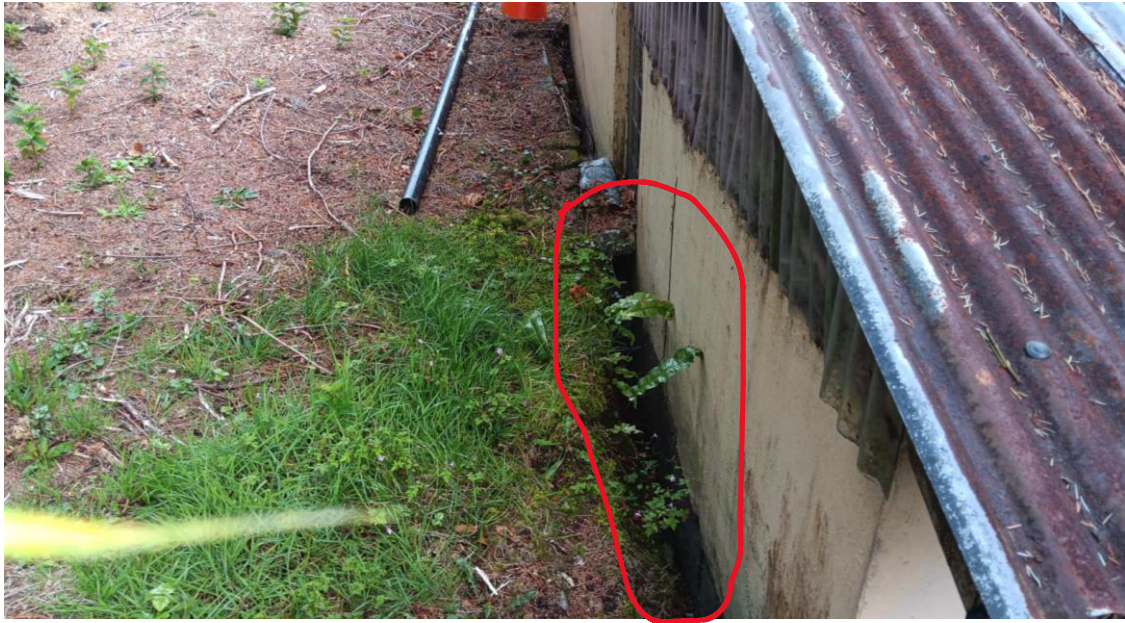
Photo 52 – Garage wall is not designed as a retaining wall - possibility of potential collapse of ground – which would compromise the wall structure.
