## Conservation of Ballybrennan Church for Wexford County Council

### METHOD STATEMENT – CMF 2026 STREAM 3

January 2026  
Rev. 1

Job No. 26002

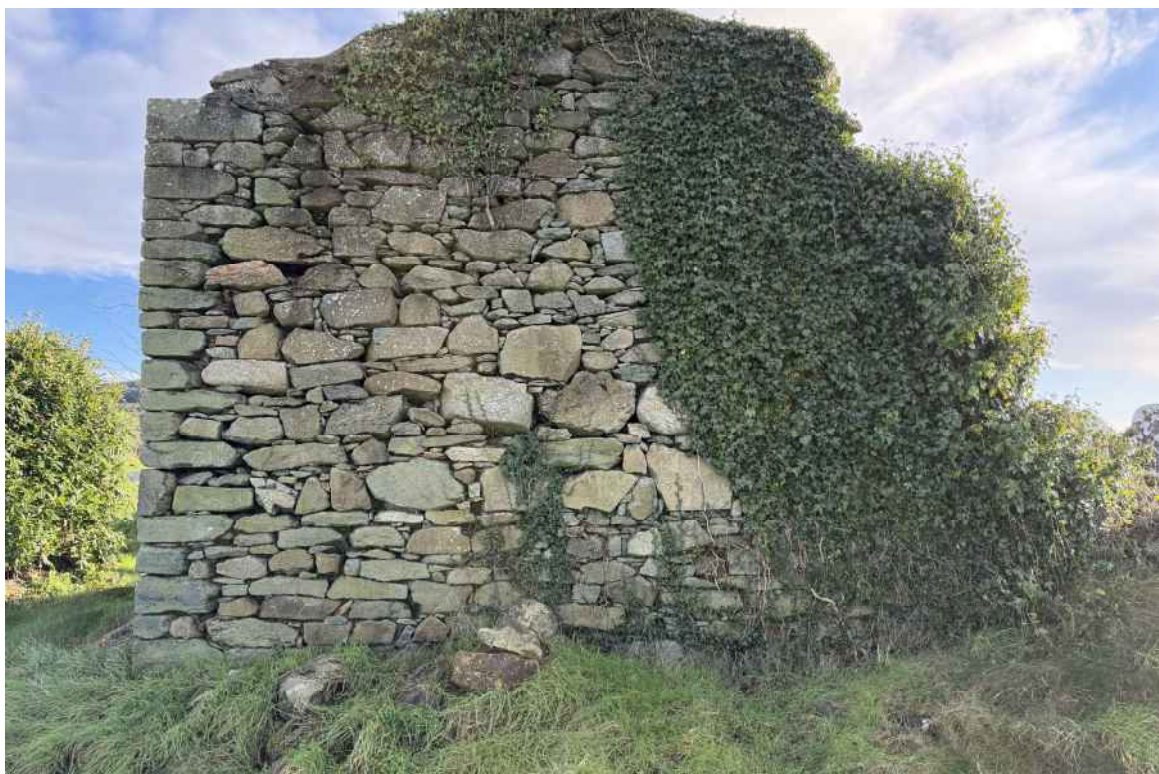
**PHOTOGRAPH 2 - WEST GABLE OUTER FACE**

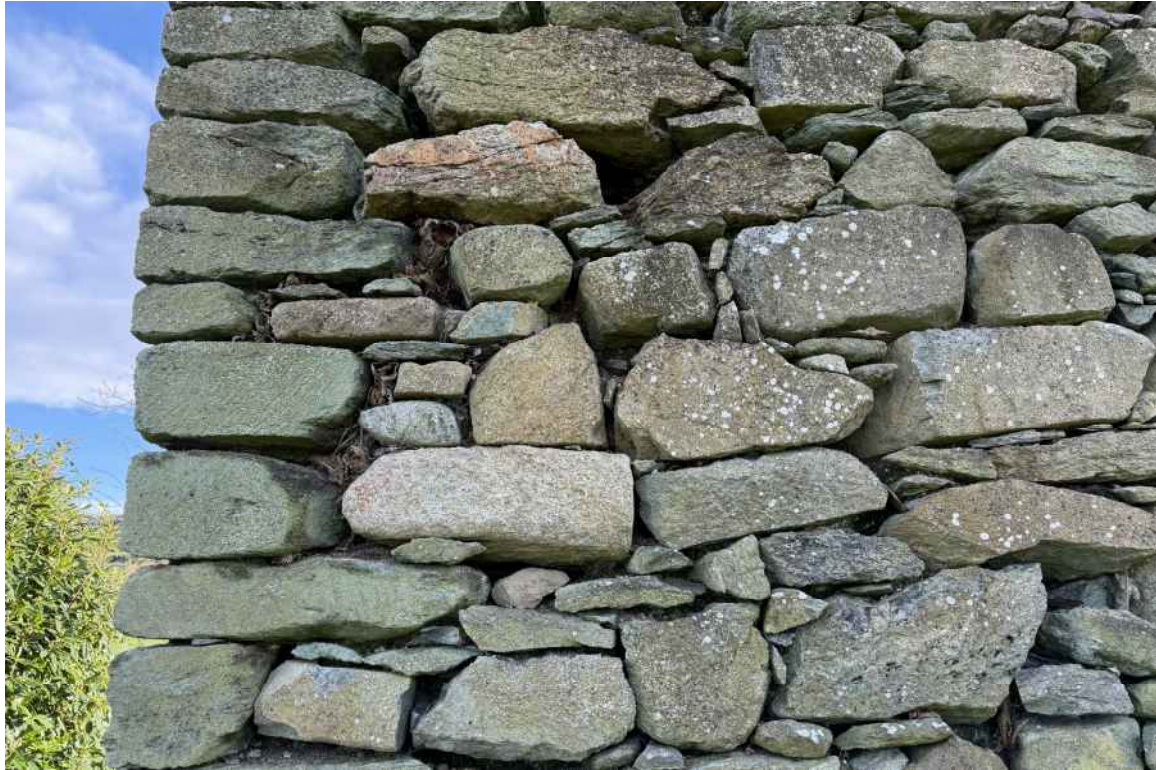
| Building Components and Condition | | | | | | | |
|---|---|---|---|---|---|---|---|
| 3B | | | Lots of pinning stones throughout with dead ivy stems visible in the joints some cementitious pointing at high level. | CC 2 | Erosion of the joints and wedging of the pinning stones from ivy stems. | Reinstate the missing pinning stones and secure the surviving ones in situ with lime mortar. | UC 2 |

**PHOTOGRAPH 3 - DEAD EMBEDDED IVY STEMS AND MISSING PINNING STONES**

| Recommendations | | |
|---|---|---|
| 3B | UC 2 | North Wall External - Reinststate the missing pinning stones and secure the surviving ones in situ with lime mortar. |

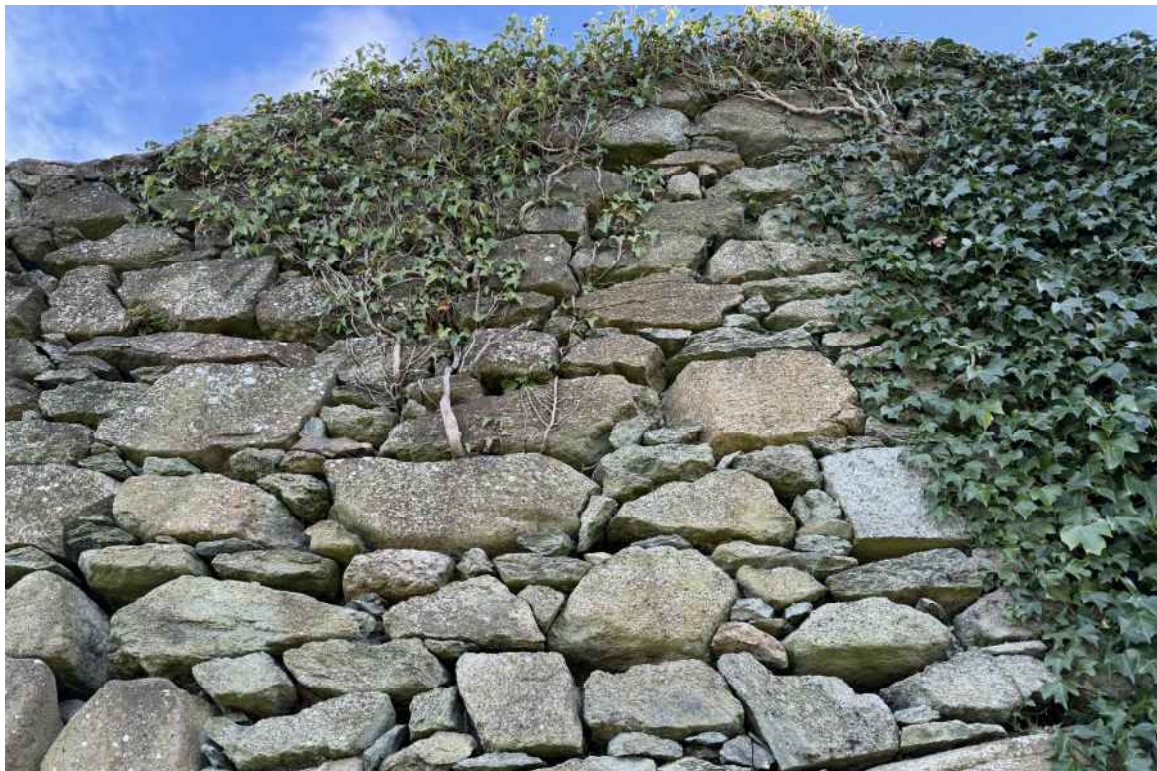
**PHOTOGRAPH 4 - IVY STEMS GROWING FROM CORE OF THE WALL AT THE WEST GABLE**

| Recommendations | | |
|---|---|---|
| 1A | UC 2 | West Gable Outer Face - Remove the ivy and vegetation. Treat any embedded stems. Repoint the eroded joints with lime mortar. |

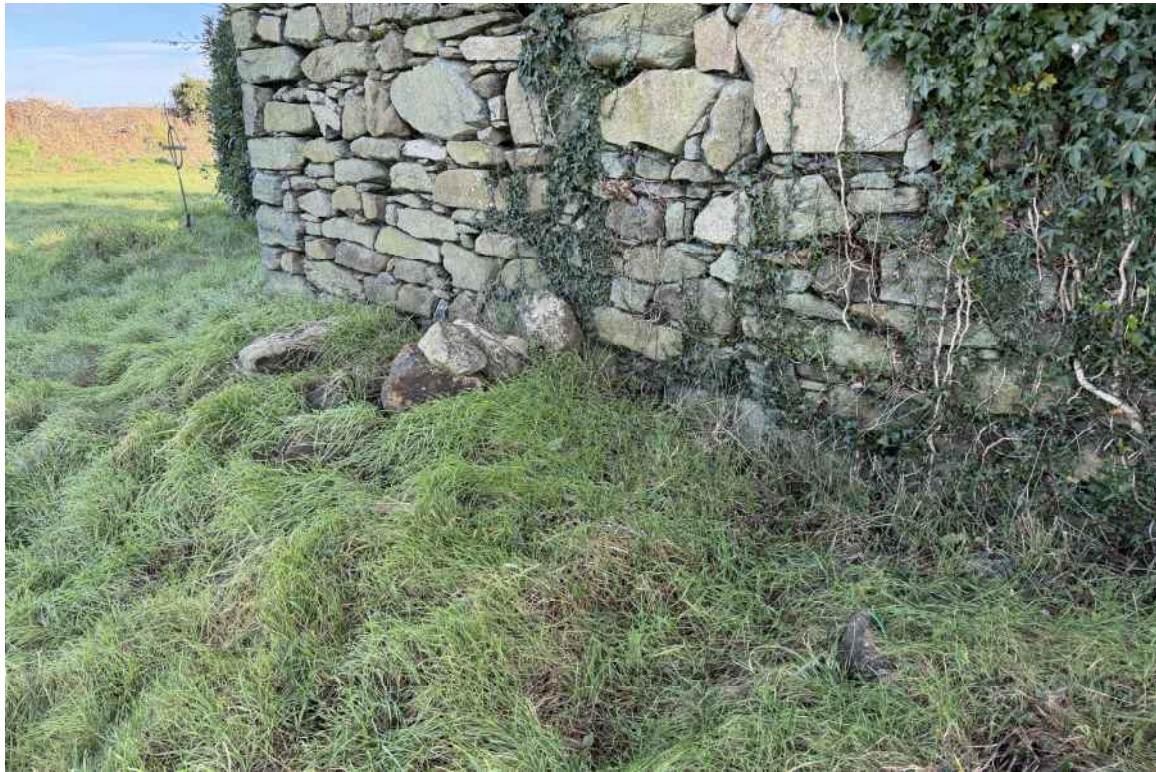
| Building Components and Condition | | | | | | | |
|---|---|---|---|---|---|---|---|
| 1D | | | Loose masonry possibly fallen from the wall top at the base of the wall. | CC 1 | Disintegration of the masonry. | Sort and stack the masonry under archaeological supervision and store on site. | UC 1 |

**PHOTOGRAPH 5 - FALLEN MASONRY AT THE BASE OF THE WEST GABLE**

| Recommendations | | |
|---|---|---|
| 1D | UC 1 | West Gable Outer Face - Sort and stack the masonry under archaeological supervision and store on site. |

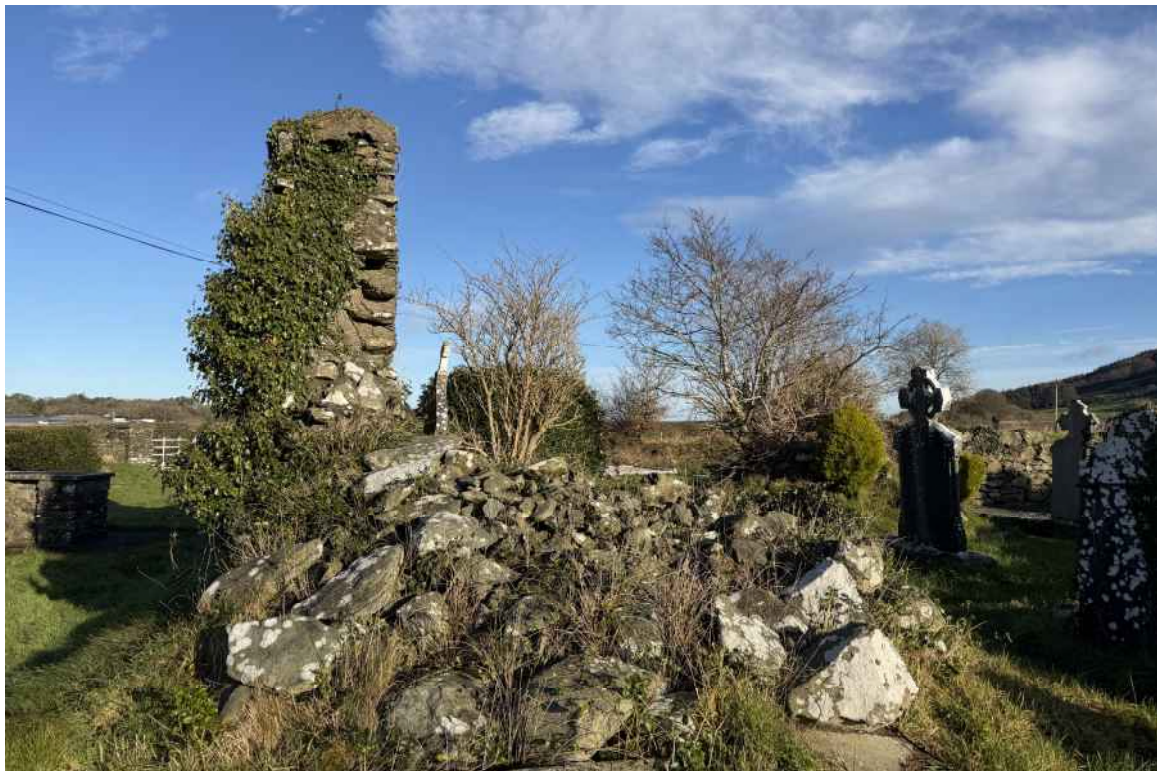
| Building Components and Condition | | | | | | | |
|---|---|---|---|---|---|---|---|
| 4A | South Wall External | Low wall not more than 600 millimetres high with loose stone piled on top and at the outer face. | Loose masonry stacked against outer face of wall | CC 1 | Collapsed masonry | Masonry is stable. Leave in situ. | UC 0 |

**PHOTOGRAPH 6 - REMAINS OF SOUTH WALL AT THE WEST GABLE WITH COLLAPSED MASONRY STACKED AGAINST IT**

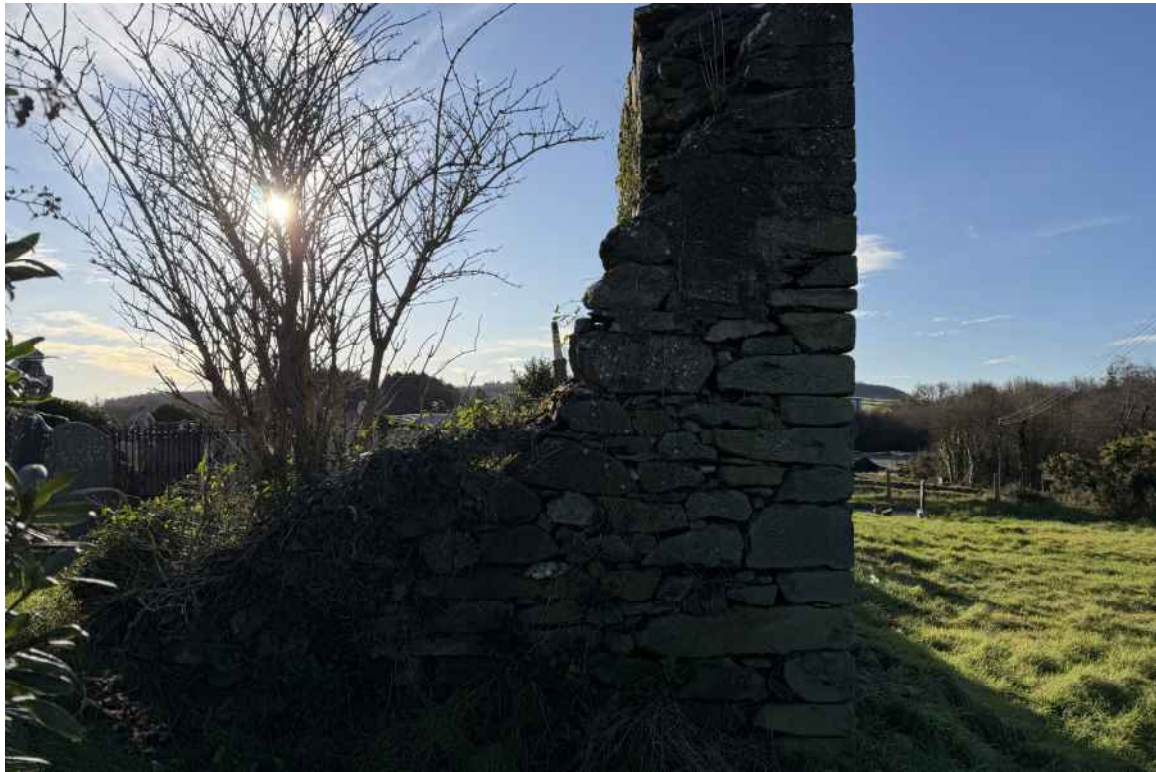
**PHOTOGRAPH 7 - NORTH WALL RETURN AT THE WEST GABLE**

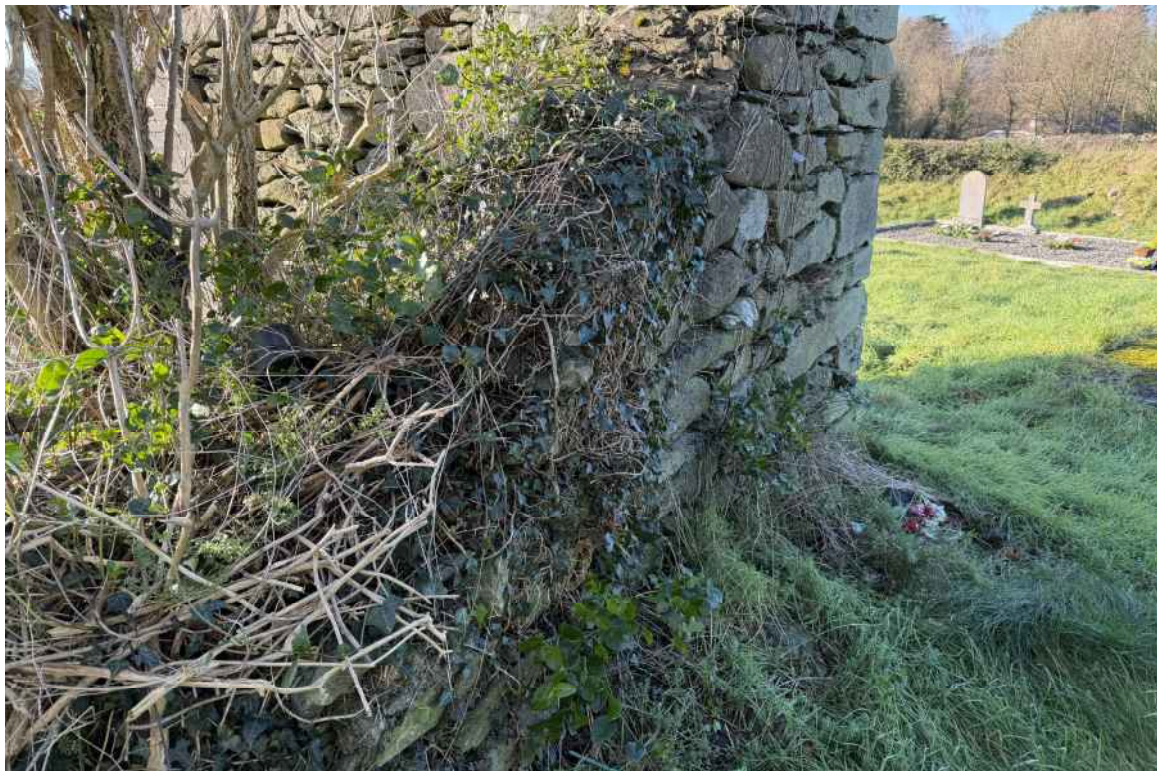
**PHOTOGRAPH 8 - DISLODGED MASONRY AT THE NORTH WALL RETURN**

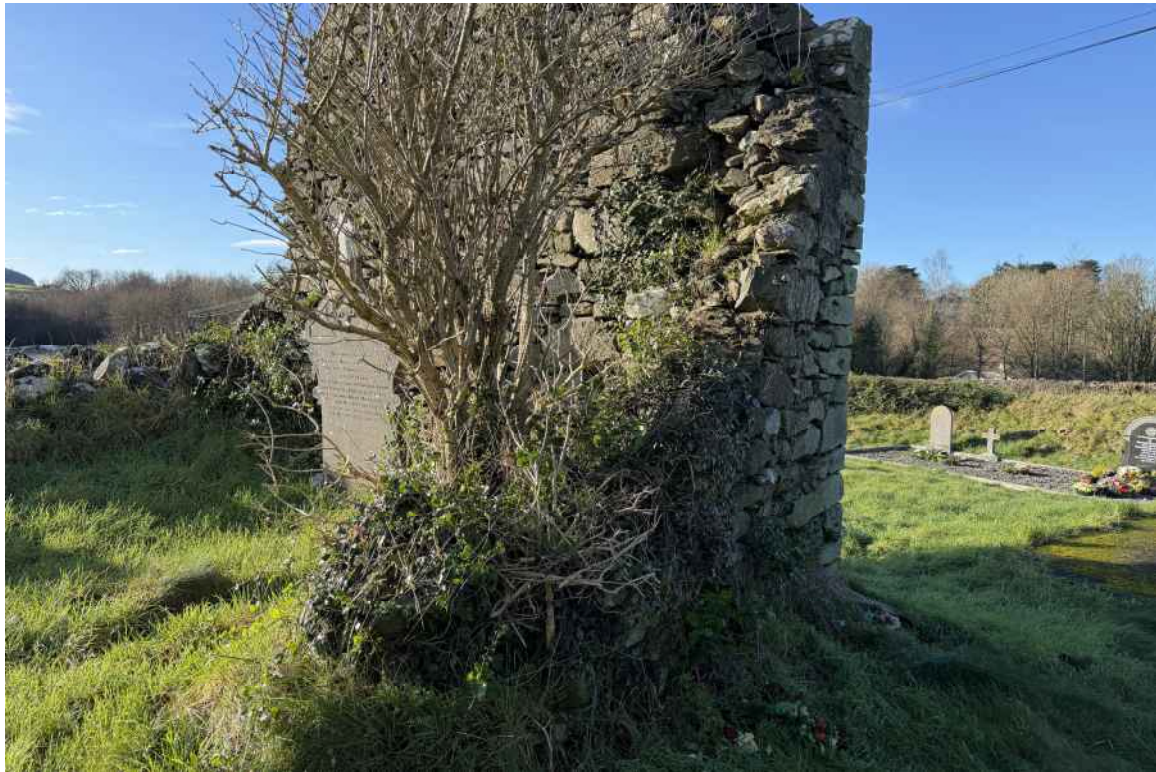
**PHOTOGRAPH 9 - SAPLING GROWING FROM THE NORTH WALL**

| Recommendations | | |
|---|---|---|
| 5. | UC 2 | North Wall Internal - Cut back the trees growing from the wall tops and treat the stumps with herbicide. Secure loose wall top masonry by re-bedding in lime water. |

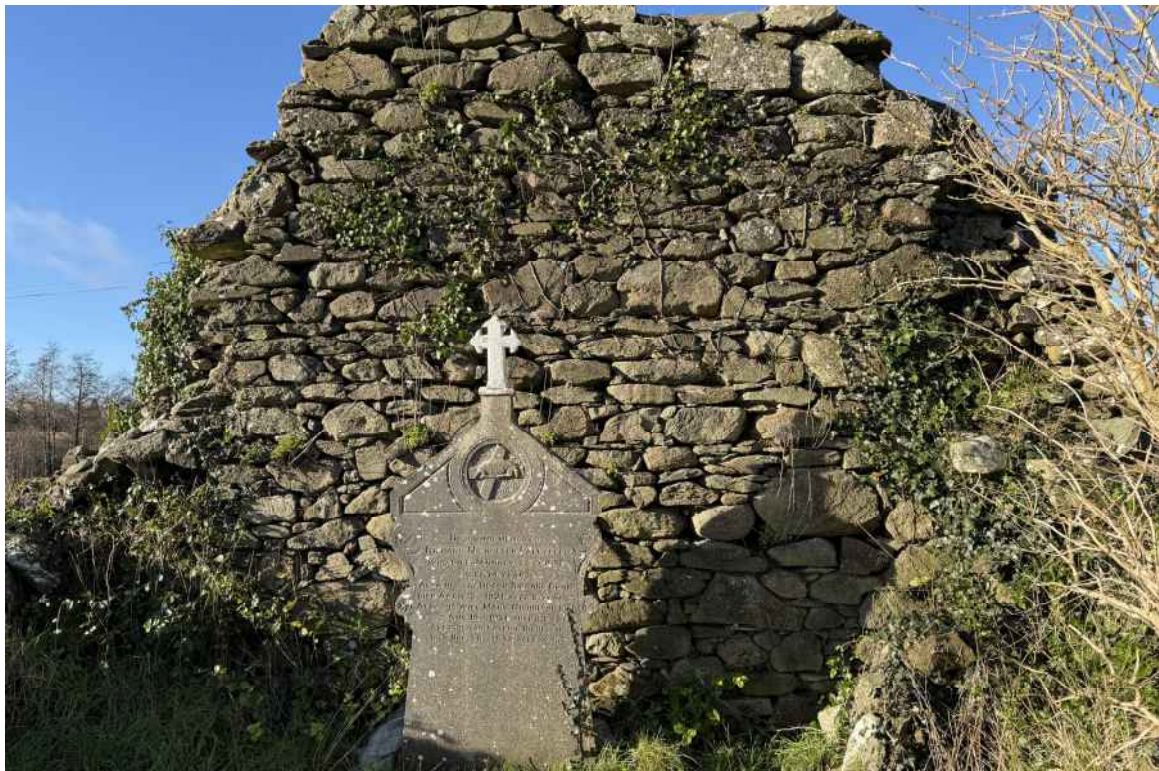
| Building Components and Condition | | | | | | | |
|---|---|---|---|---|---|---|---|
| 2. | West Gable Internal | Sandstone Rubble Masonry Wall. Internal corners are missing. | Light ivy growth on the inner face. Loss of face masonry at the internal corners particularly on the south corner exposing the wall core of the returns. | CC 2 | Collapse of the masonry. | Secure the exposed core as rough racked masonry bedded in lime mortar. Remove the light ivy and vegetation repoint the eroded joints with lime mortar throughout. | UC 2 |

**PHOTOGRAPH 10 - WEST GABLE INNERFACE**

| Recommendations | | |
|---|---|---|
| 2. | UC 2 | West Gable Internal - Secure the exposed core as rough racked masonry bedded in lime mortar. Remove the light ivy and vegetation repoint the eroded joints with lime mortar throughout. |

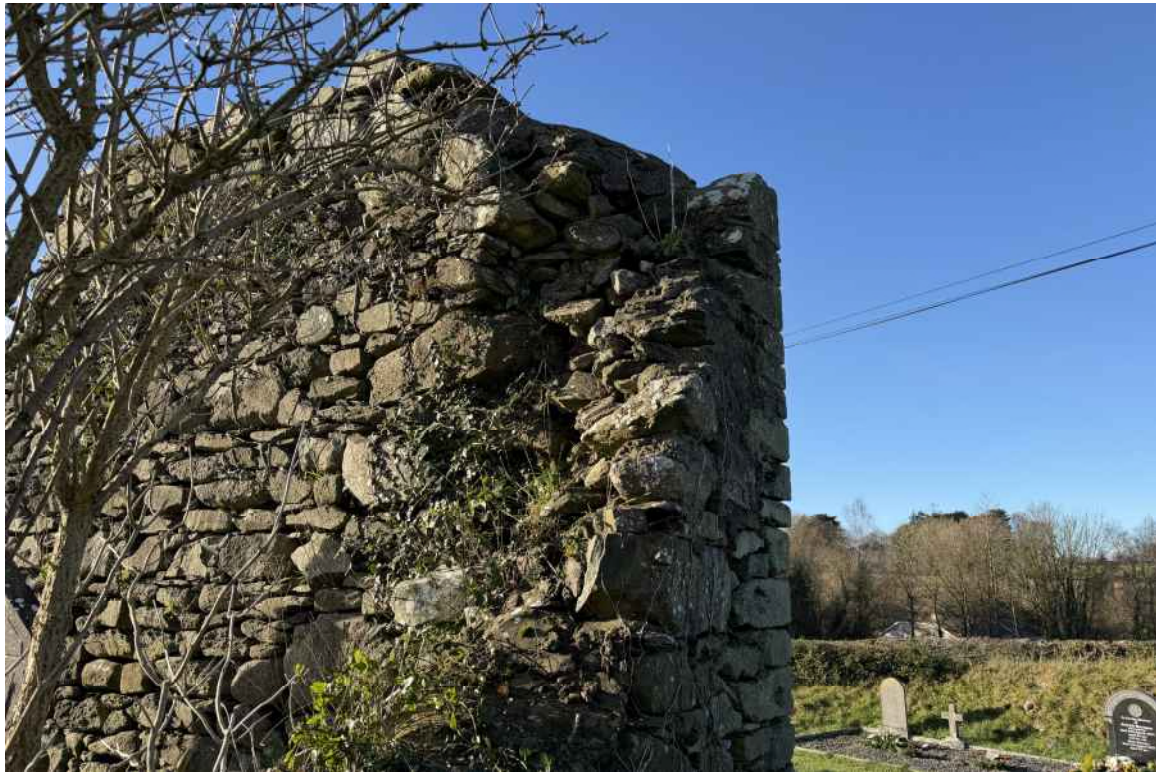
**PHOTOGRAPH 11 - EXPOSED CORE AT THE NORTHWEST CORNER**

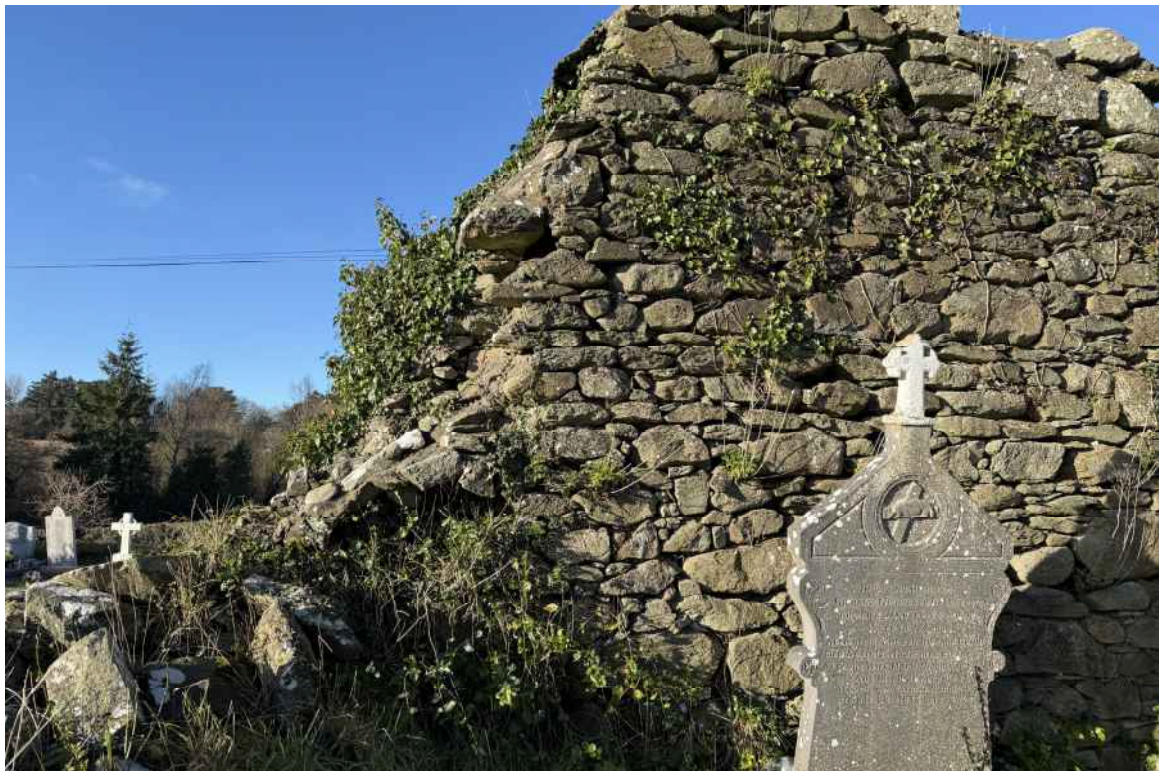
**PHOTOGRAPH 12 - LOOSE MASONRY AT SOUTH VERGE OF WEST GABLE**

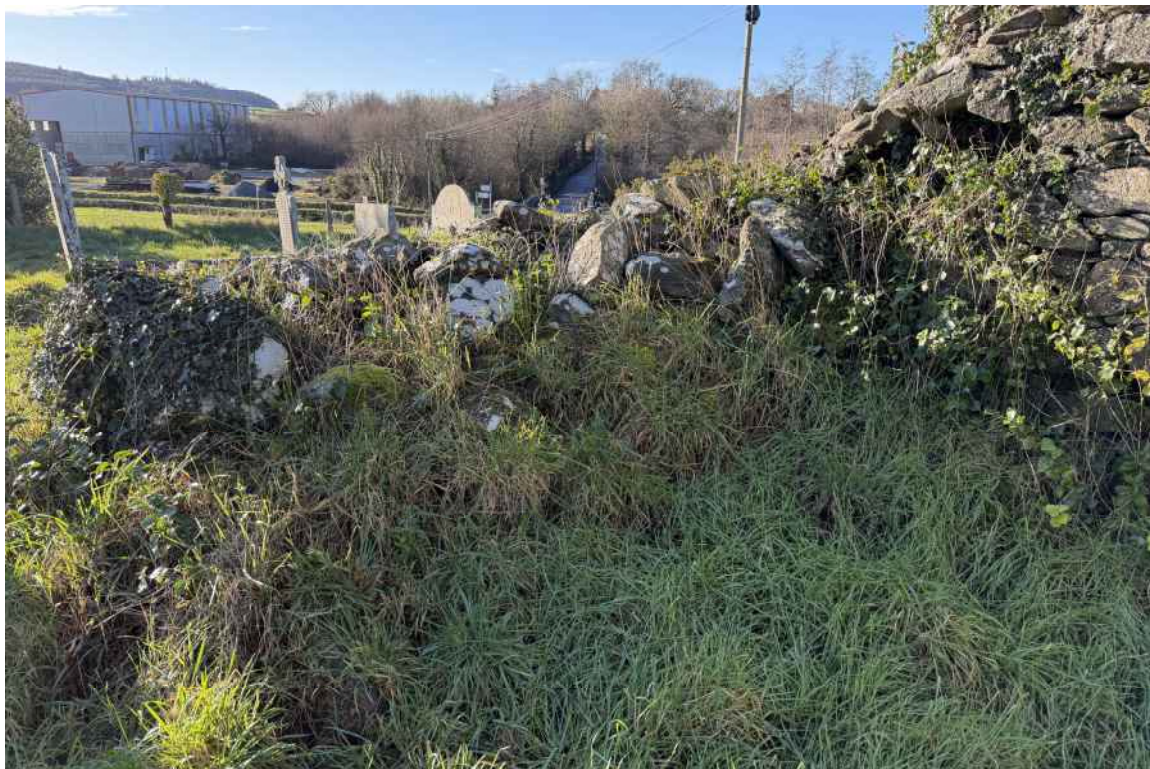
**PHOTOGRAPH 13 - REMAINS OF SOUTH WALL INNERFACE AT WEST GABLE**

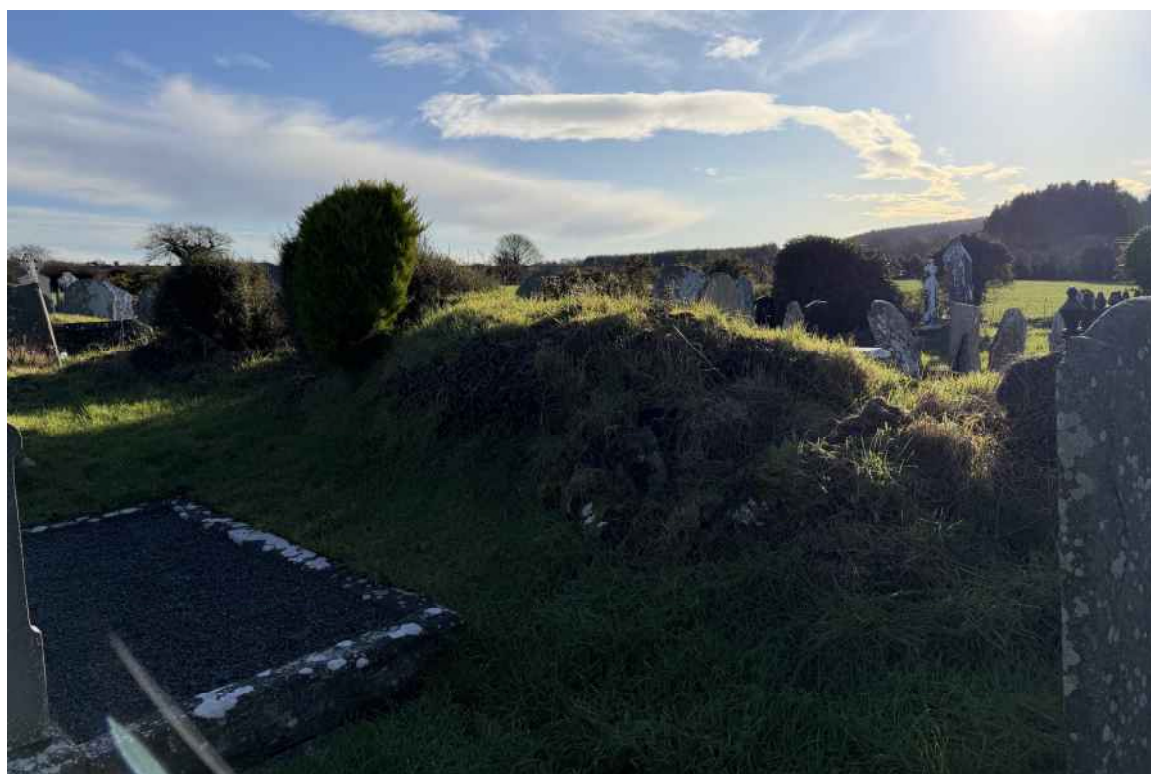
| Building Components and Condition | | | | | | | |
|---|---|---|---|---|---|---|---|
| 6. | South Wall Internal | Low masonry stump covered with grass some loose masonry at the top. | The surviving wall stumps are generally stable. Some loose pieces of masonry abutting the southwest corner. | CC 1 | Collapsed masonry gathered for storage. | Monitor. Some of the loose masonry at the southwest corner could be used to secure the return of the west gable. | UC 2 |

**PHOTOGRAPH 14 - GRASS COVERED STUMP OF SOUTH WALL**

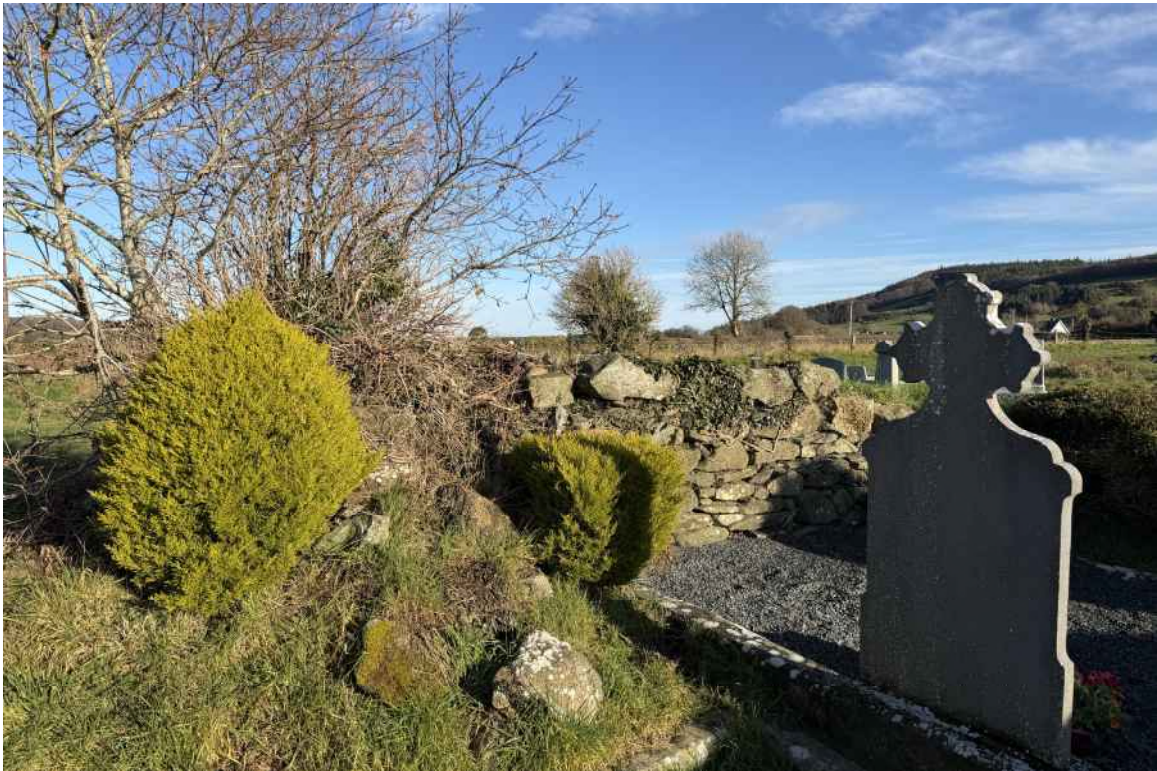
**PHOTOGRAPH 15 - SECTION OF LOW SURVIVING NORTH WALL**
