## CONSERVATION REPORT

### ARCHITECTURAL HERITAGE IMPACT ASSESSMENT

Project – Cart House, Stable, Byre & loft at Tullaghan, Co. Leitrim.  
Repair of an outbuilding to maintain and prevent further deterioration

**Prepared in support of an application for Traditional Farm Buildings Scheme Ref TF6931**

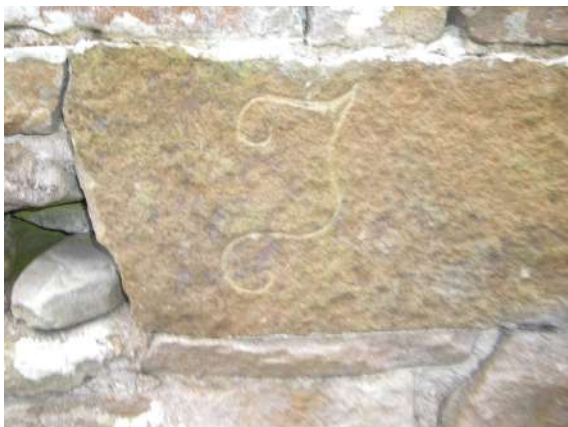
Masons mark on east gable

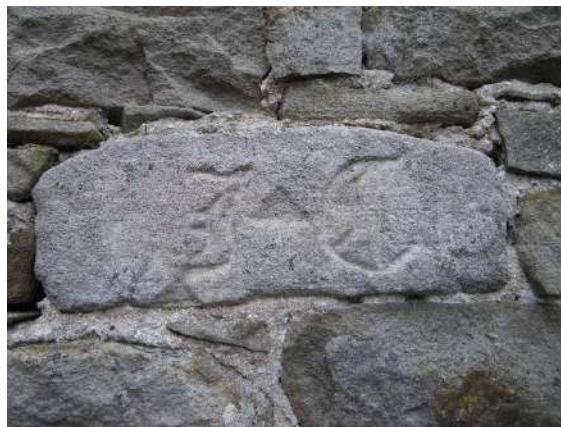
Masons mark on north wall at steps up

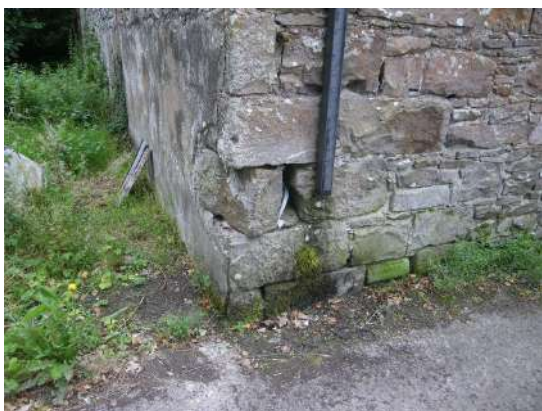
Photo E\_8 South East corner, corner stone knocked out to be reset stone

Downpipe discharging onto wall/ ground to be relocated to west gable and piped to stream

Pinning stones have come loose from some joints and a larger corner stone was knocked aside. Pinning and lime pointing will along with re-setting the stones will prevent further damage.

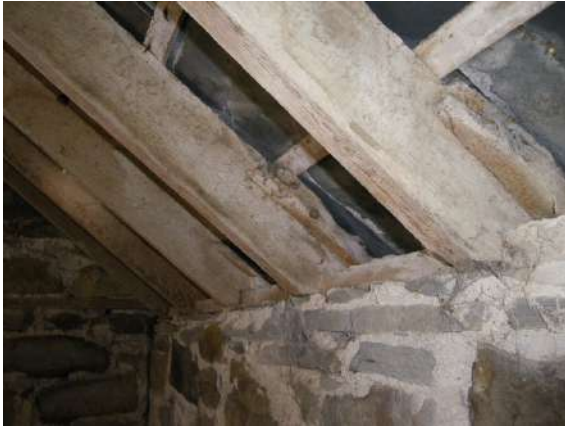
Photo R\_1 Rafter cut onto top of wall with eaves runner

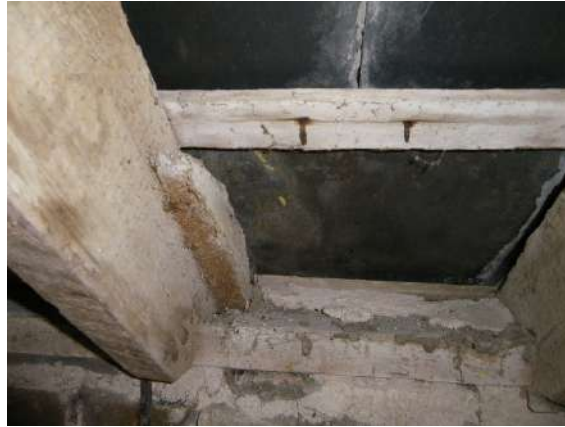
Photo R\_2 Wallplate and extender/ tilting piece

The rafters and collars are in good condition generally. The wall-plate in places is friable and it will have to be replaced along with the rafter extension pieces which are probably rotten at the ends/ eaves. To be reviewed once eaves is opened up. There doesn't seem to be much ventilation at the eaves/ gutter and care will need to be taken in the re-slatted eaves to make sure a continuous ventilation gap is maintained along the length of the eaves and that any gutter or slate overhang does not block this. Replacing the gutters and downpipes with rainwater goods more appropriate to the history of the building will improve the appearance along with better management of rainwater disposal away from the building.

k) Existing wall plate to be repaired/replaced (extent of intervention to be confirmed on site by the inspecting authority).

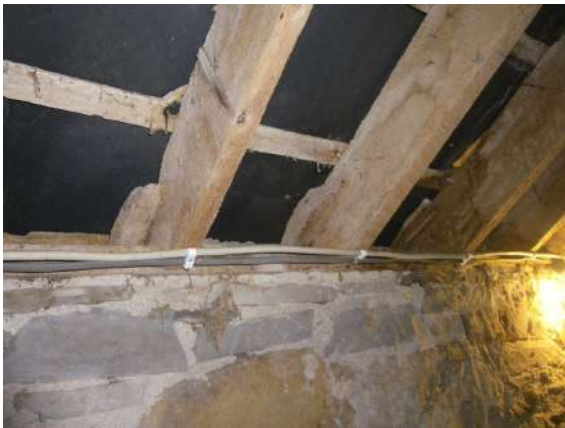
Photo R\_3 Electrical cabling fixed along wallplate

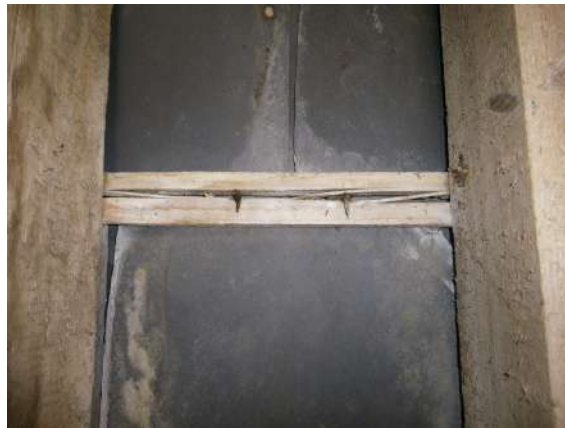
Photo R\_4 Light slating battens and nails have split the batten

The roof of the building is in poor condition with several holes and slipped slates. Some repair work was carried out but overall the slates are in bad condition and the battens have failed and nail sickness is evident. The increase in rainfall and intensity of storms associated with climate change mean that the roof is at risk of losing more slates in the next few years. The verges are in poor condition with slates exposed to the wind. The proposal is to salvage as many slates as possible and replace the battens and nails. It may be that only a small quantity of existing slates can be salvaged and in this case it may be preferable to only use new slates rather than trying to match new slates with salvaged slates.

- a) Install replacement roofing battens to centres ensuring that the coursing of the slate provides from the reinstatement of the existing arrangement.

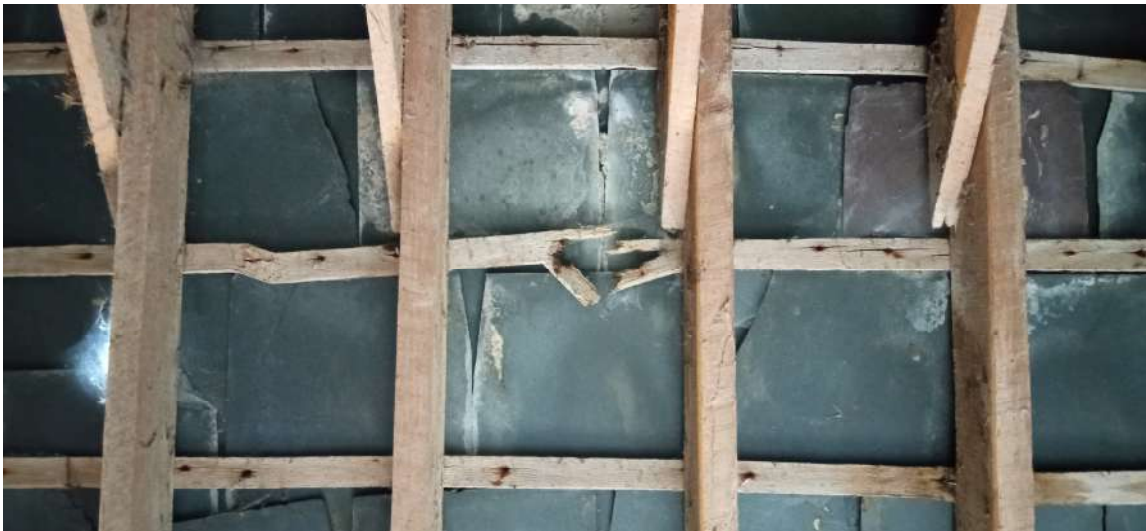
Photo R\_5 Roof detail at collar – broken battens etc/ No sign of parging or torching having ever been done

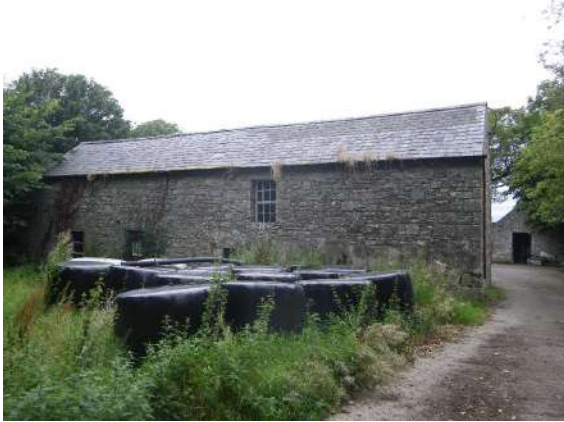
The cart house walls have a green growth from damp. This can be cleaned off. There is little or no cross ventilation in this area. The roof over the cart house was repaired and new slates added in the area over the cart house (see photo E\_2 where different in slates in noticeable)

Photo E\_2 South – Rear/ downpipe discharging to ground

Consider phasing the slate removal taking into account time available/ progress.  
Carefully remove slates and sort/ store on scaffolding in area where the slates will not be disturbed or be required to be moved to avoid double handling. It is important that the scaffolding is designed with this in mind (refer to detailed spec at end of report). Add temporary battens to underside/ to retain rafters in place.  
Repair/ replace wall-plate where friable/ unsound with like for like treated timber  
The rotten parts can be cut out and replaced with new timber laid on a damp proof membrane.  
The rafters will need to be supported during this operation. The wall plate should be cut out on a sequential basis in sections of no more than 2 meters long, rather than all in one go.  
Repair/ replace rafter extension timbers where friable/ unsound with like for like treated timbers.  
Add new gutters & downpipes. Locate new down pipes on gable nearest the river and pipe to river, exact location TBC.

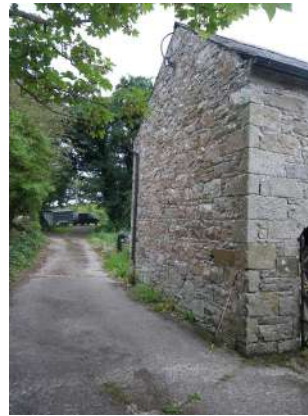
Photo E\_3 - East gable/ northeast corner

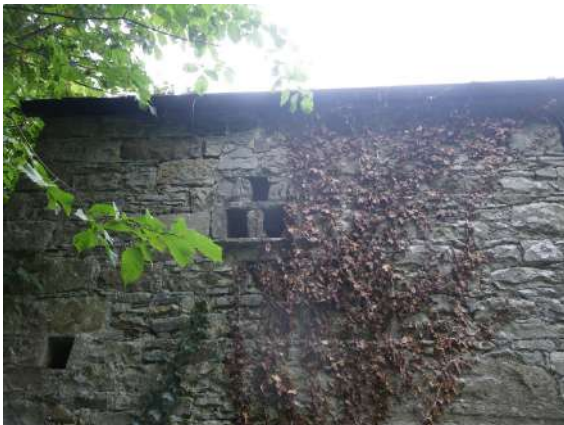
Photo E\_4 South - Rear vent holes/ blocked up window

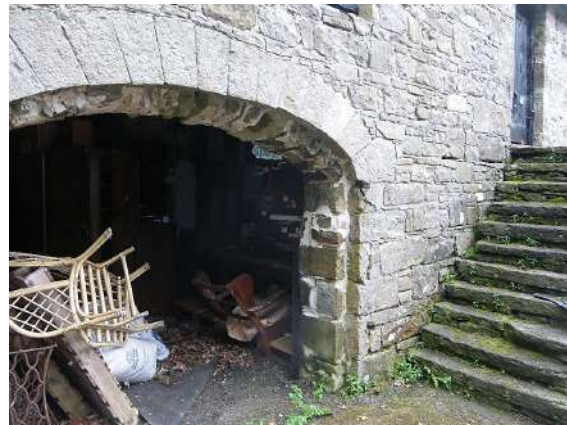
Photo E\_5 - Cart house arch and steps

The advice of an experienced stone mason should be sought for the repair of the arch.

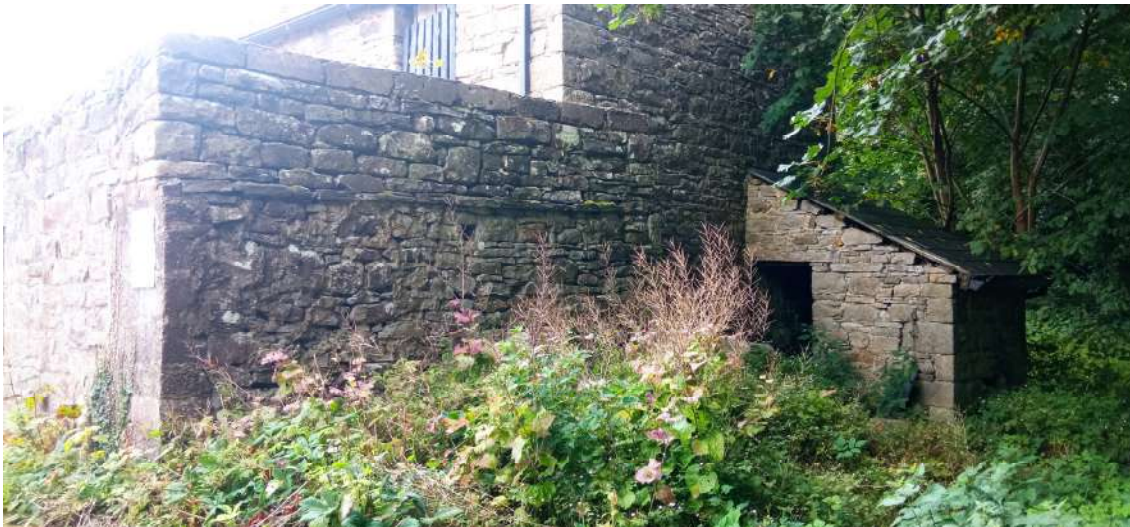
Photo E\_6 North West Corner

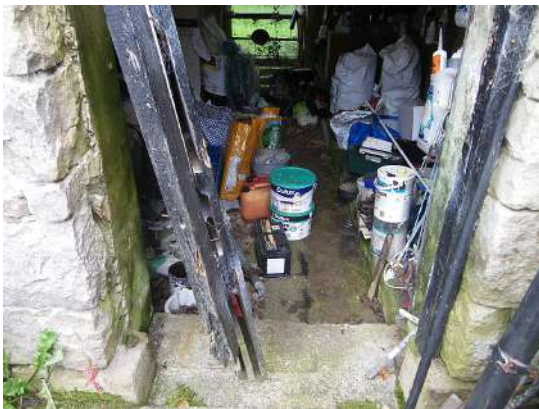
Photo D\_1 Door frame to byre to be completed/ repaired

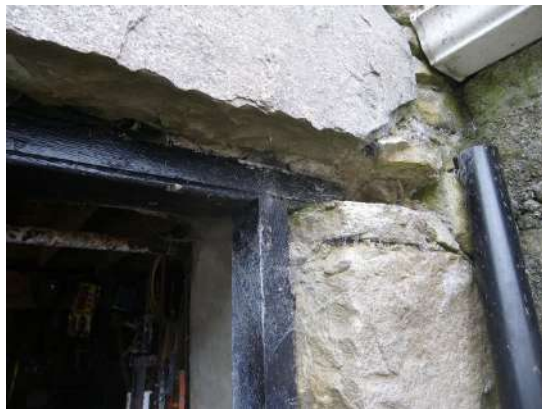
Photo D\_2 Door head built into wall

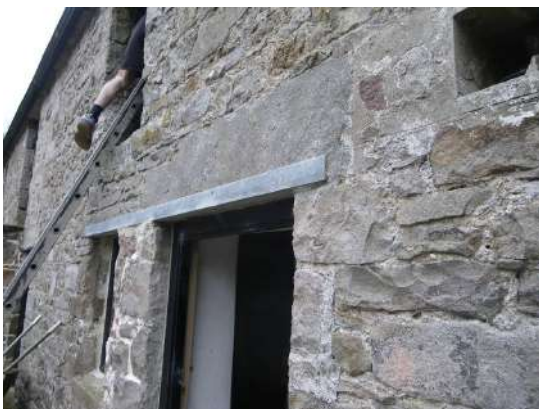
Photo D\_3 Steel angle from previous project could be removed

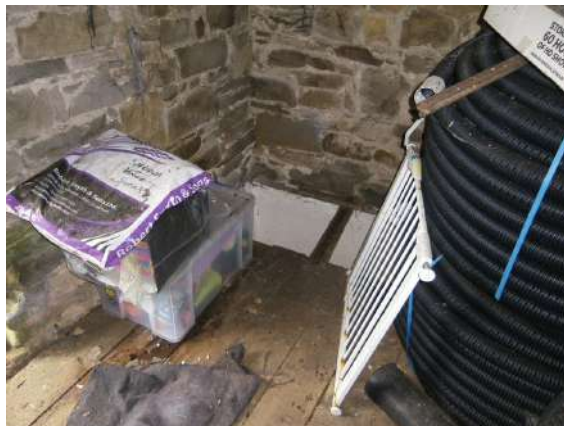
Photo D\_4 Trap door to loft could be added ( for safety)

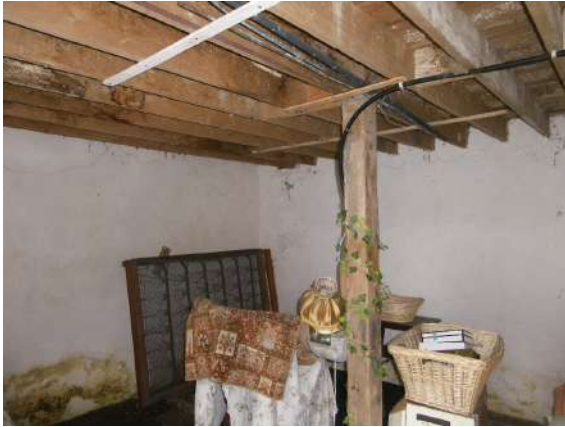
Photo F\_1 Timber post/ wall stain to be reviewed

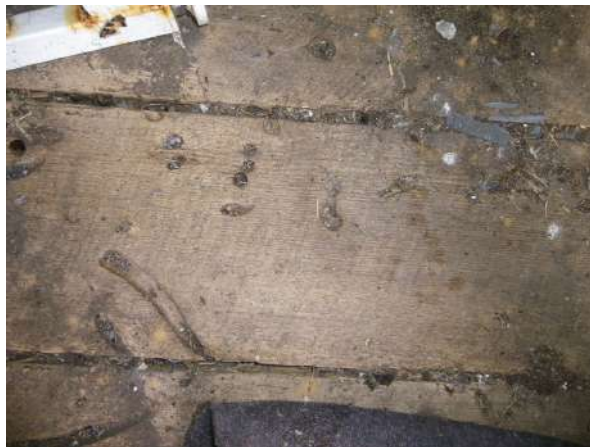
Photo F\_4 Floor boards near hatch 200x20mm approx

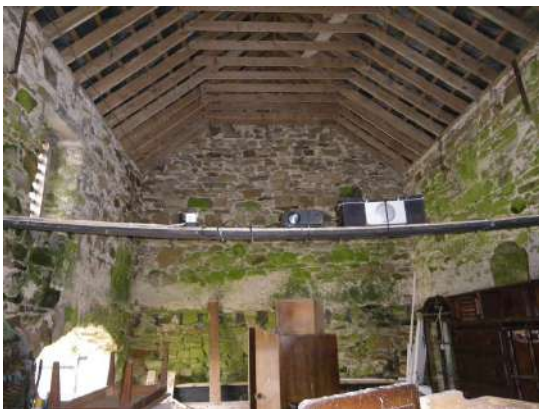
Photo C\_1 Cart House looking towards east gable

Pin & point up the internal walls. Clean off green growth on cart house walls (presumably as a result of leaking roof in that area that was fixed up) Cross ventilate the space to help drying out.

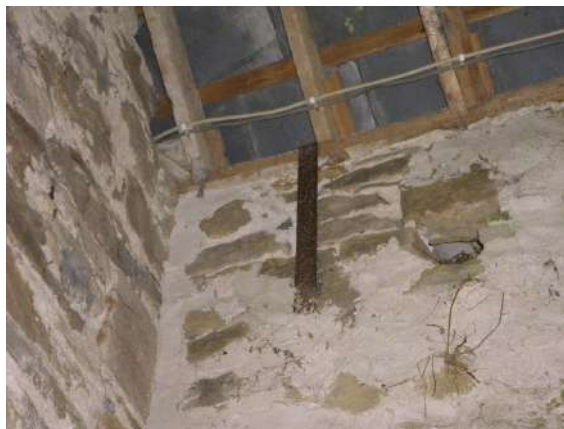
Photo C\_2 Cart House wall-plate strap SE corner

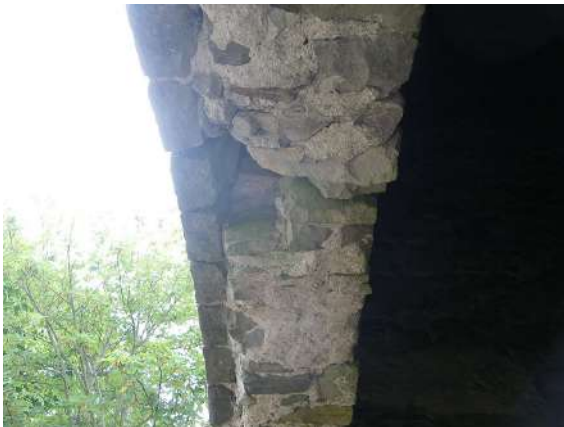
Photo A\_1 Cart house arch, cut stone facing outside

Seek advice of an experienced stone mason regarding the arch.

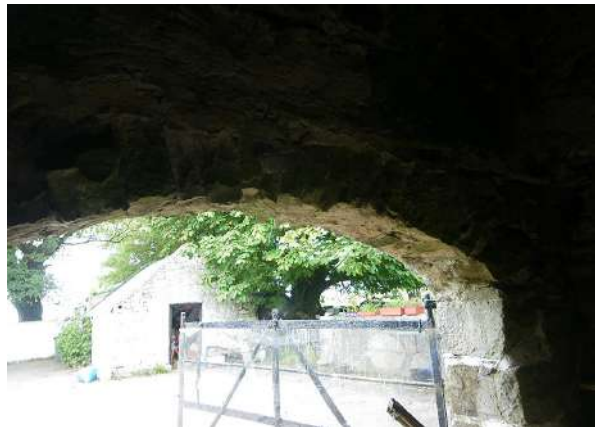
Photo A\_2 Cart house arch from inside random rubble
