# Bat Tile Installation Report

ESB Networks, Killarney

## Bat Roost Supervision Report

Site: ESB Networks, Tiernaboul, Killarney, Kerry

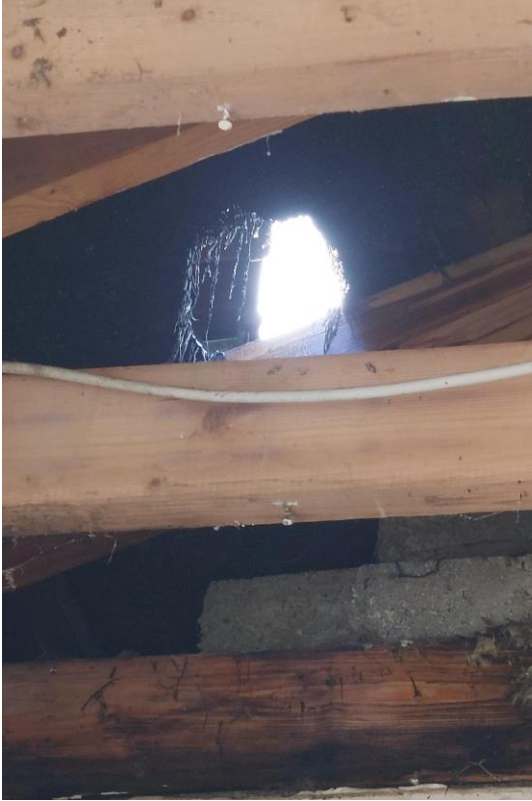
Roof before installation

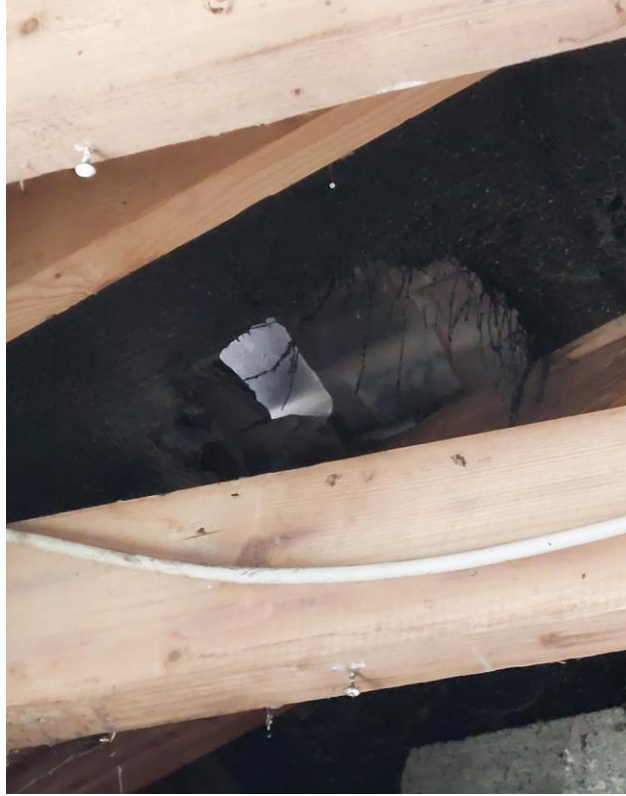
After bat tile installation

- It was recommended that one window remain open while the ceiling area is left exposed to dry, to allow bats safe exit and reorientation to the new bat access point and to prevent trapping or mortality within Office 7.
- The bat access tile was installed under supervision; no bats were disturbed.
- A minor refit was required after the builder initially misplaced the tile. This was corrected on site with oversight.

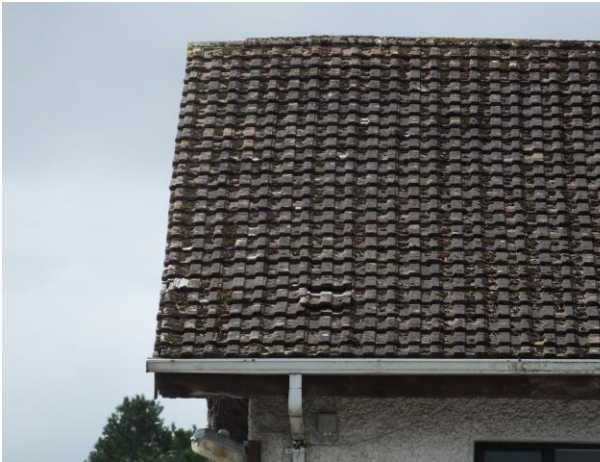
Roof prior to installation

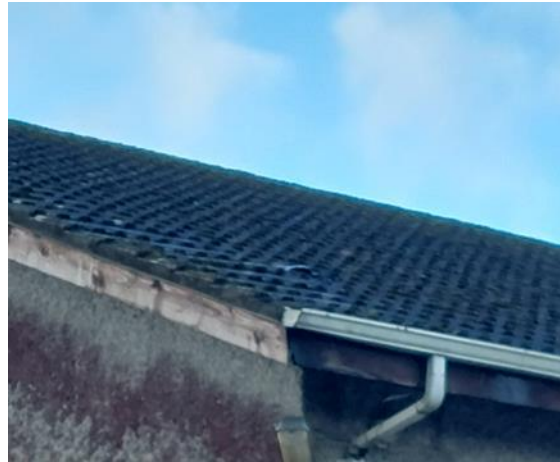
Roof with bat access tile fully installed

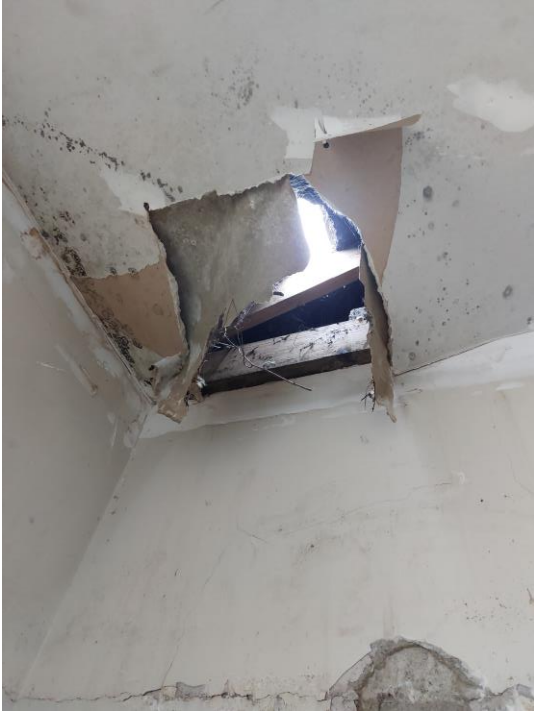
Office 7 ceiling July 2025

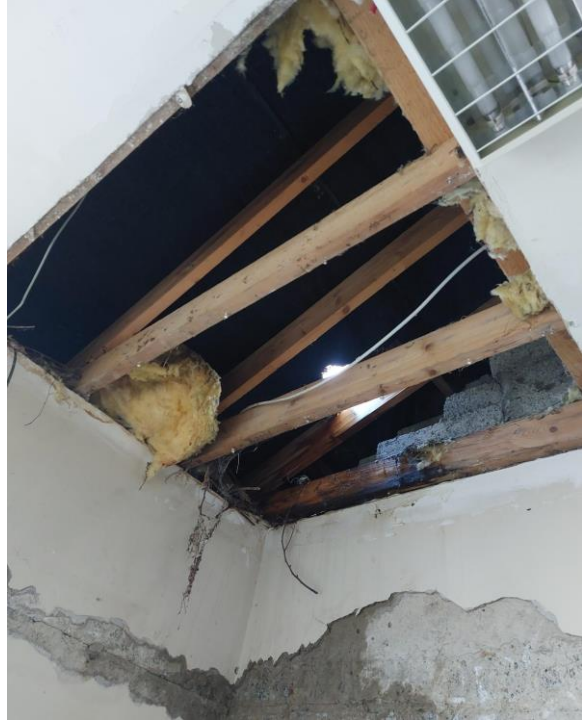
- A full attic inspection was completed prior to commencement of works.
- Bat presence confirmed: visually fresh droppings were recorded in roost areas (felt and soffit) and within approximately 2 m of the roof opening.
- In Office 7, where the ceiling was affected by water ingress, a section of plasterboard had collapsed. The ceiling edges were cleared to create a square opening between the attic, roof, and office for repair access.
- Since the July survey (when no bat activity was recorded within Office 7), new evidence of activity was observed – evidence of bats flying and landing in the office space, likely entering through open windows or the ceiling void.
- A total of 14 droppings, consistent with *Pipistrellus pygmaeus* and *Nyctalus leisleri*, were counted within Office 7.

Office 7 ceiling October (pre tile) 2025

Due to the observed increase in bat activity within and around Office 7, and confirmed use of the adjacent attic void as a roosting area, a licensed bat handler must be present during the final repair works when the ceiling and attic are sealed. This supervision will ensure that no bats are trapped or disturbed during closure of the roost area and that the works remain in full compliance with wildlife protection legislation.

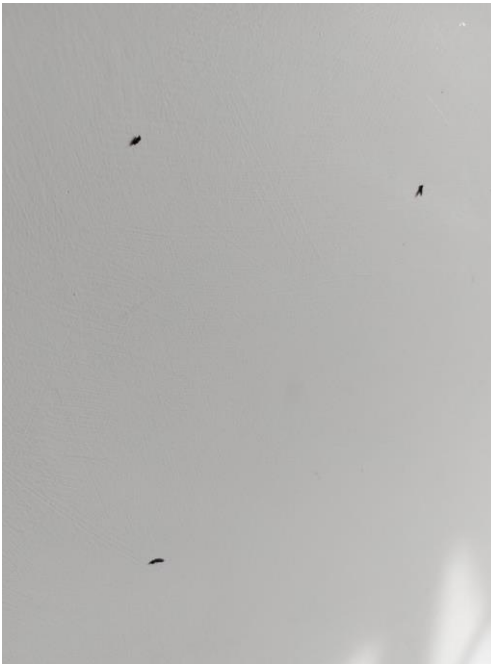
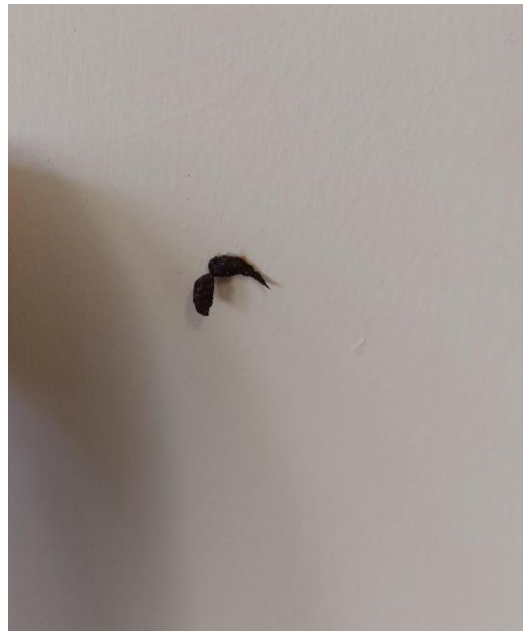
Bat droppings inside Office 7 during October 23<sup>rd</sup> inspection
