TII, RSI Review, Unresolved Design Issues

TII Site ID: N71KY_178.0

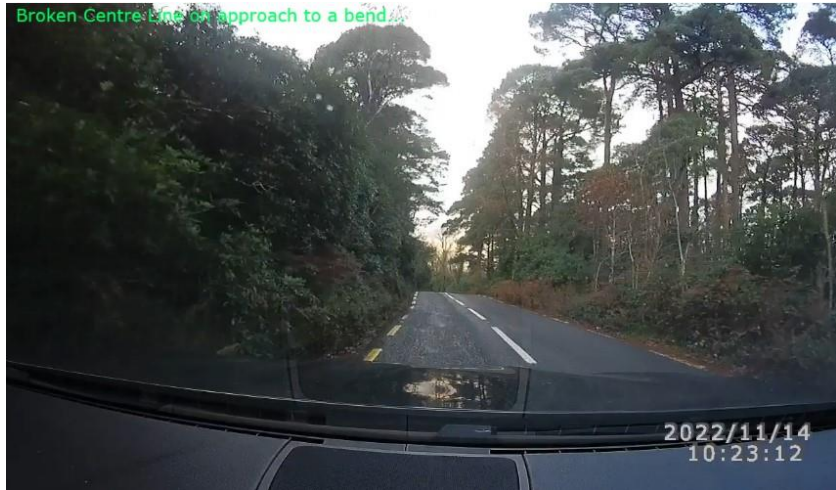
Tag ID: 110698

Broken Centre Line on approach to a bend

Risk of head on collision due to drivers overtaking when it is not safe to do so.

Risk Rating: Level 2

Review appropriateness of broken centre lining

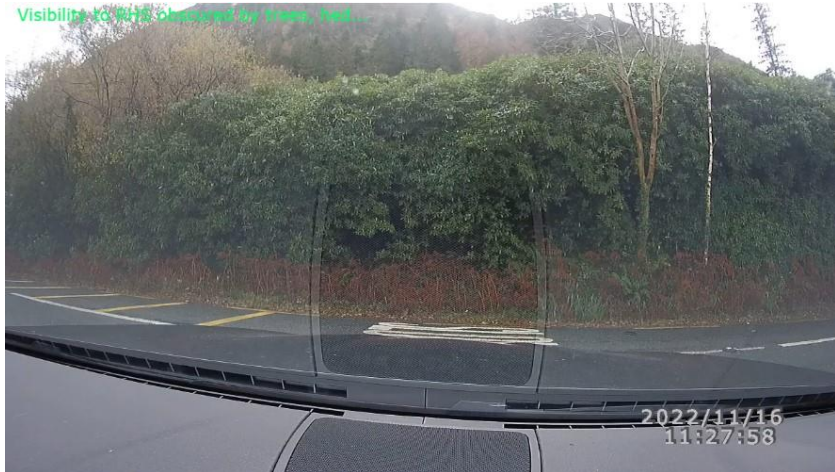
Tag ID: 111134

Visibility to RHS obscured by trees, hedgerow and mound on exit from Meeting of the Water carpark

Risk of collision due to drivers exiting without prior knowledge of oncoming vehicles on the main road.

Risk Rating: Level 3

Sightline should be improved to provide clear view of oncoming traffic on RHS

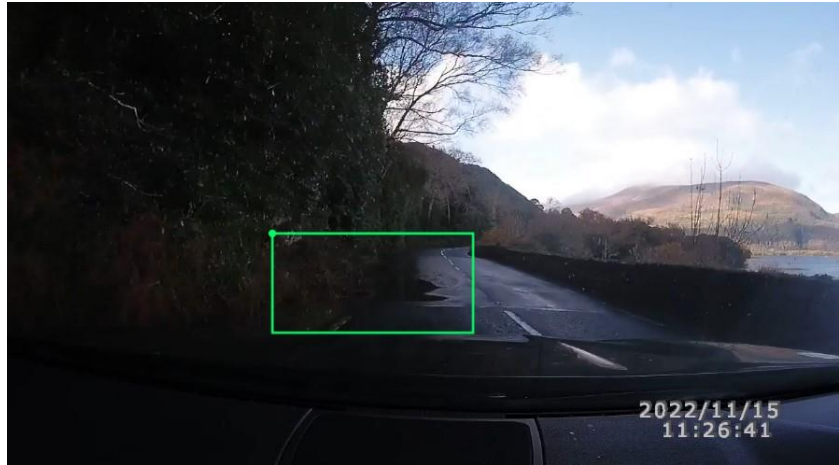
Tag ID: 111044

Road edge ponding

Risk of drivers losing control of a vehicle and veering into the path of an oncoming vehicle, due to aquaplaning on standing water.

Risk Rating: Level 2

Investigate further to find the source of the water on the carriageway. Additional drainage may be required, or existing drainage may need clearing.

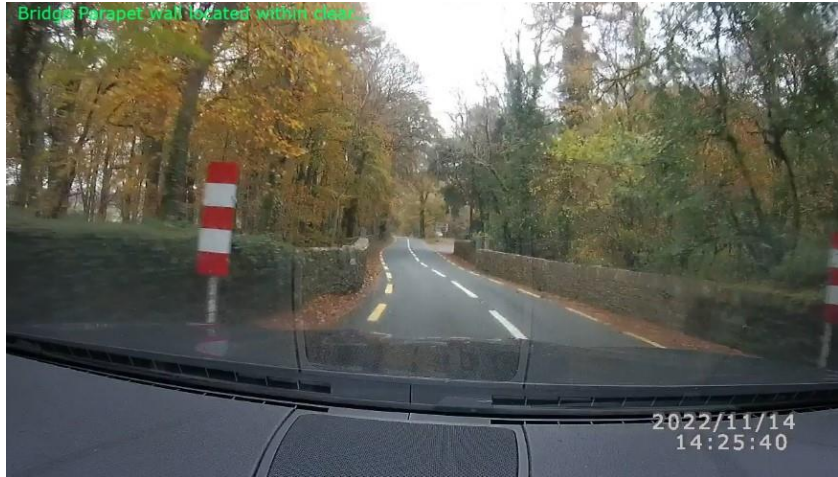
Tag ID: 110902

Bridge Parapet wall located within clear zone (unprotected) - Westbound

Risk of collision with the bridge parapet which is close to road edge if vehicle has left carriageway.

Risk Rating: Level 3

Review layout to reduce risk of errant vehicle colliding with parapet wall.

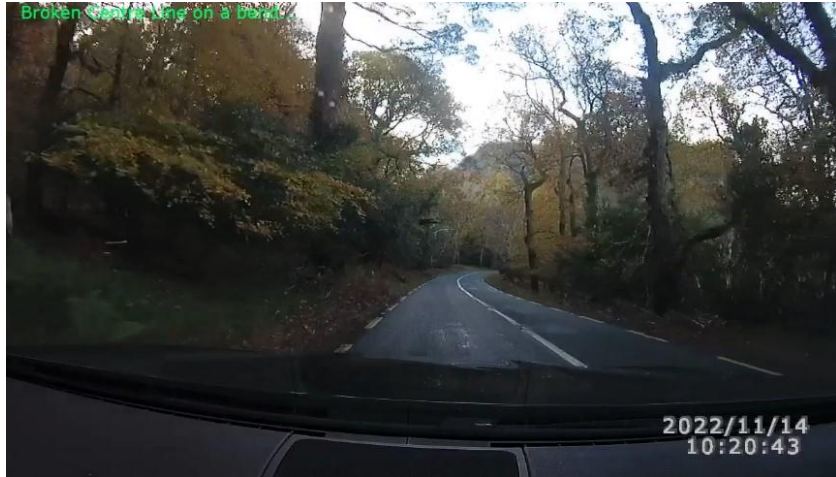
Tag ID: 110912

Broken Centre Line on a bend

Risk of head on collision due to drivers overtaking when it is not safe to do so.

Risk Rating: Level 2

Review appropriateness of broken centre lining.

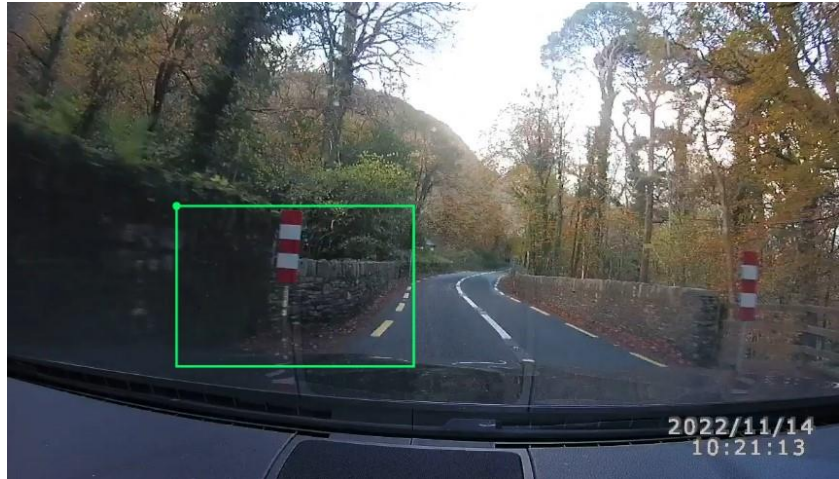
Tag ID: 110913

Bridge Parapet wall located within clear zone (unprotected) - Eastbound

Risk of collision with the bridge parapet which is close to road edge if vehicle has left carriageway.

Risk Rating: Level 3

A VRS assessment should be carried out at this location.

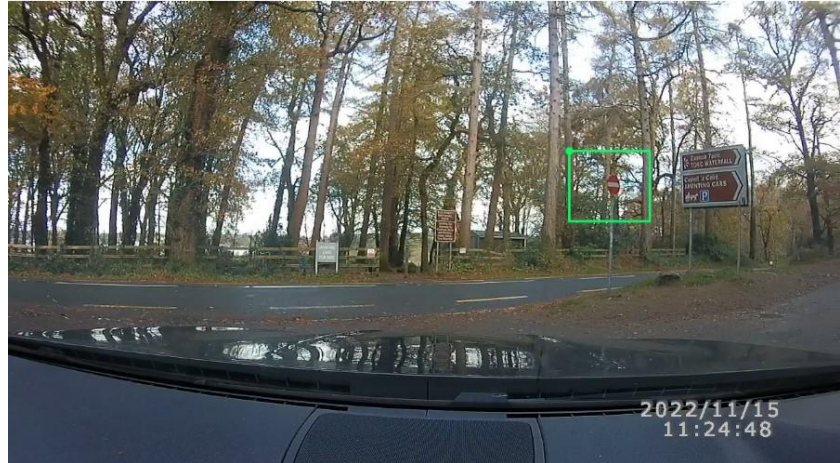
Tag ID: 111043

Junctions poorly defined and signage confusing (No Entry sign)

Risk of collision with vehicle on the mainline and a vehicle slowing/stopping on the mainline in confusion as to where the carpark entrance/exit locations are located, due to poor junction definition and confusing signage.

Risk Rating: Level 3

Access and signage to Torc Carpark to be reviewed.

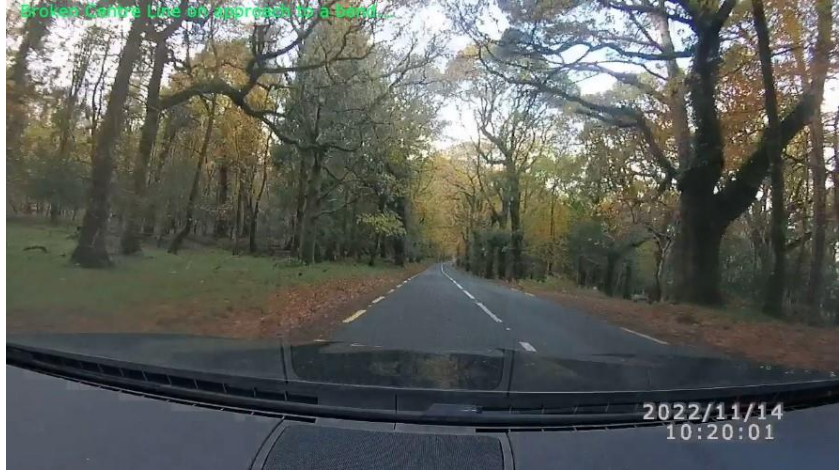
Tag ID: 110911

Broken Centre Line on approach to a bend

Risk of head on collision due to drivers overtaking when it is not safe to do so.

Risk Rating: Level 2

Review appropriateness of broken centre lining.
