CONSERVATION METHOD STATEMENT for Historic Structures Fund 2024

Project Title: **ST JOHN'S CHURCH, KILL, CO KILDARE**

ROOF REPAIRS

Client: Naas Union of Parishes

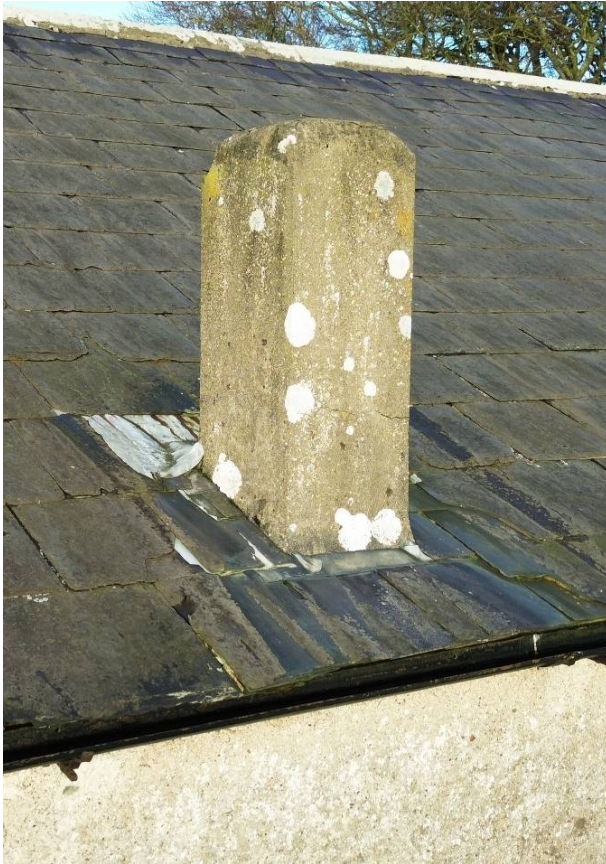
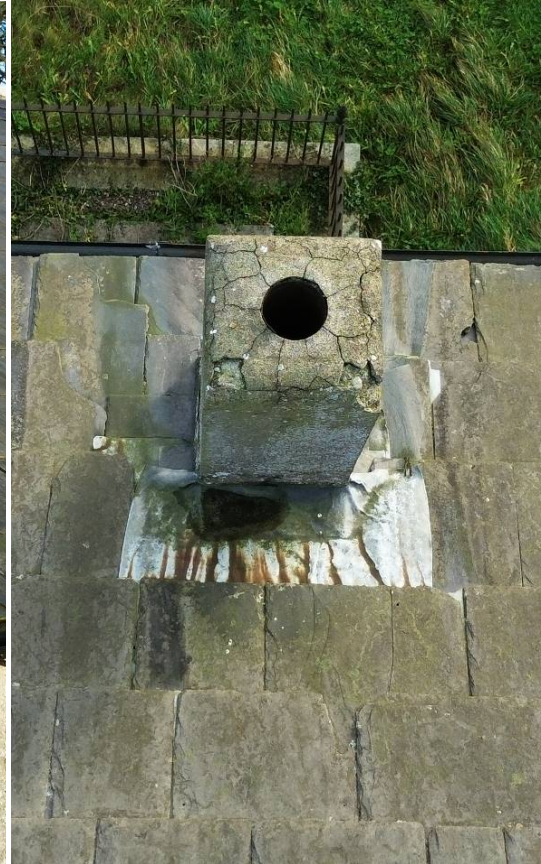
Chimney in southern slope

- The chimney in the south slope of main roof is in need of repairs. Slates have slipped around it and the lead flashings need to be repaired/renewed. The flaunching to the top of the chimney is cracked and pieces are missing. The flue is no longer in use but remains open allowing debris to build up and rainwater to get in.

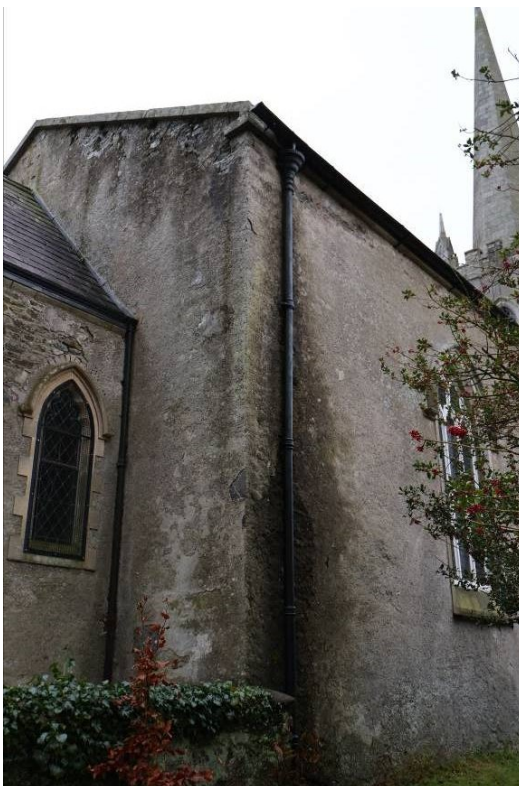
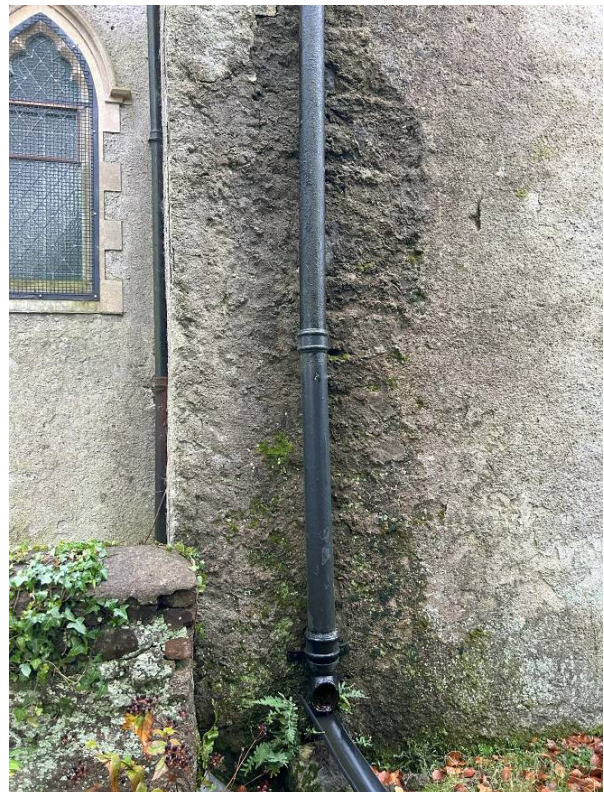
Downpipe in north-east corner

- Gutters have been repaired/replaced in the past but there is an issue with the gutter/downpipe at the north east corner of the nave where water is staining the exterior of the church and moisture damage is visible to the interior of the church with areas of paint damaged/flaking including on the wall beside the organ.

- Existing gutters and downpipes to be inspected and any damaged/broken sections to be repaired or replaced.
