GLASPISTOL CASTLE CLOGHERHEAD, CO LOUTH

Conservation Method Statement | JUNE 2025

The following conservation methodology is prepared in advance of the third phase of conservation repairs to Glaspistol Castle, a tower house located outside Clogherhead, Co Louth. Note that the second phase of works scheduled out in 2023 were deferred until 2024.

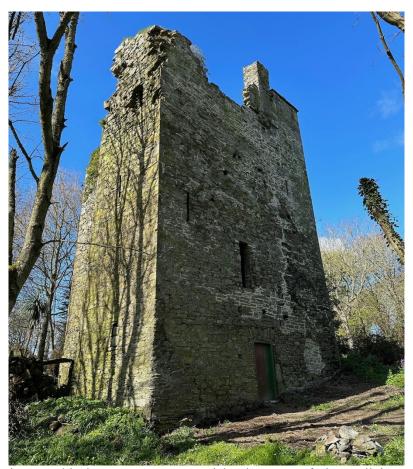
The original historic soft lime and sand mortar used for bedding and for pointing the stone blocks has long washed away leaving open joints to both interior and exterior wall surfaces. Some internal plaster has survived on the first-floor level, and elsewhere

large voids between stones and in the core of the wall have emerged which risk localised instability. During previous phases of repair works the NE corner at the base of the wall was re-pointed with Portland cement and sand mortar. Several openings and voids have been infilled with loose stonework, a precaution against accidents.

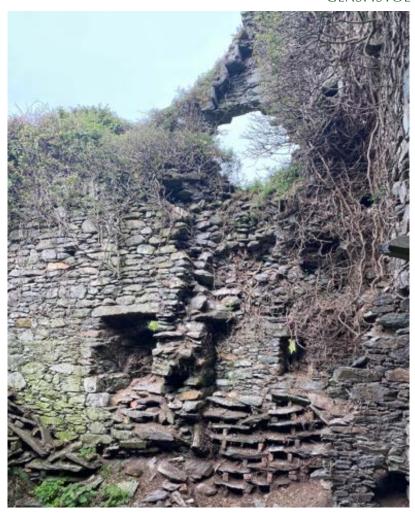
To the exterior, the large void cuts through the base of the battlements. Here the stonework sits in front of the main face set on flat stones, with weepholes of the long missing wall walk. Elsehere we have allowed for a 25-50mm set back the way we do for facework infill, but in this location, we propose to reconstruct the parapet close to its original design, matching the profile of the stone. The repair will remain distinguishable between old and new, without the loss of architectural detail.
