<div>Behan House, 10 Lower Mount Street, Dublin 2. D02 HT71 Tel: +353 (0)1 661 1100 e-mail: info@cora.ie web: www.cora.ie</div></div>							
Project Details:						Project Name: <b>Glaspistol Castle</b>			Scale:	Project Number:							
Site Address: Clogherhead						<b>Clogherhead - Phase 3</b>			NTS	21718							
Client:	Charles Markey	I1	Issued for Information.	04/06/2025	RK	Drawing Title: <b>Proposed Repairs</b>			Project:	Originator:	Zone:	Level:	Type:	Discipline:	Drawing No.:	Stage:	Revision:
Architect:	7L Architects	REV. No.	REVISION DESCRIPTION	DATE	ISSUED BY	<b>to the Internal North Wall</b>				CORA					SK300		I1

</div><div>Behan House, 10 Lower Mount Street, Dublin 2. D02 HT71 Tel: +353 (0)1 661 1100 e-mail: info@cora.ie web: www.cora.ie</div></div>						
Project Details:						Project Name: <b>Glaspistol Castle</b>		Scale:	Project Number:							
Site Address: Clogherhead						<b>Clogherhead - Phase 3</b>		NTS	21718							
Client:	Charles Markey	I1	Issued for Information.	04/06/2025	RK	Drawing Title: <b>Proposed Repairs</b> <b>To the West External Elevation</b>		Project:	Originator:	Zone:	Level:	Type:	Discipline:	Drawing No.:	Stage:	Revision:
Architect:	7L Architects	REV. No.

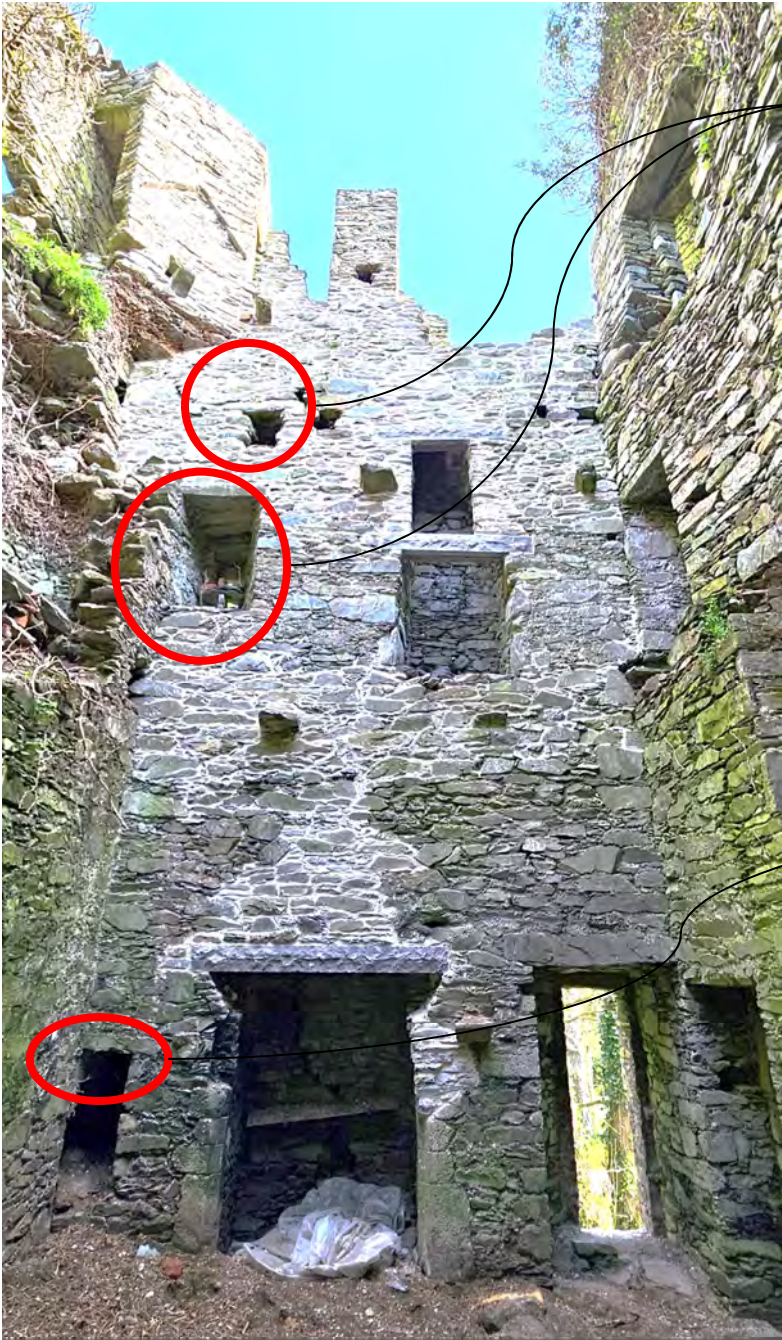
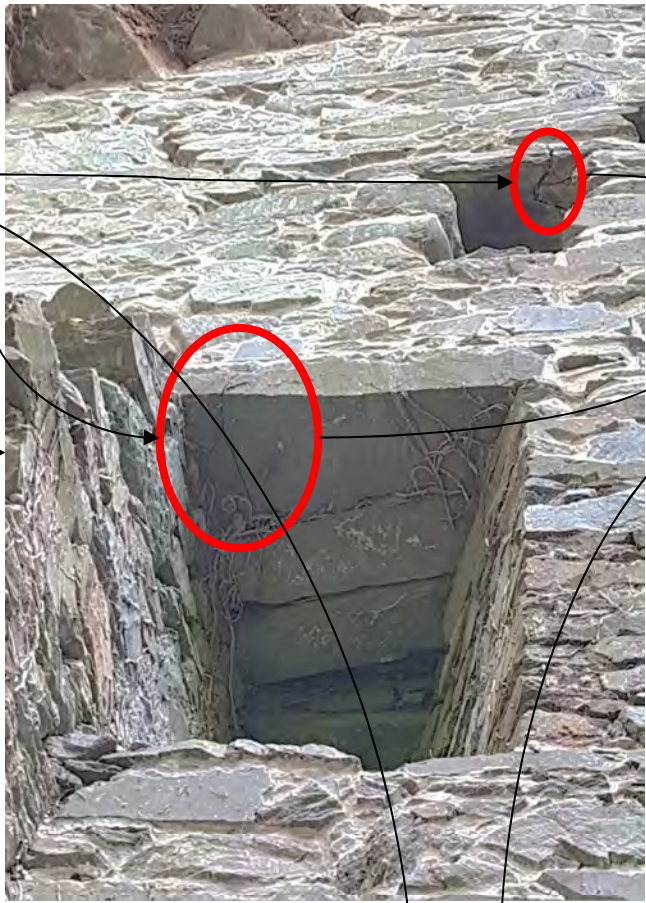
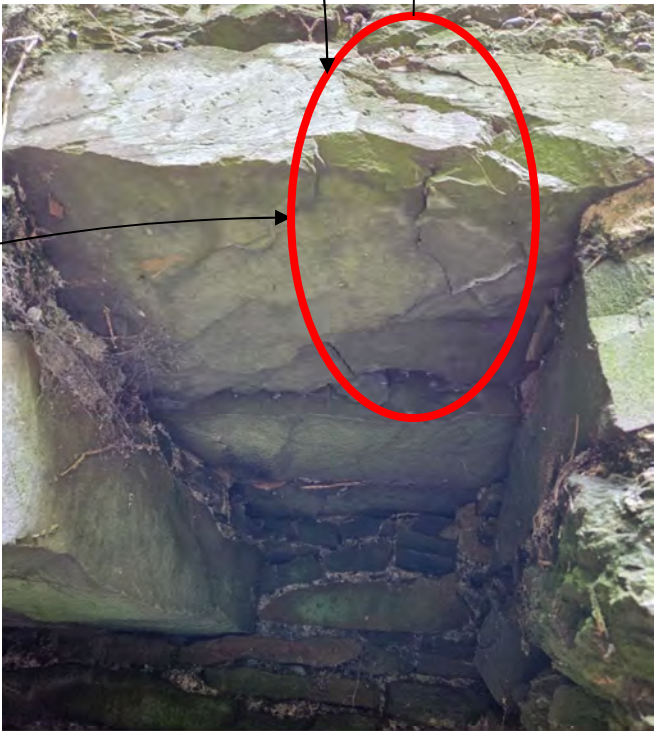
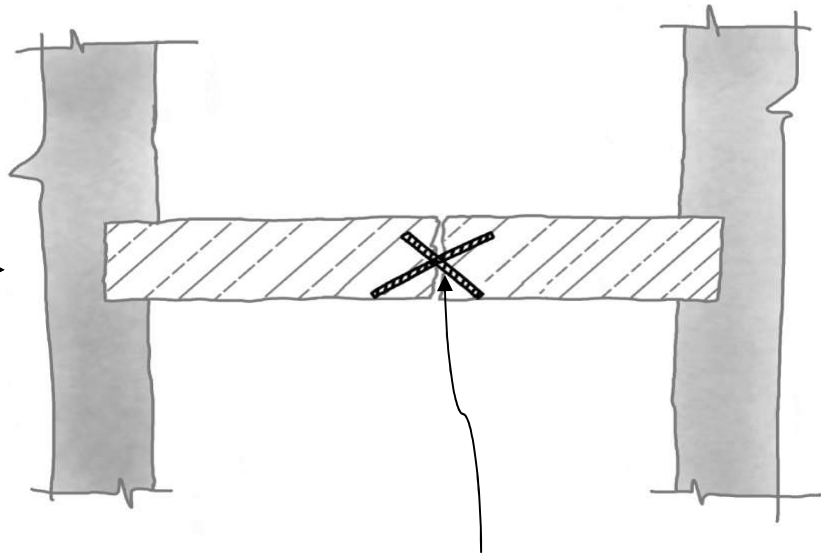
Repair the crack in the stone lintel over the openings with 2 No. M12 dowels per opening.

M12 threaded stainless steel grade 316L dowels (typically 2 per stone) minimum 200mm long, 100mm either side of the crack. Dowels to be chemically anchored into the existing stone with Hilti chemical resin compatible with the stone.

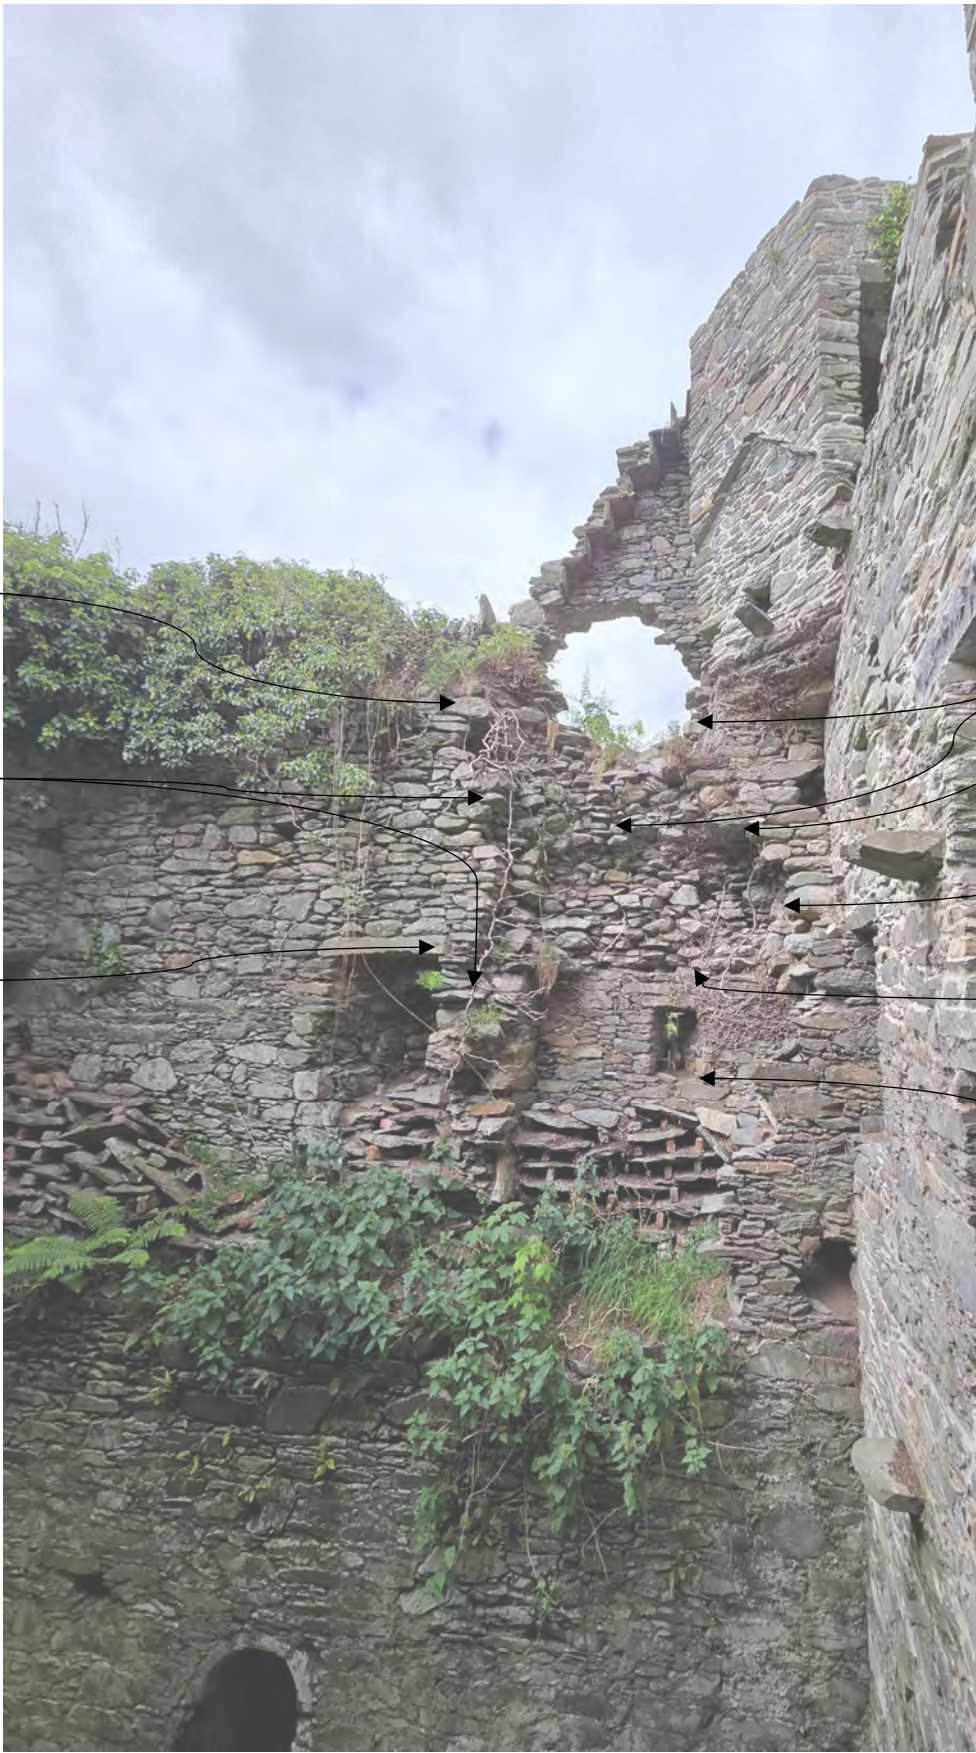
Stone lintel over the timber beam opening has no bearing on the right hand side.

End of the existing wall is unravelling and there are unsupported stones over.

Existing stone lintel over the window opening, minimum bearing on the right hand side.

Existing stone wall is unraveling and there are unsupported overhanging stone over.

Existing stone wall unsupported at the base due to missing lintel / corbel stones.

Existing stone lintel / corbel stones of the internal room are missing.

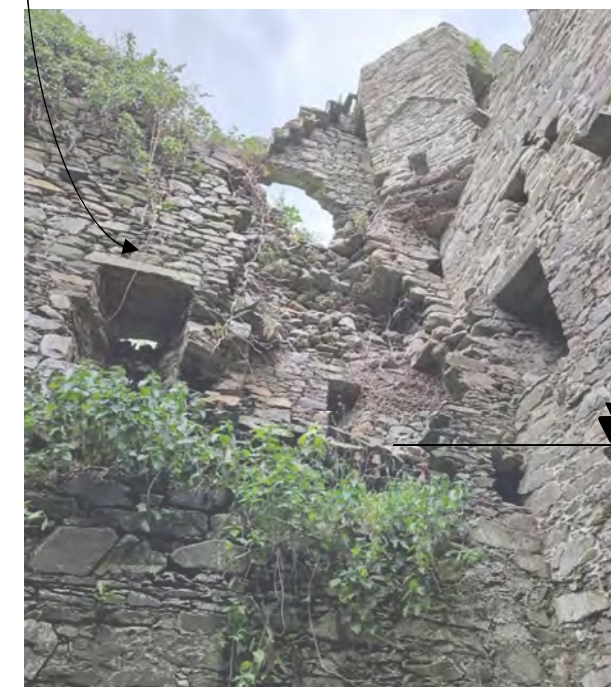
## INTERNAL IMAGE OF THE WEST WALL

Assumed  
- second floor  
level.

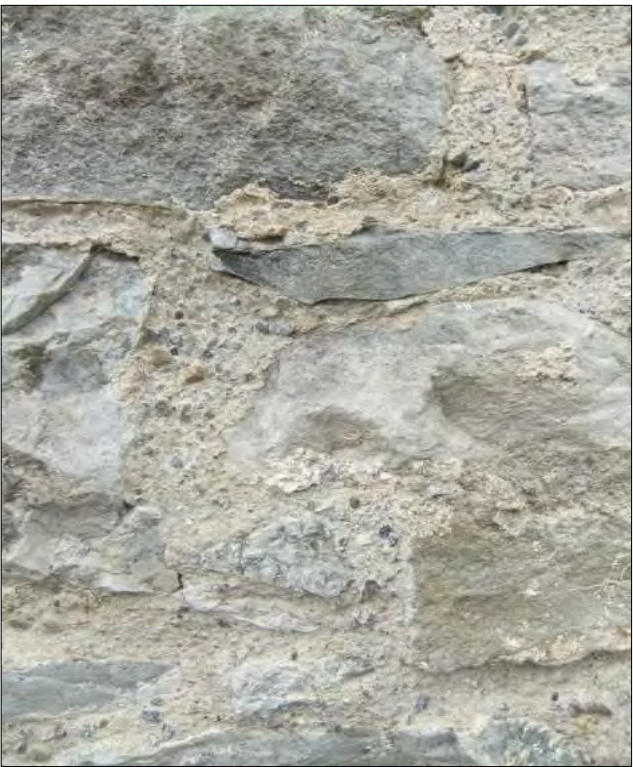
Example of flush pointing in stonework beaten back to expose aggregate

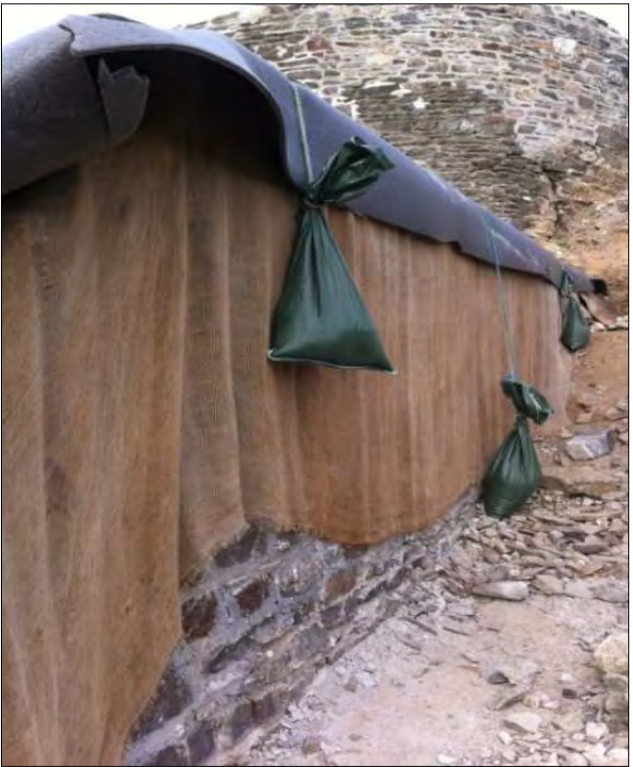
Example of appropriate protection to allow wall to dry out yet not become saturated by rain on upper
