**APPLICATION FOR DEROGATION LICENCE TO CONDUCT REPAIR WORKS  
TO ASHROE BRIDGE, CO. LIMERICK.**

**SUPPORTING INFORMATION**

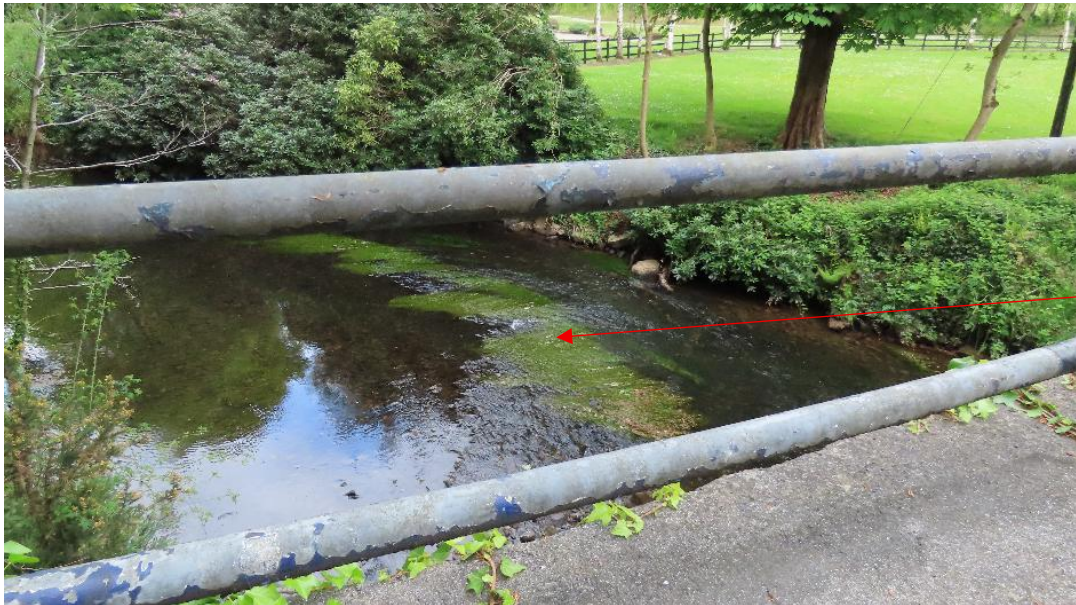
Photo 2 – watercourse upstream of bridge with floating river vegetation

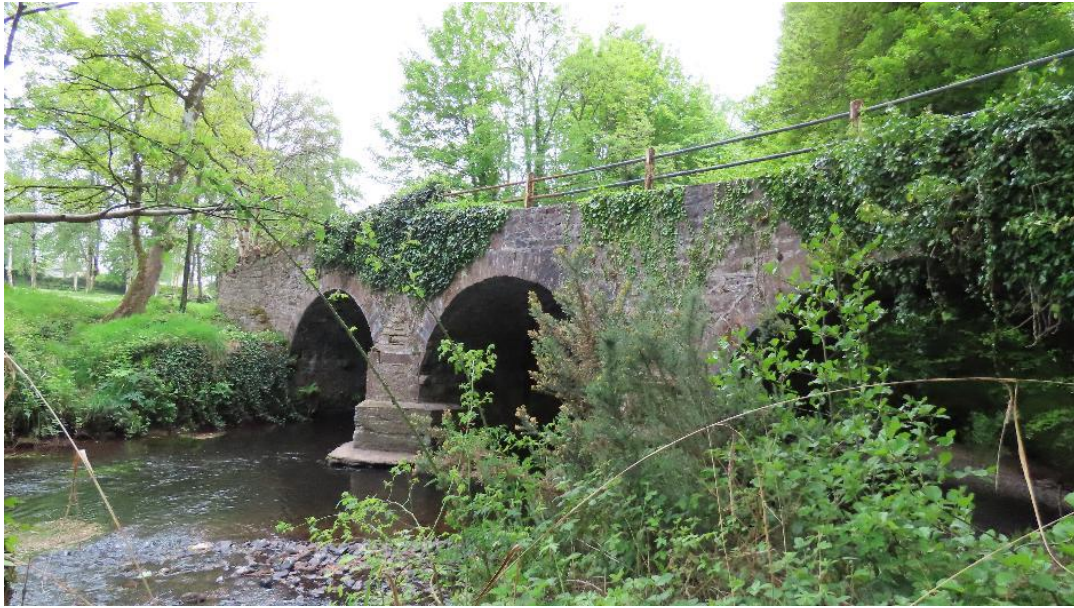
Photo 3 – upstream elevation of Ashroe Bridge

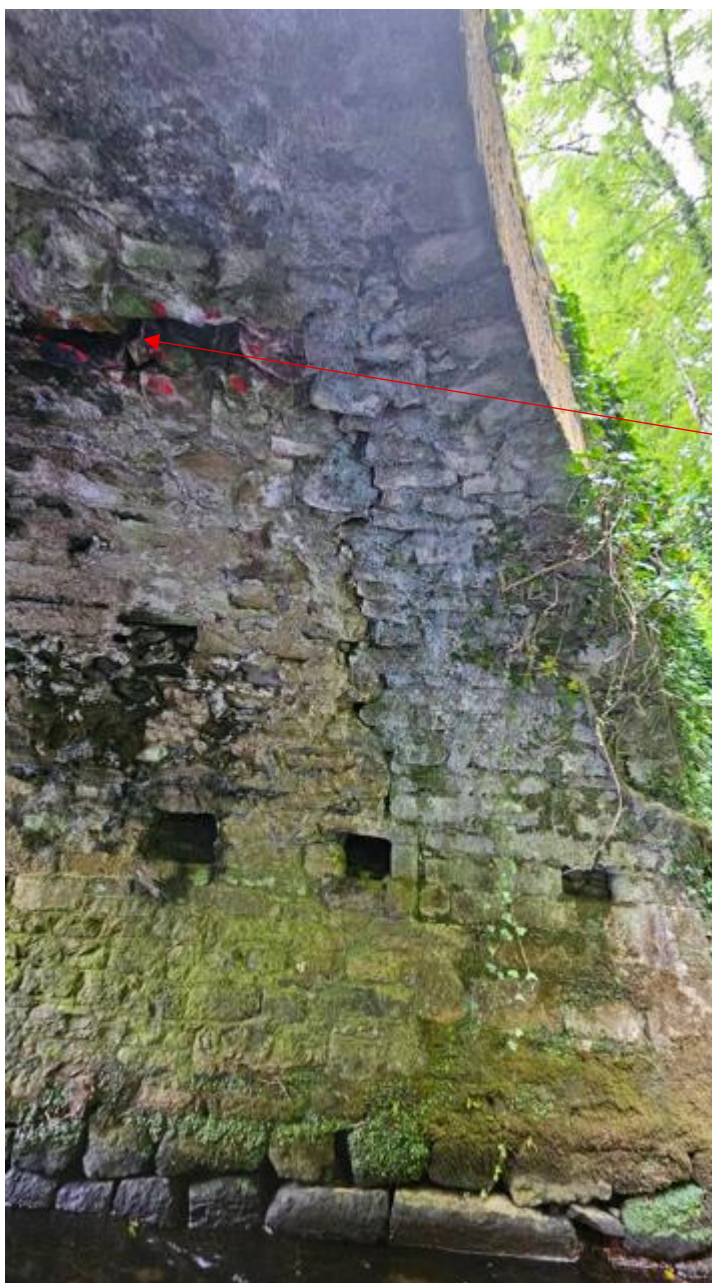
Photo 4 – view under southernmost arch showing circumferential crack running around the arch barrel and the position of the nursery colony of Daubenton's bats in a void under the arch

Ashroe Bridge requires significant repair works to ensure its ongoing safety for road users. It will be necessary to fit a saddle over Arch 1 to strengthen this arch. There is a deep circumferential crack running around the arch barrel approx 2m in from the downstream face. Arches and abutments require repointing to strengthen the stonework and prevent water leaking through the stonework. This repointing work can be conducted while also retaining crevices for bats to continue roosting in the structure. All crevices used by bats have been clearly marked for retention with red paint.

Repair existing anti-scour concrete skirts to the base of both cutwaters,  
Repair of bases to all stonework to bases of abutments and piers,  
**Install a concrete saddle to southernmost arch (Arch 1) to enhance its structural integrity.**  
Stitching of the voussoir stones and the arch barrel (downstream elevation)  
Repair of adjoining training wall to Arch 1 (downstream).

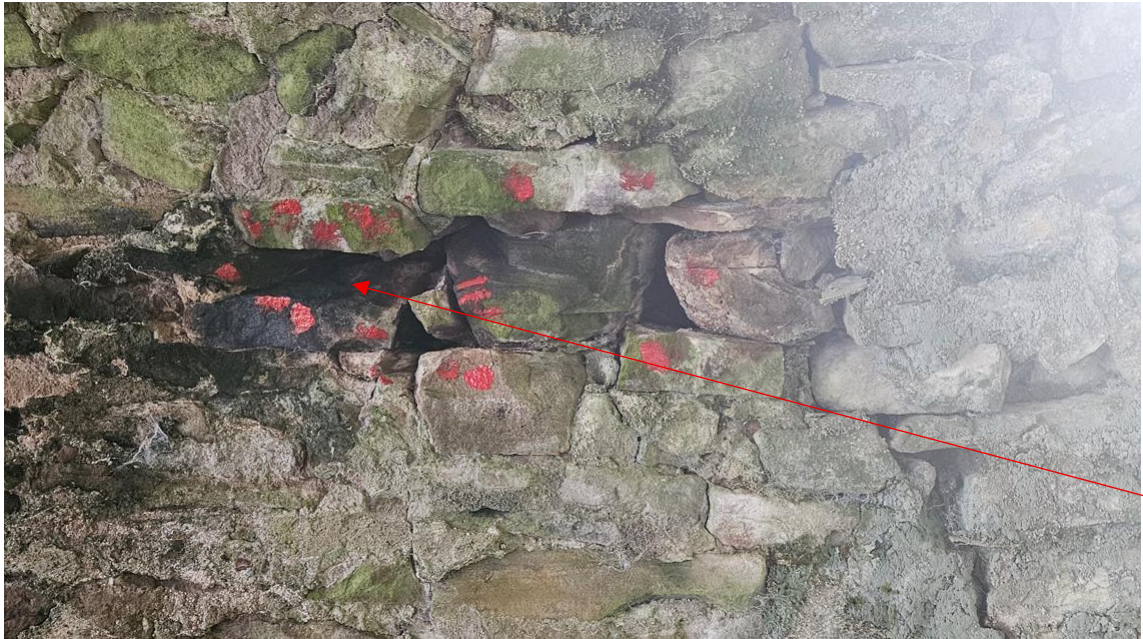
Photo 5 – close up of void used by maternity roost under southern arch

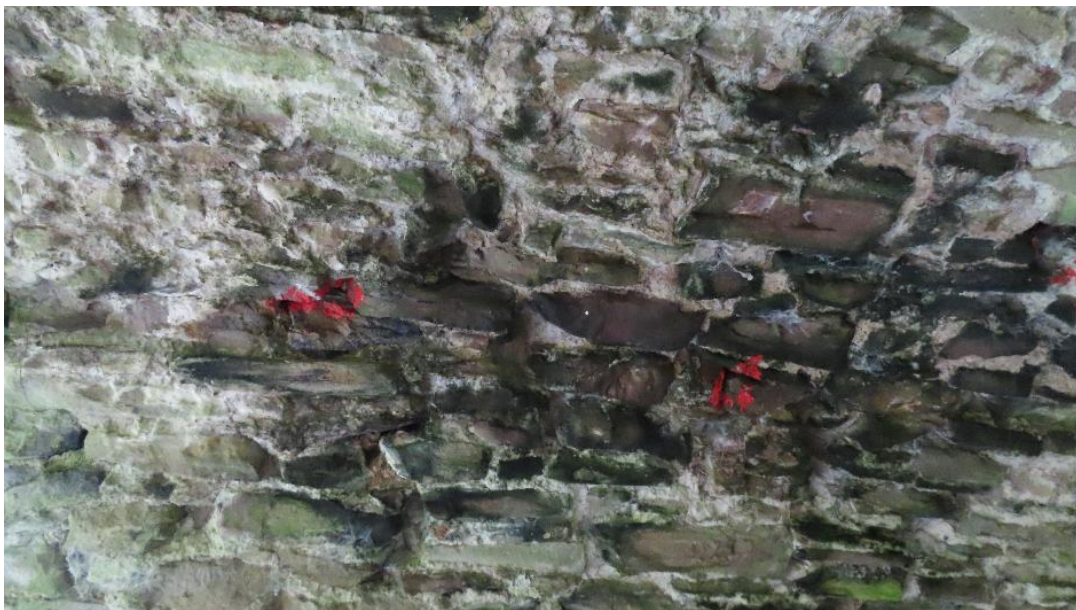
Photo 6 – crevices marked for retention for bats under southern arch (Arch 1)

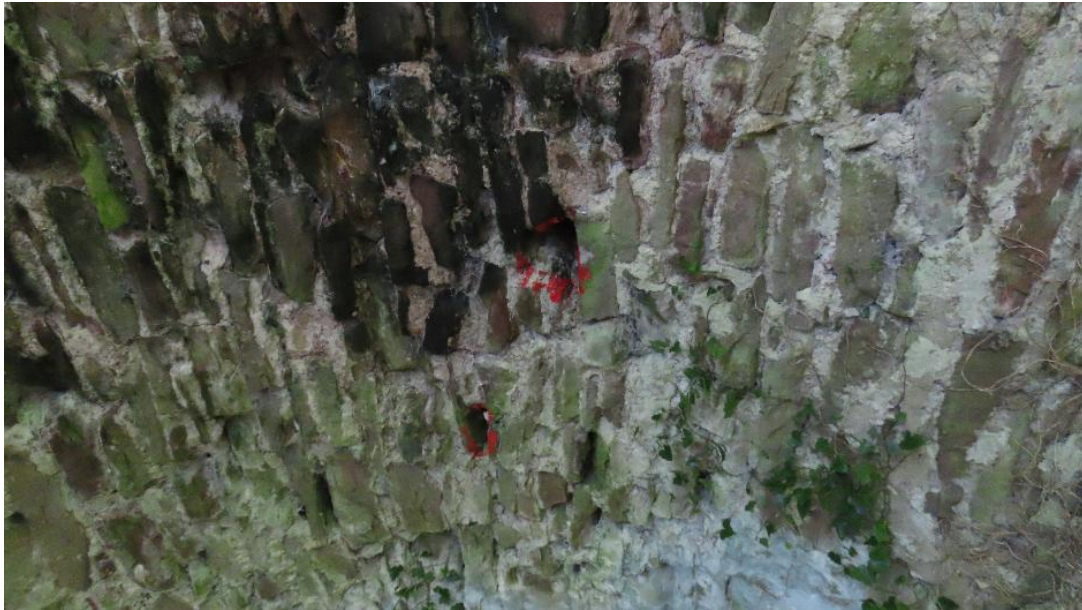
Photo 7 – crevices marked for retention under Arch 3

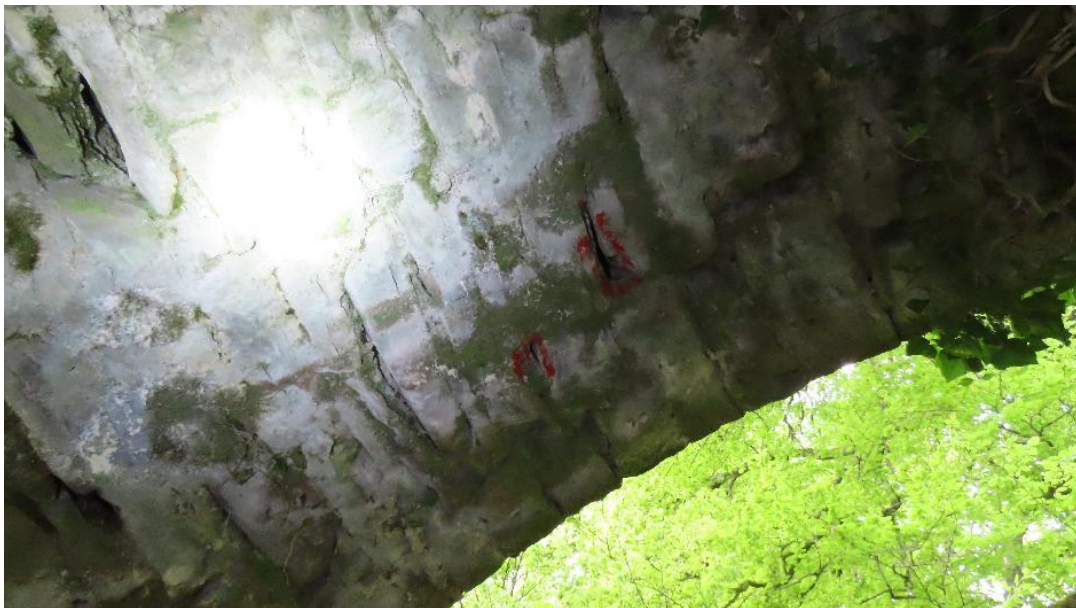
Photo 8 – crevices marked for retention under Arch 3
