## Ashroe Bridge-L1123, Co Limerick

## Engineering Inspection Report

September 24<sup>th</sup> 2024

| 221254 | | Project Title: Limerick Bridge Rehabilitation Schemes 2023-2025 | |

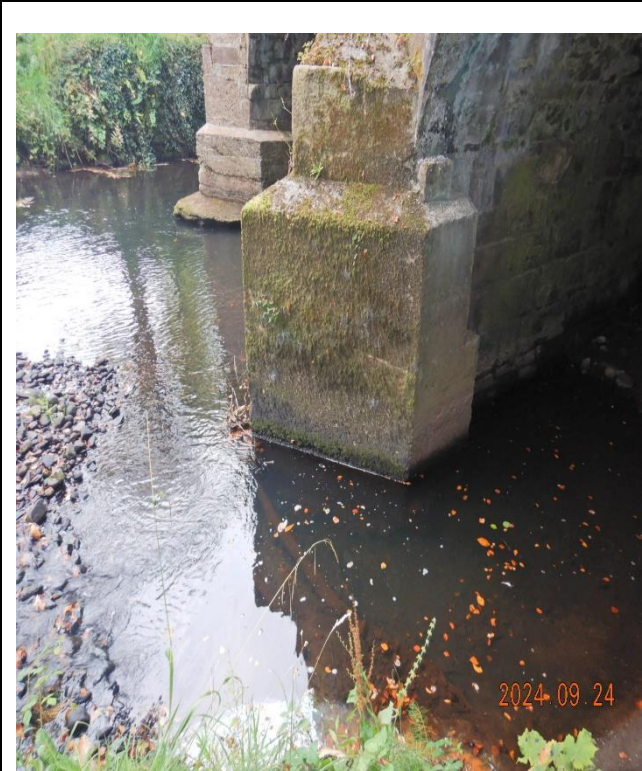
- Heavy scouring around both cutwaters to both piers on the upstream elevation was observed; previous anti-scour concrete protection is now compromised. Significant mortar loss and missing stones were observed to the base of all piers and abutments along their lengths.

Existing concrete protection to cutwaters

- Repair works would include:
  1. Repair of provision existing anti-scour concrete skirts to the base of both cutwaters.
  2. Repair of bases to all stonework to bases of abutments and piers with back check grouting subsequently.
  3. Concrete saddle to Arch 1 to enhance its structural integrity. Stitching of the voussoir stones and the arch barrel (downstream elevation).
  4. Repair of adjoining Training Wall to Arch 1 (Downstream)
  5. Removal of vegetation and repointing and stone replacement to all elements of the bridge structure.
  6. Review of existing Traffic Signage.

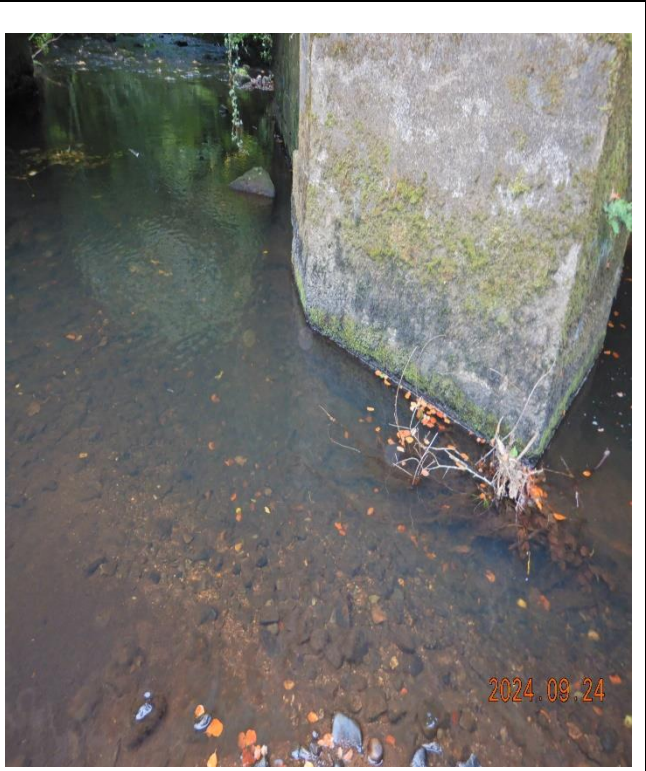
Deep Hole in front of Cutwater – Turbulent Flow

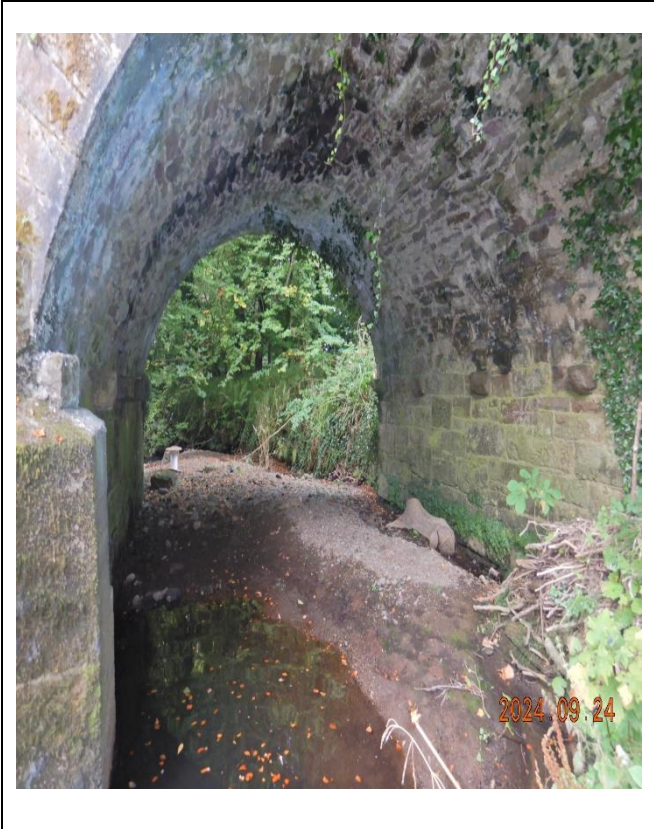
- Due to previous river realignment works the bridge is at an angle to the Clare River, which is causing silt deposits on the right bank with scouring occurring on the left bank; the landowner has placed some rock armour as an anti-scour measure. Arch 3 is dry and with heavy deposits of stone a silt. In addition, a natural wear has been formed across the river channel with deposits, which would hamper fish movements in low flow conditions.

| Arch 3 – Dry with silt & stone deposits | Vegetation on Downstream Elevation |

Consultation with the OPW & IFI to address drainage and river channel issues observed should be undertaken prior to formulating extents of works schedule.

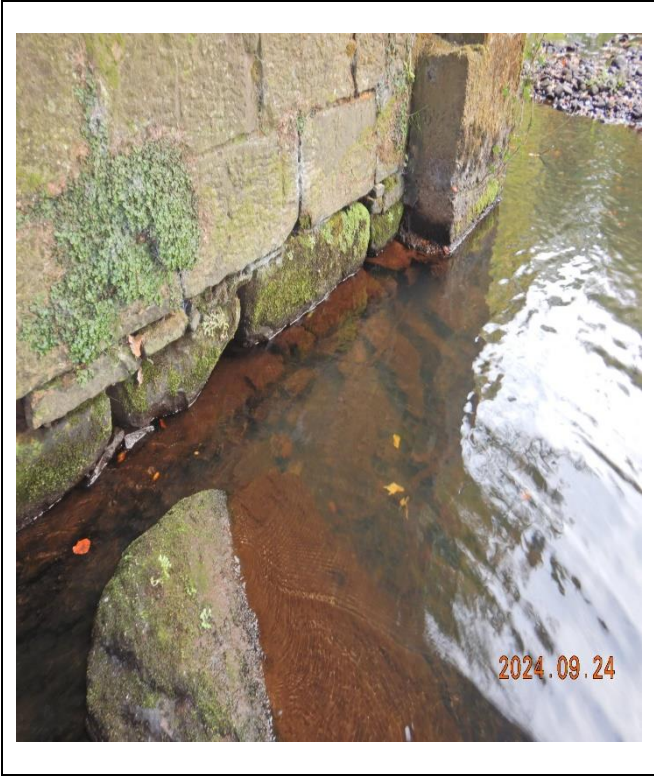
| Scouring of Pier 2 – open cracks and material loss<br>(Typical to all foundations) | Compromised Training Wall downstream of Arch 1<br>on left bank |

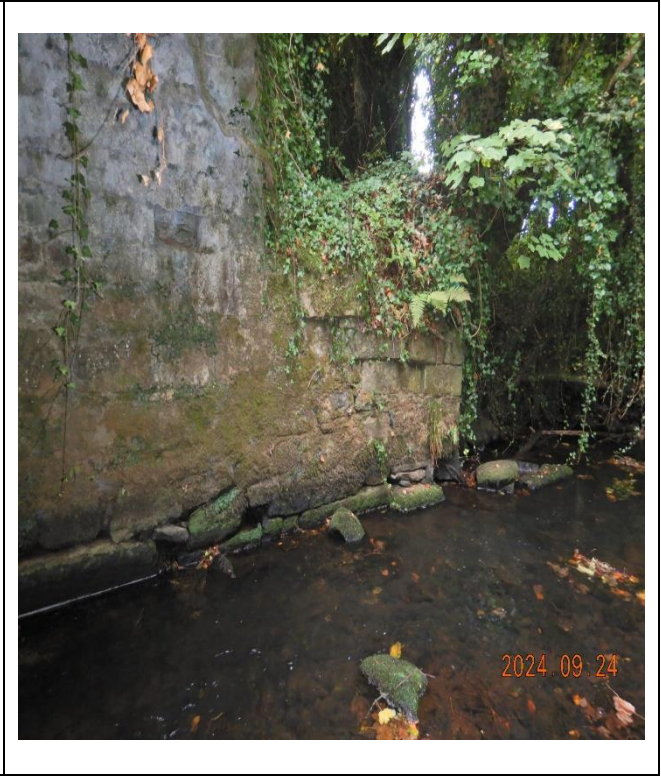
- A significant circumferential crack between the arch barrel and voussoir stones was observed on the downstream side of Arch 1. It is a large open crack which continues into the abutment wall on the left bank. Several stones are also missing in the crown of the arch barrel. The downstream Training Wall is also compromised due to lateral pressure of trees growing behind. Mortar loss and some open joints were observed on the spandrel, abutment & parapet walls and the other arch elements of the bridge.

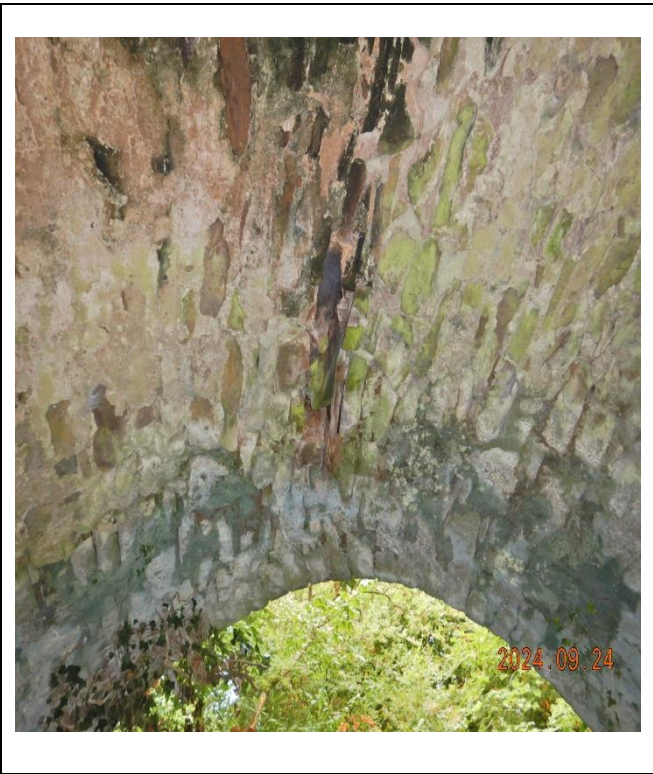
| Arch 1 – Open Circumferential crack and missing stones to crown of arch | Vegetation on Downstream Elevation |

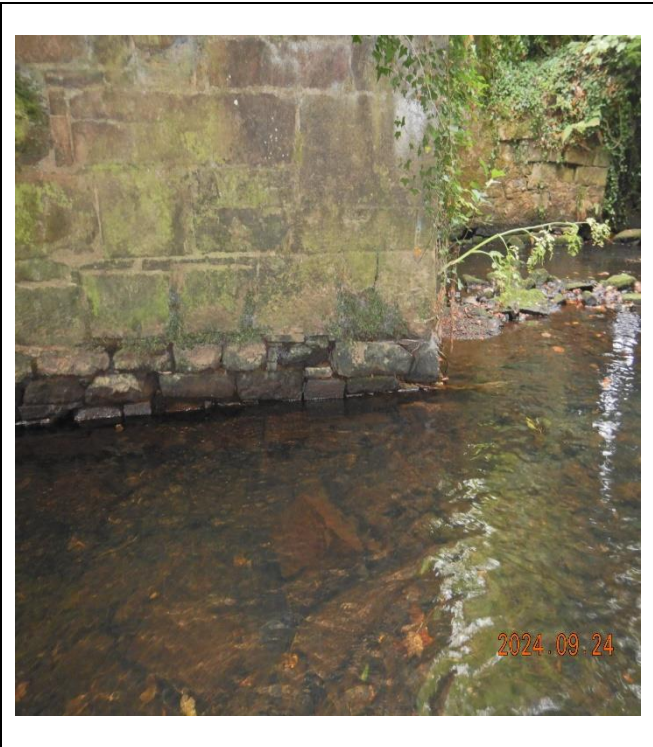
| Scouring of Pier 1 – open cracks and material loss<br>(Typical to all foundations) | Loss of mortar resulting in loose stonework to cutwater |

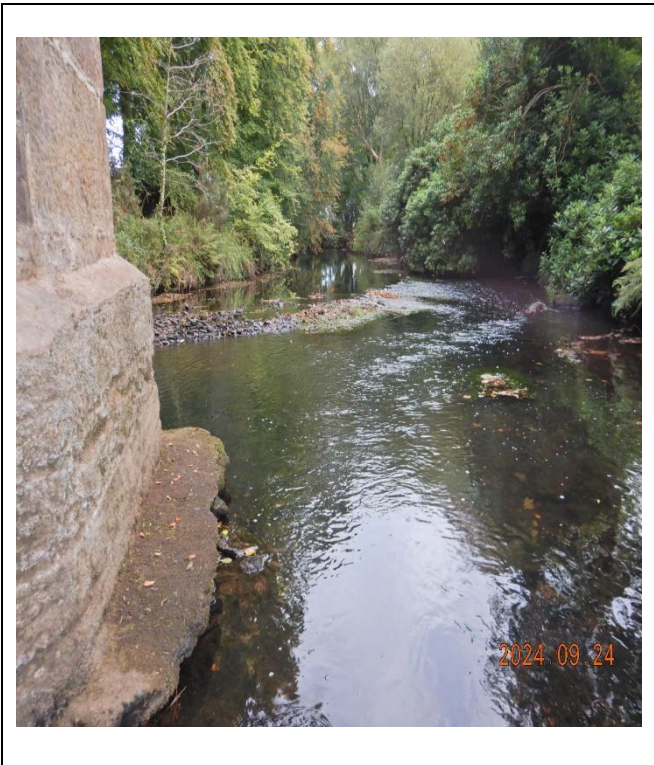
| Formation of natural weir from deposits upstream of Bridge | Scouring to Pier 1 |

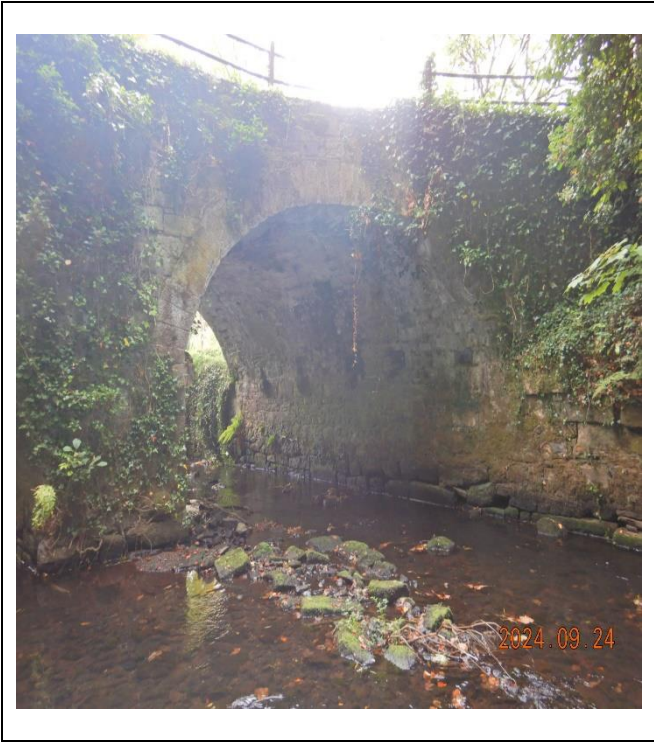
| Arch 1– Skew Arch<br><br>(Open Joints to base of Abutment Wall - Typical to all foundations) | Arch 2 – Viewed from Downstream |
