## Ballynoe Bridge-L1212, Co Limerick

**Engineering Inspection Report**  
November 12<sup>th</sup> 2024

| 221254 | | Project Title: Limerick Bridge Rehabilitation Schemes 2023-2025 | |

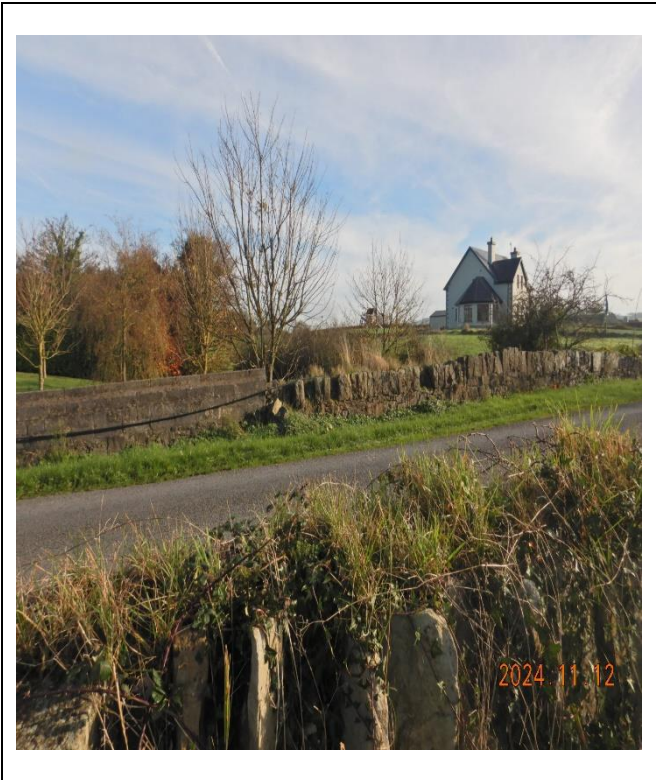
- Both parapet walls have had vehicle impacts, resulting in loose and missing stones. Mortar loss was observed on both parapet & spandrel walls.
- Cracking was observed to the arch barrel to the main arch with a small area of the barrel having dropped out of plane. Previous repair interventions have been undertaken in this area.

| Missing Coping Stones & Vegetation to both Parapet Walls | Heavy Vegetation on Wing Wall (Downstream) |

Significant damage, repair needed soon. i.e., within next financial year.
- Repair works would include:
  1. Removal of vegetation and repointing and stone replacement to all elements of the bridge structure.
  2. Repair of the intrados stones to the arch barrels
  3. Stitching of cracks to arch barrel.
  4. Stitching of Voussoirs to arch barrel.

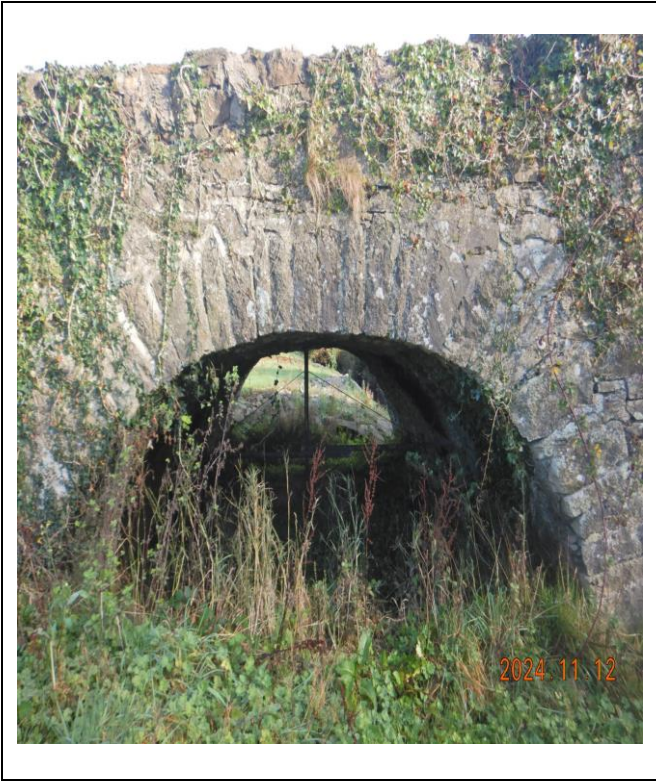
| Overflow Arch | Rock Armour in Private Residence on approach to Overflow Arch |

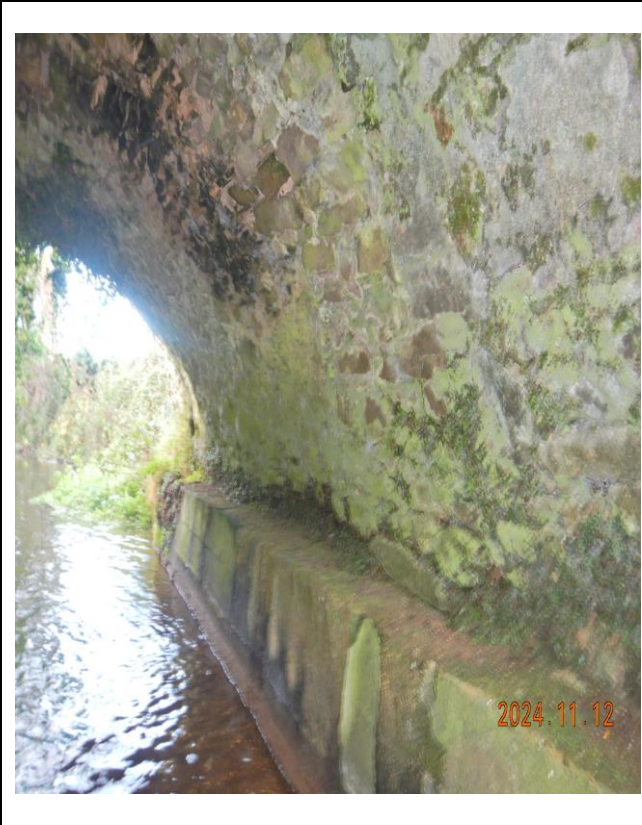
- Concrete anti-scour skirting provided to both abutments which is in good condition.

Anti-scour skirting to main arch abutment

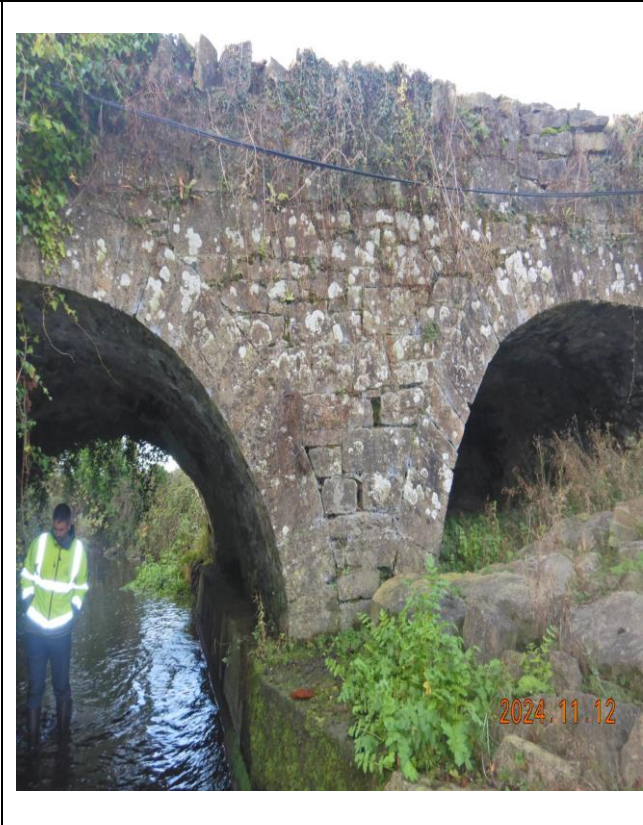
Anti-scour skirting to main arch abutment

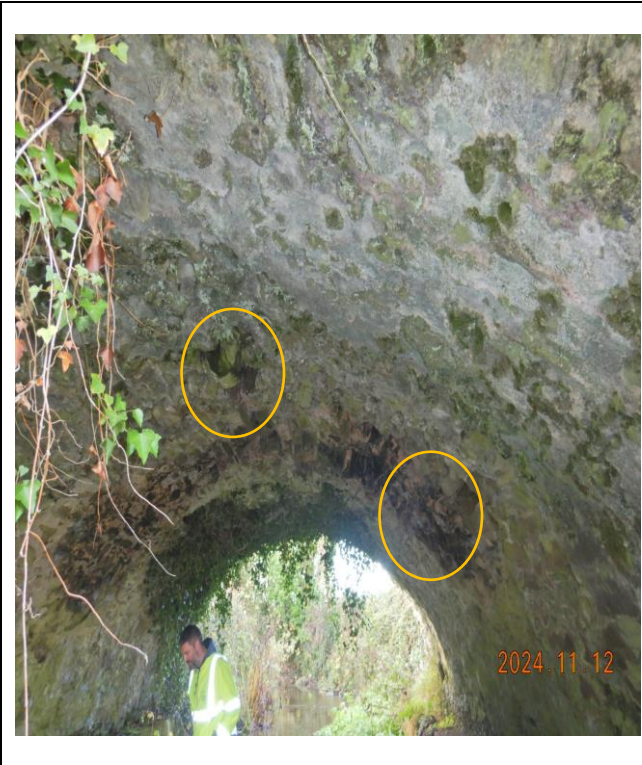
Areas of Dropped Stones to Arch Barrel

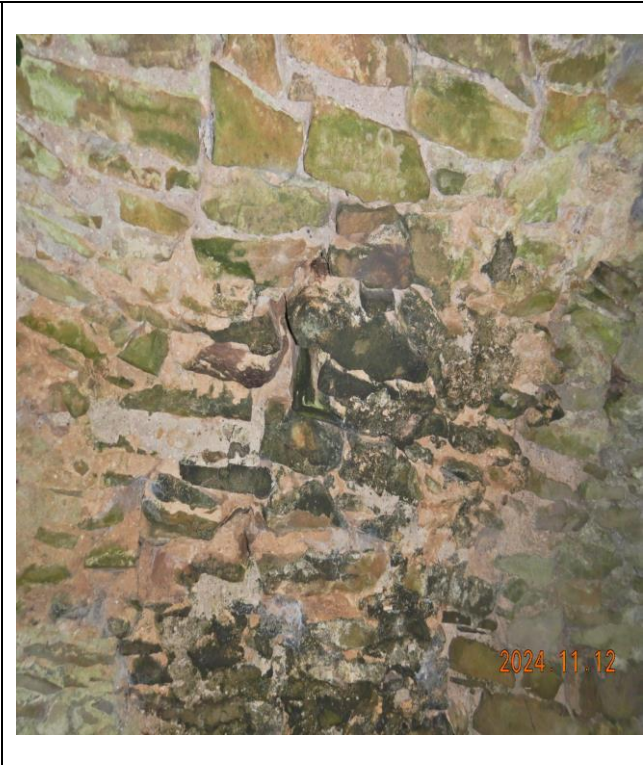
Cracking in Arch Barrel
