# BAT DEROGATION LICENCE APPLICATION – BELVEDERE HOUSE & GARDENS HEAD GARDENER’S COTTAGE

| Project Reference | 220255-a |
| Date | 11/08/2025 |
| Subject | Belvedere House & Gardens Head Gardener’s Cottage - Derogation License |

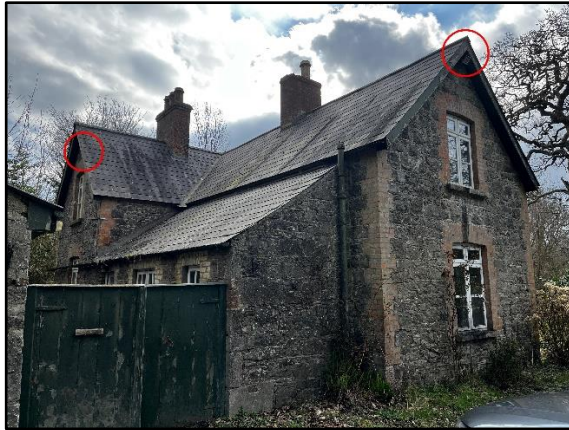
- One bat observed emerging from the soffit of the north-facing gable (Plate 1).
- Three bats were observed emerging from an access point in the fascia on the gable of the south-facing porch (Plate 2).
- One bat was observed emerging from the fascia/soffit of the south-facing first floor dormer window (Plate 2).

*Plate 1: Head Gardener's Cottage roost entrance locations. North-facing gable (left circle) 1 no. soprano observed emerging from soffit. West-facing first-floor window (right circle) with small accumulations of droppings; while no emergence was recorded here, a potential emergence point above the window is circled (See Plate 3).*

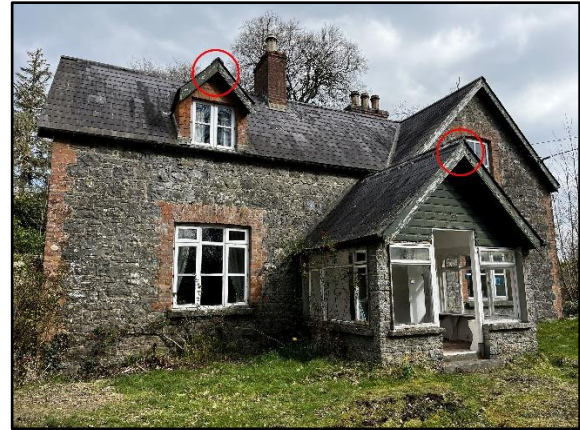
*Plate 2: 1no. Soprano pipistrelle emerged from soffit of south facing dormer window (left circle). 3 no. soprano pipistrelles emerged from fascia at apex of porch gable (right circle).*

- Where roof and fascia/soffit works are required, the identified roost access points—comprising two confirmed and one suspected fascia/soffit entrance locations—are likely to be impacted during essential repairs. To maintain roosting opportunities, purpose-designed soffit roost boxes will be installed at each of these four locations to replicate existing roost conditions and ensure continuity of access for bats post-works. As an additional enhancement measure, bat access slates may also be installed under ridge tiles or within the main roof slope where feasible, to provide further roosting opportunities within the structure.

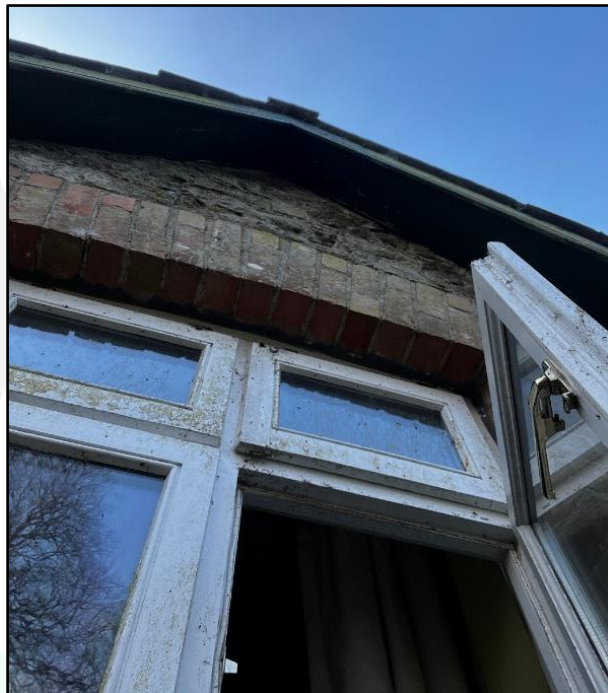
*Plate 3: Bat droppings on west-facing window*

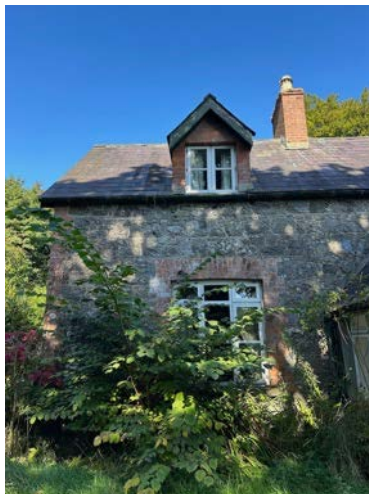
CRACK OVER WINDOW HEAD

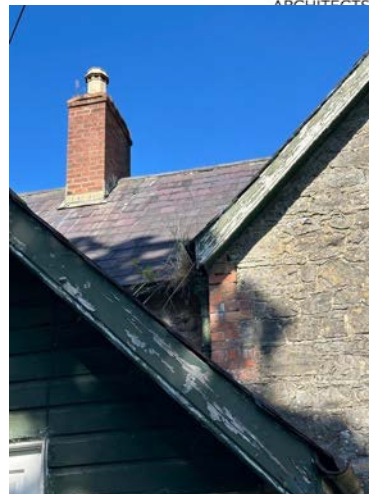
MISSING GUTTER TO GABLE

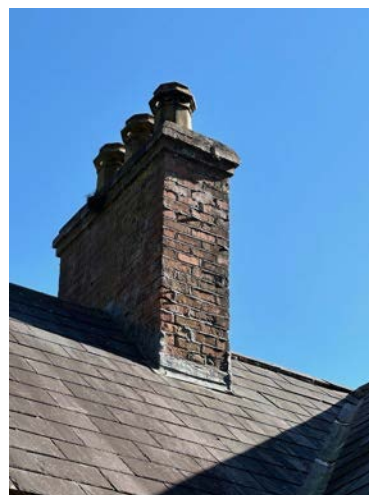
REPOINTING NEEDED TO CHIMNEY

- The raking out and repointing of the chimneys, to include re-lining of flues, repair of brickwork and flaunching with lime mortar. Localised repair of slipped slates.
- Taking down, cleaning, redecorating and refixing gutters and downpipes, replacing missing or corroded sections. Repair/ redecoration of barge and eaves boards.
- The opening up of the window lintel, replacement with new concrete lintel and making good of finishes. Localised repointing of cracks over the lintel to stonework externally.
- Finishes such as carpets and drapes should be removed, along with damaged wall or ceiling plaster to allow inspection and improved ventilation implemented.
- Removal of any areas of rot identified ensuring that structural timbers are inspected and rotten timbers removed along with structural repairs.

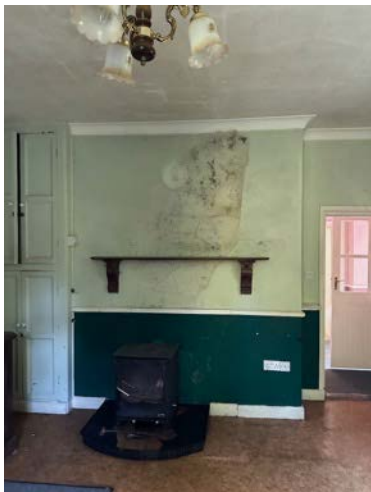
DAMPNESS AT FLUE

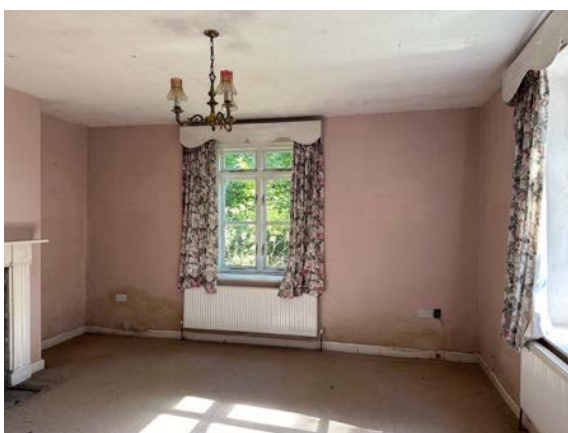
VIEW OF DAMP AT SKIRTING LEVEL TO LIVING ROOM

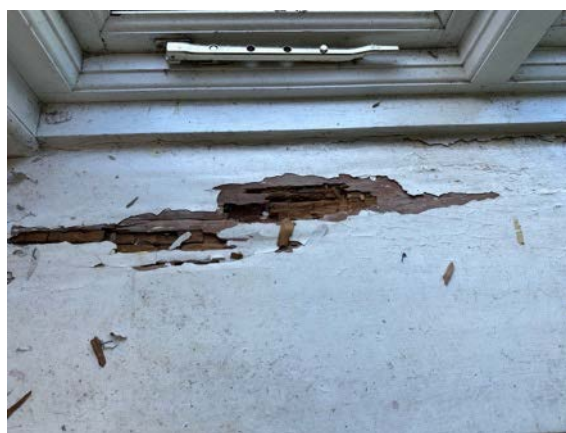
DRY ROT TO WINDOW BOARD

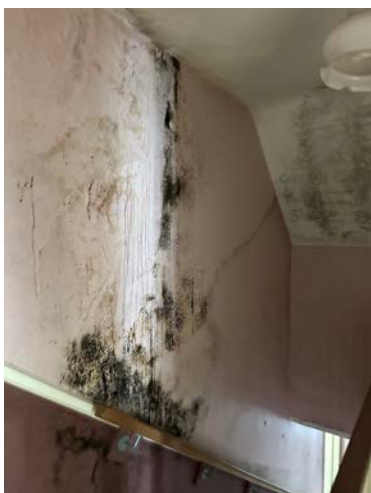
DAMPNESS OVER STAIRS

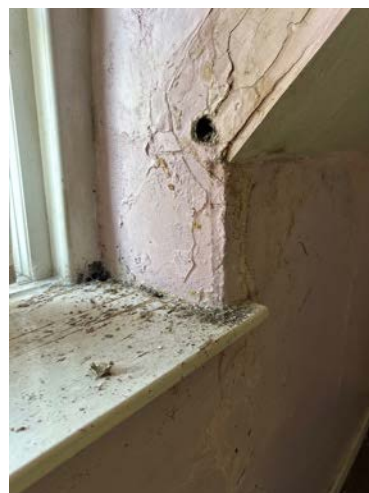
POSSIBLE ROT TO JOIST ENDS
