**CONDITION REPORT AND
CONSERVATION/REPAIR PROPOSALS
FOR
NEWCASTLE MEDIEVAL GATEHOUSE
PHASE 1 WORKS
CMF 2025**

(JOB REF 28/23)

Nov 2023/Jan 2025

The project has been accorded the CMF reference number CMF23-2-WI003 Newcastle Castle.

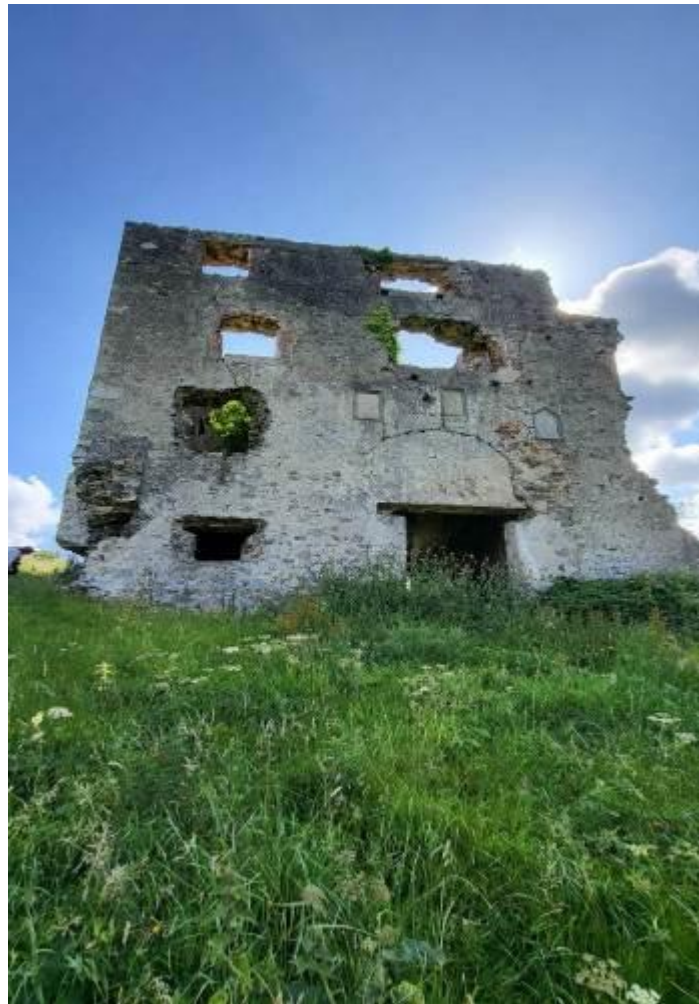
1. West elevation general

The works to openings W1-W8 are specified on drawing no 2, together with masonry repairs, lime capping, plastering and pointing.

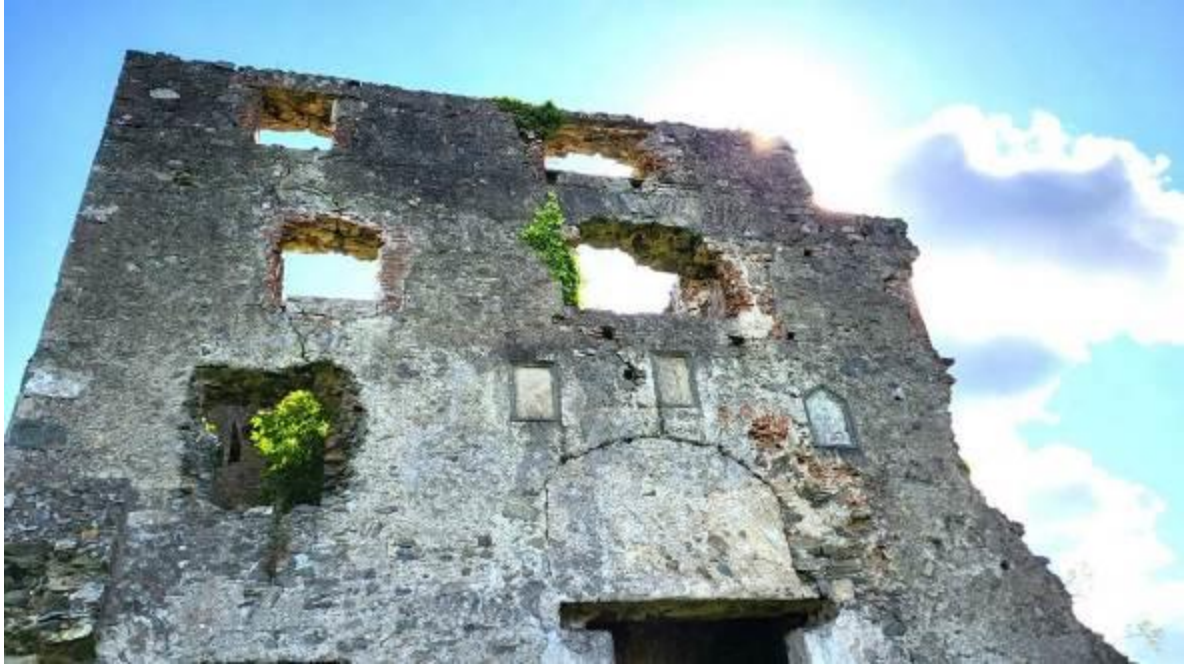
2. West elevation upper

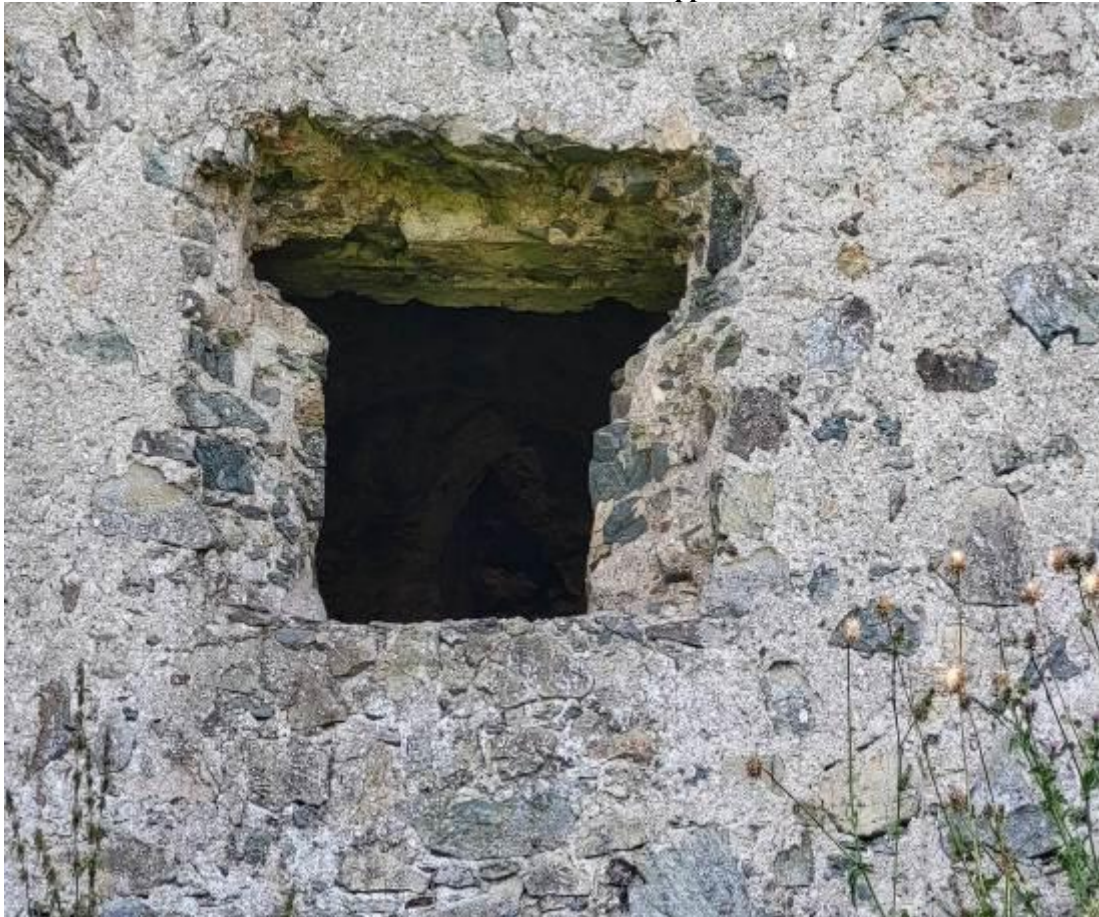
3. West elevation Window W2 (external)

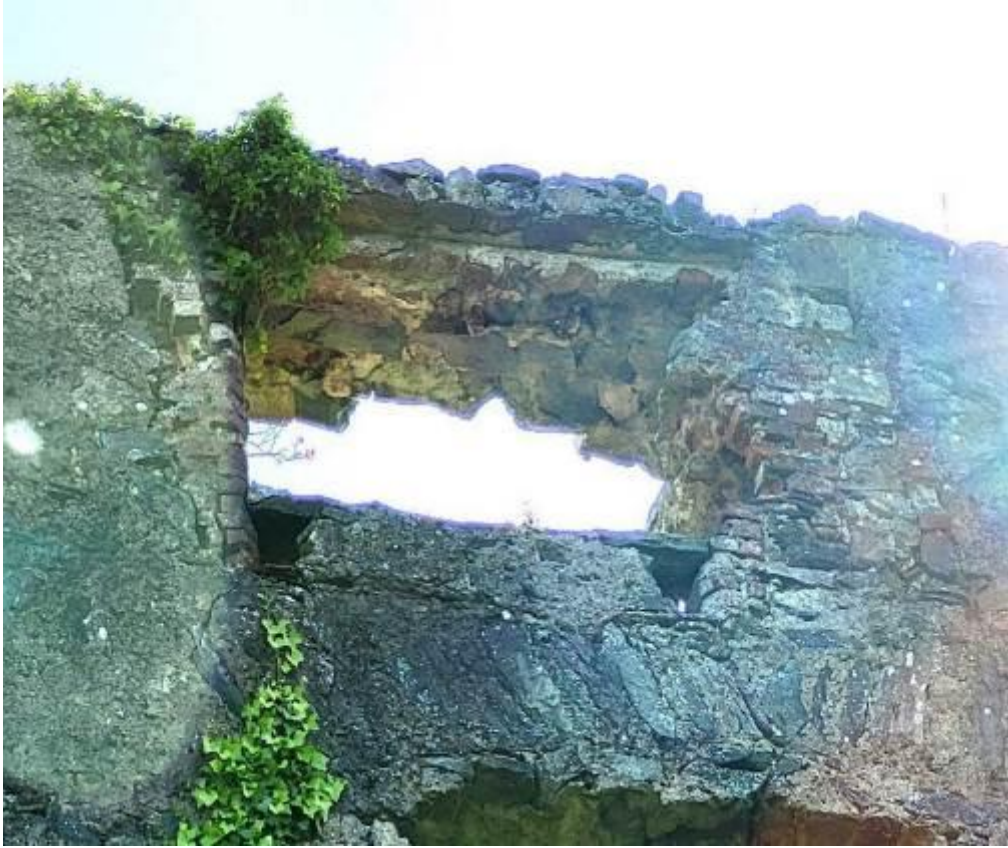
4. West elevation Window W7 (external)

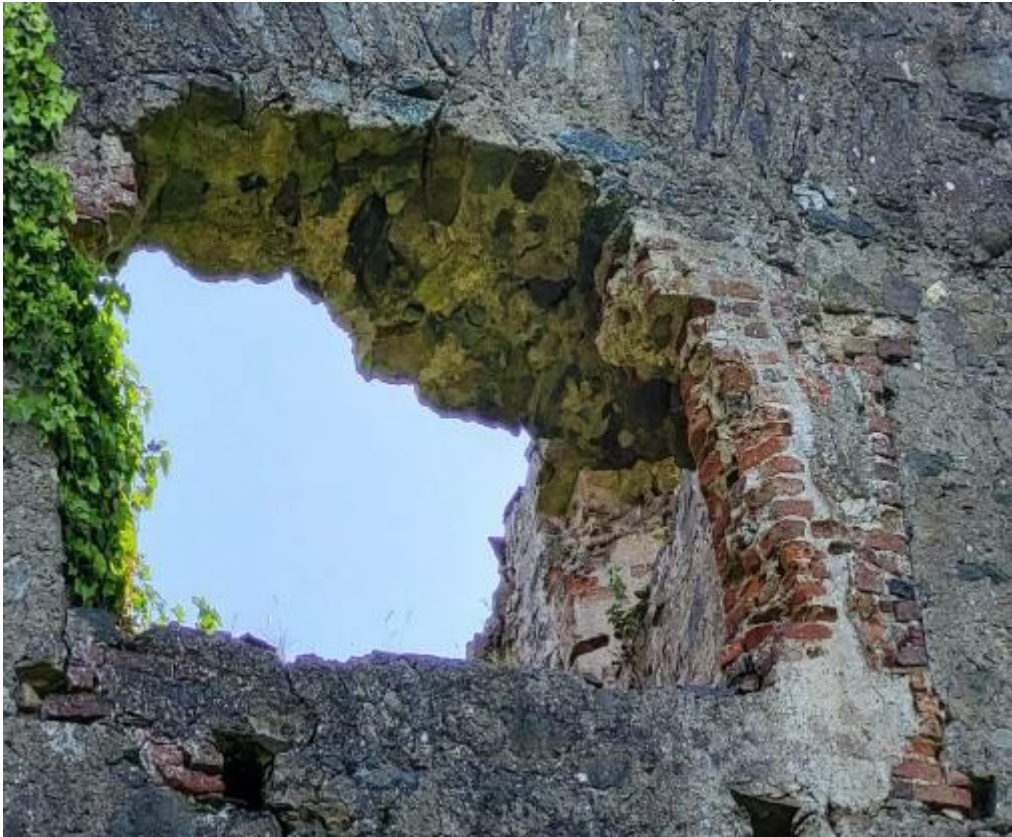
5. West elevation Window W5 (external)

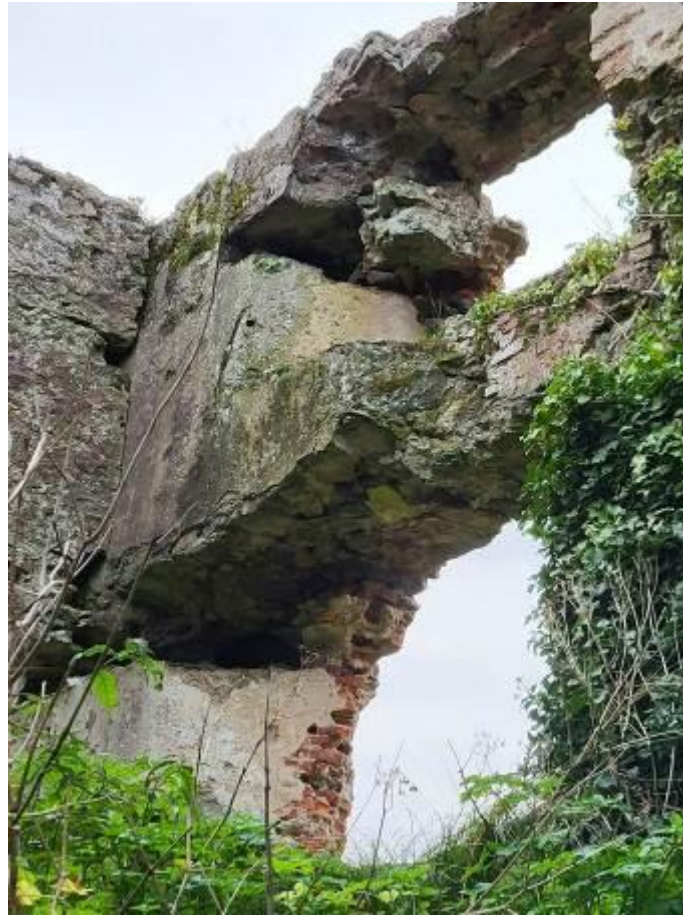
6. West elevation Windows W5 and W7 (internal)

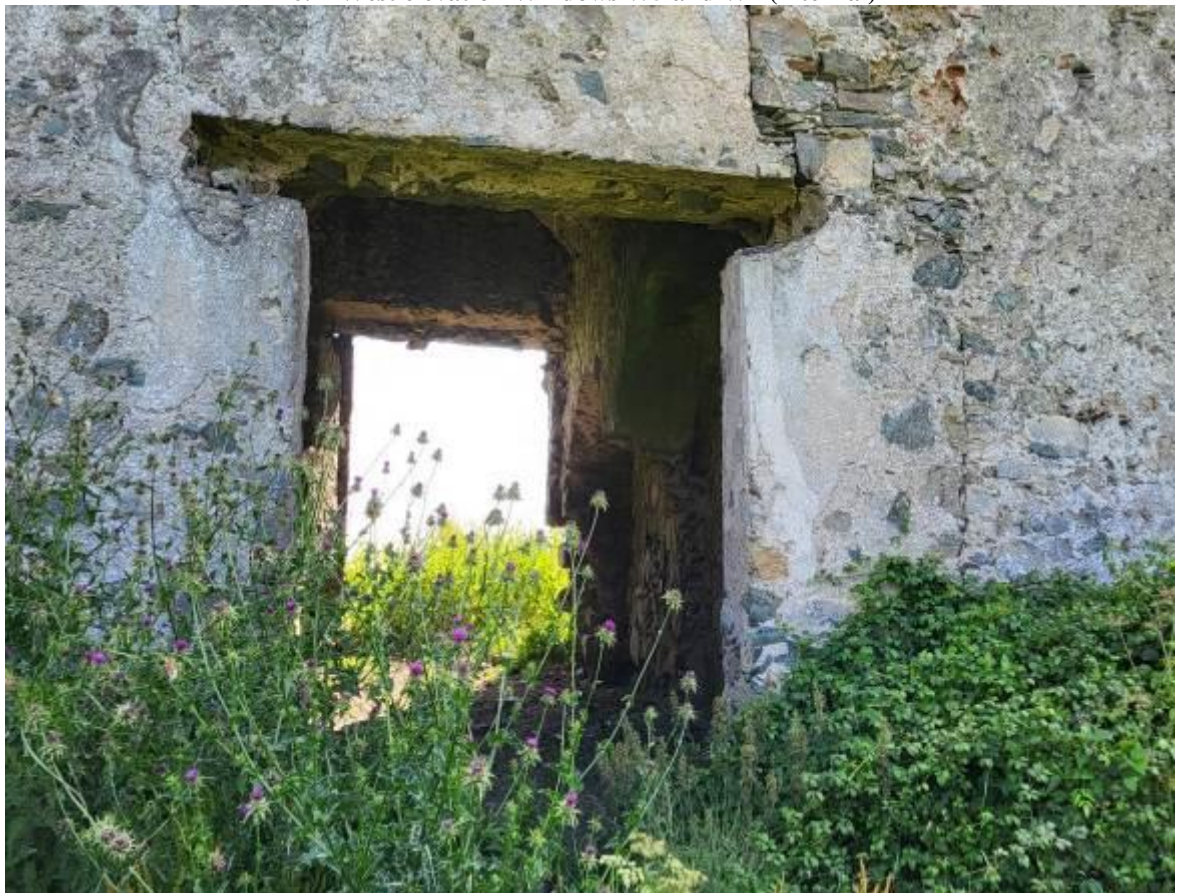
7. West elevation entrance (Opening no. W1)

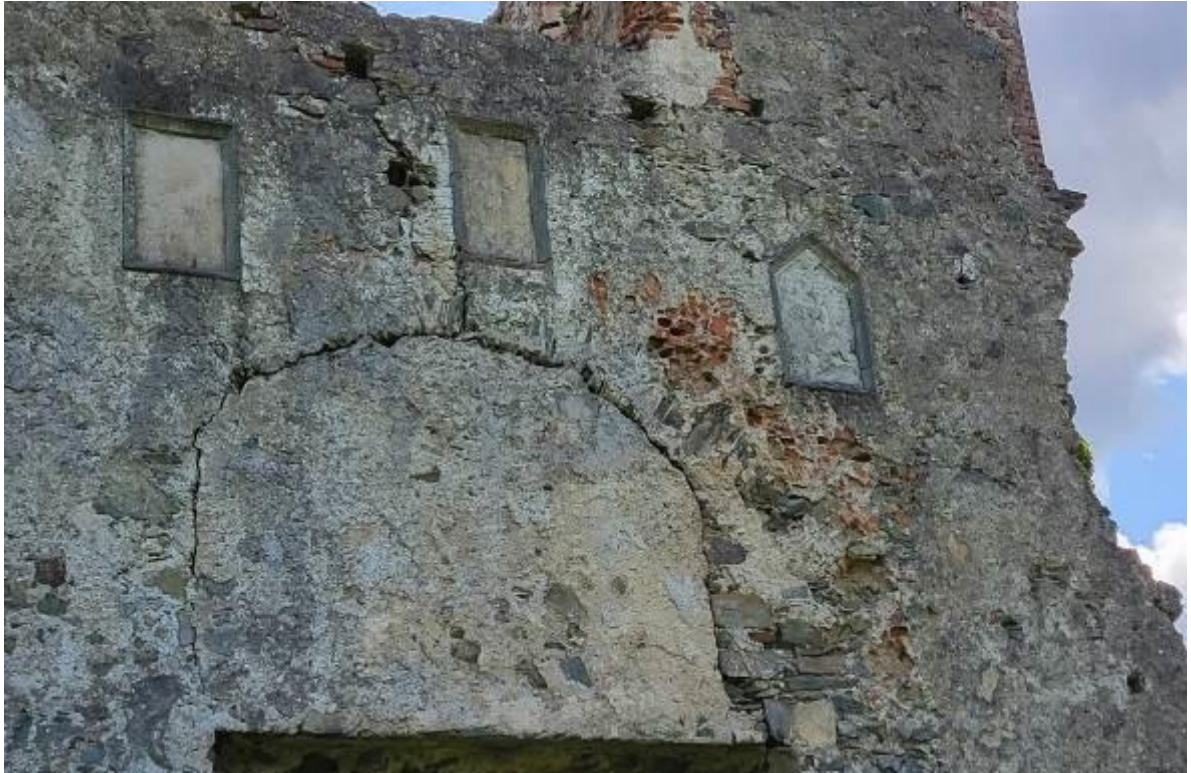
8. West elevation infill above entrance door (Note armorial plaques)

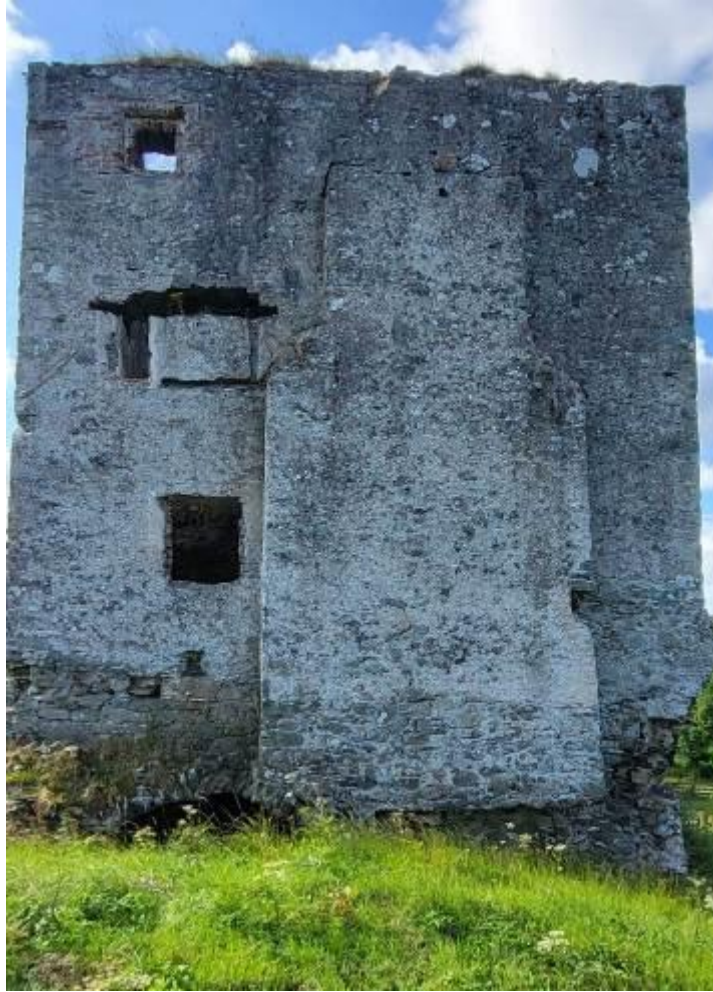
9. North elevation general

The works to openings N1-N4 are specified on drawing no 5, together with masonry repairs, lime capping, plastering, pointing and vegetation removal.

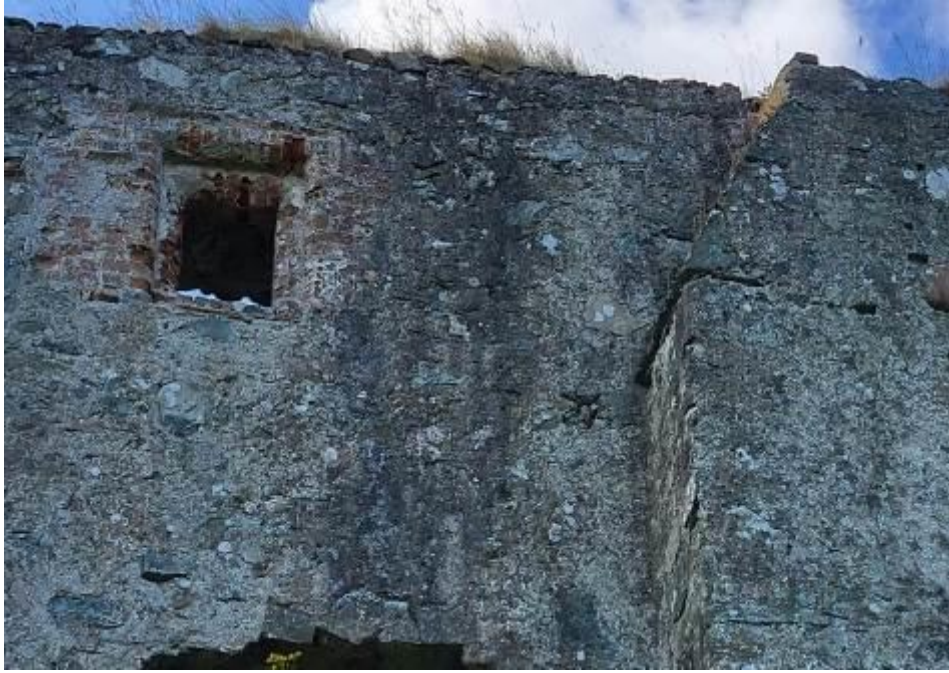
11. North elevation Window N4 detail

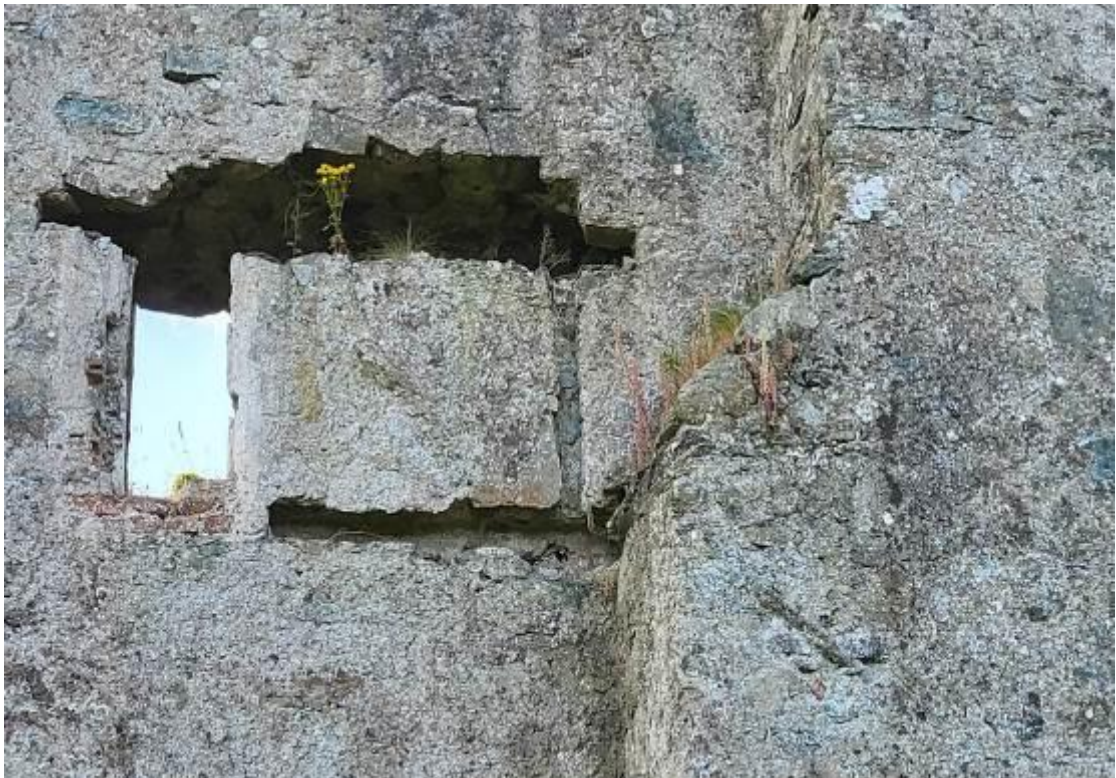
12. North elevation Window N3

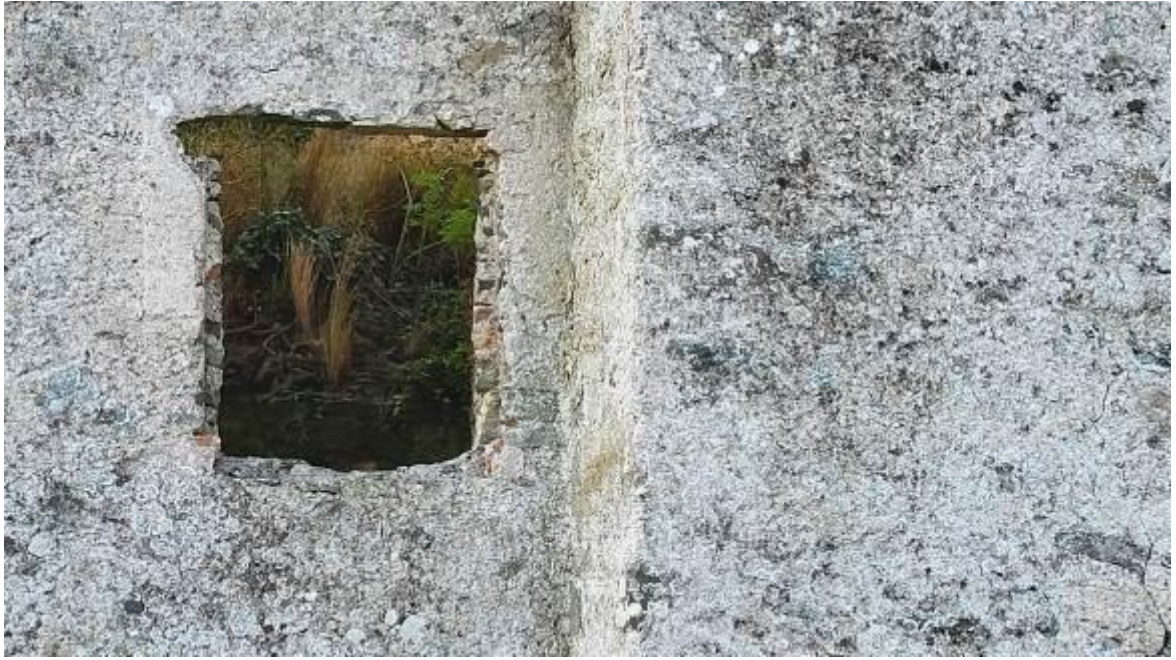
13. North elevation Window N2

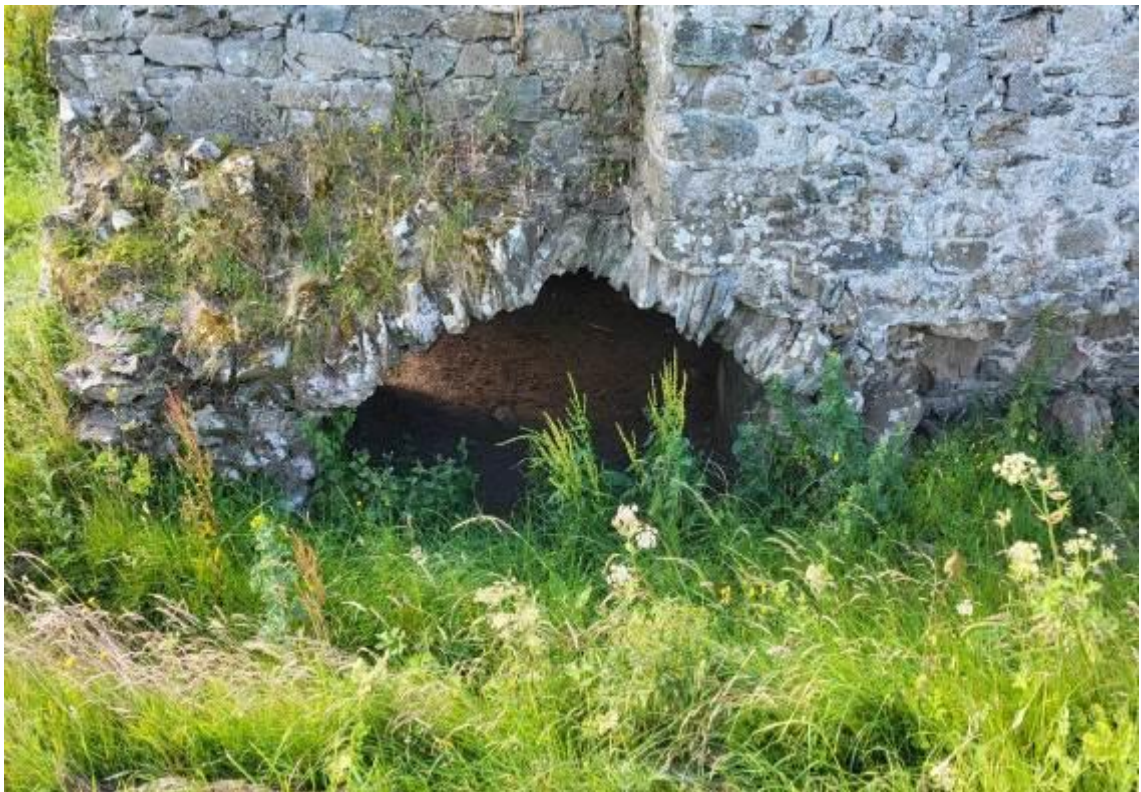
14. North elevation Opening N1

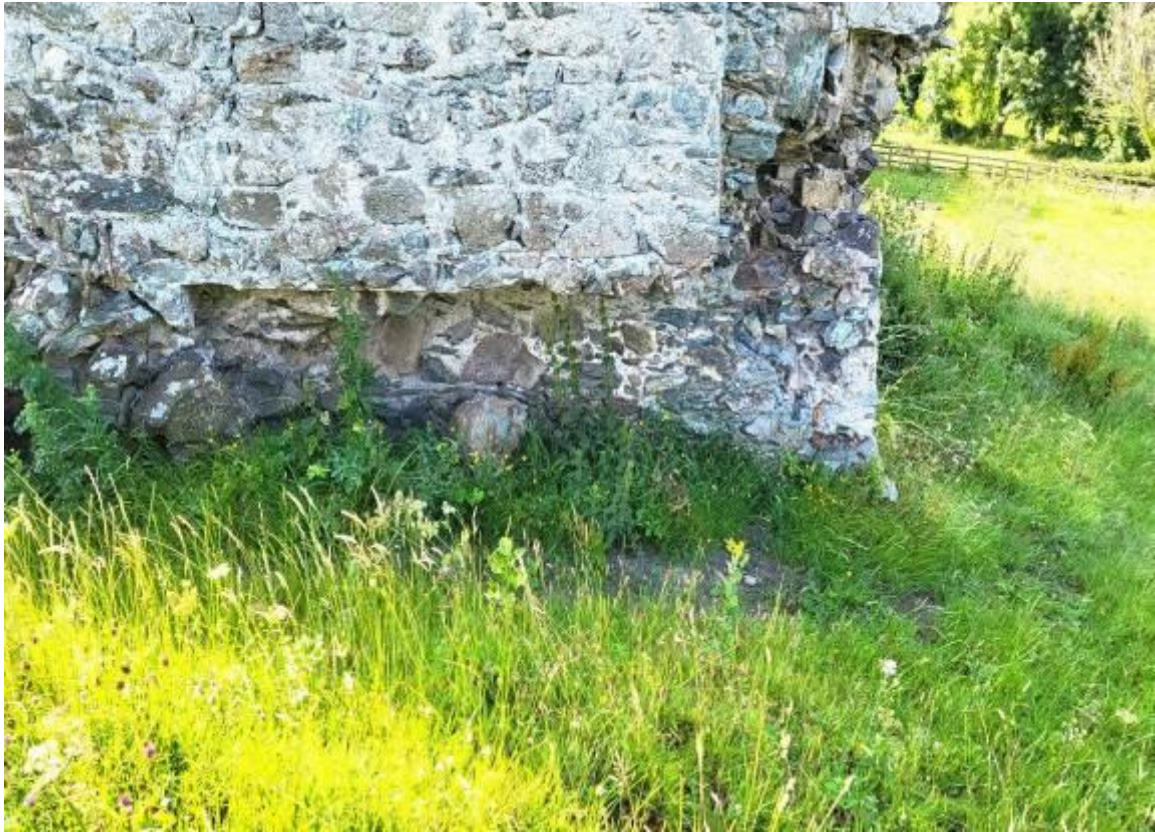
15. North elevation – damage at north-west corner

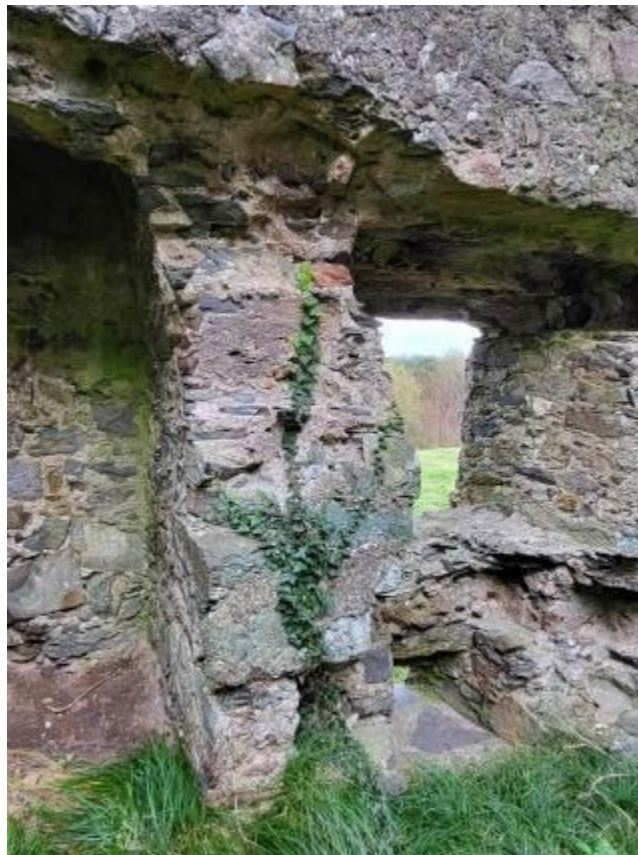
16. North elevation first floor - damaged chimney support wall at window N2

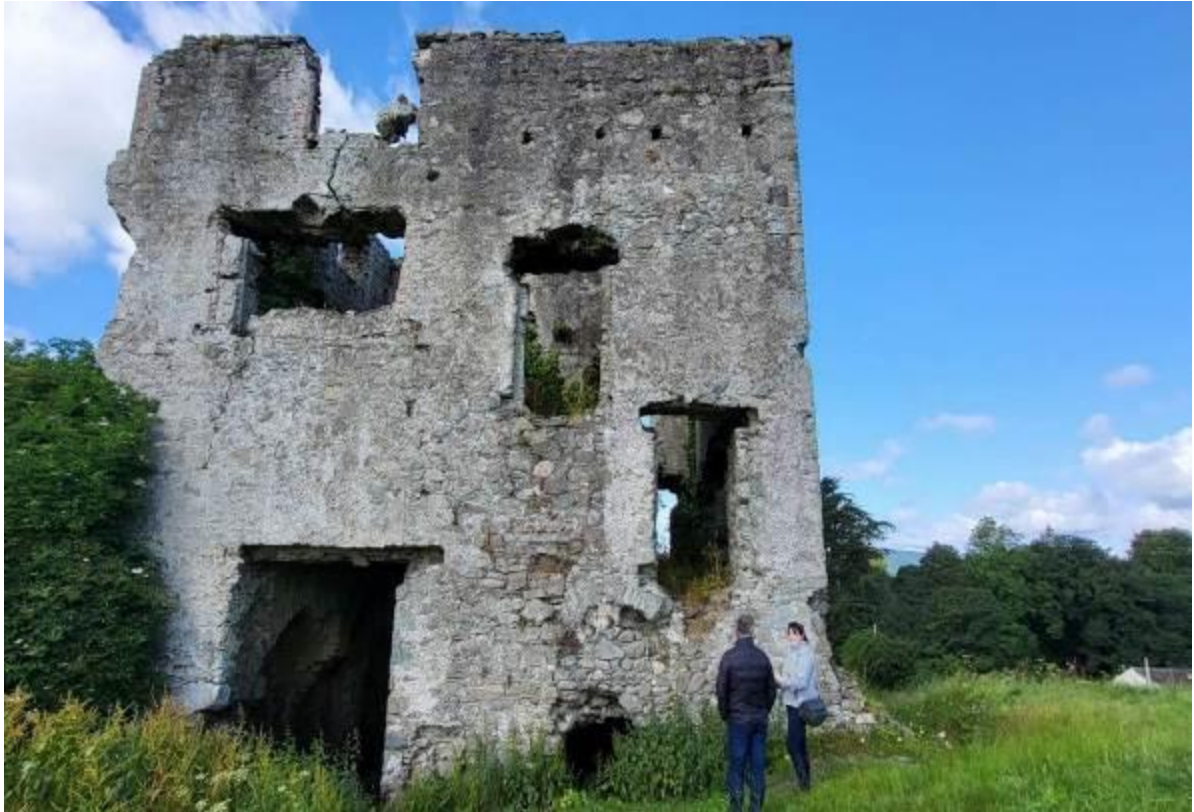
17. East elevation general view

The works to openings E1-E4 are specified on drawing no 4, together with masonry repairs, lime capping, plastering, pointing and vegetation removal.

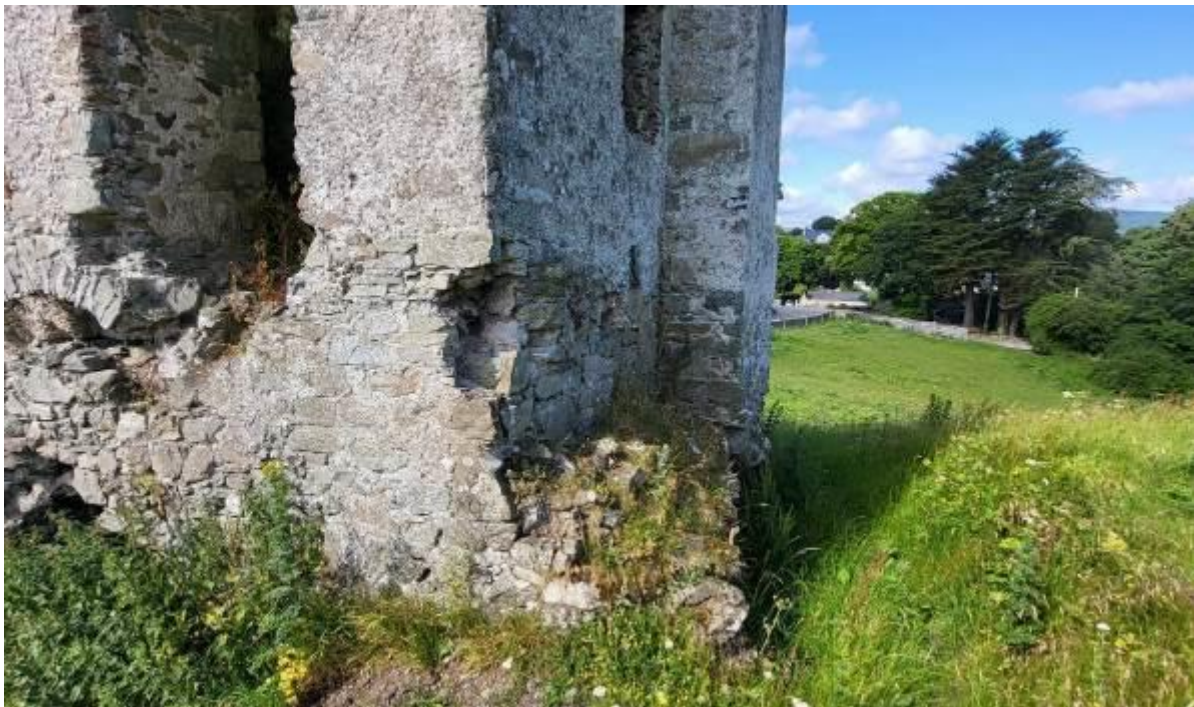
18. East elevation – damaged masonry at north-east corner

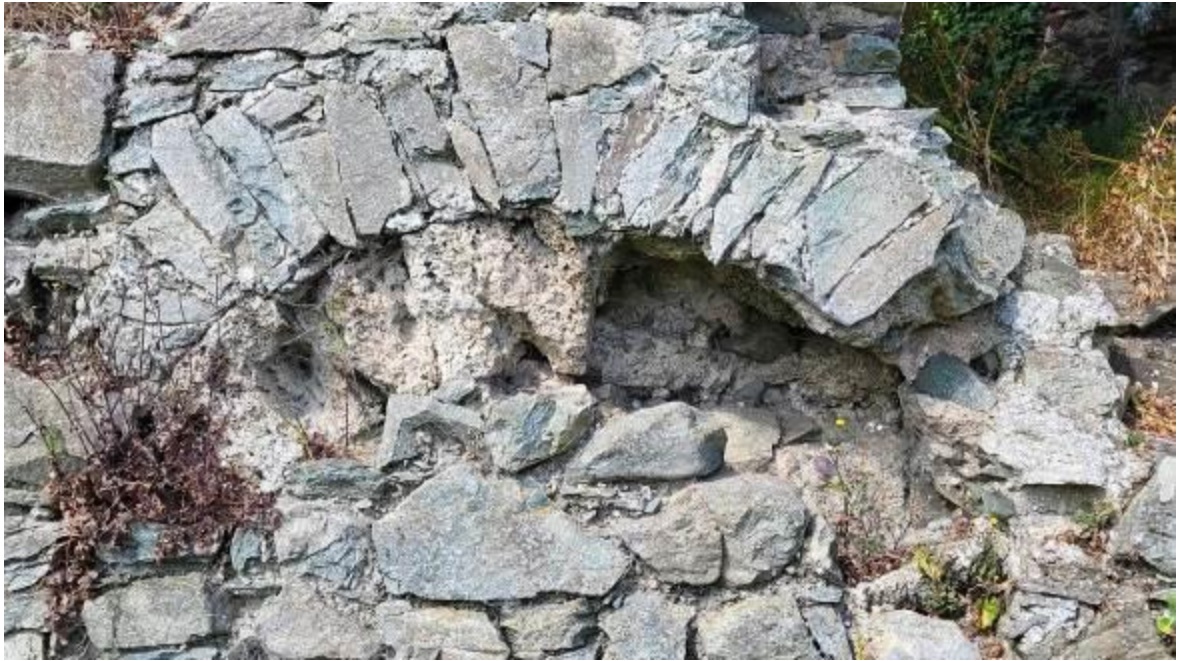
19. East elevation damaged masonry above blocked former entrance – Opening E1

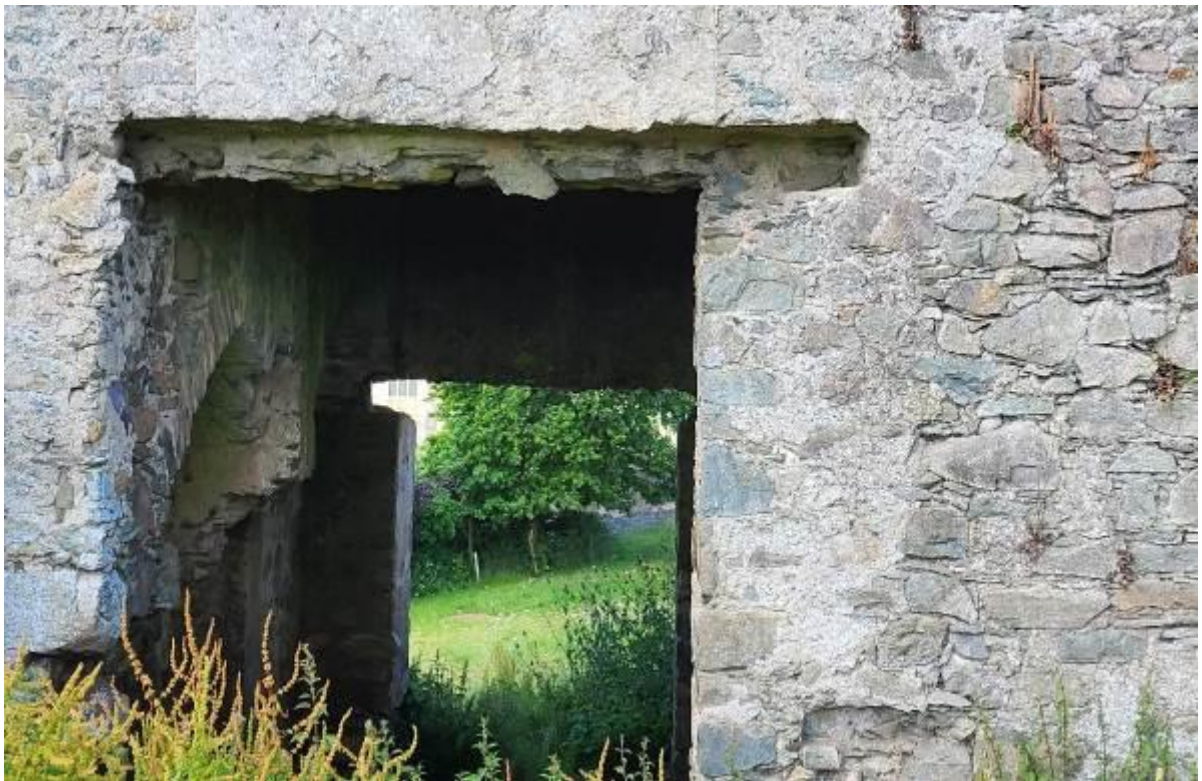
20. East elevation – entrance passageway, Opening E2

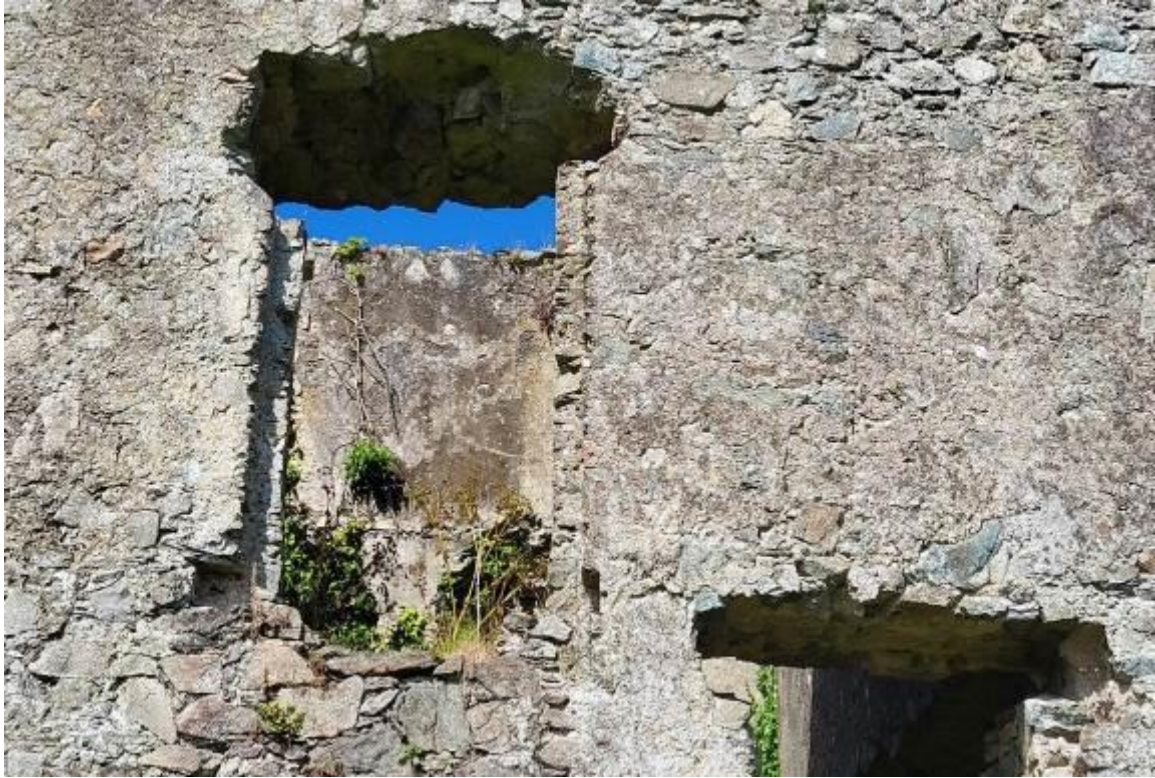
21. East elevation – Openings E4 and E3 (head)

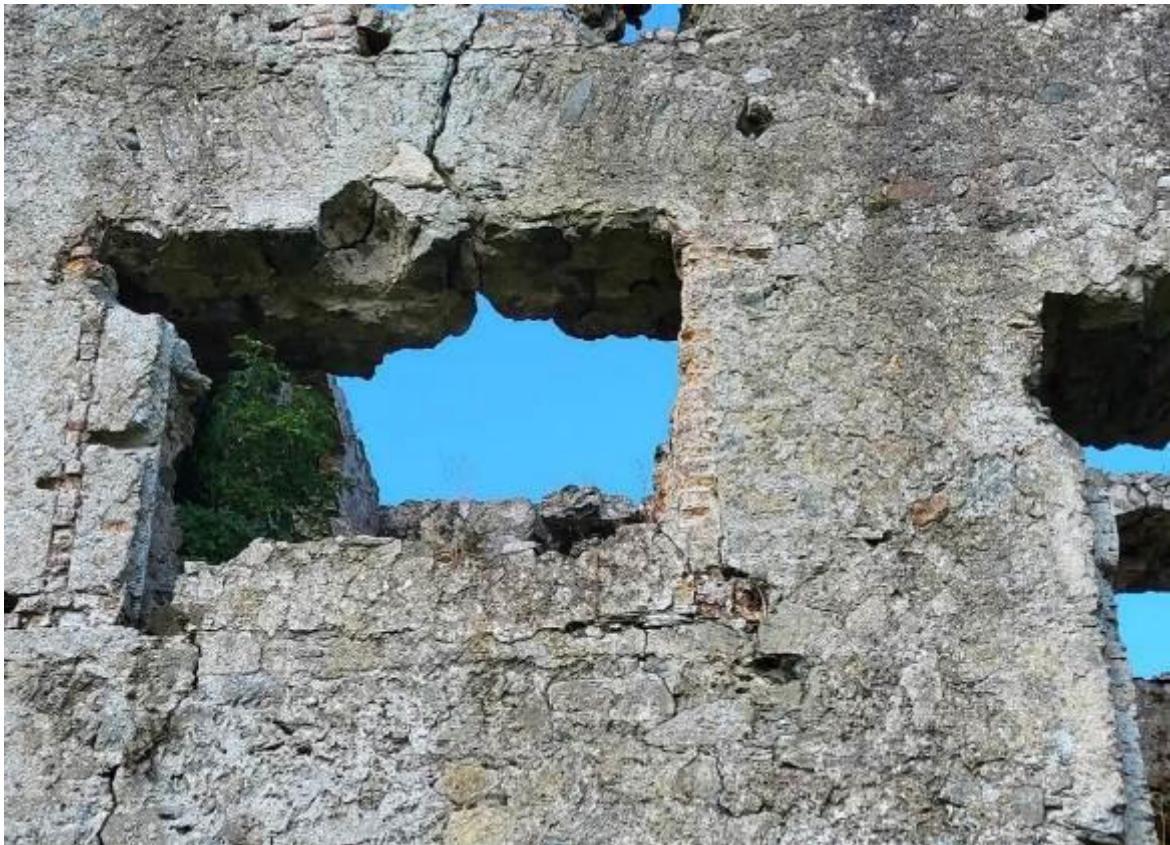
22. East elevation –Opening E5

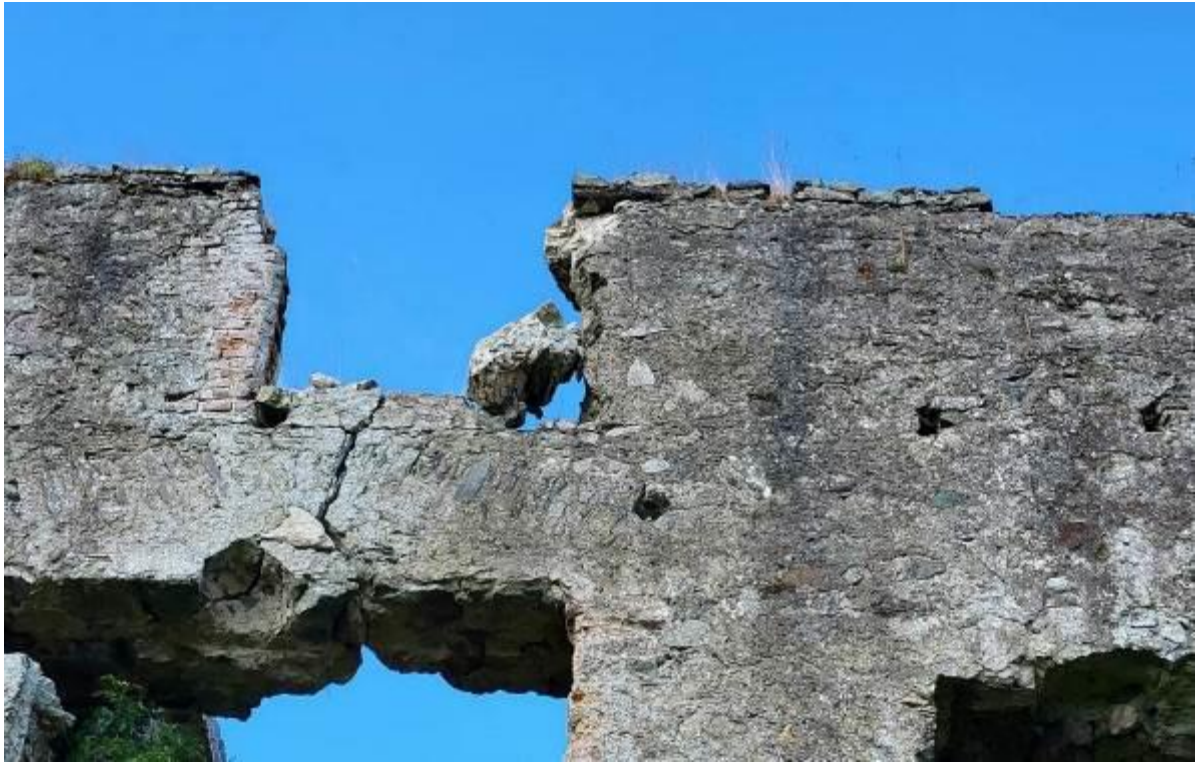
23. East elevation – damaged masonry between Openings E5 and E6

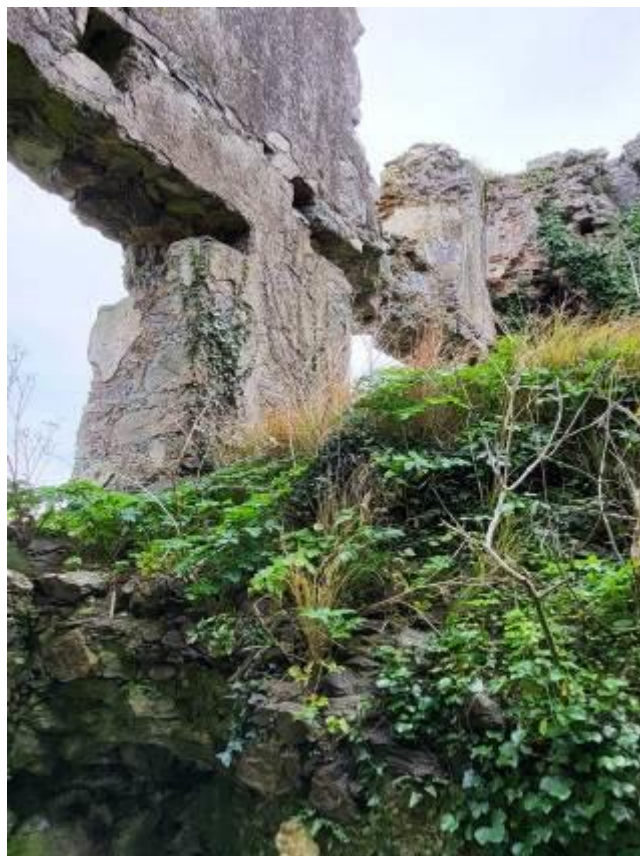
26. East elevation interior – south end (note block of brick masonry at south-east corner)

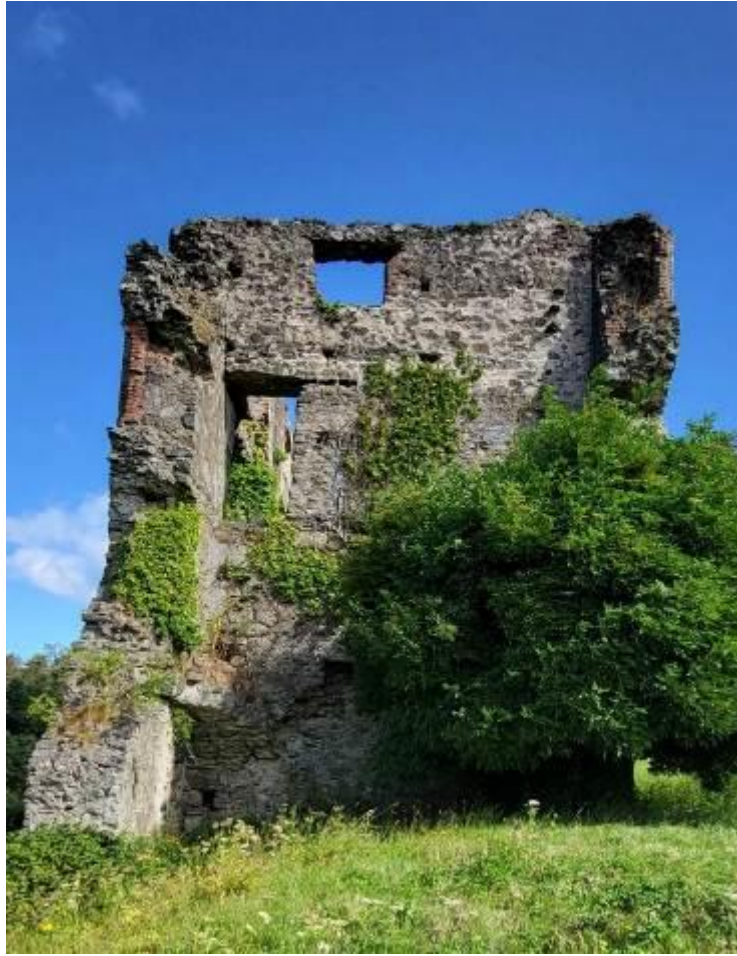
27. South elevation – general view

The works to openings S1-S3 are specified on drawing no 3, together with masonry repairs, lime capping, plastering, pointing and vegetation removal.

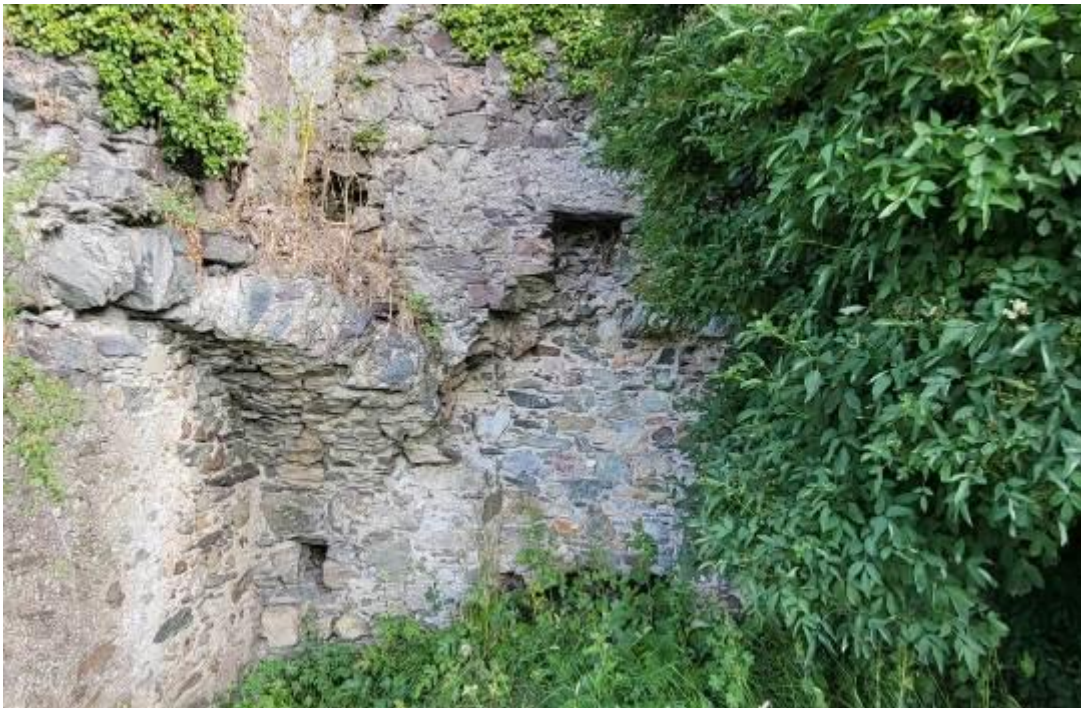
28. South elevation exterior – blocked door Opening S1

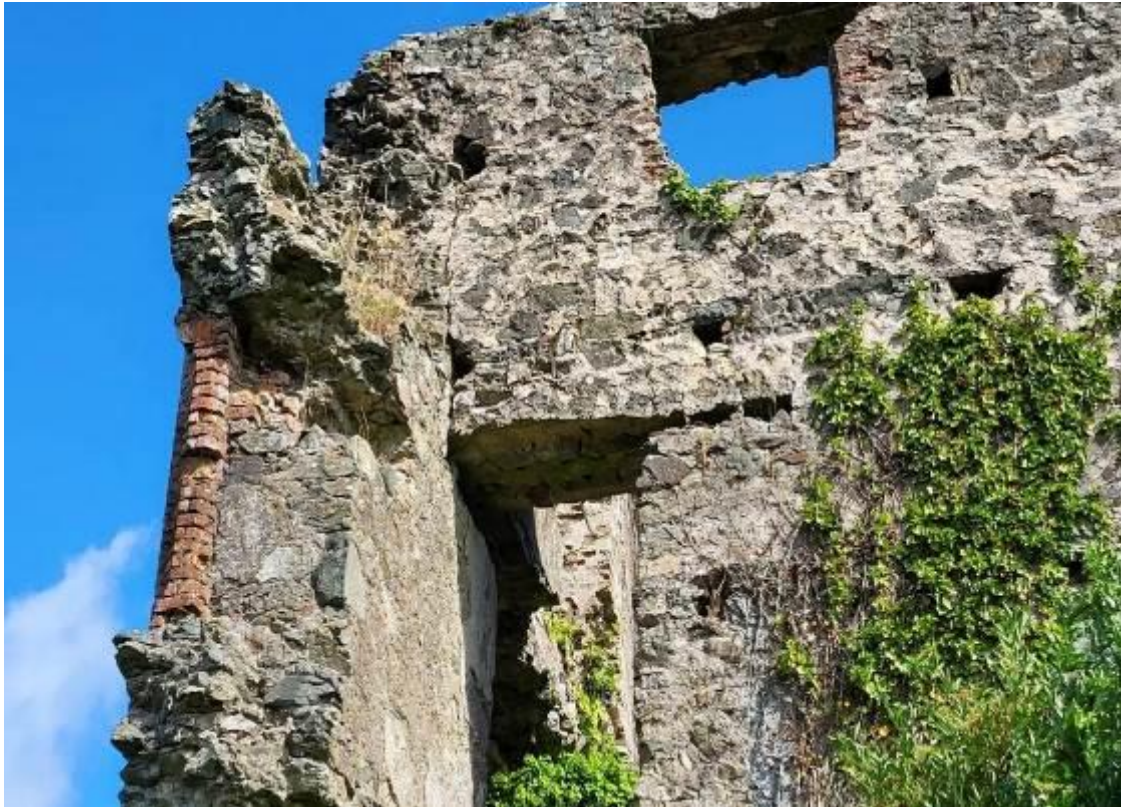
29. South elevation exterior – Windows S2 and S3 and stub of demolished west wall

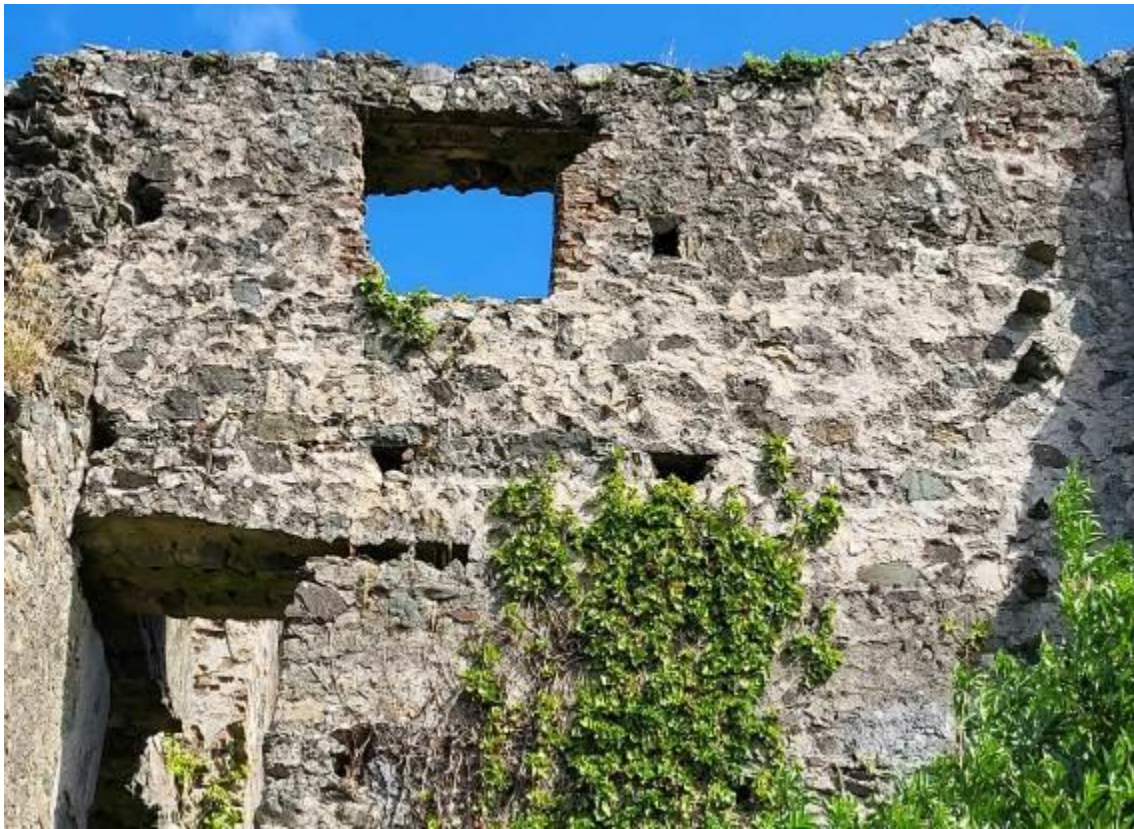
30. South elevation exterior – detail of Window S3
