**CONDITION REPORT AND
CONSERVATION/REPAIR PROPOSALS
FOR
NEWCASTLE MEDIEVAL GATEHOUSE
PHASE 1 WORKS
CMF 2025**

(JOB REF 28/23)

Nov 2023/Jan 2025

The project has been accorded the CMF reference number CMF23-2-WI003 Newcastle Castle.

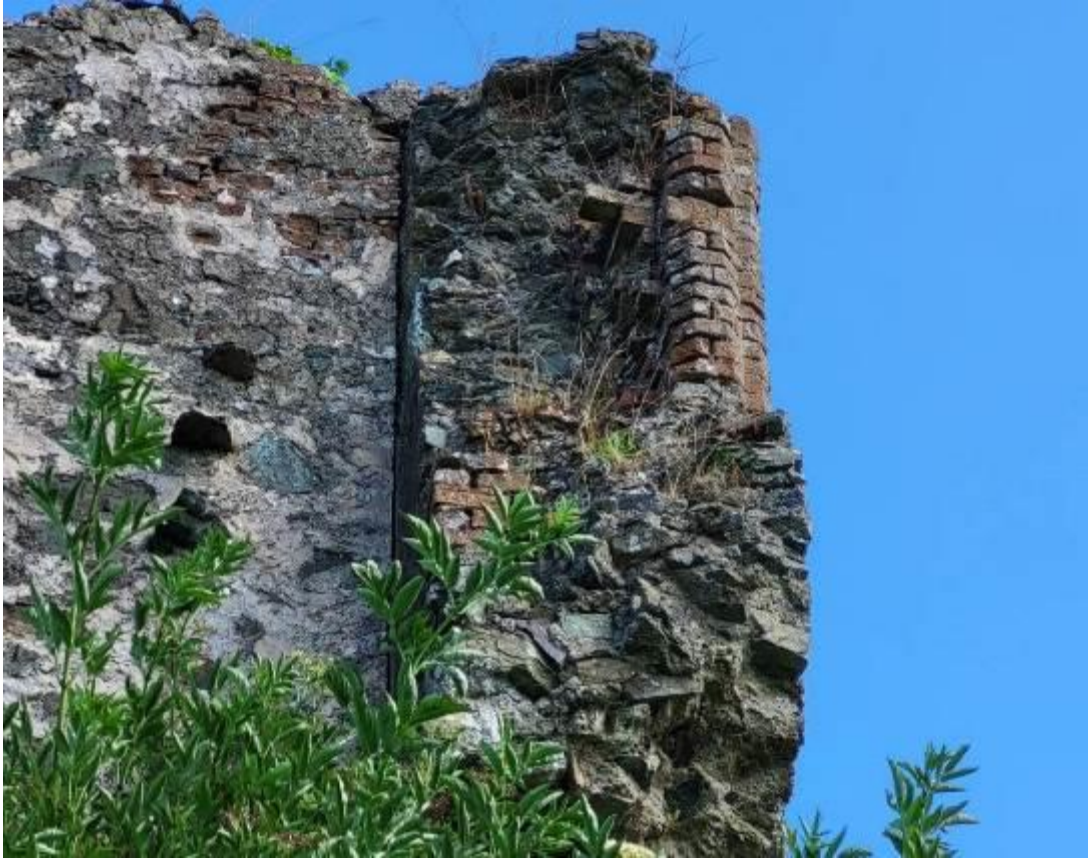
31. South wall exterior – stub of demolished east wall

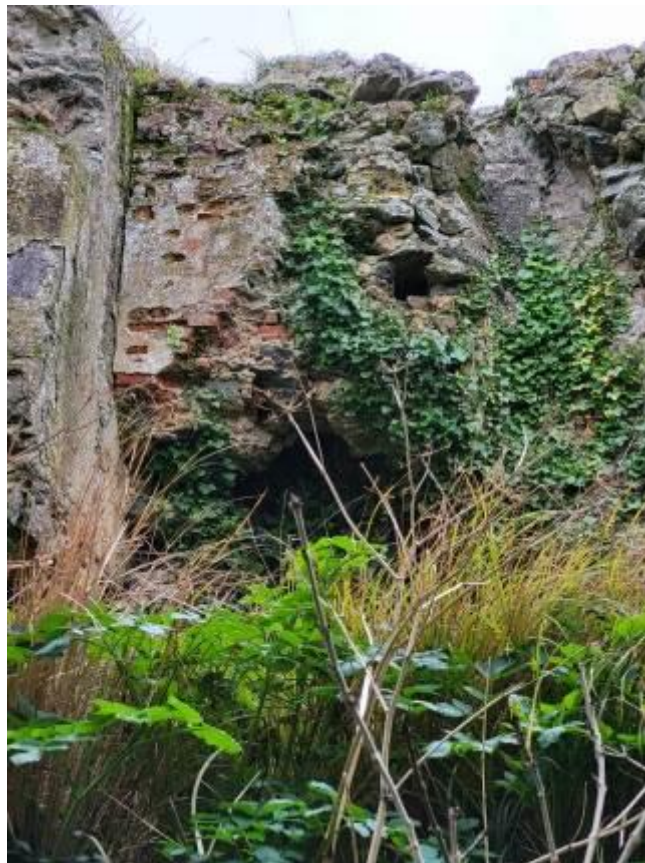
32. South wall interior – east end, note brickwork and flue.

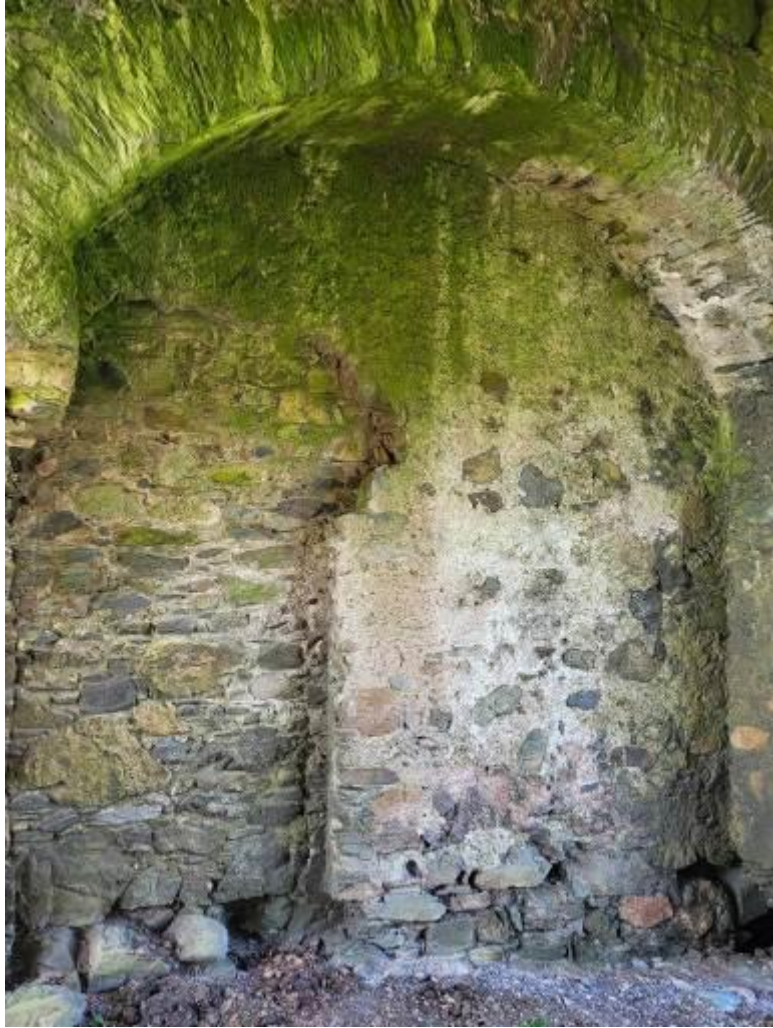
36. Entrance passage – south wall, circular arch at west end (note blocked door)

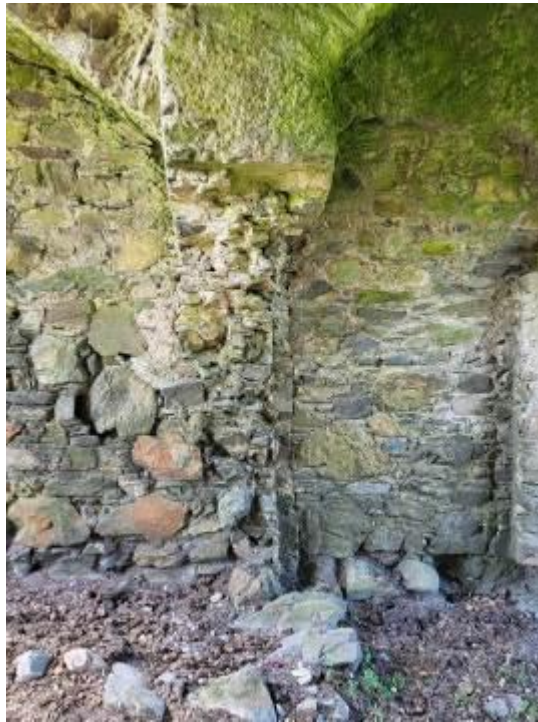
37. Entrance passage – south wall, damaged pier between the two arches

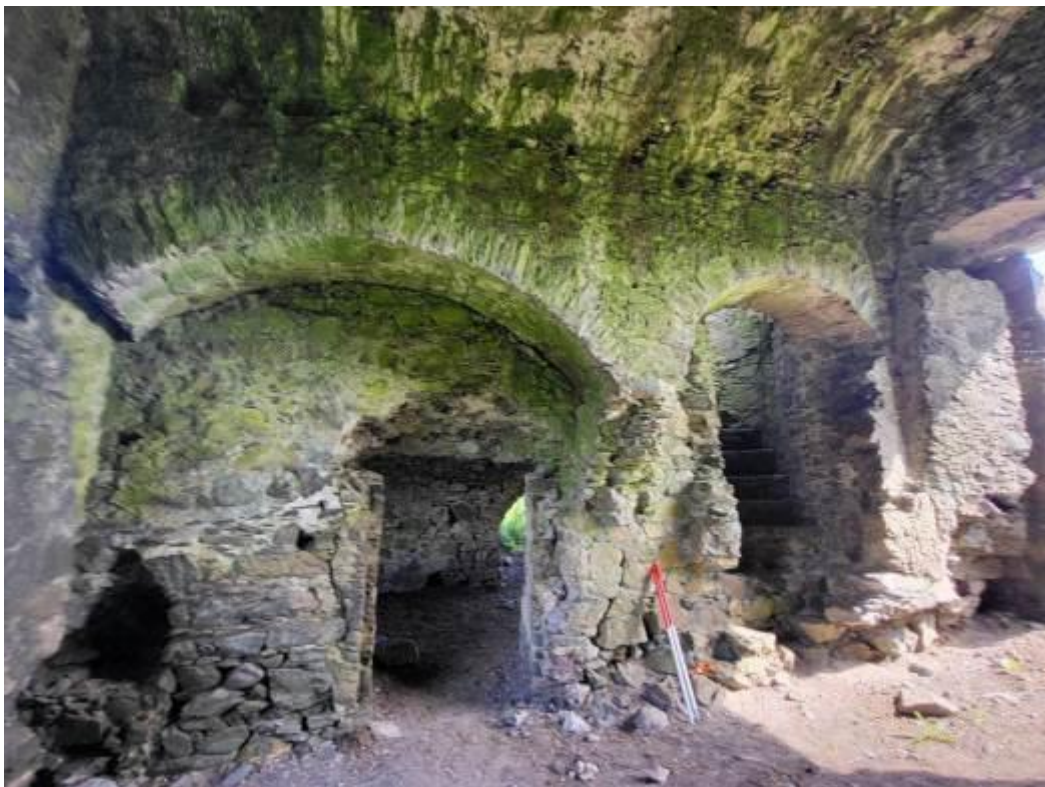
39. Entrance passage north wall – note hole in wall at west end, destroyed pier between arches and degraded masonry at wall base at the east end.

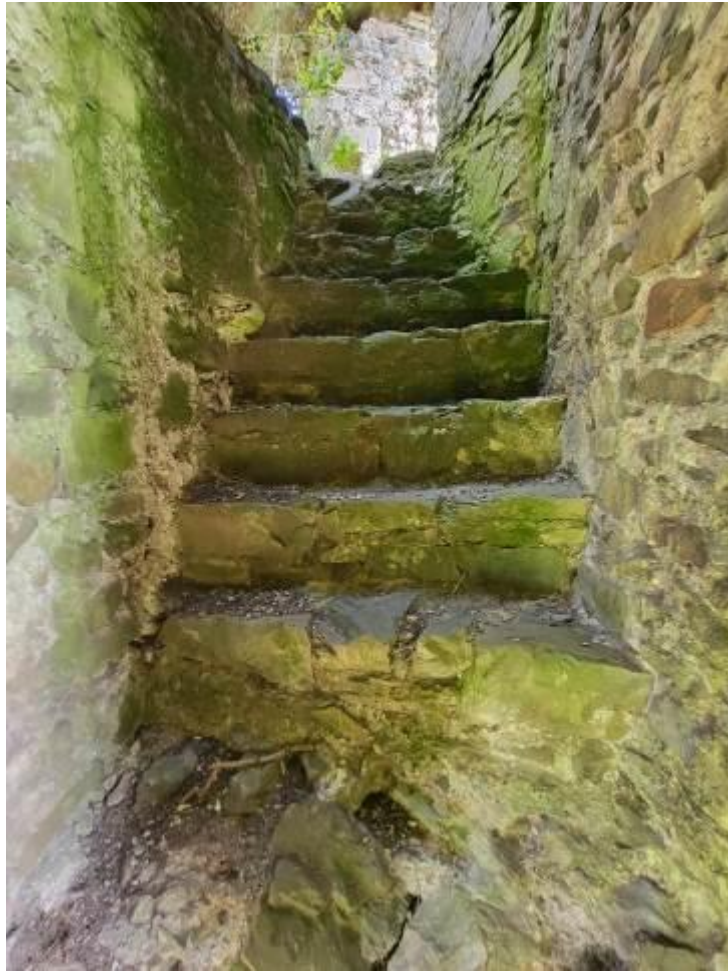
40. Rough stairs to first floor

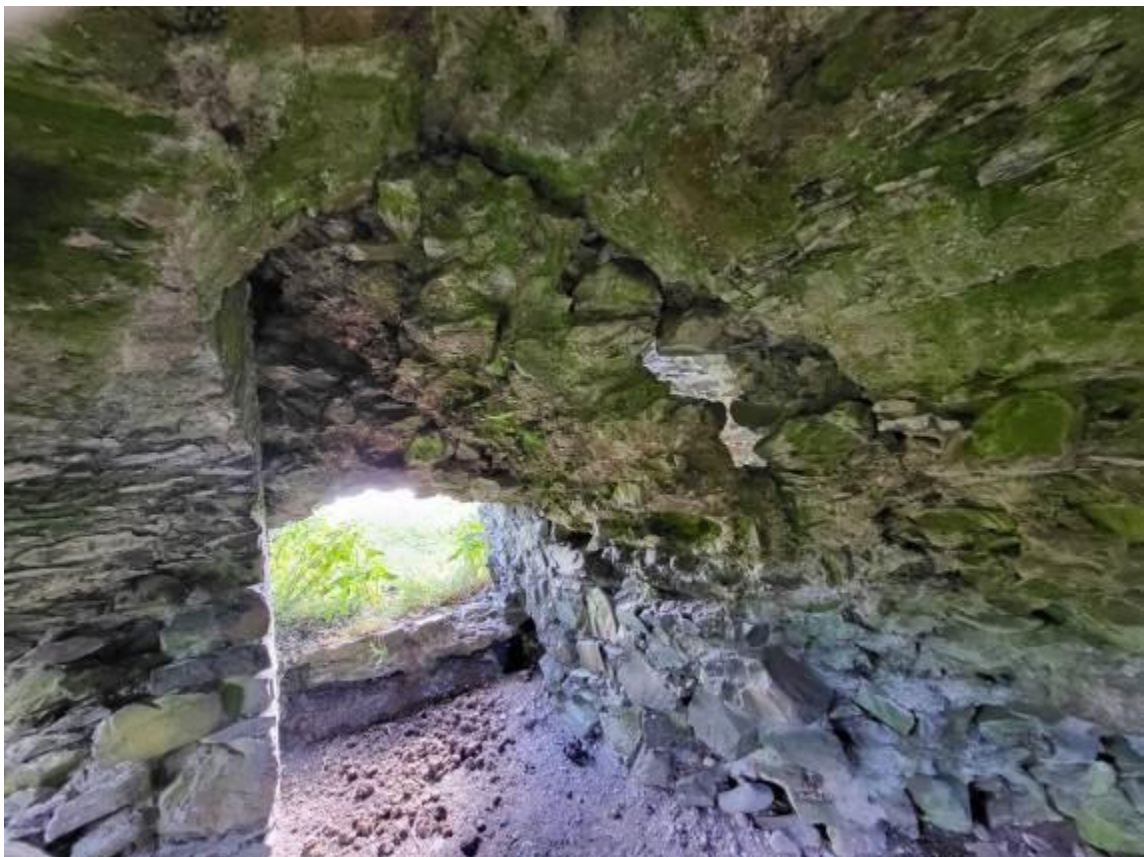
45. Undercroft looking east – note poor arching support to the stairs

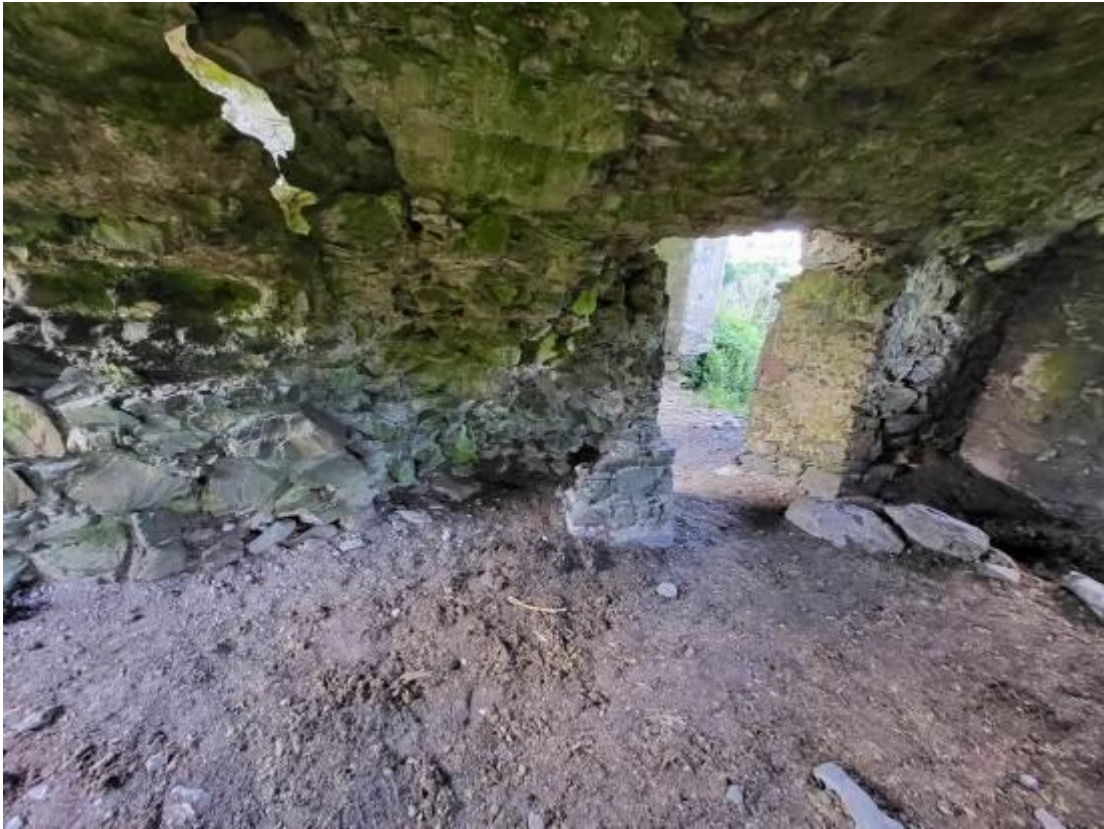
45. Undercroft south wall – note poor arching support to the stairs
