## Westport Convent Campus, Westport, Co. Mayo

### Condition Report Proposed Library Building

7011-603-002-R02

July 2023

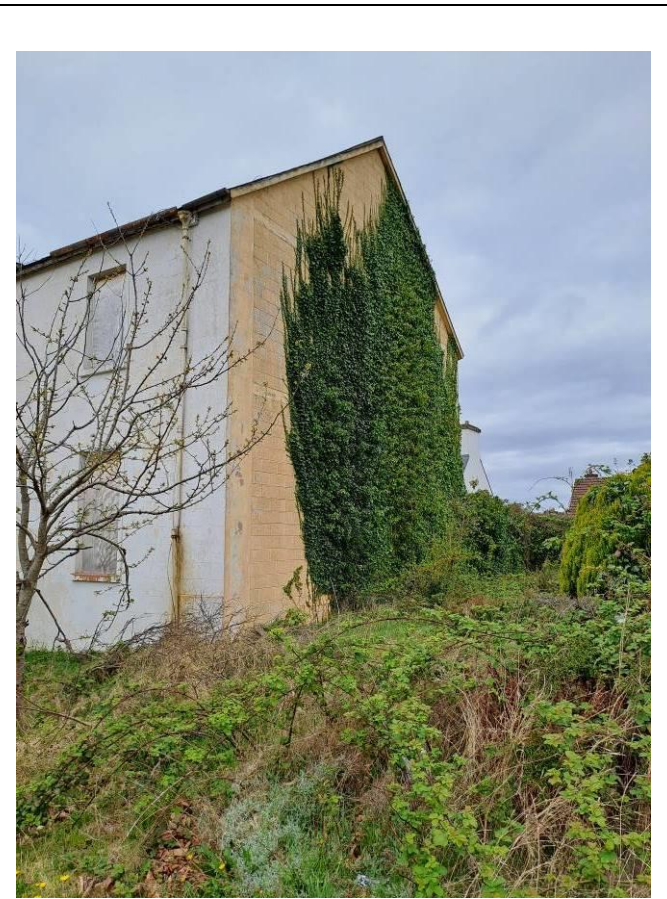
Ivy has attached itself to the East and North elevations of the building covering large portions. Ivy is evident on the remaining walls to a lesser extent.

**Photo 1: Ivy on External Wall**

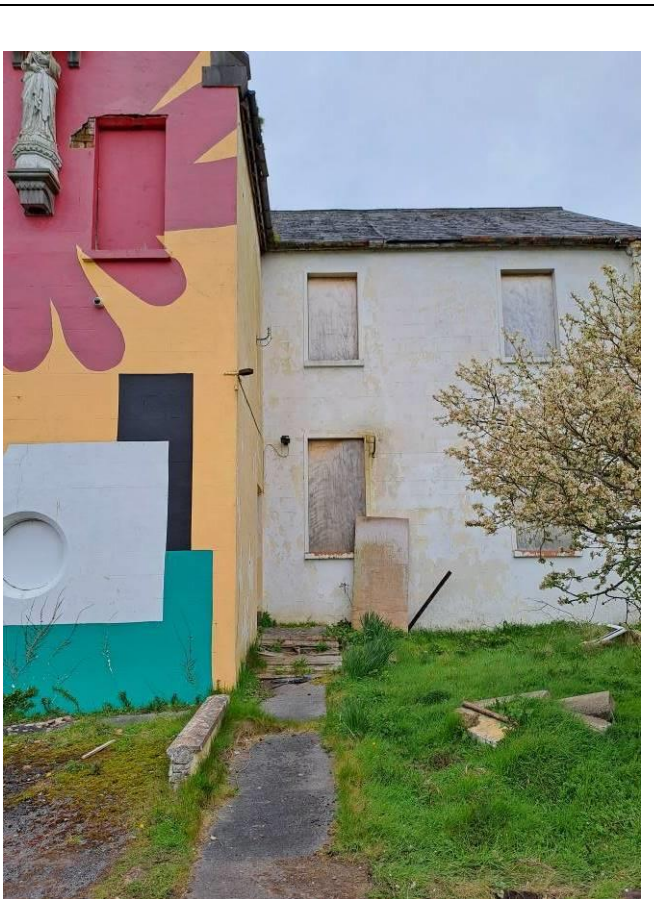
**Description:** The majority of windows (and doors) are boarded up to prevent / discourage trespassing. Windows are timber frame with single pane glass.

**Photo 2: Windows Boarded Up**

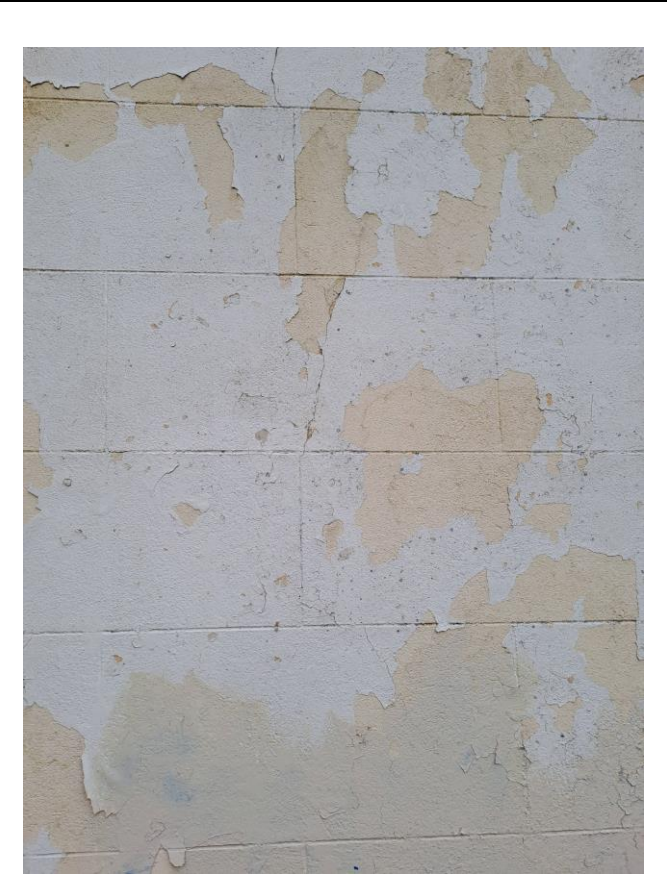
**Condition:** The plaster is cracked on all elevations specifically around window and door opens. This is an indication of minor settlement and / or thermal movement which is not uncommon for a structure of this age, these are not considered to be serious or major on-going movement. The plaster is broken in places and when lightly tapped with a hammer produced a hollow sound indicating it has detached from the masonry underneath.

**Photo 3: Cracking / Flacking of Wall Finishes**

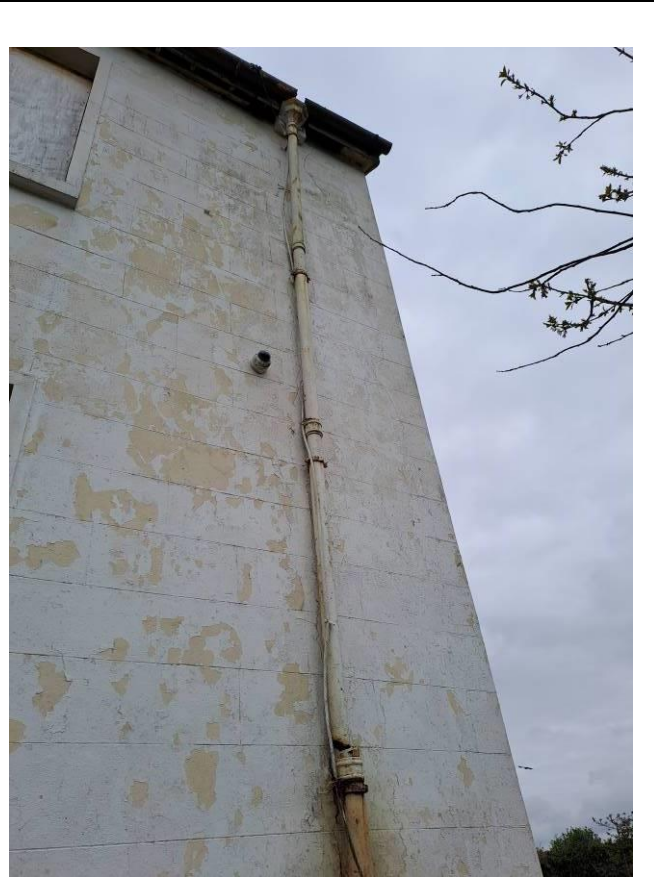
**Condition:** Several down pipes are rusted through and broken, a close inspection of the gutters was not possible, however, from the ground it could be seen that sections of the gutters have broken off and other sections are blocked up

**Photo 4: Downpipe Rusted and Broken**

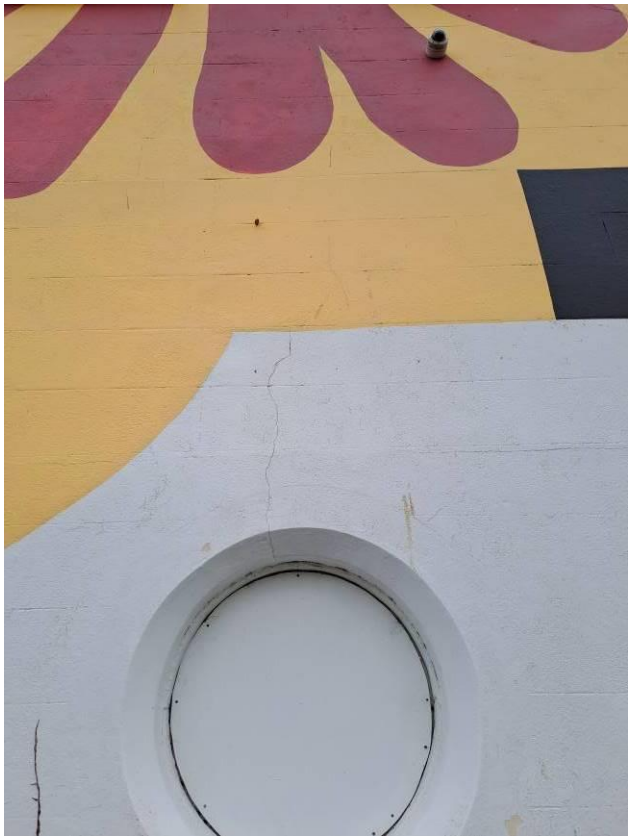
Photo 5: Cracking to Plaster

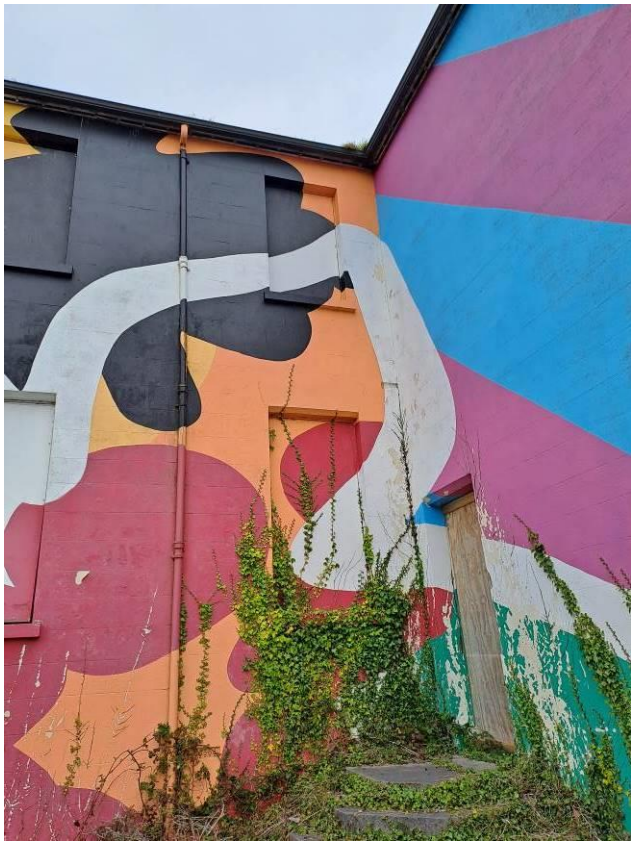
Photo 6: Ivy on External Walls

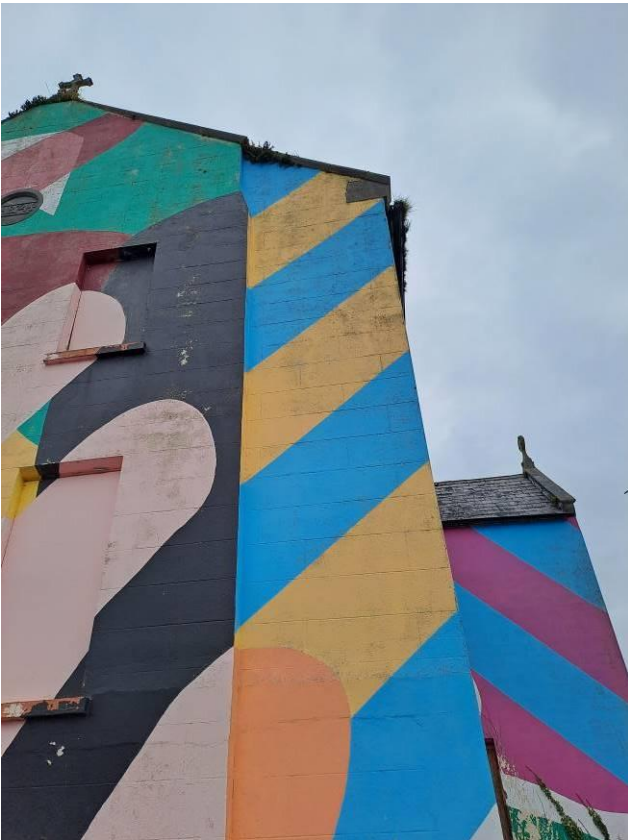
Photo 7: Gutters Blocked

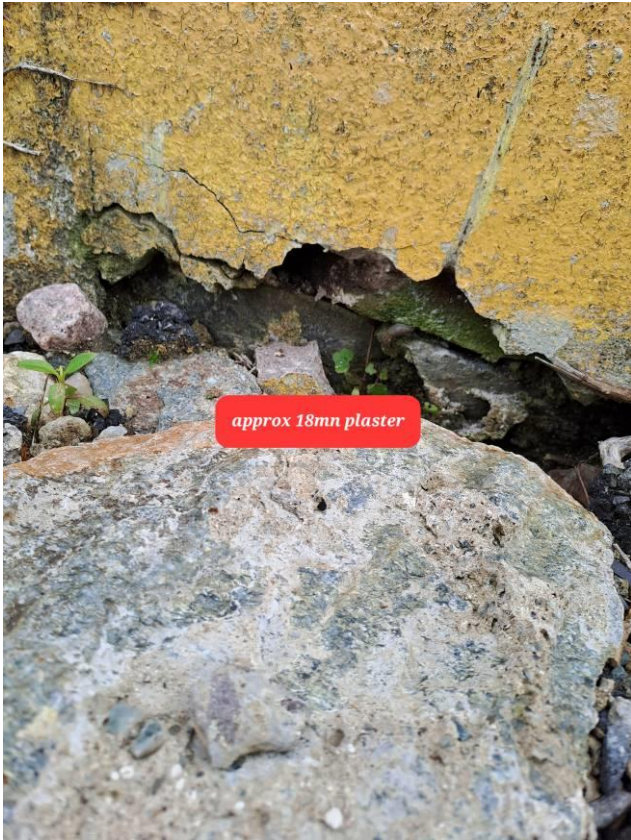
Photo 8: Plaster Cracked / Broken

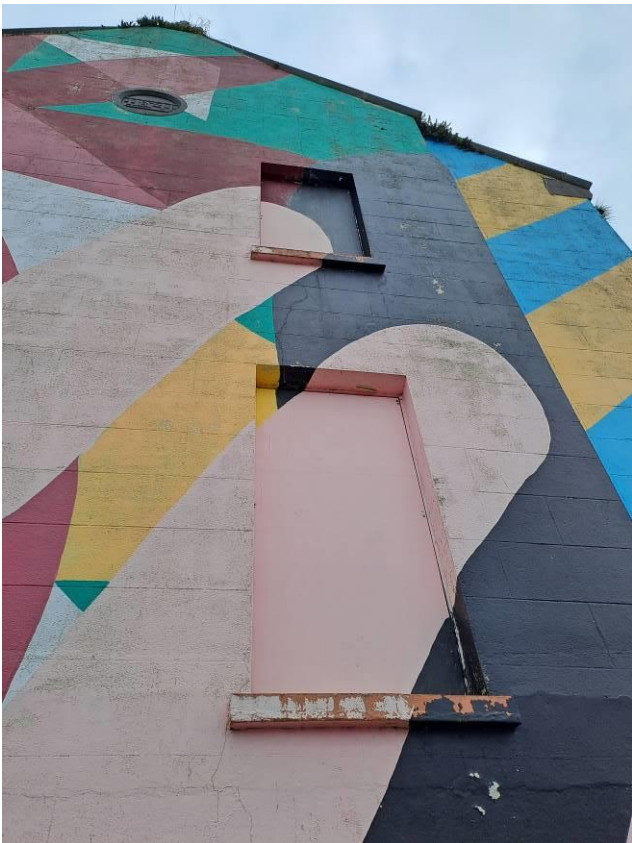
Photo 9: Cracking in Plaster around Windows

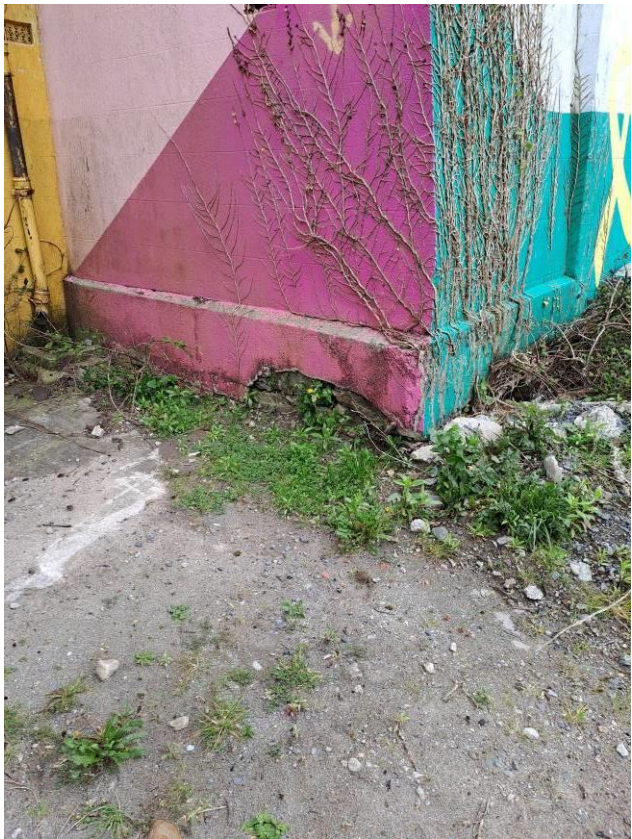
Photo 10: Plaster Broken

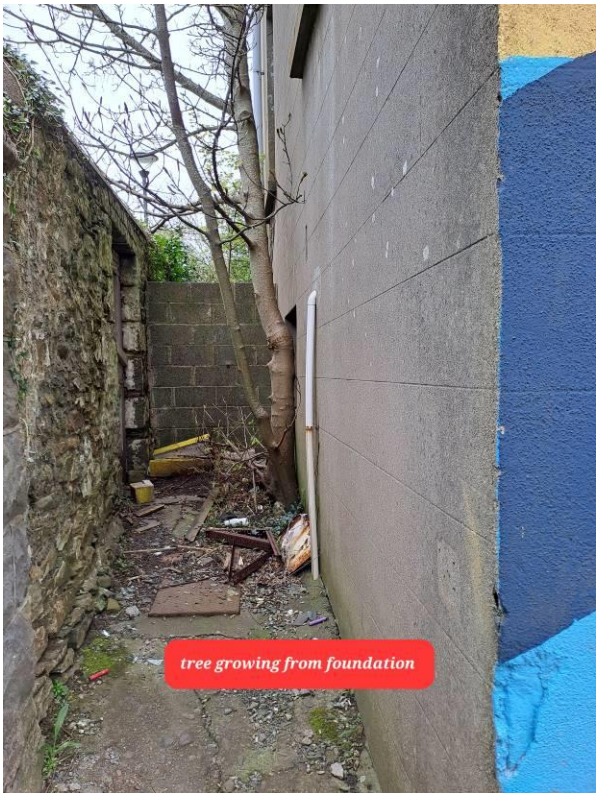
Photo 11: Tree Growing (Possibly) through Foundations

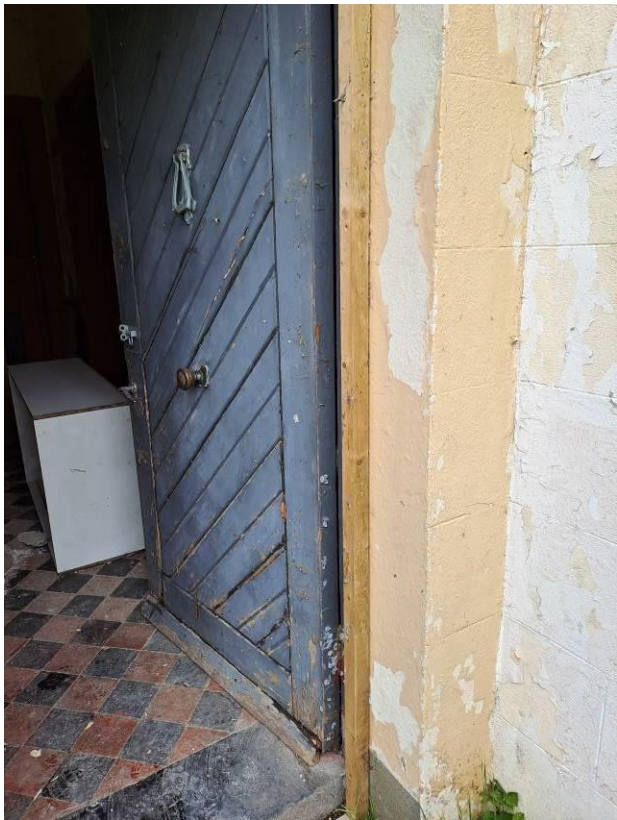
**Condition:** Exterior doors are visually damaged and in poor condition. Doors are showing signs of decay and rot – refer to [P1].

Photo 12: External Door Showing Wear and Tear

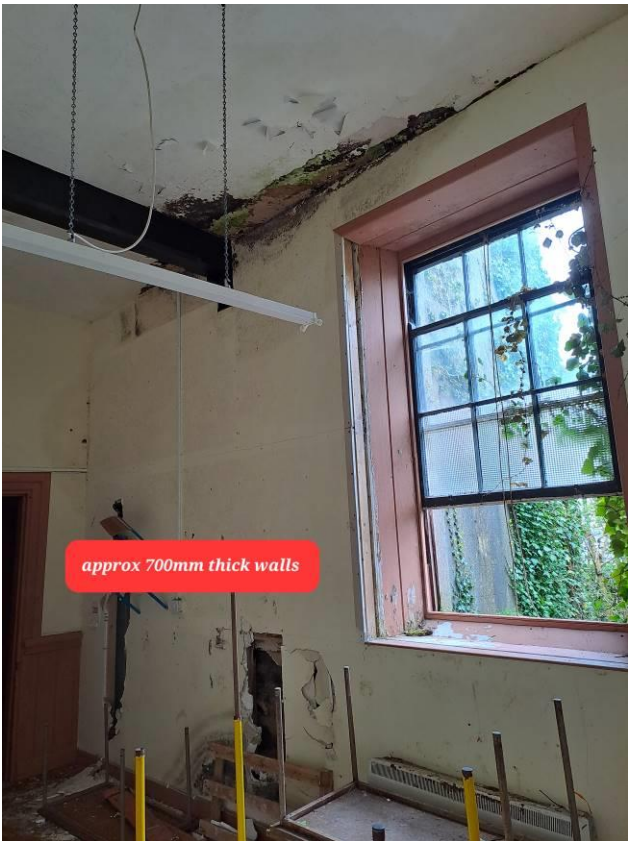
**Condition:** The ceilings are in poor condition with damp patches visibly throughout. Wet and dry rot noted – refer to [P1]

Photo 13: Damp Patch in Ceiling

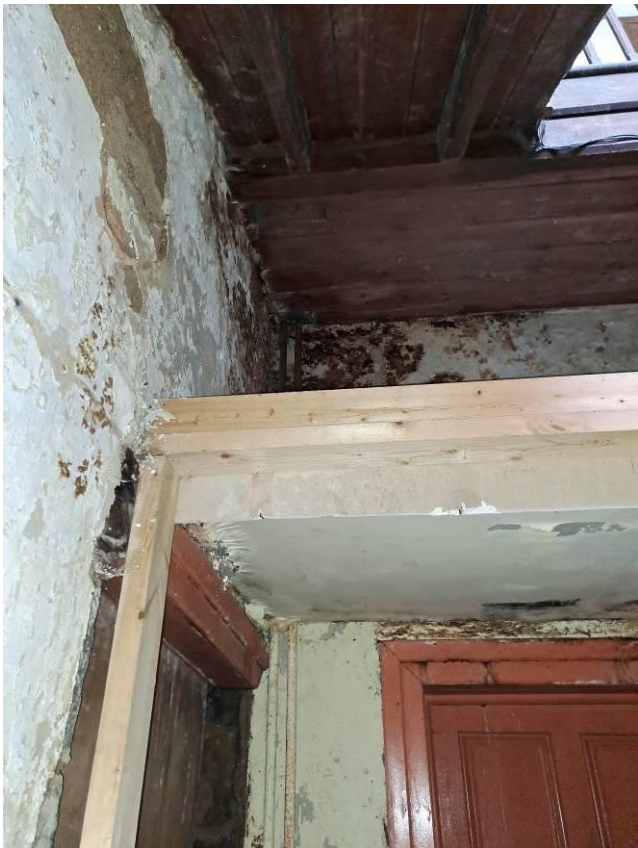
Photo 14: Mould Growing on Internal Walls

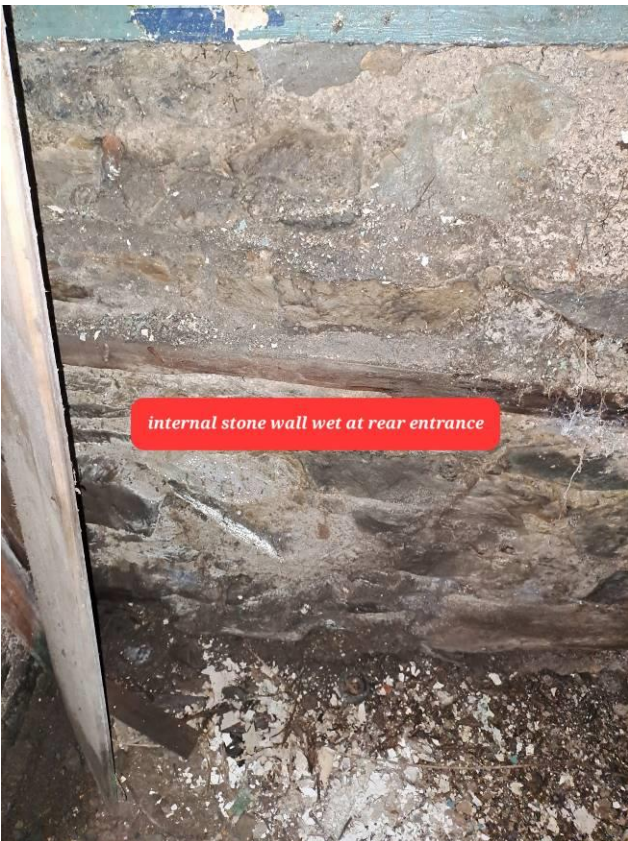
Photo 15: Internal Walls Wet – Moisture Ingress

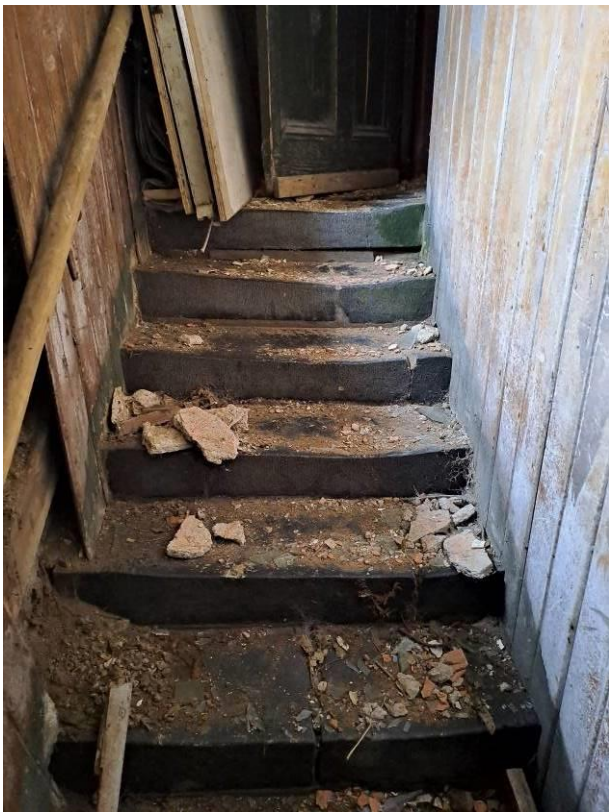
Photo 16: Staircase to Basement Level in Poor Condition

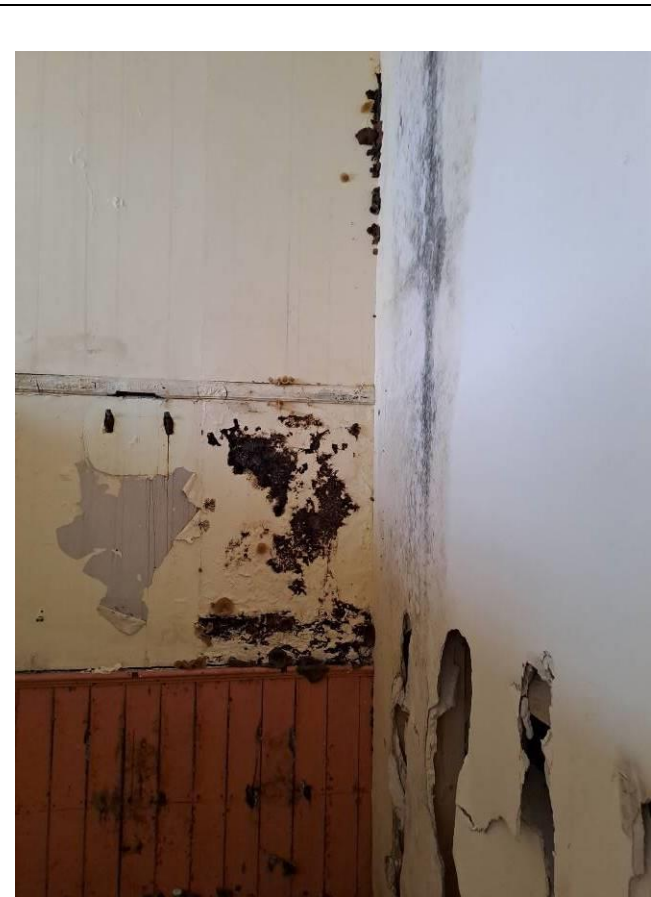
Photo 17: Mould Growth Noted

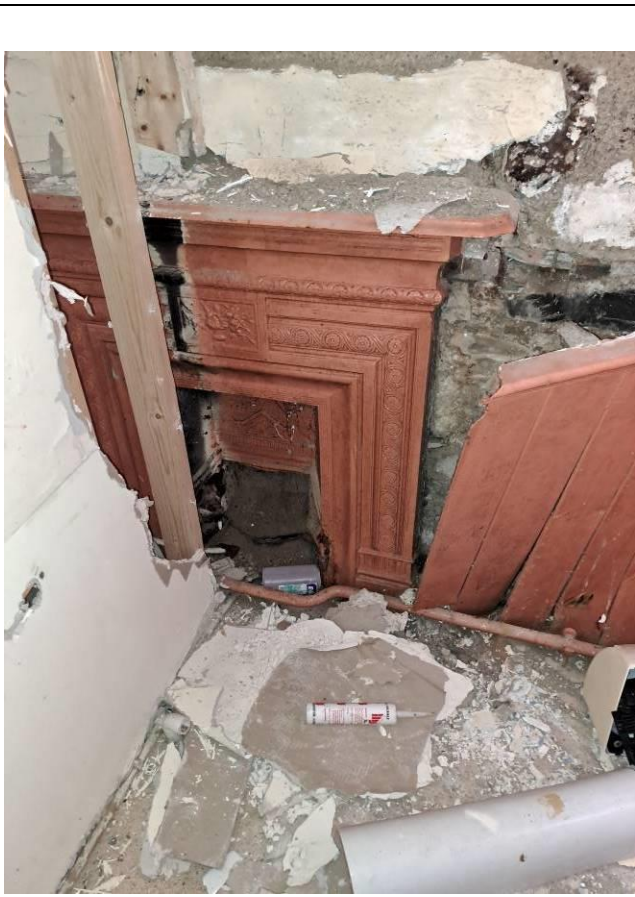
**Description:** An open fireplace without brickwork fire surround or chimney breast was located in the building – a stud partition has been constructed up to the face of the fireplace effectively placing a portion of the fireplace in each room either side of the stud wall. The rooms either side of the wall in question have been converted into toilet facilities.

**Condition:** The fireplace doesn't appear to have been utilised during the later stages of the schoolhouse owing to the positioning of the fireplace in the current layout of the building. Further investigation by a suitably qualified person should be carried out to inspect and clean the flues as necessary. Adequate ventilation should be provided around the chimney flue to prevent potential problems with moisture buildup.

Photo 18: Fireplace Closed Off with Internal Partitions

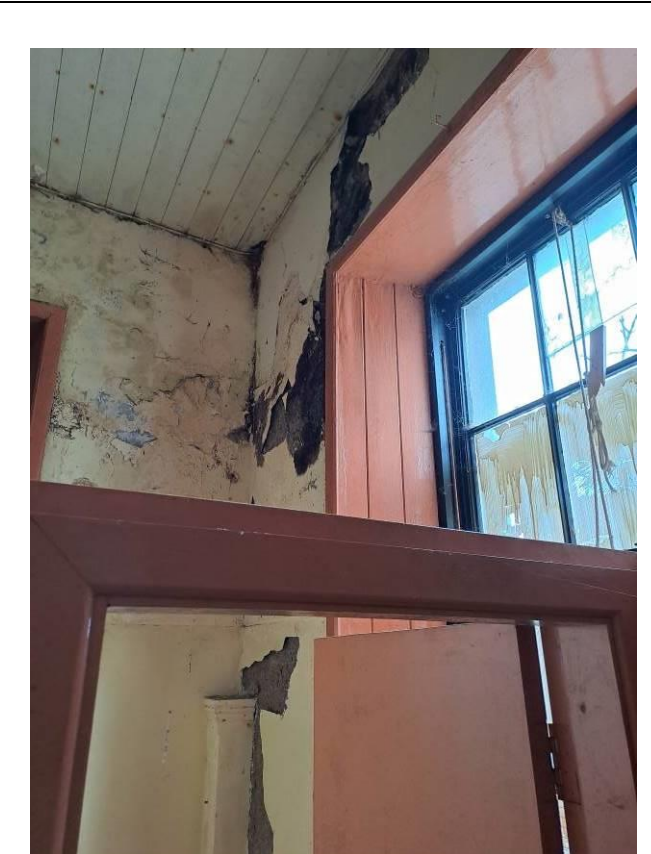
Photo 19: Mould Growth Noted

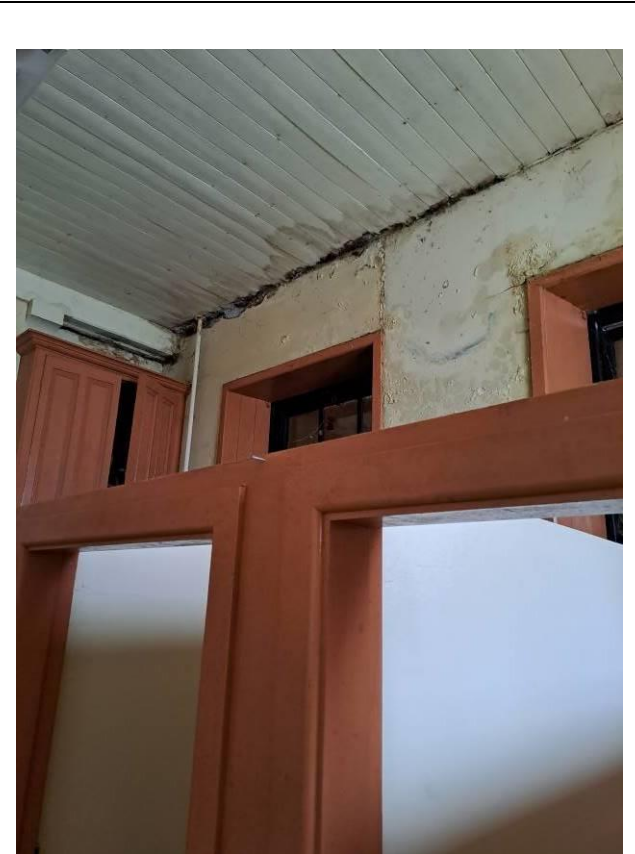
Photo 20: Damp Patch in Ceiling

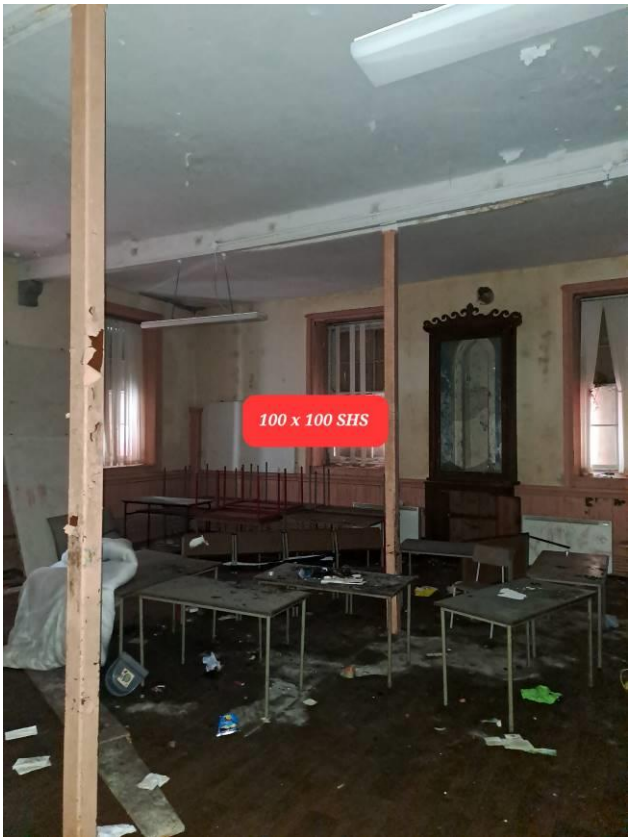
**Photo 21: 2 No. 100x100 SHS Sections Supporting Beams Above**

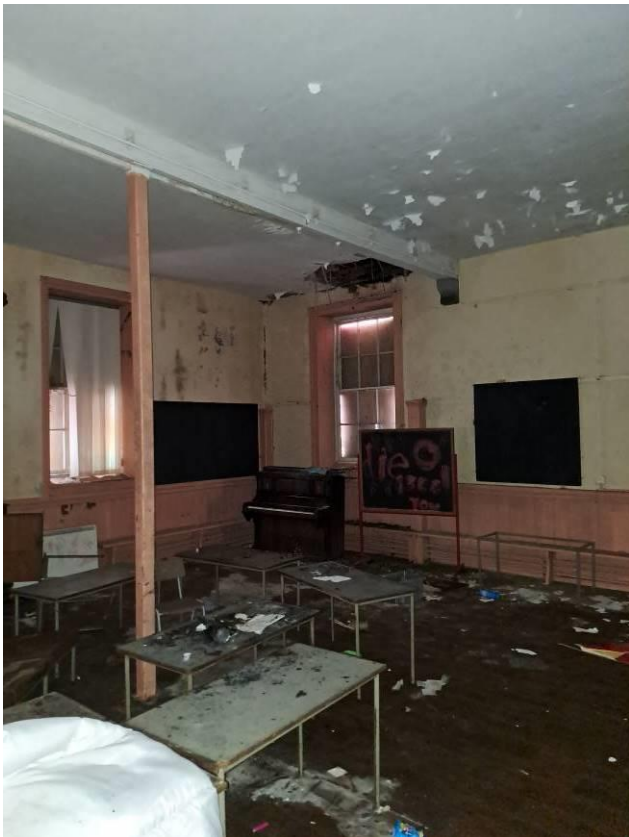
**Photo 22: Ceiling in Poor Condition – Hole in Ceiling Noted**

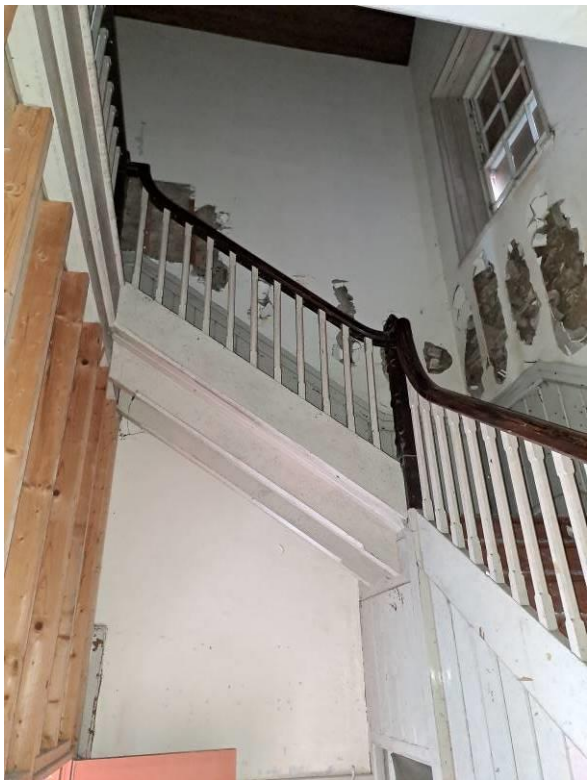
**Photo 23: Staircase**

**Condition:** The staircase appears to be functional
