## Westport Convent Campus, Westport, Co. Mayo

### Condition Report Main Annex Building

7011-603-002-R01

July 2023

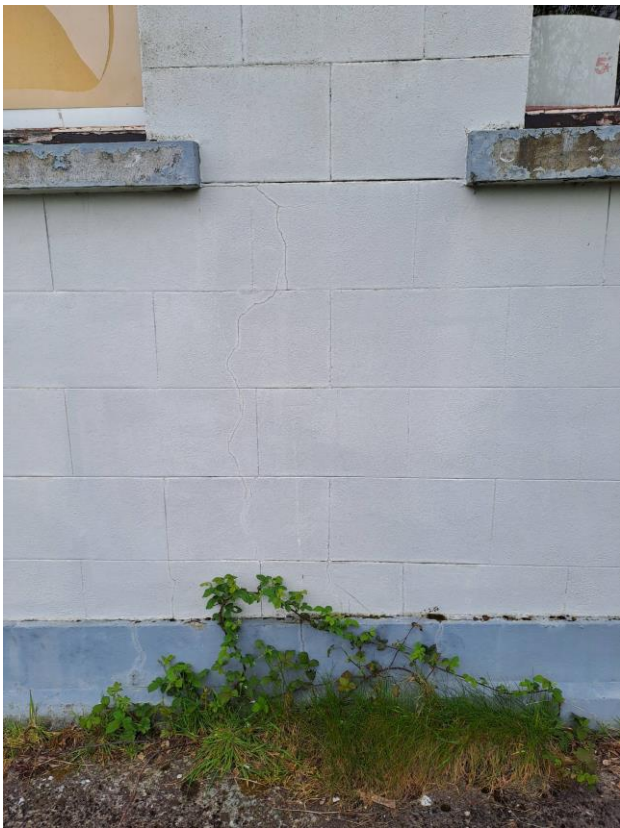
**Condition:** The plaster is cracked on all elevations specifically around window and door opes. This is an indication of minor settlement and / or thermal movement which is not uncommon for a structure of this age, these are not considered to be serious or major on-going movement. Plaster around door reveals in the internal courtyard is damaged, exposing the brick underneath. Little to no mortar is noted in these areas.

Photo 3: Surface Cracking to Plaster

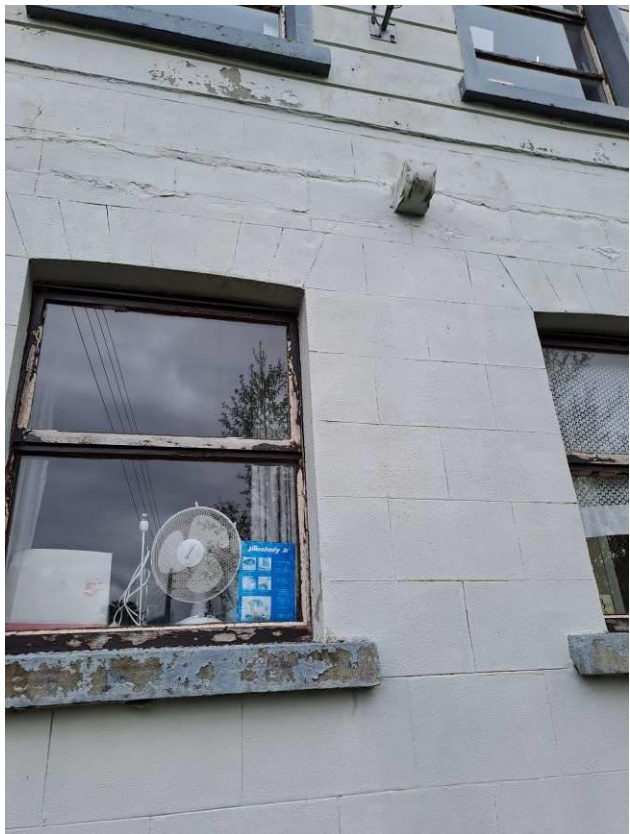
Photo 4: Plaster in Poor Condition

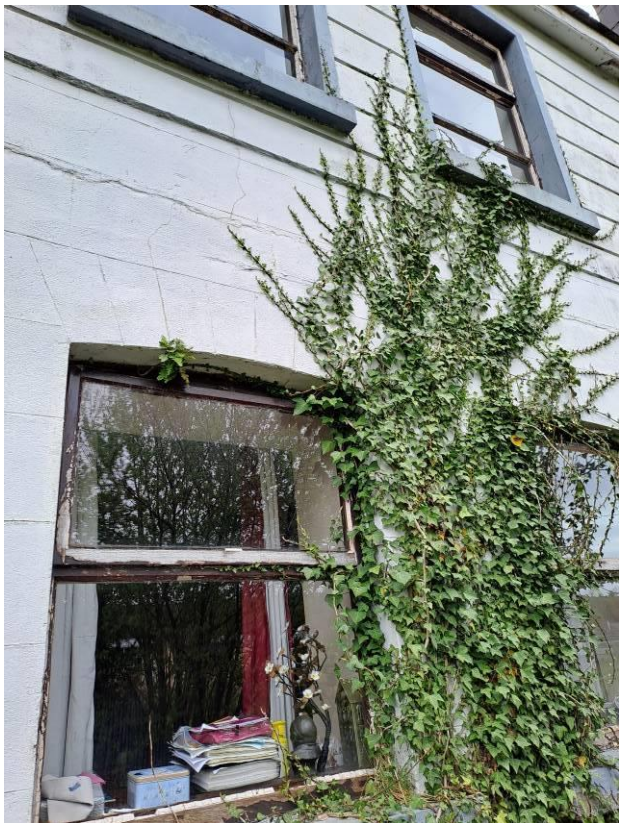
Ivy has attached itself to the Southern and Western elevations of the building covering sizeable portions of the walls.

Photo 5: Ivy on External Wall

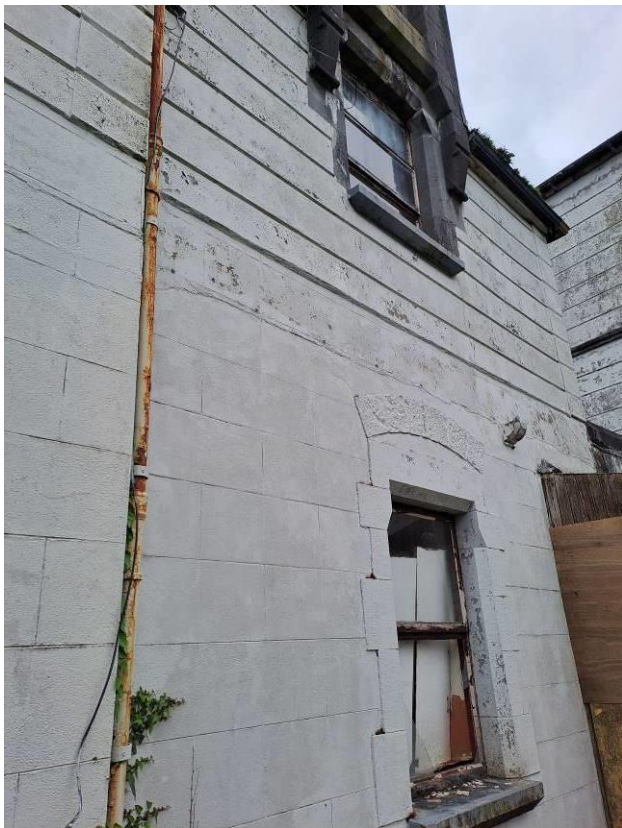
**Condition:** Several down pipes are rusted through and broken, a close inspection of the gutters was not possible, however, from the ground it could be seen that sections of the gutters have broken off and other sections are blocked up

Photo 6: Downpipe Rusting

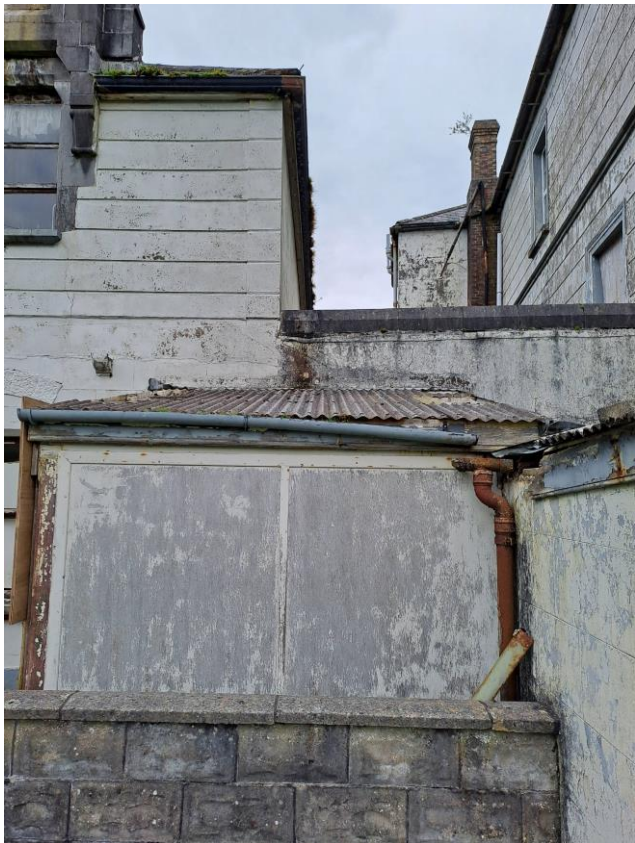
Photo 7: Gutters Blocked

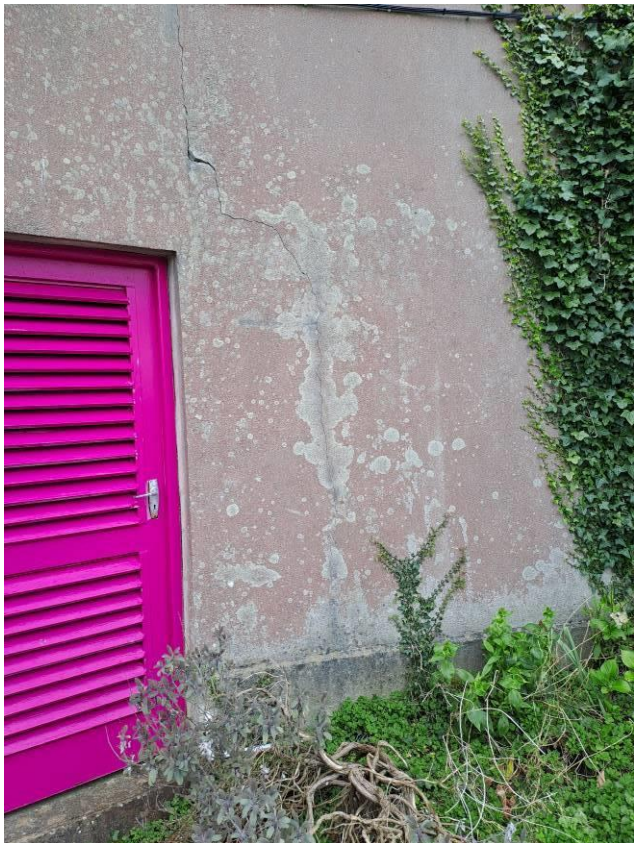
Photo 8: Cracking to Plaster

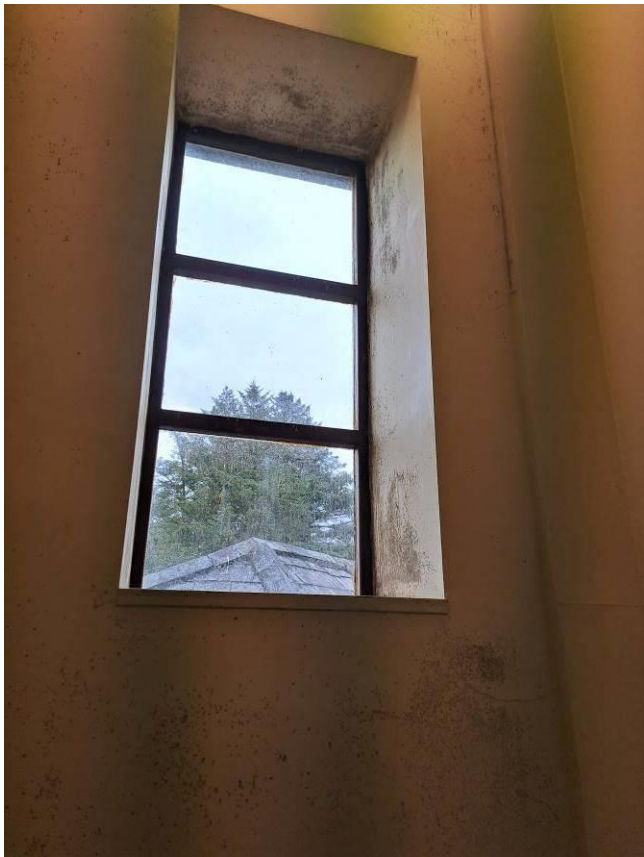
**Condition:** All internal walls in the charity shop and meals on wheels kitchen facility are kept in good condition – walls are generally clean and neat. Mould growth noted on 1 No. wall at the staircase to the charity shop.

**Photo 9: Mould Growth on Internal Wall**

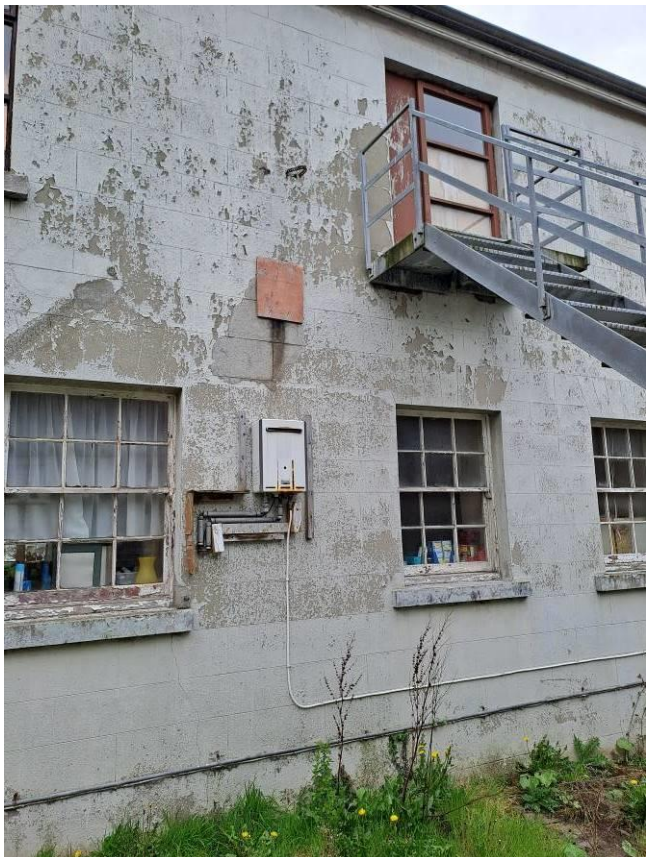
Walls to the charity shop storage facility are in poor condition. Paint is flacking off, voids appearing at connections between door reveals and walls – with some bowing of internal door reveal heads suggesting a lintel is / has failed. Damp patches from the roof are dripping down the walls creating a mould issue. Cracking is noted throughout the building.

**Photo 10: Wall Finishes in Poor Condition**

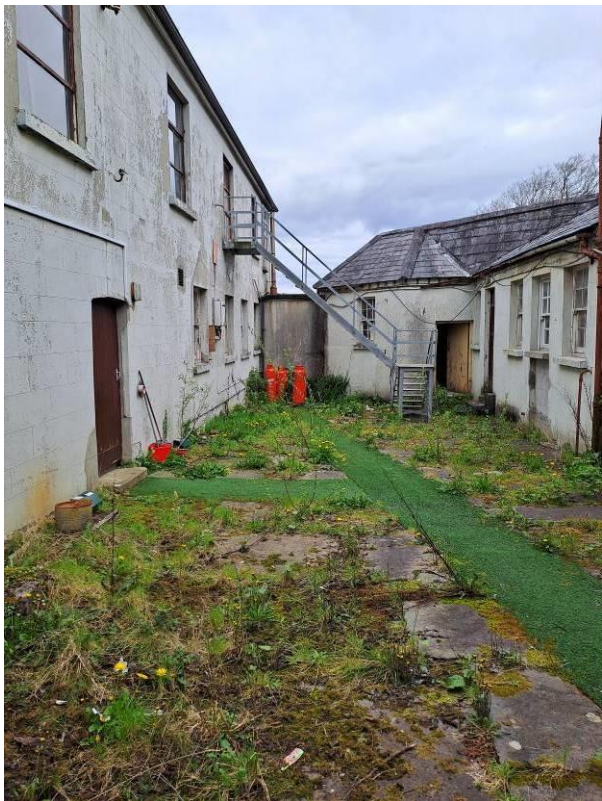
The courtyard areas are in poor condition, with cracking throughout and vegetation growth protruding through the cracks

**Photo 11: Courtyard in Poor Condition**

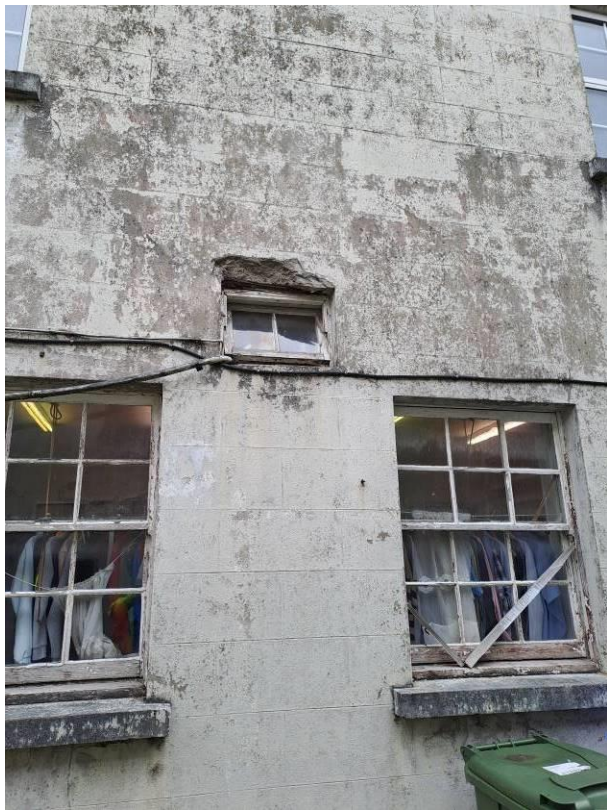
Several lintels over small windows are broken / damaged on the Northern elevation.

**Photo 12: Broken / Damaged Lintel over Window**

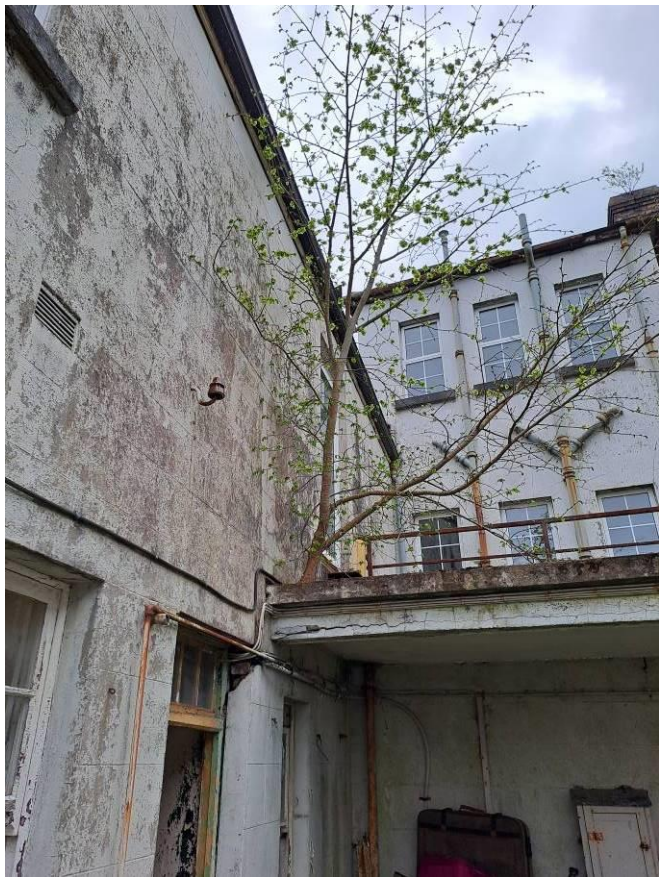
A small tree appears to be growing out of the roof structure providing shelter to a section of the courtyard.

**Photo 13: Tree Growing from Flat Roof / Shelter**

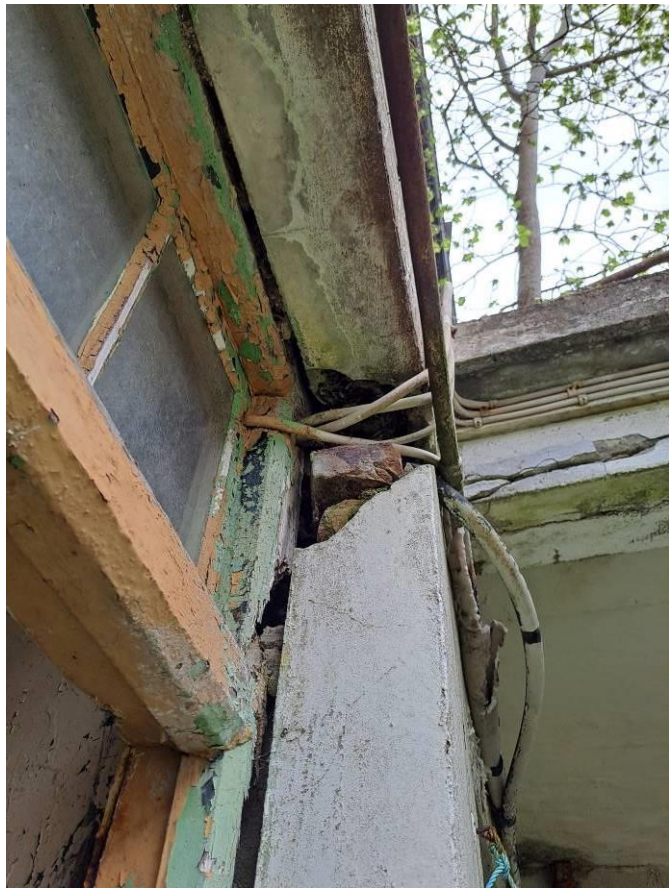
**Photo 14: Plaster Damage around Door Reveal**

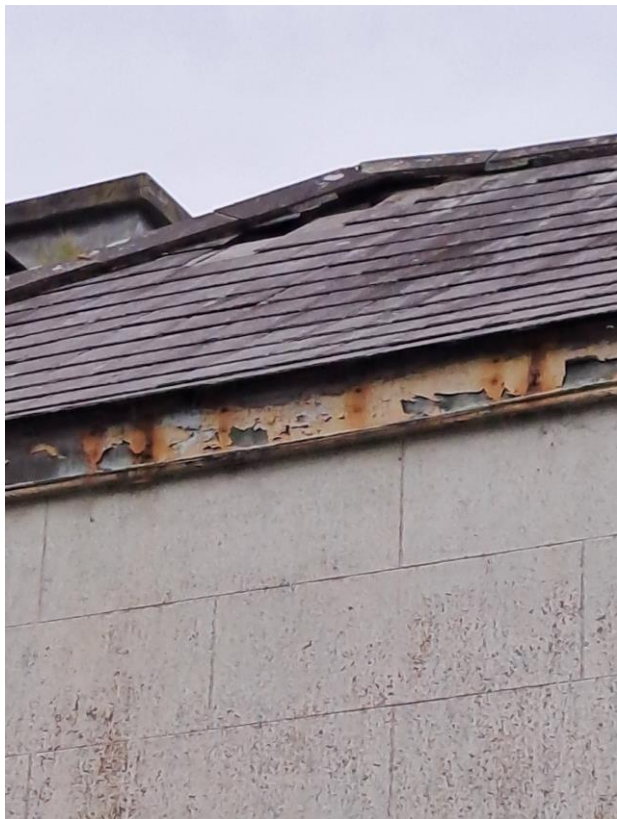
damaged. A section of the roof adjacent the Convent building is noted to have a hole in it.

**Photo 15: Hole in Roof Structure**

It is likely that the existing rafters and purlins supporting the roof structure do not comply with current codes and standards. It is recommended that some opening up works are carried out on site to determine the size, spacing and spans of the existing rafters and purlins.

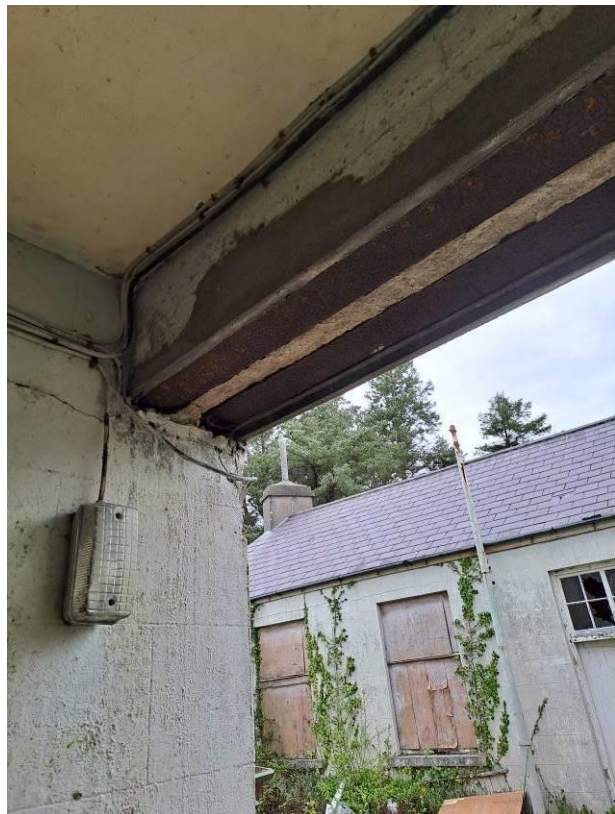
Steel beams carrying the second floor where the Main Annex building joins the Convent building are exposed and show signs of severe rusting.

**Photo 16: Beams Carrying Building Severely**

| Rusted | |

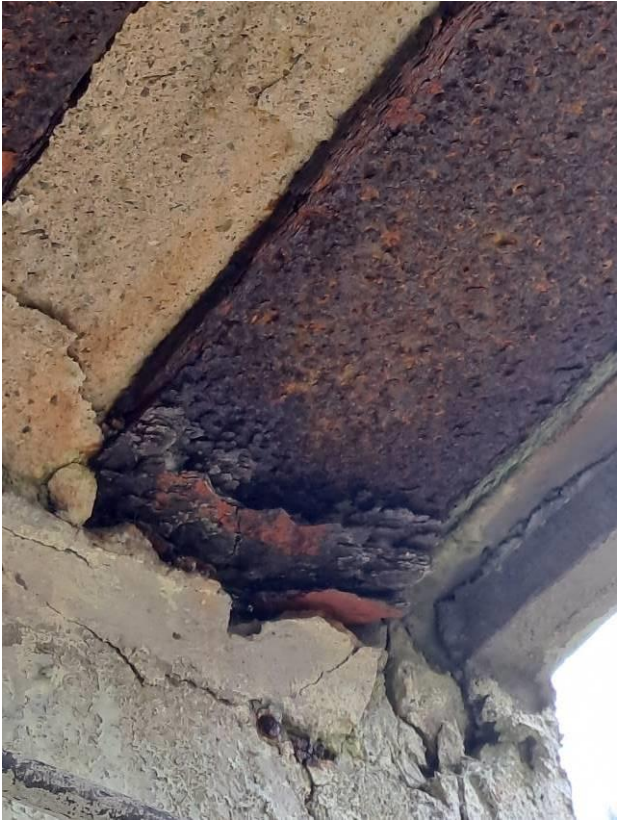
| Rusted | |
|---|---|
| <p>Photo 17: Beams Carrying Building Severely Rusted (1)</p> | <p>Photo 18: Damp in Ceiling Noted</p> |

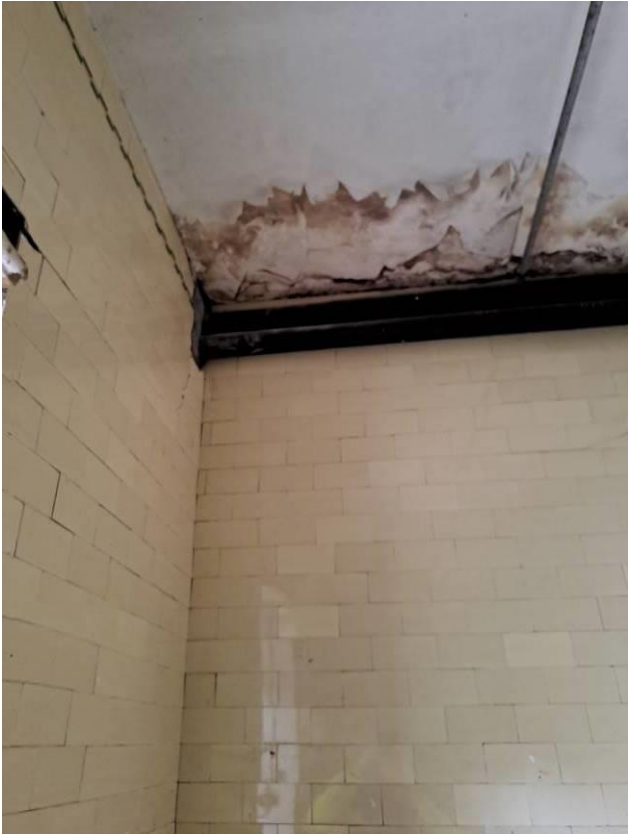
**Condition:** The ceilings are in very poor condition with damp patches visible. Cracking and flacking of the plasterboard is evident

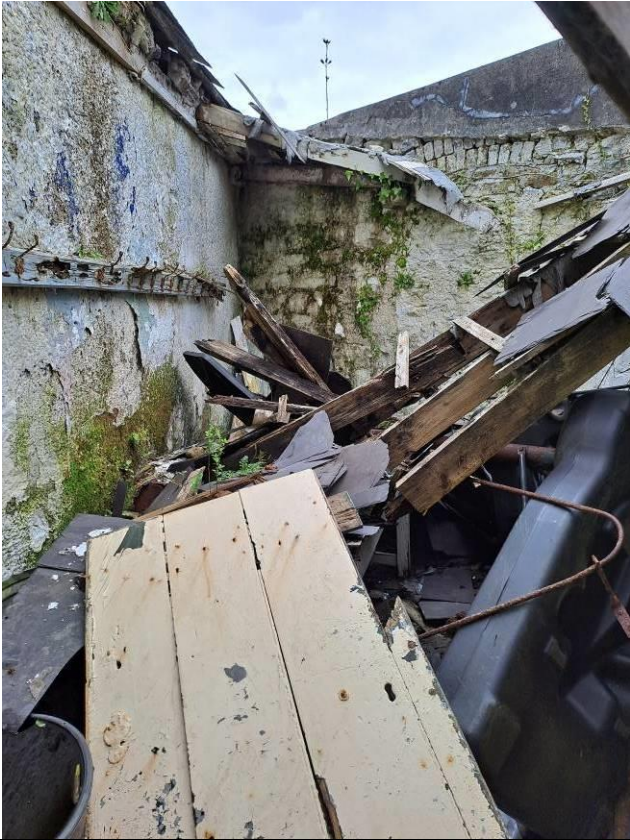
The roof structure to a small shed (possibly old coal shed) in the courtyard has collapsed.

Photo 19: Roof Collapse to Small Shed

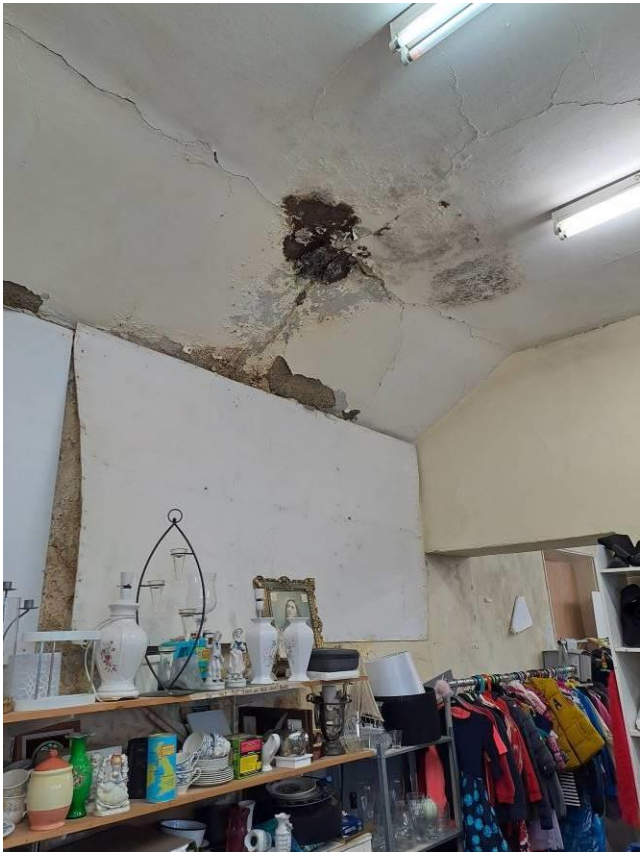
Photo 21: Damp Patch in Ceiling

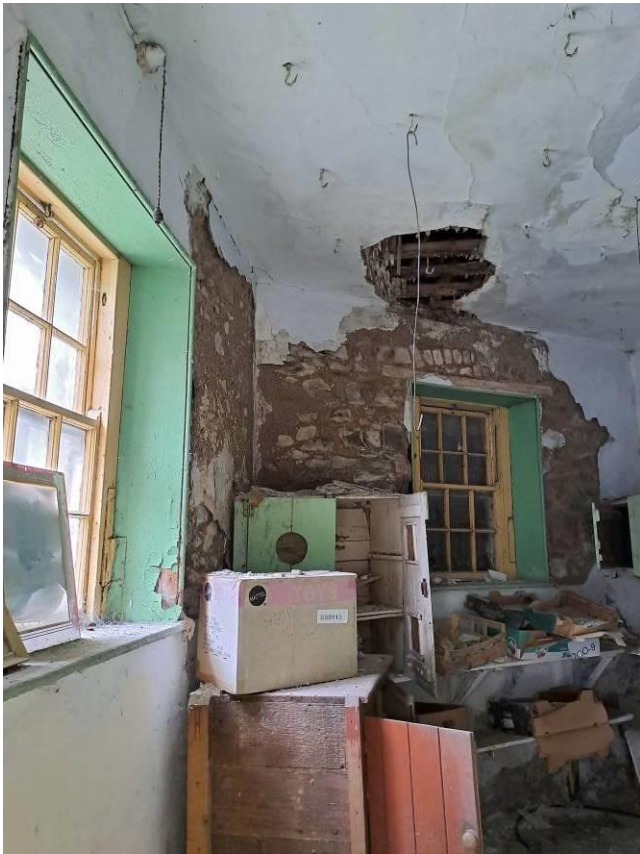
Photo 20: Plaster Cracking / Flaking

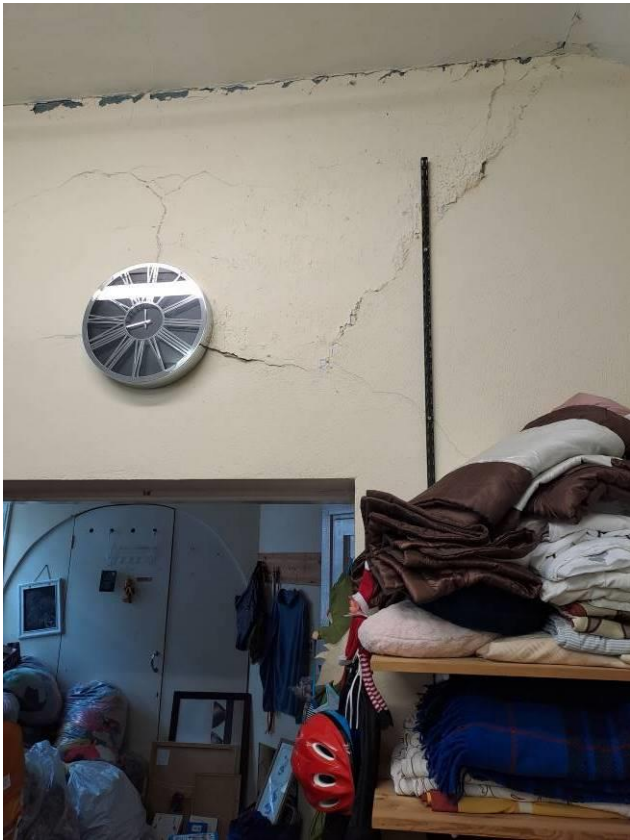
Photo 22: Plaster Cracking

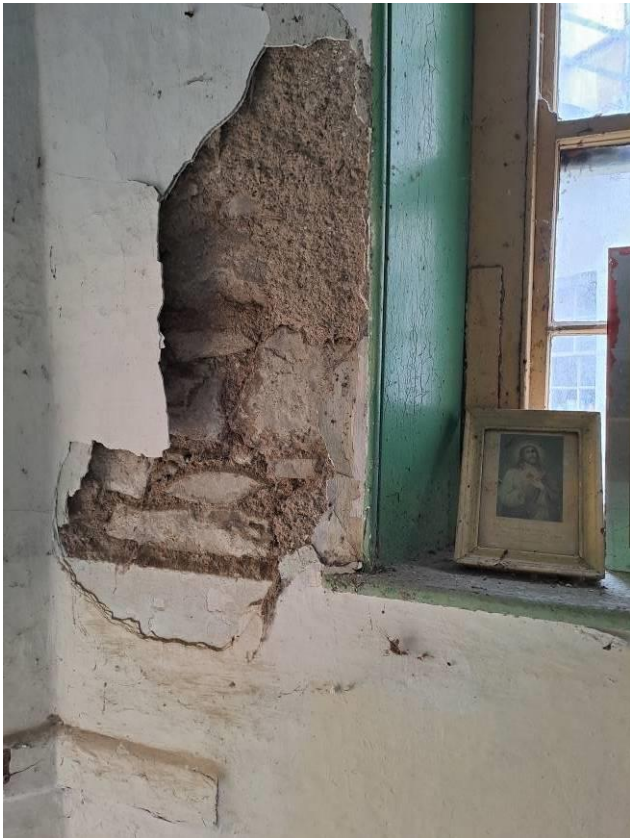
Small outhouses in the courtyard have the internal leaf exposed – majority of finishes have come off the walls.

| <b>Photo 23: Outbuilding in Poor Condition</b> | <b>Photo 24: Plaster Falling off Walls</b> |
