## Westport Convent Campus, Westport, Co. Mayo

### Condition Report Old Kitchen and Store

7011-603-004-R02

July 2023

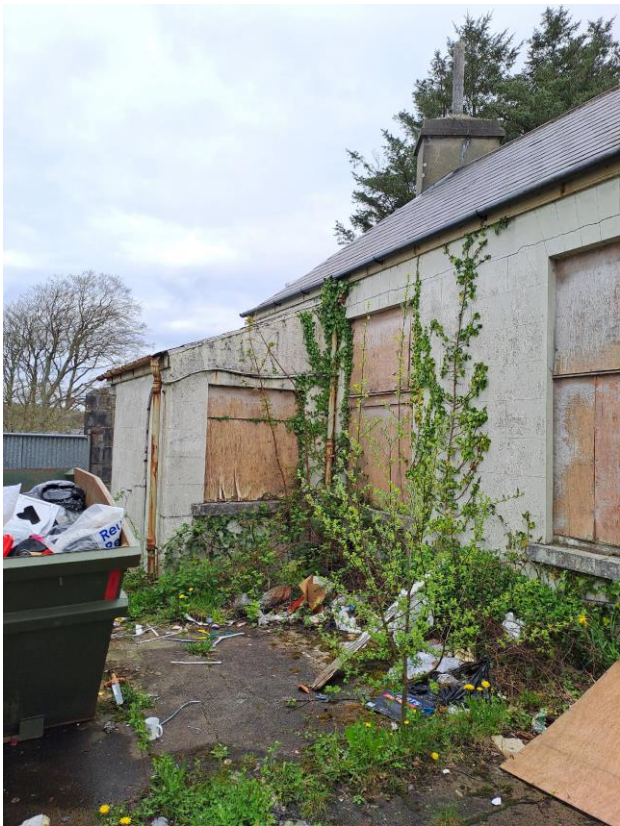
Ivy has attached itself to the Southern elevation of the building covering a small portion of the wall. Marks on the plaster suggest ivy had been removed from large areas of the wall.

**Photo 1: Ivy on External Walls**

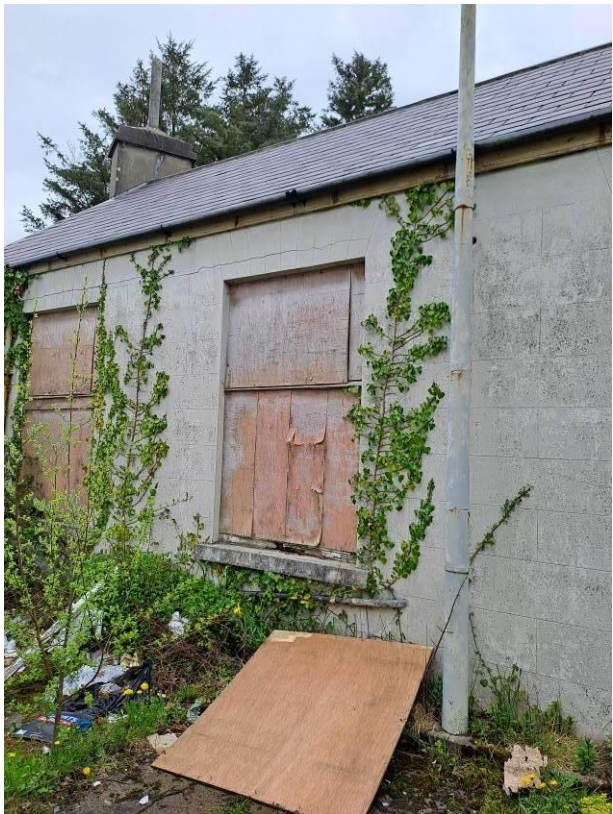
**Condition:** Windows are in poor condition. All windows have either been boarded up or have protective bars placed in front of them. Most glass has been broken – most likely as a result of vandalism.

**Photo 2: Windows boarded Up**

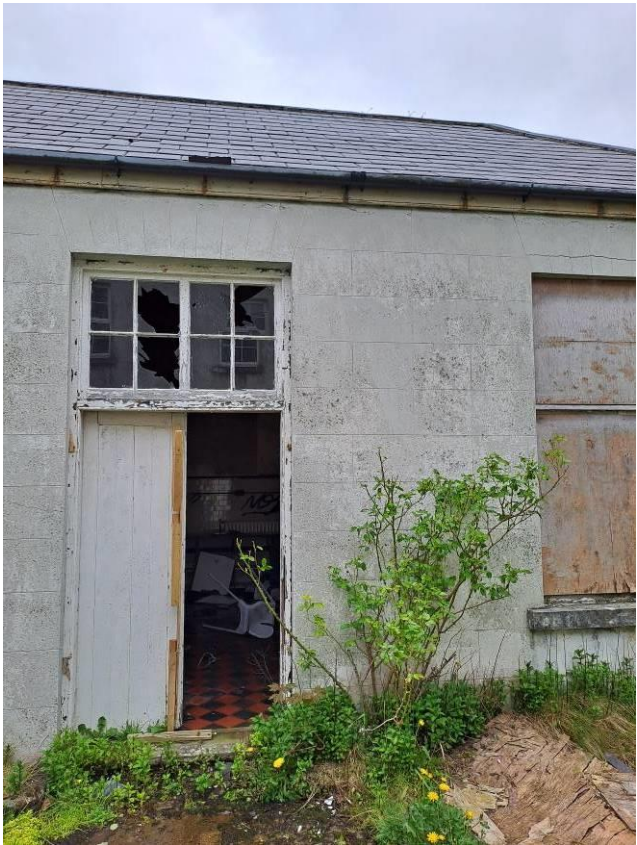
**Condition:** The exterior door is in poor condition, one of the doors that form the double door has been removed from the doorframe – most likely as a result of vandalism. A makeshift closing apparatus has been installed to hold the allow the remaining door to close.

**Photo 3: Main Entrance Door Damaged**

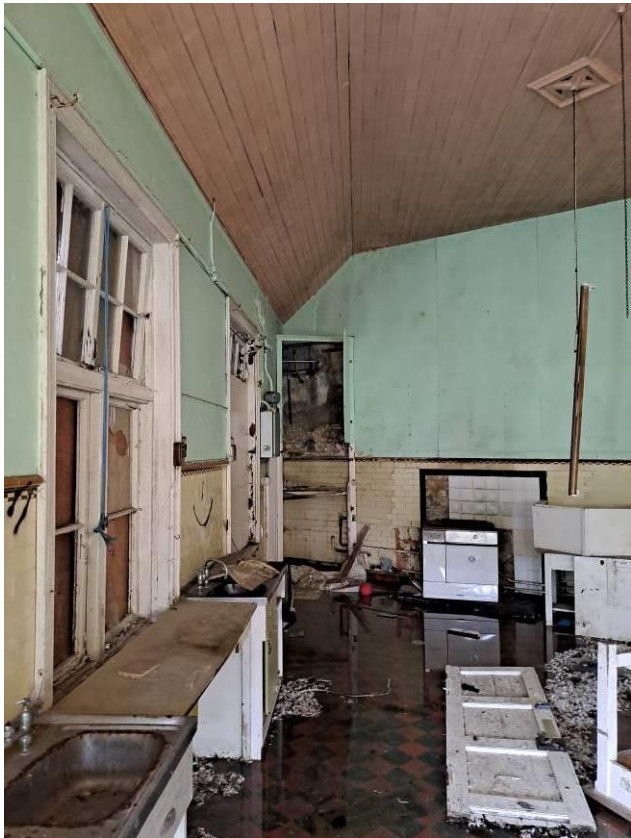
**Condition:** The floors are covered with the respective finish making it not possible to assess their condition. The tiles are in reasonable condition – a significant section of the kitchen and all the small storeroom was under a few inches of water at the time of the inspection. It is likely that the water ingress came in through the windows and doors as no visible damp patches were noted on the walls.

**Photo 4: Flooding in Kitchen and Store Area**

It is likely that the existing timber floors have deteriorated as a result of the water ingress and wear and tear over the life span of the building. It is recommended that a new floor structure is constructed as part of the renovation works.

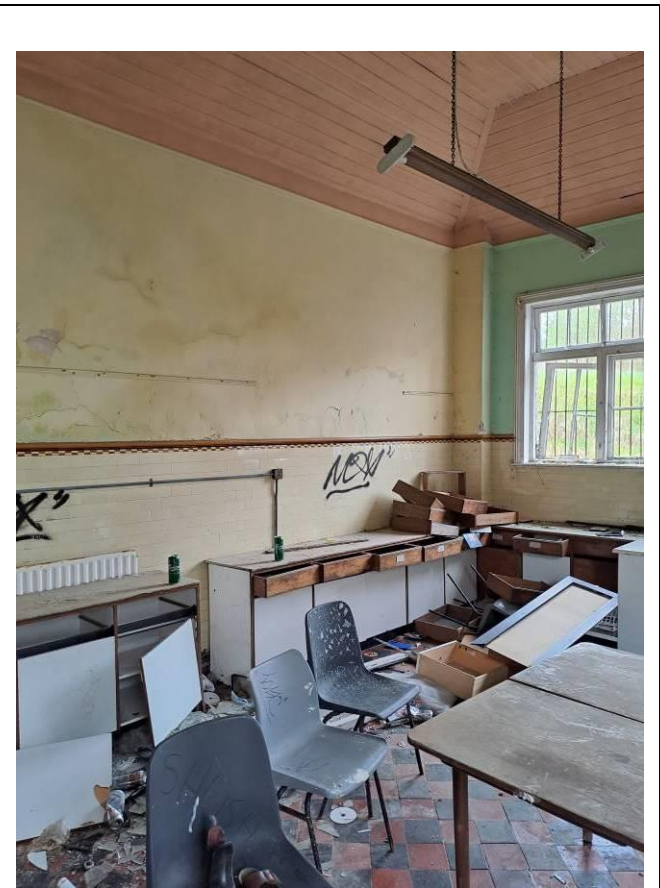
**Condition:** All internal walls are in a fair to poor condition. Graffiti is evident on all walls in the main kitchen area. Tiles on the Western wall are missing / broken, with a section of tiles warped and appear to have detached from the wall behind them.

Photo 5: General Vandalism Noted

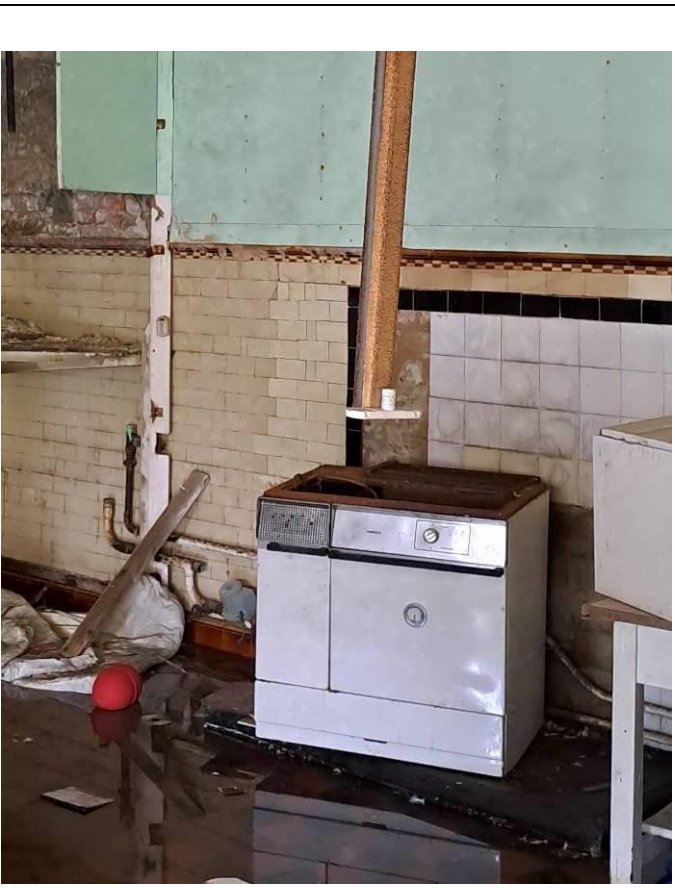
Photo 6: Tiles Bulging Away from Wall

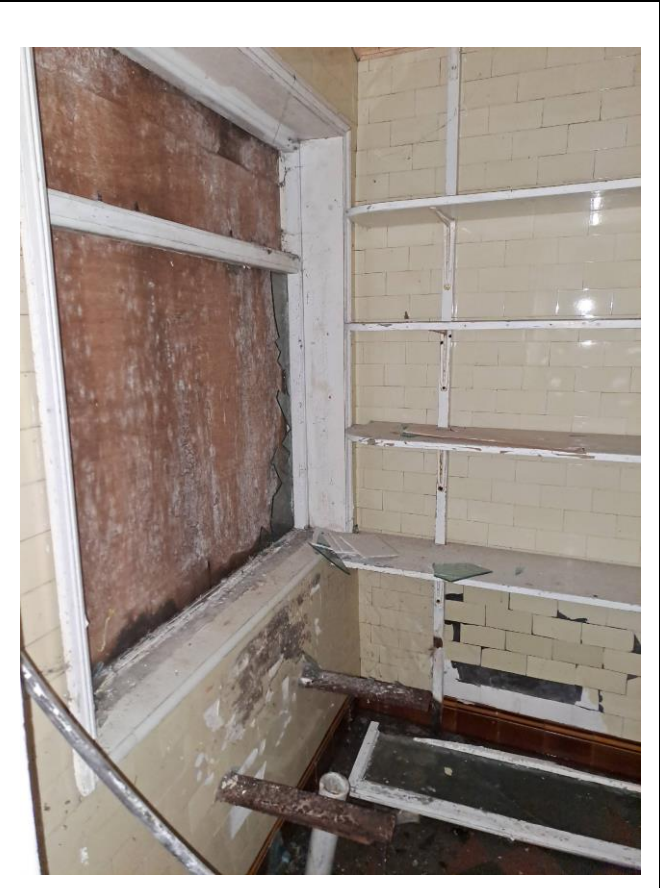
Photo 7: Tiles Damaged in Storeroom

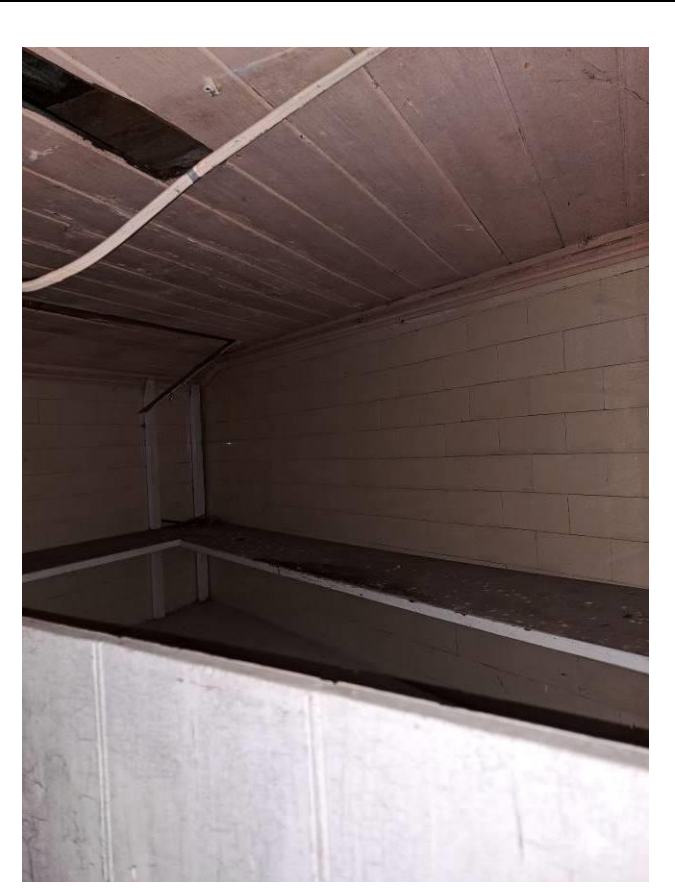
**Condition:** The ceilings are in reasonable condition with no damp patches visible. Some timber boards in the small storeroom have been damaged / broken.

Photo 8: Ceiling Damage in Storeroom

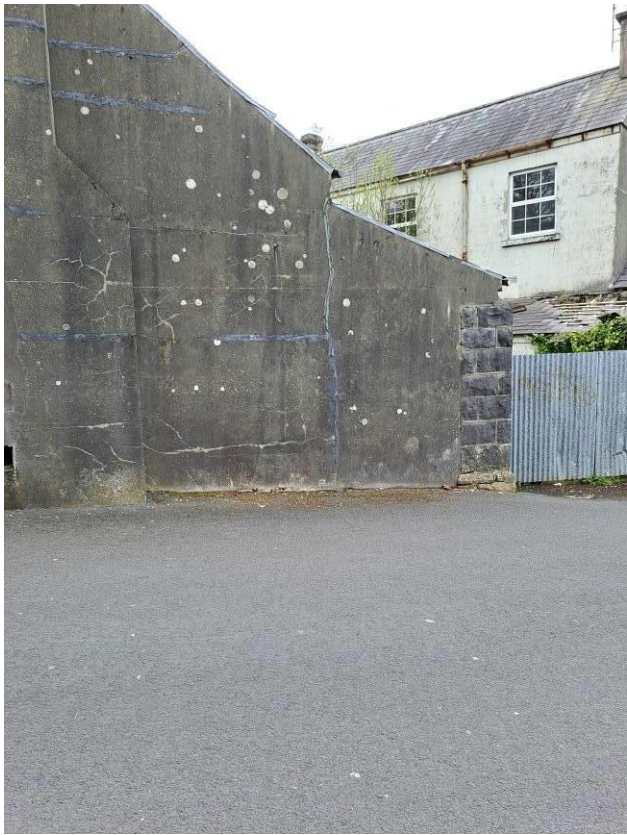
**Condition:** The plaster is cracked on the Western elevation, with several large cracks across the gable wall. The large cracks appear to have had some remedial works carried out. The cracking is an indication of settlement and / or thermal movement which is not uncommon for a structure of this age, these are not considered to be serious or major on-going movement. Plaster around window heads in the internal courtyard is cracked.

**Photo 9: External Plaster in Poor Condition**

It is recommended that the external walls remain in place for the proposed renovation works.

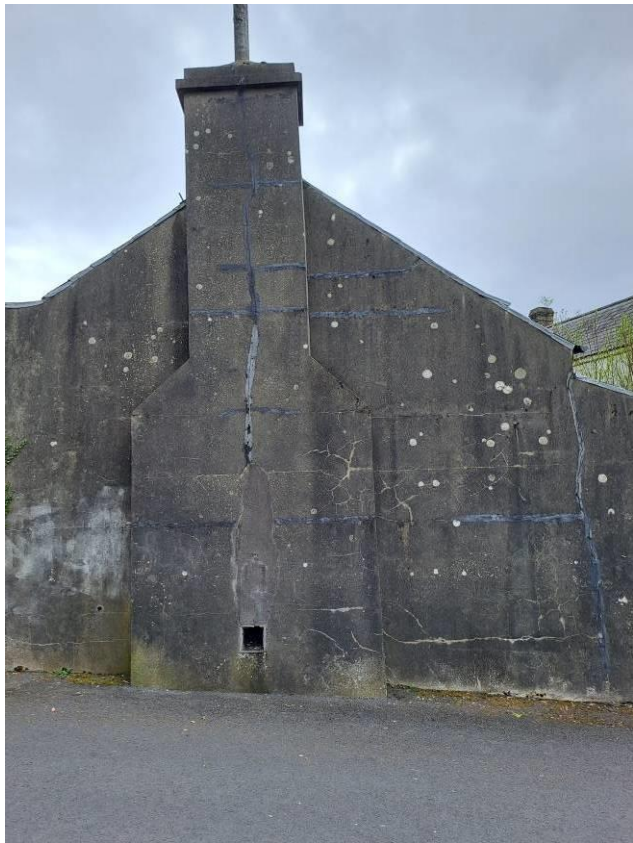
**Condition:** The chimney stack has large cracks to the external plaster that have undergone some remedial works.

**Photo 10: Chimney Stack Plaster Cracking**

It is recommended that the chimney stack be kept as part of the proposed renovation works. Any alterations to the roof structure or chimney stack throughout the building should be carried out with appropriate temporary bracing / support as needed. It is likely that the existing roof structure is fixed to the chimney stack, therefore providing lateral stability.
