| Project Details: Menlough Castle | | | | | | Project Name: <b>Menlough</b> | | | Scale: | Project Number: | | | | | | | |
| Site Address: | Menlough Castle, Galway | | | | | <b>Castle Galway Phases 5 &amp; 6</b> | | | NTS | 20612 | | | | | | | |
| Architect: | 7L Architects | REV. No. | REVISION DESCRIPTION | DATE | ISSUED BY | <b>Proposed Phasing</b> | | | | CORA | | | | | SK5001 | | I1 |

| Architect: | 7L Architects | REV. No. | REVISION DESCRIPTION | | DATE | ISSUED BY | <b>Internal Wall - Sheet 1</b> | | | | CORA | | | | | SK5020 | | I1 |

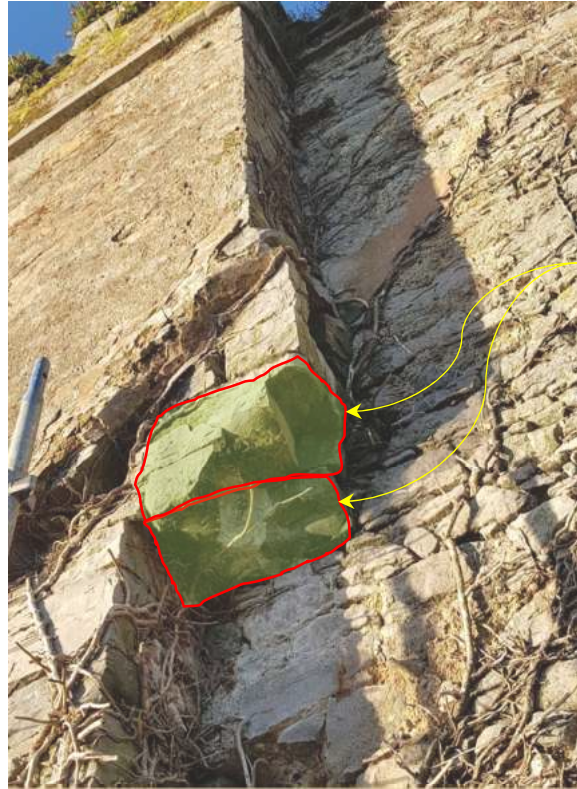
Existing stone corbels in poor condition. Allow for temporary propping of the wall over. Carefully remove the existing stone corbels. Replace the existing stone corbels with new carved stone to match the existing. Carefully remove the temporary props and make good the wall. Allow for two number new carved corbel stones. Size and location of the new stone corbels to be reviewed once access is arranged.

Allow for 2 new stone indent where the existing stone corbels have cracked and are missing stone sections. Stone indents to be dowelled to the existing stone with 2 No. M8 grade 316L stainless steel dowels in chemical resin compatible with the stone.

Allow for 2 number cracks in the existing stone corbels to be stitched across with 2 No. M8 grade 316L stainless steel dowels in chemical resin compatible with the stone.

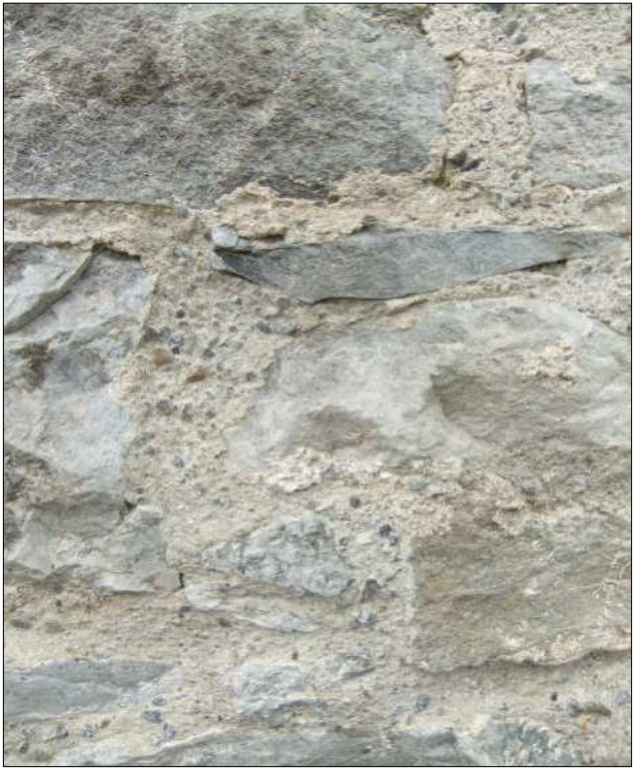
Exemplar provided of flush pointing in stonework beaten back to expose aggregate

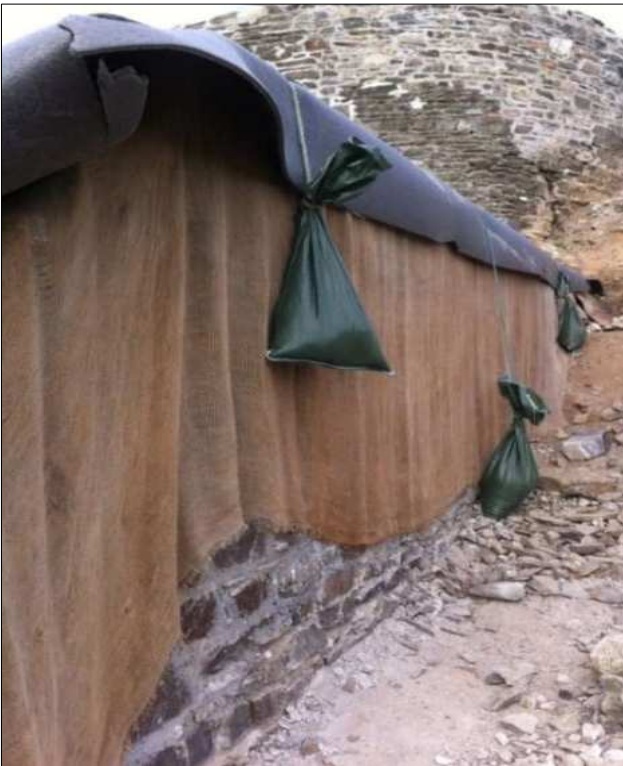
Example of appropriate protection to allow wall to dry out yet not become saturated by rain on upper surfaces
