# AIB/Marina Wall Remediation, Athy, Co. Kildare

Supporting Information for Derogation Licence  
Application for Bats under Regulation 54 & 54A of the  
European Communities (Birds and Natural Habitats)  
Regulations 2011 (as amended)

IE000622  
Athy AIB/Marina  
Wall remediation  
F01  
21 May 2026

## Supporting Information for Derogation Licence Application for Bats

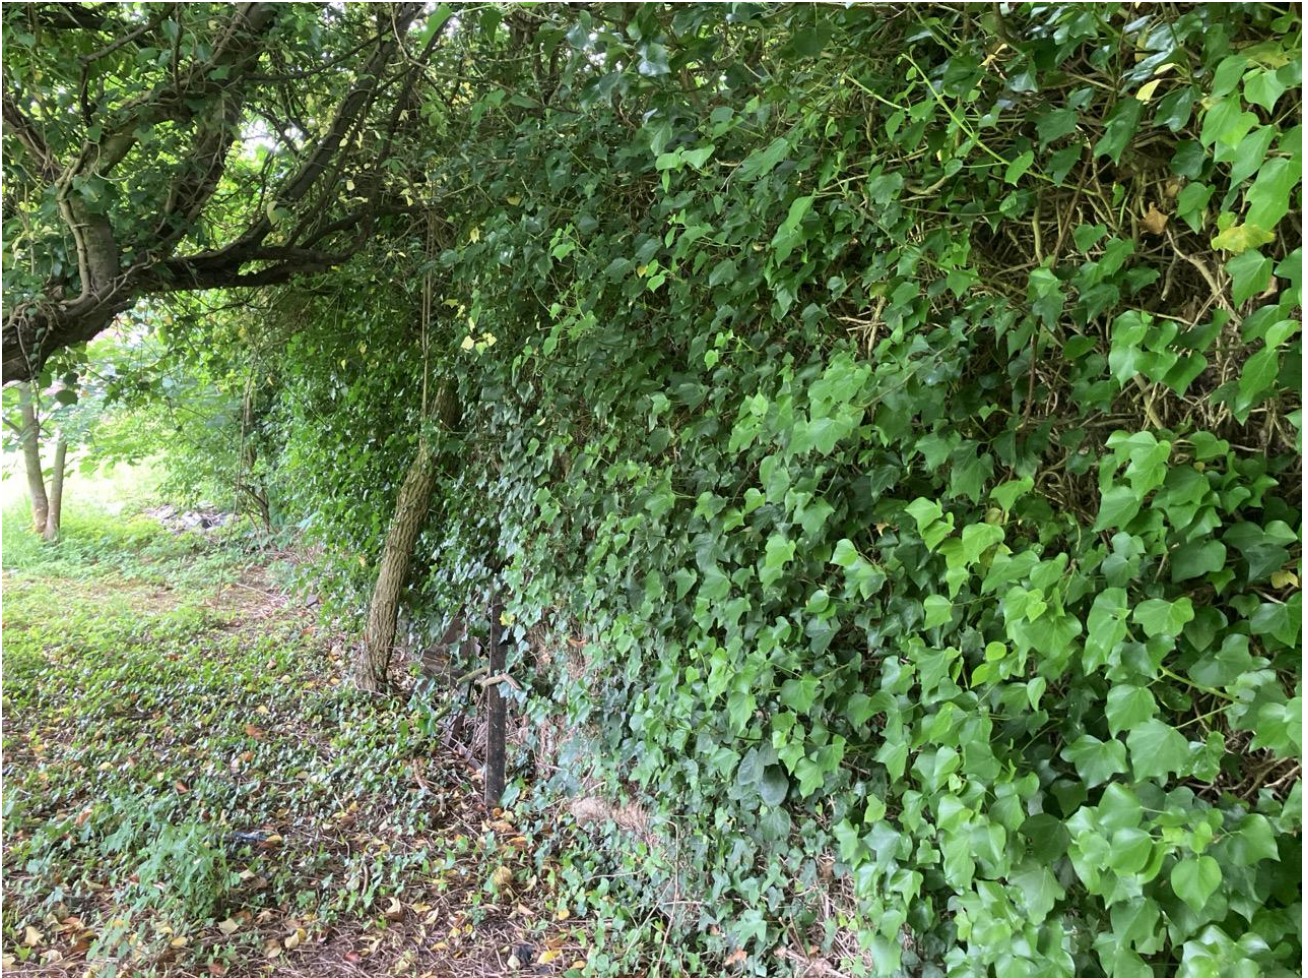
As outlined previously, dense ivy and non-native climber growth is present across the existing stone wall. This growth is particularly dense on the northern section of the wall with the roots and other parts of these vines having penetrated into the structure itself, loosening and dislodging stones (**Plate 3; Plate 4**), which is having an overall effect on the structural integrity and safety of the wall. Therefore, there is a strong need for this vegetation to be removed as there is a risk of wall collapse should the vines be allowed to penetrate further into the wall. As this wall is considered to be a heritage feature, it needs to be maintained and accordingly, remedial actions are required to prevent further deterioration and potential collapse of the wall. The removal of the vegetation will allow for full assessment of the structural integrity of the wall and for remedial actions to be undertaken. Furthermore, given the close proximity of the wall to Athy Marina, there is also a public health and safety aspect in the need to preserve this wall as a wall collapse poses a serious risk of damage to property (i.e. boats) and risk of injury (or worse) to human health. Additionally, this wall is in very close proximity to the River Barrow and River Nore SAC which has been designated for a number of different aquatic Qualifying Interests (QI). These QI are potentially at risk should the wall collapse and result in fragments of wall and mortar and other pollutants entering the River Barrow itself.

**Plate 1: The wall on the western (i.e. AIB garden) side showing extensive ivy and vine coverage. Note – this picture was taken prior to stem severance.**

Remaining stem cutting works will be carried out alongside vegetation removal. Vegetation will be carefully removed from the masonry by hand once it has sufficiently died back. Hand tools will be used if further stem cutting is required. If vegetation removal affects the integrity of the wall (e.g. causes stones to loosen or fall) remediation works will be carried out immediately post vegetation removal to minimise the risk of collapse of the wall.

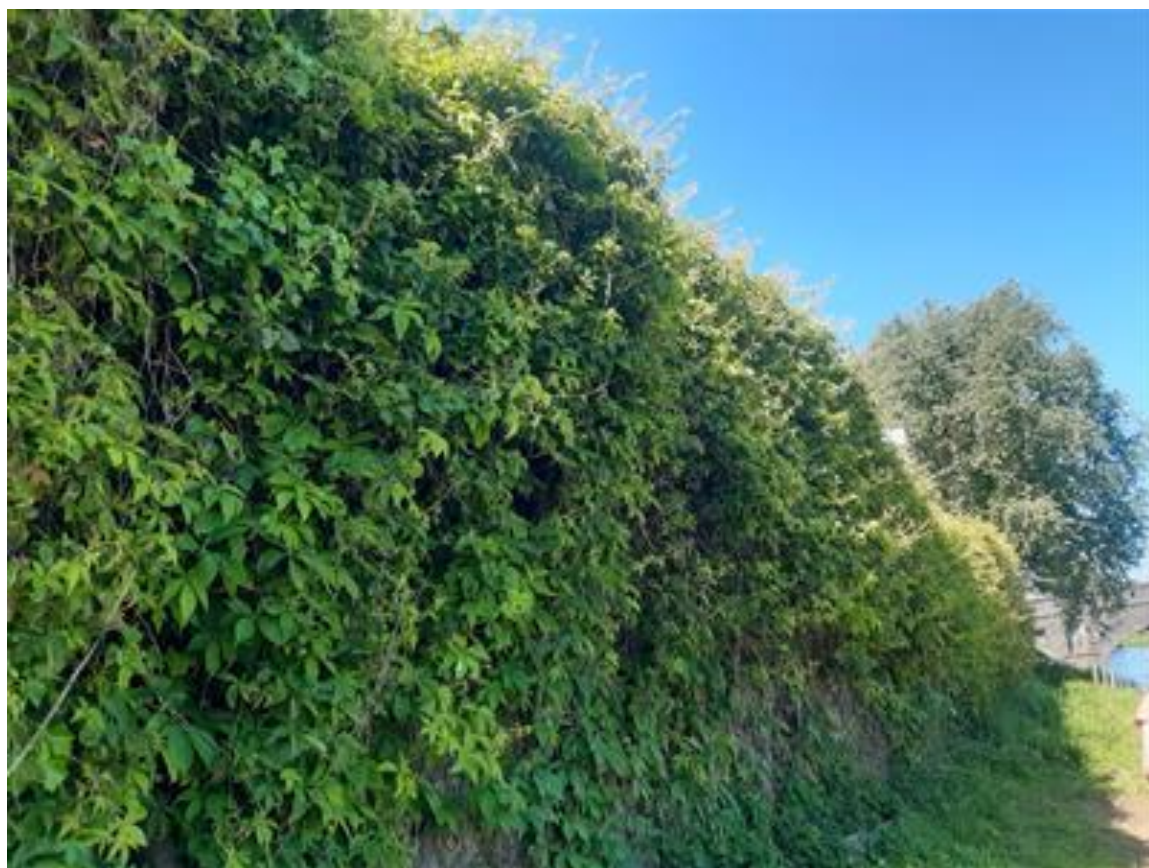
**Plate 2 The wall on the eastern (i.e. Athy Marina) side showing extensive ivy and vine coverage. Note – this picture was taken prior to stem severance.**

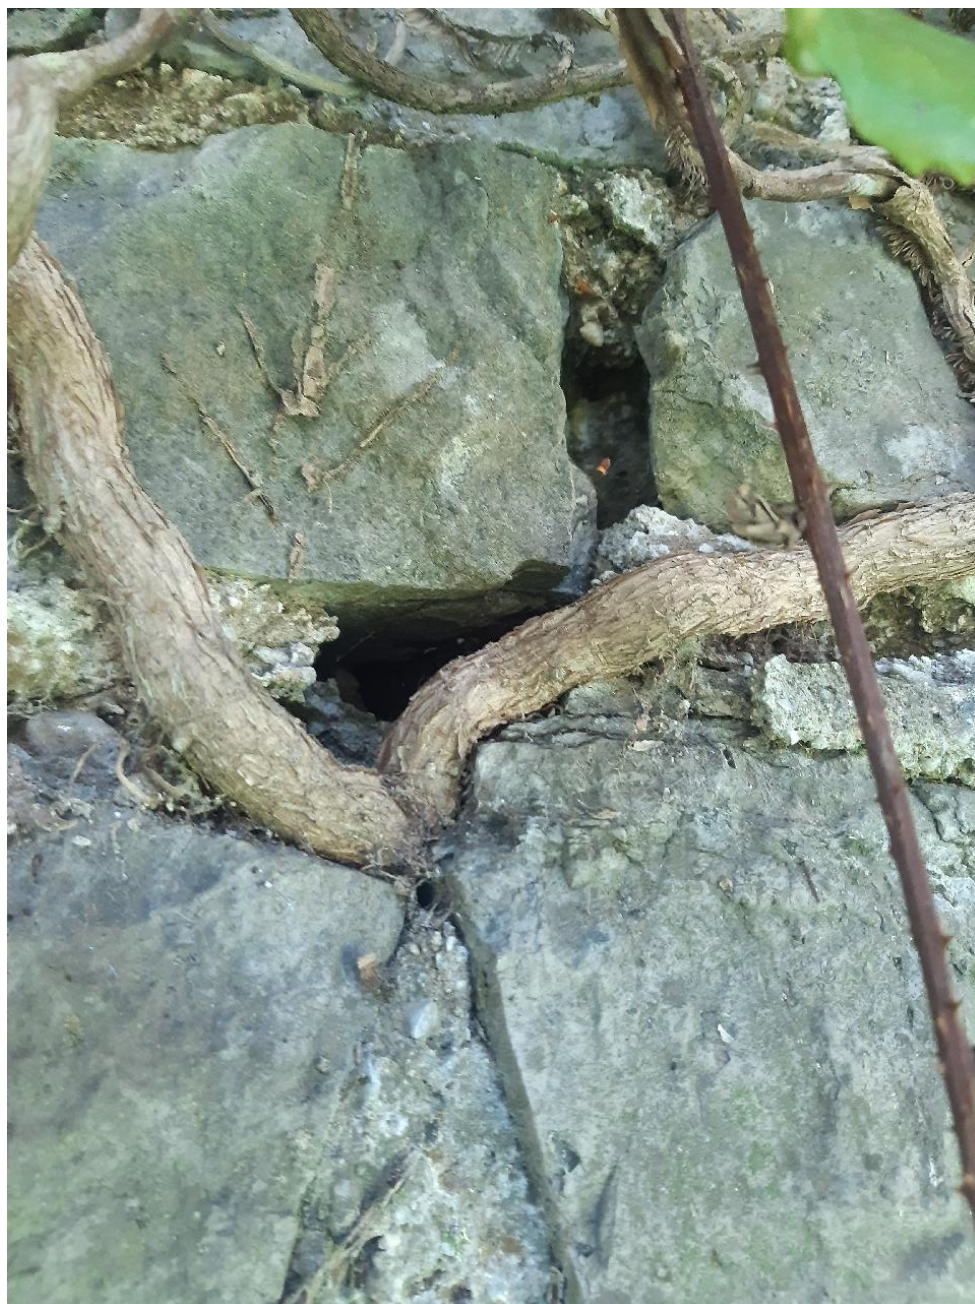
**Plate 3: An example of how the ivy and vines are penetrating in between the stonework of the wall**

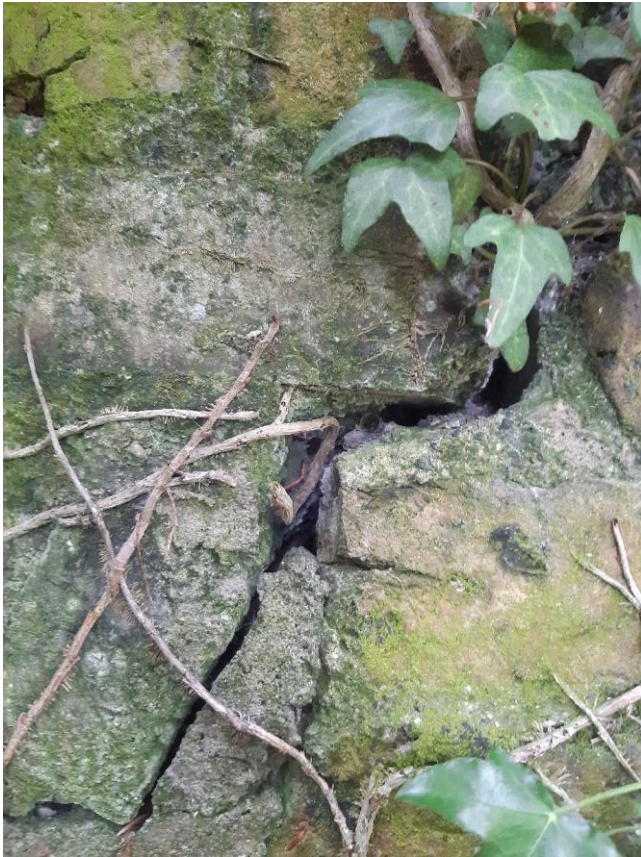
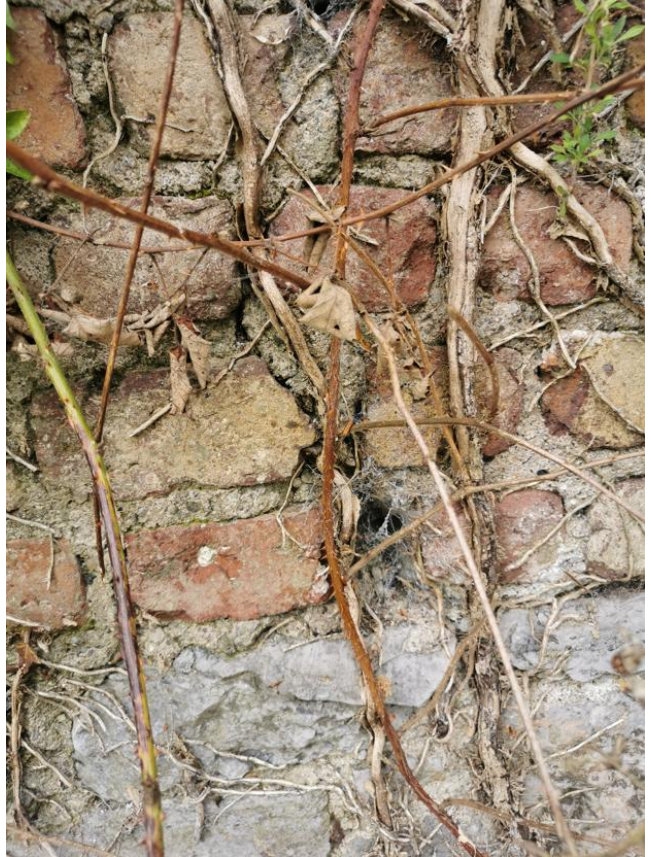
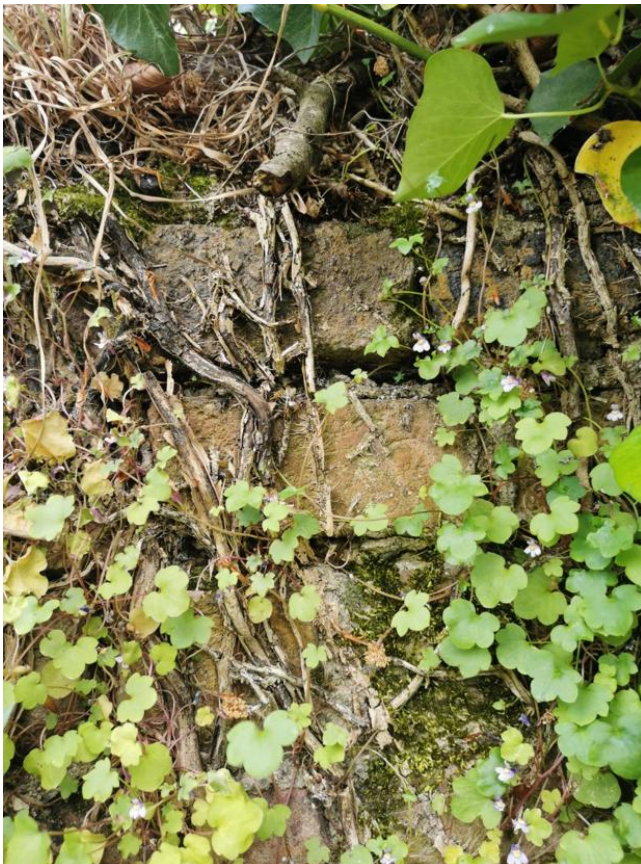
**Plate 4** Examples of a cracks in the stonework and ivy penetrating into this crack.

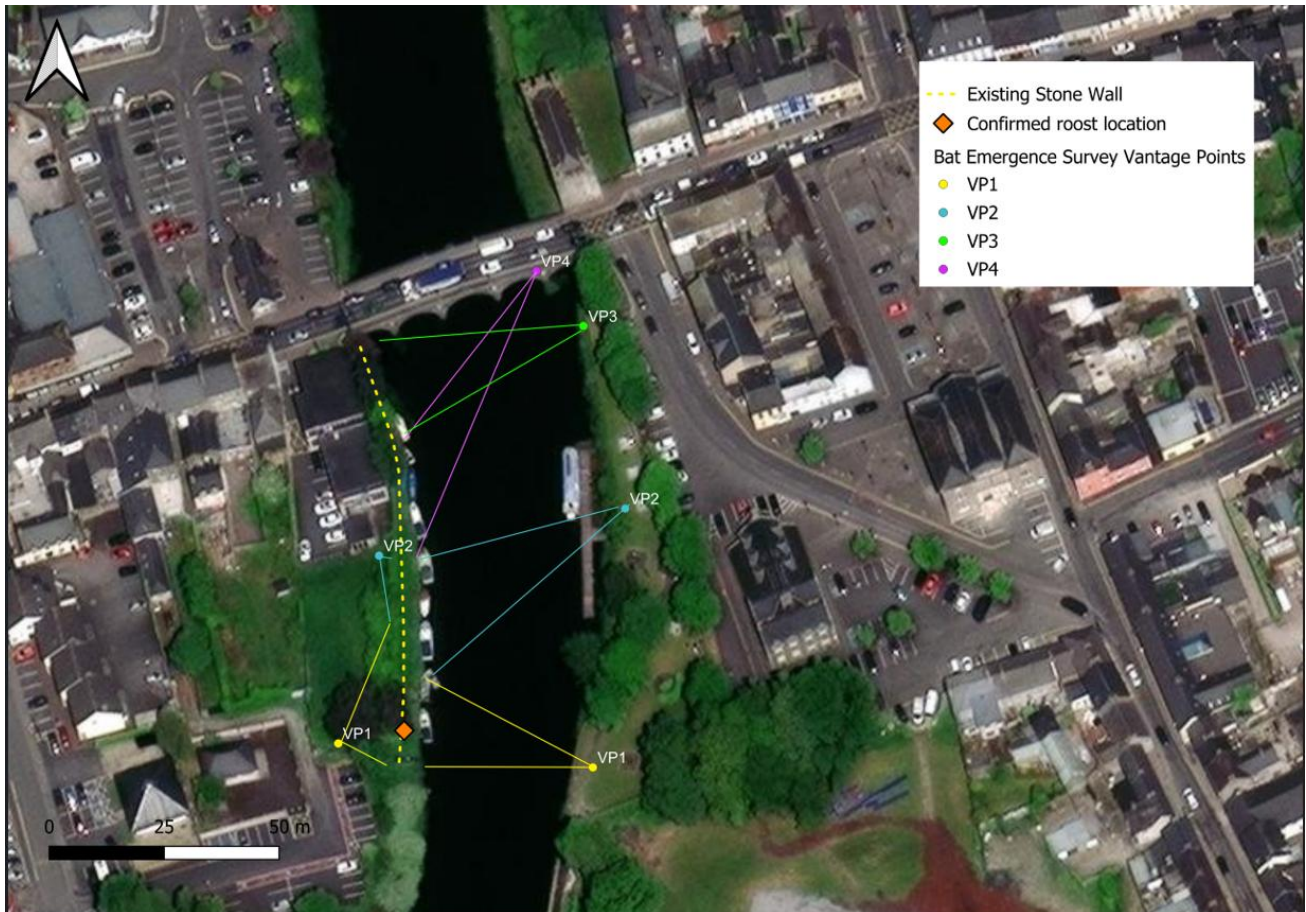
During the endoscope surveys on the 6<sup>th</sup> August 2025, a single roost was recorded in a gap in the stonework. This roost was located towards the southern section of the wall in an area where no vegetation cover was present. The roost contained two individual bats; however, the species could not be fully ascertained but on the basis of size are likely a pipistrelle species. The confirmed roost was flagged and was avoided during subsequent endoscope inspections of the structure on the 22<sup>nd</sup> of August and 27<sup>th</sup> September. The location of the confirmed roost is provided in **Figure 3-1**.

**Figure 3-1: Bat Emergence Survey Vantage Points and confirmed roost location**

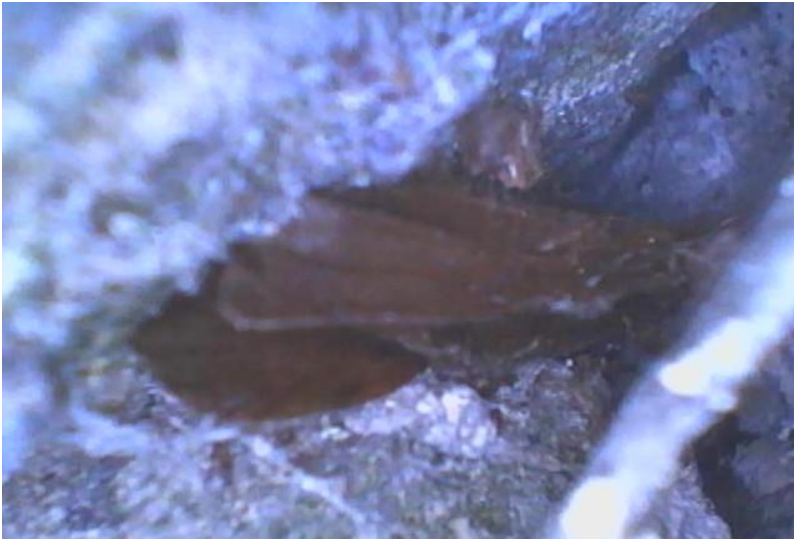
**Plate 5: Photograph of roosting bats taken during endoscope survey.**

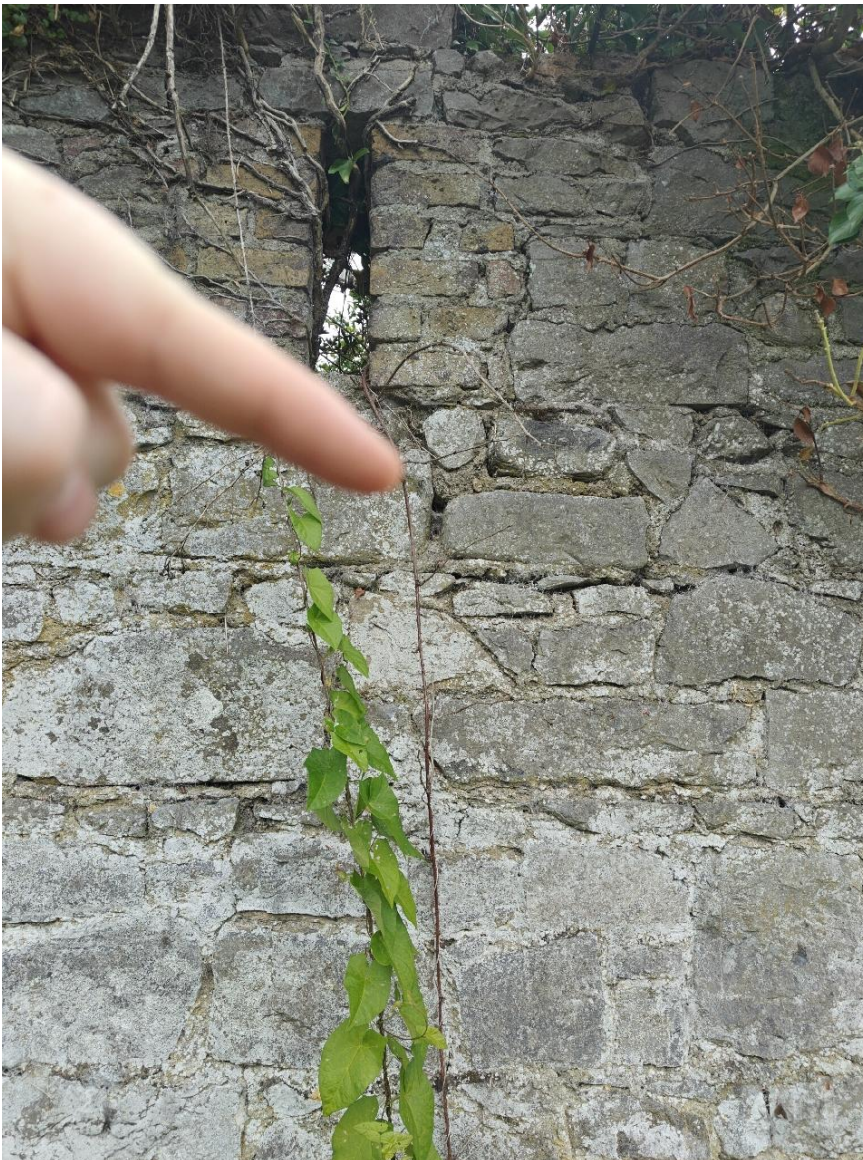
**Plate 6: Location of the known bat roost (i.e. in the gap in the stonework being indicated by the surveyor)**

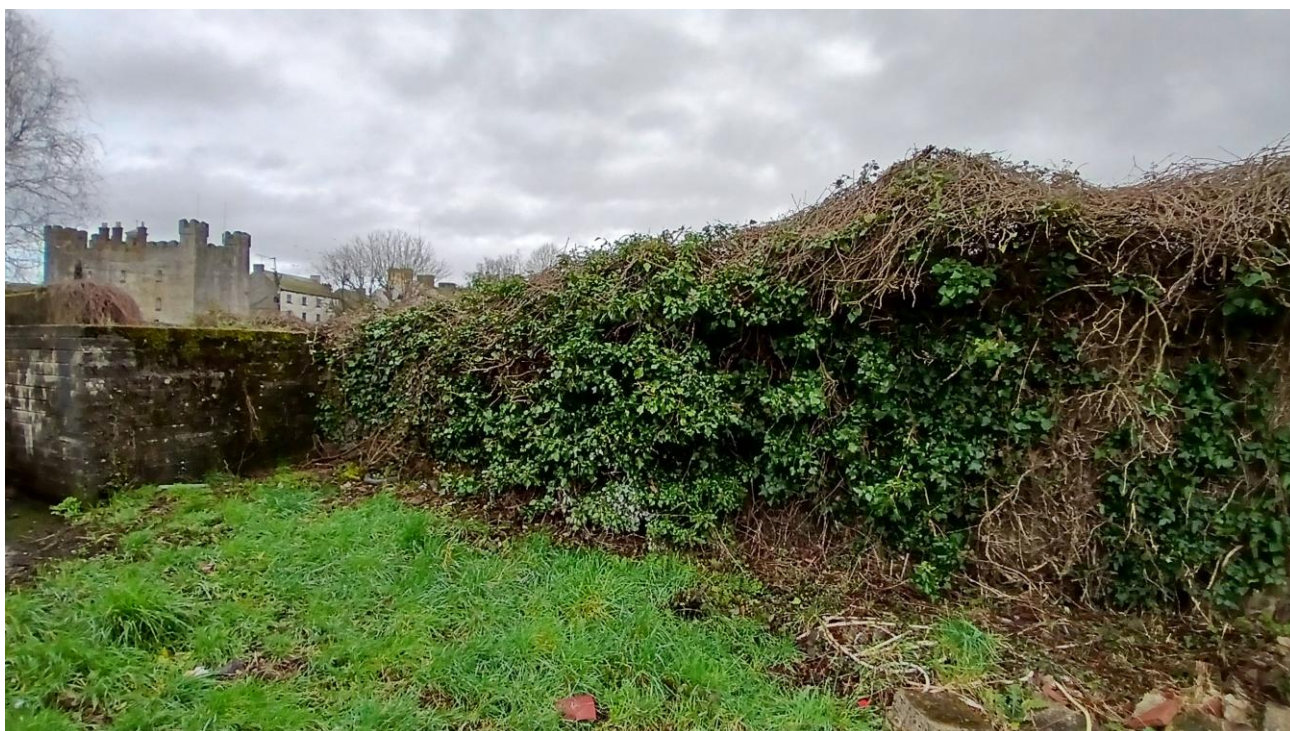
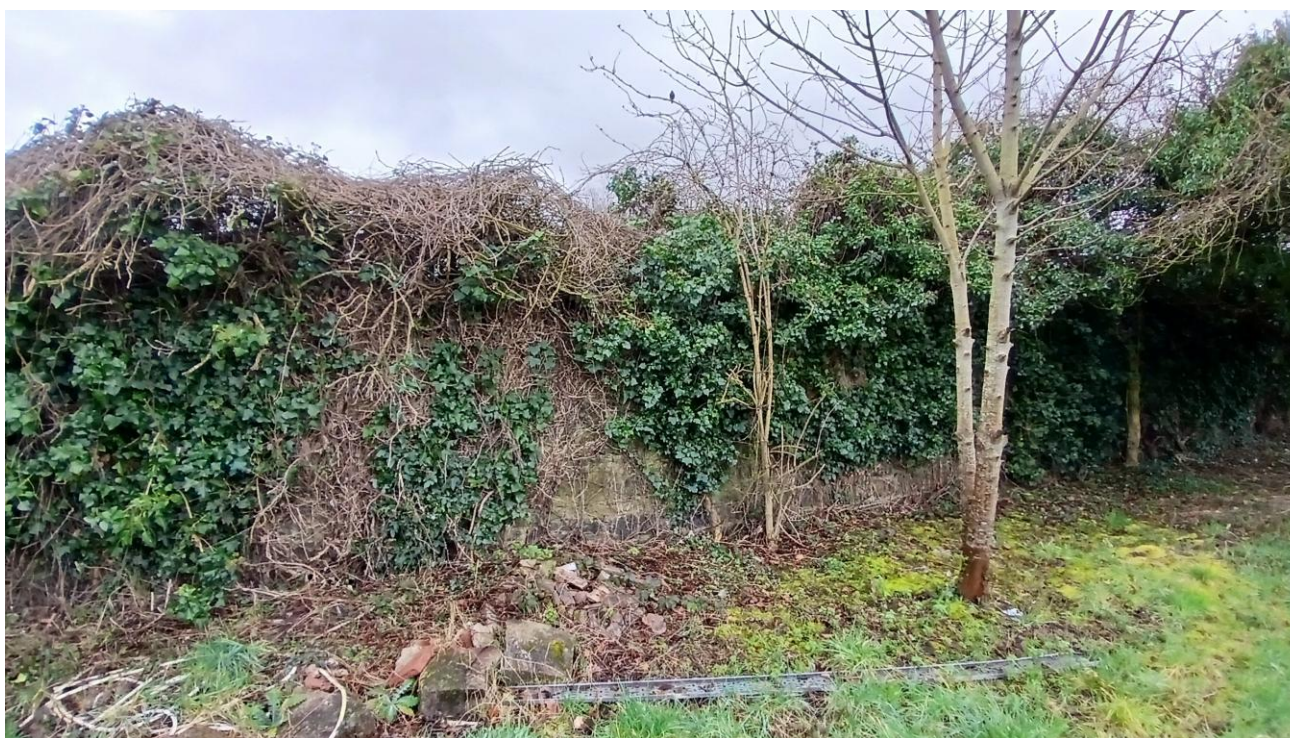
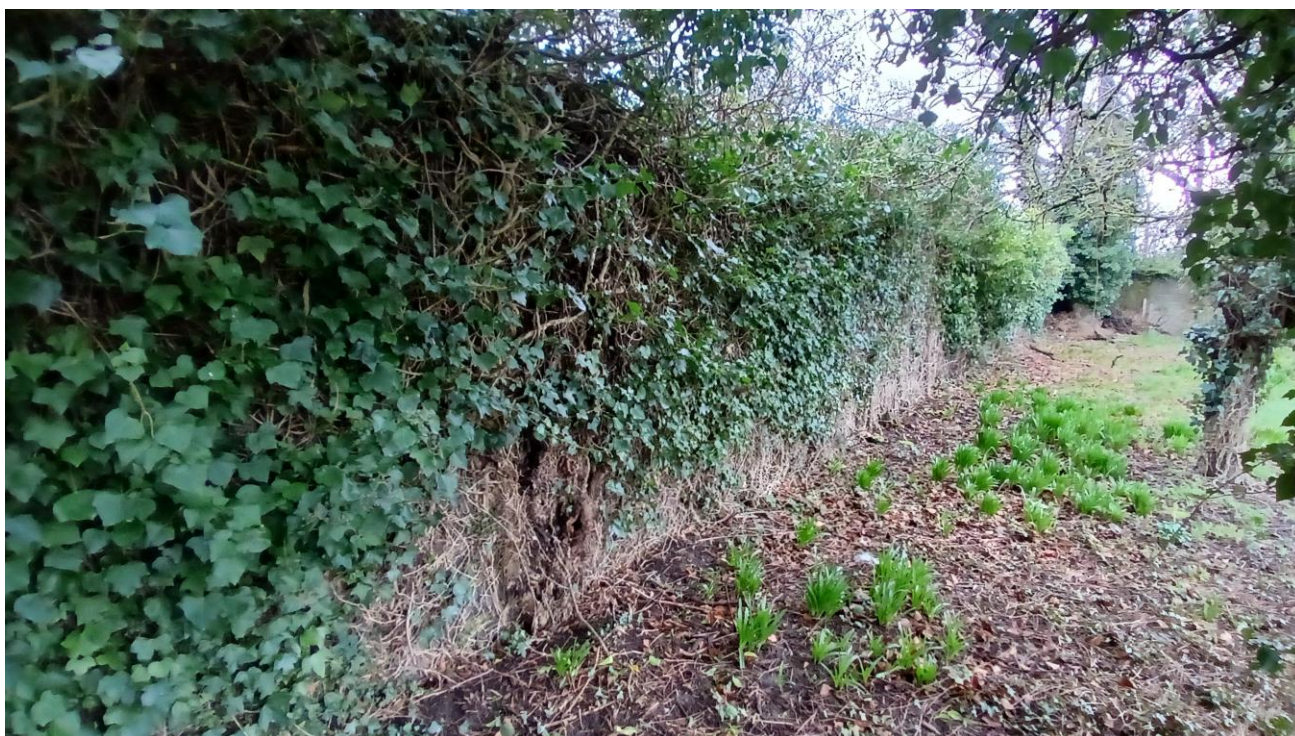
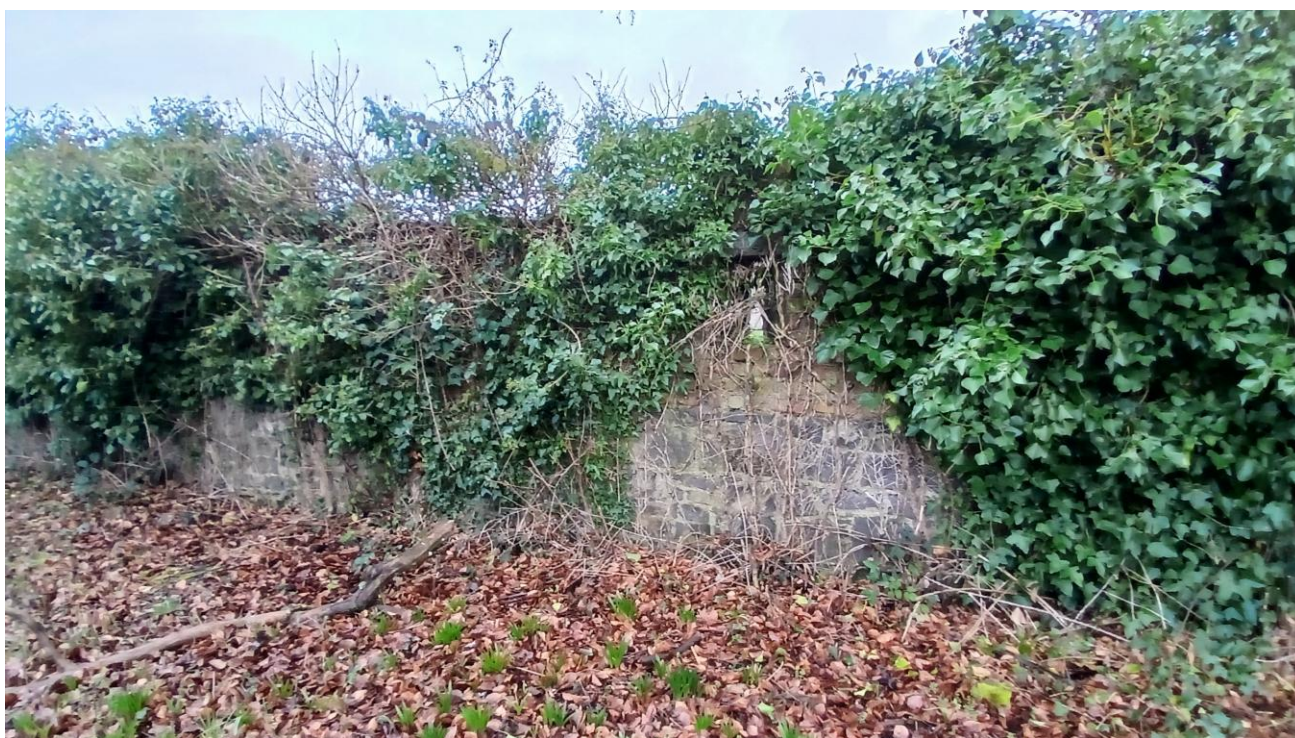
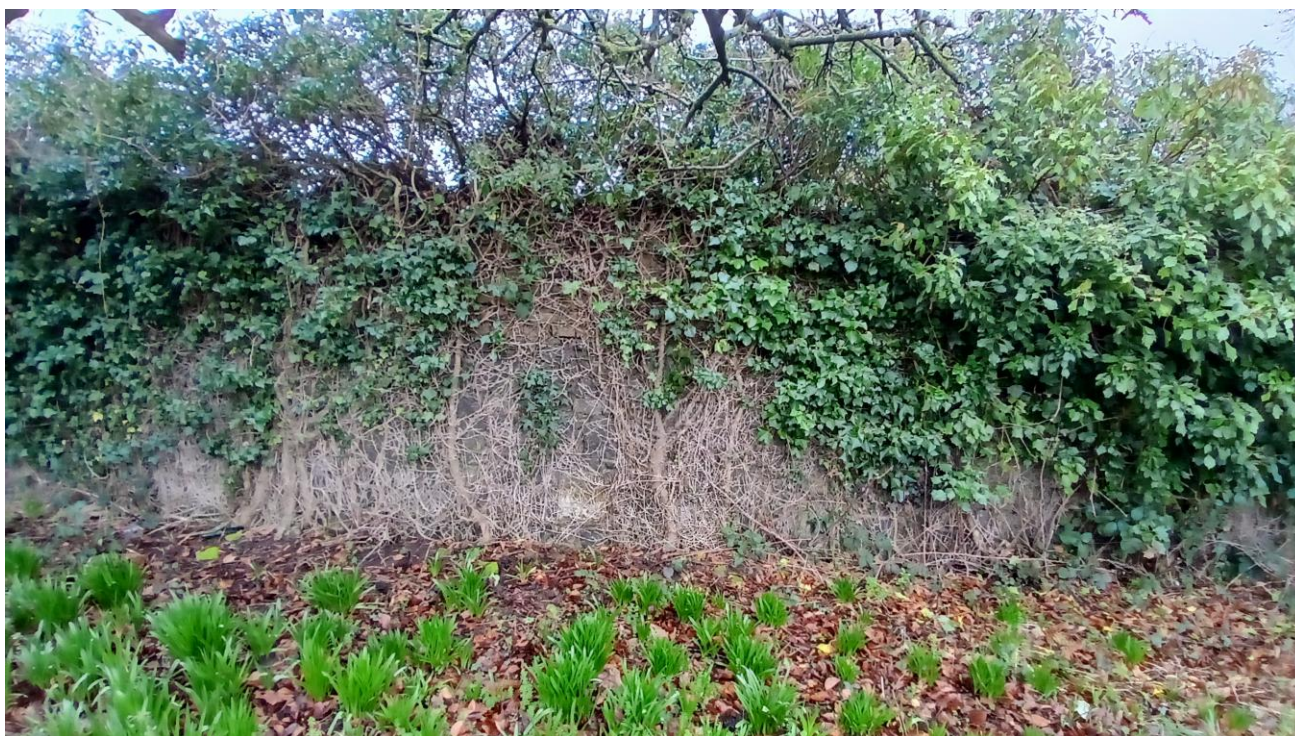
The AIB Garden was accessed through a gate to the north. Ivy rooting stems were extensive along the bottom of the wall (**Figure 3, Figure 4, Figure 5, Figure 6 & Figure 7**). The southern section of the internal wall was excluded from the works due to the presence of a known bat roost recorded during a previous survey (**Figure 8**).

**Figure 3: Extensive Internal Ivy and vines**

**Figure 4: Extensive Internal Ivy and vines**

**Figure 5: Extensive Internal Ivy and vines**

**Figure 6: Extensive Internal Ivy and vines**

**Figure 7: Extensive Internal Ivy and vines**

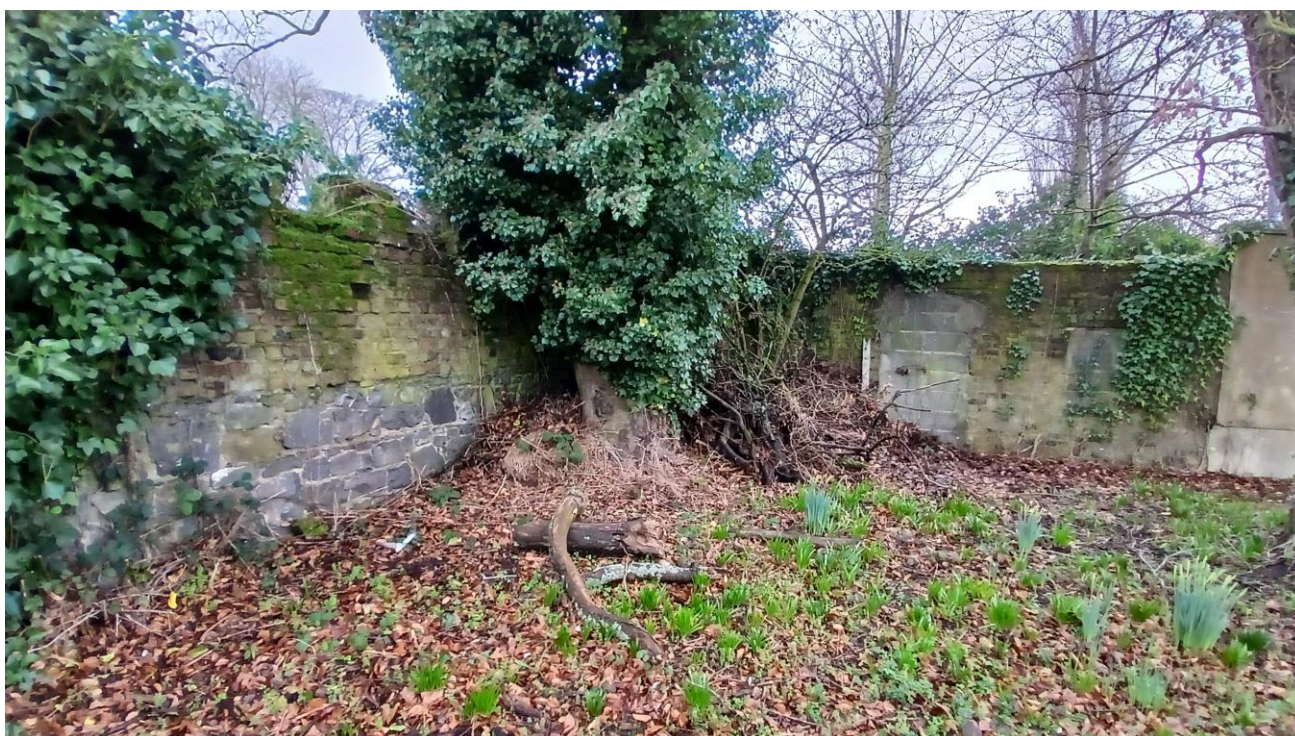
**Figure 8: Southern Corner Excluded from Removals**

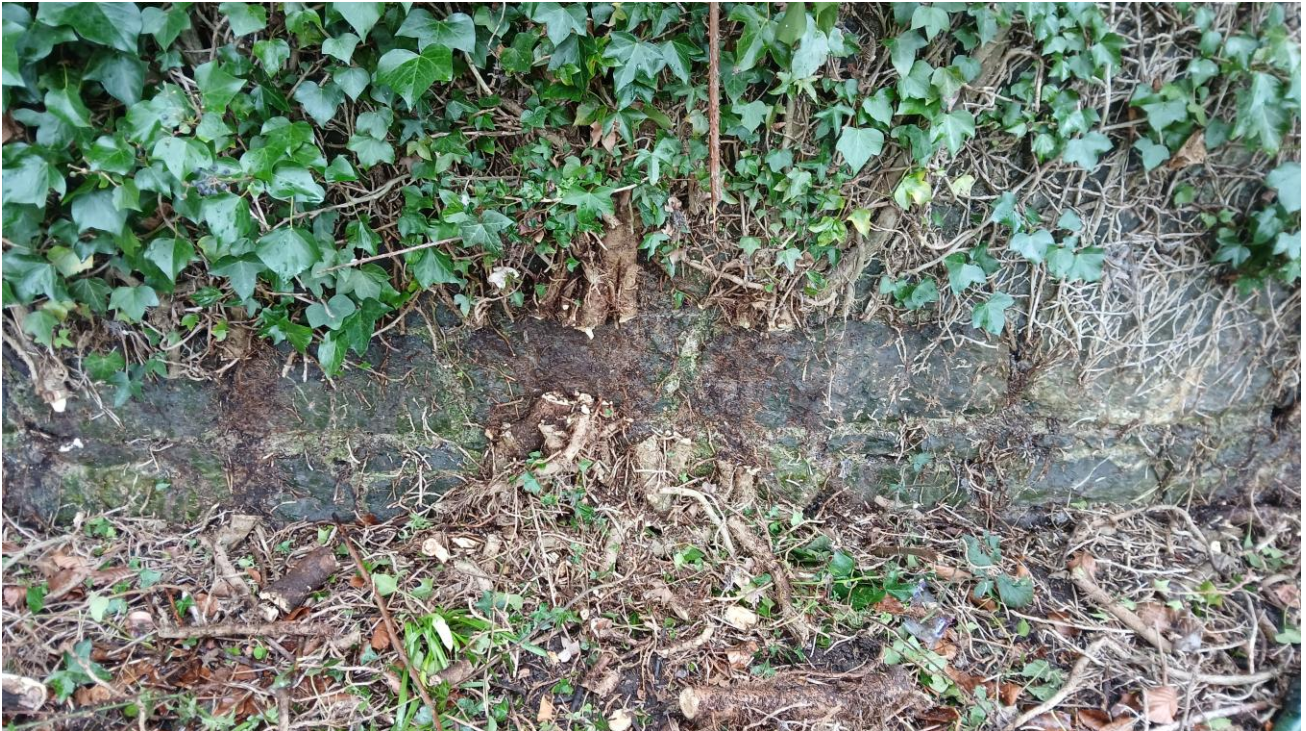
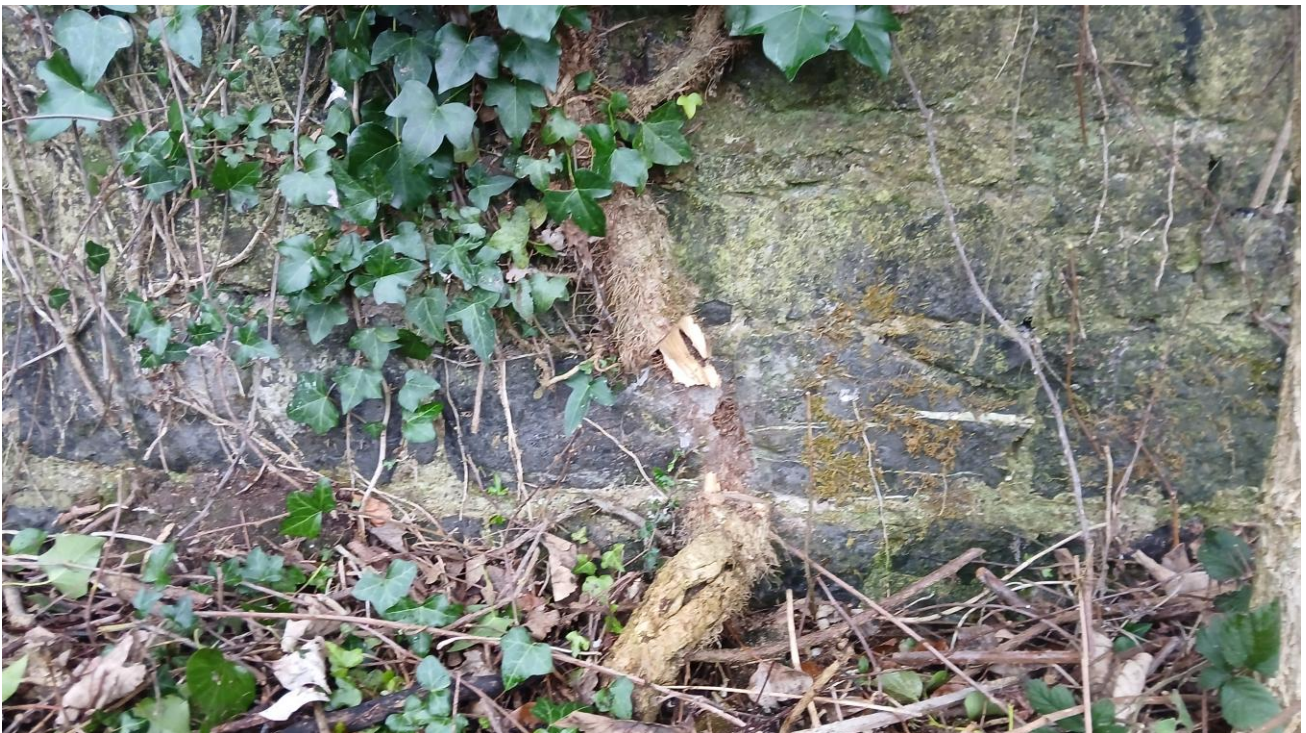
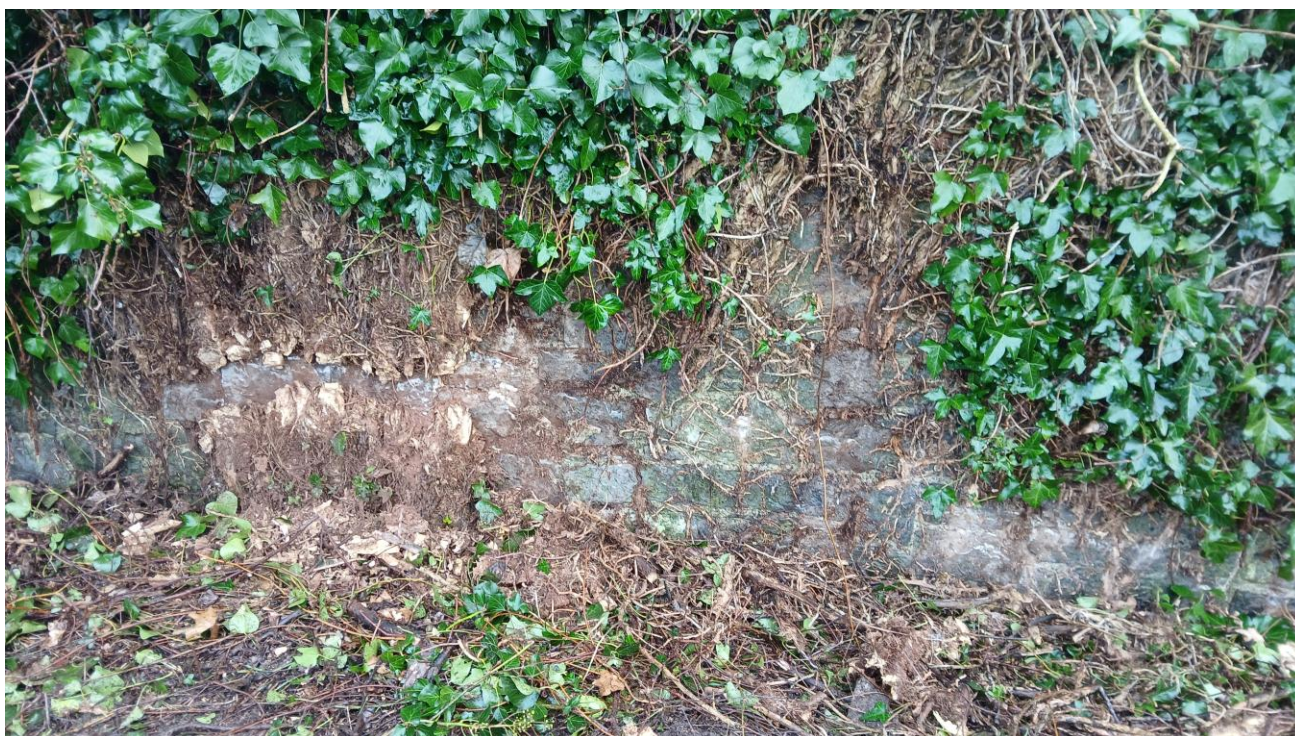
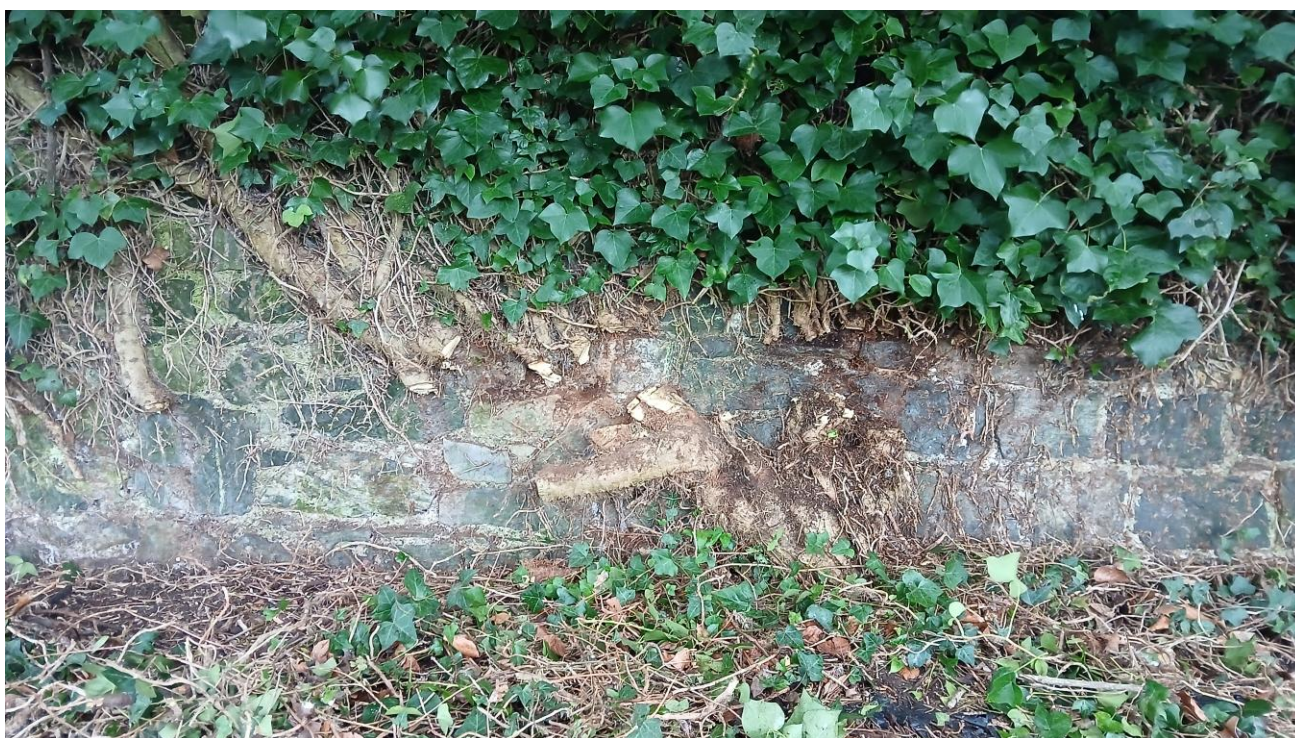
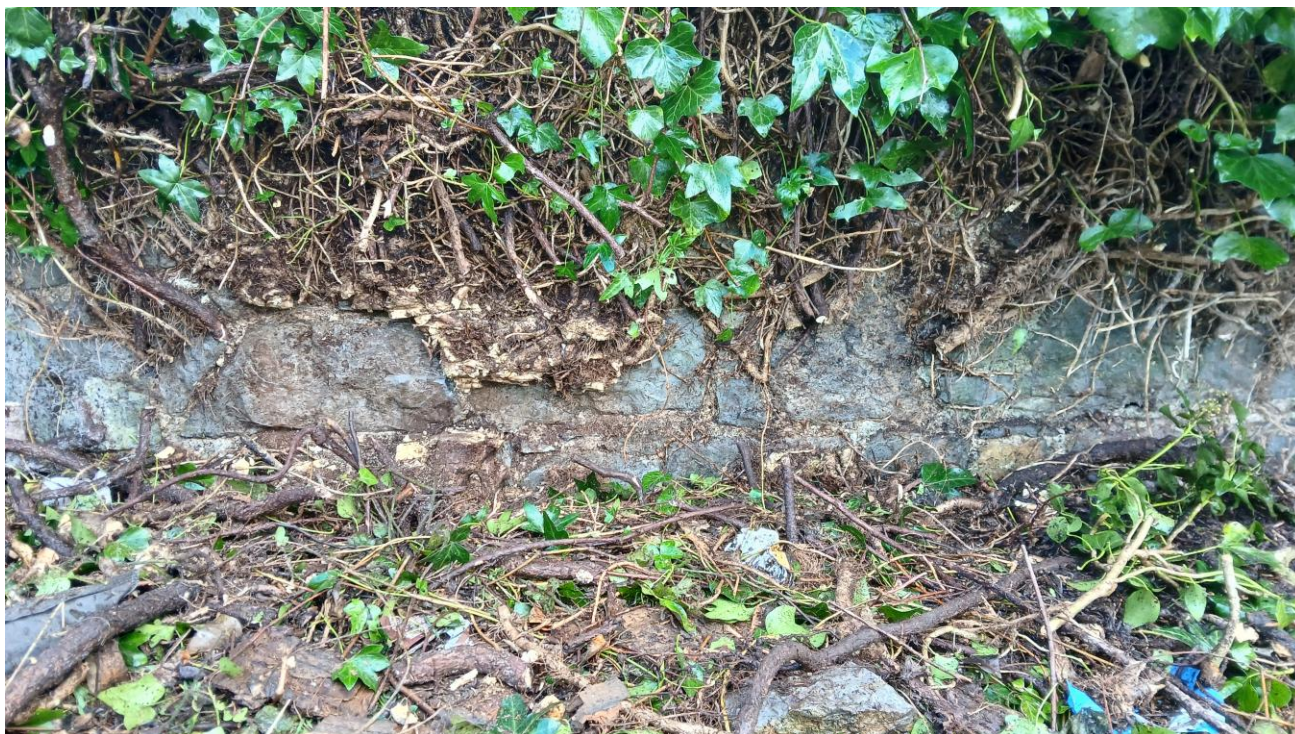
**Figure 9: Ivy Stem Cutting**

**Figure 10: Ivy Stem Cutting**

**Figure 11: Ivy Stem Cutting**

**Figure 12: Ivy Stem Cutting**

**Figure 13: Ivy Stem Cutting**

The ivy stems were severed using hand tools to ensure no vibrations disturbed any bats that may be present within the wall and to reduce any potential damage to the wall itself. Between 10cm and 15cm of ivy stem was removed to ensure stems could not re-establish connection and continue growing (**Figure 9, Figure 10, Figure 11, Figure 12 & Figure 13**). All cuttings were placed on the established vegetation pile at the southern end of the AIB Garden. Any side growths (i.e. narrower guage stems/branches) were removed from the lower stems and the wall, where possible (**Figure 14, Figure 15, Figure 16 & Figure 17**).Figure 14: Removal of Ivy Side Growth from Wall
