# AIB/Marina Wall Remediation, Athy, Co. Kildare

Supporting Information for Derogation Licence  
Application for Bats under Regulation 54 & 54A of the  
European Communities (Birds and Natural Habitats)  
Regulations 2011 (as amended)

IE000622  
Athy AIB/Marina  
Wall remediation  
F01  
21 May 2026

## Supporting Information for Derogation Licence Application for Bats

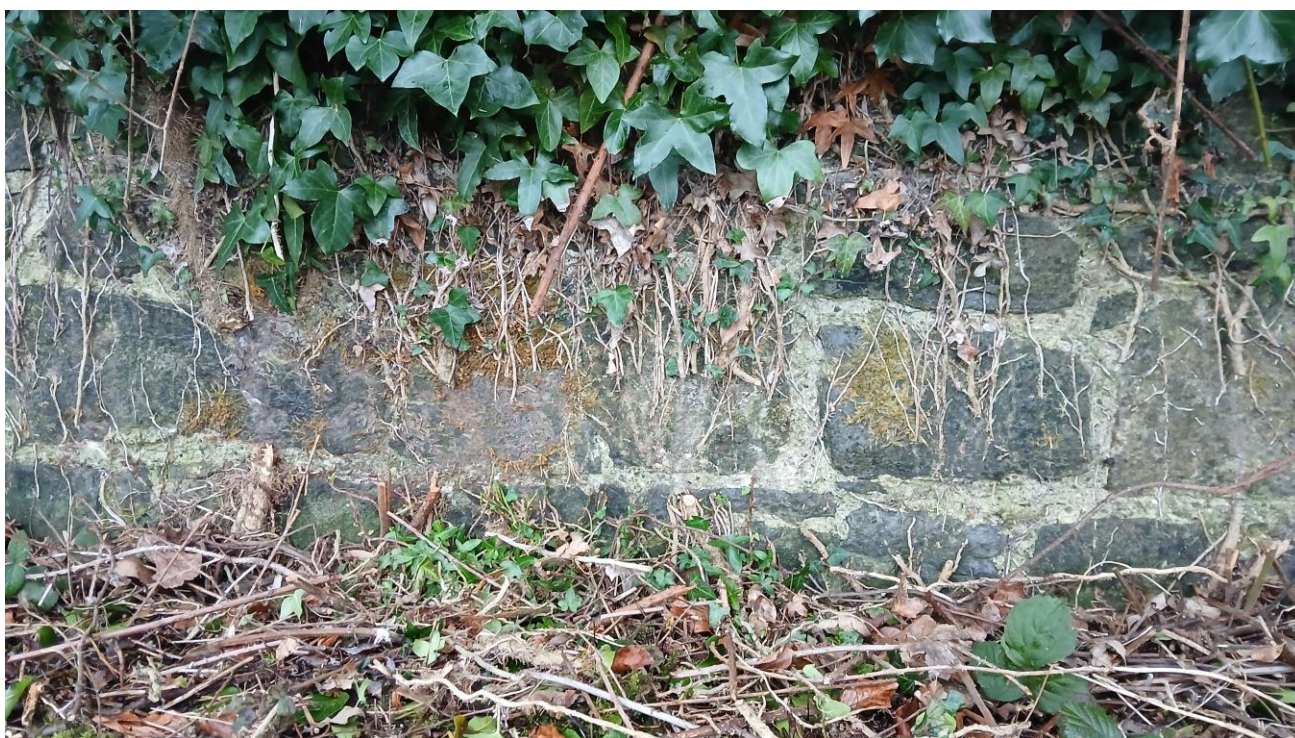
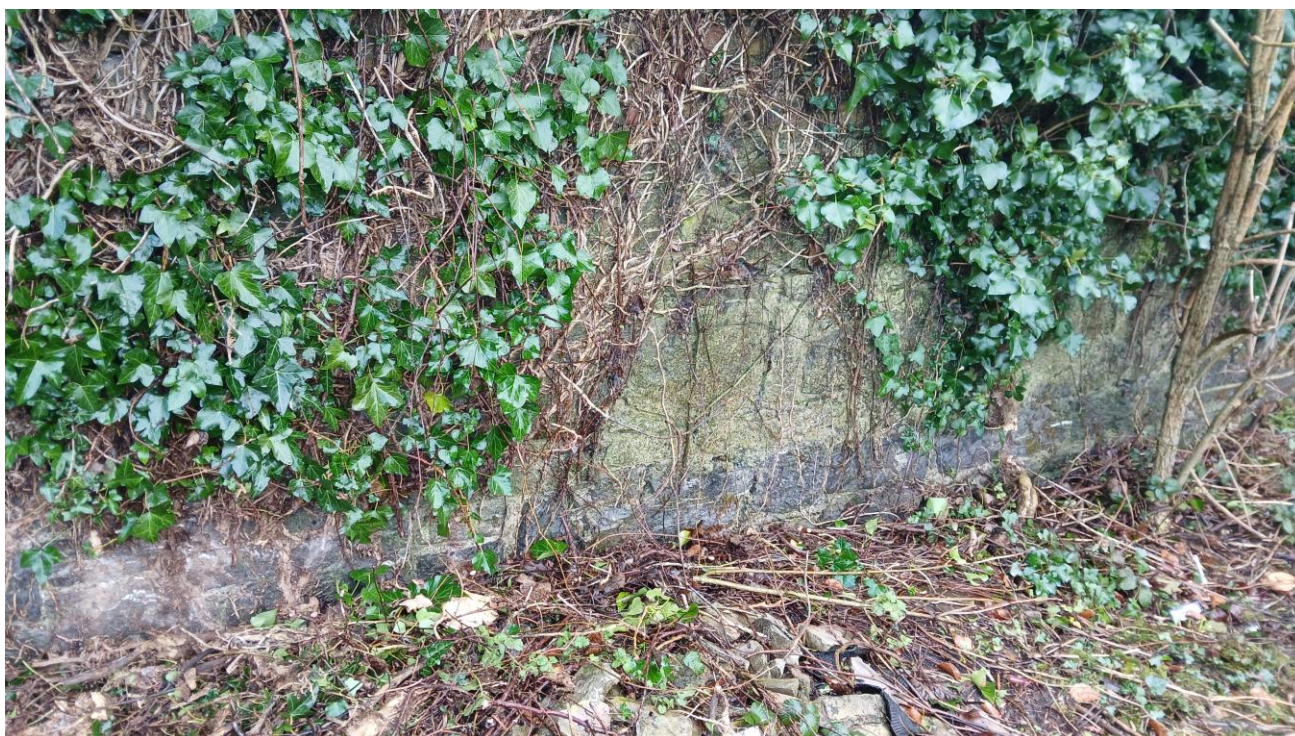
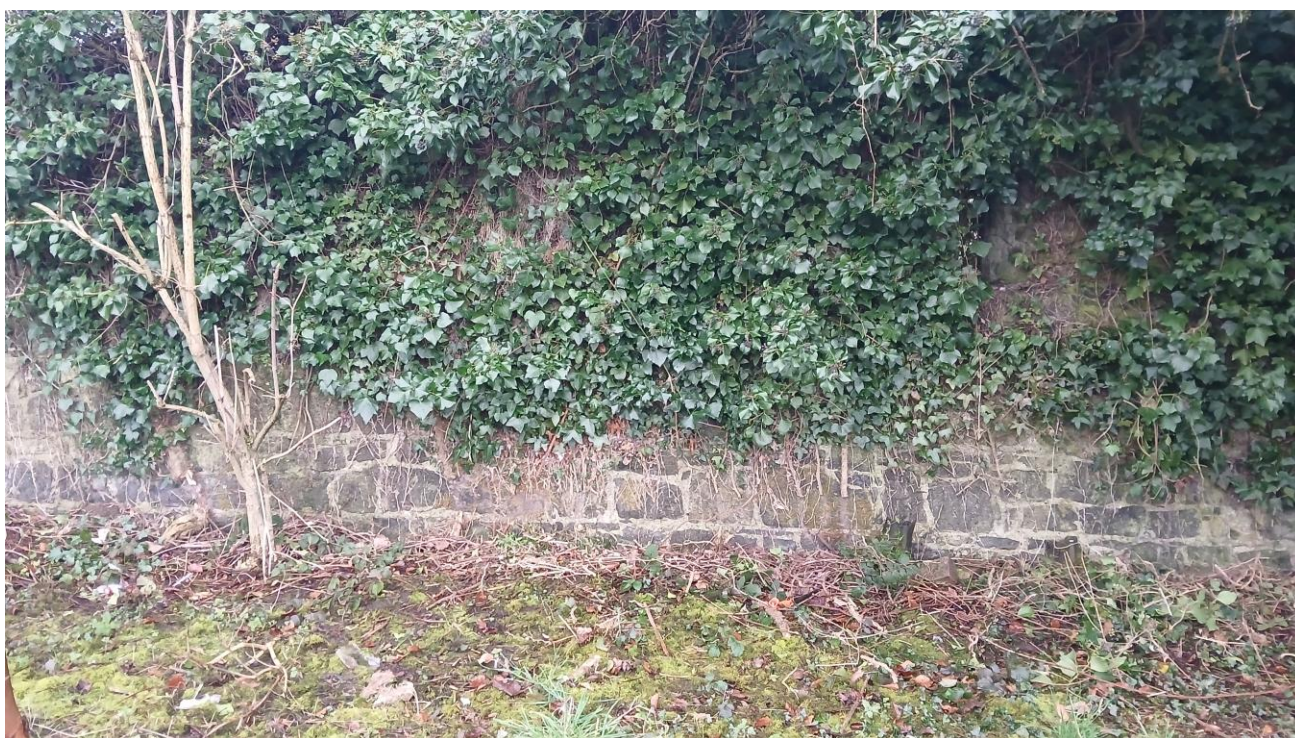
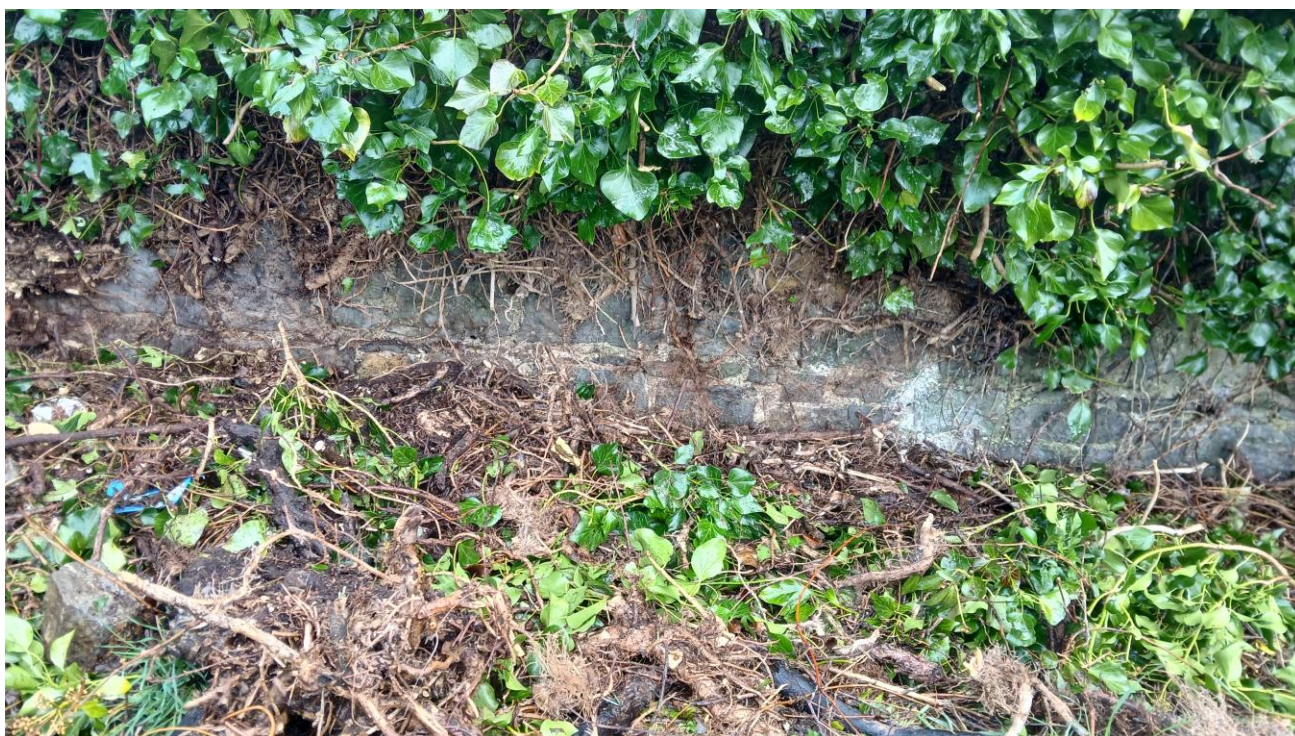
**Figure 14: Removal of Ivy Side Growth from Wall**

**Figure 15: Removal of Ivy Side Growth from Wall**

**Figure 16: Removal of Ivy Side Growth from Wall**

**Figure 17: Removal of Ivy Side Growth from Wall**

Further cutting will be required on ivy stems on the riverbank side of the wall. These works may be combined with the removal of dead ivy as a result of the works carried out. Ivy die back should be monitored to ensure works have been successful and that further cuts inside the AIB Garden are not required beyond cleaning of dead plant material.
