# Ballybrennan Church Ruin

## Bat Derogation Supporting document

JULY 2026

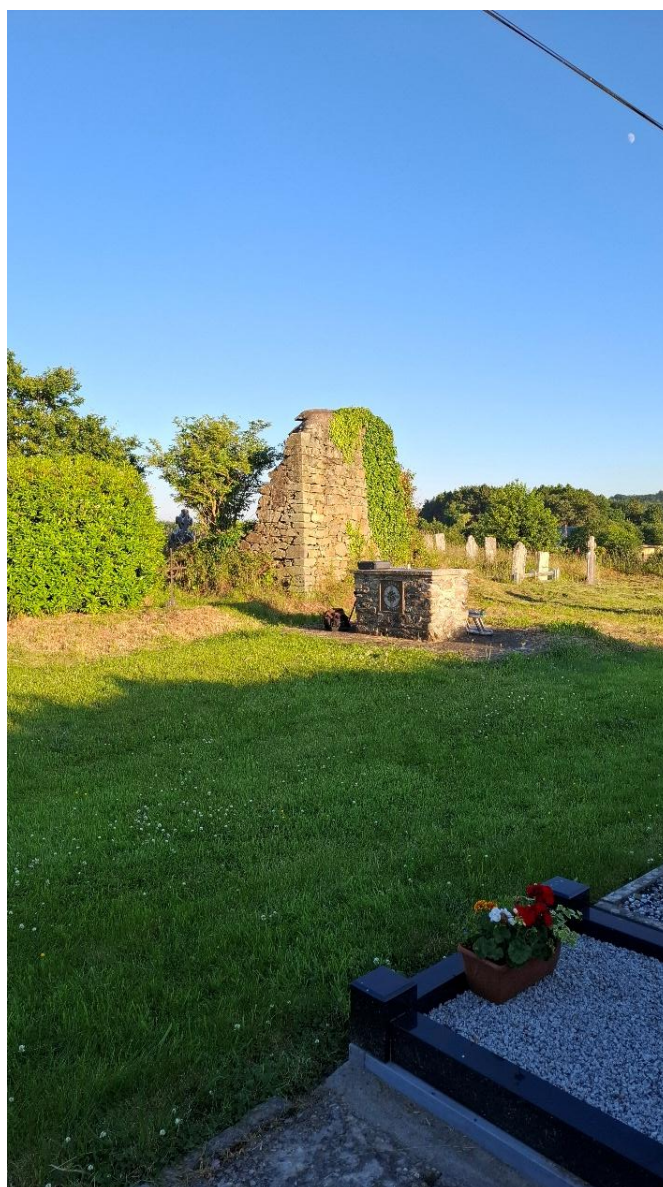
*Figure 1-1 View of the west gable of Ballybrennan Church*

Ballybrennan Church is a single cell church measuring circa 21.5m by 7m and is in a ruinous state, with only the western gable wall surviving to any height. This gable wall is in poor condition with numerous stone voids present and extensive erosion of mortar.

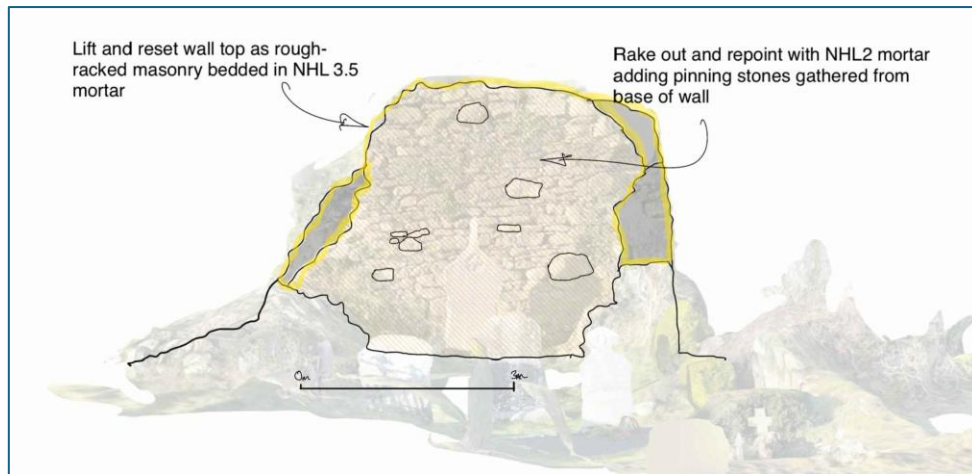
West gable External

**West Gable Outer Face:** Random sandstone rubble masonry wall with roughly dressed quoins at the northwest corner. The gable triangle is largely missing.

| <b>West gable outer face</b> | Removal of the ivy and vegetation and treatment of any embedded stems.<br>Repointing of eroded joints with lime mortar.<br>Reinstate the missing pinning stones and secure the surviving pinning stones in situ by rebedding them in lime mortar.<br><br>Remove cementitious cap and secure the wall top as rough racked masonry bedded in lime mortar. |

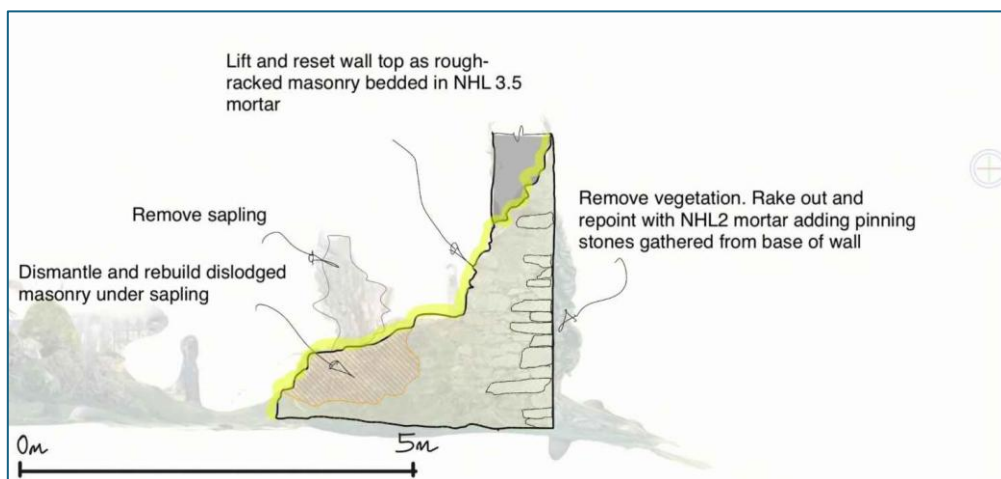
West Gable- Internal

**West Gable Internal:** Sandstone Rubble Masonry Wall. Internal corners are missing. **North Wall External:** Rubble sandstone masonry wall with roughly dressed quoins at the corner.

| <b>West Gable Internal</b> | Secure the exposed core as rough racked Masonry bedded in lime mortar. Remove the light ivy and vegetation repoint the eroded joints with lime mortar throughout |

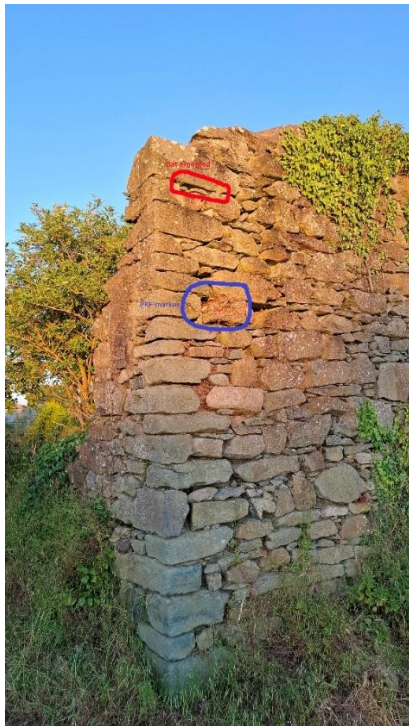
**Plate 3: West side of gable wall.**

**Red** = Confirmed Roost – common pipistrelle bat emerged;

**Blue** = Potential Roost Feature (PRF)

A roost occupied by a single common pipistrelle bat was confirmed in one crevice of the remaining gable wall of the Ballybrennan Church ruin. The bat roost present within Ballybrennan Church Ruin is considered to be of low conservation significance with reference to *IWM 134 (2022) Bat Mitigation Guidelines (Marnell et al., 2022)*. The guidance for roosts of this conservation category recommends:

Consultation with the project engineer, John Kelly of David Kelly Partnership has taken place and it has been agreed that the crevice roost site can be retained during the works. It will also be possible to retain additional crevices found to be suitable PRFs as outlined in Plate 3 and 4 above.

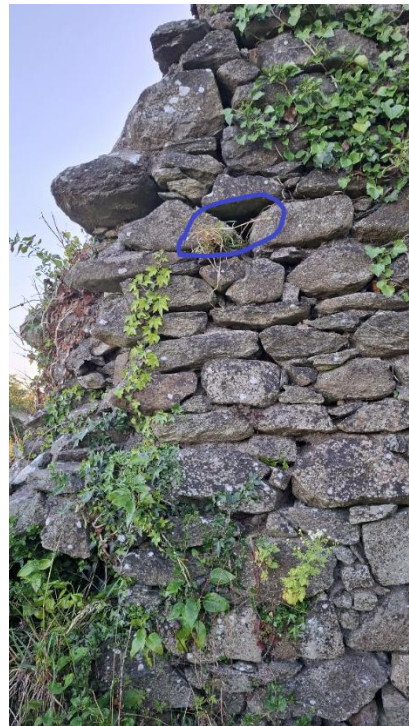
**East (internal) side of the wall:** A crevice found at approximately 2.5 metres high on the left side of the wall. (Plate 4 marked in blue).

**Plate 4: East side of gable wall**

**Blue:** Potential Roost Feature (PRF)
