See House, Kilmore Lower, Co. Cavan – Derogation Licence Application Letter

Project Name & Location: See House, Kilmore Lower, Co. Cavan

RE: Application for a Derogation Licence to fix sections of the roof of See House, Kilmore Lower, Co. Cavan.

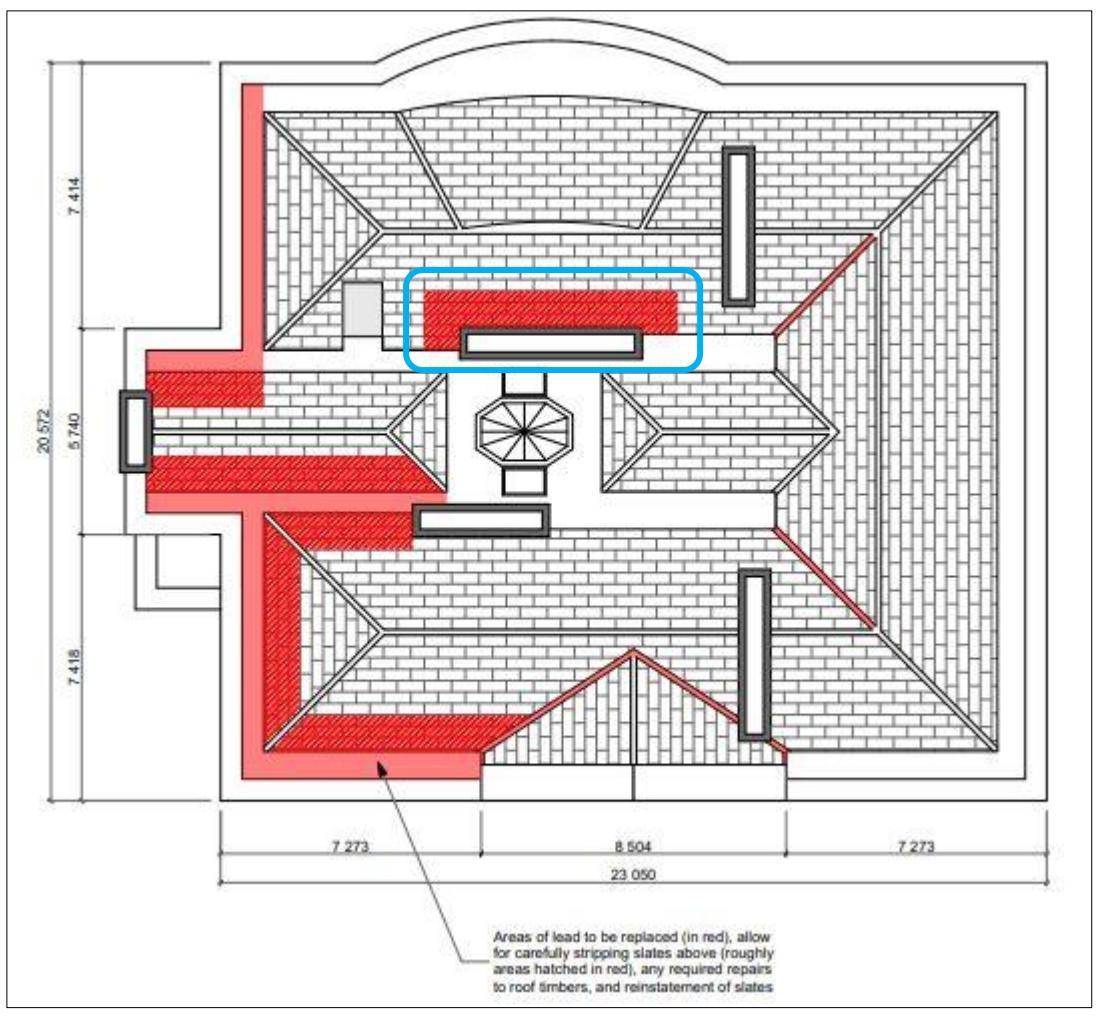
Funding is available to undertake essential remedial works on the sections of the roof marked in Red on the figure below. If further funding is available, the remainder of the roof will also be tackled in a similar fashion. The attic space is a channel running around the boundary of the roof space with a flat area in the centre. The external section of the roof is accessible through a door in the attic and this allows a person to walk around the external area of the roof. This is a 4-stroey building and therefore difficult to survey from the ground level. Any future surveys will be undertaken at the roof level.

Figure 2: Overhead shot of roof complex of See House, Kilmore Lower, Co. Galway. Red areas = proposed work areas.

- Remove the bottom 3 row of slates.
- Replace lead waterproof layer.
- Re-instate the slates.
- During re-slating, insert a bat slate in specific areas (please see next section).
- Internally, replace one rotten timber beam (located in first attic space area Plate 2) marked in Blue on Figure 2.

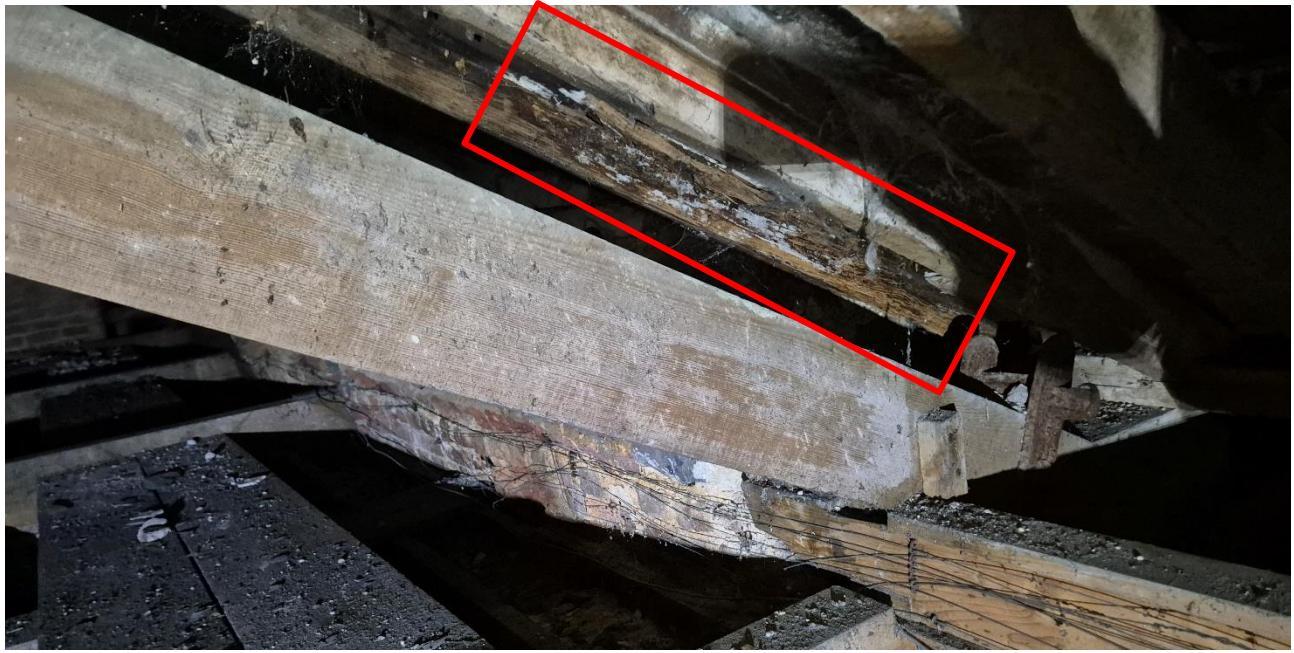
Plate 2: Timber beam required to be replaced – note the white residue on the beam..

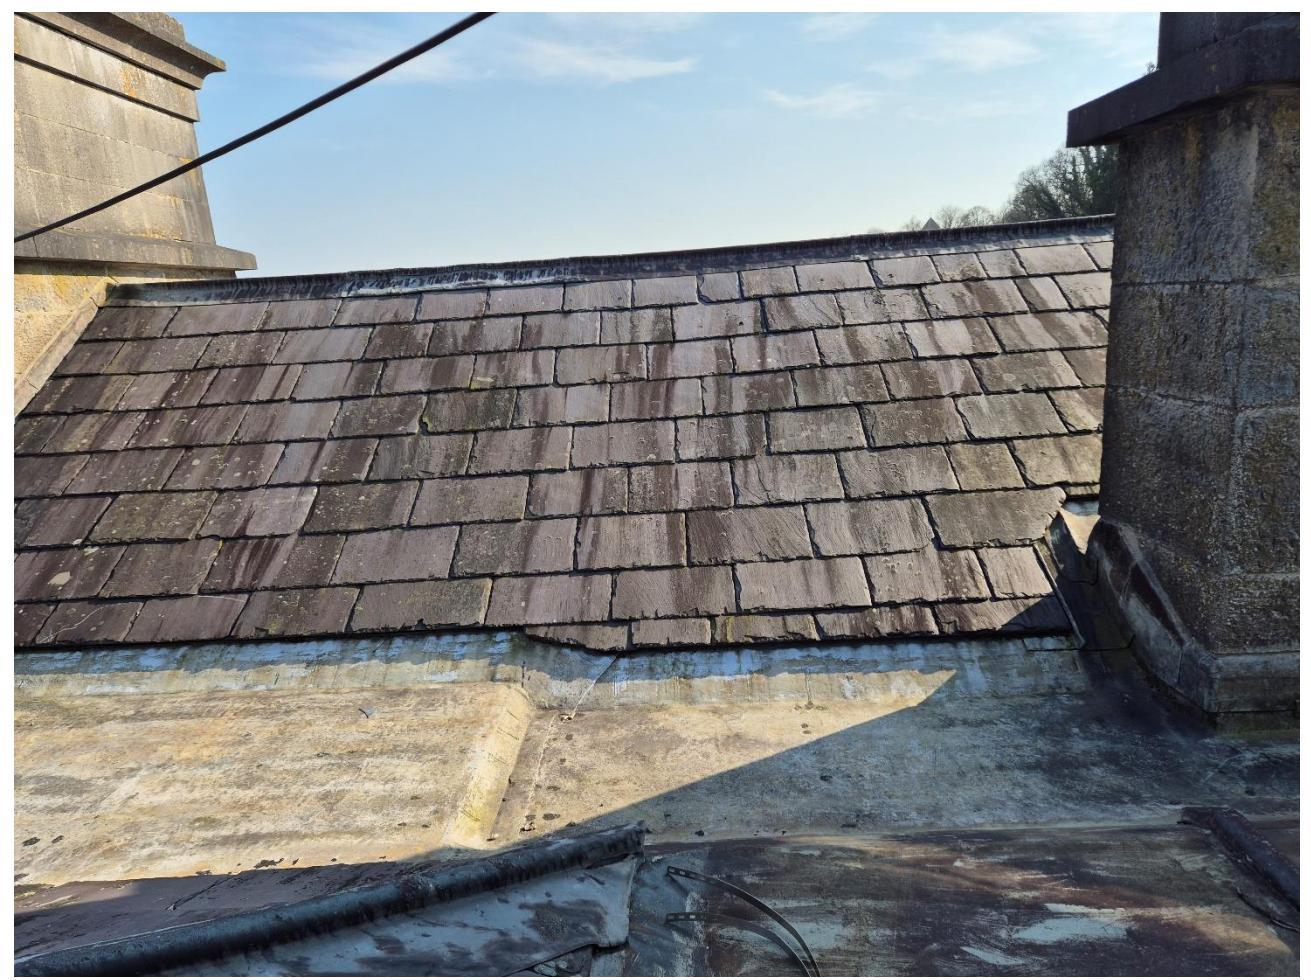
Plate 3: The lead waterproof layer that folds up under the slates is proposed to be replaced. In order to do this the bottom three slates will need to be removed.

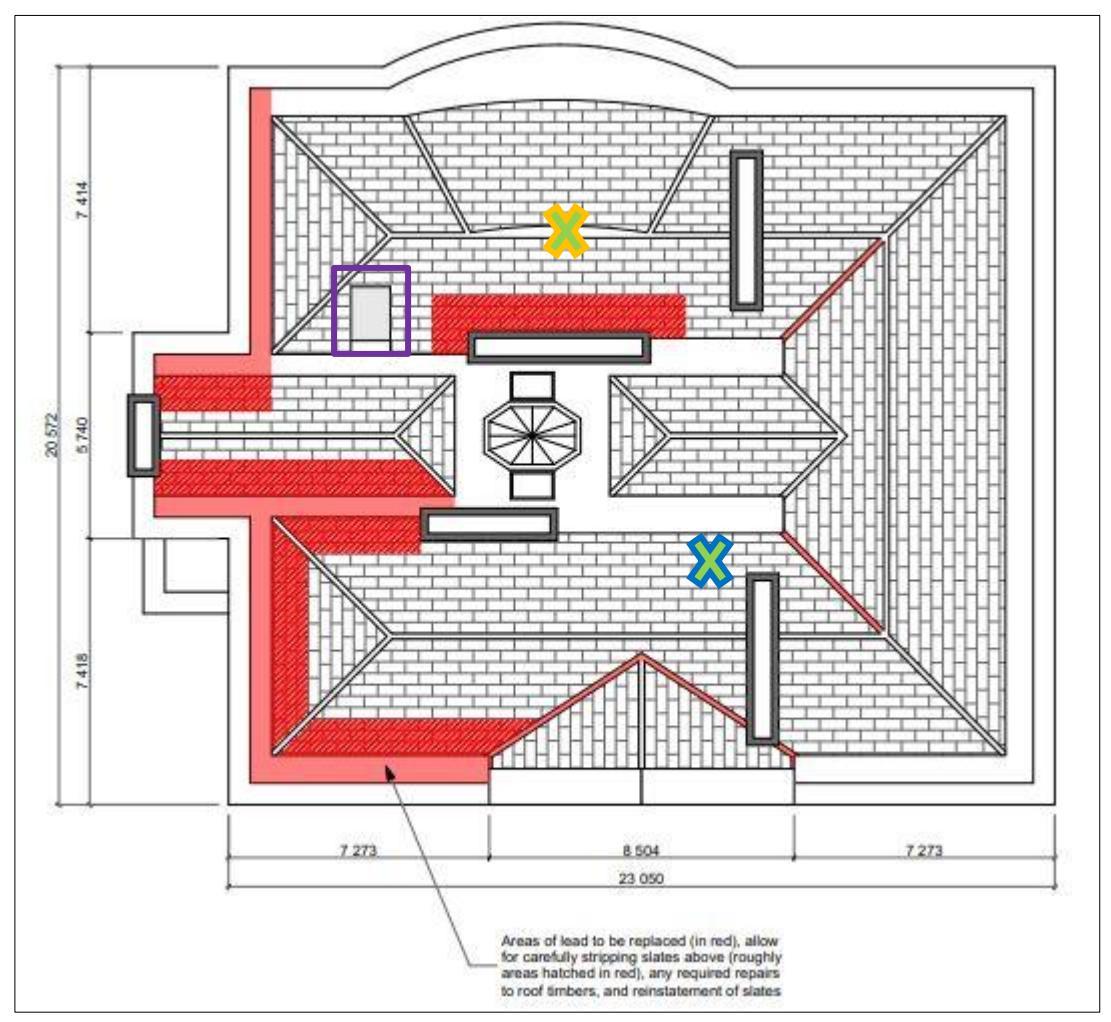
Figure 2: Overhead shot of roof complex of See House, Kilmore Lower, Co. Galway. Orange X = Static 1; Blue X = Static 2. Purple rectangle = door to roof.

During the static surveillance (18th to 25th September 2024), the following tables depict the level of bat activity for brown long-eared bats recorded on the statics (Please note: this was the only species of bat was recorded in the attic). Static 2 recorded a higher level of brown long-eared bat activity. This particular section of the attic space was inaccessible as there is a narrow space along the chimney and as a consequence the static unit was placed at arm's length into this space. But the activity level indicates that this section maybe the most likely location for the roost, while there is a very visible exit point adjacent to Static 1 where there are gaps along the door exit point onto the roof (Purple Square, Figure 2).

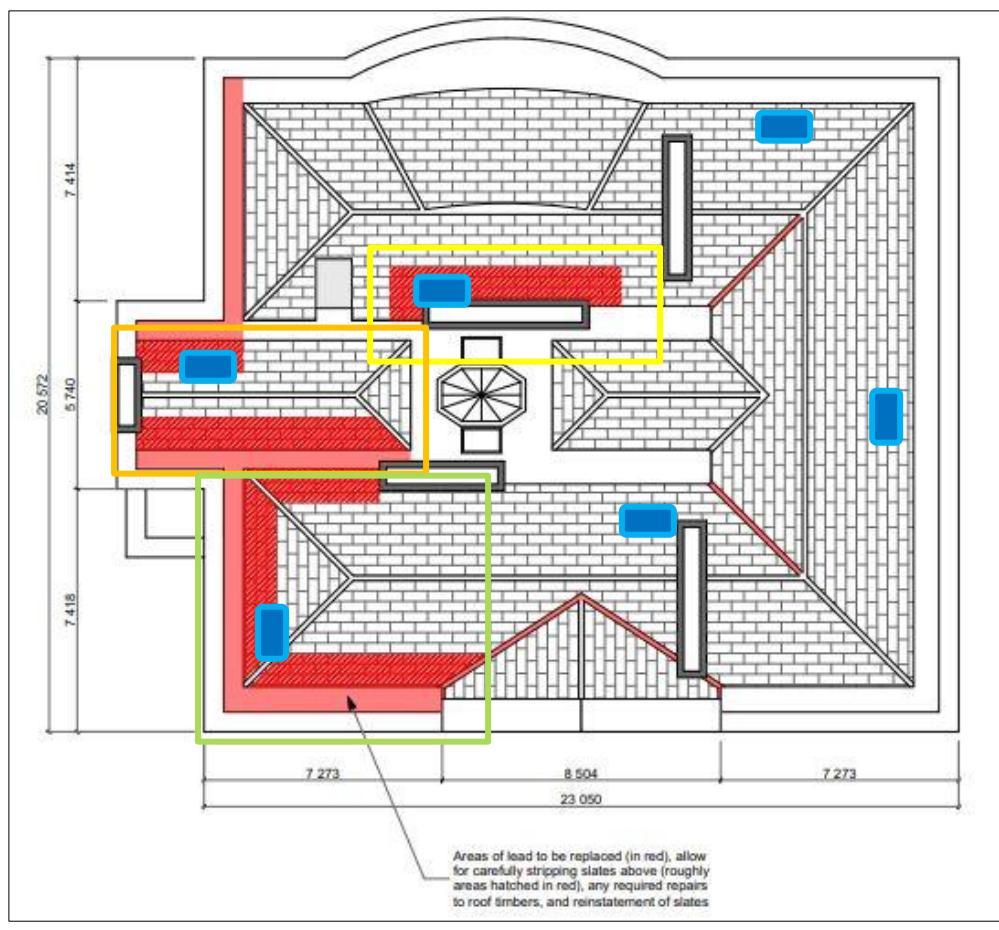
Figure 2: Overhead shot of roof complex of See House, Kilmore Lower, Co. Galway. Red areas = proposed work areas. Blue areas = proposed bat slate locations.

During the re-instatement of the slates, a bat slate will be inserted in the locations marked up on the figure below (Figure 2). This will ensure that there are a total of six bat exit points are available post works, three for the current funded works. Information on bat slates are provided as a separate document.
