Application for Derogation Licence

**Russell Environmental and
Sustainability Services Limited**

BAT SURVEY RAILPARK

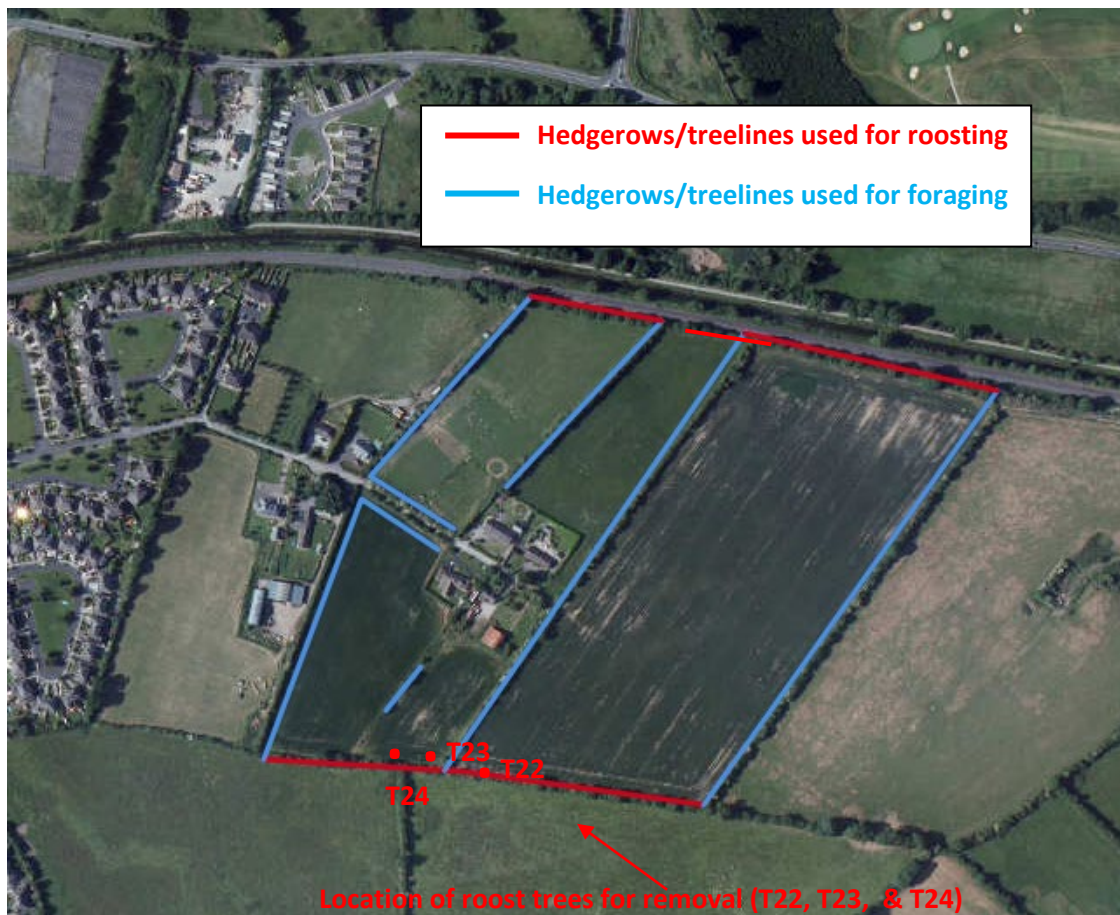
Figure 2 Hedgerows/treelines used by bats during the survey (including roost trees scheduled for removal (T22, T23, and T24)

However, the derogation licence is only required for 3 Ash trees to be removed in the southern boundary as per Figure 2, where there were Common pipistrelle *Pipistrellus pipistrellus* and Soprano pipistrelle *Pipistrellus pygmaeus* roosting (Leisler's Bat *Nyctalus leisleri* was only found in the northern boundary).

With reference to the attached Tree Schedule as part of the Arboricultural Report (Appendix v), all three trees have deadwood in their crown and show signs of infection of Ash die-back and therefore the progression of this disease is likely to result in trees that become unstable and dangerous, due to the progression of deadwood. Trees T22 and T23 are already of poor condition and are classified as U, 'whereby they are trees that are in such a condition that they cannot realistically be retained as living trees in the context of the current land use for longer than 10 years' (McCorkell, 2024). Tree T24 is categorised as C2, 'which is of low quality' (McCorkell, 2024). There are a number of other suitable, large trees within the southern hedgerow/treeline where the two bat species may use as alternative roost sites.

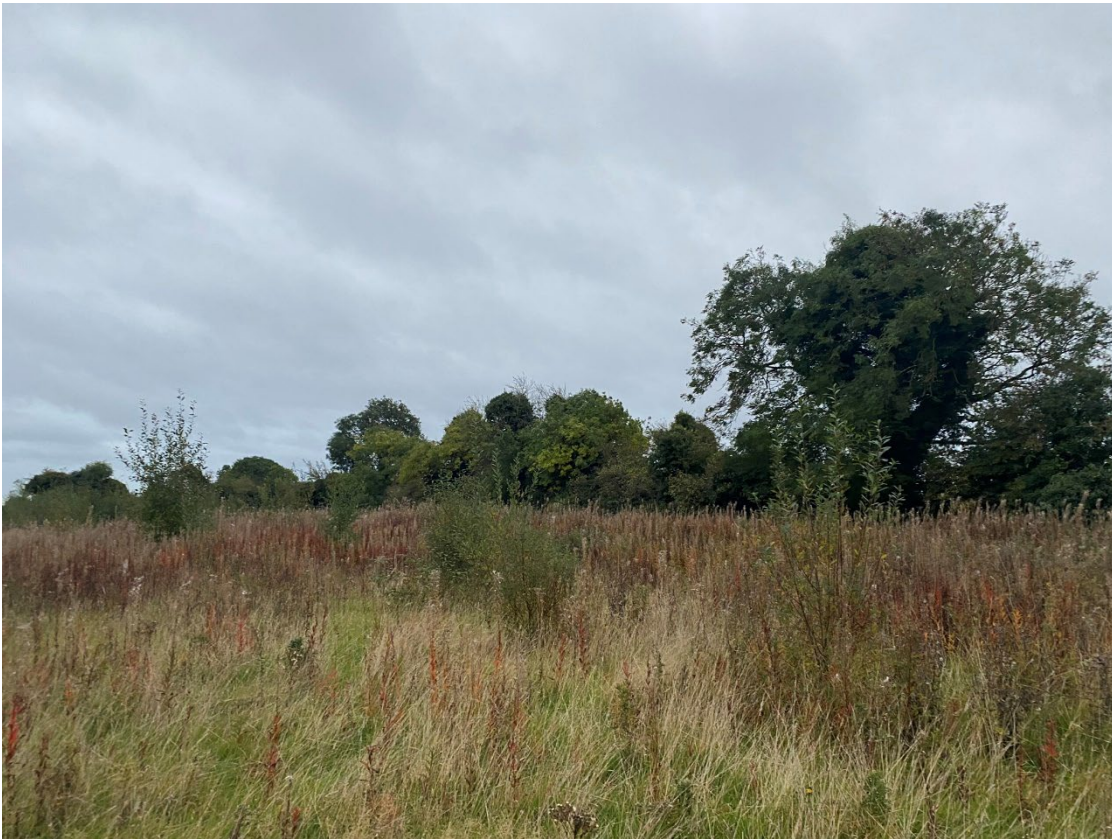
Figure 1 Hedgerow/treeline in the largest field where bats are roosting adjacent to the trainline

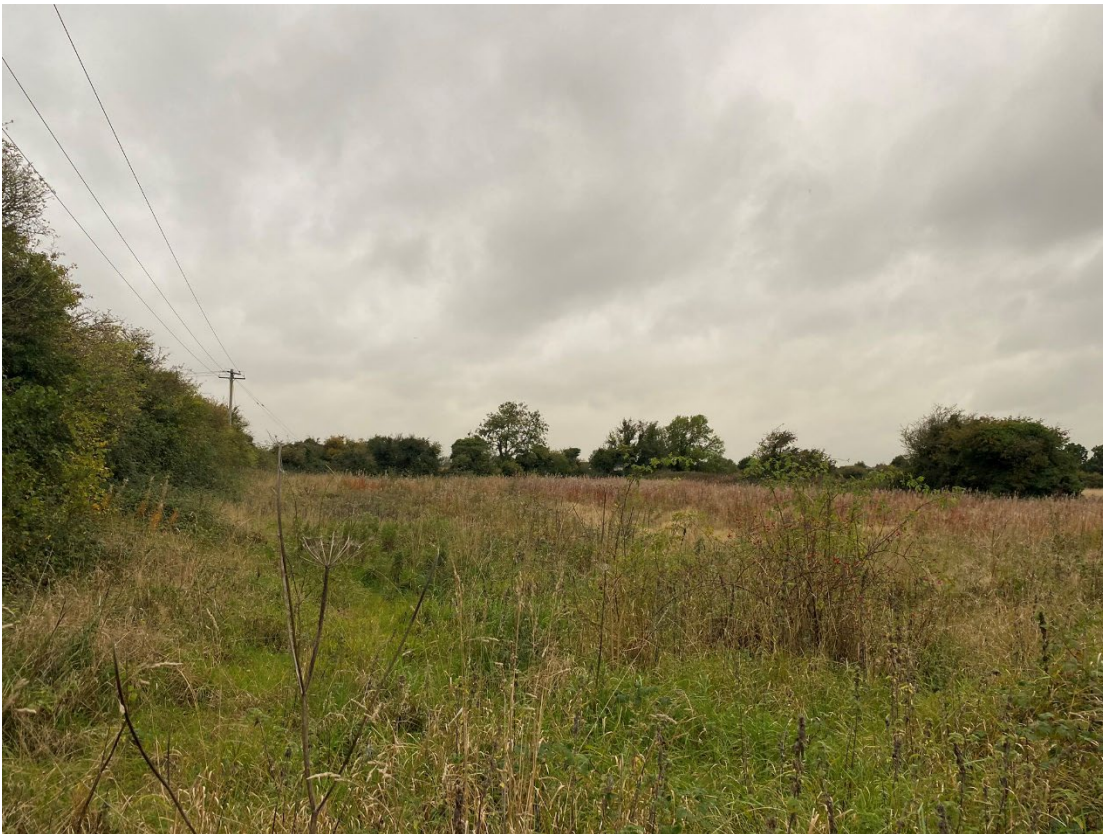
Figure 2 The Hedgerow/treeline where ats are roosting in the large Ash trees

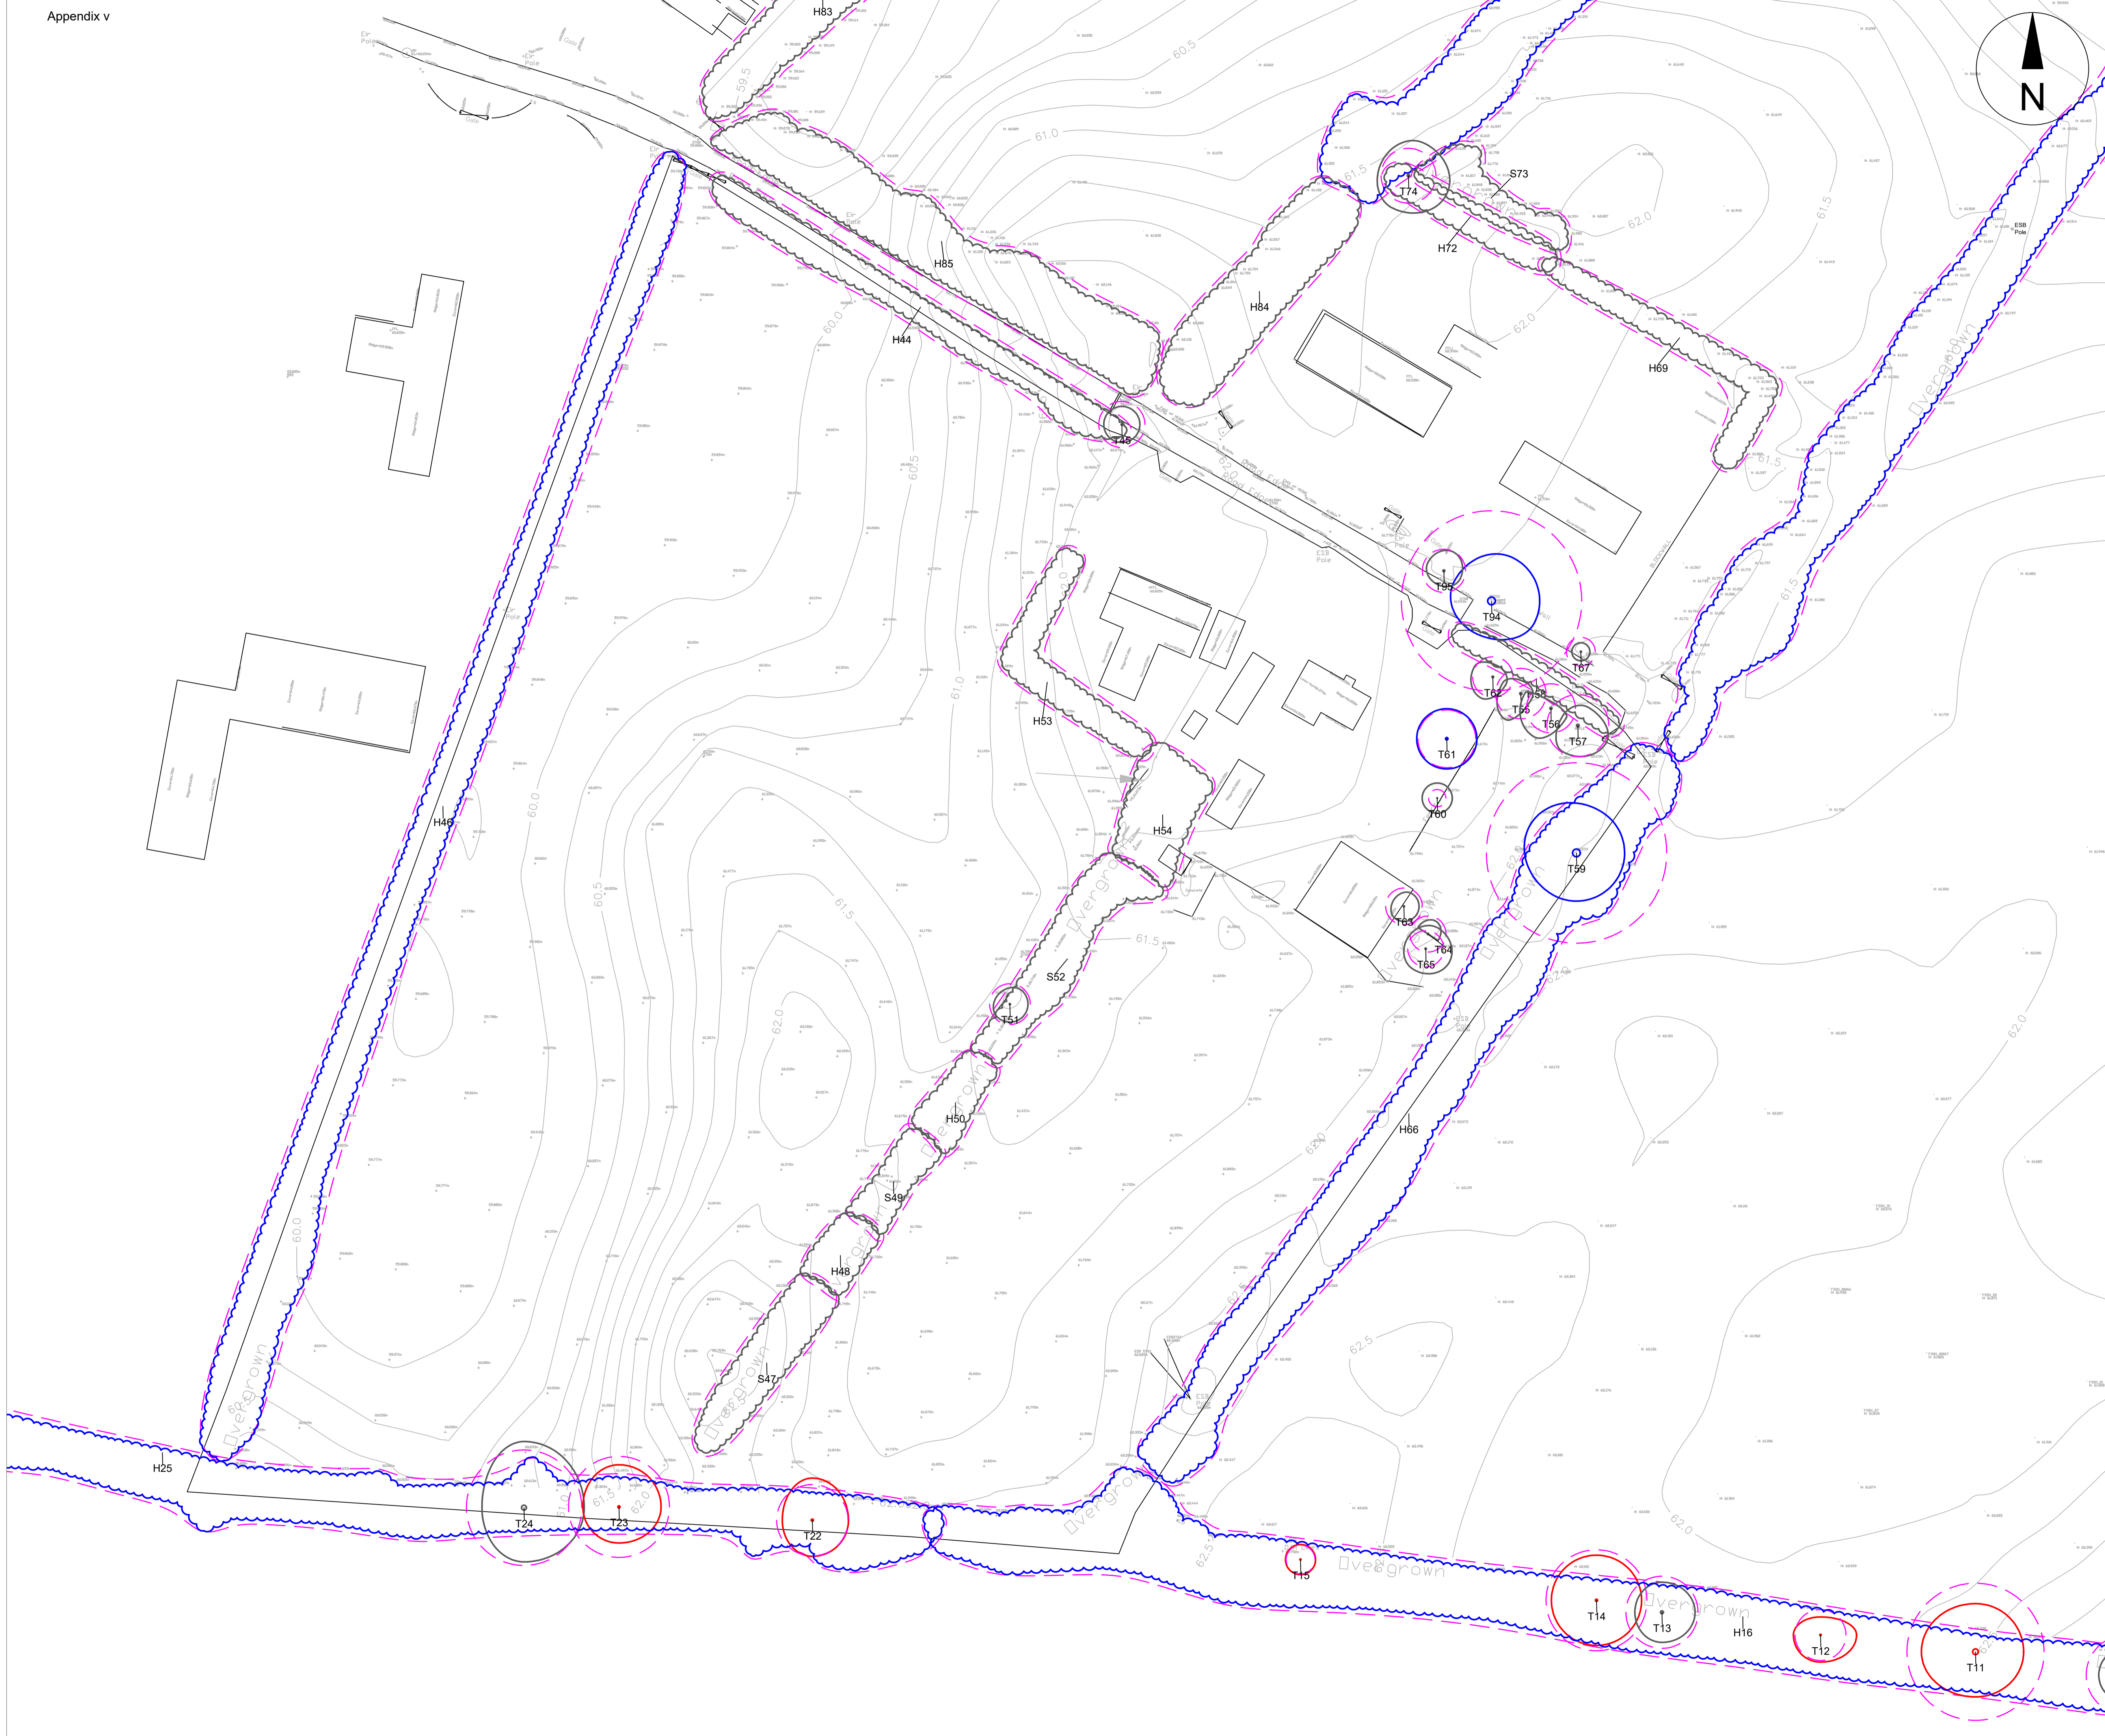
Title: **Tree Survey & Constraints Plan 01**

| Tree ID | No. Species | Height (m) | Stem diameter (cm) | No. of Stems | CROWN SPREAD (m) | | | | | | | | Crown clearance (m) | L.B. (m) | Life stage | Condition Notes | Survey date | RPA (m ²) | RPR (m) | Life expectancy (yrs) | BS Category |
|---|--|---|---|---|---|---|---|---|---|---|---|---|---|---|---|---|---|---|---|---|---|
| Tree T22 | 1 Fraxinus excelsior (Ash) | 13.0 | 49 COM | 2 | 7.0 | 6.0 | 6.0 | 5.0 | | | | 1.0 | | Mature | Structural condition Fair. Physiological condition Poor. Access to inspect base - Not possible. Branch - Broken. Die-back - Upper crown. Deadwood - Minor. Ivy or climbing plant. Unable to inspect tree closely due to dense undergrowth. Tree is infected with ash dieback - moderate stages. | 28/10/2024 | 110.8 | 5.9 | 0-10 | U | |
| Tree T23 | 1 Fraxinus excelsior (Ash) | 13.0 | 70 COM | 4 | 7.0 | 7.0 | 6.0 | 6.0 | | | 3.0 | | Mature | Structural condition Poor. Physiological condition Poor. Access to inspect base - Not possible. Die-back - Throughout crown. Decline - Evident / observed. Deadwood - Minor. Ivy or climbing plant. Unable to inspect tree closely due to dense undergrowth. Tree is infected with ash dieback - advanced stages. | 28/10/2024 | 221.7 | 8.4 | 0-10 | U | | |

| Tree ID | No. Species | Height (m) | Stem diameter (cm) | No. of Stems | CROWN SPREAD (m) | | | | | | | | Crown clearance (m) | L.B. (m) | Life stage | Condition Notes | Survey date | RPA (m ²) | RPR (m) | Life expectancy (yrs) | BS Category |
|---|---|---|---|---|---|---|---|---|---|---|---|---|---|---|---|---|---|---|---|---|---|
| Tree T24 | 1 Fraxinus excelsior (Ash) | 15.0 | 80 | 1 | 11.0 | | 10.0 | | 9.0 | | 7.0 | | 2.0 | | Mature | Structural condition Fair. Physiological condition Fair. Access to inspect base - Not possible. Branch weight - Heavy. Dieback - Upper crown. Deadwood - Minor. Ivy or climbing plant. Unable to inspect tree closely due to dense undergrowth. Tree is infected with ash dieback - early stages. | 28/10/2024 | 289.5 | 9.6 | 10-20 | C2 |
