**Bat Conservation Plan and Supporting Information for Bat  
Derogation Licence Extension August 2025**

**for the Consented Strategic Housing Development,**

**Coolevally, Shankill, Dublin 18.**

prepared for Cairn PLC

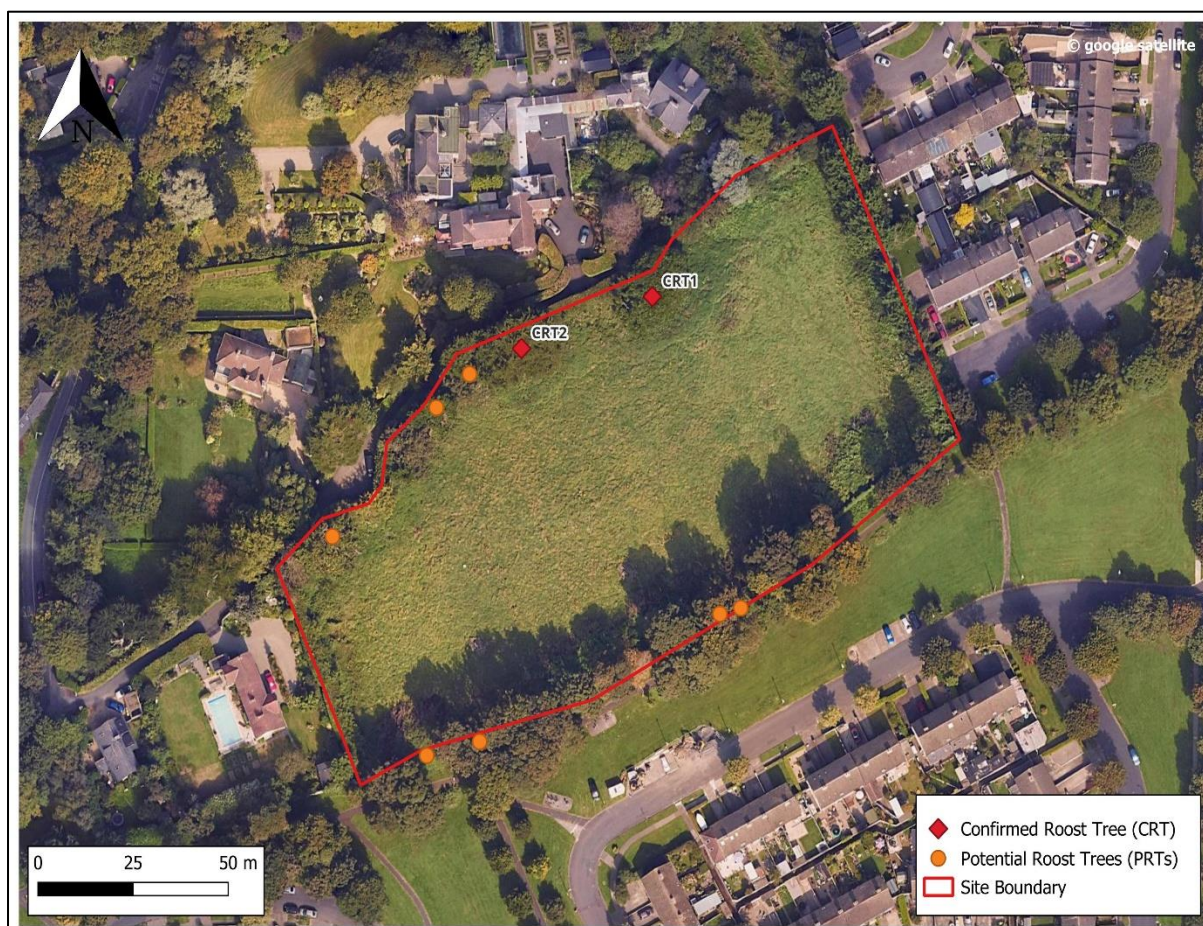
**Figure 2: Illustrating locations of trees with confirmed roosts, potential roosts and negligible roost potential.**

During the emergence survey, two soprano pipistrelle bats were observed emerging at dusk from a mature Monterey pine tree (labelled CRT1 in **Plate 2**). While three Leisler's bats and up to four common pipistrelle bats, were noted emerging from a mature Monterey cypress tree (labelled 'CRT2' in Figure 2 and shown in **Plate 1**).

Three to four common pipistrelle were observed re-entering during the dawn survey into CRT2. However, it was noted that, due to the large number of PRFs and complexity of roosting features observed on all marked PRF trees (especially the trees labelled CRT1 and CRT2 in Figure 2), it was possible that additional emergence of bat species was occurring throughout the northern treeline boundary.

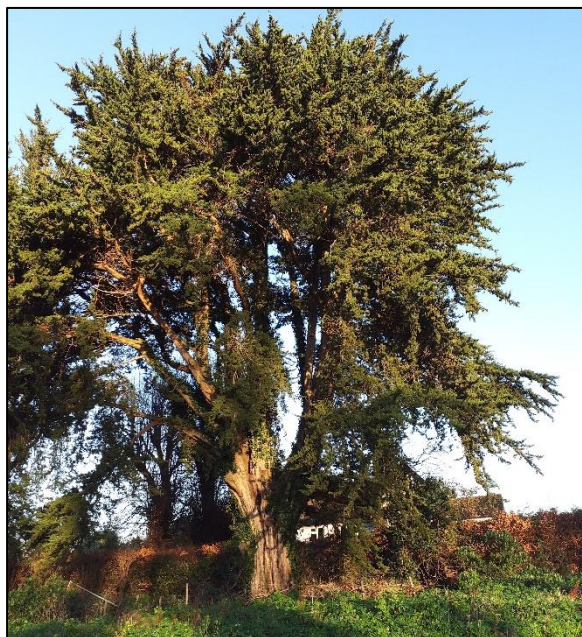
**Plate 1: A veteran Monterey cypress tree 'CRT2' with known bat roosts**

**Plate 2: A mature Monterey pine tree 'CRT1' with known bat roosts**

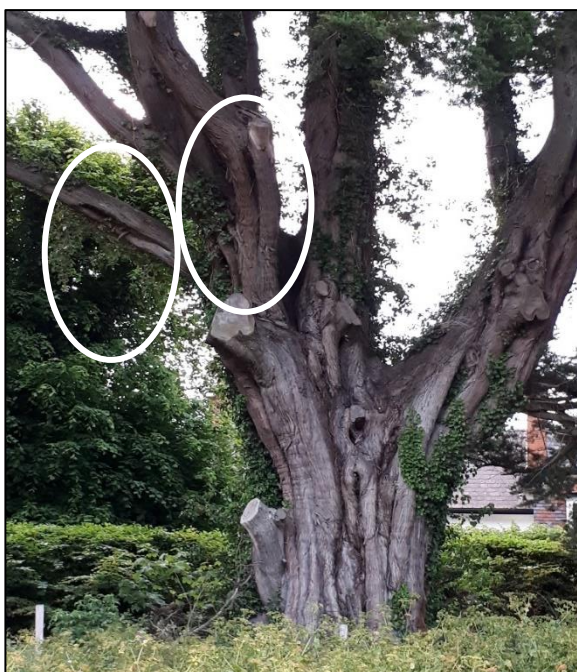
**Plate 3: Locations of bat roosts in 'CRT2' identified in June 2020**

**Plate 4: Locations of bat roosts identified in 'CRT2' in June 2020**

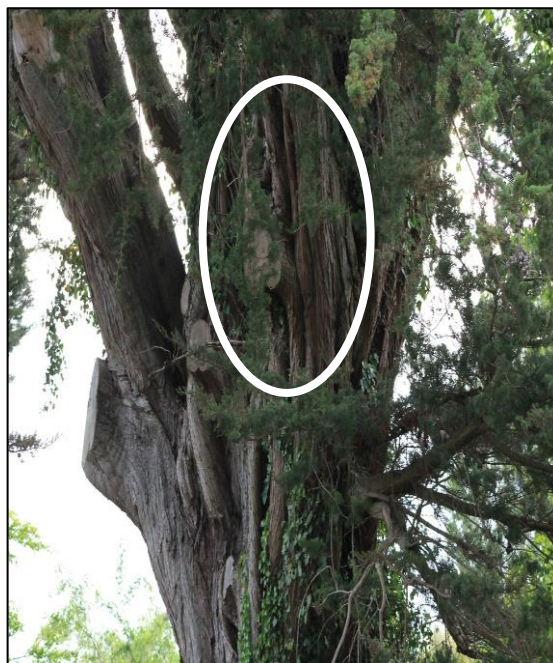
**Plate 5: Location of a bat roost identified in 'CRT1' in June 2020**
