ECOLOGICAL SURVEY

GRAND CANAL

Part 2 Conservation Management Plan 1991

**Prepared for
The Wildlife Service and Waterways Section,
Office of Public Works. 1992.**

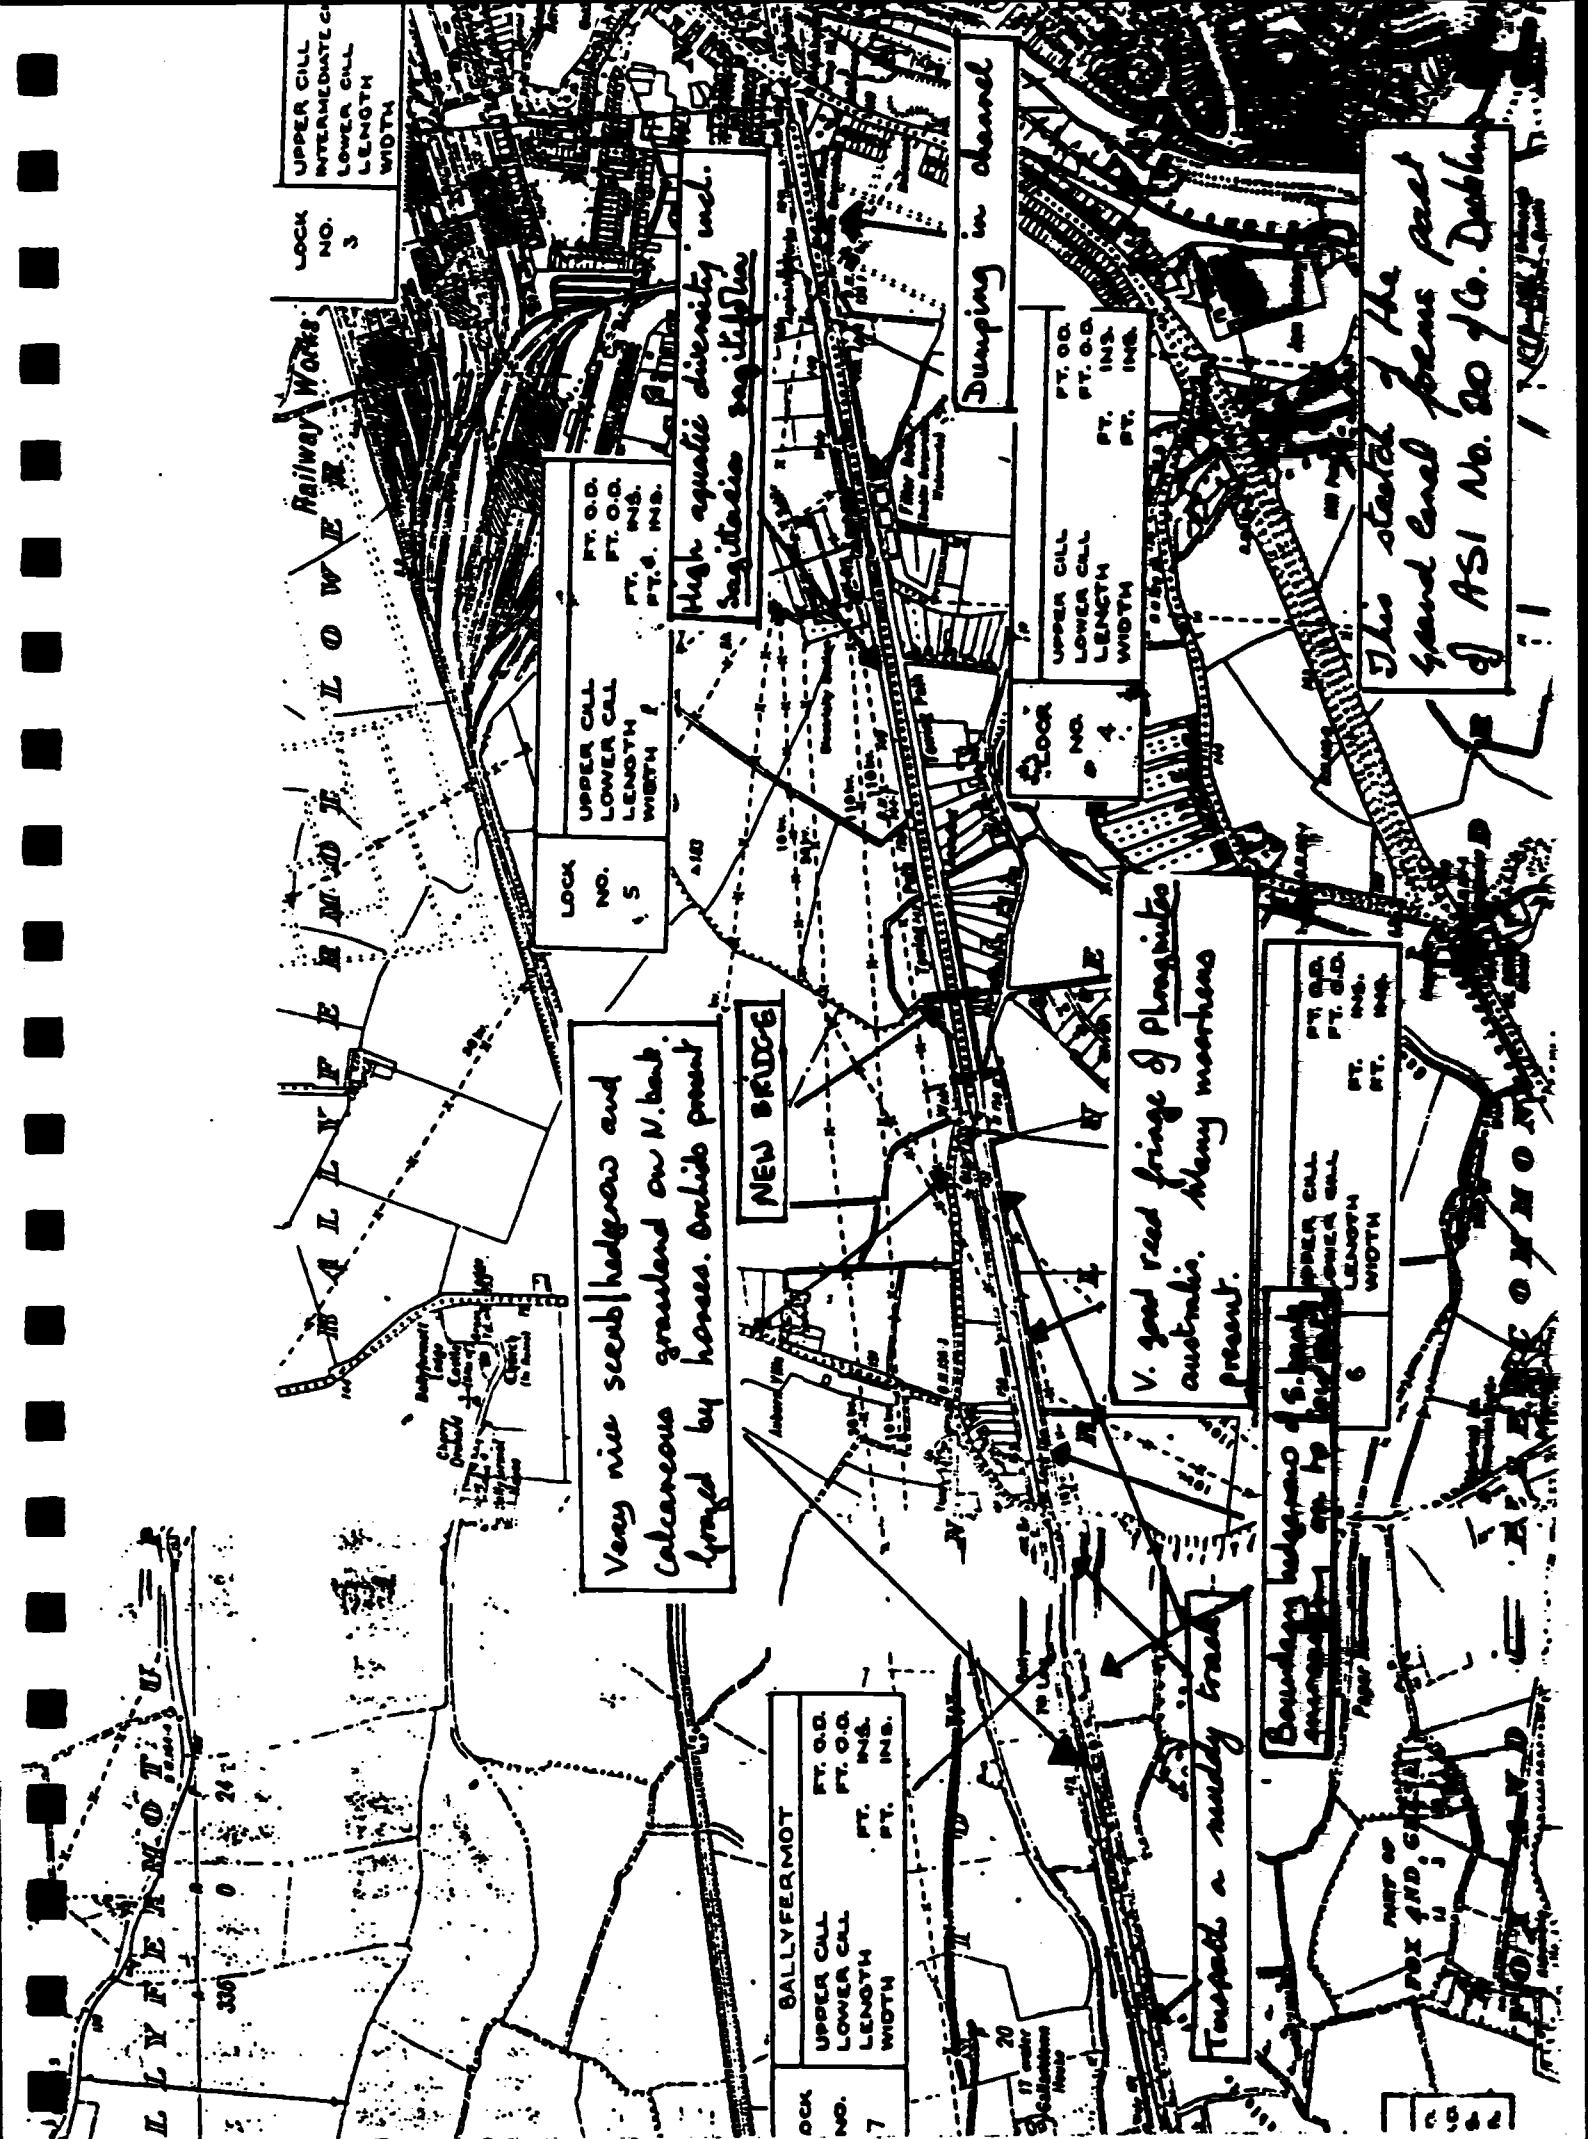
Very nice scrub/hedgerow and
calcareous grassland on N. bank.
fringed by hedges. orchids present

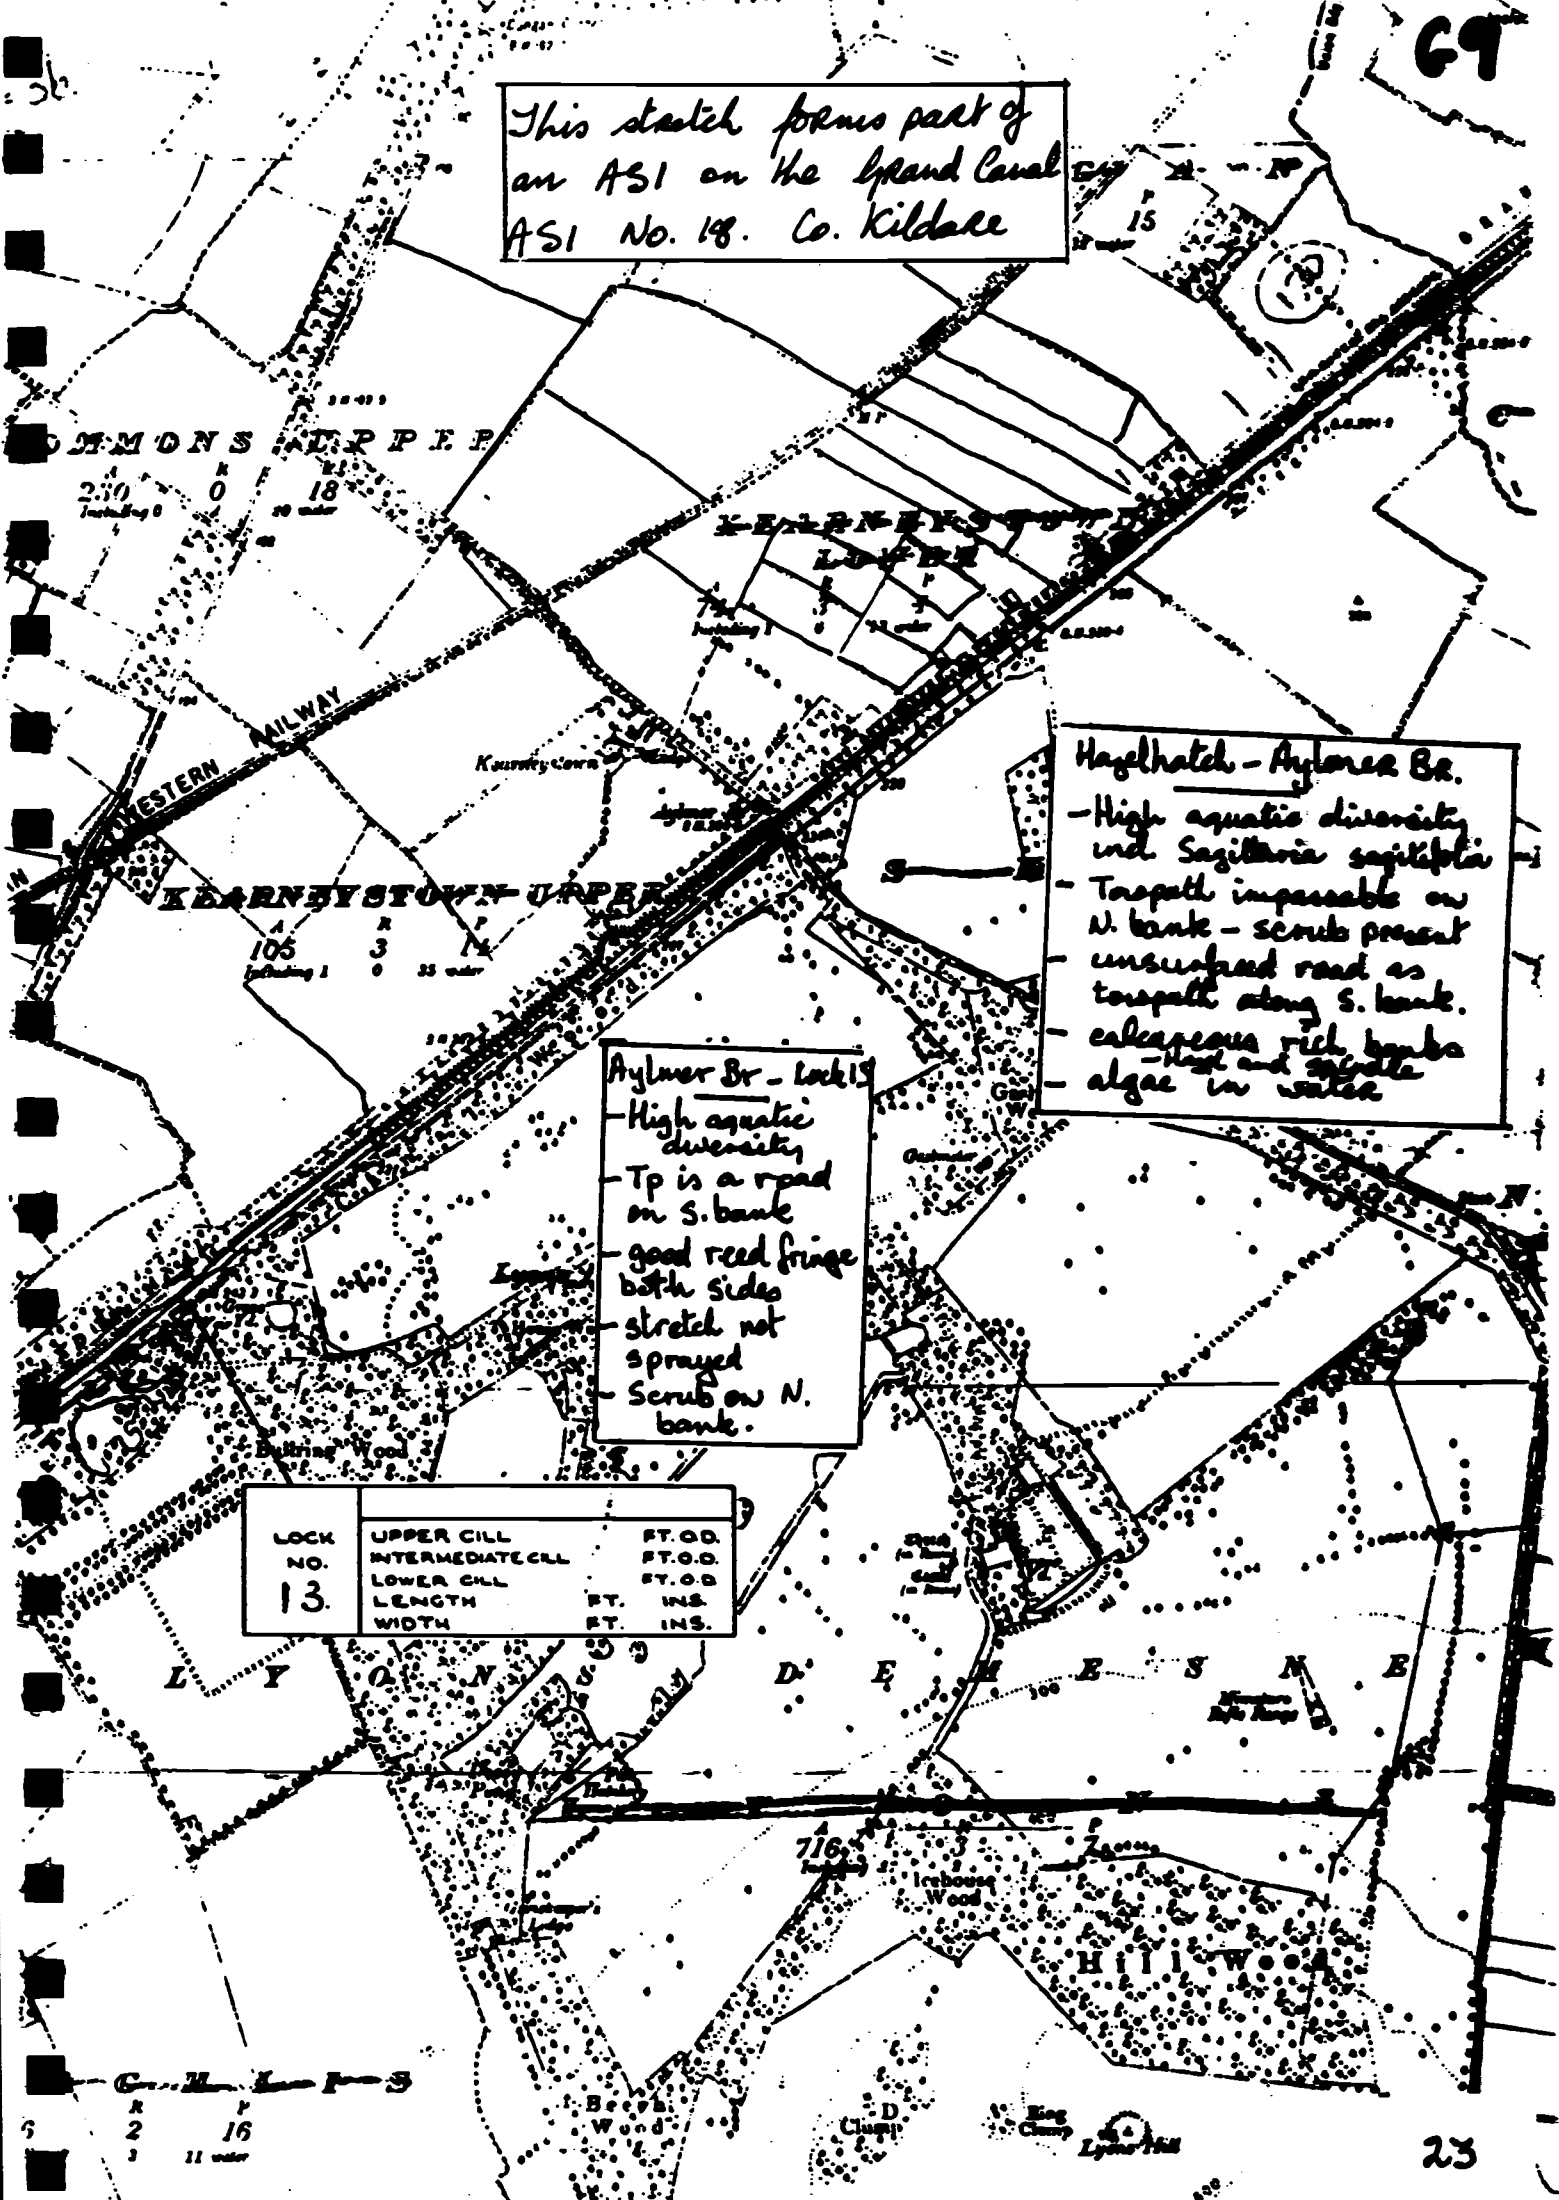
Hazelhatch - Aylmer Br.
 - High aquatic diversity
 incl *Sagittaria sagittifolia*
 - Troopth impassable on
 N. bank - scrub present
 unsurfaced road as
 troopth along S. bank.
 calcareous rich banks
 - High and middle
 algae in water

Aylmer Br - Lock 13
 - High aquatic
 diversity
 - Tp is a road
 on S. bank
 - good reed fringe
 both sides
 stretch not
 sprayed
 - Scrub on N.
 bank.

- Continue to mechanically cut and remove aquatic plants.
- Protect the existing reed fringes.
- If claying of the eroded banks is to take place ensure topsoil is spread on top. Seeds can germinate quicker when on or in the soil.
- Bank verges to be cut on a three year rotation basis to ensure against encroachment to towpath and damage to the banks. Some saplings to be left at each cutting.
- Take active measures to discourage dumping.
- Investigate the source of nutrients which is resulting in an abundance of algae. Joe Caffrey (1990) identified this stretch as being very high in nitrates/nitrites.

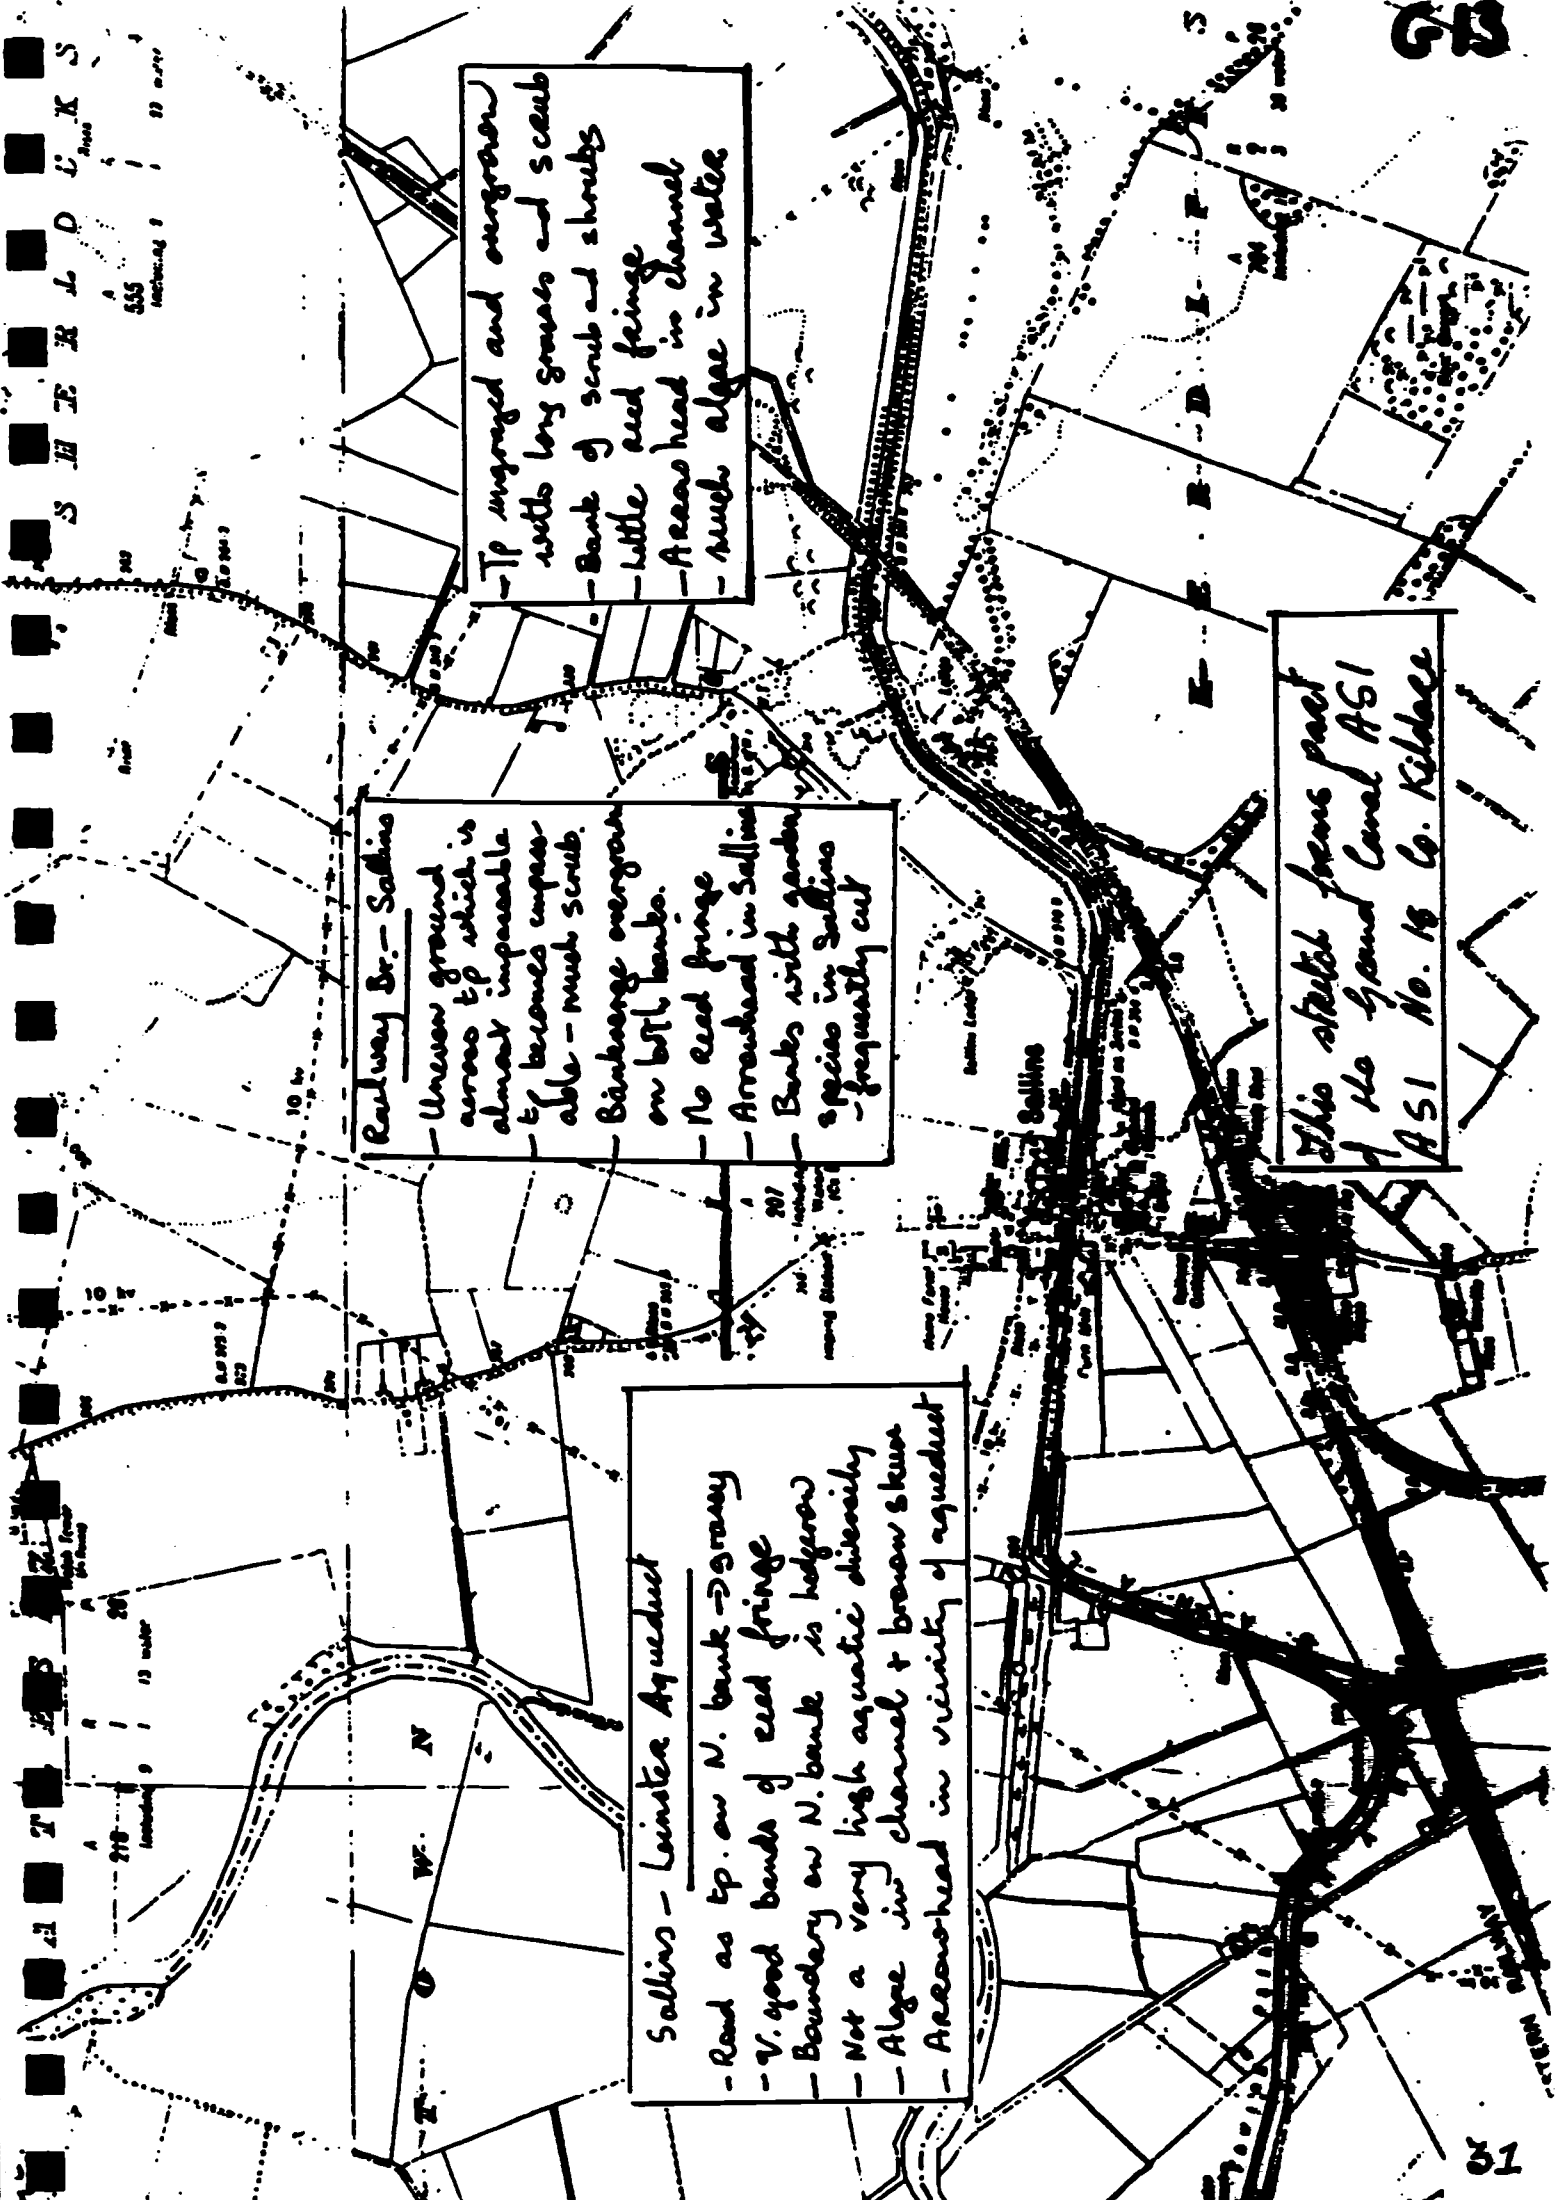
Railway Br. - Sallins

- Unweeded ground across tp which is almost impassable - becomes impassable - much scrub.
- Bankings overgrown on both banks.
- No eed fringe
- Arched in Sallins
- Banks with garden species in Sallins - frequently cut

- Continue to remove aquatic plants mechanically.
- Cut bank, towpath and boundary verge vegetation once a year in August/September and remove cuttings. This will ensure that a seed bank will be maintained and also encroachment with bramble and scrub species does not gain a stronghold. Leave some saplings on the bank after each cutting.
- Protect the reed fringes during canal operations.
- Ensure that nutrient - poor stretches are not enriched with cuttings.
- Cover clayed banks with topsoil to ensure quicker germination of seeds.
- Investigate water quality.
- Cattle to be prevented from poaching.

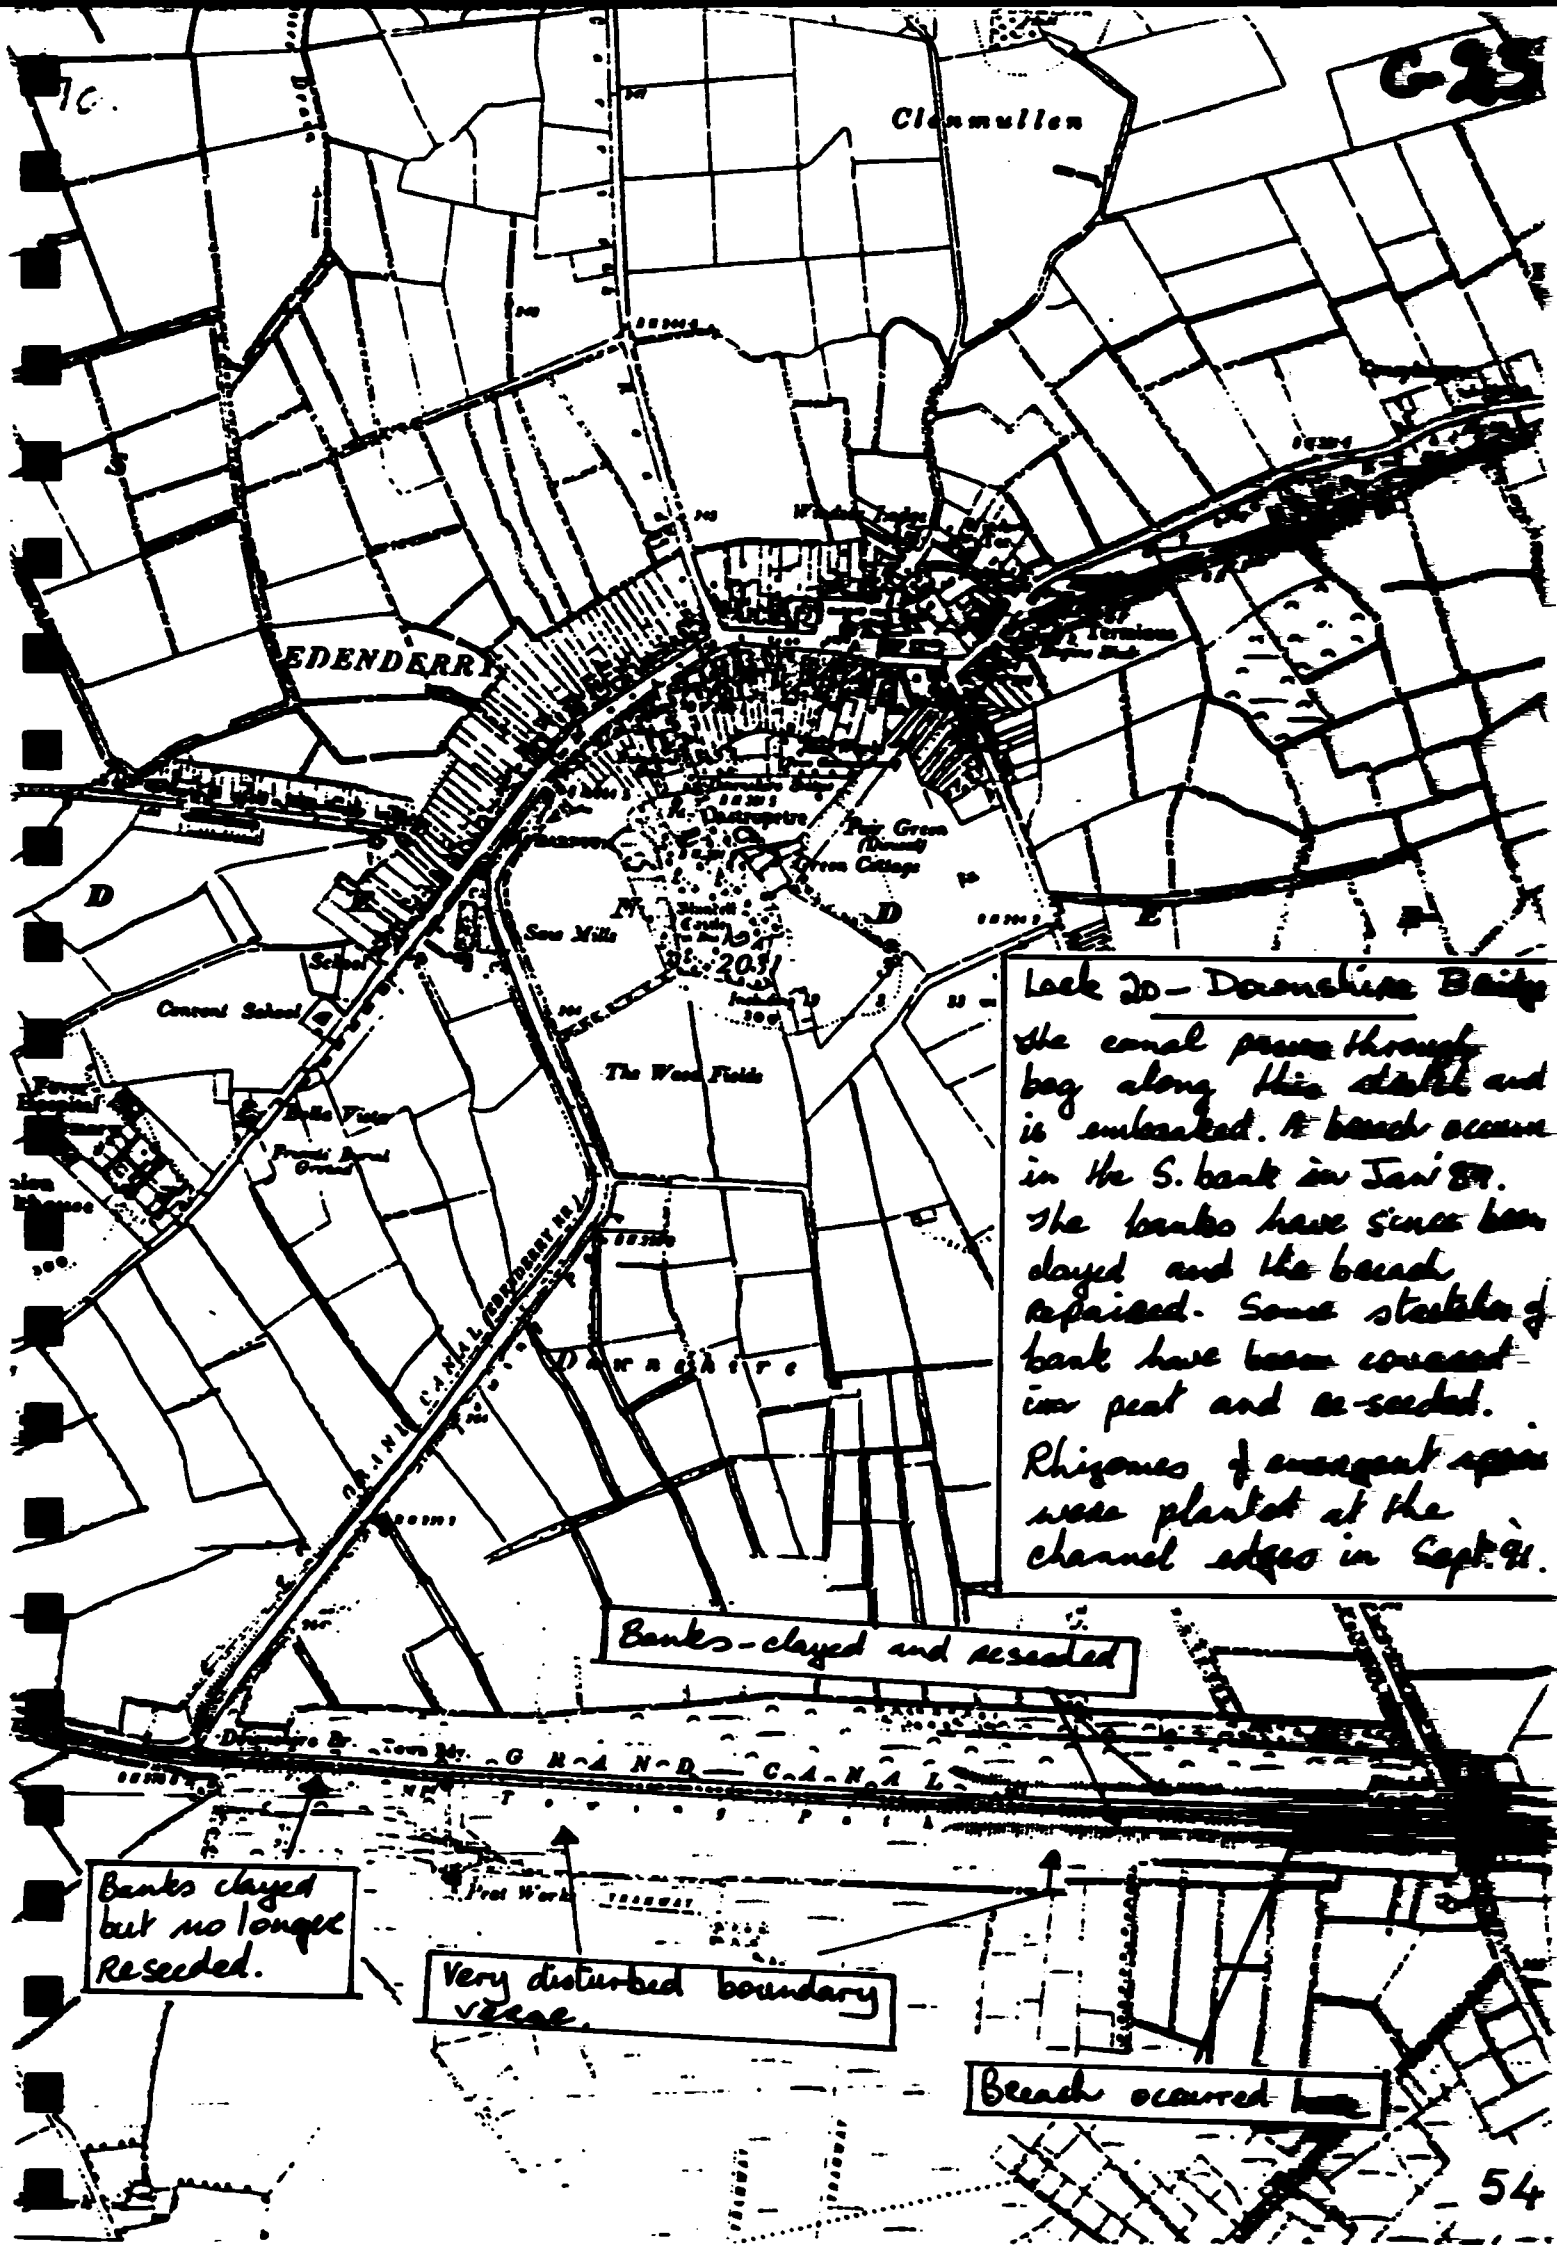
Lock 20 - Downshire Bridge
 The canal passes through bog along this ditch and is embanked. A bench occurs in the S. bank in Jan 88. The banks have since been clayed and the bench repaired. Some stretches of bank have been covered in peat and re-seeded. Rhizomes of emergent sedge were planted at the channel edges in Sept 91.

Banks - clayed and reseeded

- As there is so little aquatic vegetation or reed fringe, this stretch should not be treated with herbicides in 1992.
- Cut the calcareous banks and towpaths once a year at the end of the growing season. Remove cuttings.
- Cut the bank and boundary verge east of George's Bridge twice in 1992 and thereafter every year at the end of the growing season.
- Protect the hedgerow.
- Cover the clayed banks with topsoil to encourage germination and bank stabilization.

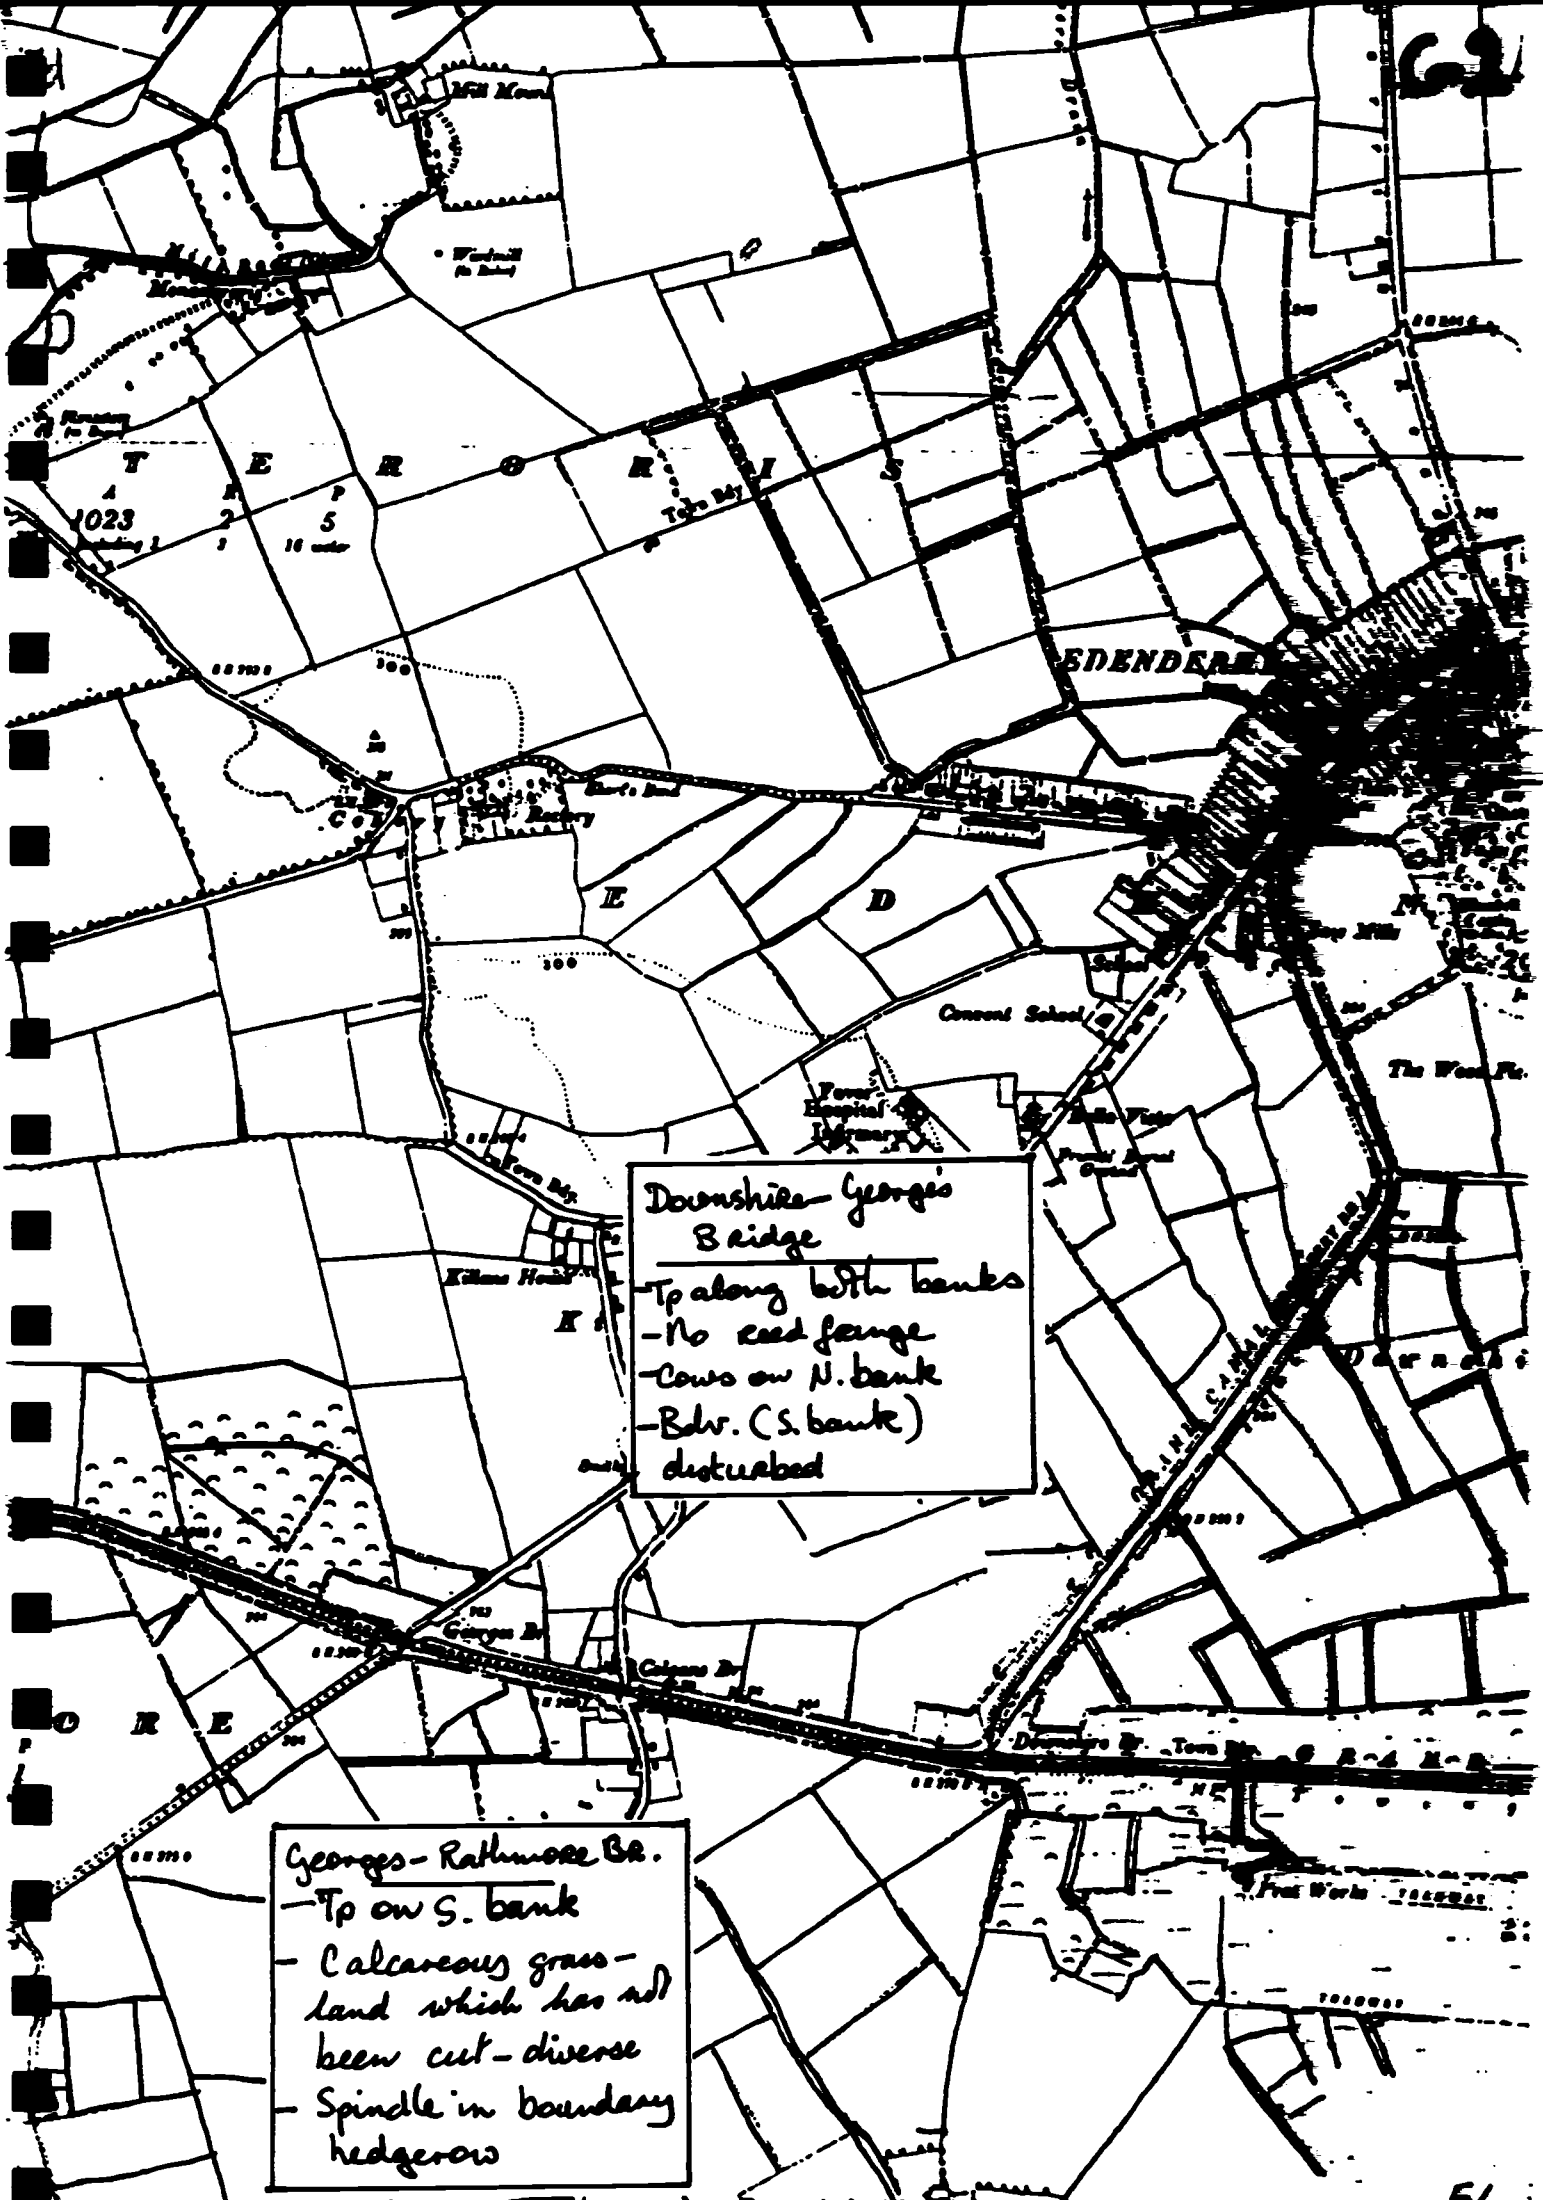
Downshire-George's
Bridge
Tp along both banks
- No reed fence
- Cows on N. bank
- Bdr. (S. bank)
disturbed

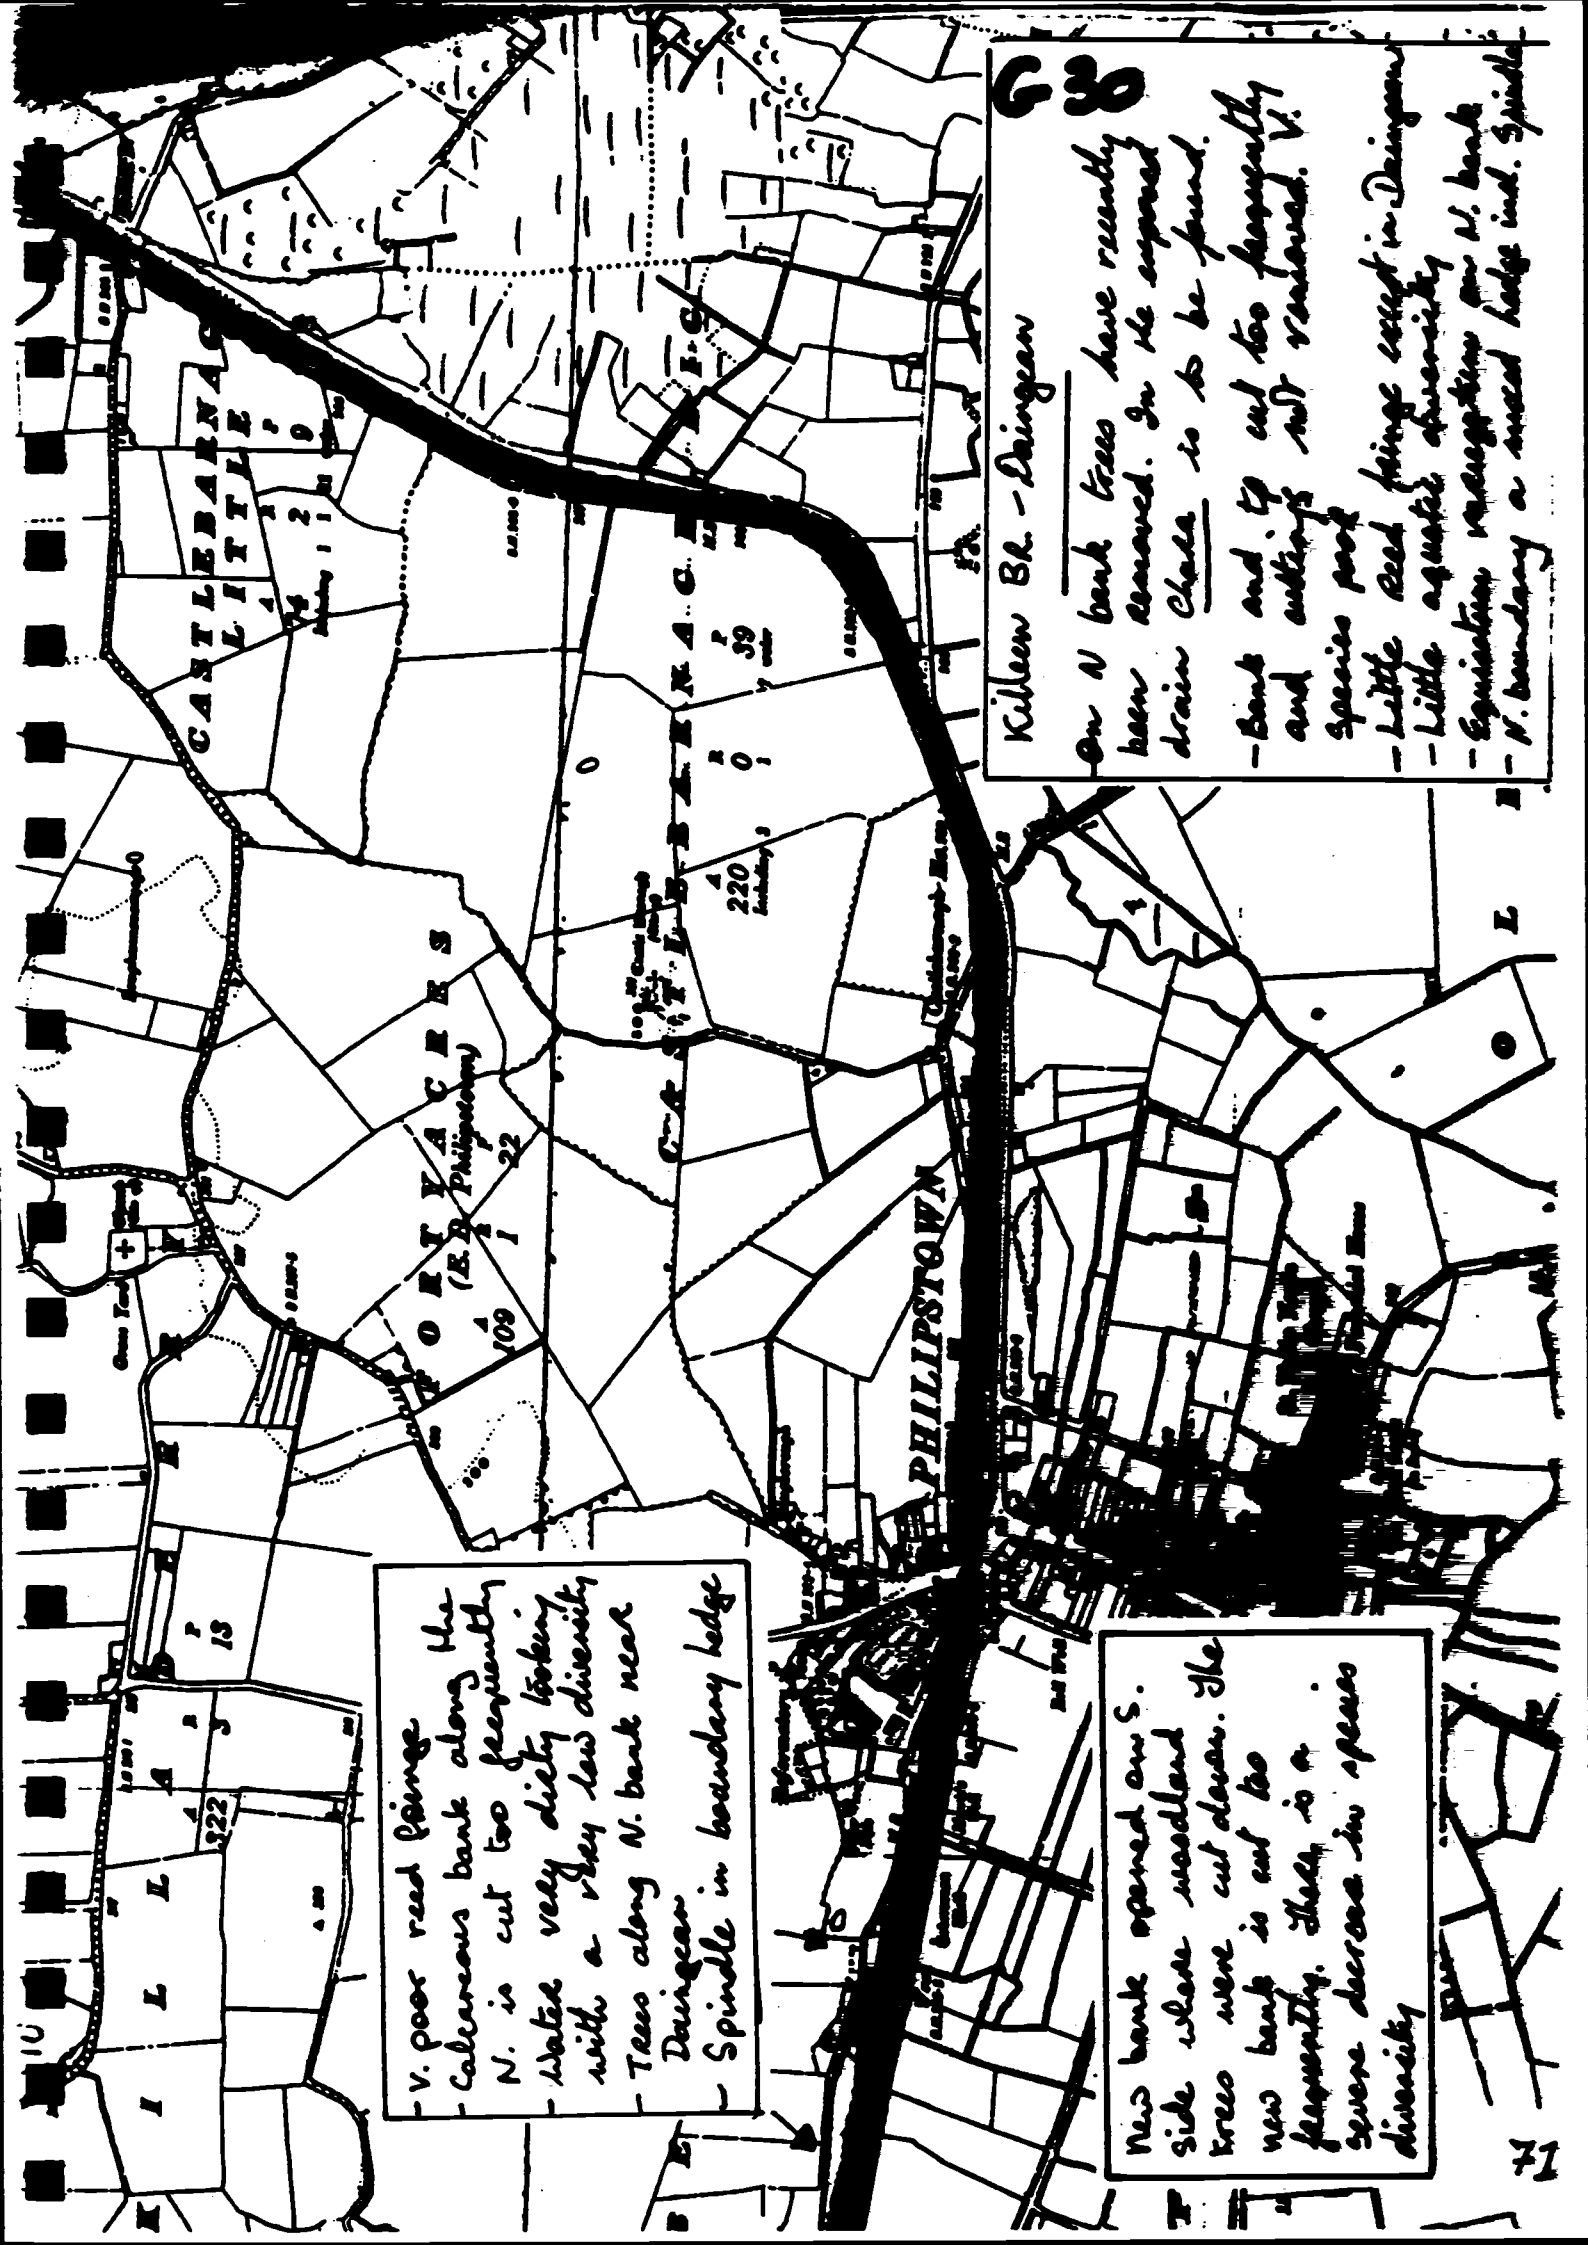
Kilkew Bl. - Daingean

On N bank trees have recently been removed. In the exposed drain Chama is to be found.

- Do not carry out any form of control on the aquatic plants in 1992, following the recommendations of the CFB (Caffrey, 1991).
- Cut the north bank, and the bank and towpath of south side once a year at the end of the growing season. Collect cuttings. In this way plants will be able to produce seeds and so ensure diversity again the following year. Invertebrates will have a food supply in the flowers. These various zones will be allowed to develop into a meadow and add to the beauty of the canal. The cuttings must be removed in order to ensure against enrichment which leads to the success of competitive species.
