ECOLOGICAL SURVEY

GRAND CANAL

Part 2 Conservation Management Plan 1991

**Prepared for
The Wildlife Service and Waterways Section,
Office of Public Works. 1992.**

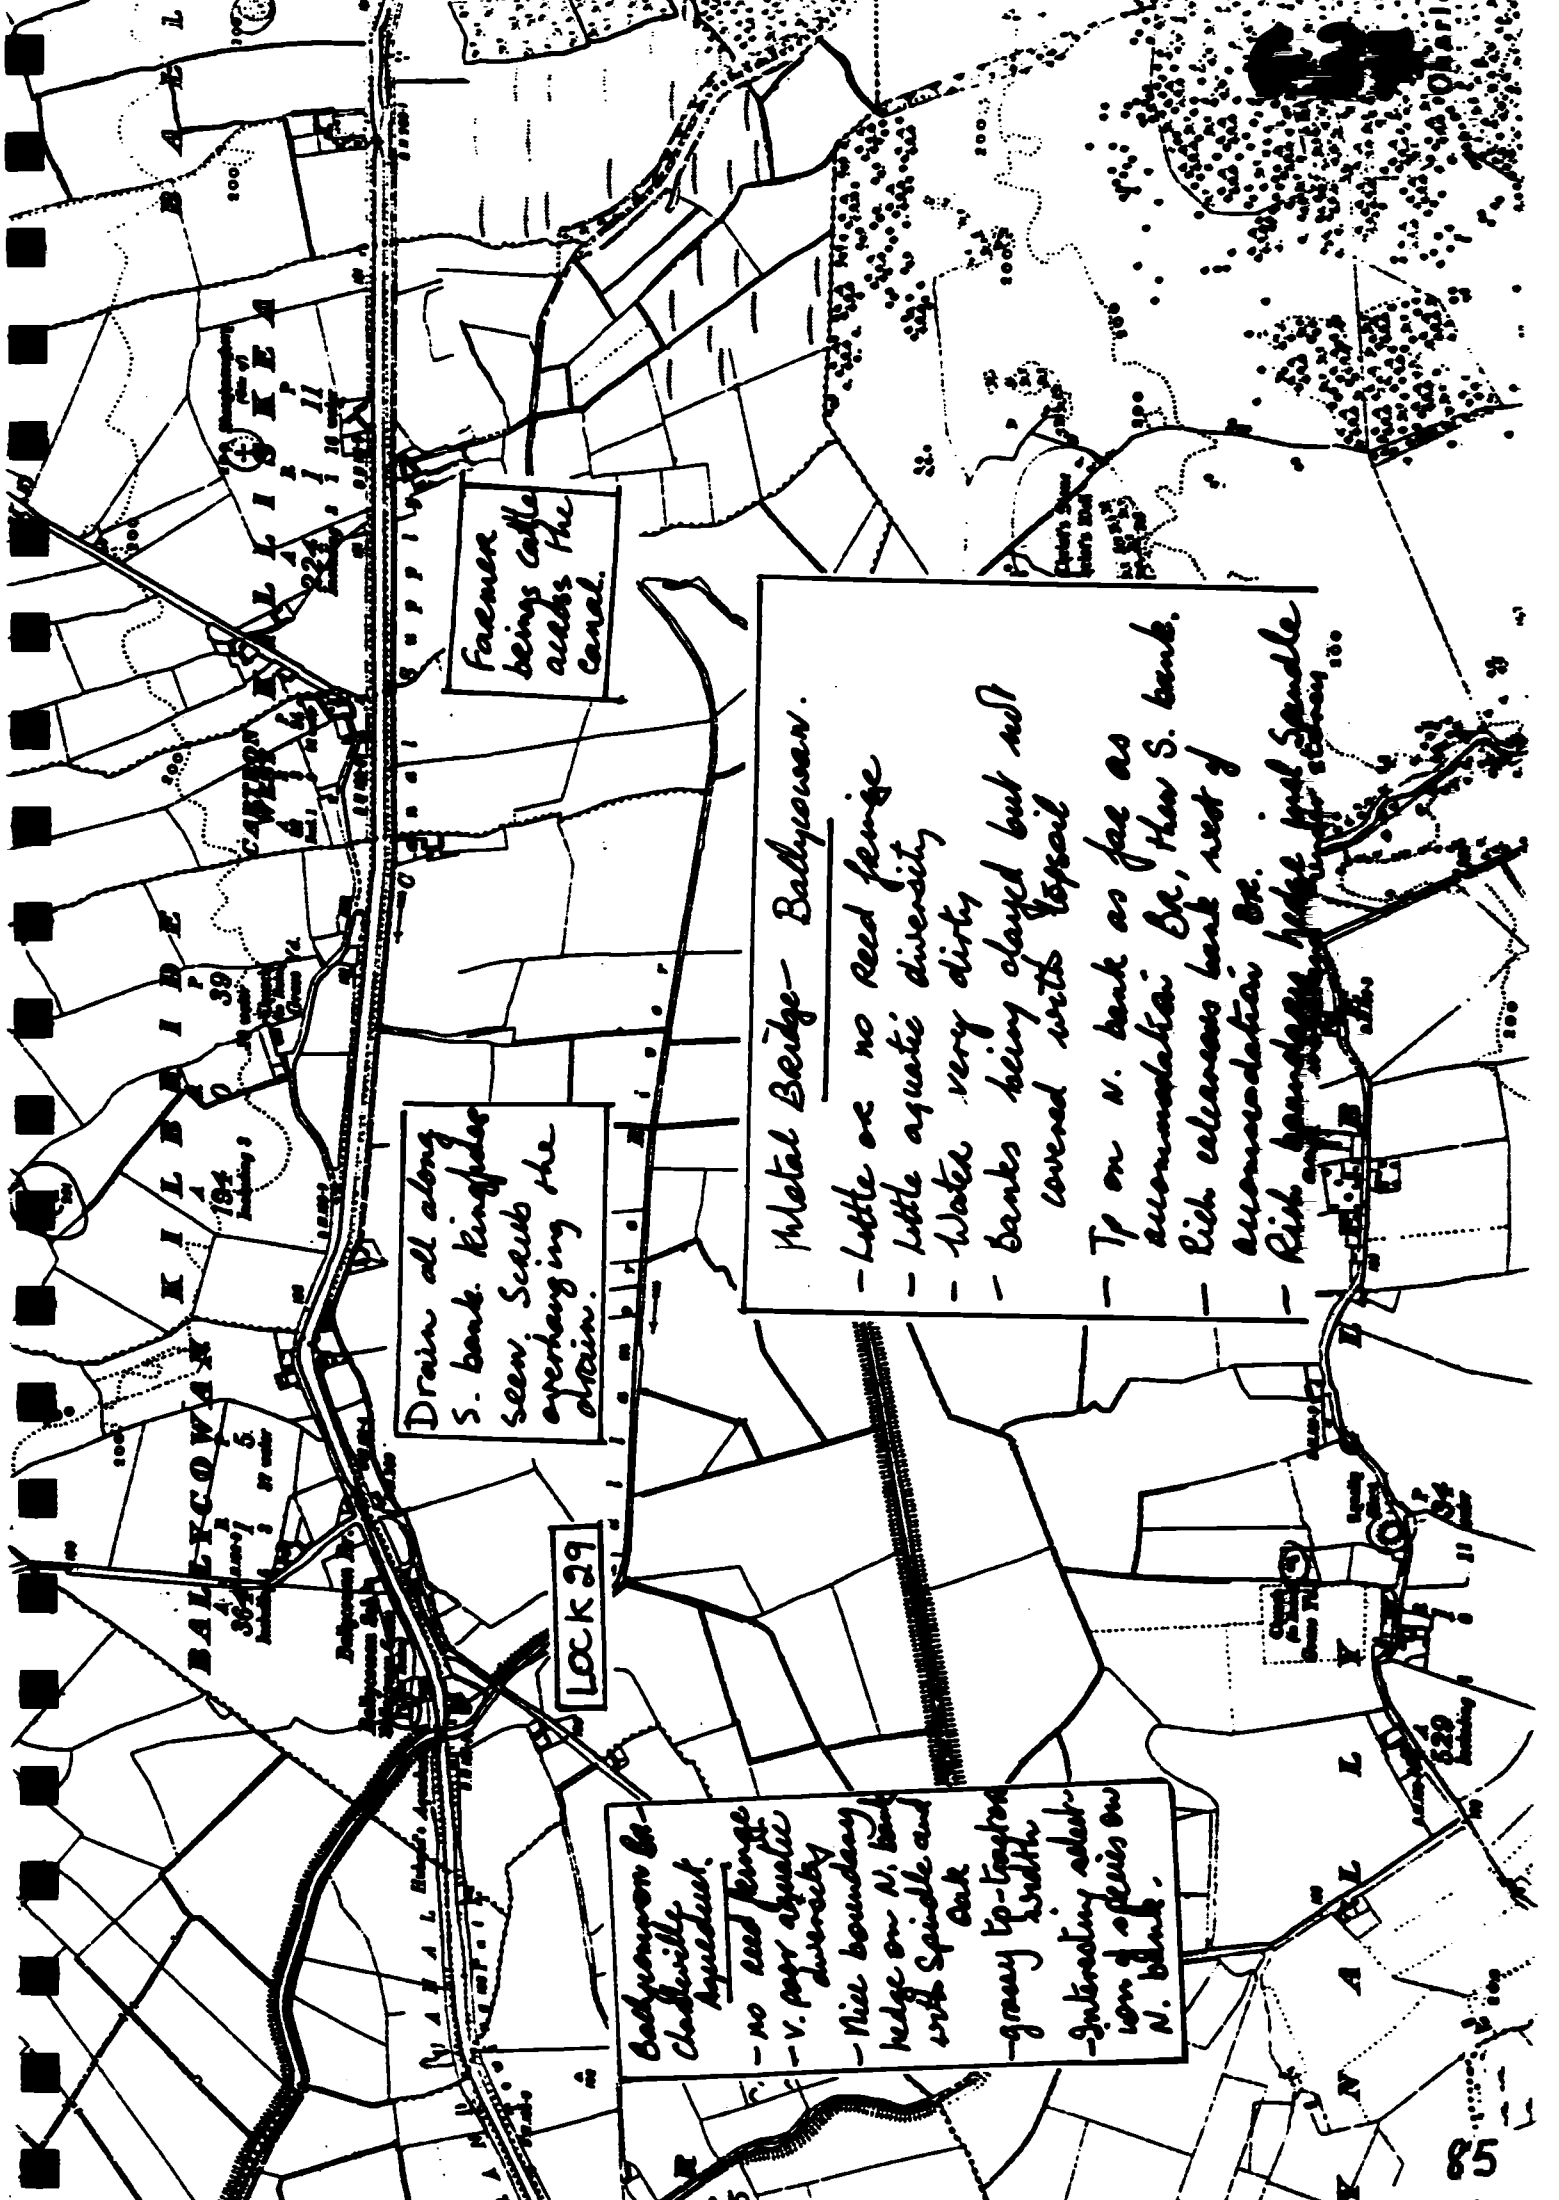
Farmers
beings cattle
across the
canal.

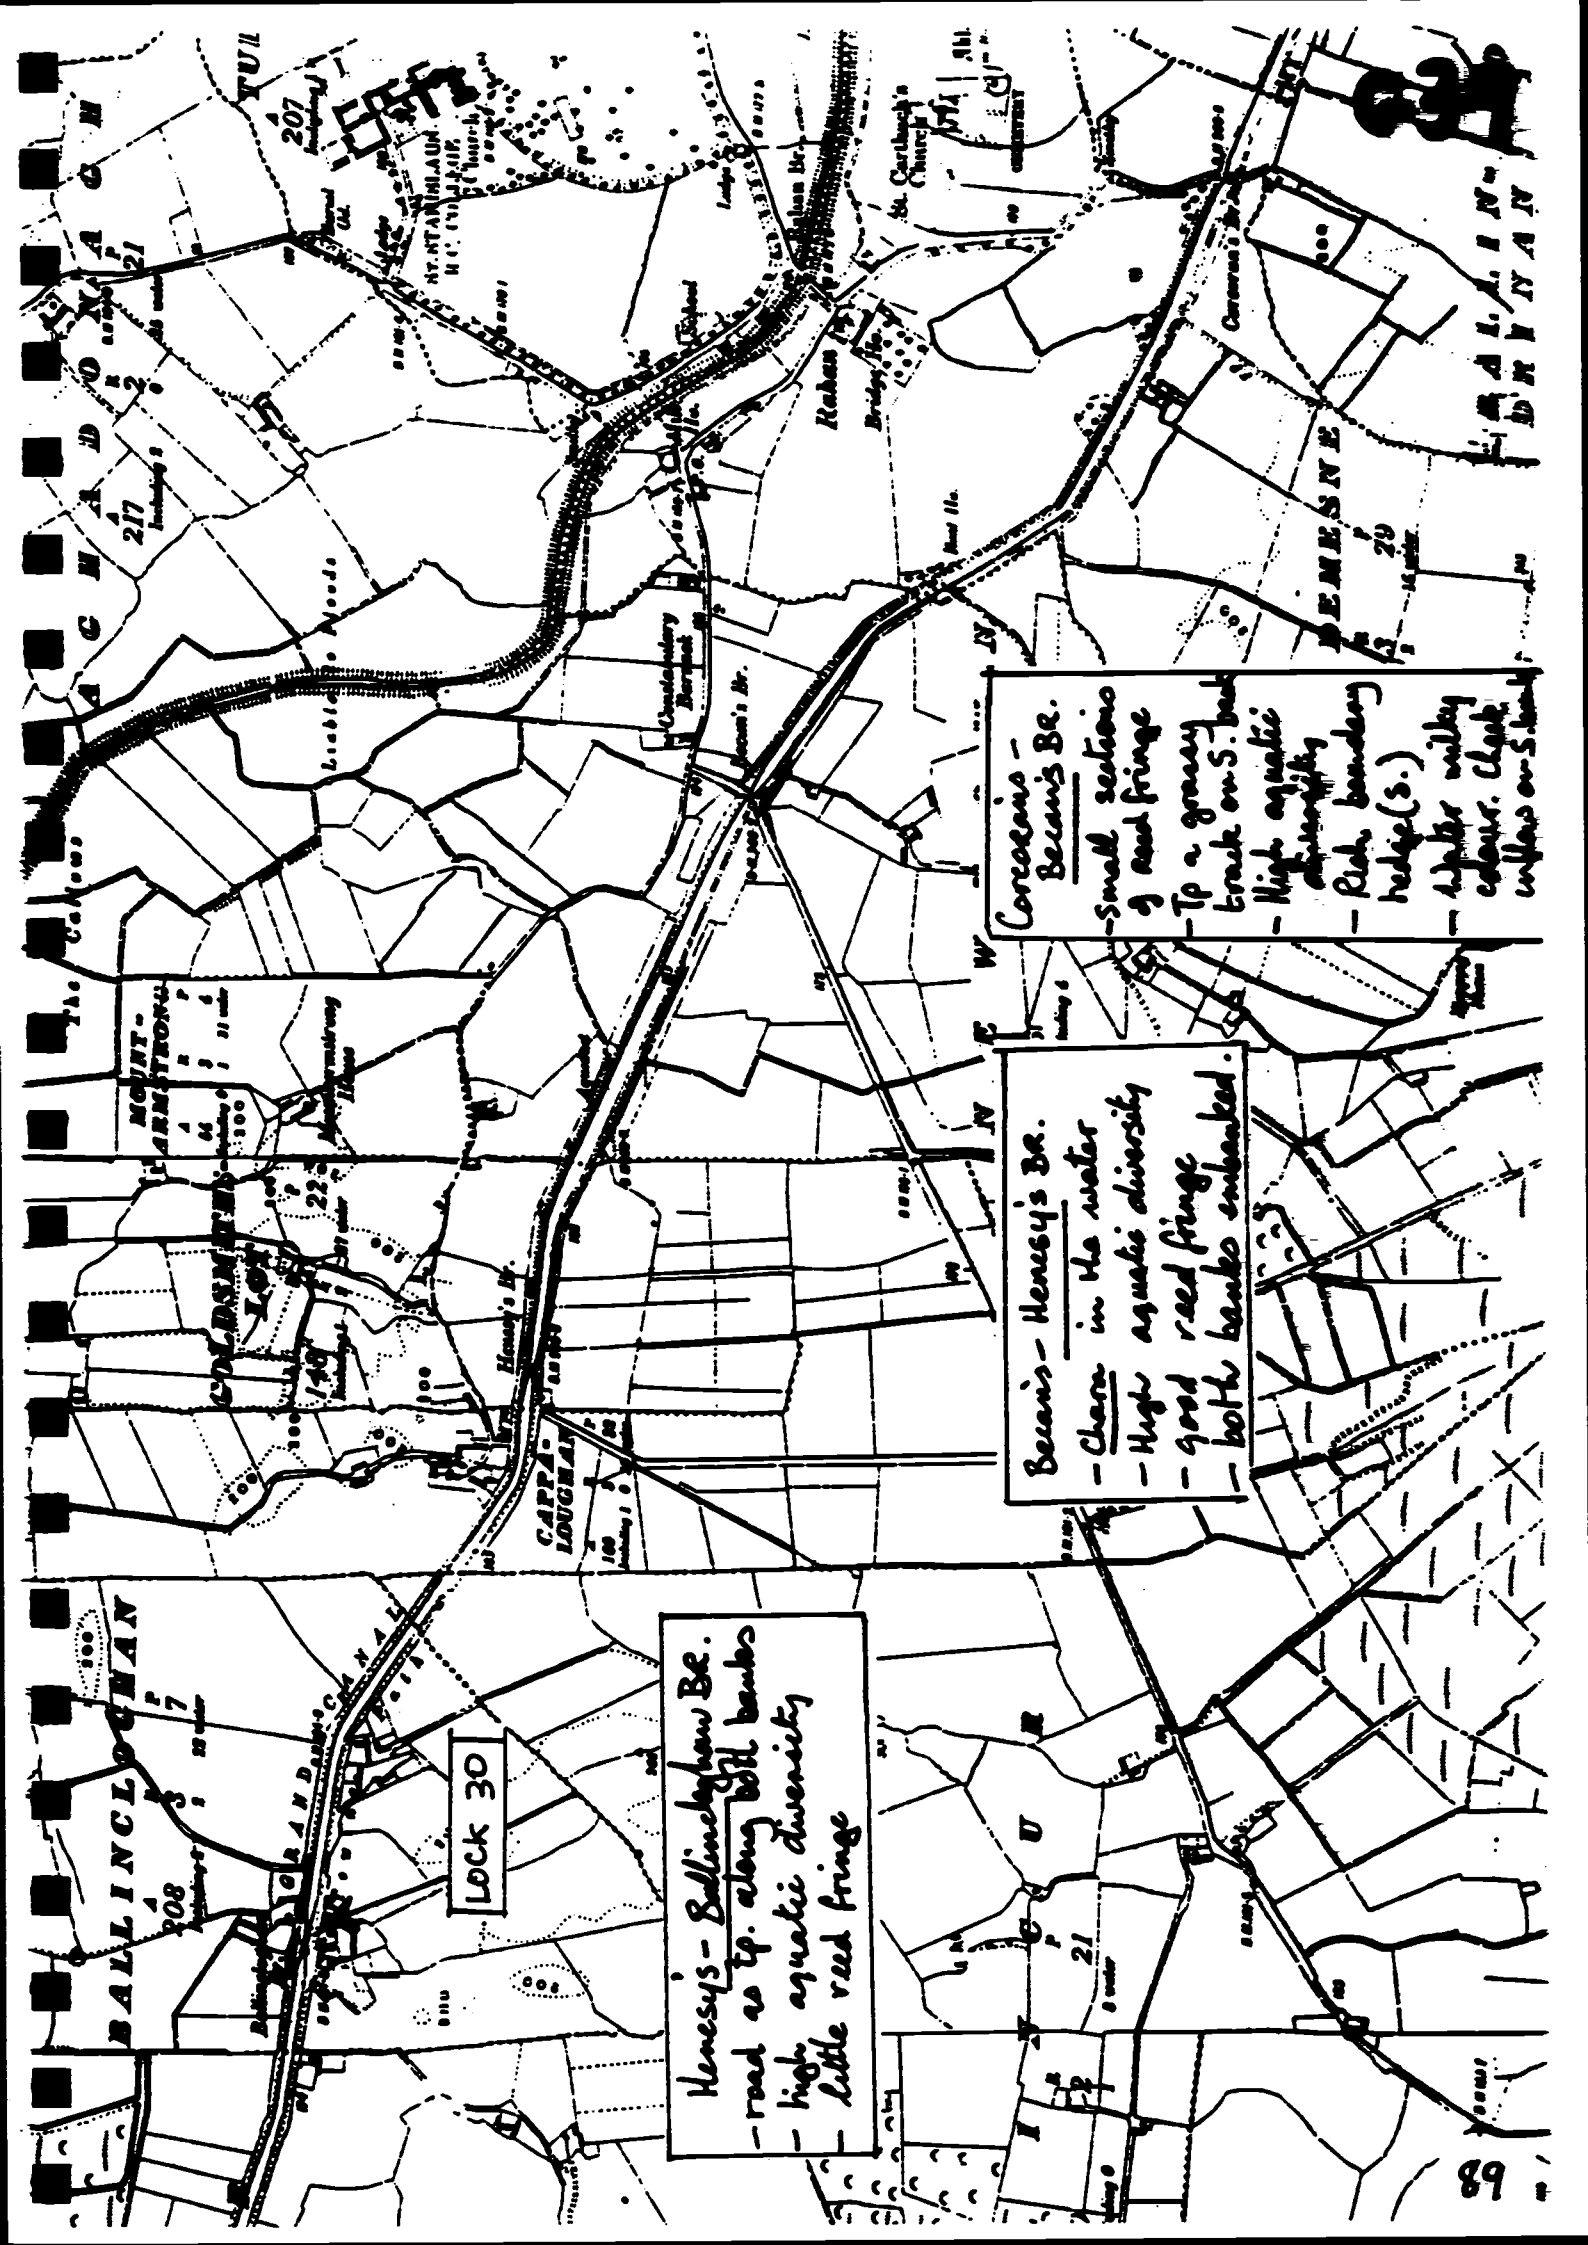
Honey's - BallincloUGHAN BE.
- road as tp. along both banks
- high aquatic diversity
- little reed fringe

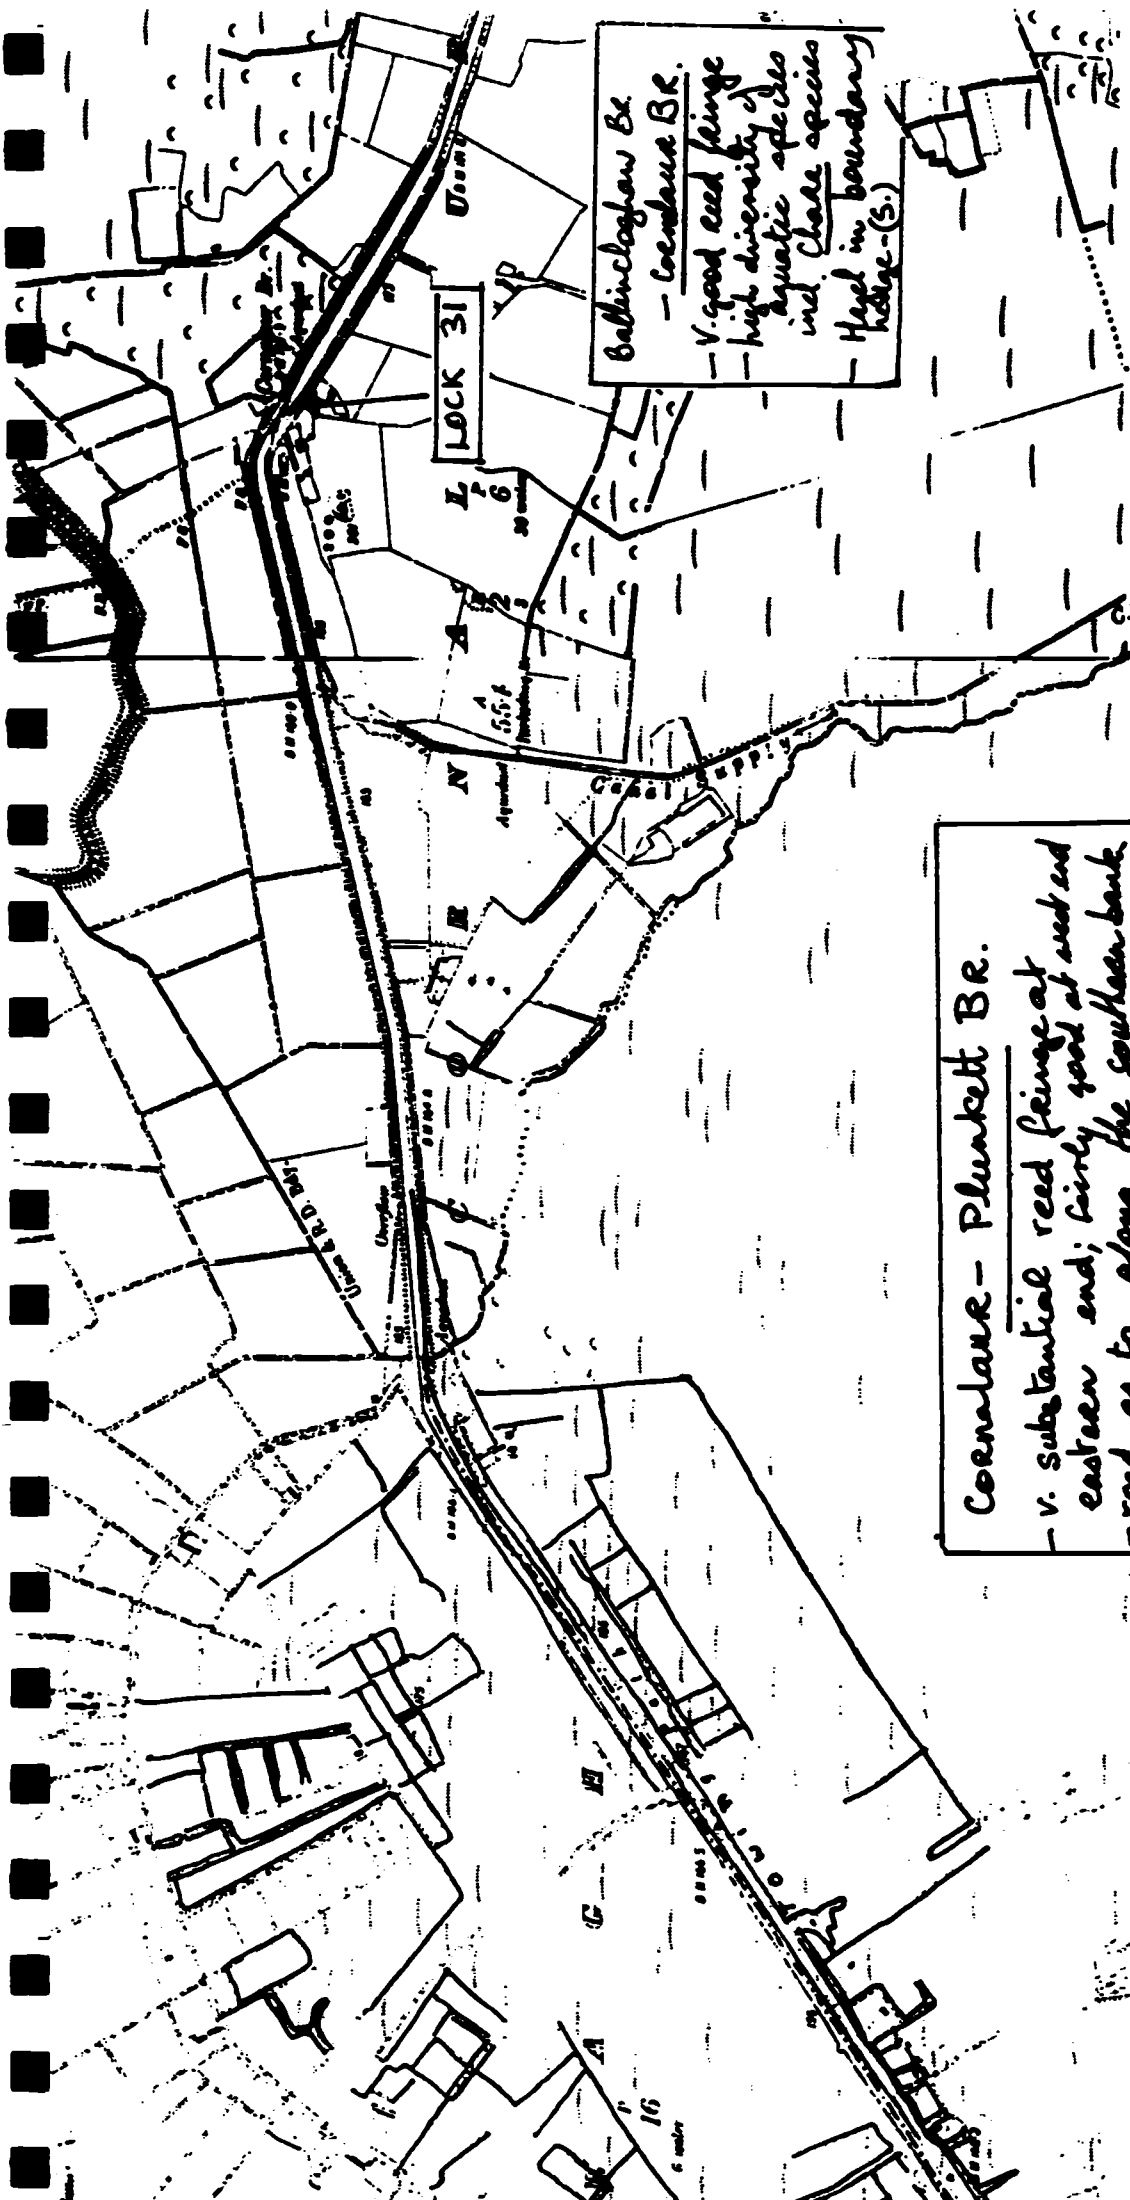
Ballynagowan Br.
 - Coenlaur Br.
 - V. good weed fringe
 - high diversity of aquatic species incl. Clas species
 - Heel in boundary hedge (S.)

Coenlaur - Plunkett Br.
 - v. substantial weed fringe at eastern end; fairly good at west end
 - road as tp. along the southern bank
 - removal of a wide band of trees from the N. bank
 - clayed banks not covered with
 - misc. bdr. (S. B. beyond it to S.)
 - v. nice Calamagrostis S. bank especially at the western end
 - good diversity of aquatic species.

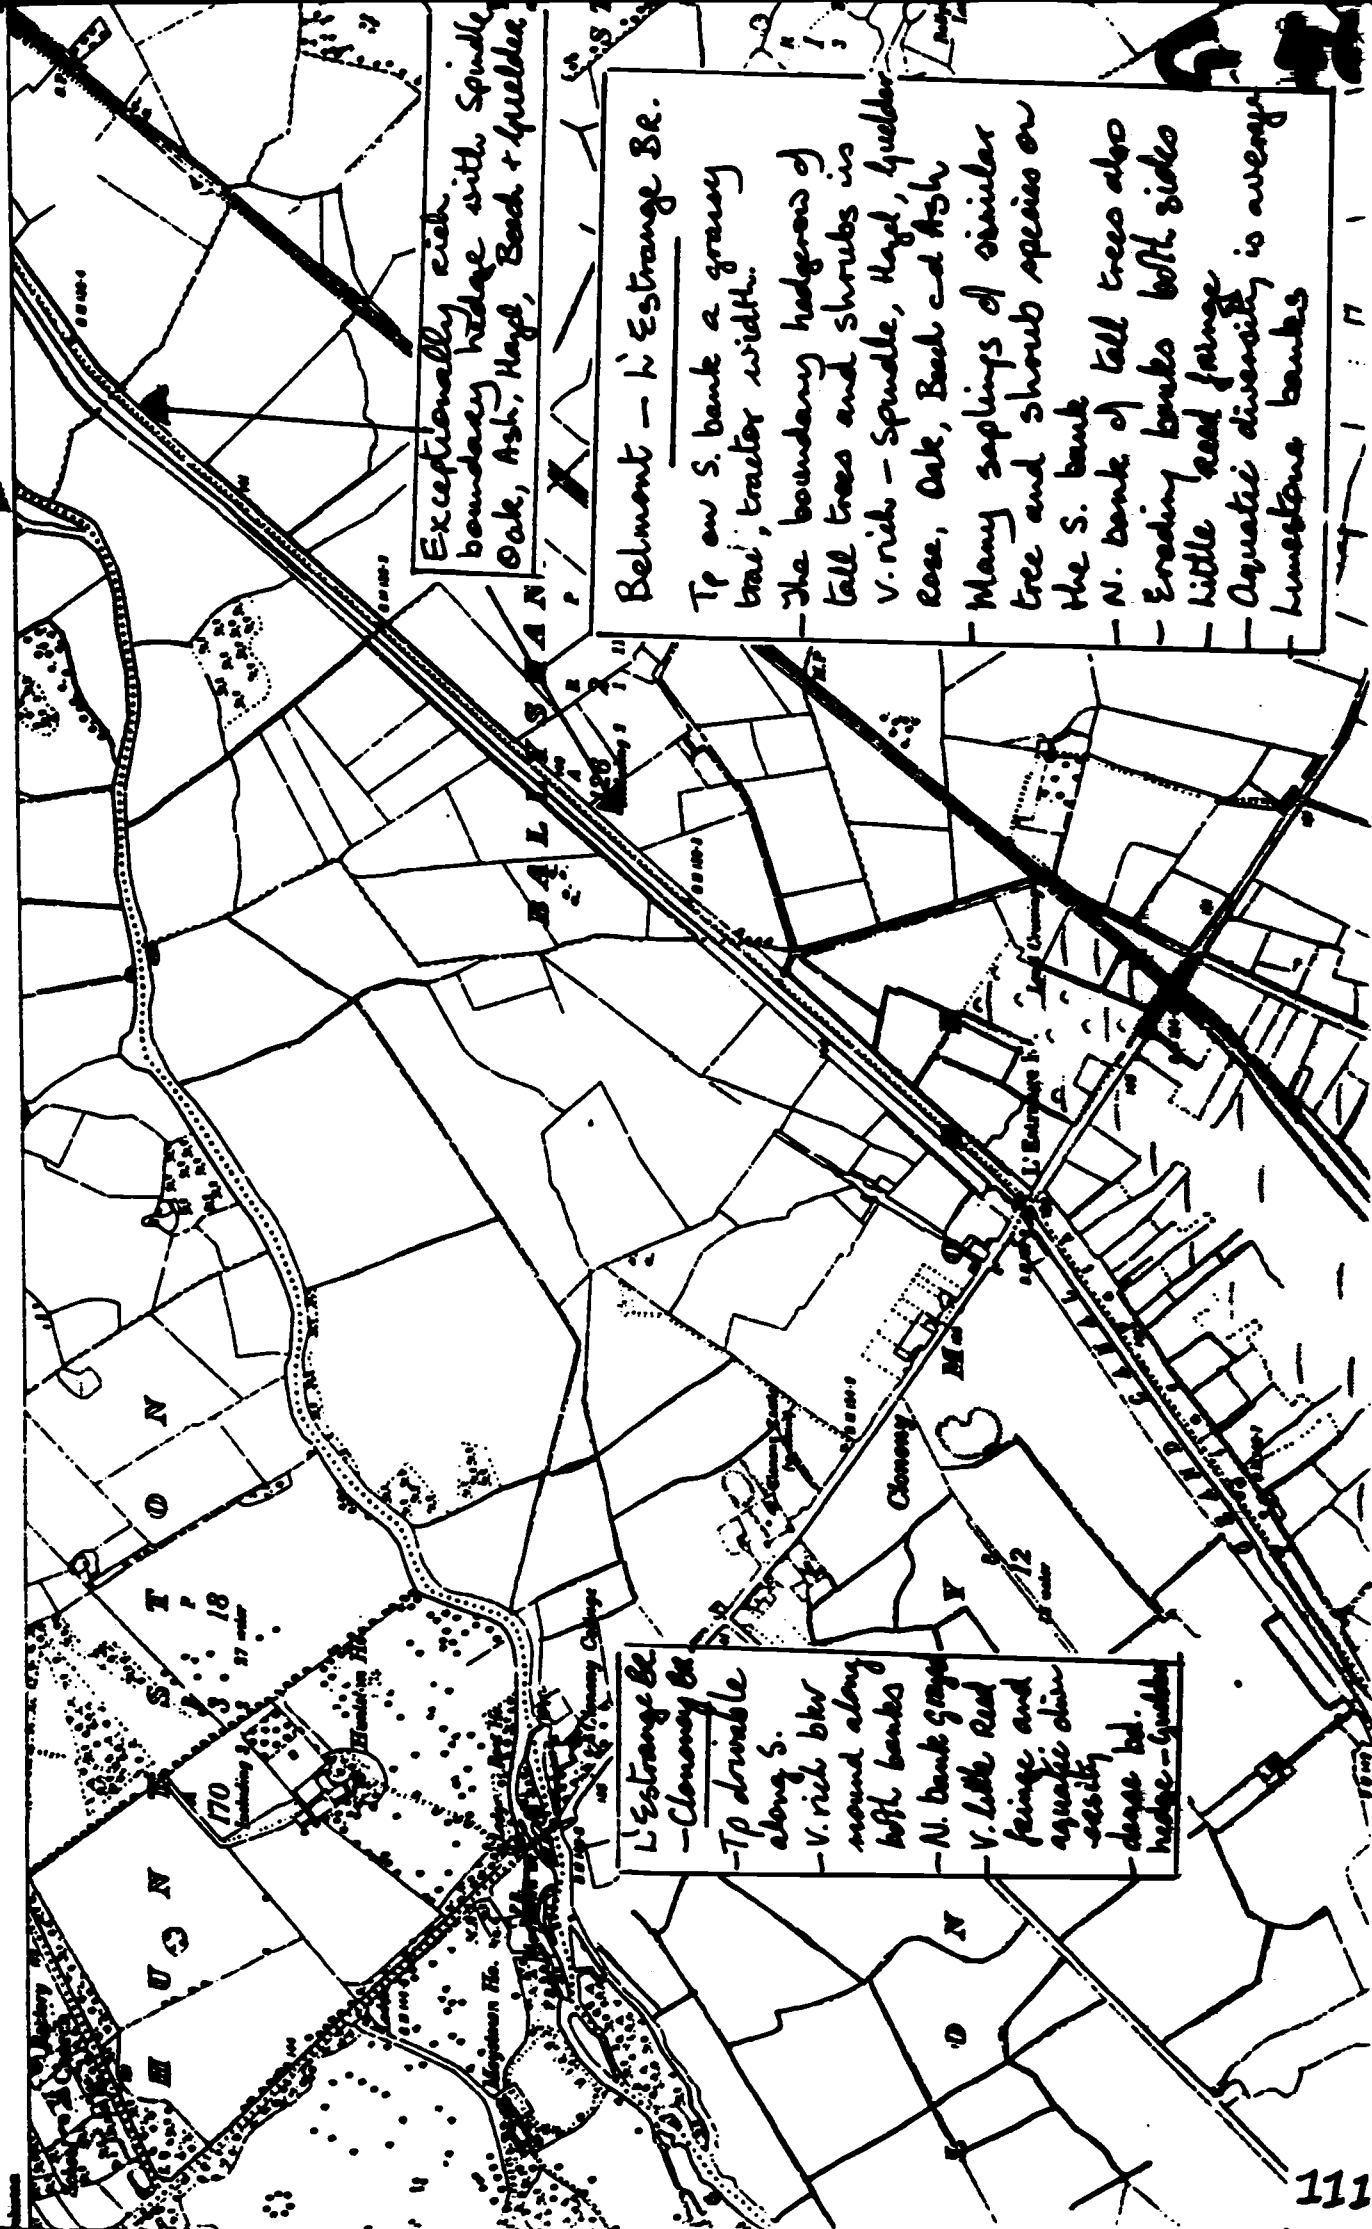
Exceptionally rich
boundary hedge with Spindle
Oak, Ash, Hazel, Bush & Quelder

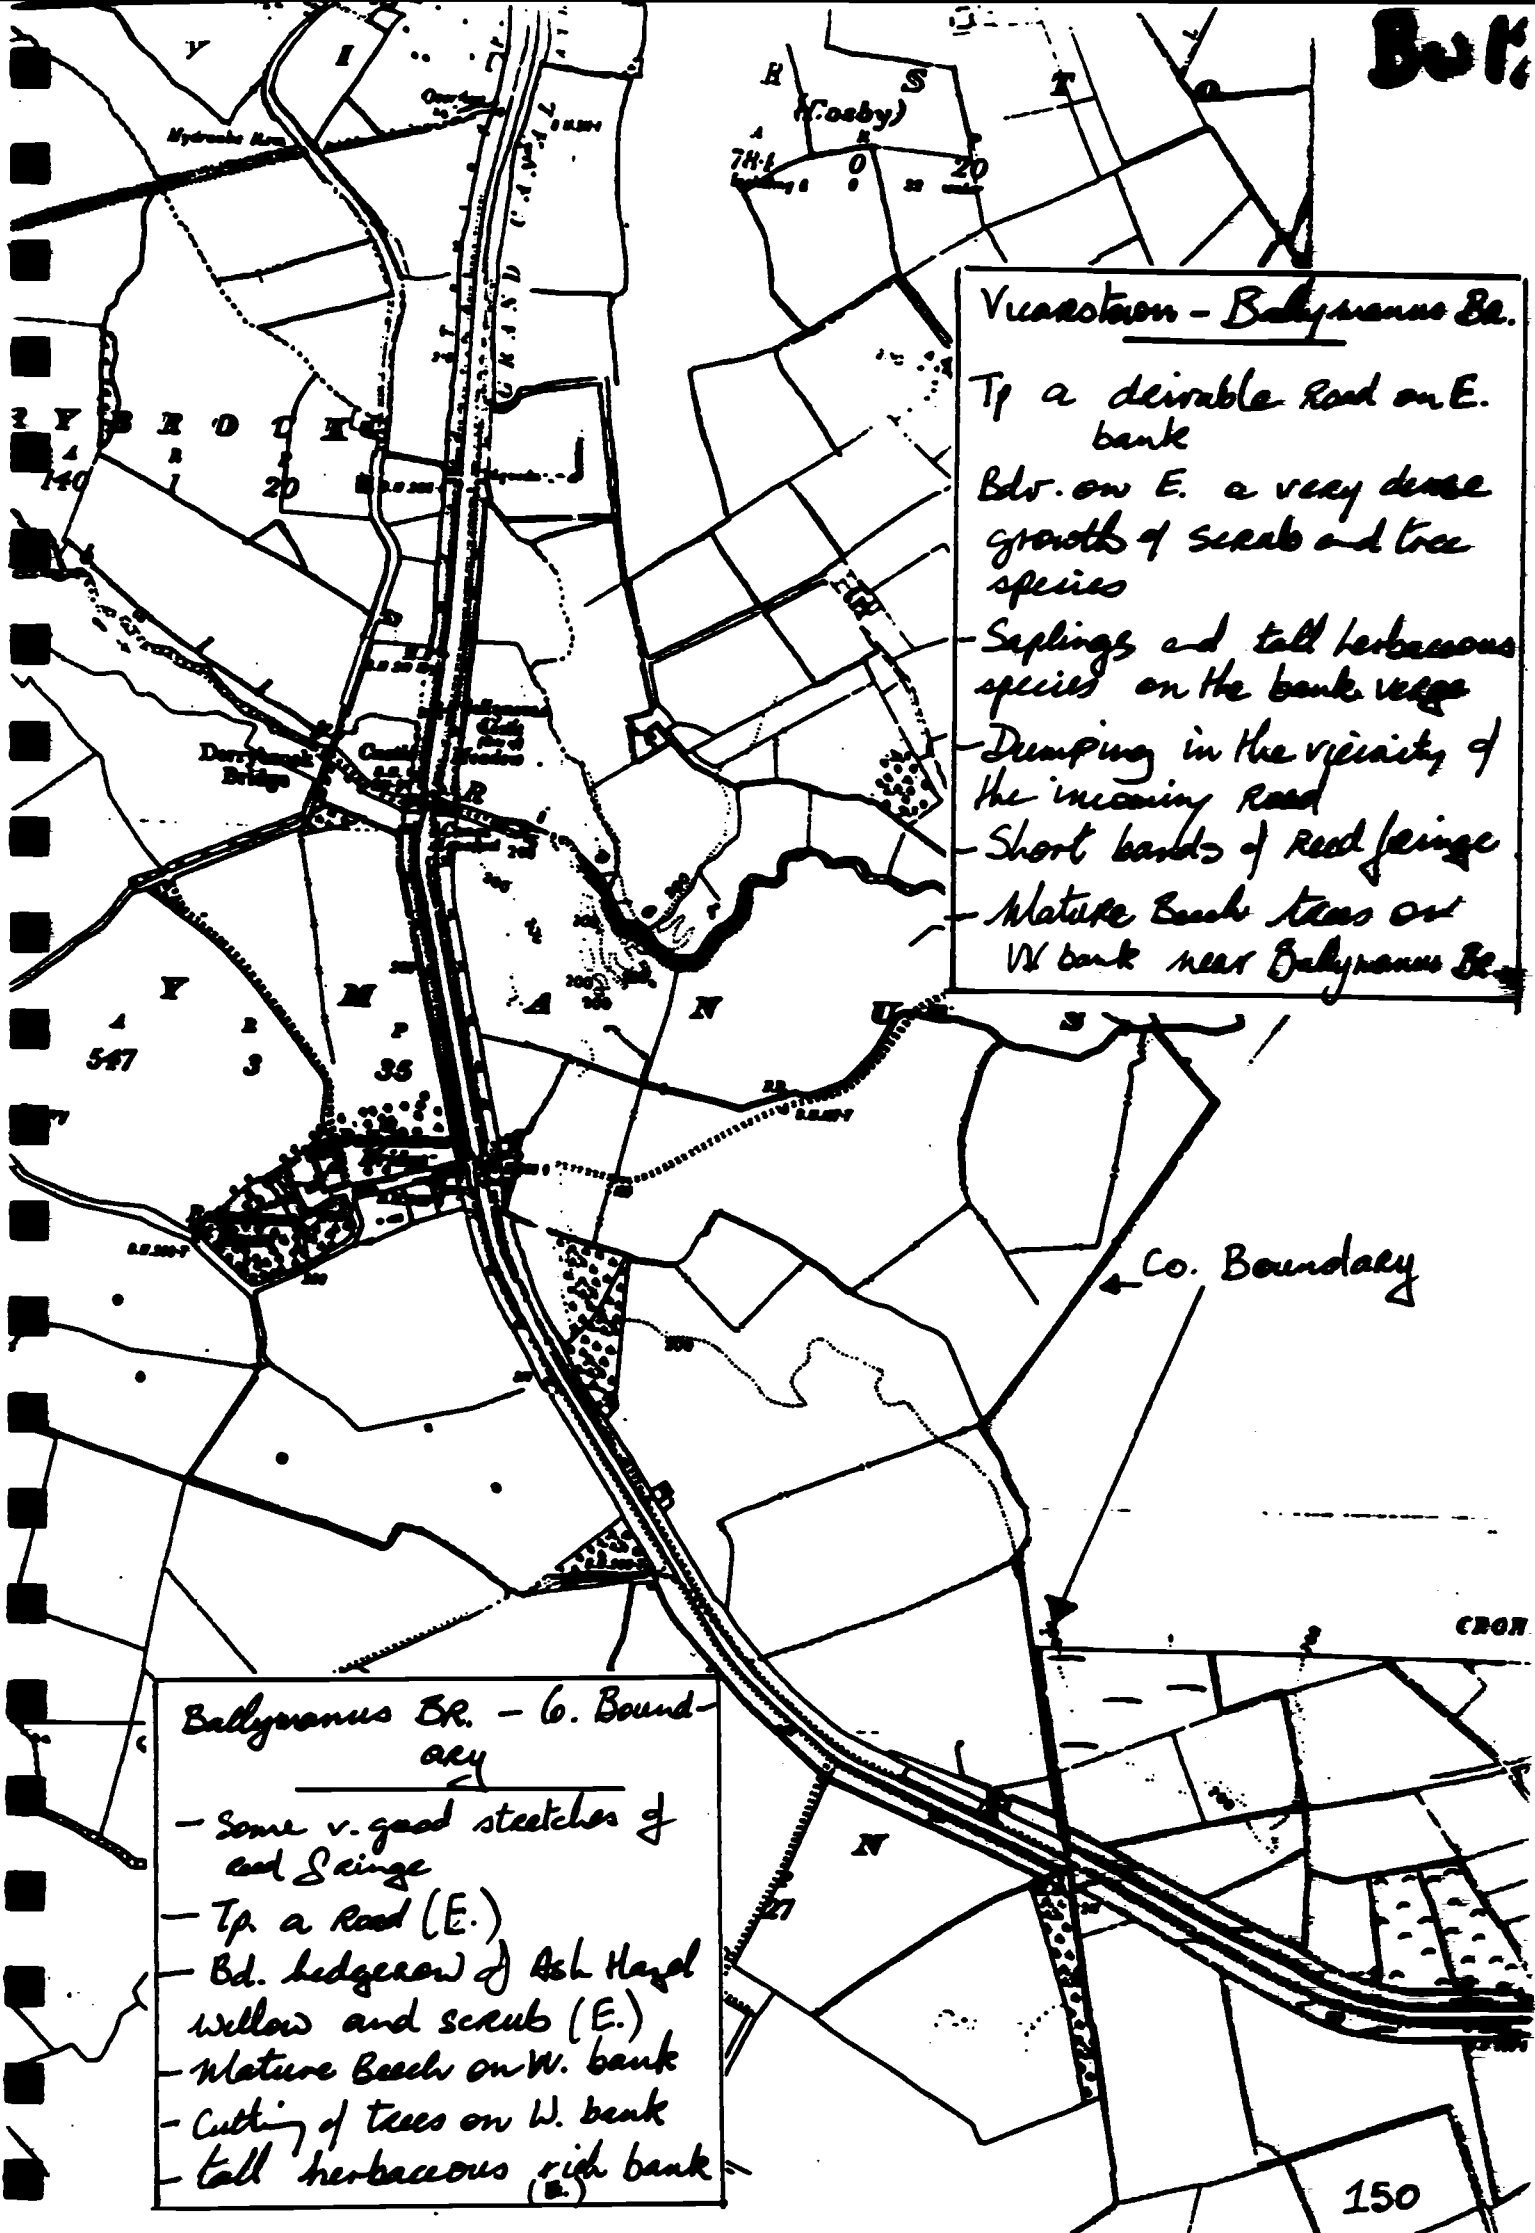
Vicarstown - Ballynarus Br.

- Some v. good stretches of cut Sedge
- Tp a Road (E.)
- Bd. hedgerow of Ash Hazel willow and scrub (E.)
- Mature Beech on W. bank
- Cutting of trees on W. bank
- tall herbaceous rich bank (E.)

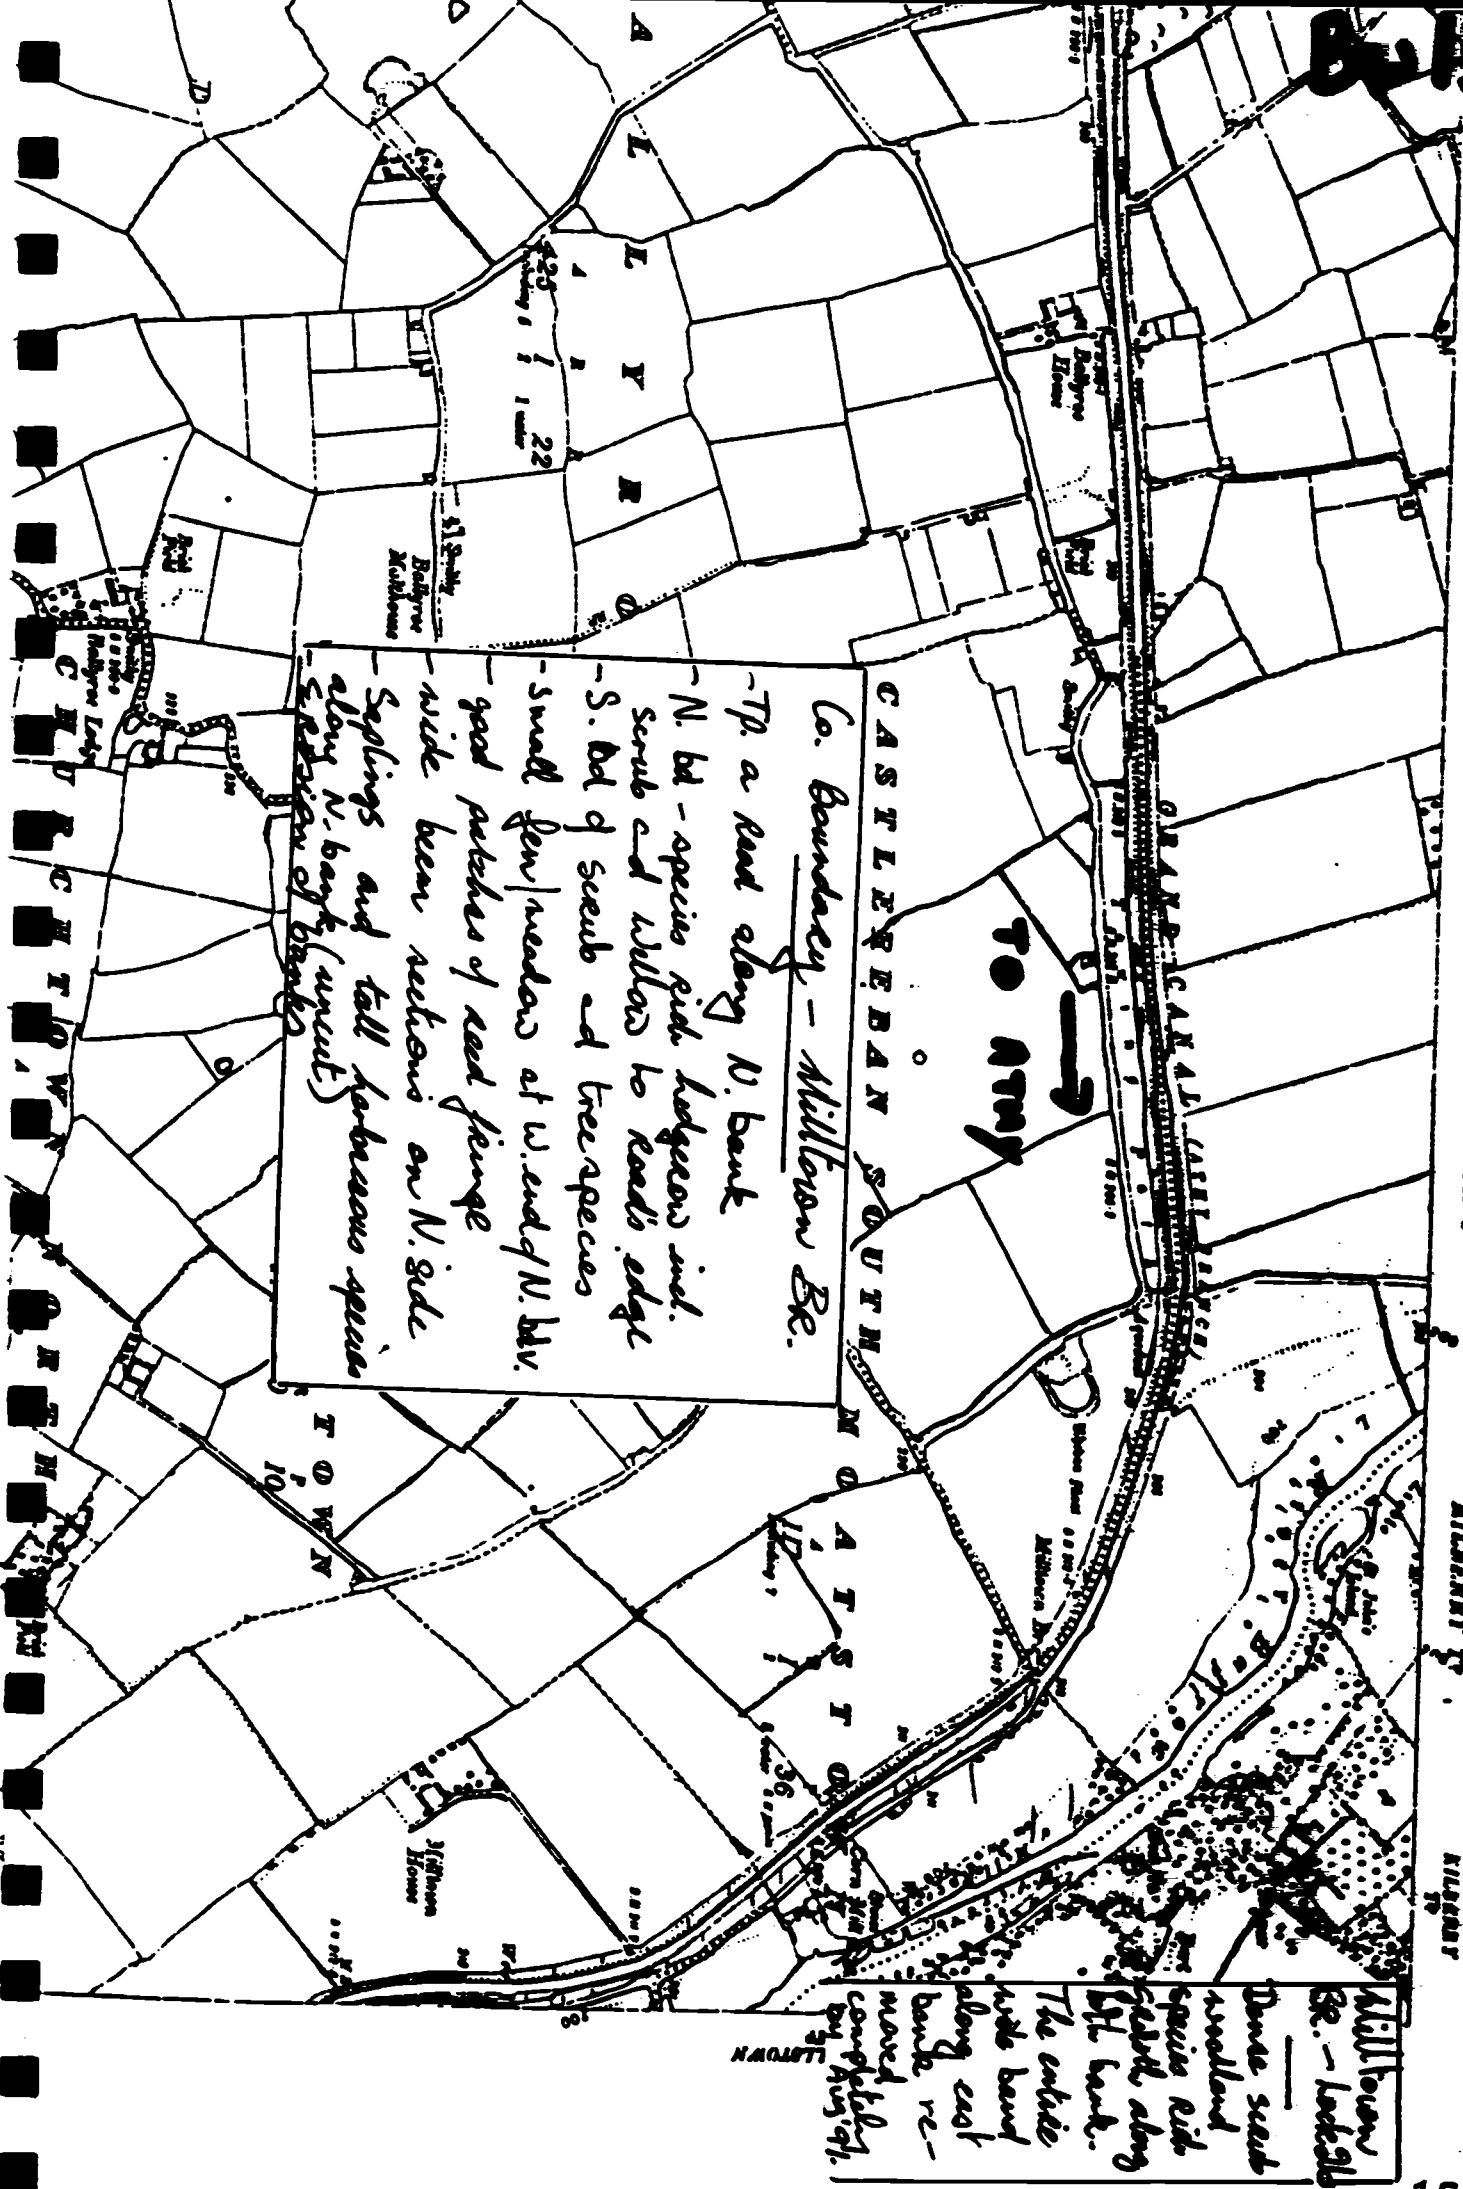
Co. Boundary - Milltown Br.
-Tp. a road along N. bank
-N. bd - species rich hedgerow incl.
scrub and willows to road's edge
-S. Bd of scrub and tree species
-small fen/meadows at W. end of N. bd.
-good patches of reed fringe
-wide open sections on N. side
-Saplings and tall herbaceous species
along N. bank (uncut)
-sections of banks

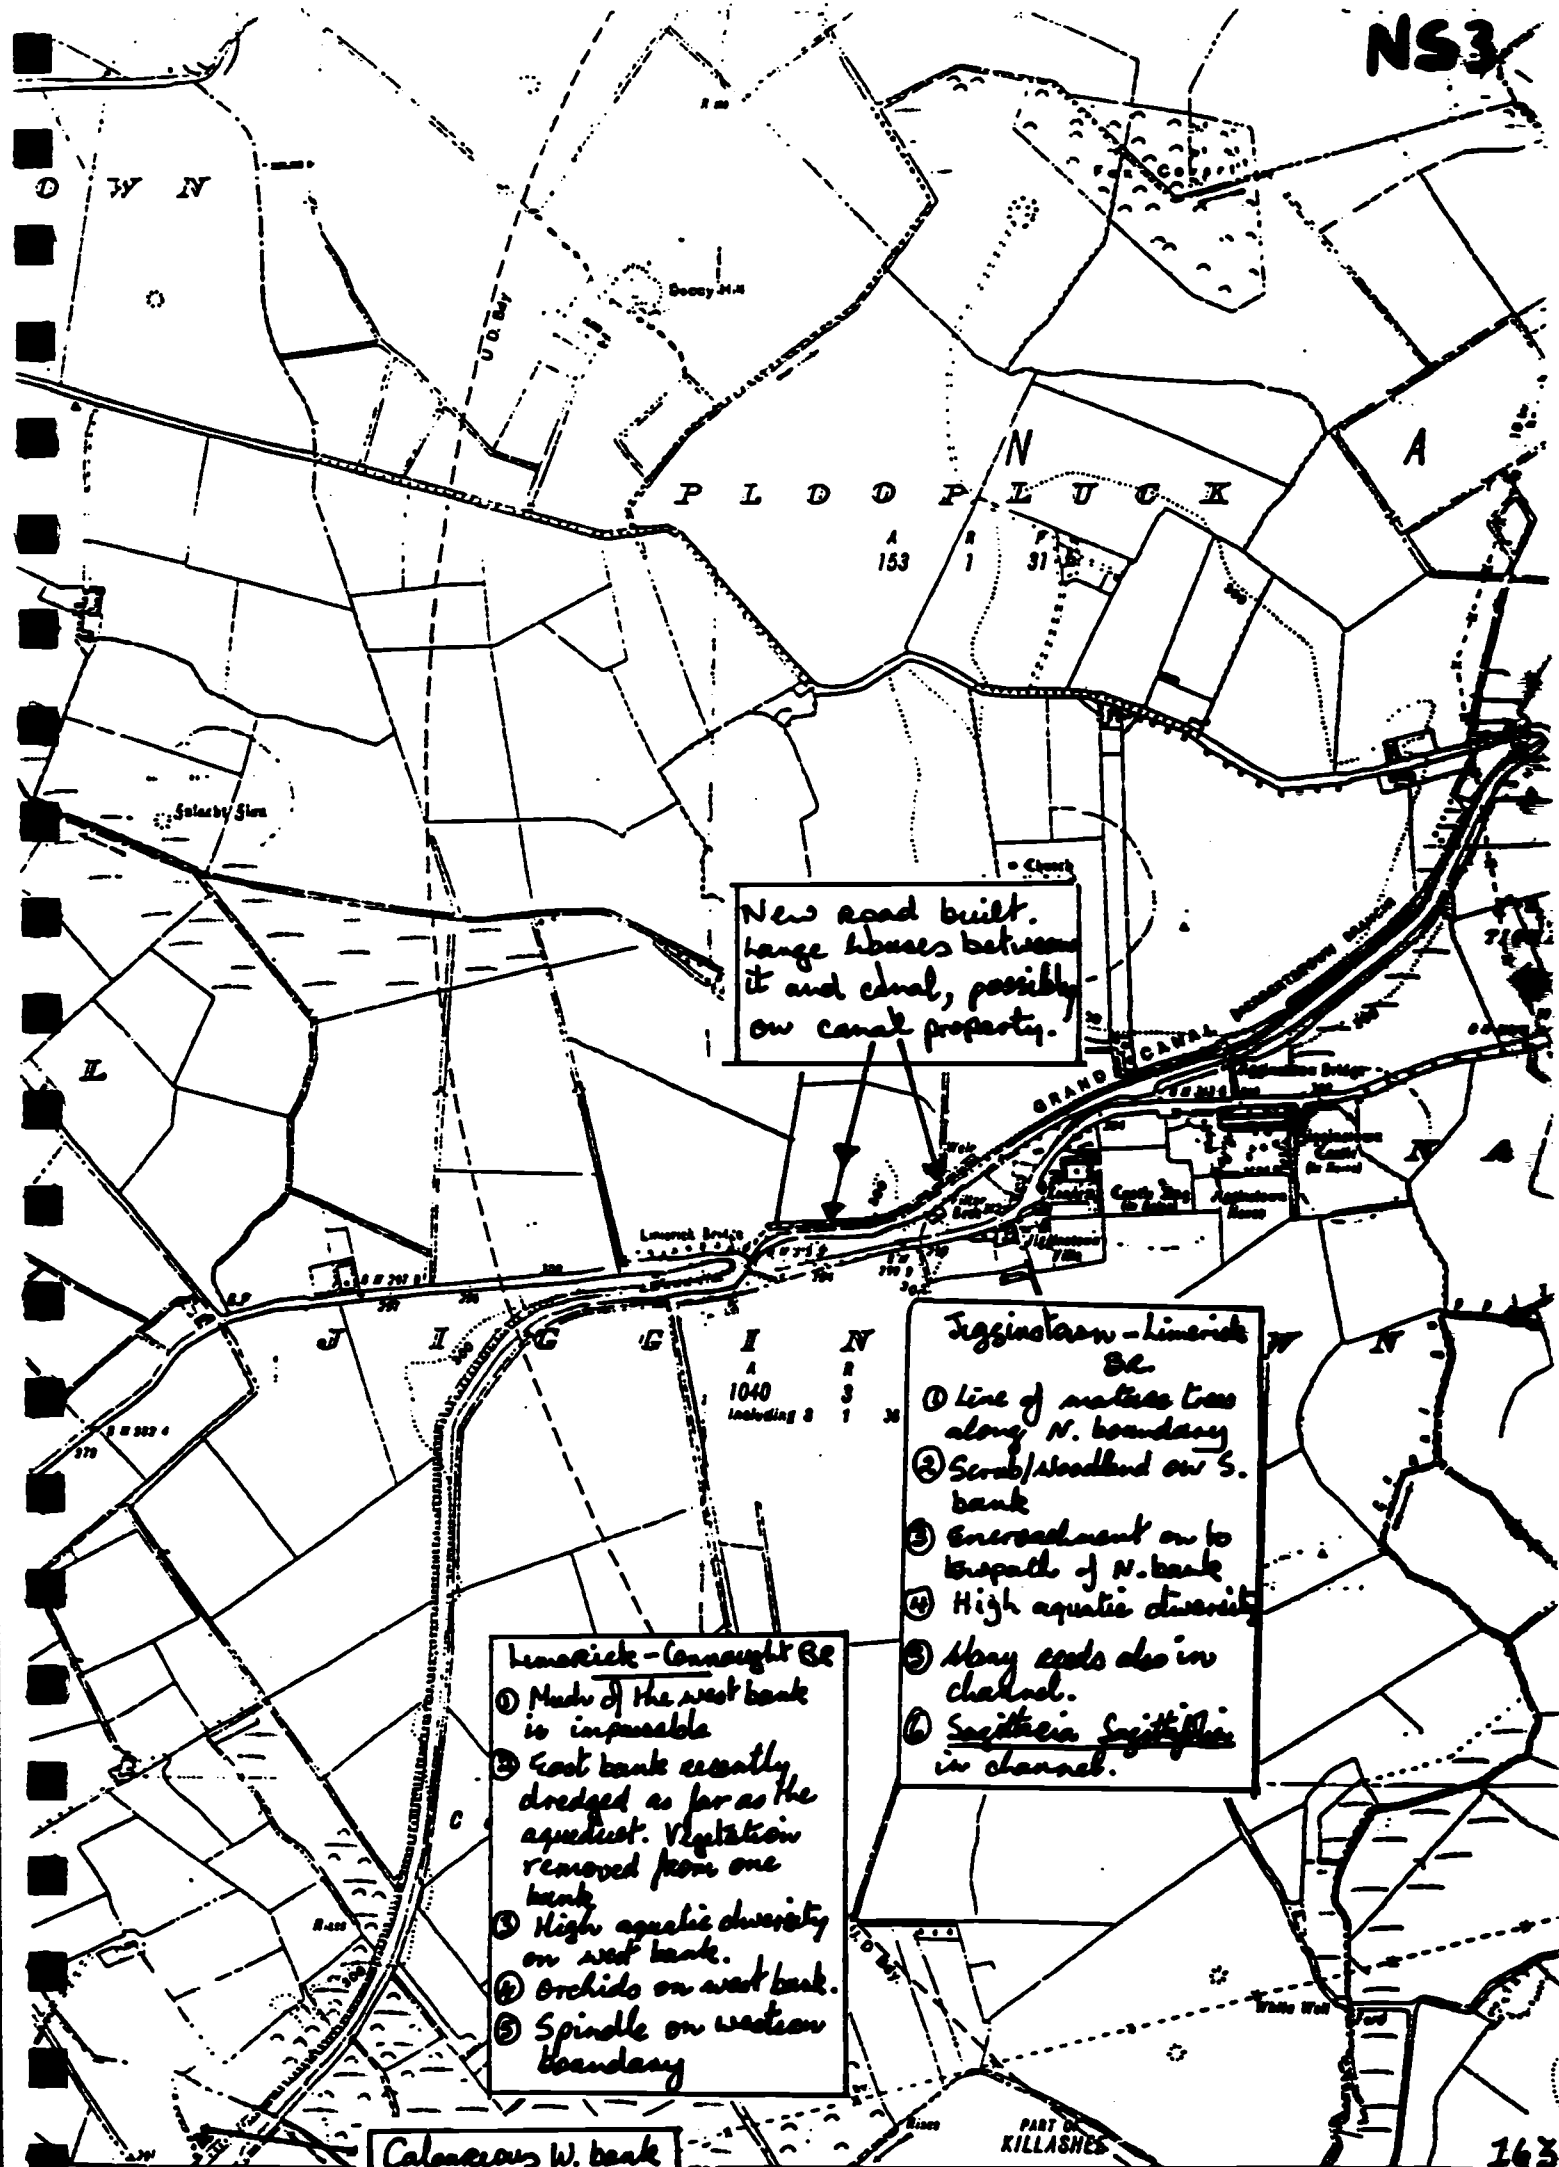
New road built.
Large houses between
it and canal, possibly
on canal property.
