ECOLOGICAL SURVEY

GRAND CANAL

Part 2 Conservation Management Plan 1991

**Prepared for
The Wildlife Service and Waterways Section,
Office of Public Works. 1992.**

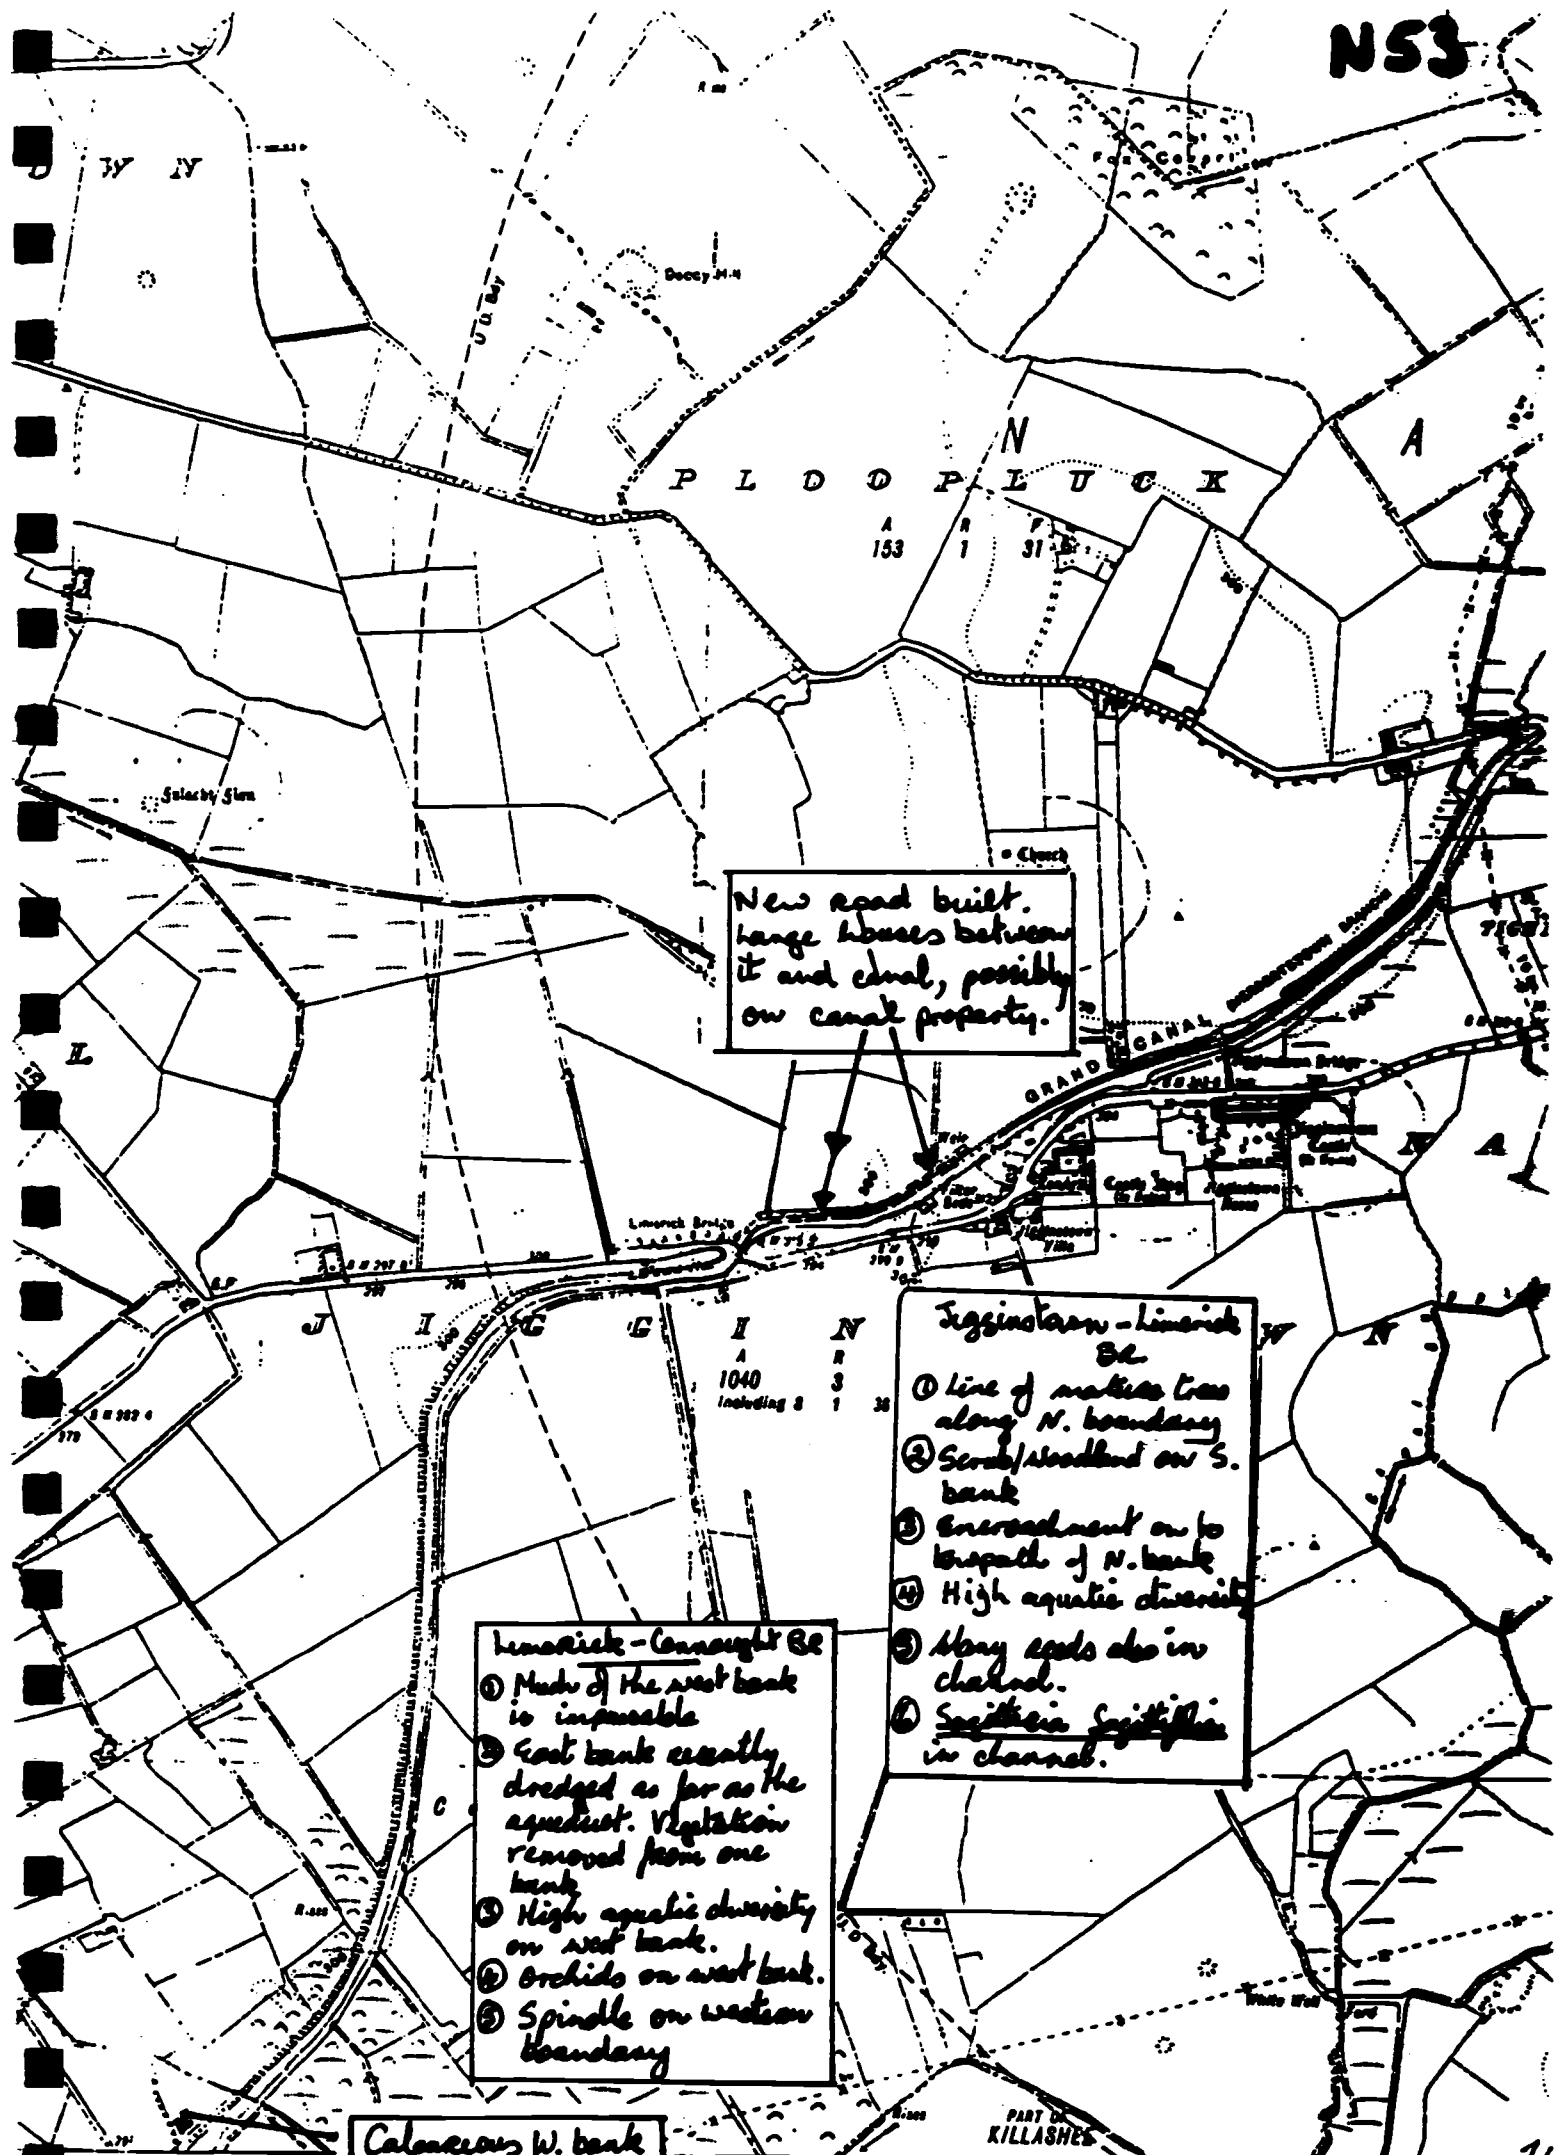
New road built.
large houses between
it and canal, possibly
on canal property.

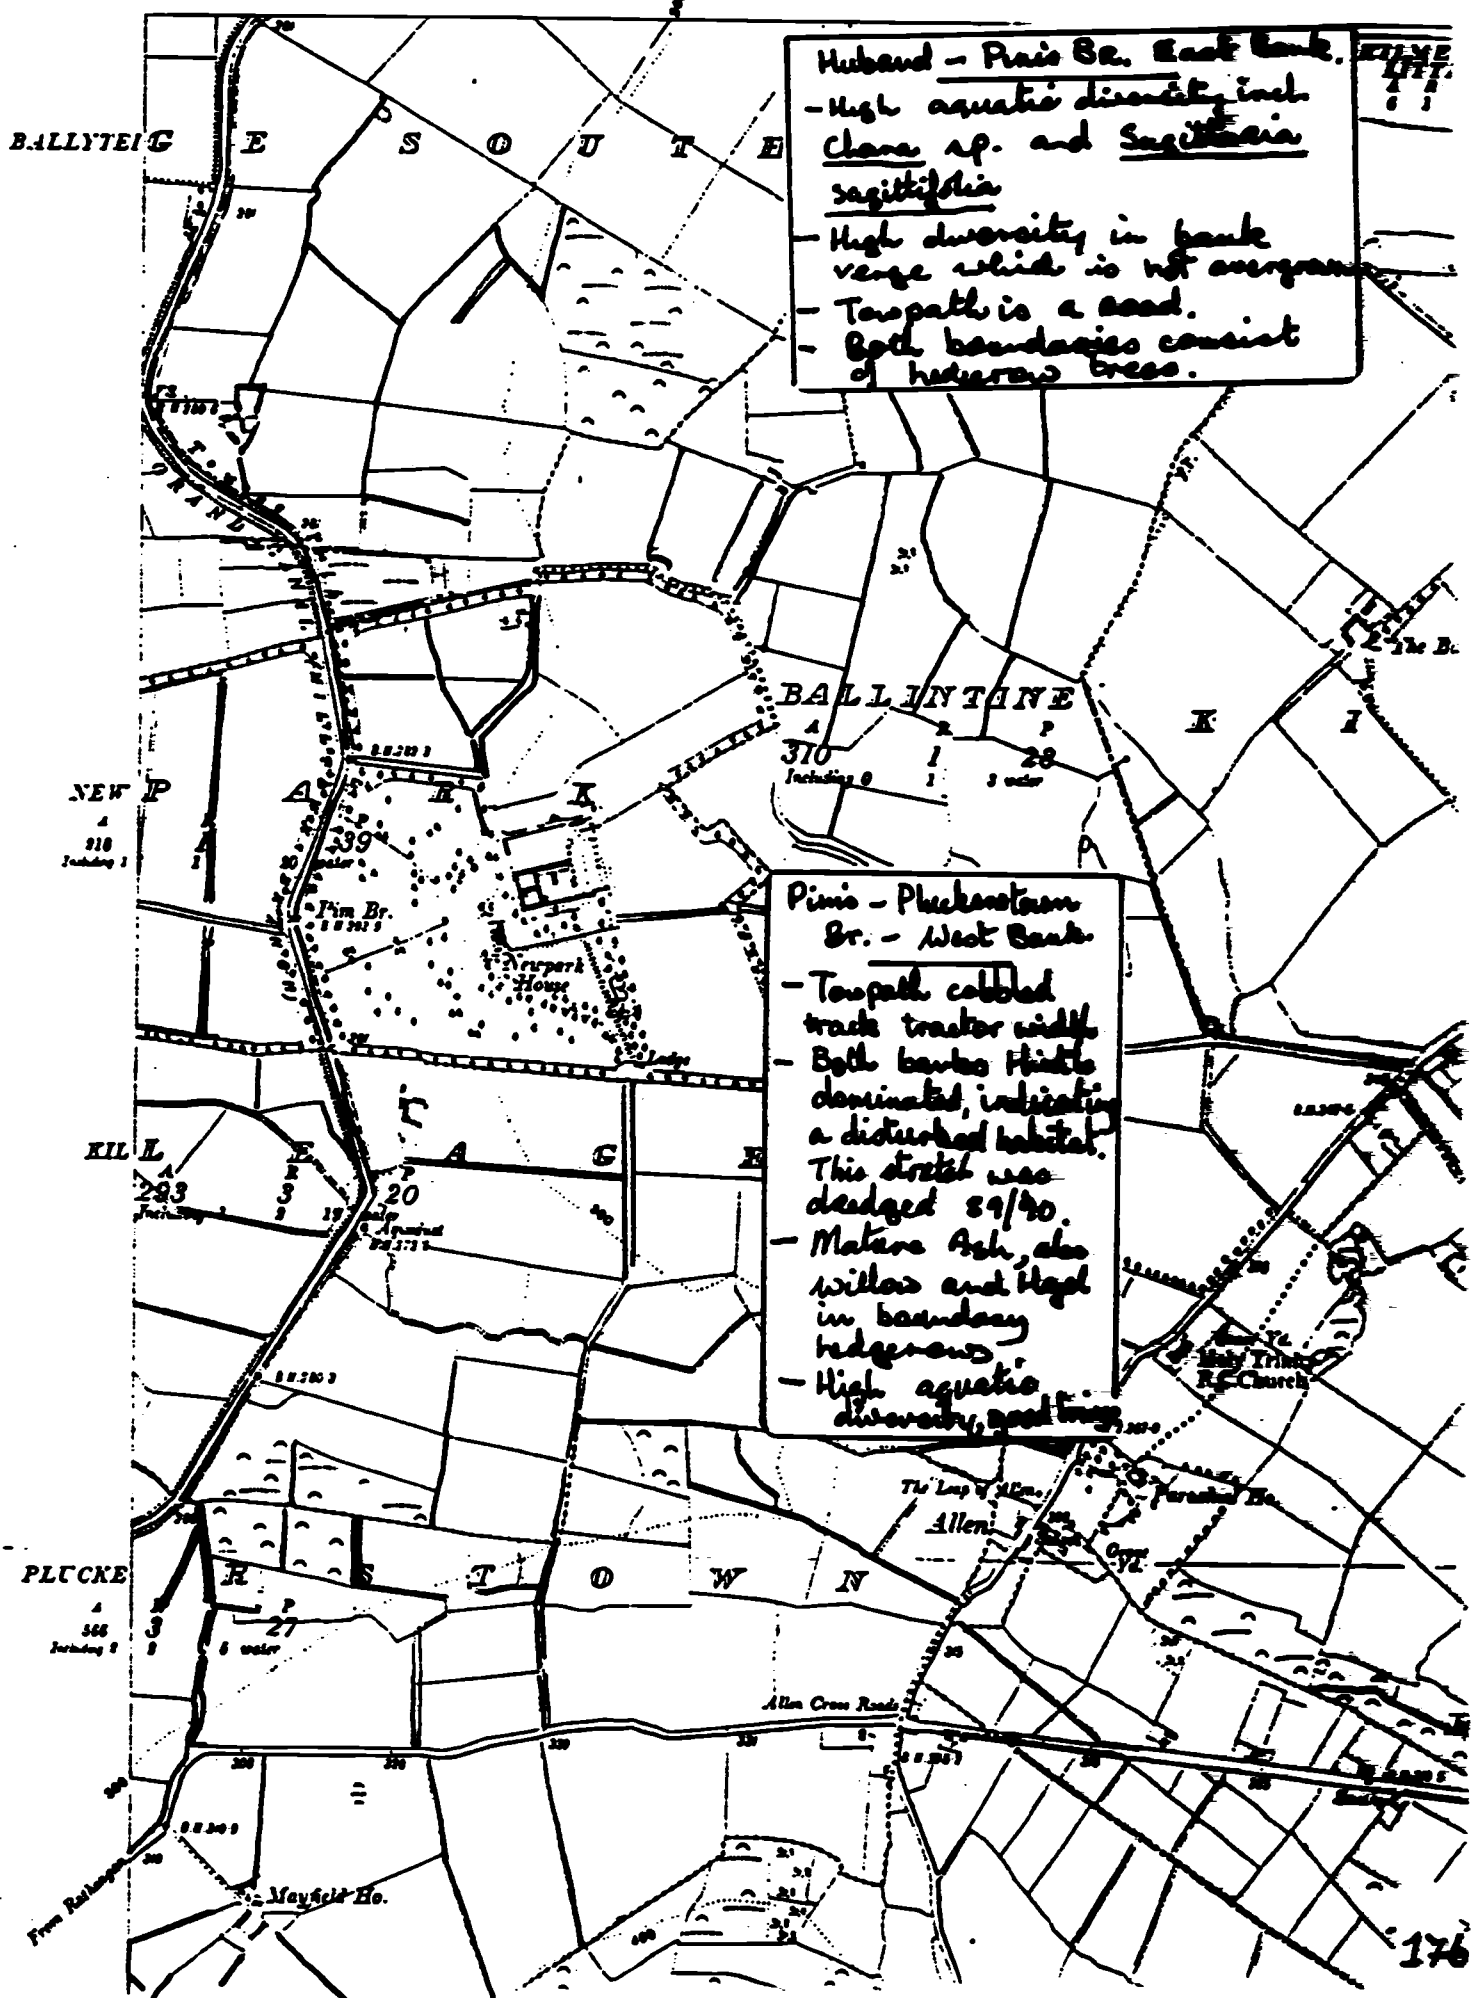
Huband - Prais Br. East Bank.
- High aquatic diversity incl. Clava sp. and Sagittaria sagittifolia
- High diversity in bank verge which is not overgrown
- Towpath is a road.
- Both boundaries consist of hedgerow trees.

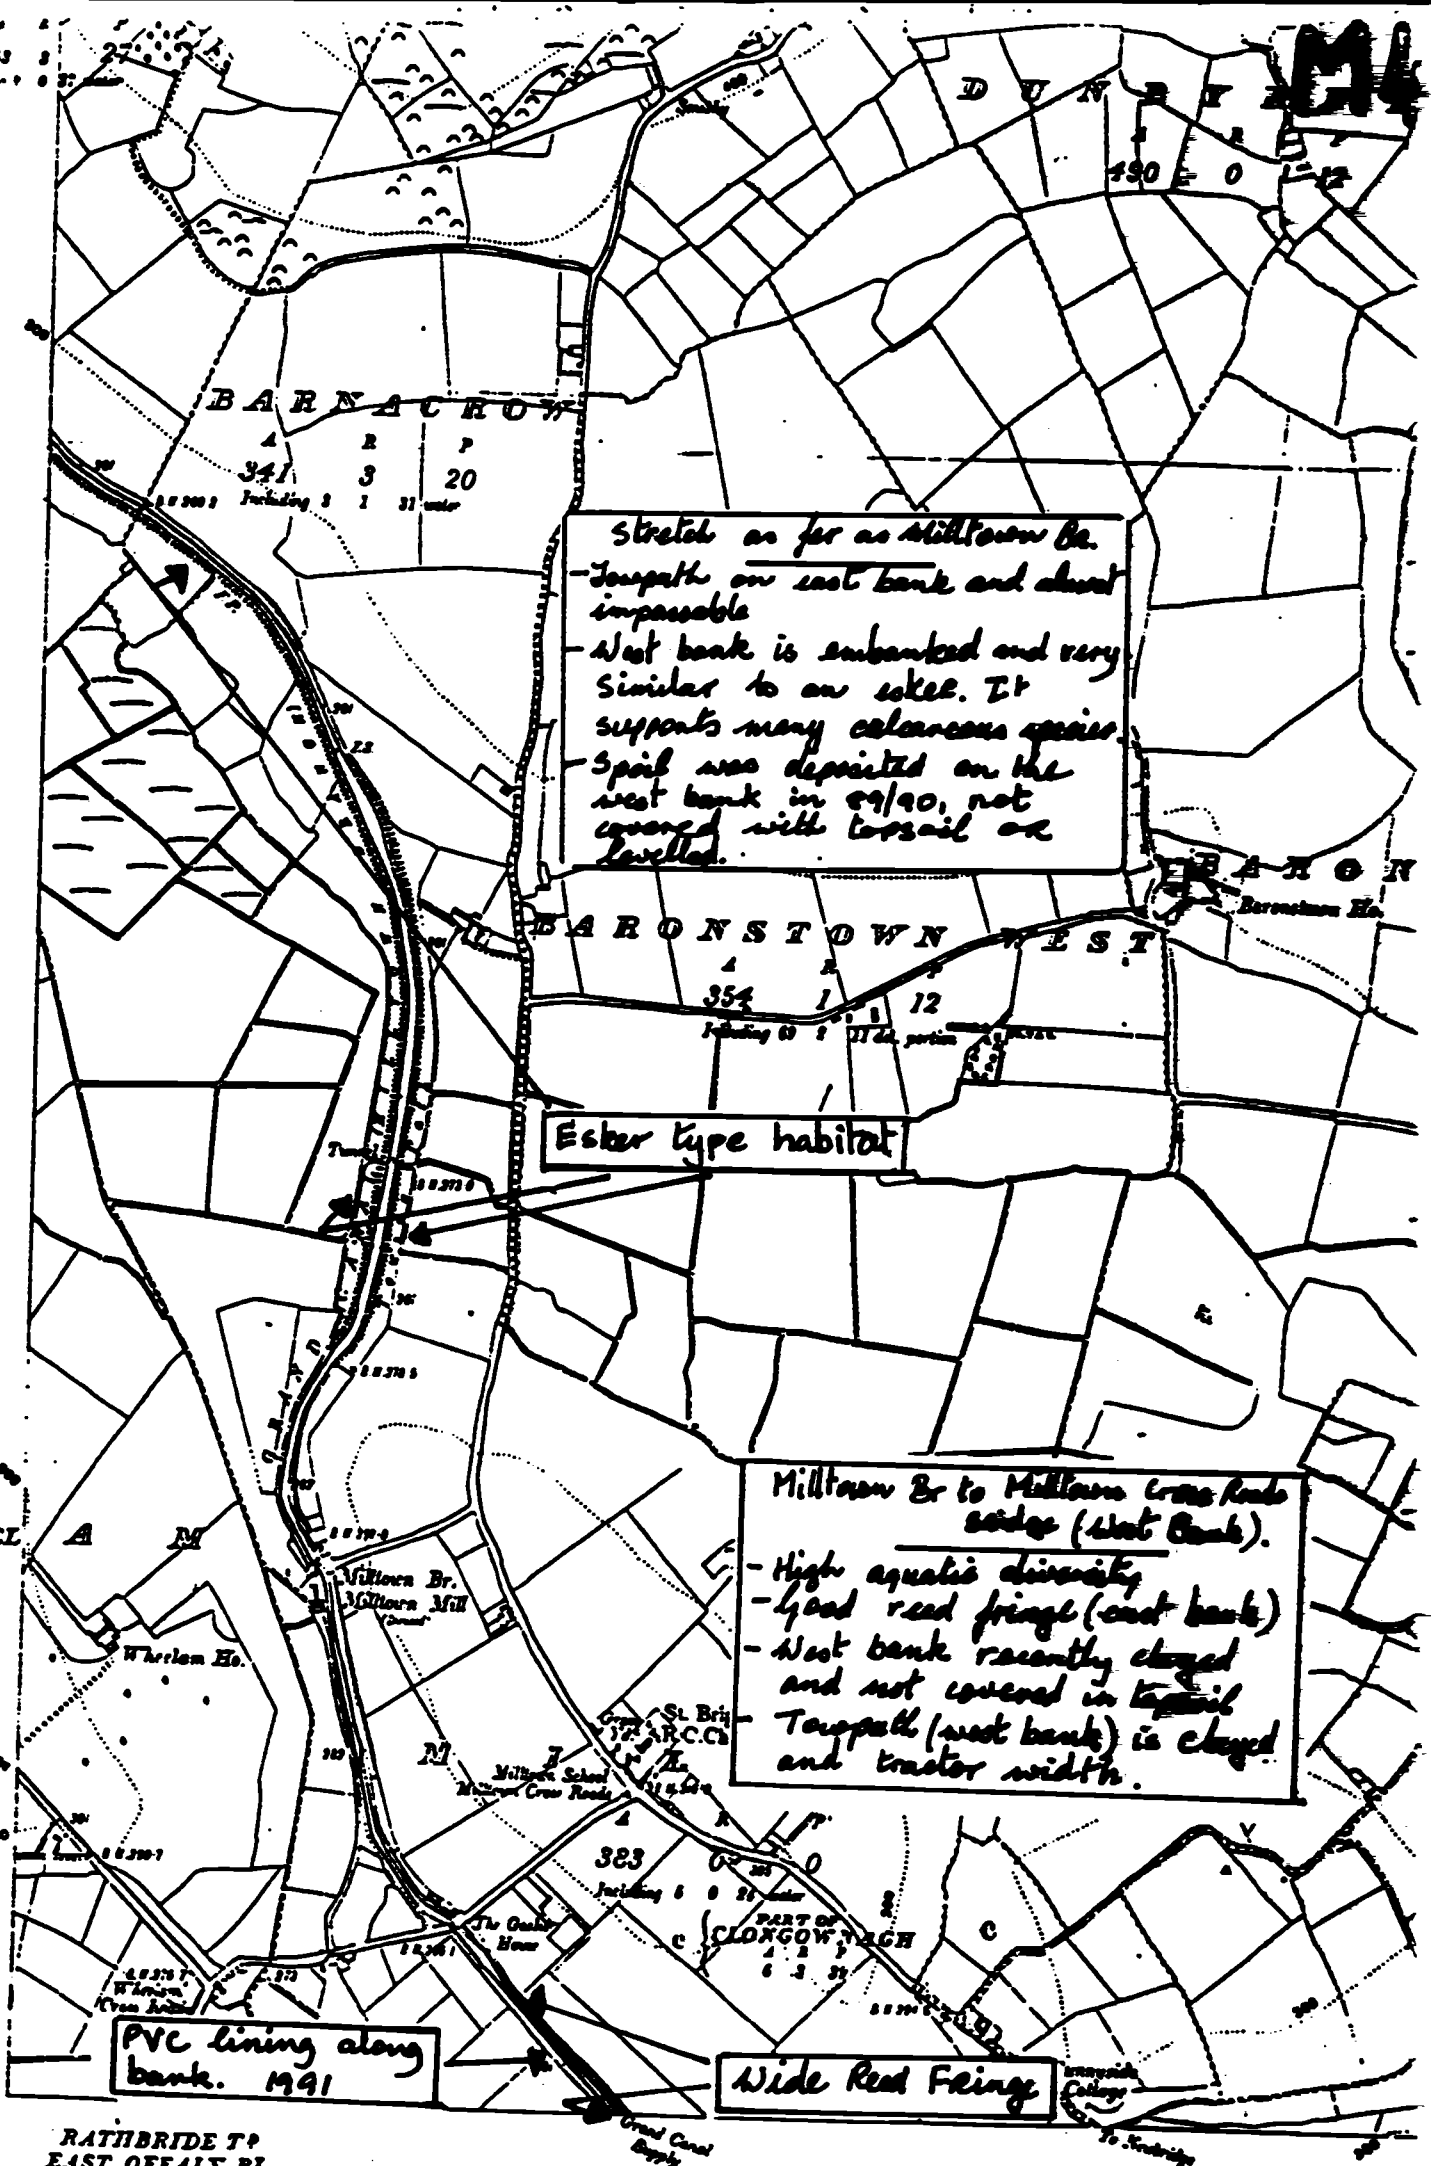
Stretch as far as Milltown Br.
 - Footpath on east bank and almost impassable
 - West bank is embanked and very similar to an esker. It supports many calcareous species.
 - Spoil area deposited on the west bank in 89/90, not covered with topsoil or levelled.

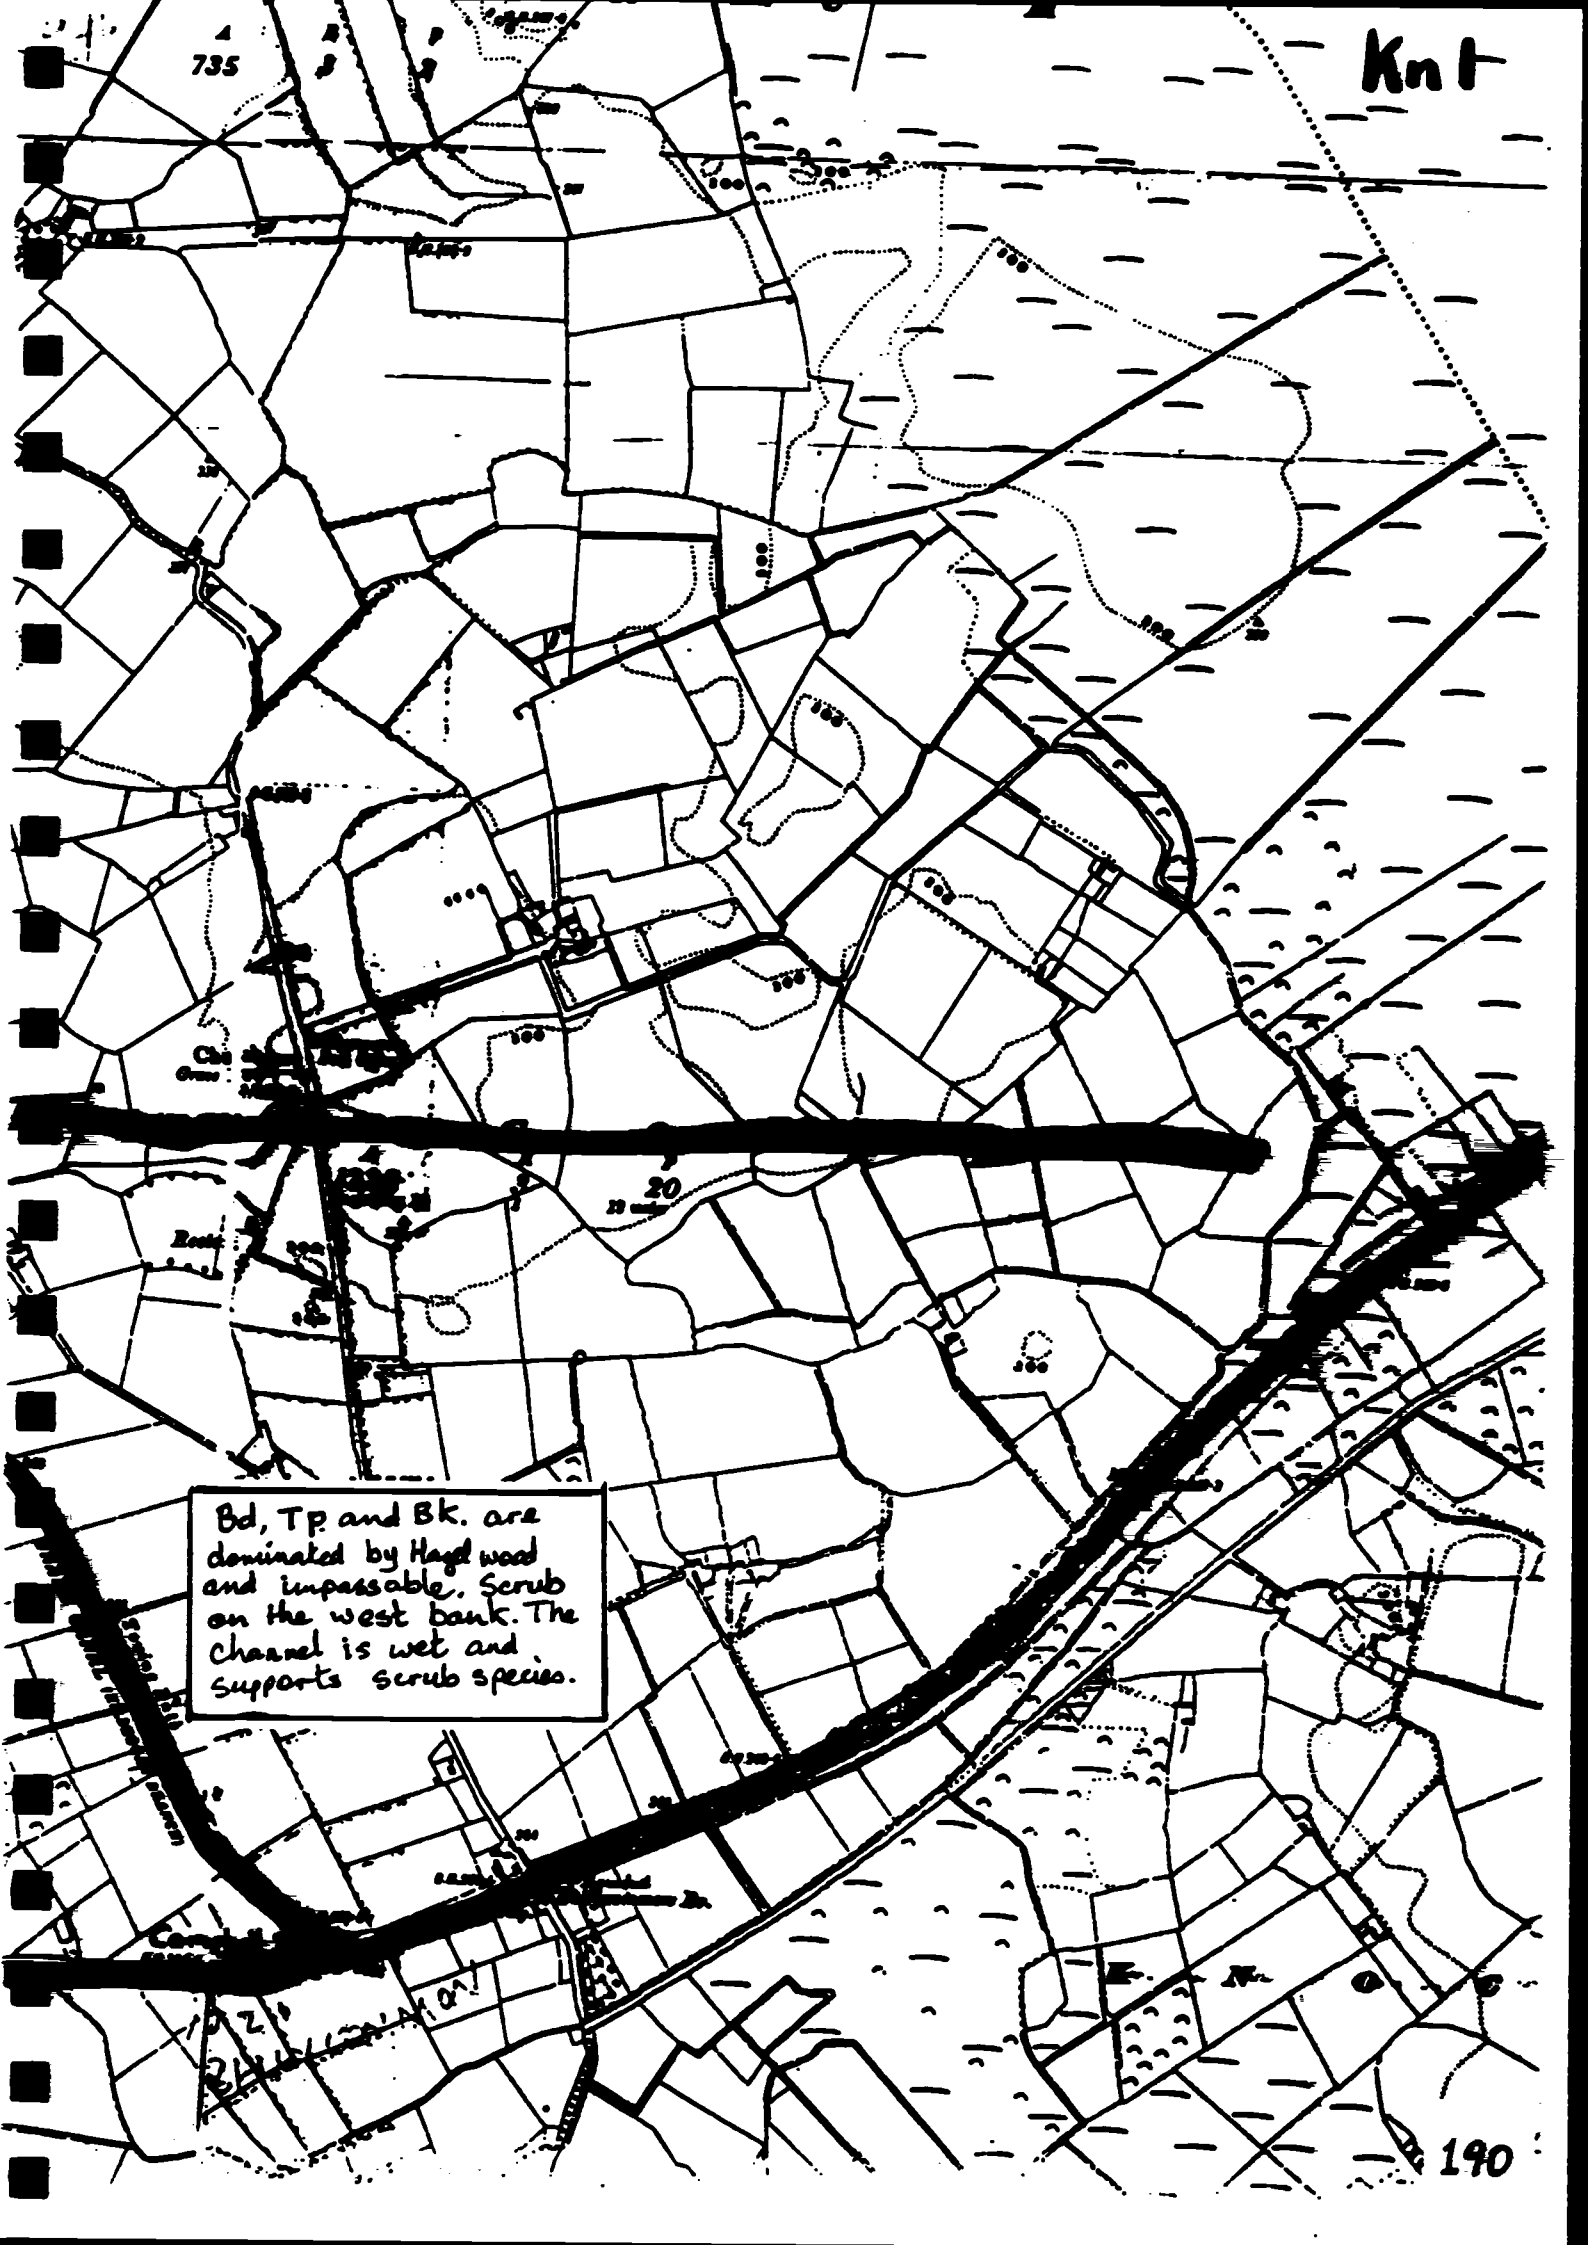
Bd, Tp and Bk. are dominated by Hagl wood and impassable. Scrub on the west bank. The channel is wet and supports scrub species.
