# Monitoring and Assessment of EU Habitats Directive Annex I Priority Habitat Petrifying Springs, 2025

## Irish Wildlife Manuals 160

## **Monitoring and Assessment of EU Habitats Directive Annex I Priority Habitat Petrifying Springs, 2025**

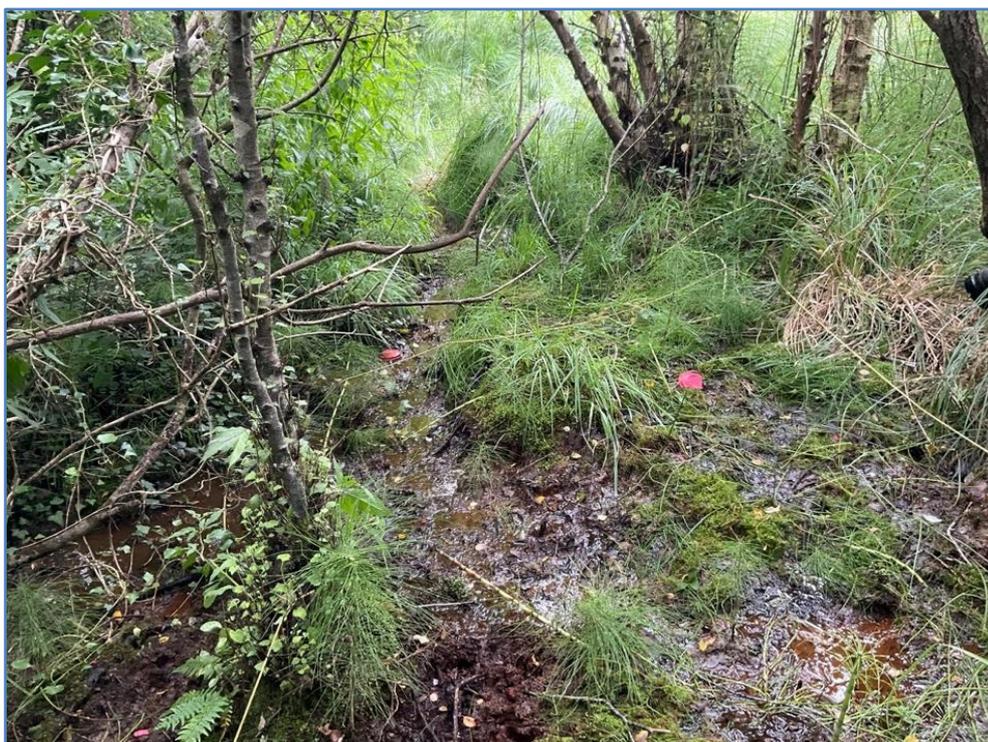
**Photograph 2** Petrifying spring in wet woodland with iron staining, *Equisetum telmateia* and *Palustriella commutata* frequent. Cartridges from clay pigeon shooting present. Photograph Joanne Denyer.

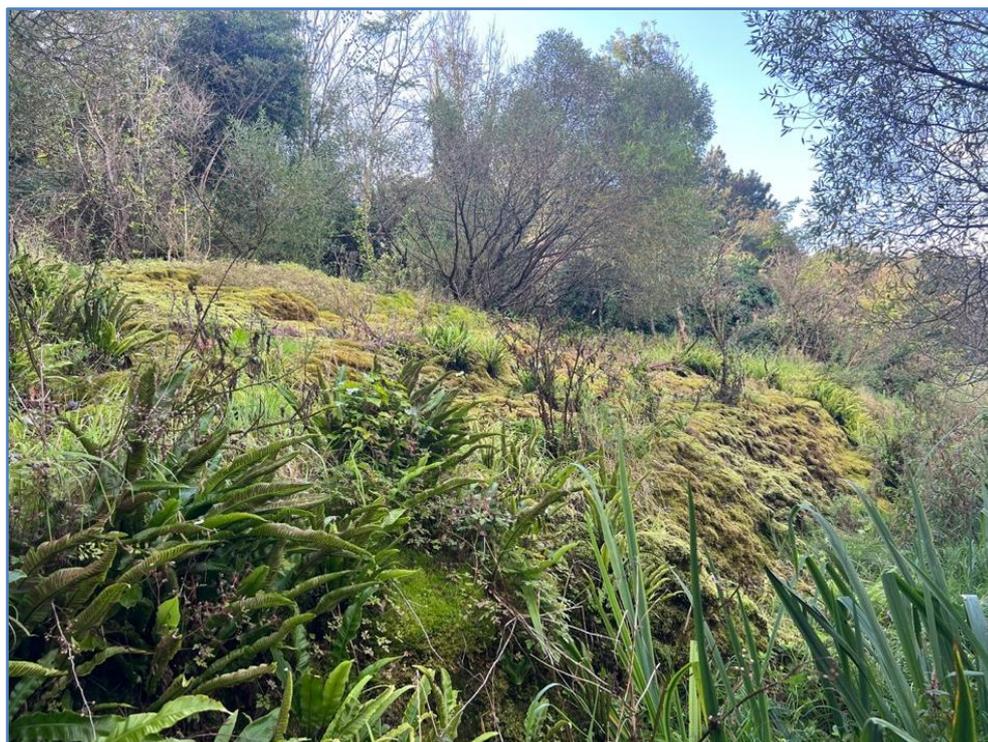
**Photograph 1** View of massive cascade mound, at least 2 m in height, dominated by negative bryophyte indicator species *Cratoneuron filicinum*. Photograph Joanne Denyer.

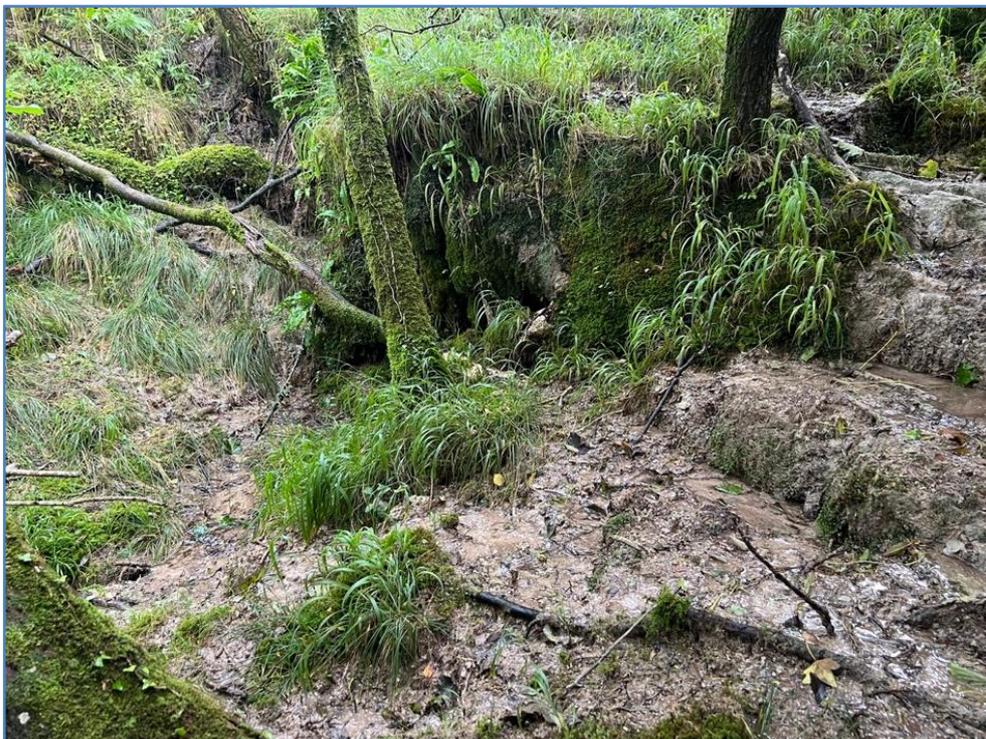
**Photograph 1** Petrifying spring vegetation in woodland with large cascade mound and cascade 'steps' with soft mud (deer trampled). Photograph Joanne Denyer.

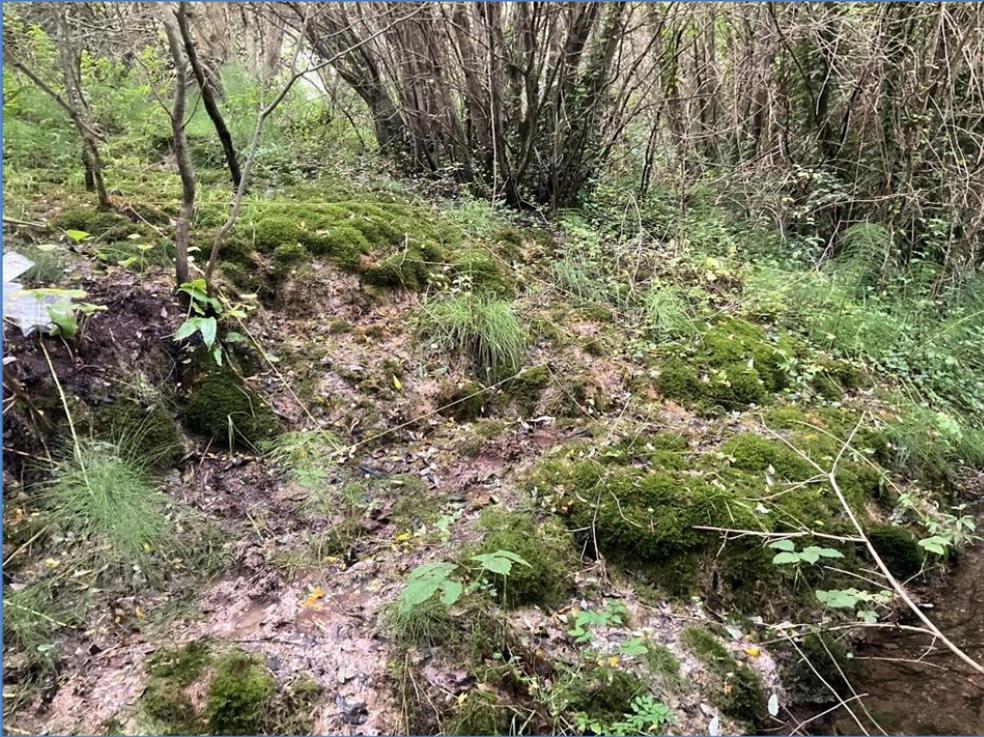
**Photograph 2** Large wooded cascade petrifying spring north of Bog Meadow, open areas caused by deer trampling. Photograph Joanne Denyer.

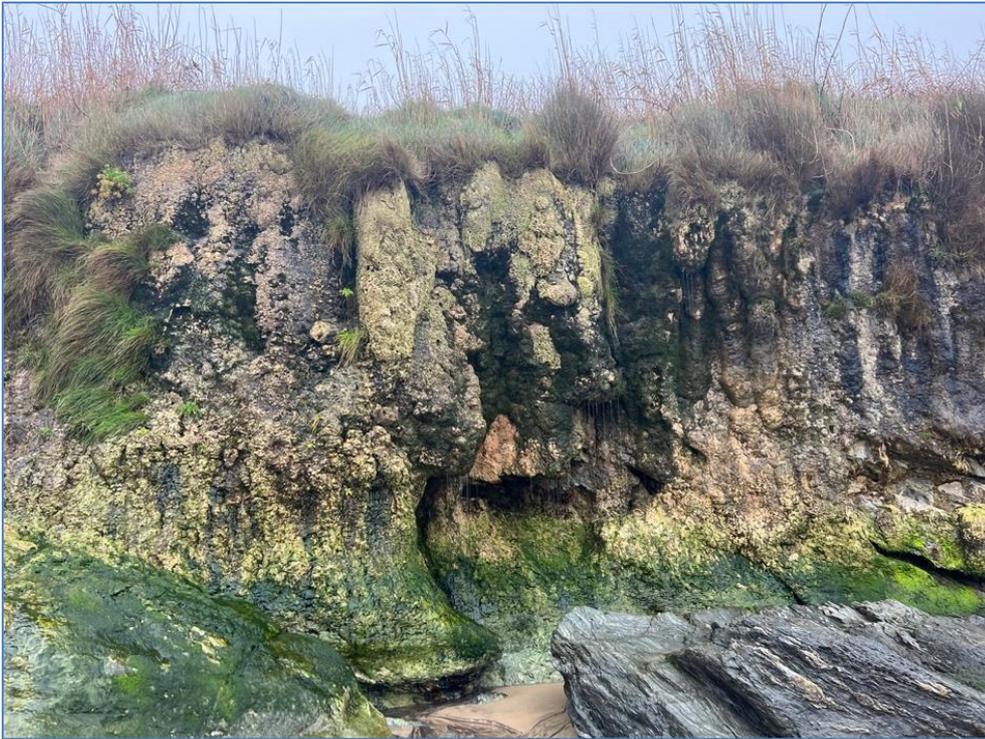
**Photograph 1** Coastal petrifying spring with massive cascade tufa formation, north of Magheramore Beach. Degraded with inactive tufa and low vegetation cover. Photograph Joanne Denyer.

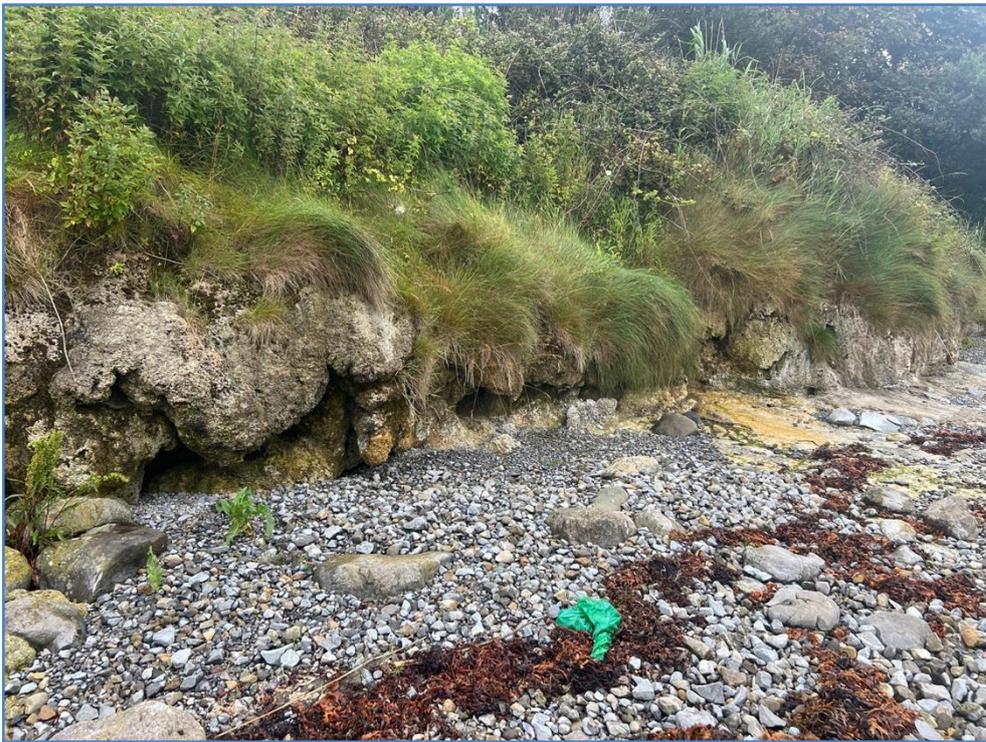
**Photograph 1** Cascade tufa along shore at Ballincar with dry (white) inactive tufa. Photograph Joanne Denyer.

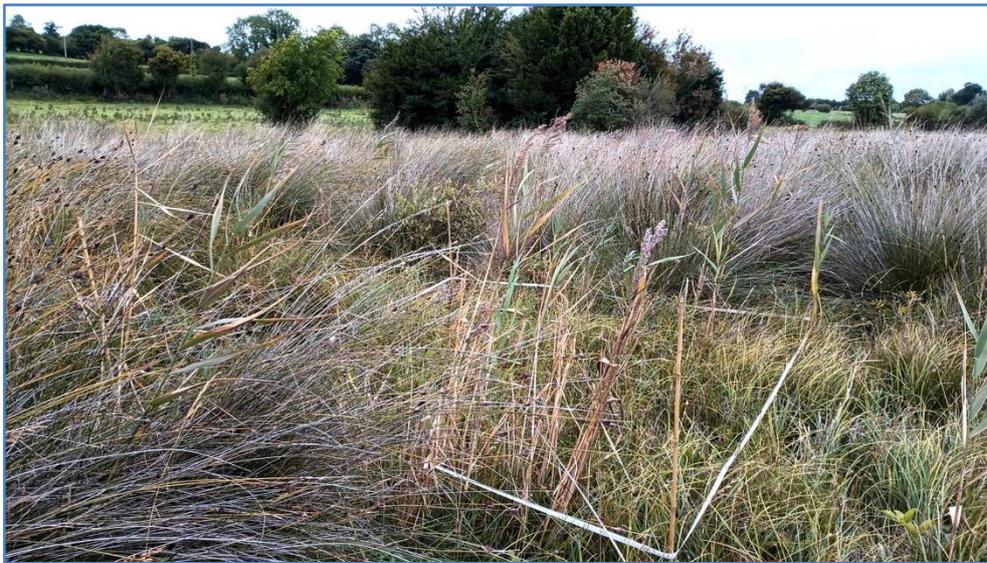
**Photograph 1** Overgrown petrifying spring within *Schoenus* alkaline fen. Photograph George Smith.

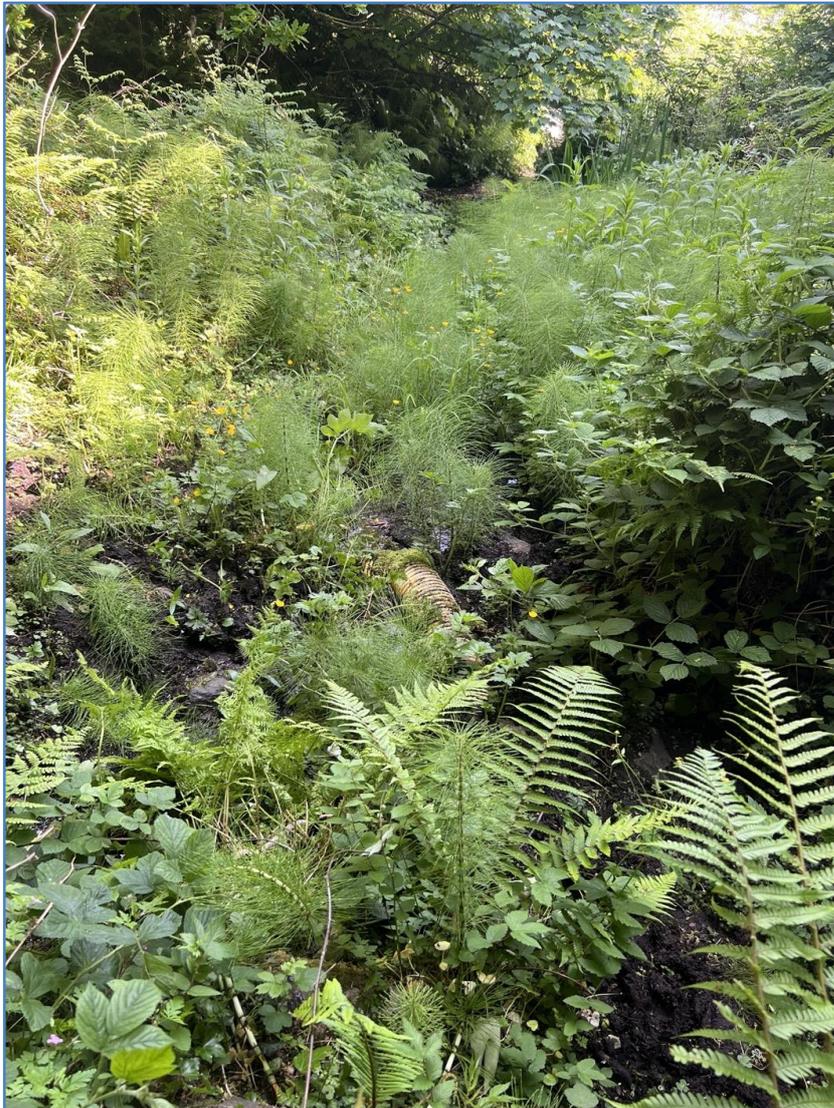
**Photograph 1** Spring with *Equisetum telmateia* but no tufa with plastic pipe in spring channel. Photograph Joanne Denyer.
