Derogation Licence – Supporting Information

Dromoland Castle and Estate, Dromoland Co. Clare

Prepared for the Attention of the Licensing Unit of NPWS

October 2025

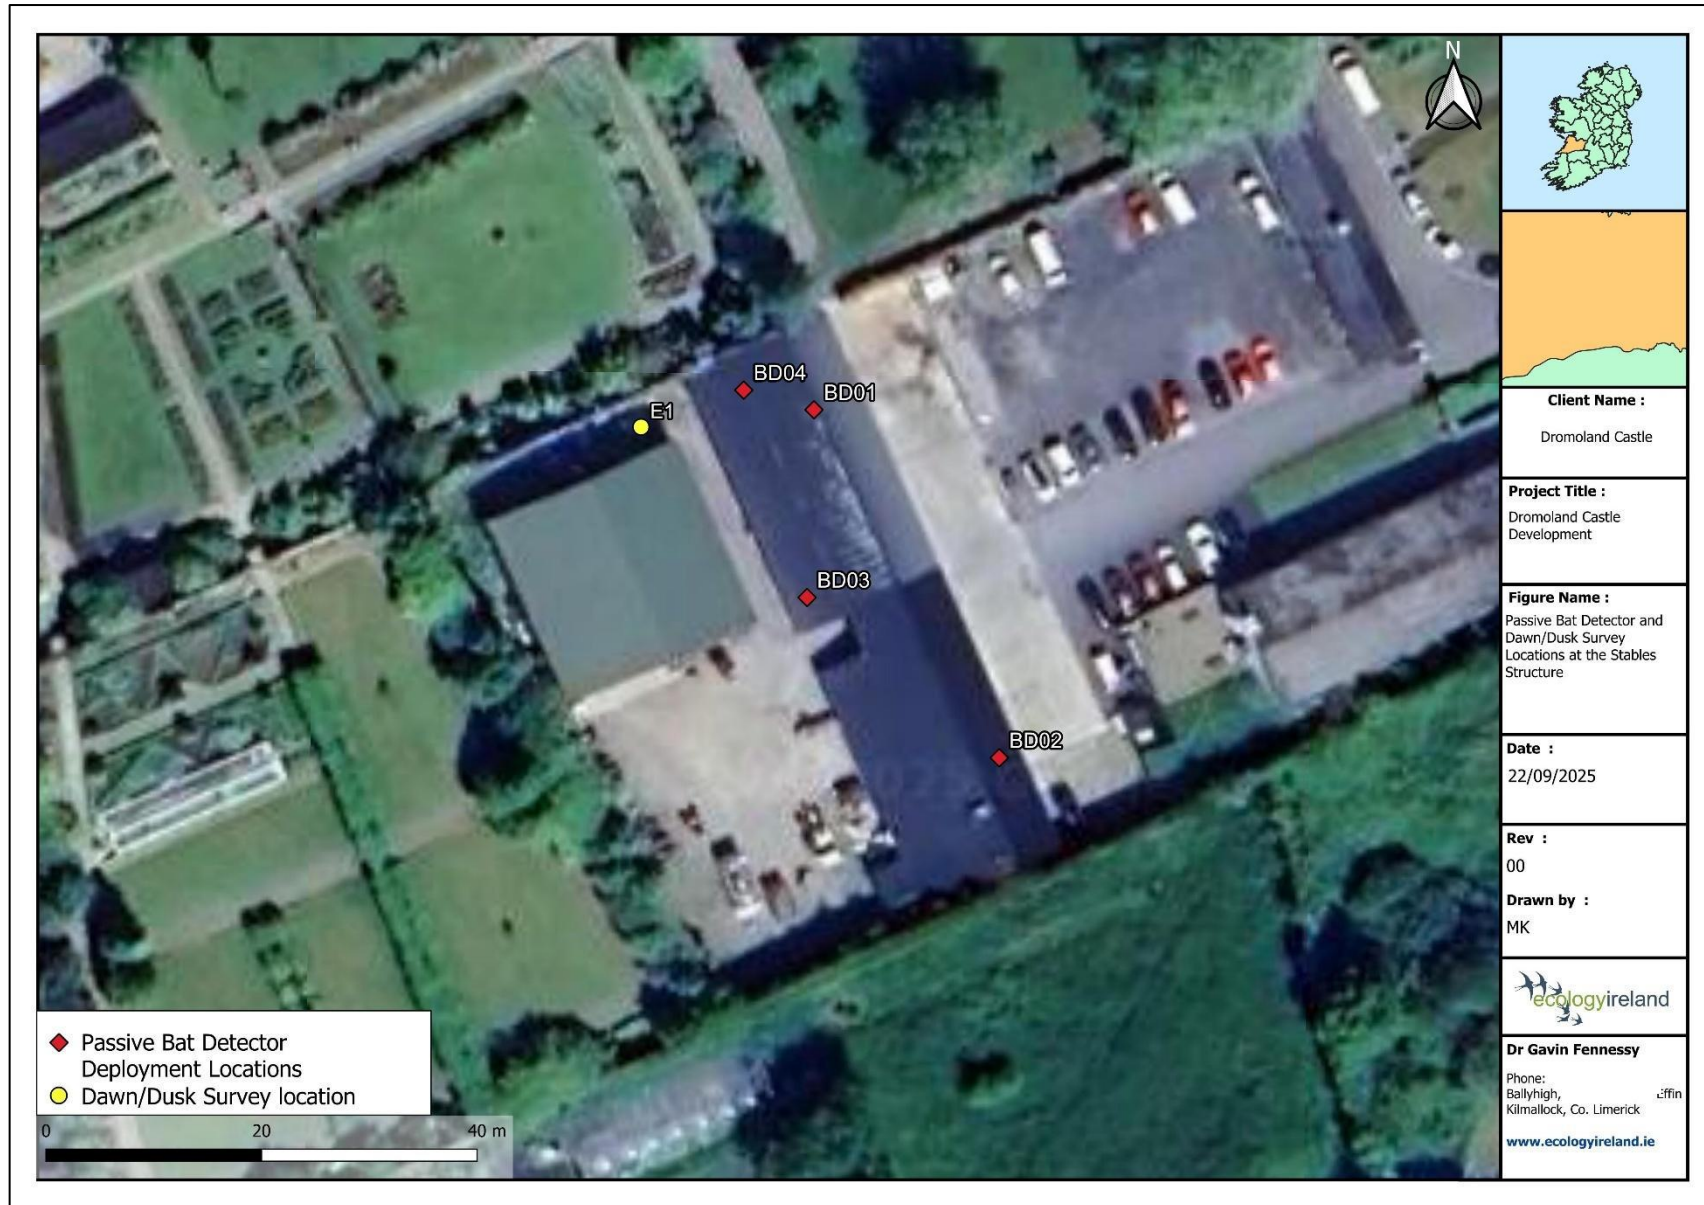
Figure 3. Deployment locations of Passive Bat Detectors and the location of the surveyor for the dawn/dusk surveys at the Stables structure.

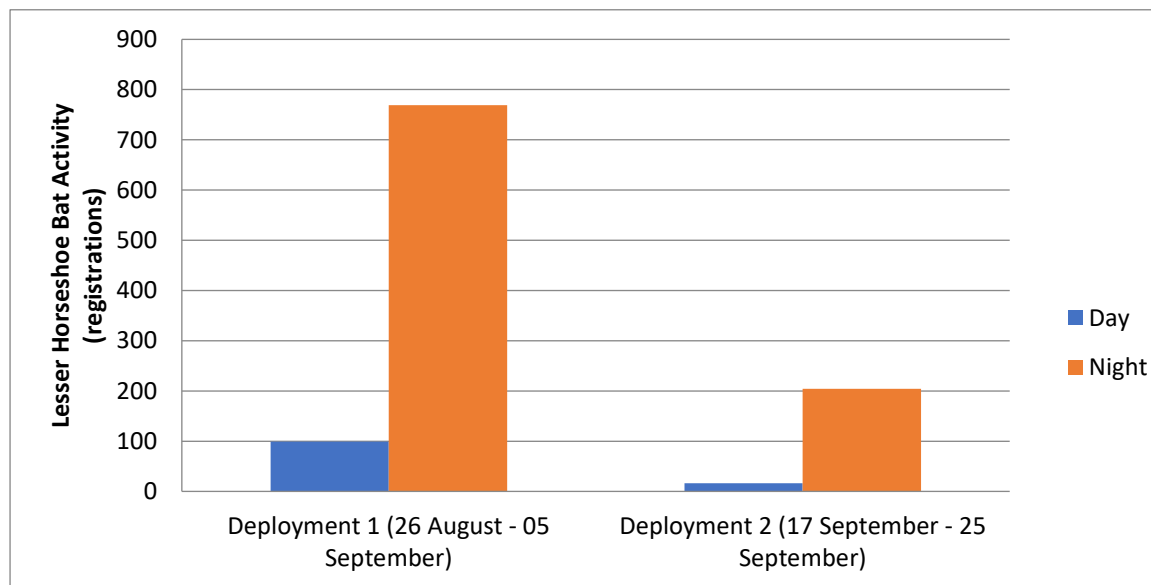
The highest rate of Lesser Horseshoe Bat registrations occurred at BD04, which was located in the northwest corner of the north building in proximity to the shallow recess containing bat droppings. In total, 1088 Lesser Horseshoe Bat registrations were recorded with a mean number of c. 57 Lesser Horseshoe Bat registrations recorded at this location during Deployment 1 and Deployment 2, with a peak count of 156 registrations on the 27th of August. As shown in Figure 5, Lesser Horseshoe Bats were primarily active within the north building of the stables between sunset and sunrise. However activity after sunrise, while considerably less, was still recorded, so it is likely that the bats are using this structure as a day roost, albeit in very small numbers. Also shown in Figure 5, the majority of the registrations were recorded during Deployment 1 which was carried out earlier in the season, between the 26th of August and the 5th of September, than in the later Deployment 2 which was carried out between the 17th and the 25th of September. Figure 6 shows that activity has markedly decreased between the earlier and later deployments.

Figure 5. Lesser Horseshoe Bat activity at BD04 between sunrise and sunset (Day) and between sunset and sunrise (Night).

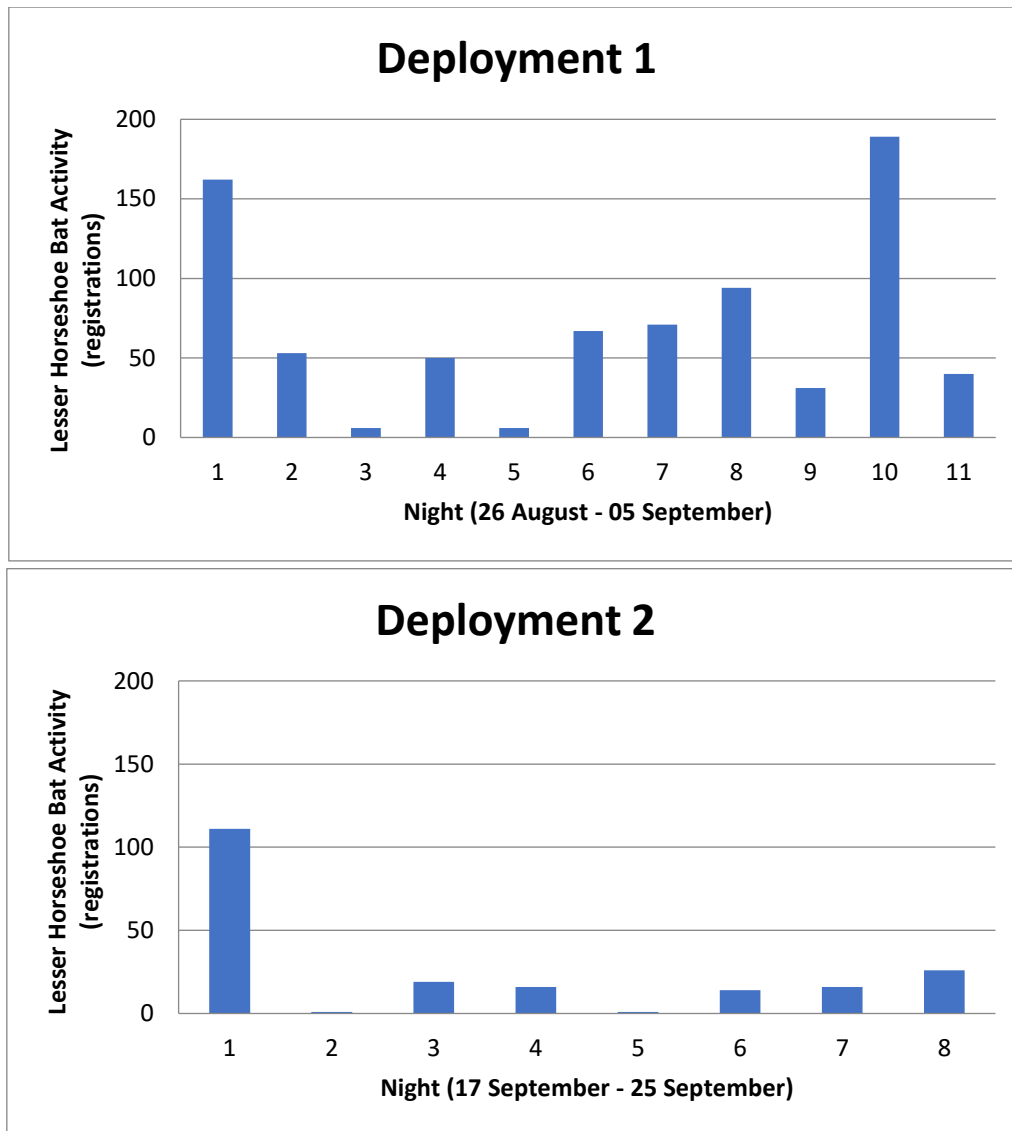
registrations for any one night (the 3rd September). Between the 26th of August and the 17th of September, BD01 was set to run continuously, and 12 Lesser Horseshoe Bat registrations were picked up between 06:00 - 20:00, 6 of which were recorded after 19:30. The passive placed within the attic space of an office in the north building (BD03), recorded 11 Lesser Horseshoe Bat registrations across 16 nights of active deployment.

Figure 6: The number of Lesser horseshoe Bat registrations per night during Deployment 1 and Deployment 2.

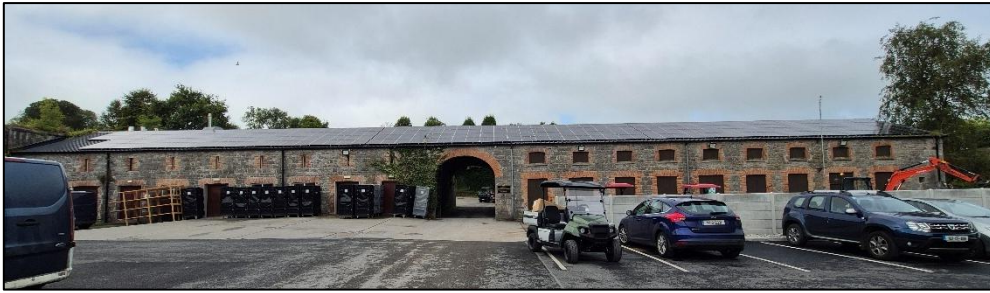
Plate 1: East side of the Stables structure.

The Stables is located to the west of Dromoland Castle and comprises a long structure with a pitched roof, joined by a large central archway providing access through to the Stables yard (See Plate 1). The structure is built of traditional stonework with a modern corrugated sheet roofing on which solar panels are installed. The east face of the building looks out over staff car-parking while the west side faces onto the golf maintenance yard and associated galvanized steel shed. The north boundary of the structure forms a high wall running east to west, that overlooks the hotel's manicured gardens and golf club house. The south boundary is also connected to a high stone wall running east to west, overlooking additional gardens.

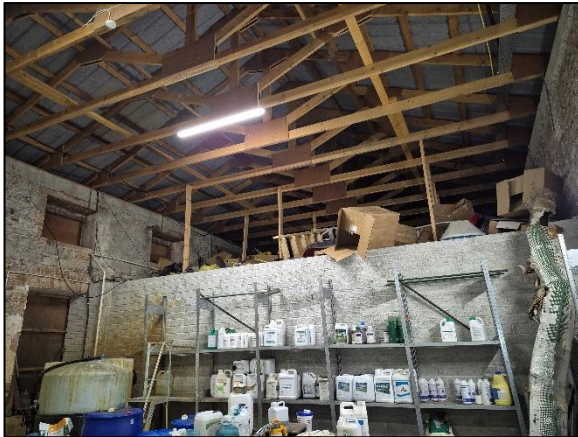
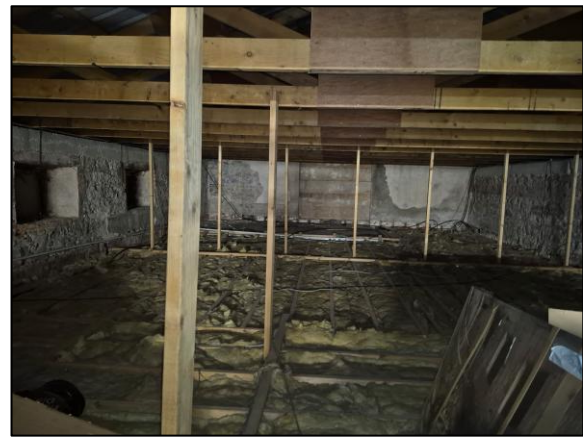
Plate 2: Internal photos of the north building – chemical store with loft space extending over the staff facilities.

The north building of the Stables is currently in use as a fuel, storage, and chemical store associated with the golf maintenance facility, and also contains offices, canteens and welfare facilities. The building is roofed with corrugated sheeting which does not provide a stable internal temperature regime. The roof is supported internally by wooden trusses in the larger chemical store section, which is open with a loft space that extends over the staff facilities (Plate 2). At night the building is secured, with the exception of an entry point at the northwest corner that remains open, providing access to the storage and chemical store areas. There is no internal lighting at night; however, security lighting illuminates the west and east elevations externally. The golf maintenance team begin work within and external to the Stables between 05:30–06:00 during the summer, and 6:30 – 07:30 over the winter period, at which time the interior of the north building becomes noisy, active, and artificially lit (Plate 3).

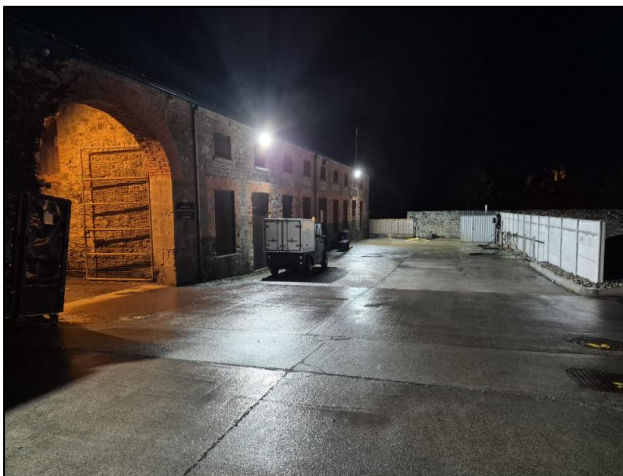
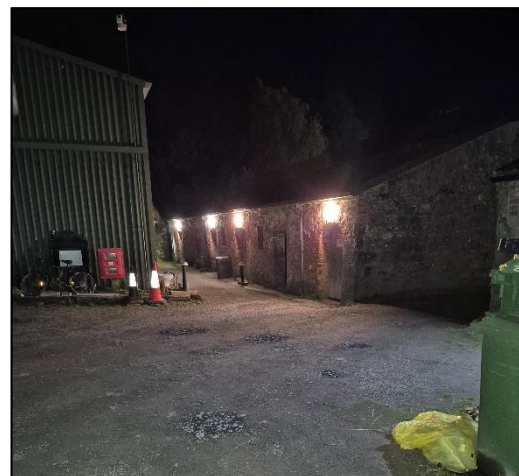
Plate 3: External photos of the north building lit up at night on the east side (Left) and west side (Right).

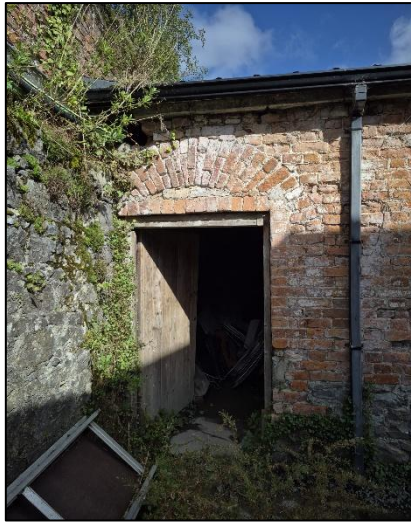
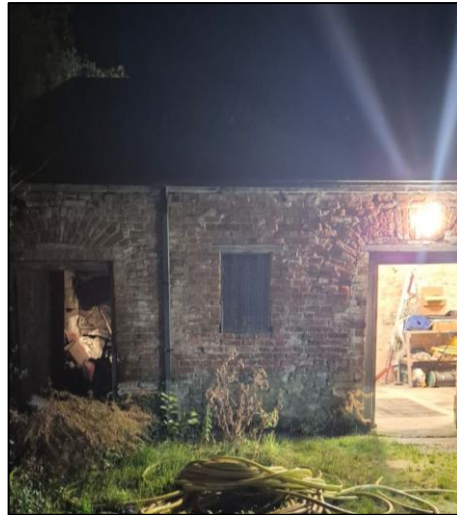
The most obvious access point for bats into the north building is through the doorway at the northwest corner of the north building, which is the only doorway in the Stable structure that remains open overnight (Plate 4). There is missing blockwork just above the doorway that also can provide access for species, such as Lesser Horseshoe Bat, that typically enter roosts in flight rather than by crawling. Other access points include gaps beneath the gutters where the sheet roofing meets the stonework of the building wall as well as gaps beneath the archway.

Plate 4: Doorway used by Lesser Horseshoe Bat to enter the north building of the Stables structure during the day (Left) and in the early morning (Right).

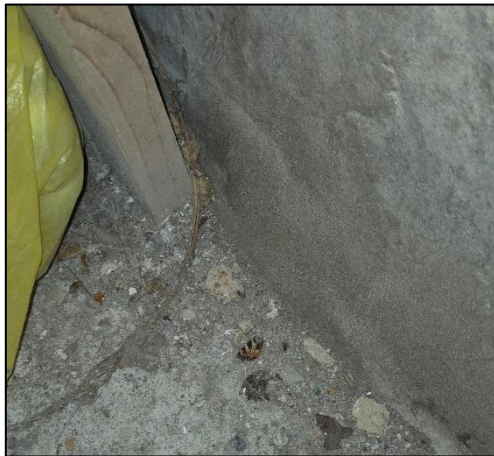
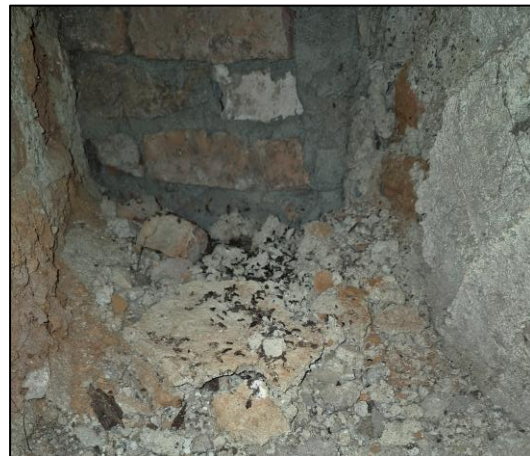
Internal inspections confirmed the presence of bat droppings and feeding signs, indicating use of the building by bats, with the highest concentration of droppings found within one shallow recess in the internal stonework (Plate 5). Additional scattered droppings were observed across insulated loft areas, showing intermittent use for roosting and feeding. The nature of the droppings suggests regular bat presence, though no large accumulations were consistent with a maternity site.

Plate 5: Bat signs in the north building of the Stables in the form of feeding remains (Left) and droppings (Right).

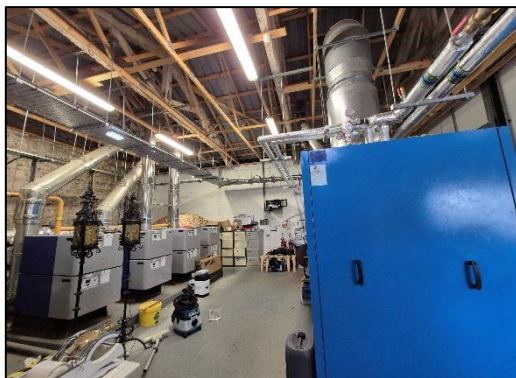
Plate 6: Interior of the south building of the Stables structure showing the Energy Centre (Left) and Linen Storage (Right).

The south building of the Stables structure is currently used as a mixed facility containing the energy centre for Dromoland Castle and Estate, a linen storage and sorting facility, and some areas of general storage for the golf maintenance team (Plate 6). The energy centre occupies a substantial portion of the building and is warm, loud, and brightly lit at all times due to the presence of large industrial plant. The linen storage and sorting facility also takes up significant space and is busy with human activity during daylight hours. This section has an installed ceiling with a void space above, containing

fibreglass insulation and utility services, which was inspected where accessible. No evidence of bats (e.g. droppings, staining, feeding remains) was recorded within the energy centre, linen facility, or ancillary storage areas during the inspections. The constant heat, light, and disturbance levels within the energy centre, make this space unsuitable for roosting.

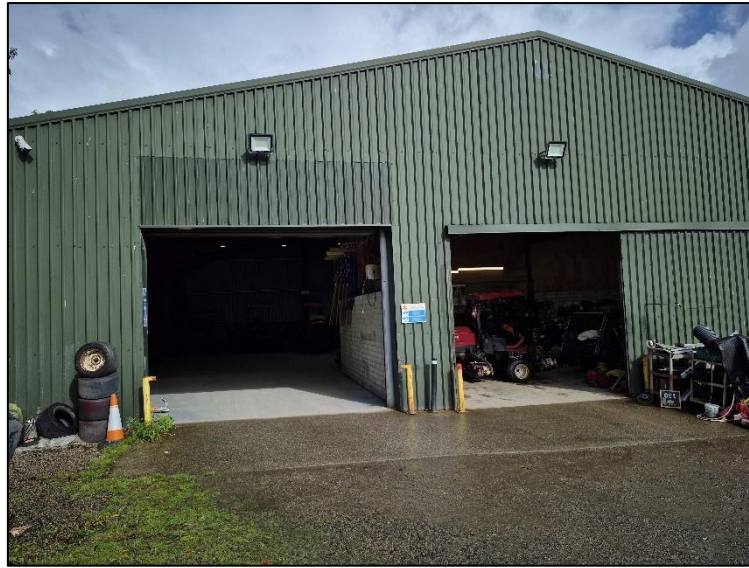
Plate 7: Galvanized steel shed to the west of the Stables, inside the yard.

To the west of the structure is the Stables yard, which contains a large shed comprised of galvanized steel and is used as a garage and as storage for the quad bikes used by the golf maintenance team (Plate 7). No feeding signs or droppings were recorded here during inspection, and the structure is deemed to have little to no value as a roosting structure for bats.

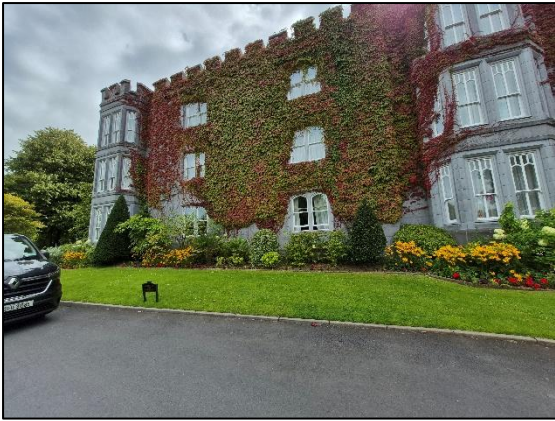
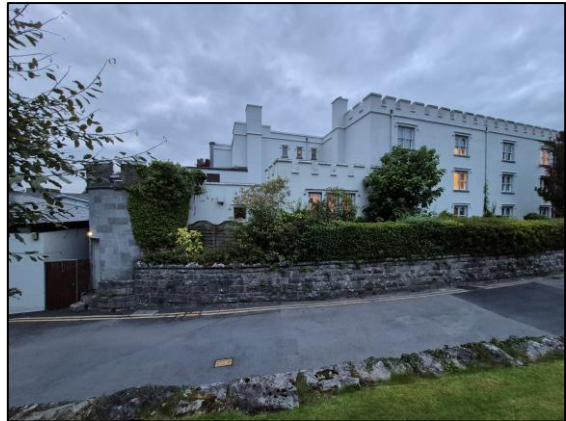
Plate 8: The front (Left) and the rear of the East Wing building (Right).

The north-facing frontage of the East Wing is ivy-clad, brightly lit at night, and overlooks managed lawns, roads, and the main castle to the north. The rear of the hotel is bordered by a hotel access road and overlooks treelines and scrubby vegetation and is comparatively darker, although some light spill from the west, originating from the security lighting associated with the Stables area and staff car-parking area, was noted, along with light spill from hotel rooms.

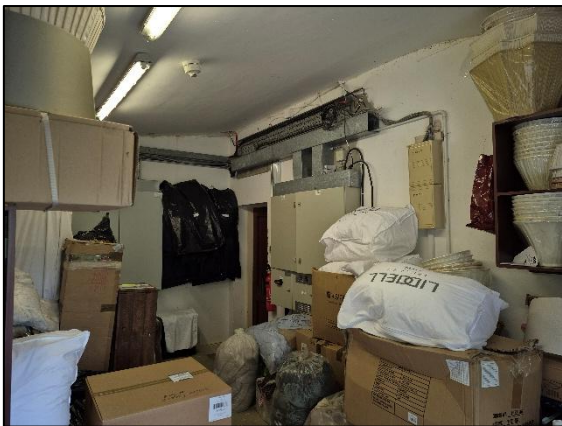
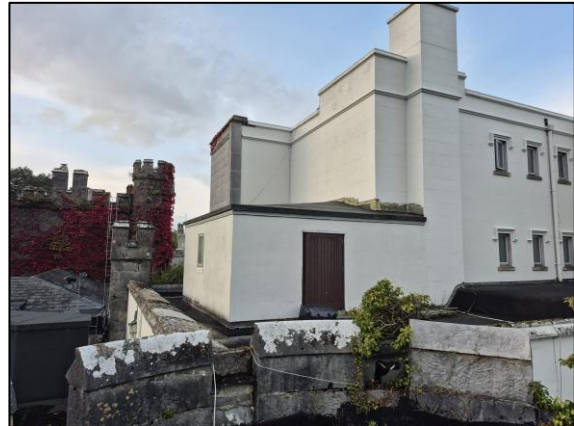
The East Wing Storage Room contained cavities within walls and ceilings and a single window obscured by a blanket, reducing natural light. No direct evidence of bats was recorded internally in this room. Externally, the East Wing Storage Room was found to have gaps beneath the roof overhang and wall junction on the south-facing external wall (See Plate 10). No other gaps along the west-facing or north-facing external walls were noted. Bat droppings were observed trapped within cobwebs beneath some of these gaps.

Plate 9: A photo of the interior (Left) and exterior (Right) of the East Wing Storage Room.

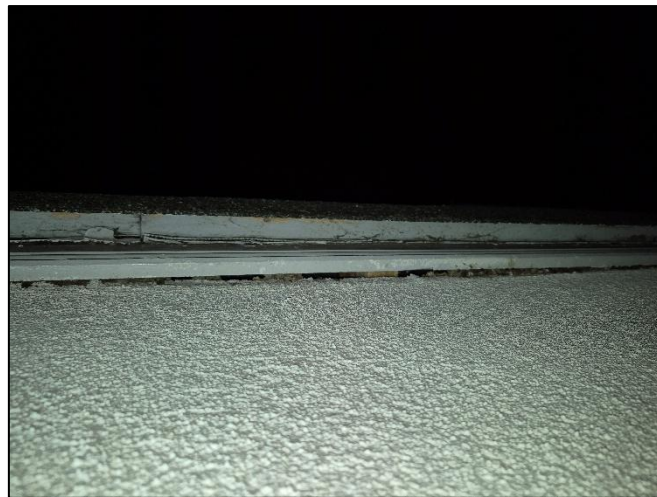
Plate 10: A photo of the interior (Left) and exterior (Right) of the East Wing Storage Room.

The East Wing Storage Building is a relatively quiet section of the East Wing with only minimal light spill from the Stables and carpark located to the west. While no signs of bat activity were recorded within the room, bats were observed entering/exiting the roof space.

Based on the dawn/dusk surveys and the registrations recorded by the deployed passive bat detector, the roof space of the East Wing Storage Room provides a roosting site Soprano Pipistrelle. This site is likely used as a small day/satellite roost, with a max of 8 Soprano Pipistrelle recorded entering the roost during the dawn survey.

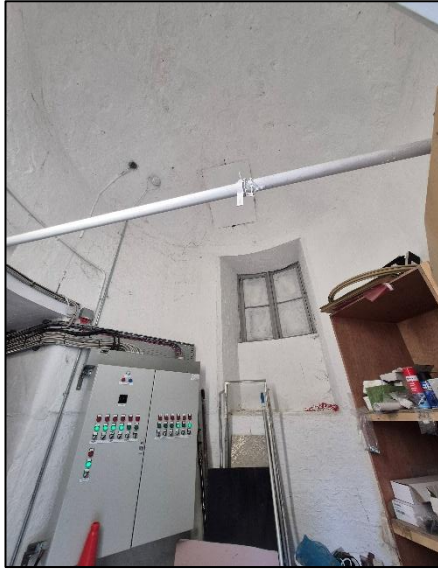
The turret structure was inspected and found to be permanently lit and noisy from plant operation (See Plate 11). No evidence of bat use was recorded, and it is considered to provide negligible roosting suitability.

Plate 11: Interior of the turret at the rear of the East Wing.

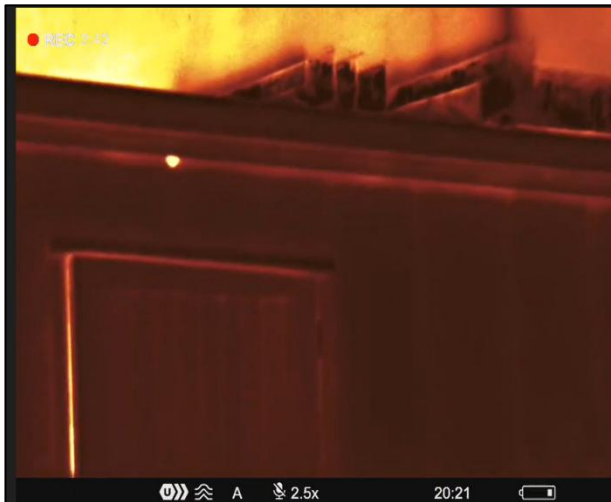
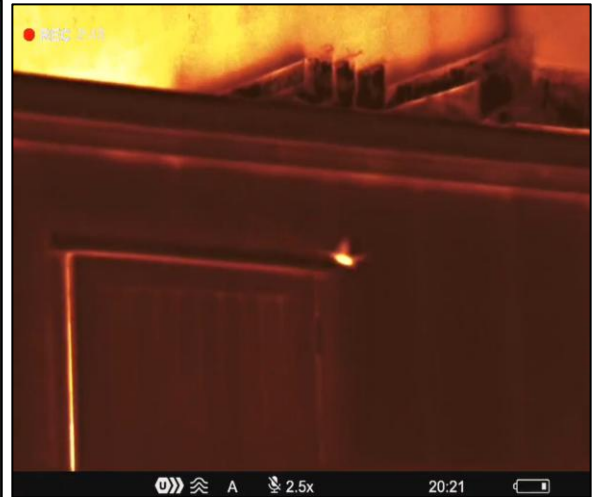
Plate 12: Thermal Imager stills of a Soprano Pipistrelle emerging from under the roof of the lean-to structure at 21:21.

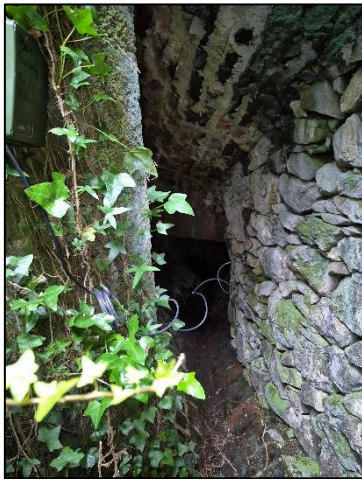
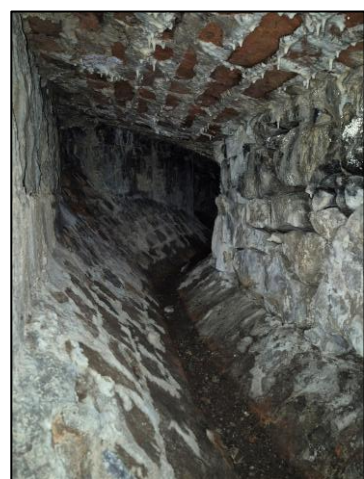
Plate 14: Drain interior.

The Drain comprises an underground drainage structure that appears to circle beneath the northeast section of Dromoland Castle and Estate. Access is via a heavy steel grate located along the southern boundary of the original Castle (Plate 13). The underground structure is built of a mixture of stonework and brickwork, with surfaces heavily encrusted in calcium deposits. Internally, the Drain extends in two directions, reducing to narrow tunnels (Plate 14). The drain was visited on an occasion when there was rainfall, with water dripping steadily into the tunnel.

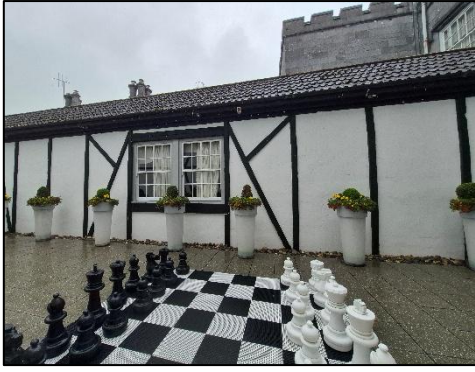
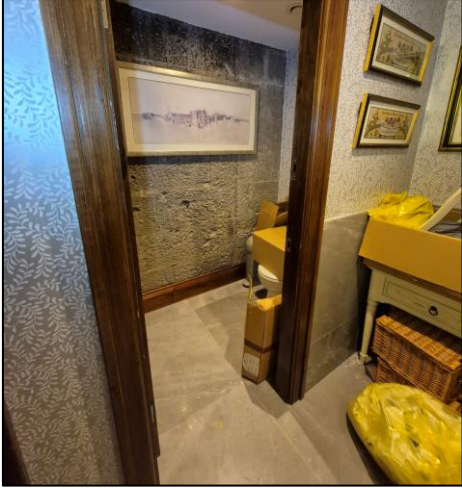
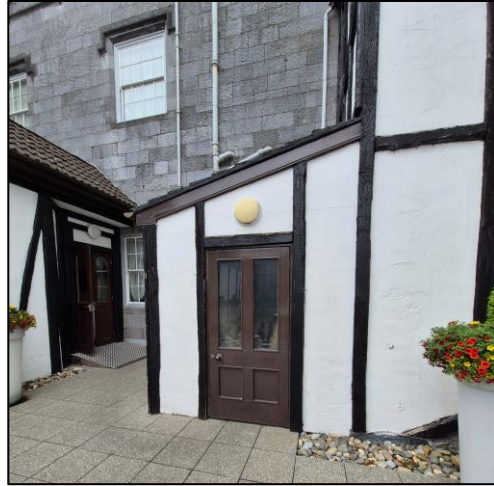
Plate 15: the Courtyard, comprising an external space (Top Left), Room 200 (Top Right), Washroom Facilities (Bottom Left), and a Lean-To structure (Bottom Right).

The Courtyard is located centrally within Dromoland Castle and Estate. For the purposes of this report and based on the proposed Palm Court part of the project, The Courtyard includes; an outdoor courtyard space, a small lean-to shed used to store furniture, and an internal room (Room 200) with associated washroom facilities and access corridor (Plate 15). At the time of survey, Room 200 and associated spaces were used primarily for storage. The Courtyard sits above the spa facilities, with a glass roof from the spa protruding into the courtyard area above (Plate 16). The courtyard is lit up at night (Plate 16).

BD10 was deployed within the lean-to shed, hanging from the rafters, from the 13th of August to the 26th of August. Both Leisler's Bat (18) and Soprano Pipistrelle (40) were recorded here albeit in low numbers. As previously discussed, no signs of bat activity were observed within the structure during the building inspection, although there are access points present.

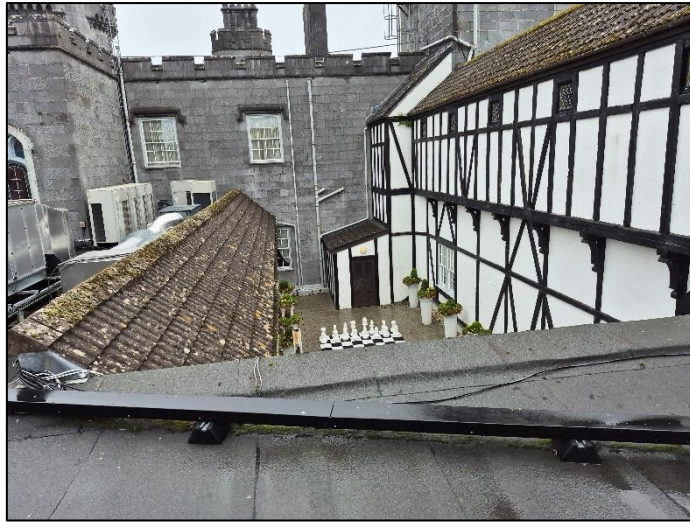
The roof of Room 200 is largely flat and houses hotel plant equipment, which was operational at the time of inspection and generated a constant level of noise. A section of false roof extends above Room 200, facing into the Courtyard (Plate 17). This structure is hollow but was not accessible internally for inspection. Externally, several potential access points for bats were noted where the false roof abuts the main wall, and at the rear of the structure. The false roof is adjacent to the aforementioned hotel plant.

Plate 17: False roof overlooking the courtyard.

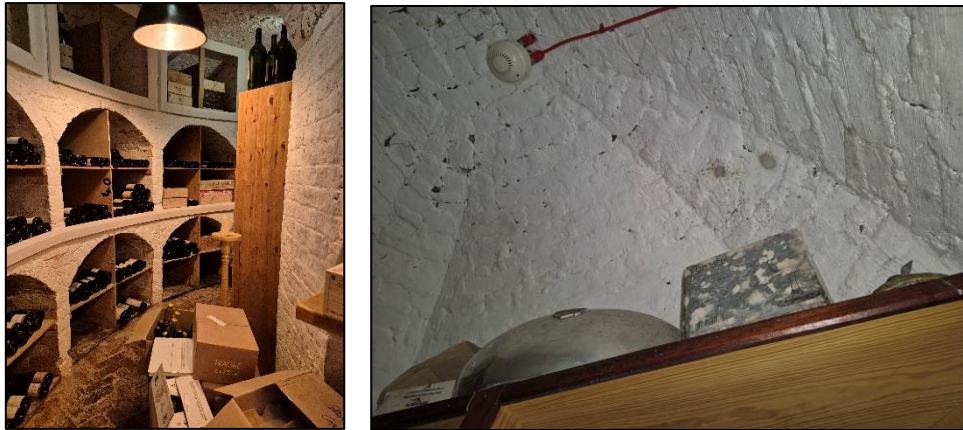
The basement area of Dromoland Castle includes the cellar, staff changing facilities and offices, bedrooms, and a connecting corridor. The cellar is in use as a wine store and is warm and humid (Plate 18). During the inspection, no potential access points were identified other than the secure access door, which remains locked when the cellar is not in use by hotel staff. No signs of bat activity (droppings, staining, prey remains, or direct sightings) were observed within the cellar.

Plate 18: Basement Wine Cellar.

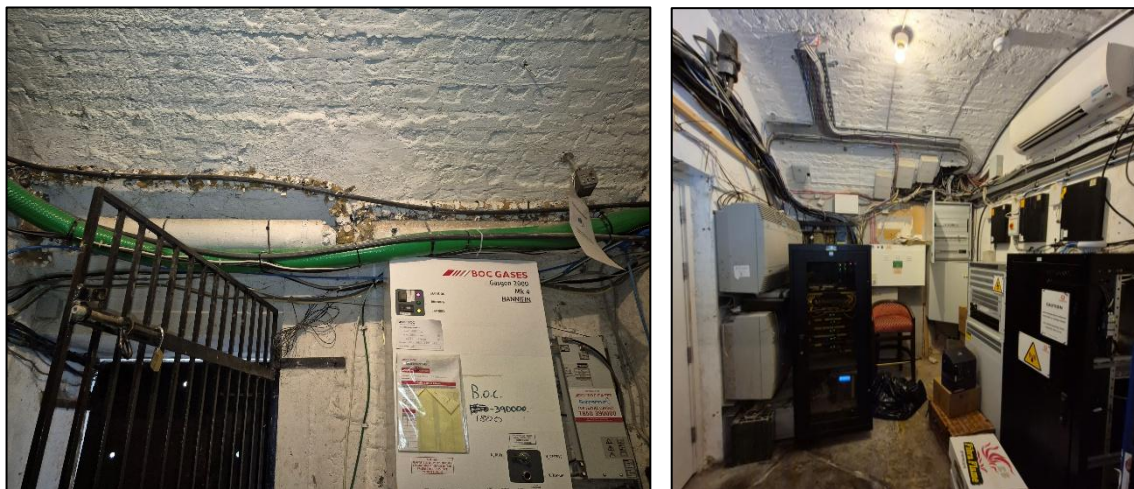
Immediately outside the cellar, are storage areas associated with the cocktail bar on the level above, containing plant and services for the bar and include an old wall hatch providing some limited access to the exterior (Plate 19). These areas were examined, and no evidence of bats was observed.

Plate 19: Basement area outside the wine cellar.

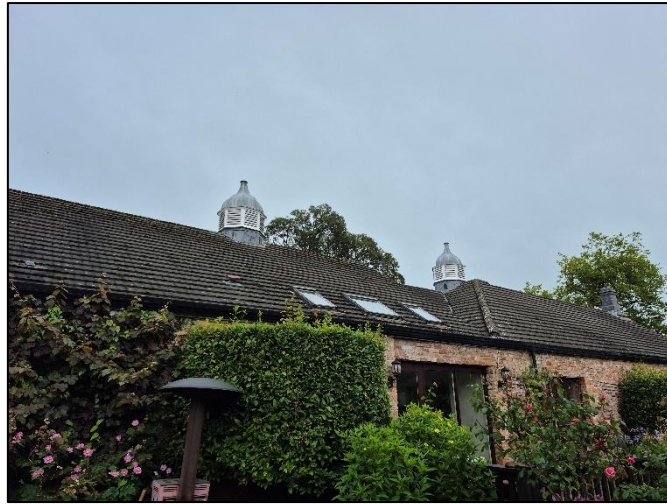
Plate 21: Photo of the roof on the exterior of the Golf Club House.

The Golf Club House contains a restaurant, shop, guest changing facilities, and the hotel's leisure facilities, including the swimming pool, sauna, steam room, and gym. The external survey identified potential access points into the attic space through vent structures located along the roof apex (Plate 21). The attic space was accessed and inspected. No evidence of bat activity (e.g. droppings, staining, feeding remains, or scratch marks) was recorded. The attic is largely occupied by plant and ducting infrastructure associated with the restaurant and leisure facilities (Plate 22). Skylights in the roof contribute to internal light spill, further reducing its suitability as a roosting environment.

Two passive bat detectors (BD14 and BD15) were deployed within the attic space of the Golf Club House from the 26th of August to the 9th of September (14 Nights). No bat activity was recorded.

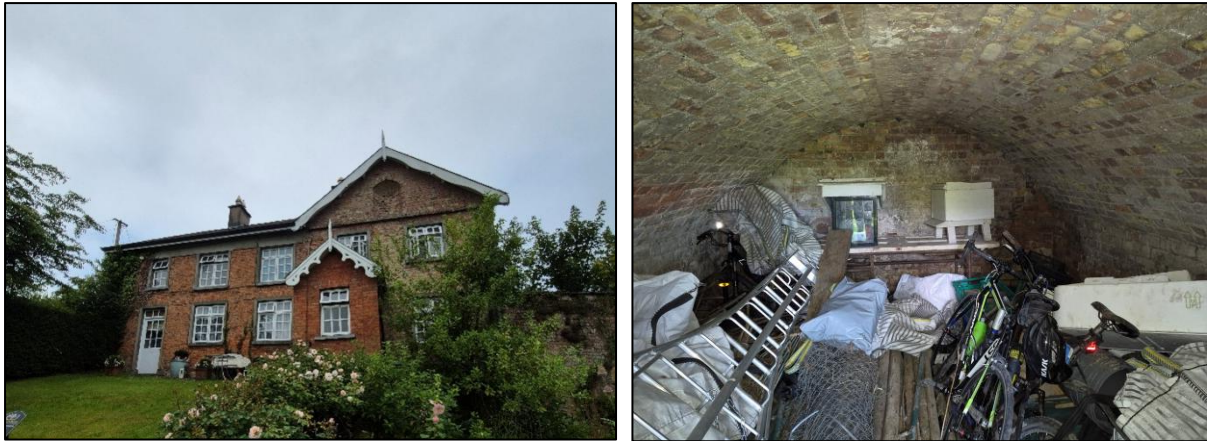
Plate 22: The Cottage (Left) and underground cellar (Right).

Three passive bat detectors were deployed in this location from the 26th of August to the 9th of September (14 Nights). The passive deployed in the cottage attic (BD18) recorded no bat activity. The passives deployed in the stone shed with minimal light-spill, and the passive deployed in the lean-to structure by the cottage both recorded a single Pipistrelle call each. In both cases, the call was faint and likely originated outside of the structures.

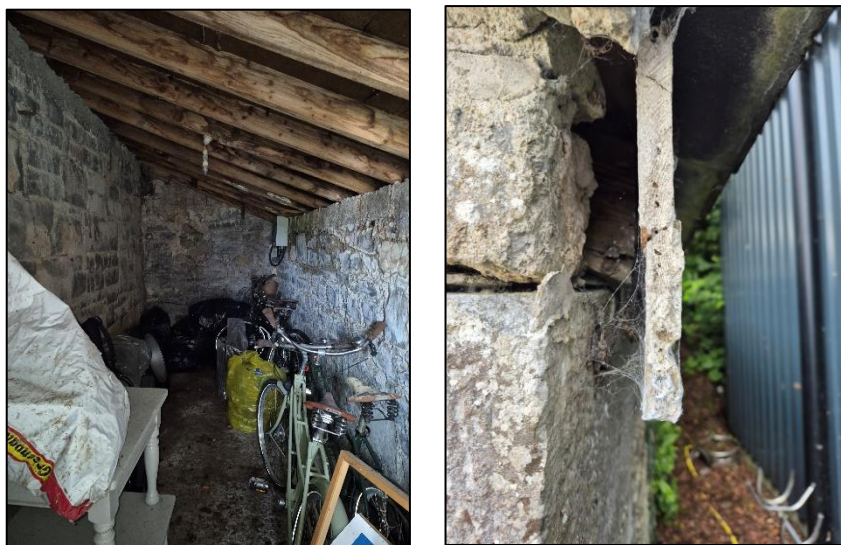
There are other small buildings in proximity to the Cottage. There is a small lean-to shed on the north side of the Cottage containing the gas boiler. This shed is wholly unsuitable as the access door is always open and the roof is partially collapsed, with large gaps. There is a long narrow lean-to building with a slate roof against the Cottage to the rear, which is accessed via a locked door and is used as storage (bikes, refuse, etc.) (Plate 23). On inspection, no signs of bat activity were recorded, although a number of access points were noted. To the west of the lean-to and Cottage is galvanized steel shed used as storage for the quad bikes used by the golf maintenance team. The structure is deemed to have little to no value as a roosting structure for bats.

Plate 23: Lean-to shed interior (Left) with visible access point (Right).

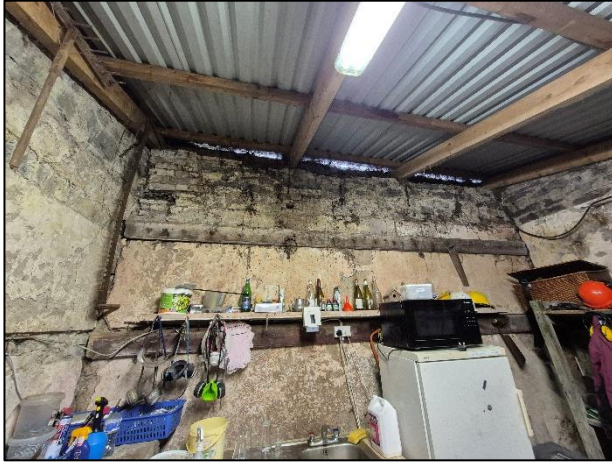
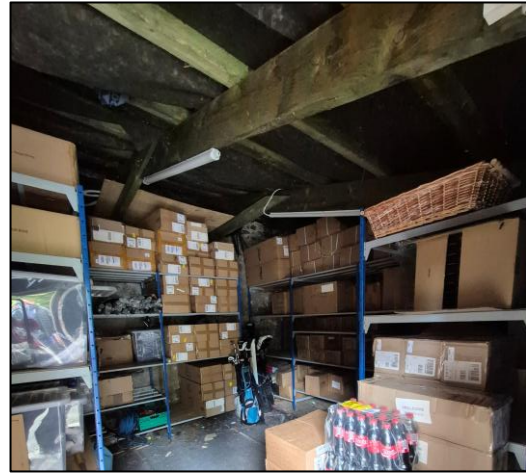
Plate 25: Interior of one of the stone sheds, showing gaps beneath the corrugated roof (Left) and interior of one of the three stone sheds where light-spill from a window has been minimised (Right).

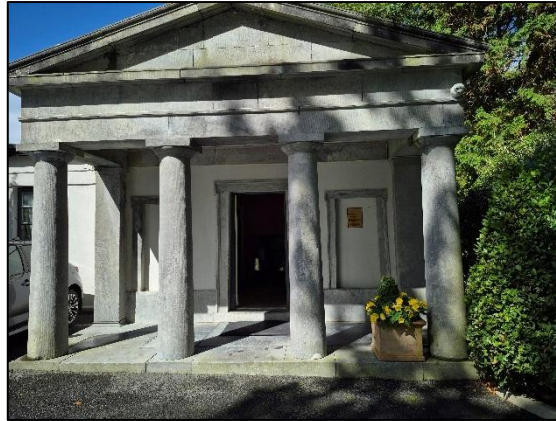
Plate 26: Gate Lodge exterior.

A passive bat detector (BD21) was deployed from the 29th of August to the 17th of September (19 Nights). No species were recorded.

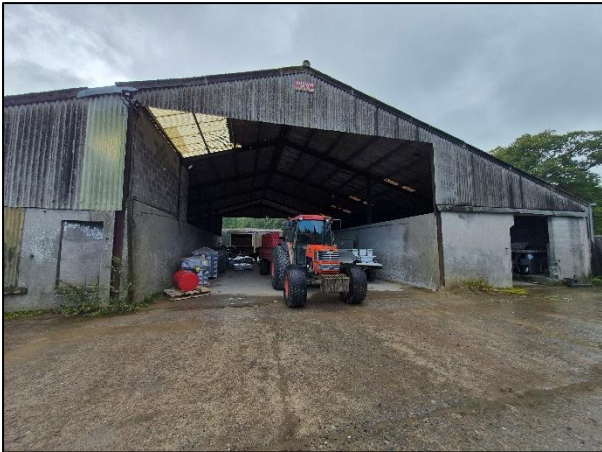
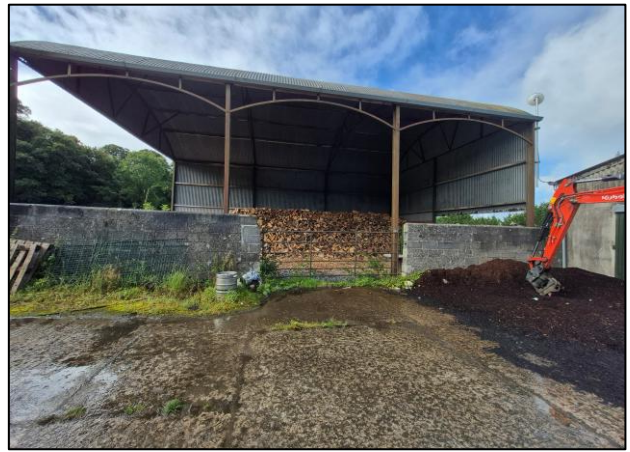
Plate 28: Example of the large open sheds at the Farm.

Of all the structures present on the Farm, the large, locked shed is the least subject to weather disturbance, although it is still a bit drafty, particularly on the first-floor level, with light-spill from the Perspex sheeting. The small room within the shed is also, in places, largely protected from the elements and is subject to light-spill. Evidence of swallows nesting was recorded in both.

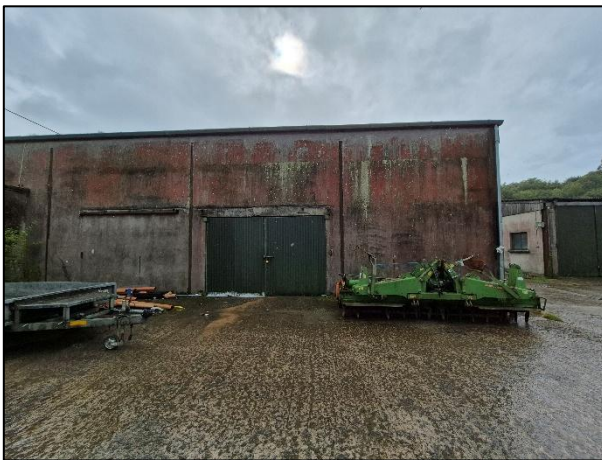
Both areas contained signs of bat activity in the form of droppings and feeding signs. Based on the number of Soprano Pipistrelle registrations, it is considered likely that this structure is used as a roost for these species. The majority of recorded activity was spread out over night which, combined with the presence of feeding remains, suggests that the structure is used primarily as a night roost. However, the level of dusk activity suggests that it could be used as a day roost as well, although there was no such activity recorded at dawn. It is likely that Brown Long-eared Bats will also use this structure as a roosting site, with recorded activity suggesting that this species uses the structure spread out over night, with no peak in activity at dawn or dusk.

Plate 29: Locked shed with signs of bat activity (droppings and feeding signs).

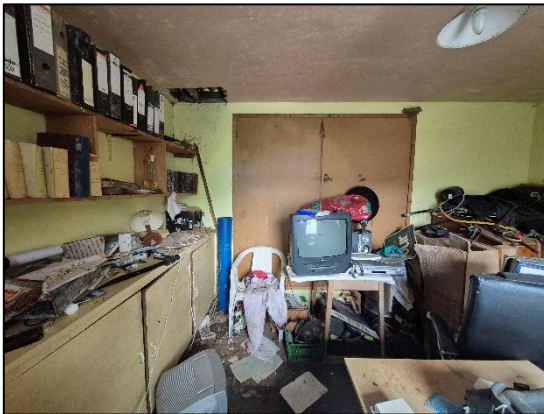
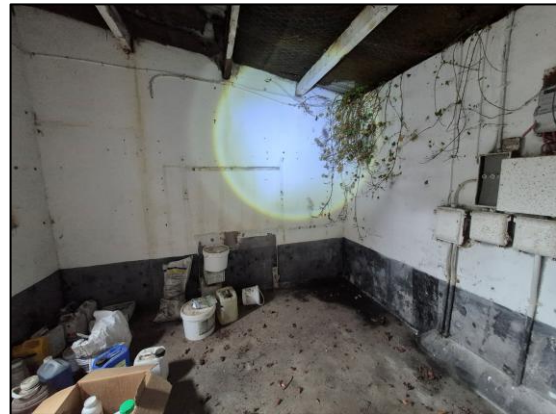
The two ancillary single-storey buildings (former office and electrical shed) were in poor condition (Plate 32). The office showed light spill from a window, a broken pane, and a hole in the ceiling where daylight entered through gaps in the corrugated roofing. Both small buildings were drafty. No evidence of bat activity internally was recorded.

Plate 32: Interior of the now-derelict farm office (Left) and the former electric room (right).

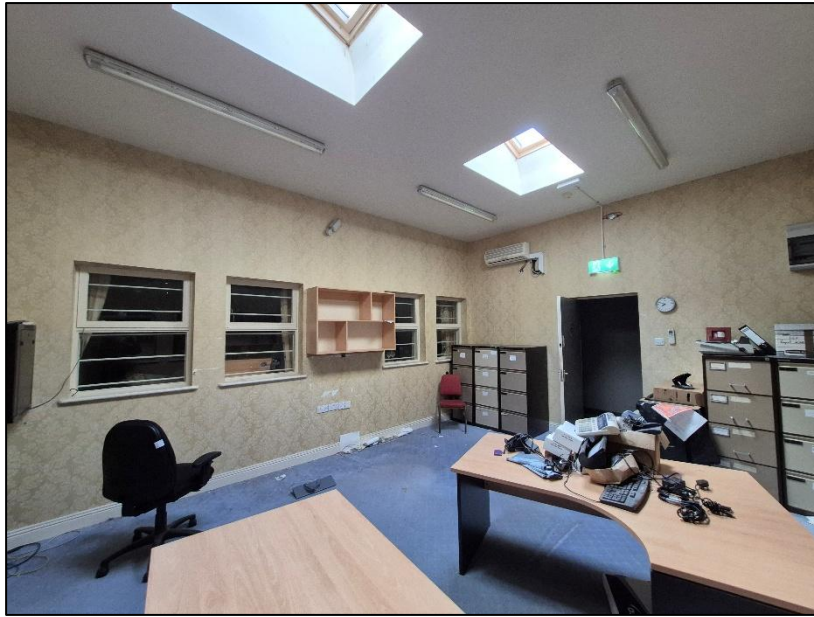
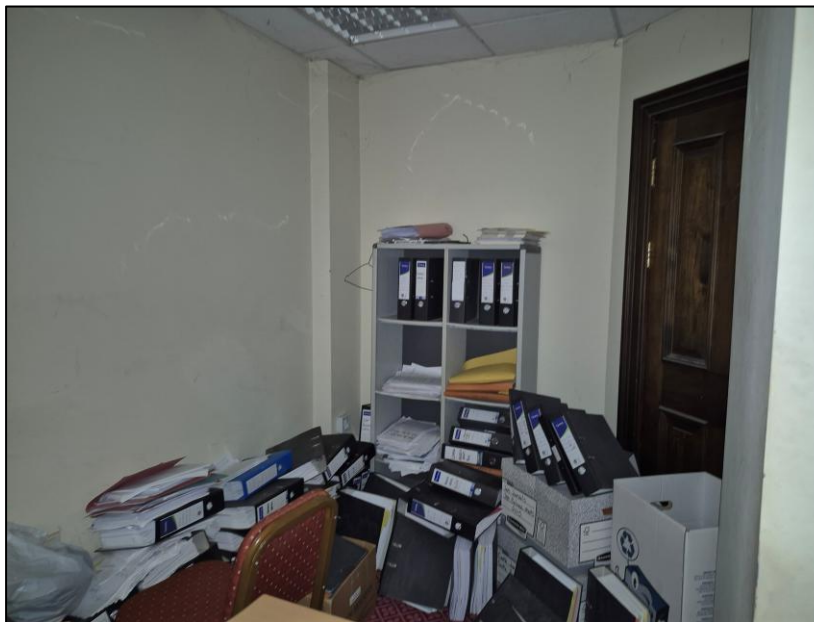
Plate 33: Brian Boru office space.

The Brian Boru Offices are located internally within the Brian Boru Conference Centre section of Dromoland Castle and Estate. These offices are no longer in use and currently function as storage and disused office space (Plate 33). They have no external frontage that would be accessible to bats. No potential bat access points were identified. The rooms vary in use, with some still containing office furniture, filing cabinets, and storage boxes. The condition of the offices is generally good, with no significant cracks, voids, or cavities that would offer potential roosting opportunities. Lighting is provided by ceiling strip lights and skylights with light-spill from internal windows. No evidence of bat activity was recorded during the survey.

A passive bat detector (BD19) Passive deployed from the 29th of August to the 17th of September (19 Nights). No species were recorded.

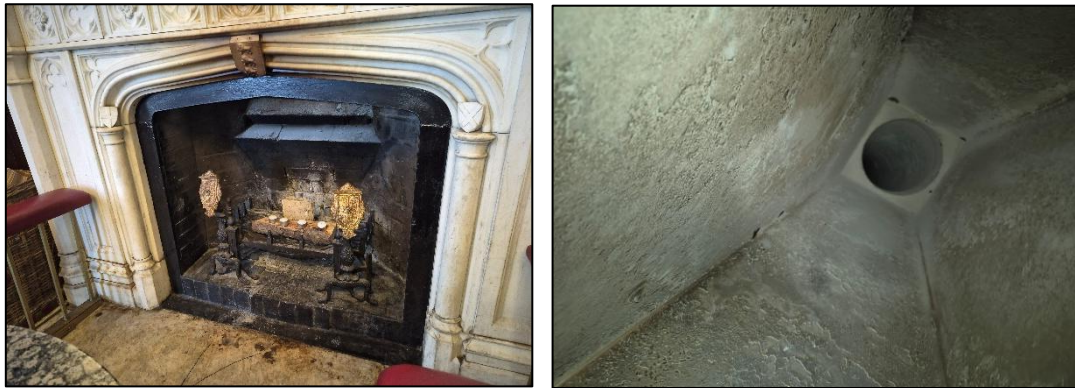
Plate 34: Chimney in the cocktail bar inspected for signs of bat activity.

Other areas within the hotel subject to inspection include the cocktail bar, dining areas and kitchen, and the terrace room and smoking area, located within the original Castle. The cocktail bar, dining areas and kitchen, face north (Plate 34 – Plate 35) while the Terrace Room and Smoking Area are on the south side of the castle (Plate 36 – Plate 37). These areas are all operational areas of the hotel. No sign of bat activity was recorded within these areas.
