**Derogation Licence Application under  
the European Communities (Birds and  
Natural Habitats) Regulations  
2011 - 2021**

**Supporting Information – Proposed  
Demolition at Ballybeggan, Tralee, Co. Kerry**

**Ard-Rí Group 2025**

Appendix 1 – ‘Bat Survey and Assessment Report’ for the proposed Demolition at Ballybeggan, Tralee, Co. Kerry

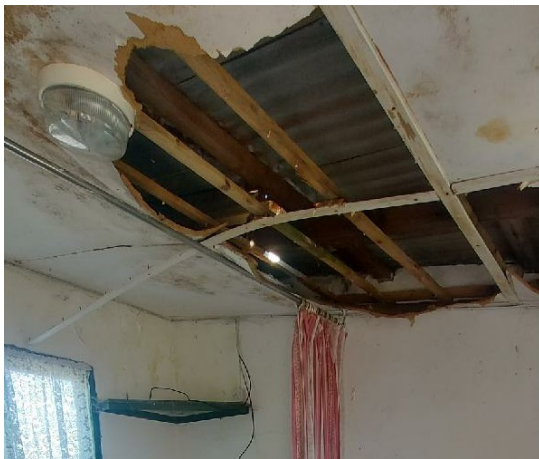
**Plate 1. Damaged roof**

Many of the buildings have no fully intact roof or external wall structures. Buildings have been severely damaged by weather and the ingress of water over time. There are extensive areas of broken windows and glazing along with semi- collapsed roof elements that in themselves are a risk to safety, particularly due to high winds and storm effects.

Consequently, and in terms of public safety, we recommend that the buildings be demolished safely and in a managed fashion and all materials be safely removed from site.

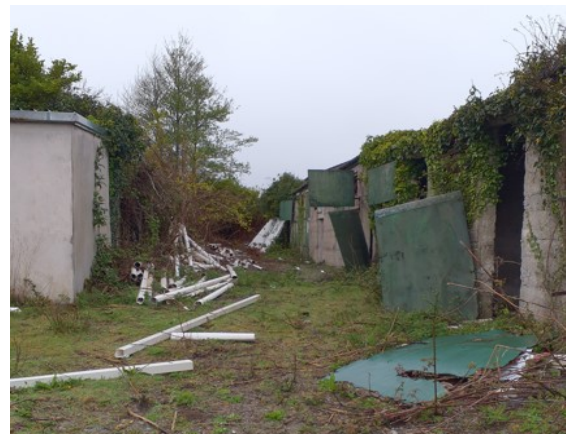
**Plate 4. Damaged stables**

Boundary walls , gate and stable buildings are in a poor state of repair and unsafe. Access to the site is controlled at present but requires full time security.

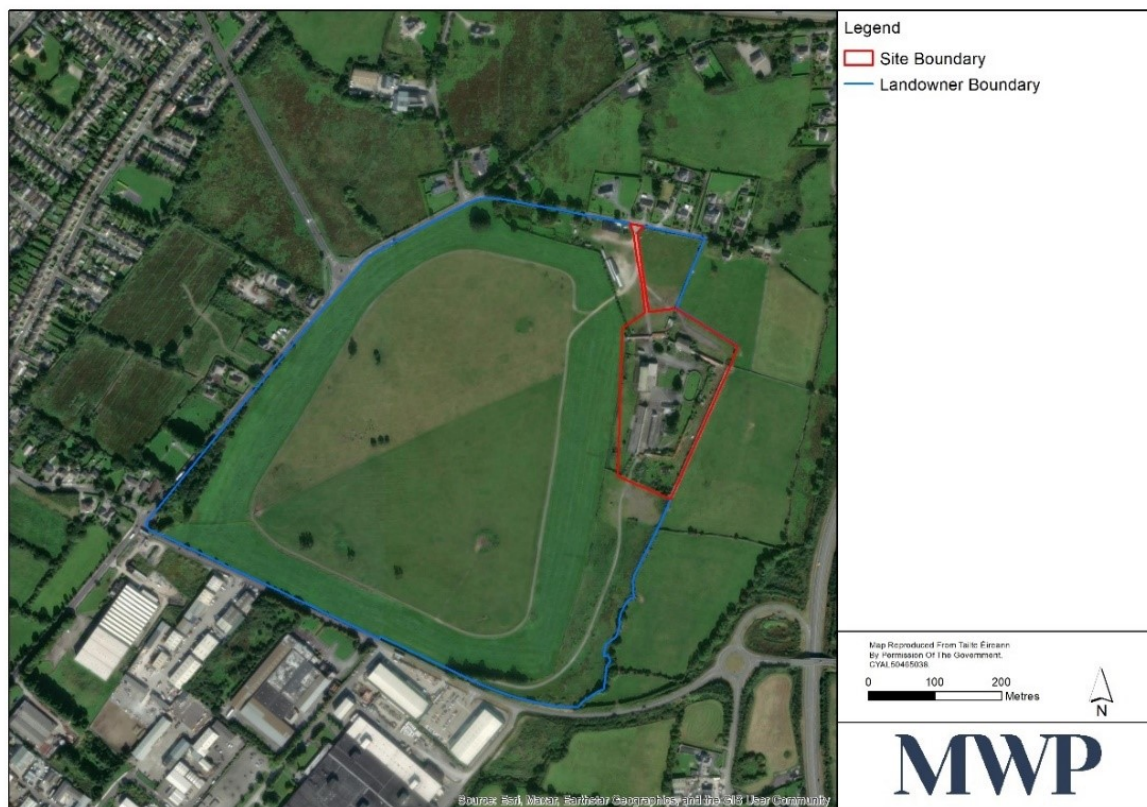
Figure 2. Site Boundary and Study Area

The study area is taken to be the full extent of the of lands within the redline boundary encompassing the demolition area. The study area is shown in **Figure 2** below. All buildings and structures within the study area have been numbered and labelled, and will be referred to throughout this report, see **Figure 3** below.

It is proposed to demolish all existing buildings, structures, extensions, and landscaping elements and the decommissioning of existing septic tank and all associated site works within the study area shown in **Figure 2 above**. The works will be phased and will include preparation before demolition wherein any potential hazards will be identified, all hazardous material will be appropriately removed, and the dismantling of current roofing will be carried out. The it is envisioned the duration of the proposed works will be approximately 6 – 9 months.

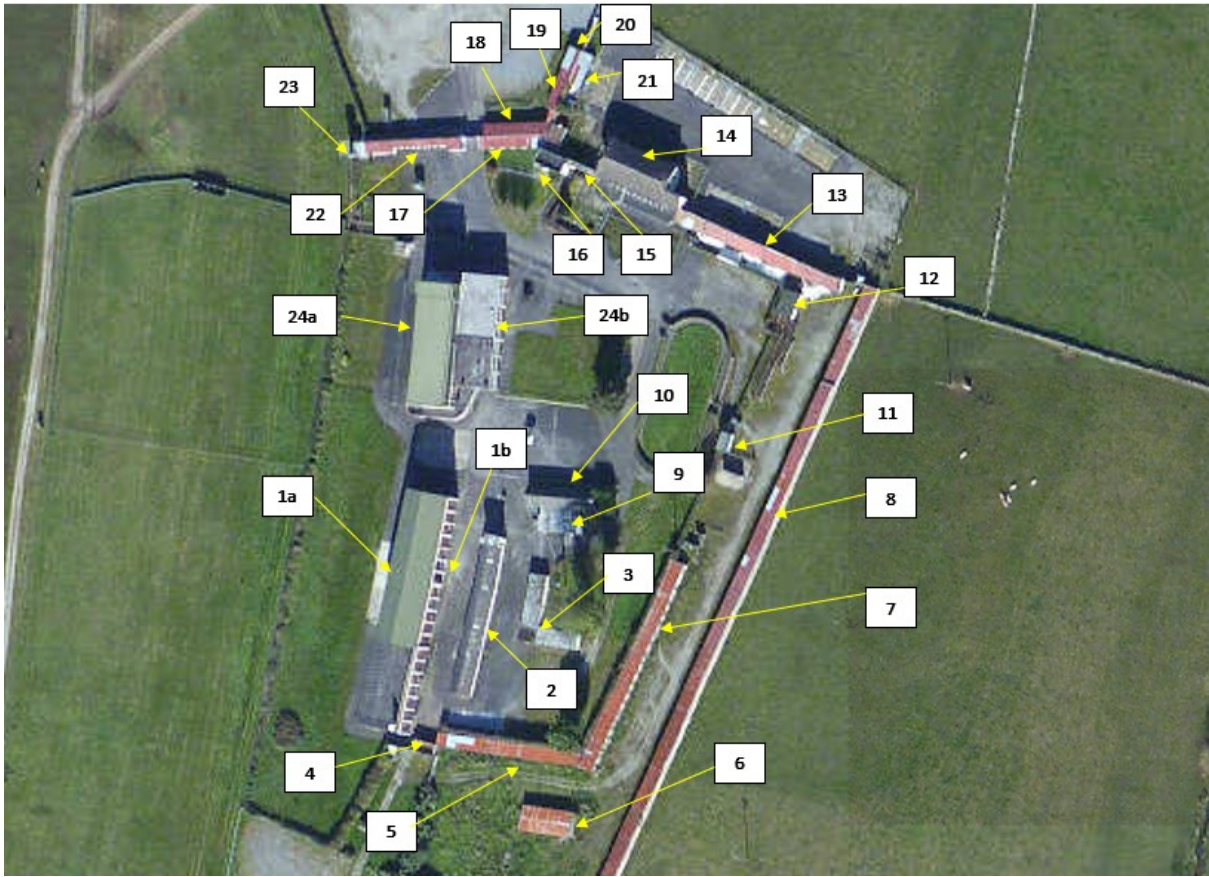
Figure 4. All buildings and Structures Surveyed Within the Study Area

Over 20 buildings/structures were surveyed, each of which are labelled 1 – 24 and are listed in **Table 5** and shown in **Figure 4** below.

Building No.	Description
1a	Large Stand
1b	Reception Areas Below Large Stand
2	Tote Kiosks
3	Ancillary Building no. 1
4	Working Entrance Building
5	Stables no.1
6	Stables no.2
7	Stables no.3
8	Stables no.4
9	Ancillary building no.2
10	Ancillary building no.3
11	Stewards tower
12	Ancillary building no.4
13	Stables no.5
14	Jockeys Facilities
15	Stables no.6
16	Male WC Block
17	Stables no.7
18	Stables no.8
19	Stables no.9
20	Stables no.10
21	Stables no.11
22	Turnstile Block
23	Officials tower
24a	Spectator Stand
24b	Reception Areas beneath Stand

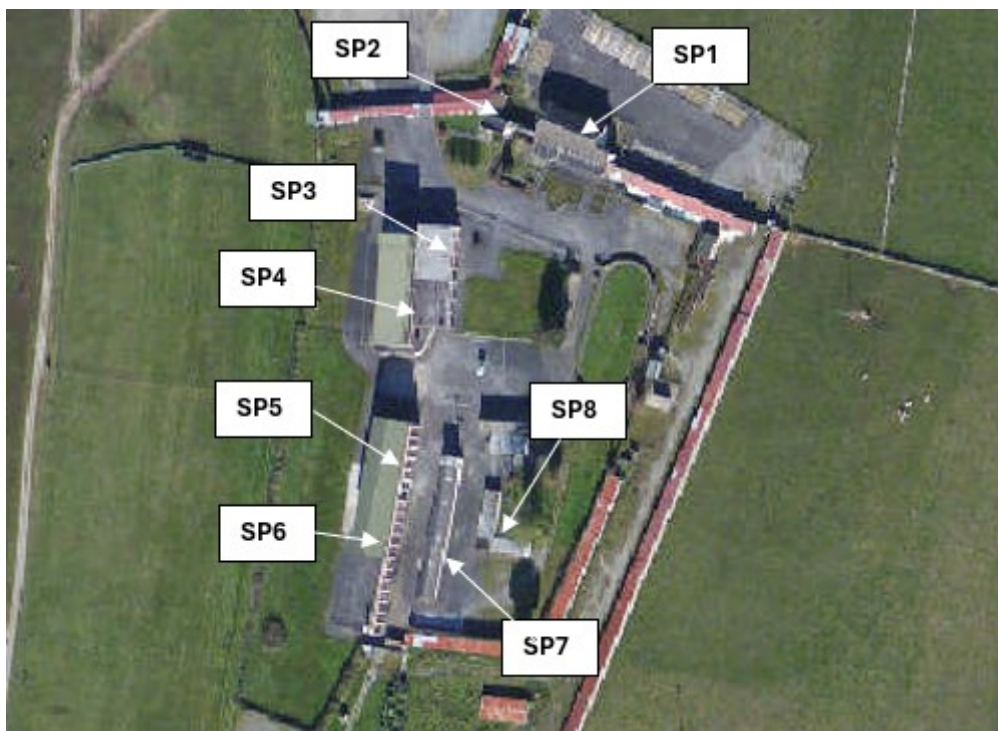
Figure 5. All Sampling Points

All sampling points and locations are listed in **Table 9** and shown in **Figure 5** below.

Sampling Point	Building No.	Building	Location in Building
SP1	14	Jockeys Facilities	1st floor in function room
SP2	16	Male WC Block	Inside the front door to the toilets
SP3	24b	Reception Areas beneath Stand	Ground floor in middle bar room
SP4	24b	Reception Areas beneath Stand	1 <sup>st</sup> floor in larger bar room
SP5	1b	Reception Areas Below Large Stand	In the first bar room (northern entrance)
SP6	1b	Reception Areas Below Large Stand	In kitchen area in middle of building
SP7	2	Tote Kiosks	In the middle section of building
SP8	3	Ancillary Building no. 1	The men's toilets (southern section of building)

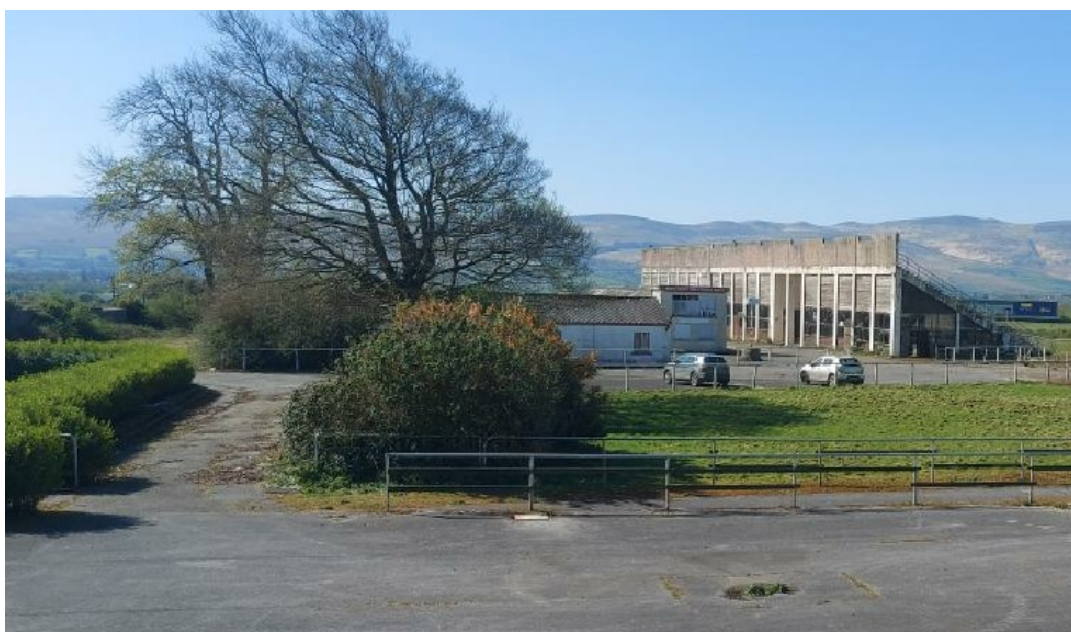
Figure 6. View from Building No. 14 Looking Southwards

The study area is dominated by artificial features such as buildings, sheds stables, access roads and pathways. Some of these hardcore areas have been colonised by grass and moss in places. There are some areas of scrub at the southern end the east side of the study area growing alongside the stables to the east. Some ornamental non-native shrubs and a few grassy areas occur within the centre of the study area. There are no woodland areas within the study area but there are a small number of scattered mature trees which include ash (*Fraxinus excelsior*), Italian alder (*Alnus cordata*) and oak (*Quercus* spp.). See **Figure 5** below showing the central part of the study area.

Immediately to the west of the study area is a large racecourse which is very open and although there are a few scattered trees and small treelines this is a largely open habitat. The racecourse is currently used by grazing livestock and for the production of silage. To the north there is a local road and a number of private residential dwellings. To the east are a number of agricultural and rough grassland fields which are bounded by linear hedgerows and treelines, and beyond that is the Ballybeggan River (EPA Code 23B76) which is situated approx. 140m from the boundary of the study area. To the south area some agricultural fields, a continuation of the racecourse and an access track leading southwards.

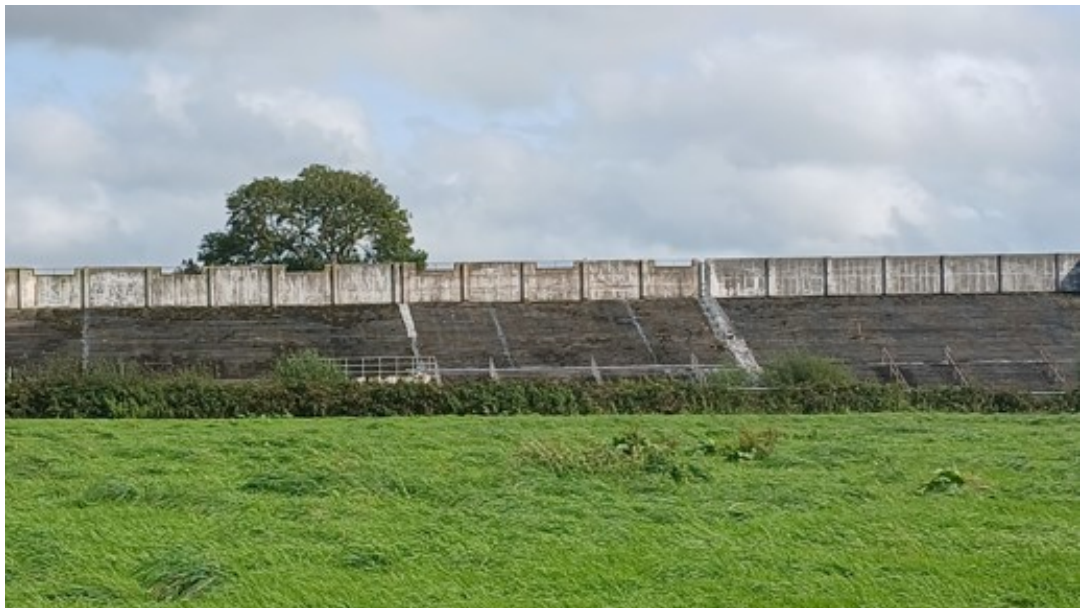
Plate 1. No.1a - Large Stand

This west facing side comprised a large stand with concrete levels and metal railings. This structure is completely open and did not show any evidence of bat use and did not have any roosting potential. See **Plate 1** and **Table 12** below for observations.

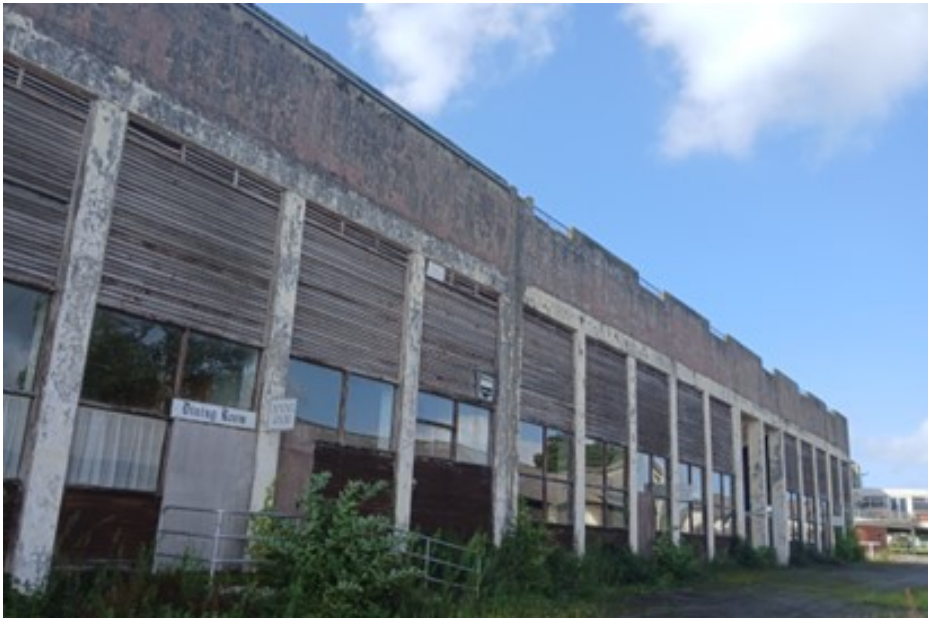
Plate 2. No.1b - Reception Areas Below Large Stand

This is the east facing side of the building which comprised three large bar rooms and a kitchen with a dark cellar-like room to the back. The building is in a state of disrepair with water leaking in through parts of the roof/ceiling, peeling paint, broken tiles and evidence of nesting birds. A pair of jackdaws were present in the bar room furthest south. See **Plates 2, 3 and 4** and **Table 13** below for observations.

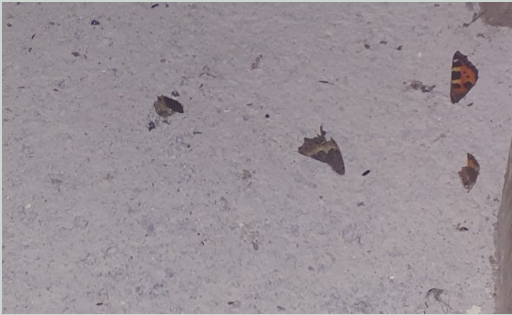
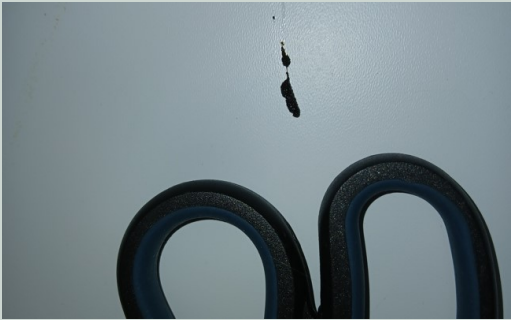
Observations	
Bats found	No
Evidence of bat use	Yes – In various places there were droppings found on the walls and some discarded butterfly/moth wings on the ground.

Potential for bat use	Yes – Several access points observed such as open/broken windows and gaps between wood panels. Inside there were many cracks and small crevices in the walls and peeling paint which may offer roosting potential.
Overall Roost Suitability Assigned	Moderate

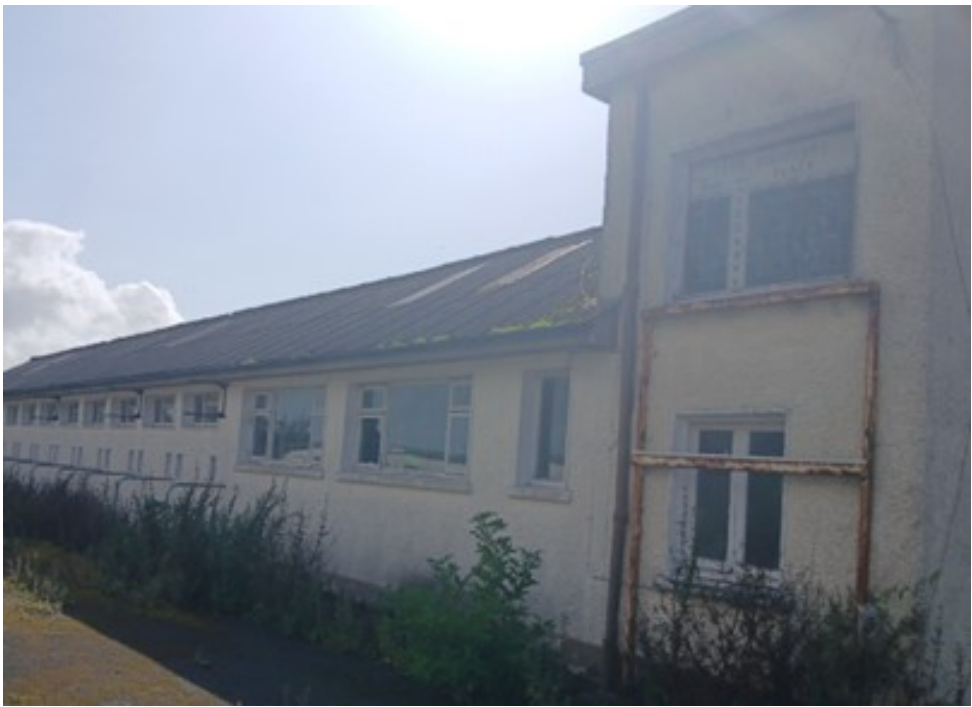
Plate 5. No.2 - Tote Kiosks

Large building with many small windows on the east side, some of which are missing or broken. The west side of the building comprised mainly of large metal shutters. There was one small room above the front door accessed via a small hatch. There were a number of dead birds in this small room and broken windows. Throughout the building there were nesting pigeons along the wooden beams under the roof. The corrugated roof was damaged in a number of places with some parts missing. This has led to the partial collapse of the inner plywood ceiling. See **Plates 5, 6 and 7** and **Table 14** below for observations.

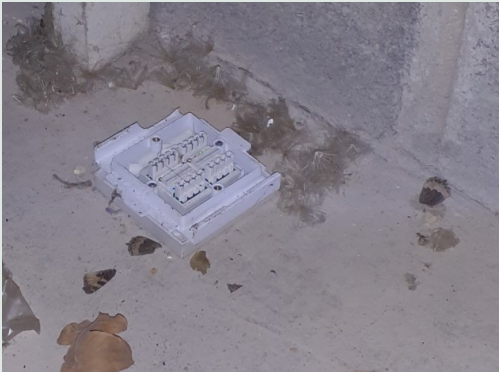
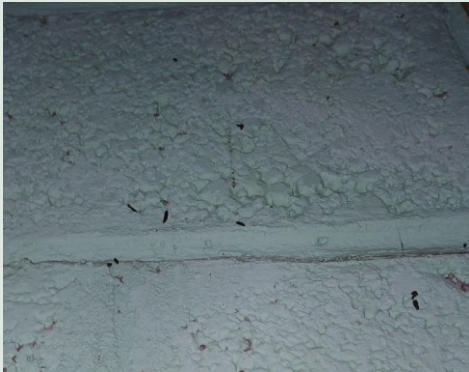
Plate 6. Discarded butterfly/moth wings	Plate 7 . Droppings on the wall
Potential for bat use	Yes – several access points observed such as open/broken windows and gaps and holes in the roof. Inside there were many cracks between block work and wooden beams which may offer roosting potential.
Overall Roost Suitability Assigned	Moderate

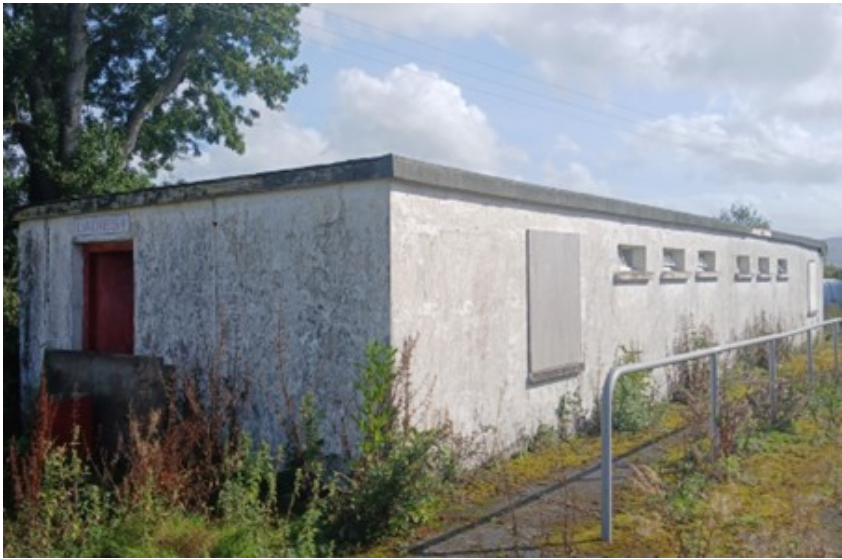
Plate 8. No.3 - Ancillary Building no. 1

A large ‘L’ shaped building with men and women’s toilets which featured a number of stalls and sinks with tiles inside. The women’s toilets are accessed from the north and men’s from the south. The walls appeared solid from the outside and inside. The roof is flat with supporting wooden beams on the inside. Ivy was growing quite vigorously in the men’s toilets, growing through gaps in the roof. See Plates 8, 9 and 10 and Table 15 below.

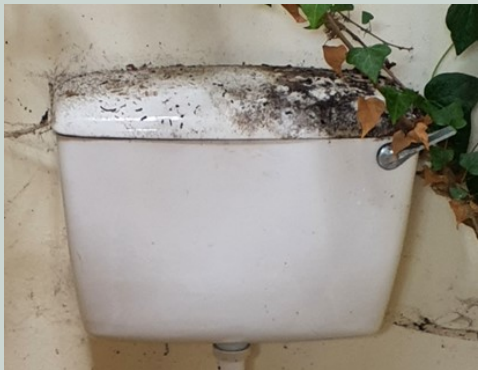
<p>Plate 9. Droppings on toilet cistern</p>

Observations	
Bats found	No
Evidence of bat use	Yes – Many droppings found in the men’s toilet on some of the cisterns and tiles on the walls.

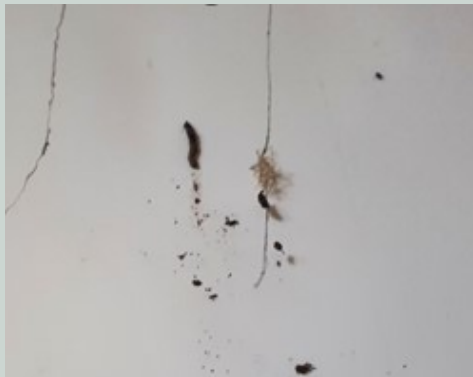
<p>Plate 10. Droppings on the wall</p>
Potential for bat use	Yes – Several access points observed such as open/broken windows and gaps between wood panels. Inside there were many cracks and small crevices in the walls and peeling paint which may offer roosting potential.
Overall Roost Suitability Assigned	Moderate

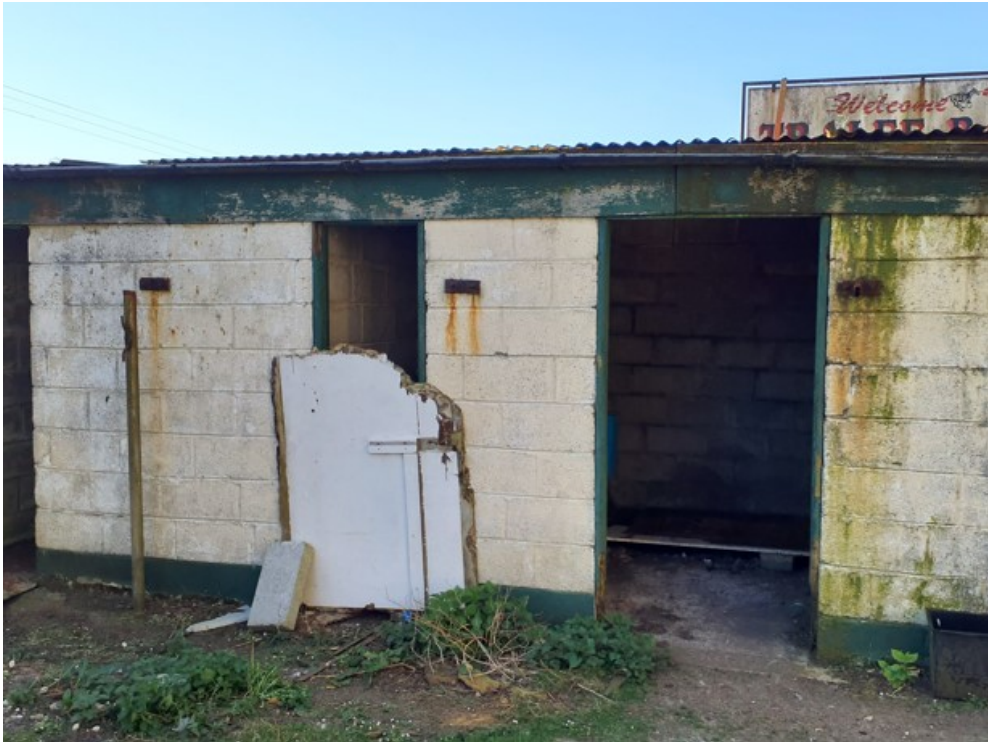
Plate 11. - No.4 - Working Entrance Building

Small structure comprised a small number of old ticket stalls with solid walls and corrugated tin roof. The walls were in good condition, but the roof was rusty and damaged with a few holes and some panels missing. There were no doors on any of the stalls at the front. There was one square hole in the wall which appeared to be a type or ‘window hatch’ with a few old swallows nests inside. There was no evidence of bat presence within the structure. See **Plate 11** and **Table 16** below.

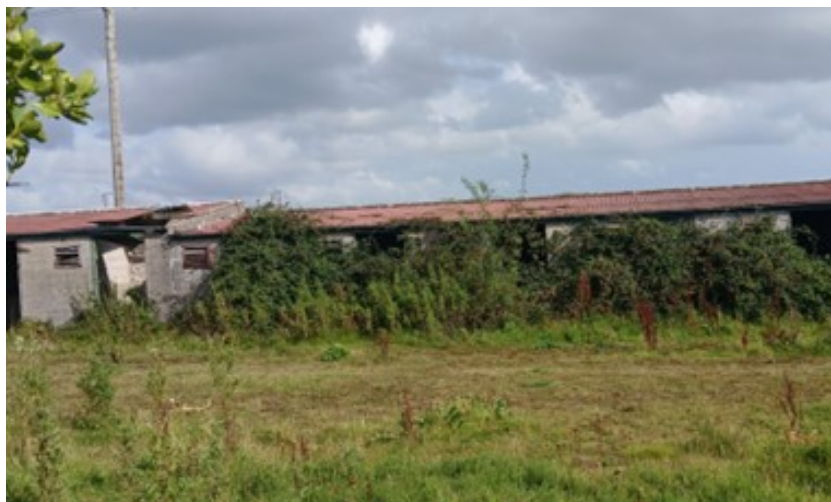
**Plate 12. No.5, 6 , 7, 8, 13, 15 - Stables**

The stables in buildings No. 5, 6, 7, 8, 13 and 15 all have corrugated tin roof, many with holes, rust and some have collapsed fully or partially leaving some stalls damp and open to the elements. Old swallows’ nests were observed inside, and many of the stables were damp inside from rain water seeping in. There was no evidence of bat presence within the structure See **Plate 12** and **Table 17** below.

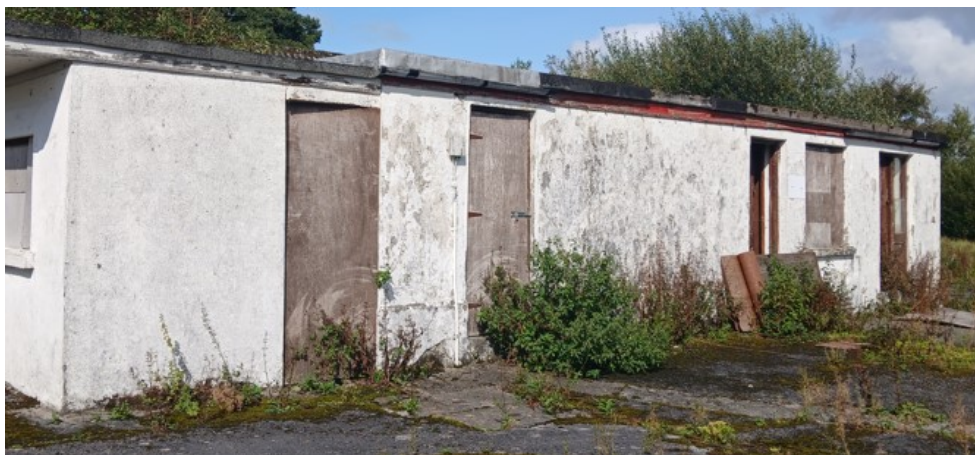
Plate 13. No.9 - Ancillary building no.2

This small building comprised a flat roof with small rooms containing electrical equipment and fuse boxes. It appeared these rooms had been well-sealed/boarded up for an extended period of time prior to survey access to the building. The building appeared solid with no obvious signs of damage and each room was dry with no water damage. Each window was tightly boarded up and there were many cobwebs within the rooms, indicating a lack of bat activity within. There was no evidence of bat presence within the structure. See **Plate 13** and **Table 18** below.

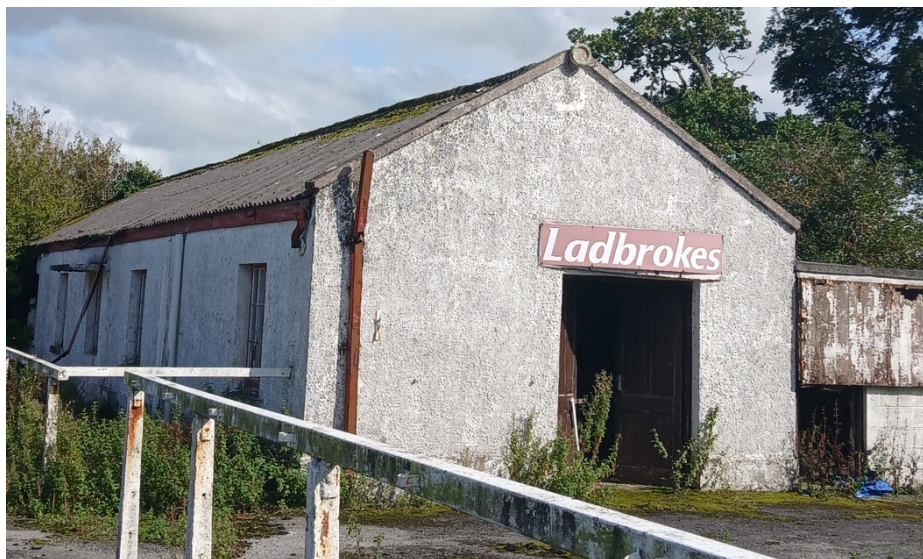
Plate 14. No.10 - Ancillary building no.3

This building had a large room when entering through the door on the west of the building leading to some smaller rooms (bathroom) and hallways. Areas of the roof had holes and gaps and throughout this building the ceilings were all very damp and some areas had dripping water coming through the light fixtures causing partial ceiling collapse in places. Most windows appeared to be intact and two exterior doors on the east side of the building leading outside were nailed shut. See **Plate 14** and **Table 19** below. There was no evidence of bat presence within the structure, however, due to health and safety concerns, a full PRA of the building was not carried out.

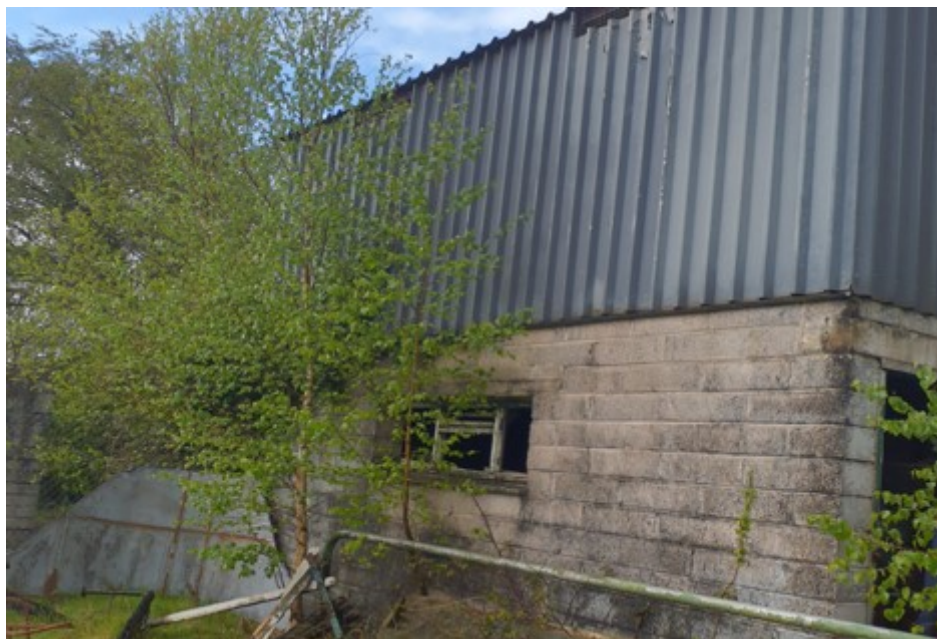
Plate 15. No. - 11 Stewards tower

A small structure called the 'stewards tower' with a room on the ground floor with block walls and some metal beams supporting the corrugated roof/ceiling and the floor of the first floor. The ceiling was damp and showed signs of water damage. There were gaps between the stone blocks and metal beams and ivy growing in from outside. The door and the windows were broken. The first floor had a room with corrugated walls and roof. This room was not accessed due to safety. The wood on the stairs was rotten and the ceiling of the lower floor was damaged making them unsafe. See **Plate 15** and **Table 20** below.

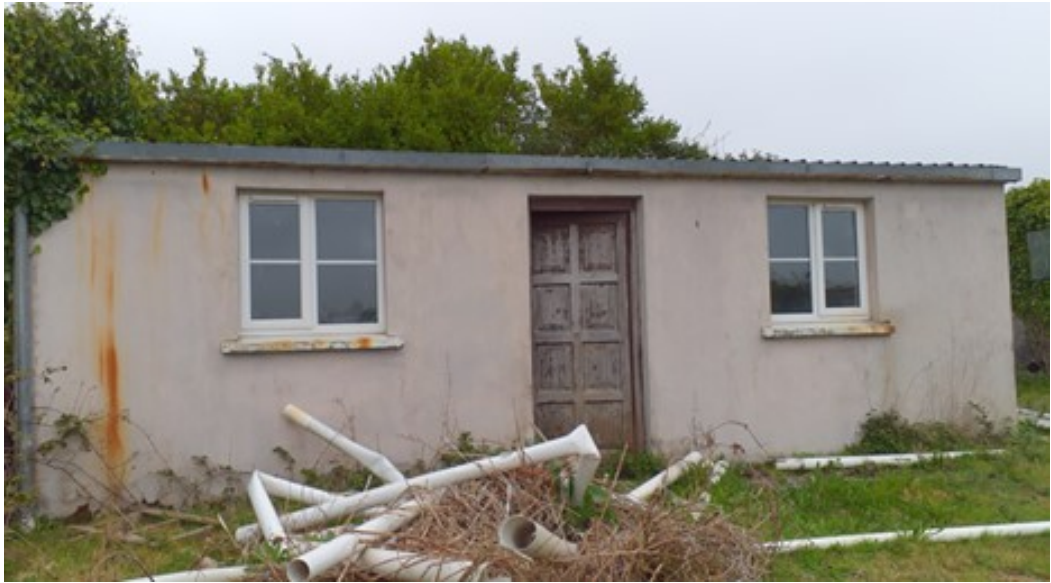
Plate 16. No. 12 - Ancillary building no.4

This was a small building with solid block walls and a corrugated tin roof that was likely used as a kitchen/canteen facility as there were cupboards, worktop, old fridge and sink. The roof was supported with mostly metal beams with some wooden beams and panels. Some ivy was growing through the gaps between the back wall and the roof. The back of the building and one side was heavily covered with ivy. There was evidence of bat presence within the structure; see **Plates 16, 17 and 18** and **Table 21** below.

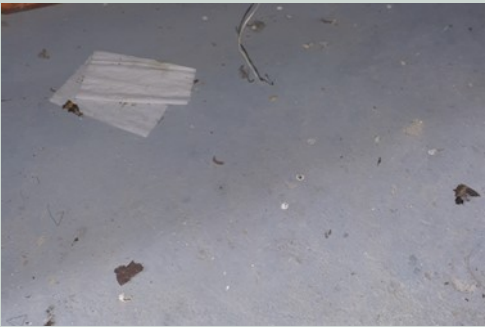
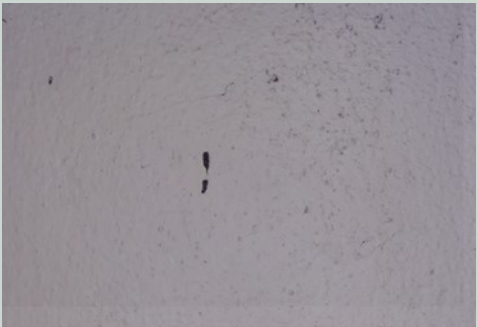
Observations	
Bats found	No
Evidence of bat use	Yes – A few droppings found on the wall and some discarded butterfly/moth wings on the ground.
Potential for bat use	Yes – Potential access point via the door which is ajar and potential gaps between the wall and the roof. Inside, some wood panels and beams with gaps between may offer roosting potential.

Plate 17. Discarded butterfly wings	Plate 18. Droppings on wall
Overall Roost Suitability Assigned	Moderate

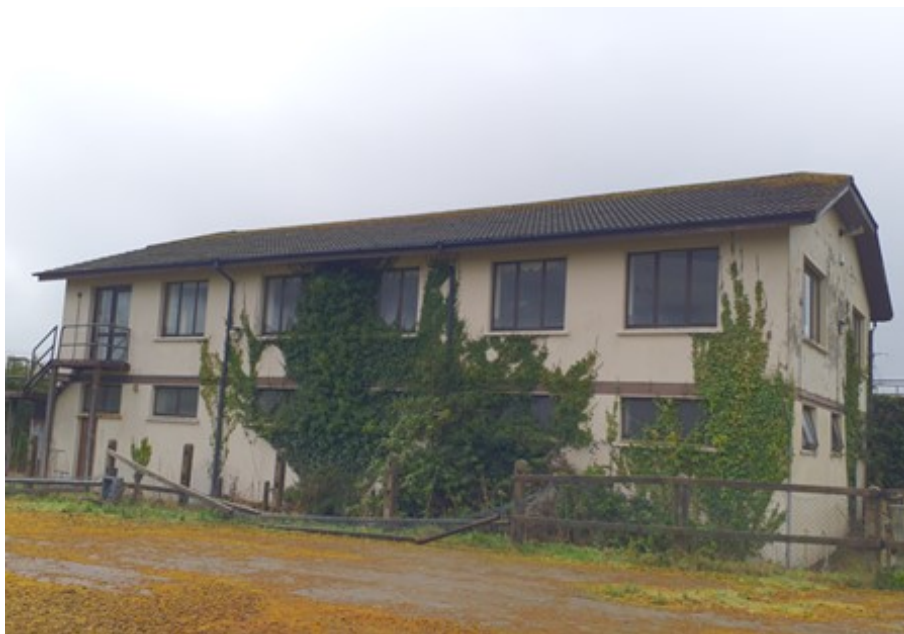
**Plate 19. No.14 - Jockeys Facilities**

This was a large building with solid walls and a tiled roof. The ground floor comprised a number of rooms which included showers, sauna, toilets and office rooms. The first floor comprised one large function room with a small office area, kitchen and a door leading to a stairwell on the eastern side. There was also a hatch leading to a large attic space. The building was largely in good condition with no major structural damage and no obvious roof tiles missing. There were some cracks and holes in parts of the wooden fascia along the roof and a number of broken windows, mostly on the southern side (front) of the building. Dense ivy was present on the north side and east side of the building. See **Plate 19** and **Table 22** below.

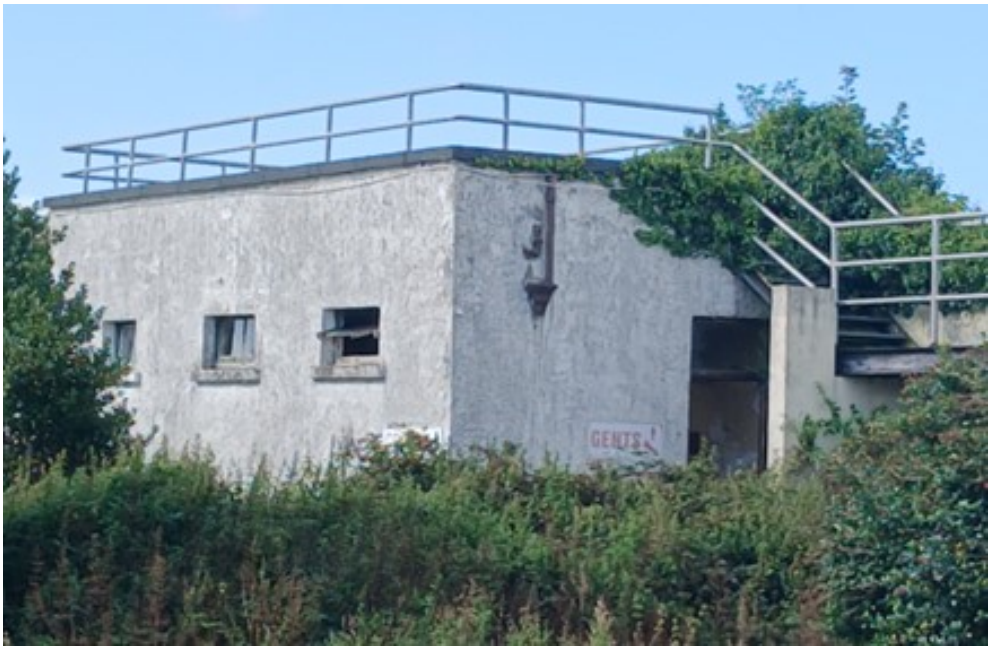
Plate 20. No.16 - Male WC Block

This buuilding comprised a small toilet block with solid walls with a flat roof. The entrance door was broken and lying on the ground. Two windows were intact, with one window open and one window broken and missing its pane of glass. Inside were a number of toilet stalls, urinals and sinks with mirrors. There was also a small hole in the ceiling, perhaps where a light fixture once was. Dense ivy cover above and beside the door. See Plates 20, 21 and 22 and Table 23 below.

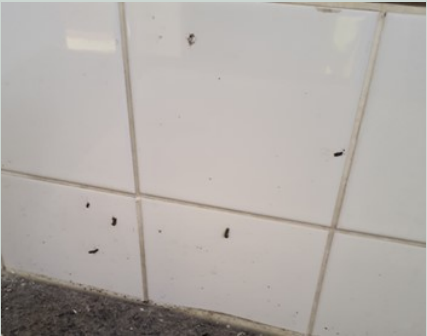
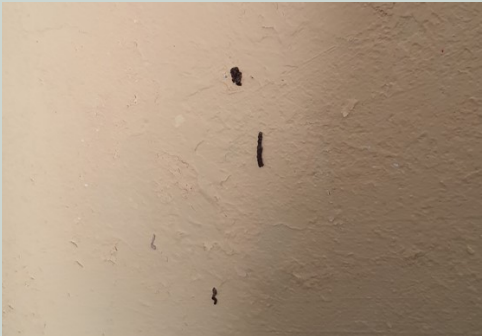
Plate 21. Droppings on tiles	Plate 22. Droppings on wall
Overall Roost Suitability Assigned	Moderate

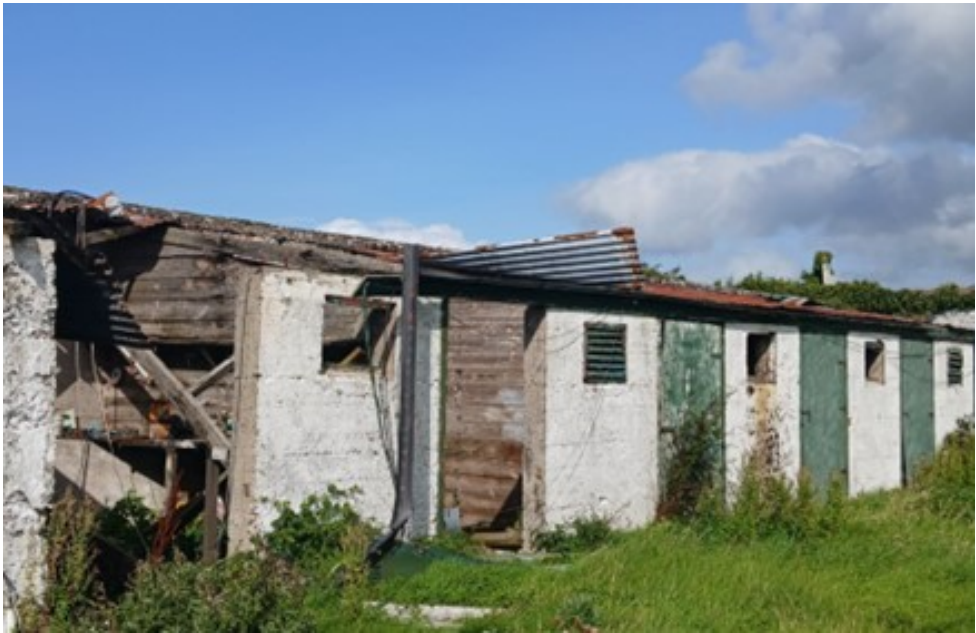
Plate 23. No. 17 - Stables no.7

Structure No. 17 comprised a number of stalls/small rooms. Some of these stalls had a missing roof, partially collapsed roof, or differing levels of damage leaving them open to the elements. Stalls with relatively intact roofs were drier inside and appeared more structurally sound. There were a lot of bird droppings observed and some old swallow nests between the metal beams and roof in two of the stalls. See **Plate 23** and **Table 24** below.

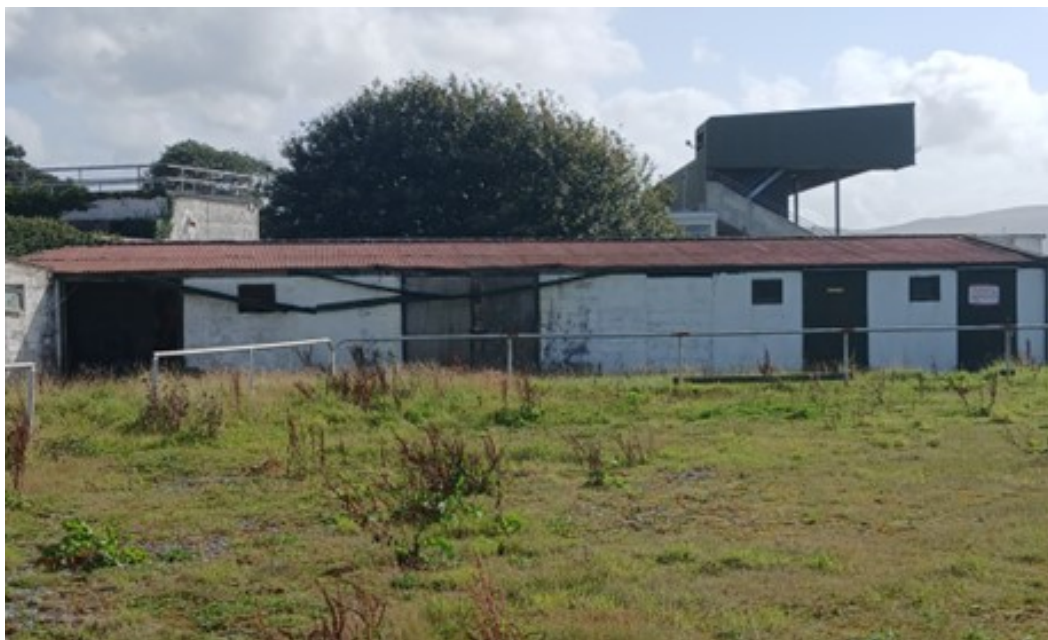
**Plate 24. No. 18 - Stables no.8**

Structure No. 18 comprised a number of stalls/small rooms with solid block walls and corrugated tin roof. Mostly used for storage. One part was open with no doors, and the other three rooms had doors. The roof was mostly intact with some rust and small holes here and there. The walls were in good condition and the windows not boarded up appeared to be intact and closed. See **Plate 24** and **Table 25** below.

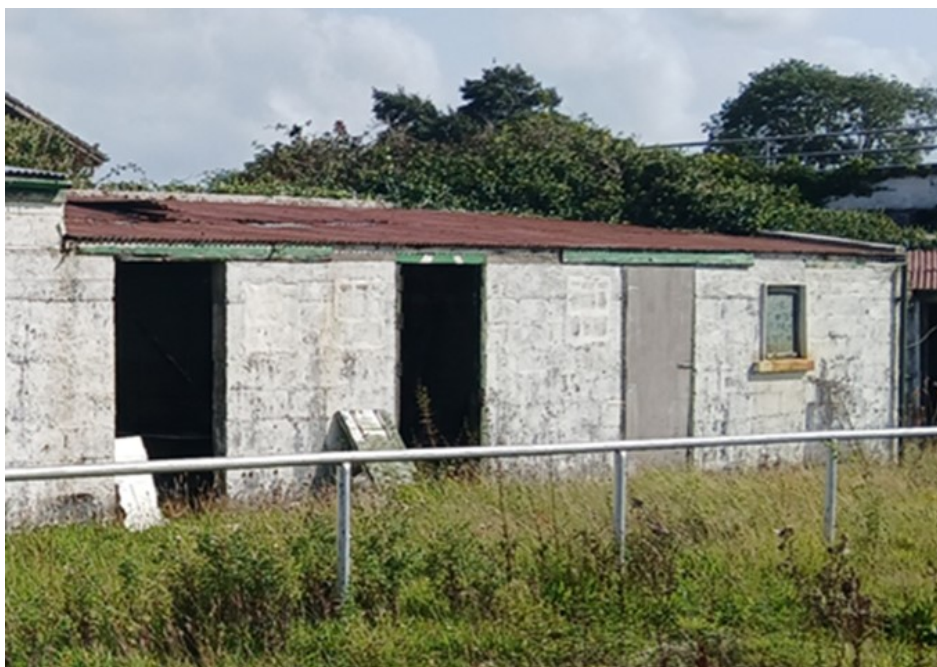
**Plate 25. No. 19 - Stables no.9**

Structure No. 18 comprised three stalls/small rooms. These were being used for the storage of horse racing signs and fences, and one had chairs and a small kitchen area. The roof was quite rusty with parts missing. The walls appeared solid and in good condition. There were clear signs of water damage from rain getting in through the damaged roof. Along some of the metal and wooden beams were a number of old swallows' nests. See **Plate 25** and **Table 26** below.

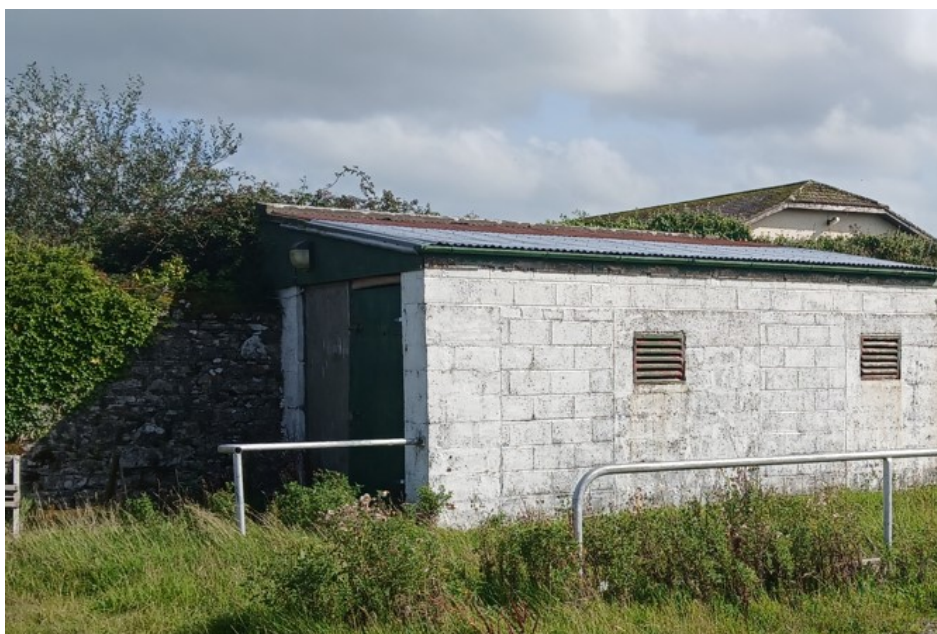
Plate 26. No. 20 - Stables no.10

This small building comprised one room with solid block walls and corrugated tin roof. This building was used for storing signs and fencing. Both the walls and roof were in good condition, and the room was dry with no signs of rain coming in. Dense ivy was growing along the roof on the eastern side. Lots of rabbit droppings in one corner and a few old swallows' nests between the wooden beams and the roof. See **Plate 26** and **Table 27** below.

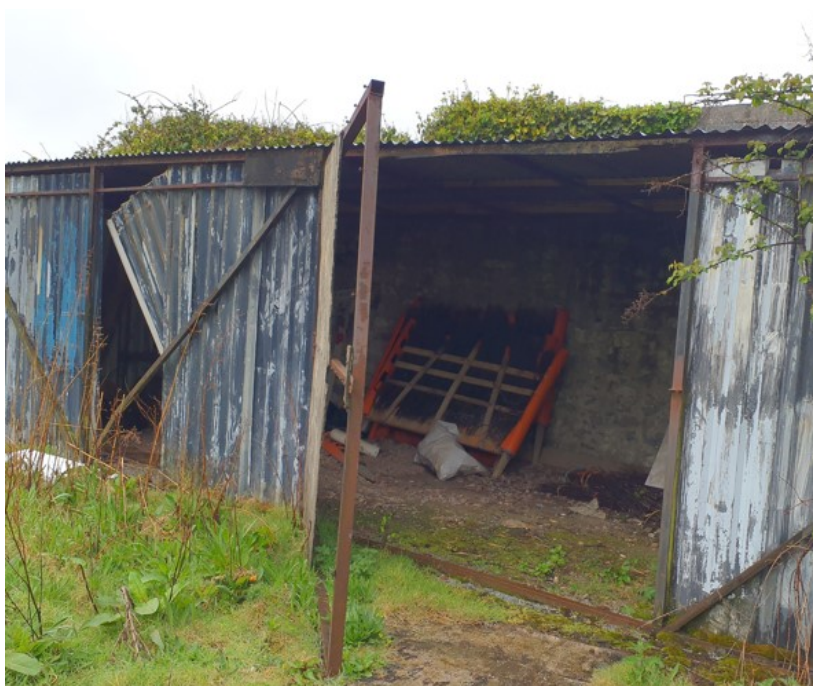
Plate 27. No. - 21 Stables no.11

Structure No. 21 comprised a small shed with stone wall at the back and corrugated tin roof, doors and outer walls. Metal panels were missing off the main door and some of the wall panels were damaged or missing. The roof was mostly intact with some small holes and rusted parts. The shed was currently being used to store various horseracing equipment. See **Plate 27** and **Table 28** below.

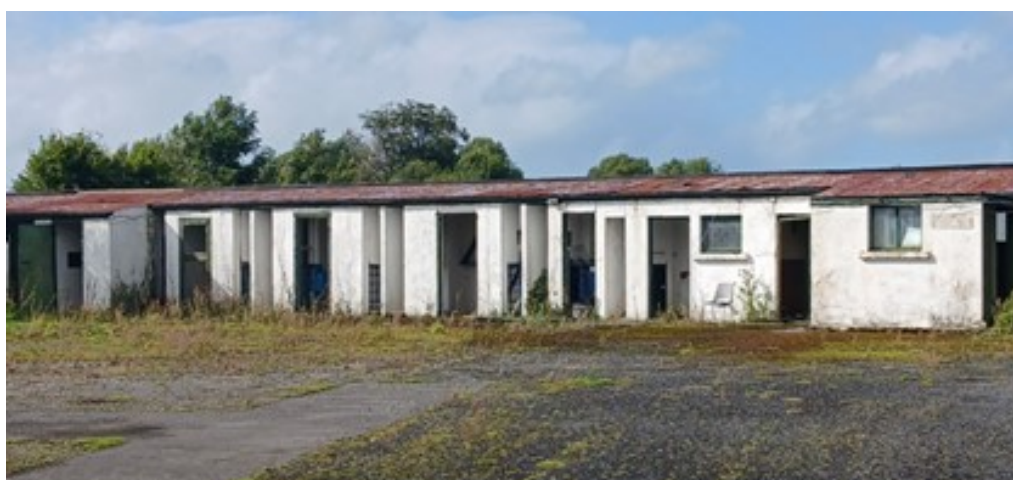
**Plate 28. No.22 - Turnstile Block & No.23 - Officials tower**

Structure No. 23 was situated at the western end of this row and comprised a small metal box described as the 'official's tower'. Safe access to this structure was not possible due to the condition of the ladders.

See **Plate 28** and **Table 29** below.

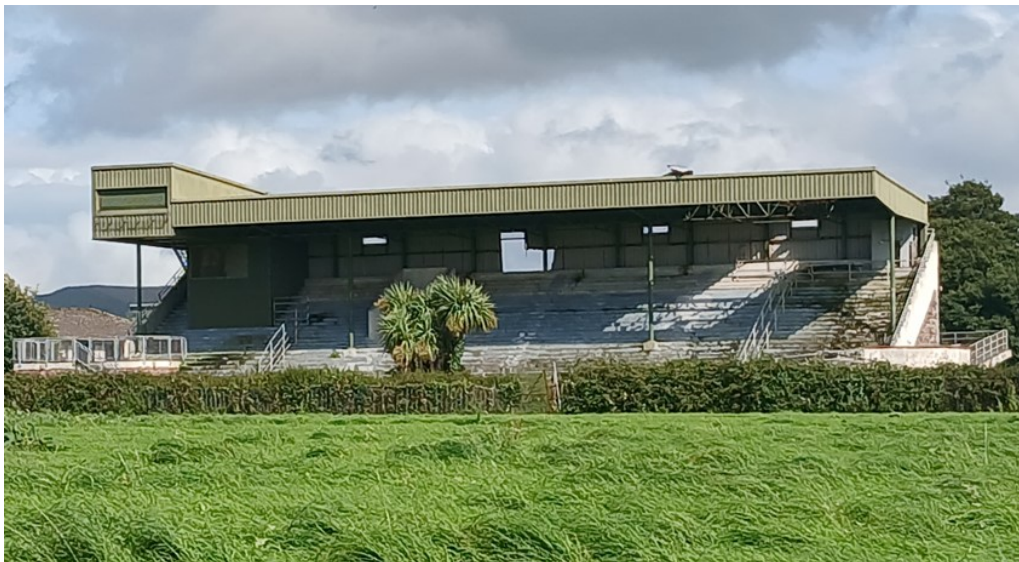
**Plate 29. 24a - Spectator Stand**

Most of this structure is open with the exception of a small room (commentators' box) which was accessed via a metal staircase at the north-western corner. This small room had wooden flooring, metal walls and ceiling/roof with metal beams. The room was dark with some light shining through the metal shutter at the front.

See **Plate 29** and **Table 30** below.

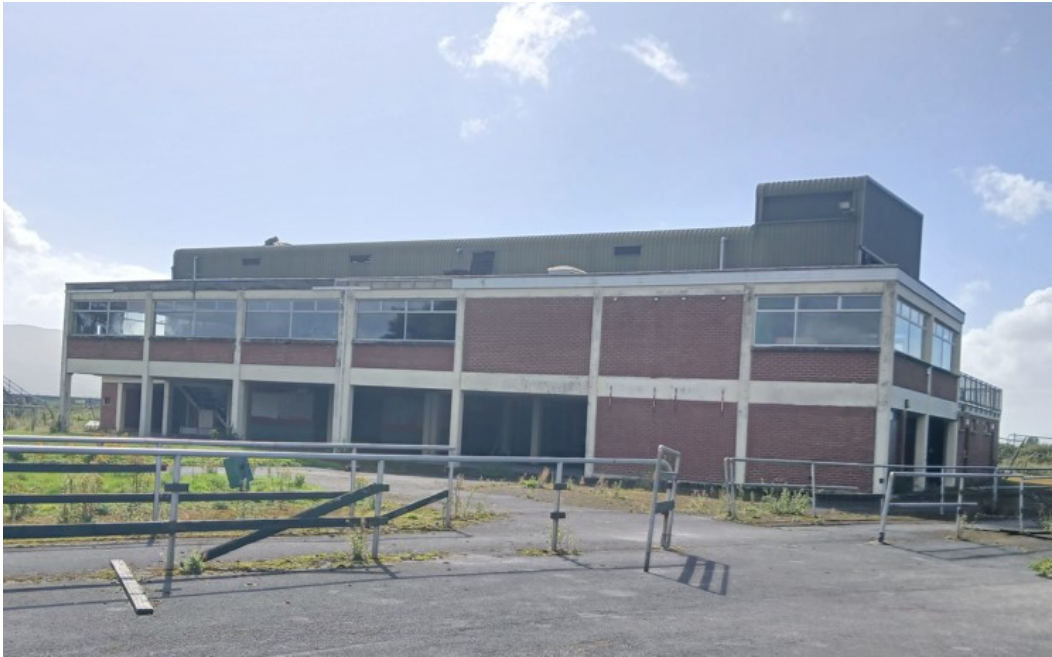
Plate 30. 24b - Reception Areas beneath the Spectator Stand

To access the 1st floor there were two sets of stairs leading from outside, one located at the north site and the other one located at the northwest of the building. There was also an enclosed stairwell accessed via a door on the ground floor at the northeast side of the building. The 1st floor comprised a large bar with two adjoining rooms. Some of the windows had been boarded up whilst some remained broken with glass still attached. There were jackdaws actively nesting within the gaps between the walls and ceiling and were observed entering through a hole on the wooden panels on the southside entrance. There was some signs of water damage in some of the corners from rainwater. See Plates **30** to **34** and **Table 31** below.

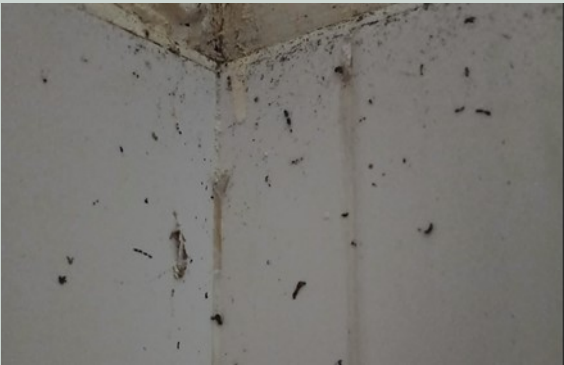
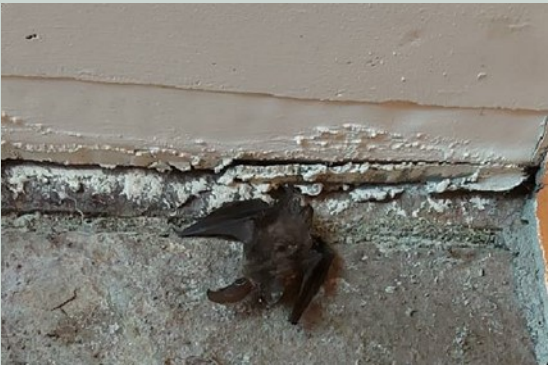
Observations	
Potential for bat use	Yes - A number of potential access points via open/broken doors, broken window and gaps and holes in wood panelling along the top of the first floor. Peeling paint and gaps between the walls and roof provide roosting potential.

Plate 33. Droppings on wall in toilet on ground floor	Plate 34. Deceased brown long-eared bat found on a wall on the 1st floor
Overall Roost Suitability Assigned	Moderate
