**Derogation Licence Application under  
the European Communities (Birds and  
Natural Habitats) Regulations  
2011 - 2021**

**Supporting Information – Proposed  
Demolition at Ballybeggan, Tralee, Co. Kerry**

**Ard-Rí Group 2025**

Appendix 1 – ‘Bat Survey and Assessment Report’ for the proposed Demolition at Ballybeggan, Tralee, Co. Kerry

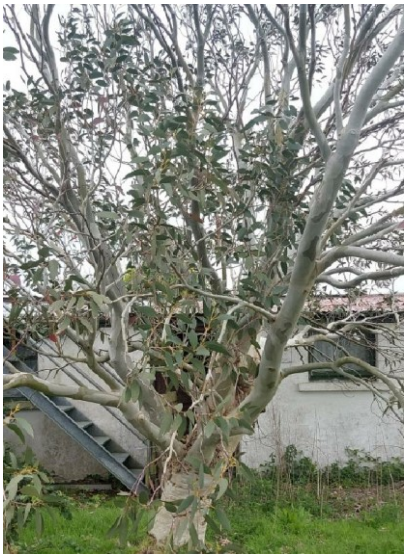
Plate 35. Eucalyptus Tree Assessed

During ground-level assessment there were no potential roost featured such as hole, cracks and crevices observed. Additionally, no evidence of bats (droppings, staining etc.) was recorded. Having regard to guidelines in Collins (2023), this tree all was classed as having ‘negligible’ suitability for roosting bats. See **Plate 35** below.

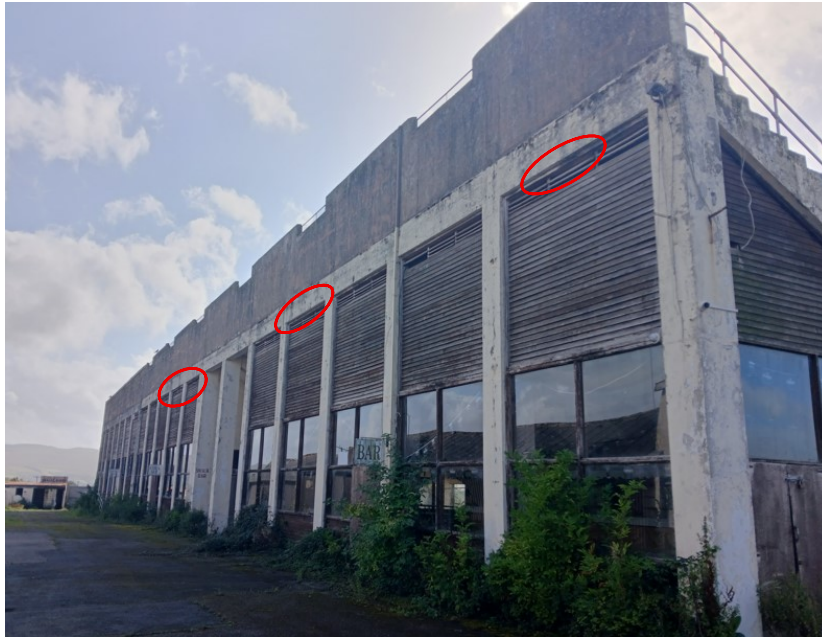
**Plate 36. Exit and Entry Points on Building No. 1b used by bats**

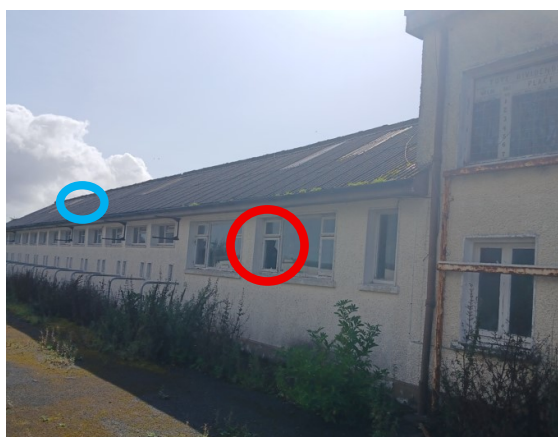
**Plate 37. Exit/entry points east side of building no. 2 used by bats**

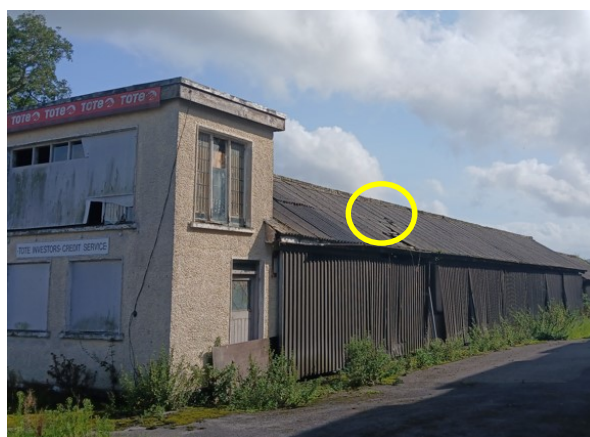
**Plate 38. Exit/entry points west side of building no. 2 used by bats**

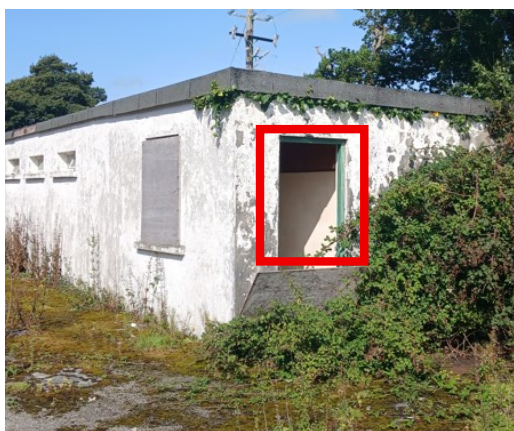
**Plate 39. Door to male toilets (southern end) of building No. 3 used by bats**

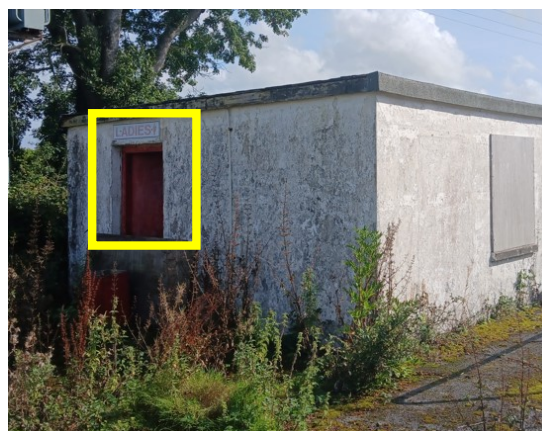
On the second survey night, one soprano pipistrelle was observed at 22:24 exiting the female toilet block (marked yellow in **Plate 39**).

**Plate 40. Door to ladies' toilets (northern end) of building No. 3 used by bats**

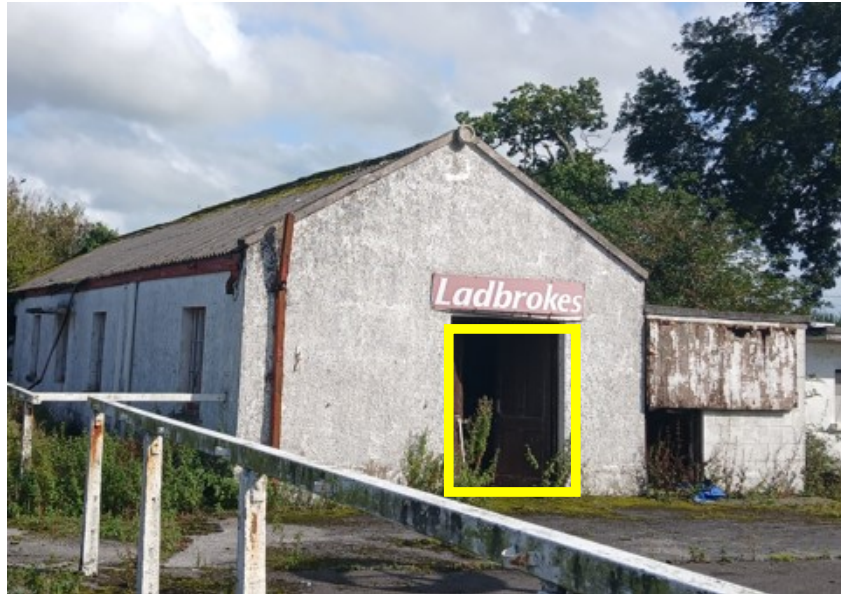
Plate 41. Exit and Entry point of building No. 10 used by bats

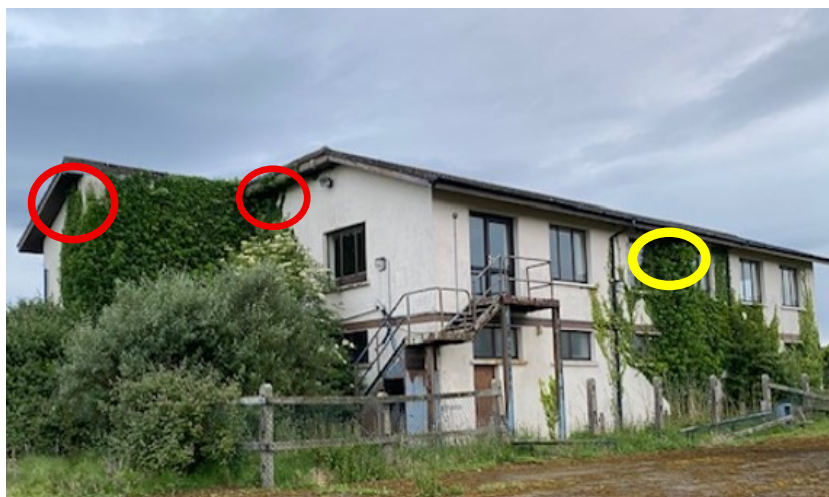
Plate 42. Exit and entry points of building No. 14 used by bats

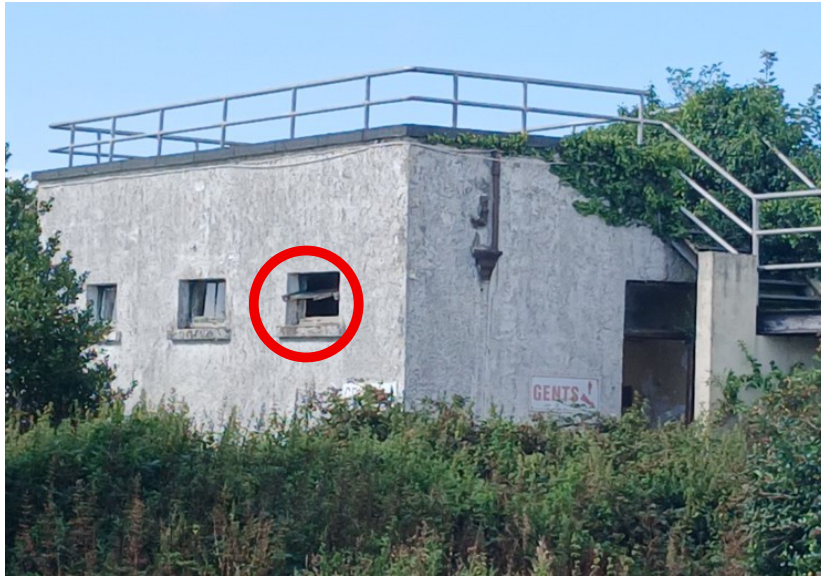
Plate 43. Entry point of building No. 16 used by bats

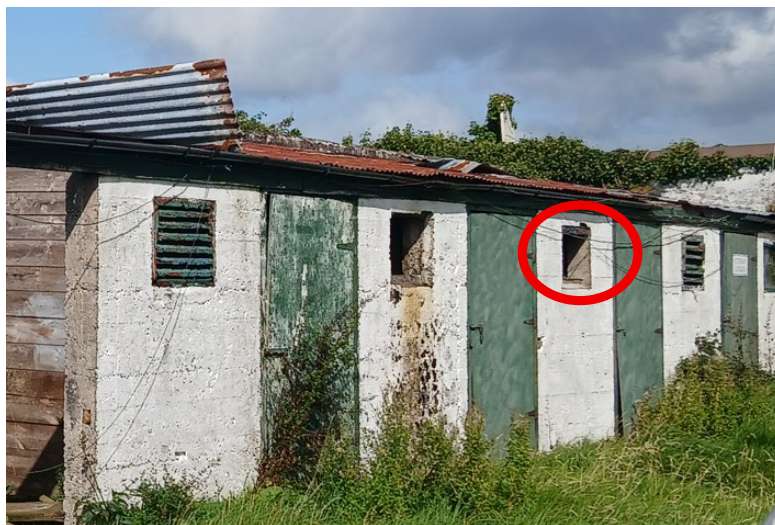
Plate 44. Exit and entry point of building No. 17 (stables no. 7) used by bats

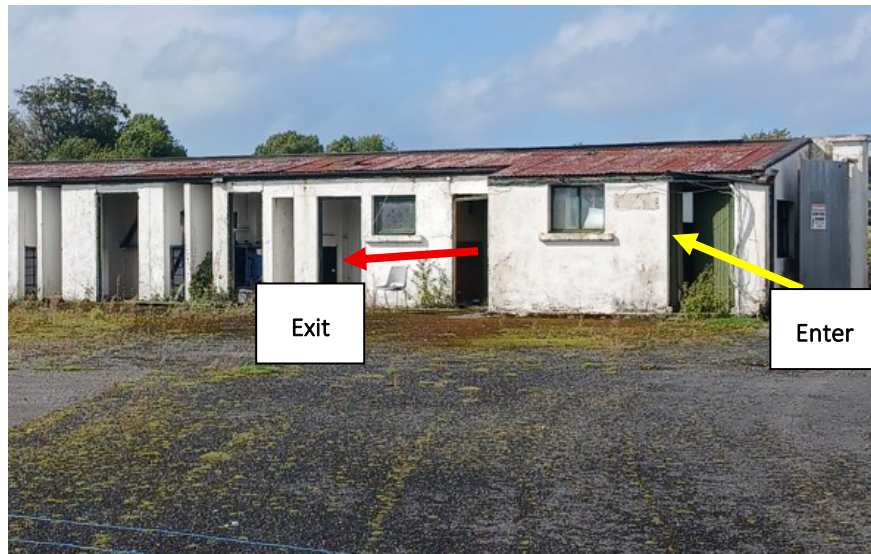
Plate 45. Exit and entry point of building No. 22 used by bats

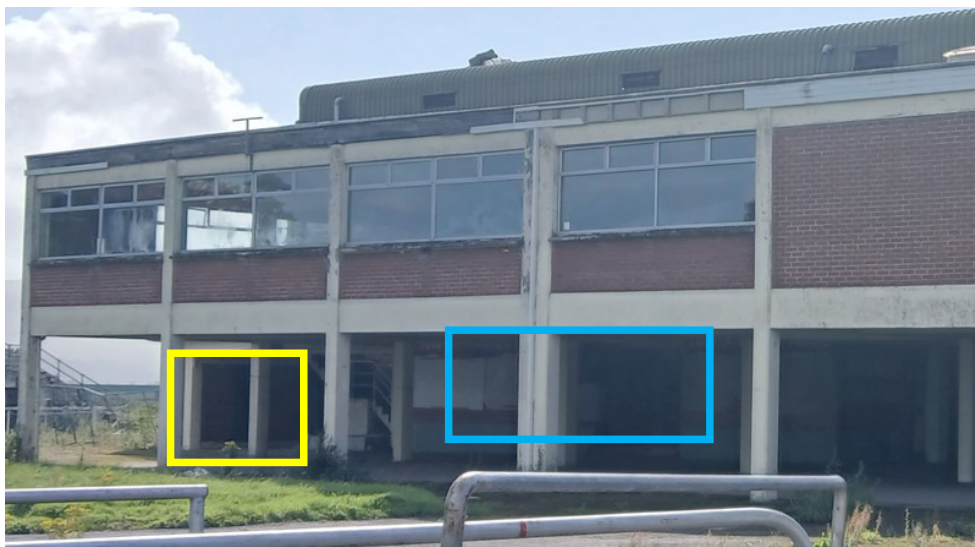
Plate 46. Area of activity on ground floor of building No. 24b

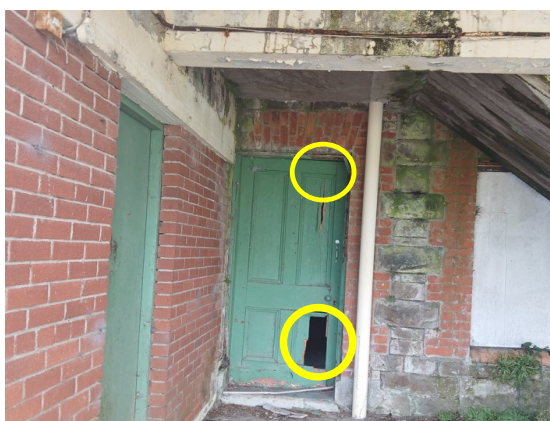
Plate 47. Exit points used by bats on ground floor (yellow area) of building No. 24b

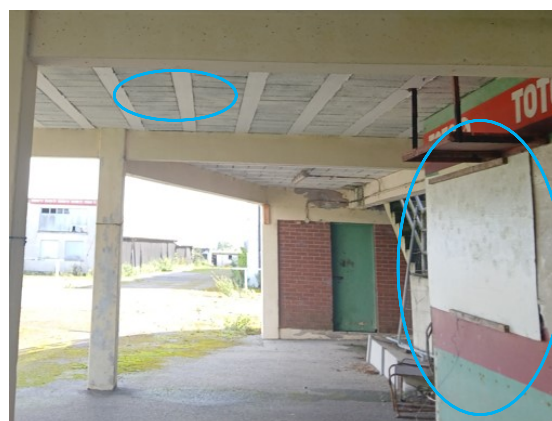
Plate 48. Exit and entry points used by bats on ground floor (blue area) of building No. 24b
