Application for Derogation

Supporting information for application for derogation licence to exclude colony of Soprano pipistrelle bats *Pipistrellus pygmaeus* from the roof of the new courthouse building in Carrick on Shannon, Co. Leitrim

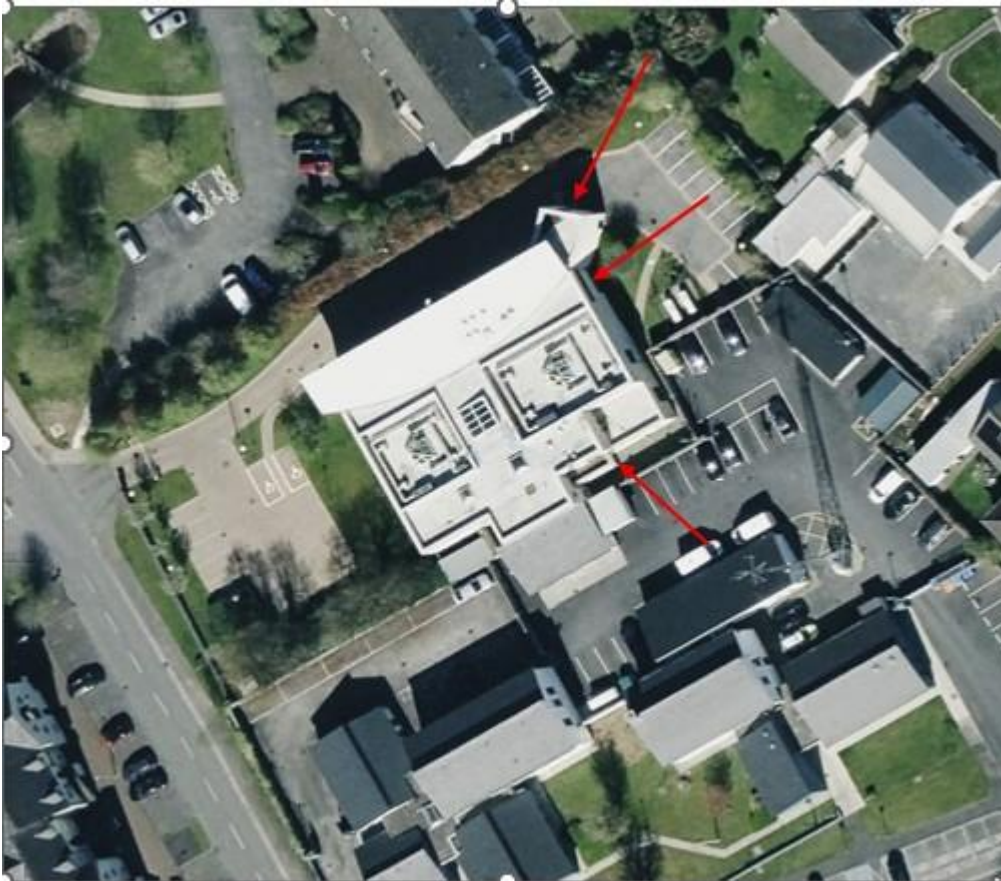
Examination of the exterior wall of the building revealed three main exit-entry points being used by the bats. The largest number of droppings were on a window pane and on the wall above the window on the second floor at the front of the building (north-east elevation). It was evident from shining a strong torch up at the wall plate that there were numerous gaps where bats could gain entry to the building. There was a second entry/exit point used by at bat at the northeastern corner of the building. Some fresh bat droppings were recorded on the bins stored directly beneath this section of roof. A third entry point was obvious at roof level adjacent to the boiler room at the rear of the building. Gaps were visible at the top of the wall plate and there was obvious staining by bats on the exterior wall,

Three Soprano pipistrelles were recorded exiting from a gap above the window on the front (north eastern) elevation. Two soprano pipistrelles were recorded exiting from the north east corner of the building. A single Pipistrelle bat was recorded emerging from the roof beside the boiler house at the rear of the building.

Figure 1 – showing the 3 points where bats were recorded emerging from the building

It is proposed to exclude the bats from building by sealing all gaps at wall plate level around the entire building.

However, 3 Schwegler 1FF bat boxes should be mounted on the rear of the building close to the exit beside the boiler room to provide temporary accommodation for bats until they find an alternative roost.
