Report in support of Derogation Licence  
Application

Proposed Large Scale Residential Development (LRD),  
Janeville,  
Shannonpark,  
Carrigaline,  
Co. Cork

<b>Project</b>	<b>Report in support of Derogation Licence for Proposed Residential Development, Former Janeville, Shannonpark, Carrigaline, Co. Cork</b>	
Client	Astra Construction	
Project Ref.	26008	
Report No.	26008.03	
Client Ref.	-	
<b>Date</b>	<b>Revision</b>	<b>Prepared By</b>
27/02/26	Issue to client	Carl Dixon BSc MSc
		Sorcha Sheehy BSc PhD
DixonBrosnan Lios Ri Na hAoine, 1 Redemption Road, Cork.

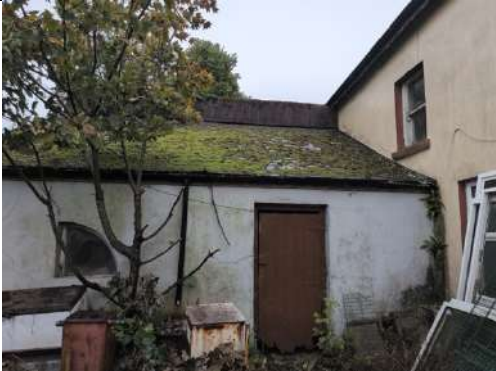
Building	Building description	Building photograph
<p>Shed/extension are rear of dwelling</p>	<p>Shed extension to rear of dwelling used for general building supplies and farming materials. Draughty loft space partially open. Gaps for entry on door where this is starting to decay.</p> <p>Wooden fascia is poor condition.</p> <p>No signs of bats.</p> <p>Low potential for roosting bats.</p>

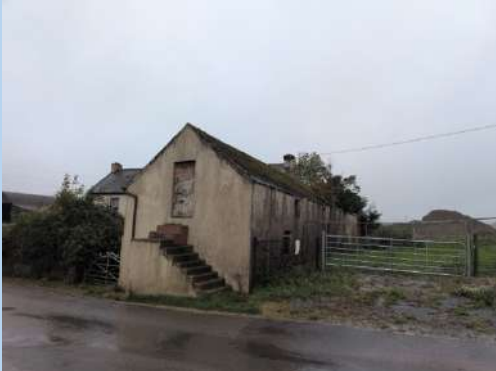
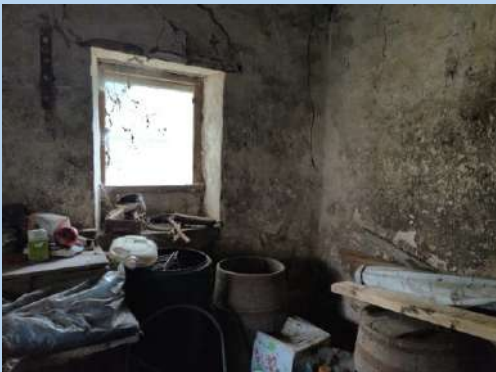
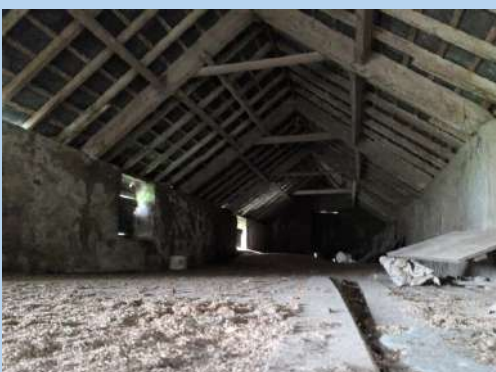
<p>Old outhouse adjoining dwelling</p>	<p>Large lean-to structure adjoining farm house. Stored farming and building machinery</p> <p>Generally cold. Open window at the rear and one Swallow nest recorded.</p> <p>Wooden loft space large opening on the gable end of building. Building very draughty and cold.</p> <p>No signs of bats.</p> <p>Low potential for roosting bats.</p>

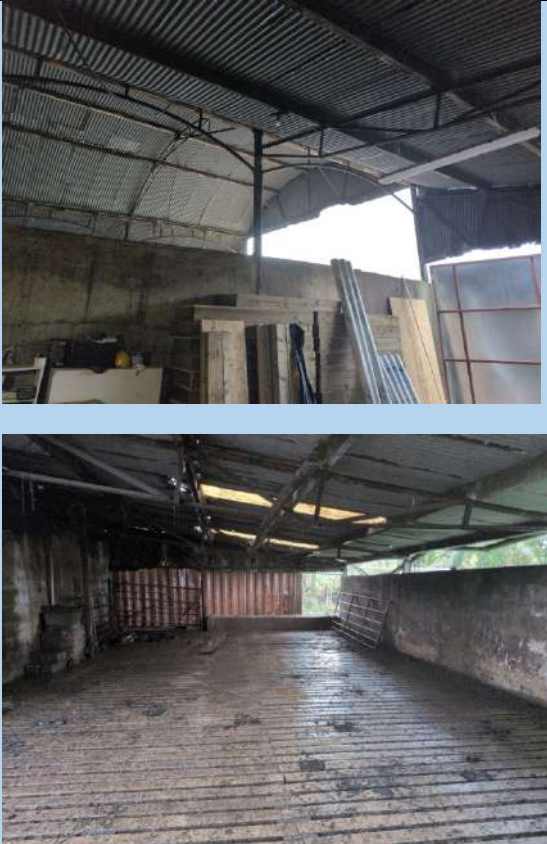
Building	Building description	Building photograph
<p>Outbuildings</p>	<p>Complex of sheds to south of house.</p> <p>Buildings in generally poor condition. Open windows and doors. Draughty. Slate roof largely intact. Some wooden fascia remaining on exterior. Modern precast concrete walls</p> <p>Used for stored material Lots of fouling by pigeons. Old swallow nest recorded.</p> <p>No signs of bats.</p> <p>Low potential for roosting bats.</p>	 
<p>Farm shed and slatted unit</p>	<p>Generally empty sheds partially used as work sheds. Corrugated iron roofs. Open, draughty</p> <p>Slatted unit open and draughty. But could provide foraging habitat for bats.</p> <p>No signs of bats.</p> <p>Negligible potential for roosting bats.</p>

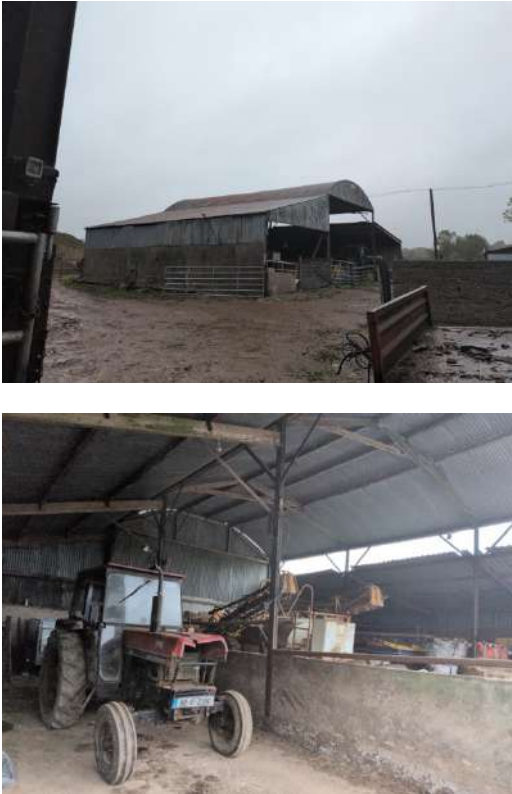
Farm shed	<p>Corrugated iron sheds with partial concrete walls used for parking vehicles etc. Very open and draughty. I would say</p> <p>No signs of bats.</p> <p>Negligible potential for roosting bats.</p>

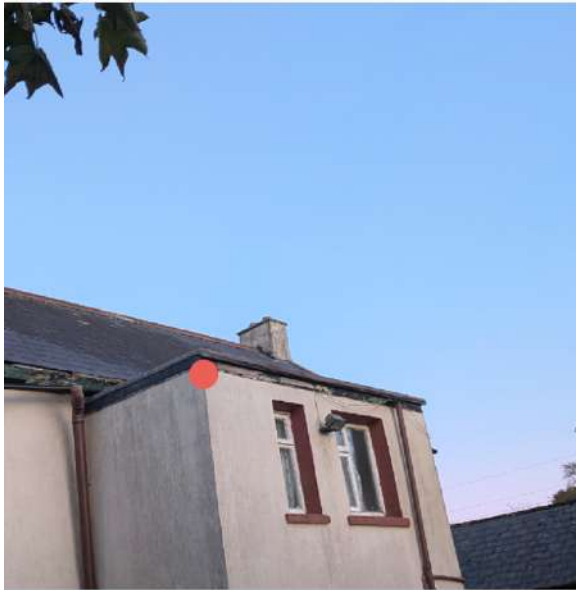
The survey on the 26<sup>th</sup> of September recorded similar levels of Pipistrelle activity and bats were recorded emerging from the rear of the dwelling (See **Figure 3** and **Figure 4**). Approximately eight bats were recorded emerging from damaged fascia on a flat roof, two storey extension at the rear of the farmhouse. Subsequently bats were recorded foraging around the farmyard and along the treeline. No bat activity was recorded within the remainder of the proposed development site boundary. Sporadic signals for Leisler's bat were also recorded which was indicative of a small number of bats (1-2) foraging at height in the wider landscape.

**Figure 3. Emergence point for Soprano Pipistrelle**

The results indicate that a small maternity roost of Soprano Pipistrelle is located within the rear of the farmhouse (damaged fascia). The farmyard area also provides a sheltered foraging area for Soprano and Common Pipistrelle bats post emergence. However, no signs of roosting bats were recorded in any of the other site buildings.

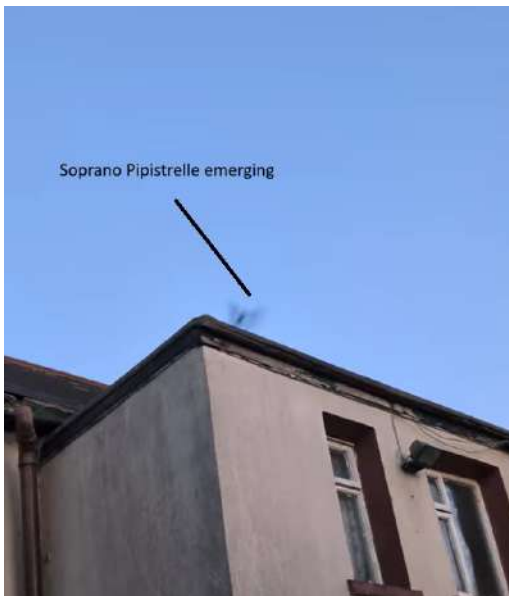
**Figure 4. Bat emerging from fascia on flat roof extension at rear of dwelling**

As outlined above, an external fascia housing a small maternity roost for Soprano pipistrelle will be removed during the restoration of the farmhouse.

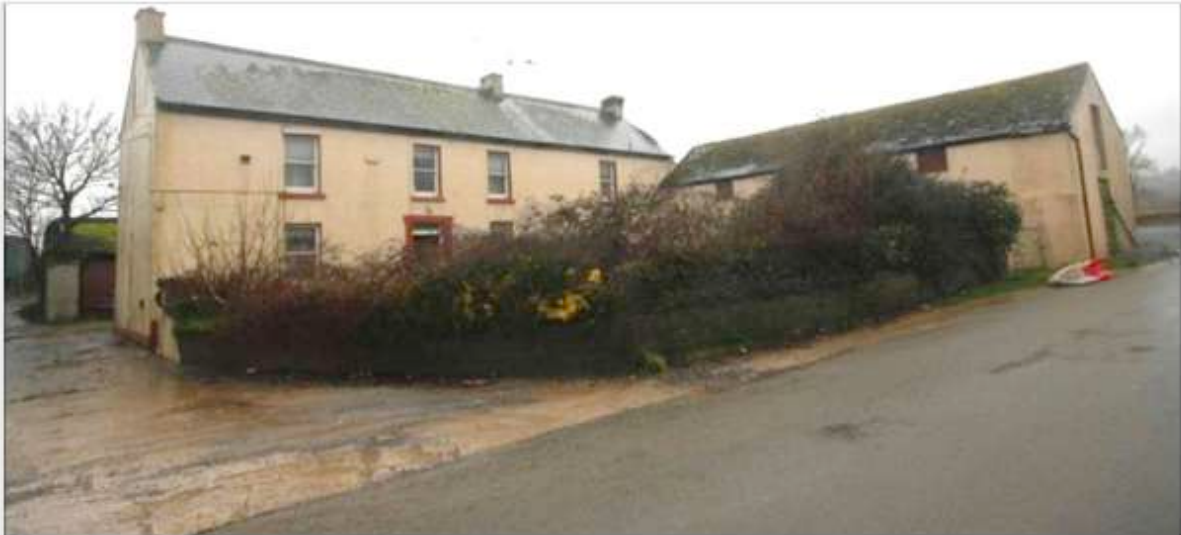
**Plate 1. Farmhouse (on left) and Building B adjoining outhouse (on right) to be refurbished for housing**

The Architectural Heritage Impact Assessment (AHIA) prepared by Donal Anderson Conservation Architect concluded that the dwelling house is in good structural condition and could be restored to form part of the proposed development which would positively contribute to the built heritage environment of the area. The proposed development also provides for the partial restoration of adjoining Building B (A former barn) while other structures on site are not of cultural heritage value or appropriate for restoration.

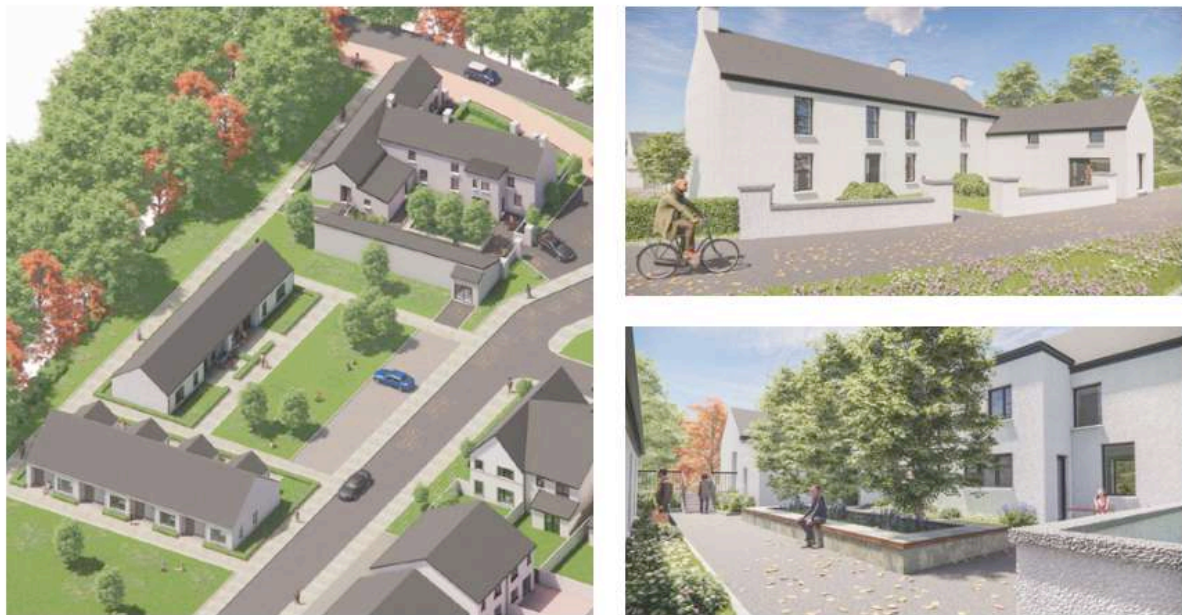
**Figure 6 Character renders of proposed farmhouse and outbuildings retained and refurbished within proposed development.**

The proposed development will involve refurbishment of the farmhouse. It is noted that two adjoining outbuildings will also be refurbished and will retain a sheltered area at the rear of the farmhouse which can be potentially used by roosting bats (See **Figure 6**). Three bat boxes will be placed around this courtyard area to maximise the chances of this area being used

following development. As noted above, given the small size of the roost and the location of the roost within an external fascia, the use of the bat box at this location is considered appropriate.

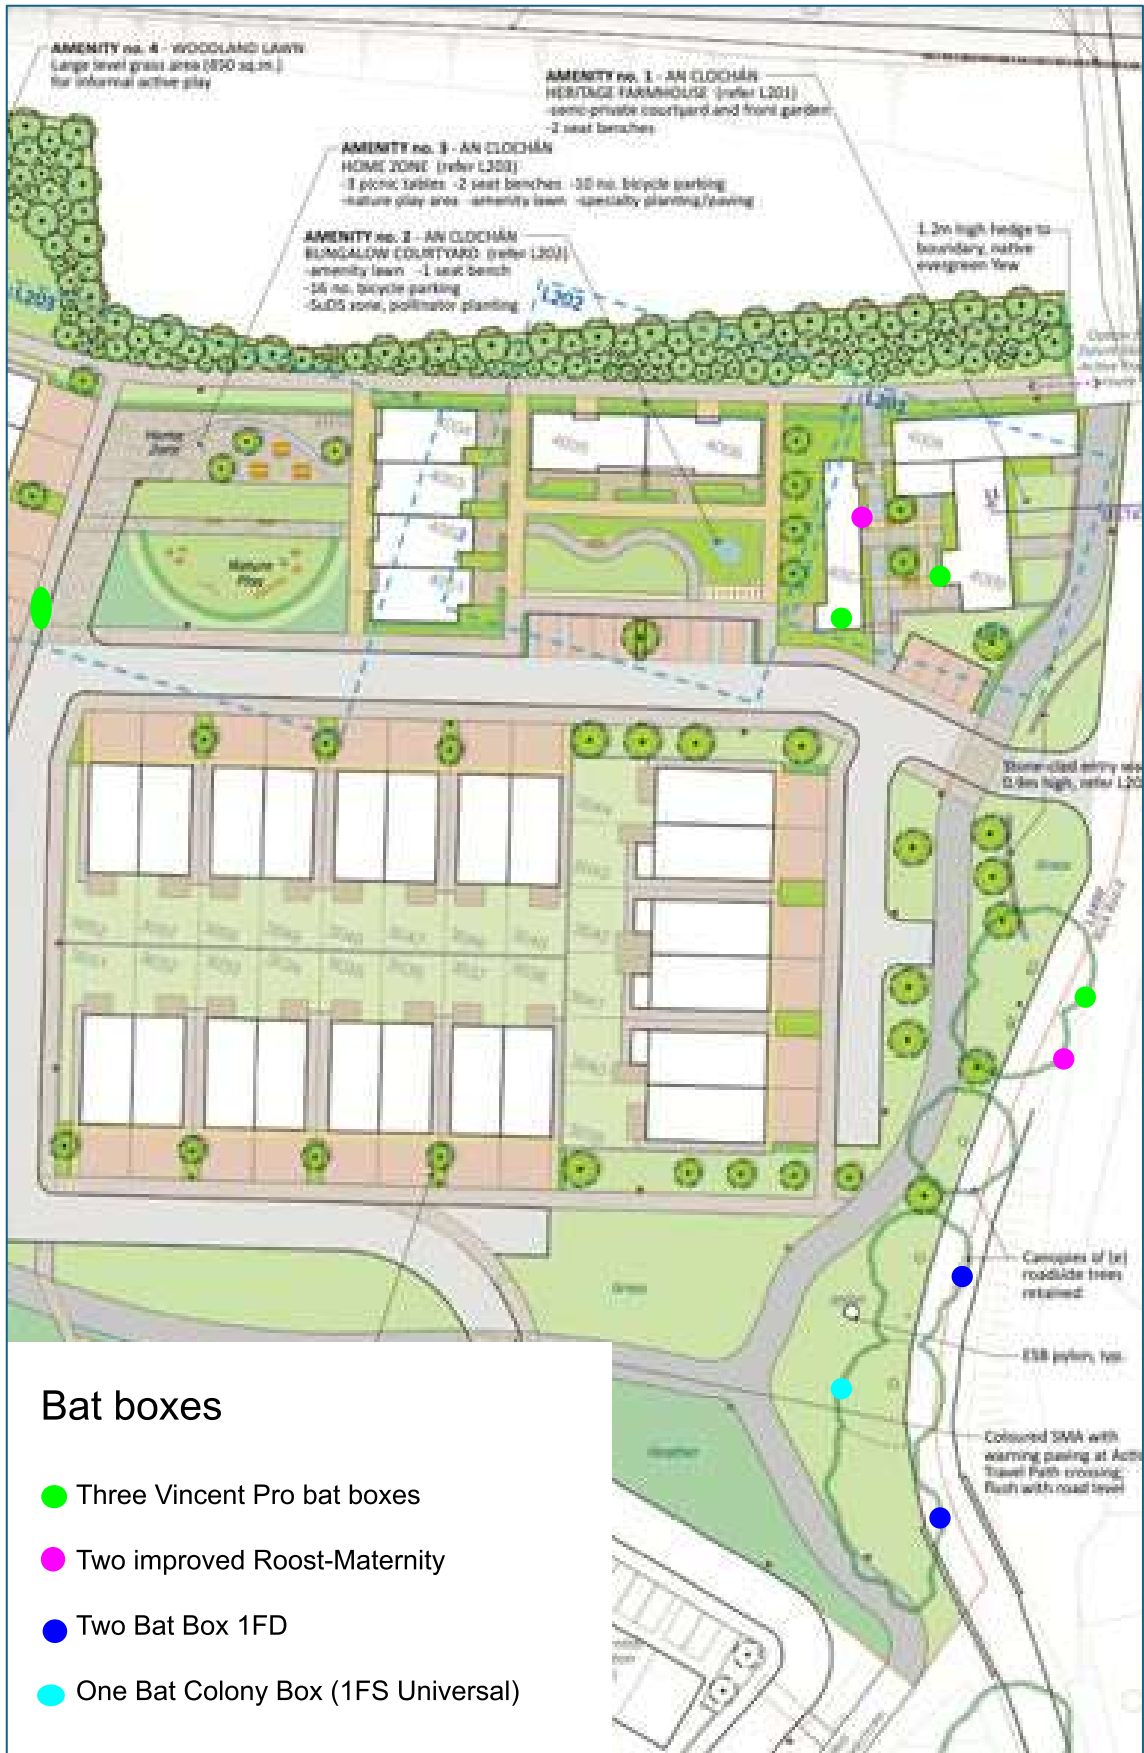
Figure 7. Proposed bat box locations

- Bat boxes will be placed on mature trees along the eastern treeline to provide potential roosting sites for bats (See **Figure 7**). It is noted that a

supervising ecologist will specify the exact locations/heights etc will be based on up to date survey data and in consultation with the building contractor.
