Bat Report

**In support of a Derogation
Licence for Refurbishment Works**

**Ardsallagh House
Ardsallagh, Co. Tipperary**

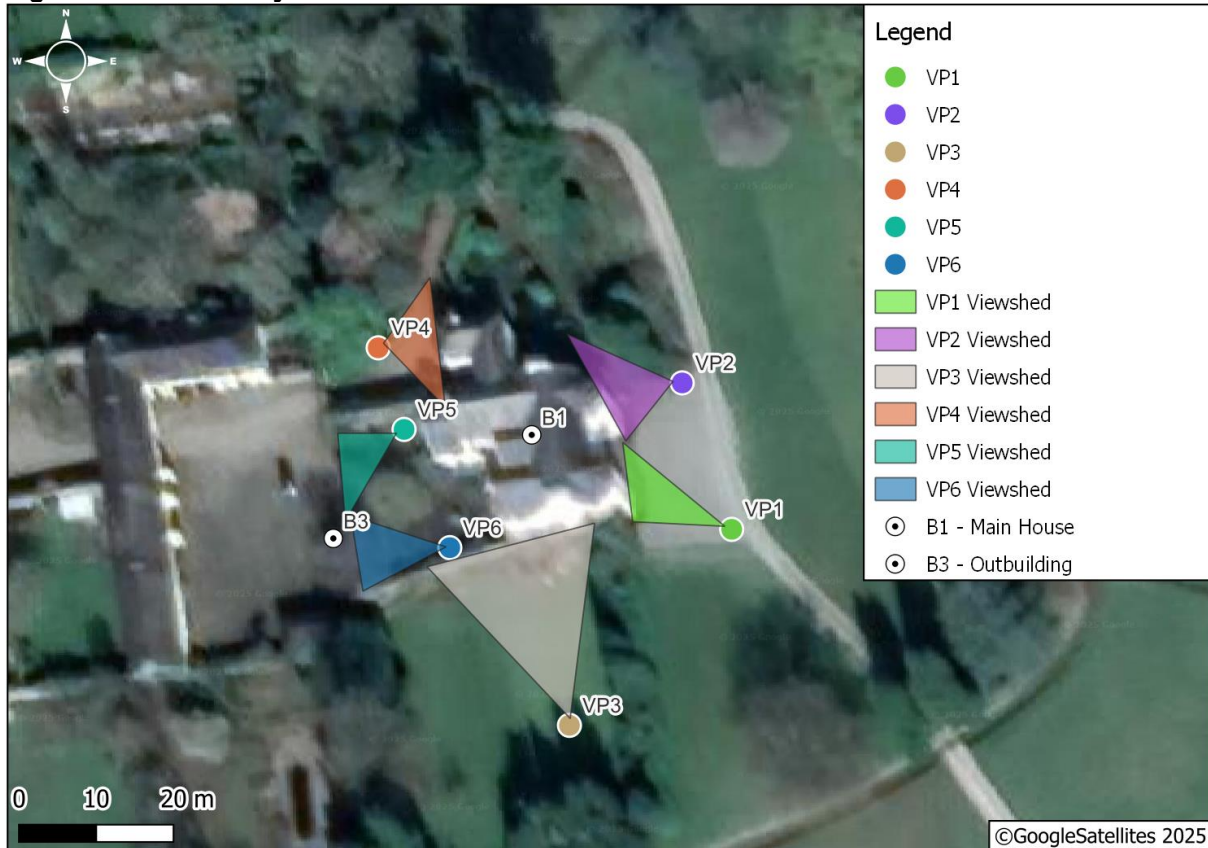
Figure 2-1: Bat Survey VPs and Viewsheds

Each surveyor used one HIKMICRO Lynx 2.0 Pro Thermal Monocular as a night vision aid during the emergence survey to aid in monitoring the trees within the Site for bat emergence. See Plates 2-1 to 2-6 below for the viewshed from VP1 – VP6 inclusive.

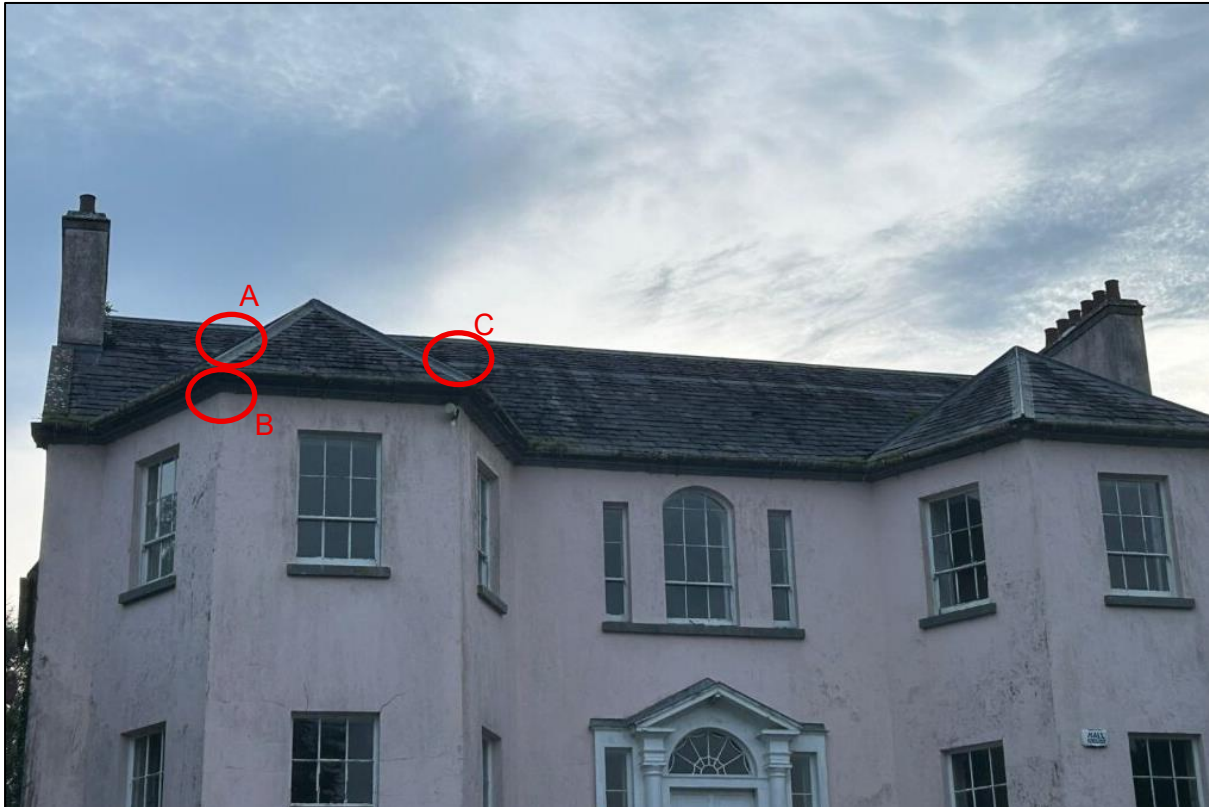
Plate 3-1: Soprano pipistrelle emergence points from VP1 at B1 on 07/08/2025

In total, five soprano pipistrelles were observed emerging from three different points of the roof of B1 at VP1.

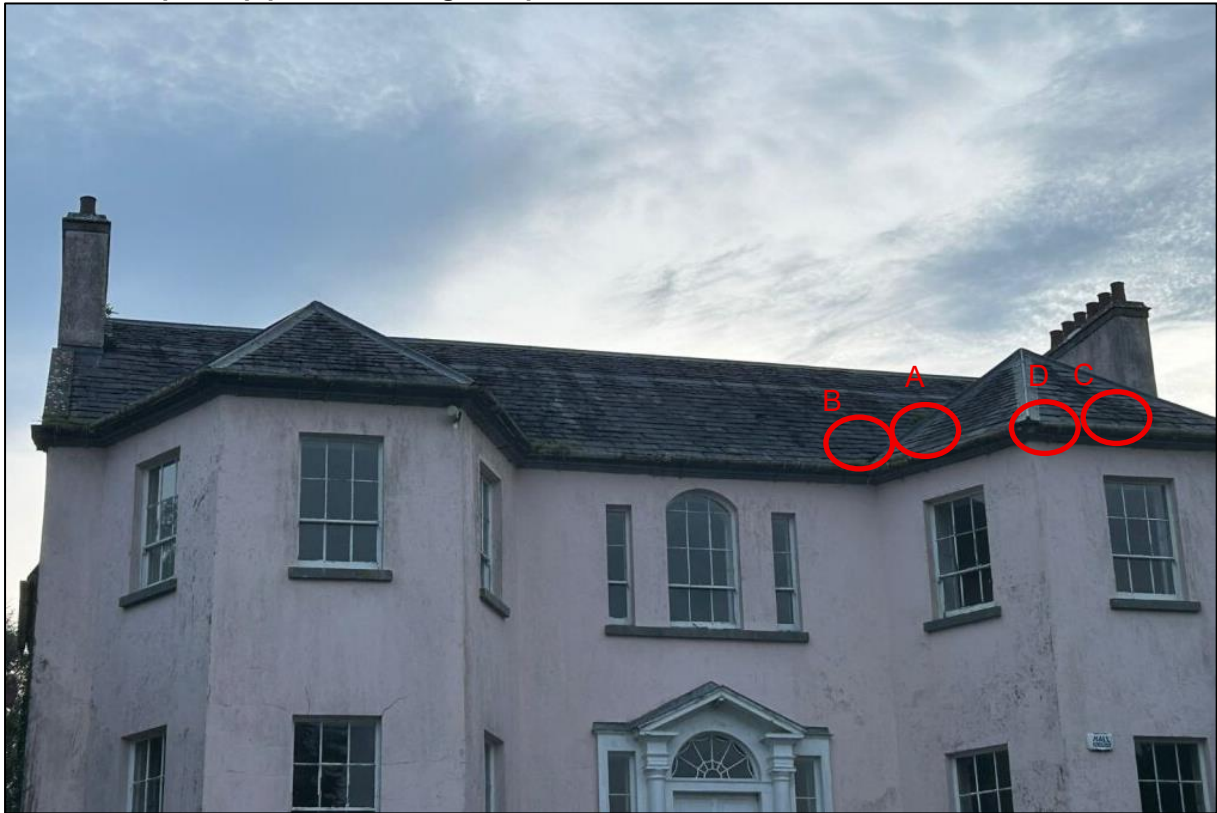
Plate 3-2: Soprano pipistrelle emergence points from VP2 at B1 on 07/08/2025

In total, 16 soprano pipistrelles were observed emerging from four different points of the roof of B1 at VP2.

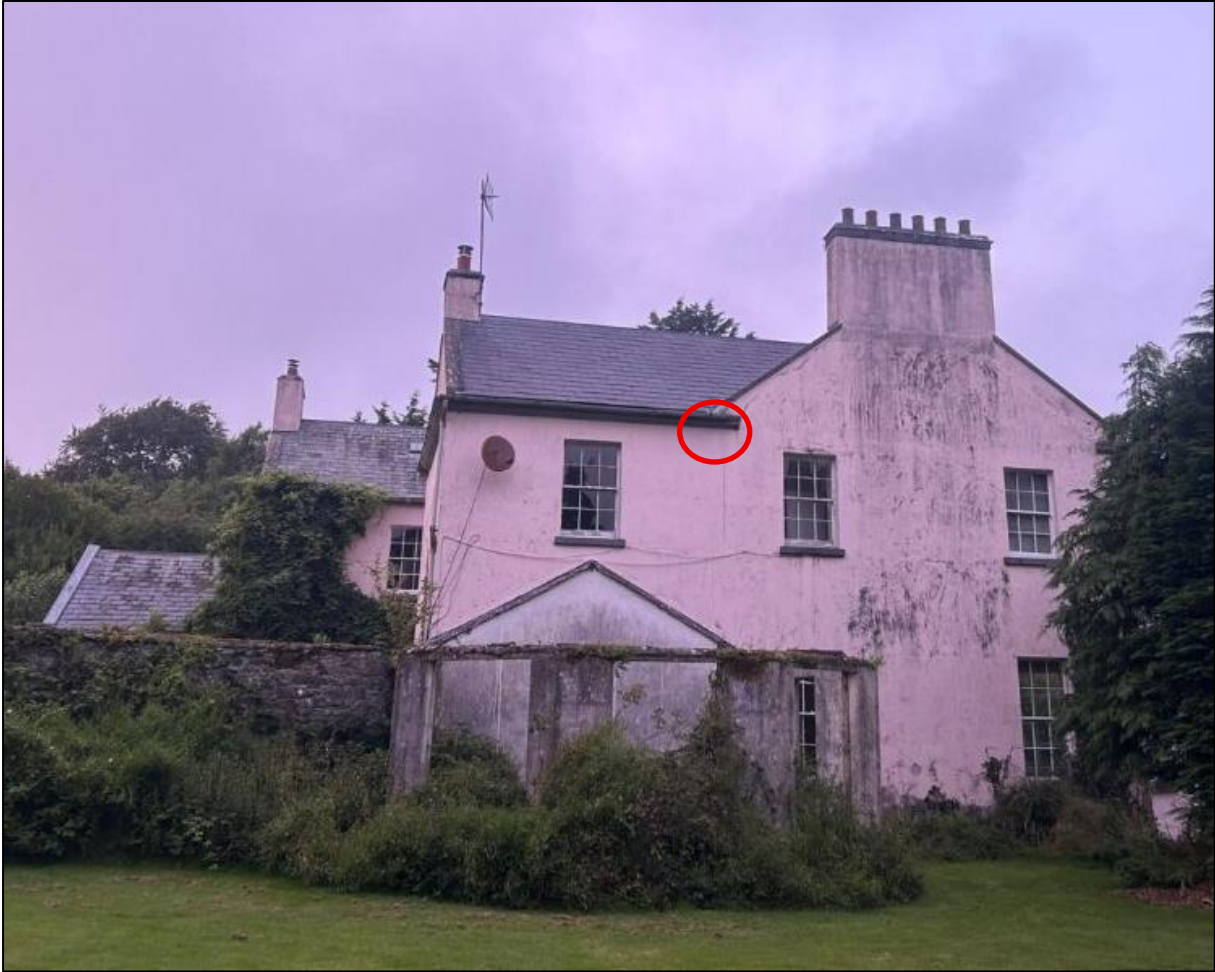
Plate 3-3: Soprano pipistrelle emergence point from VP3 at B1 on 07/08/2025

The surveyor at VP3 observed one soprano pipistrelle emerge from a roof tile of the Main House at 21:34 (see Plate 3-3 below). No other emergence was observed from B1 at VP3. A review of the NVA footage from VP3 also confirmed no other bat emergence from B1 at VP3.

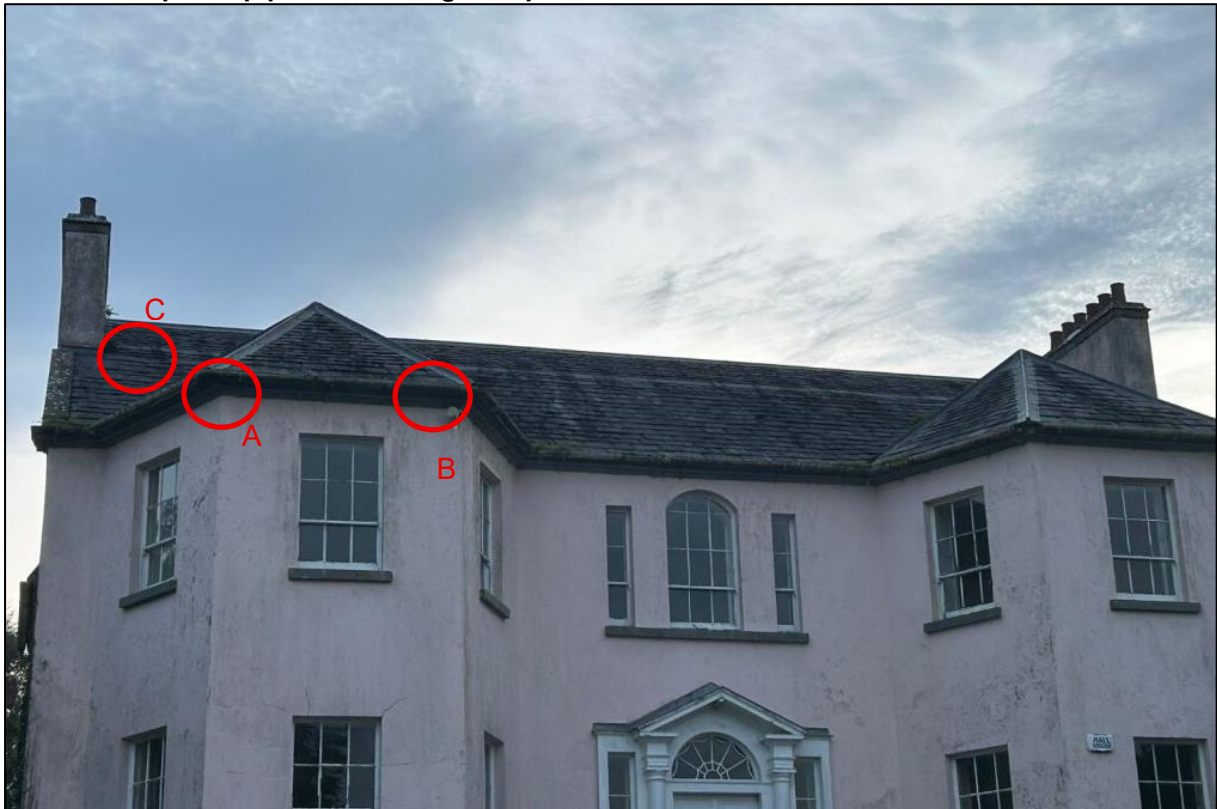
Plate 3-4: Soprano pipistrelle emergence points from VP1 at B1 on 19/08/2025

In total, 11 soprano pipistrelles were observed emerging from the three different points of the roof of B1 at VP1.

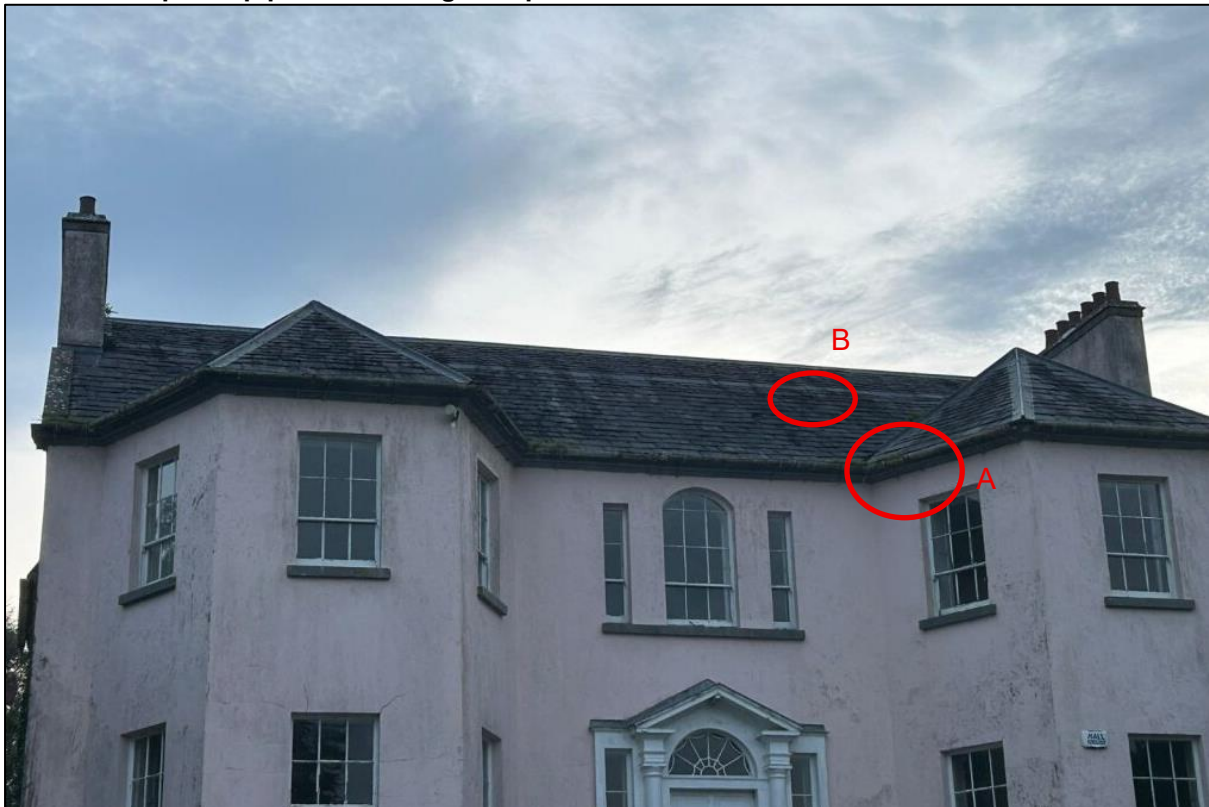
Plate 3-5: Soprano pipistrelle emergence points from VP2 at B1 on 19/08/2025

- One soprano pipistrelle at 21:02 (roof tile – Plate 3-5, reference A);
- One soprano pipistrelle at 21:04 (roof tile – Plate 3-5, reference A);
- Two soprano pipistrelles at 21:05 (roof tile – Plate 3-5, reference B);
- One soprano pipistrelle at 21:09 (roof tile – Plate 3-5, reference A);
- One soprano pipistrelle at 21:19 (roof tile – Plate 3-5, reference A);
- One soprano pipistrelle at 21:22 (roof tile – Plate 3-5, reference A); and,
- One soprano pipistrelle was observed re-entering the roof at 22:06 (Plate 3-6, reference A).

In total, seven soprano pipistrelles were observed emerging from two different points of the roof of B1 at VP2 and one soprano pipistrelle was observed re-entering the roof of B1 at a different point.

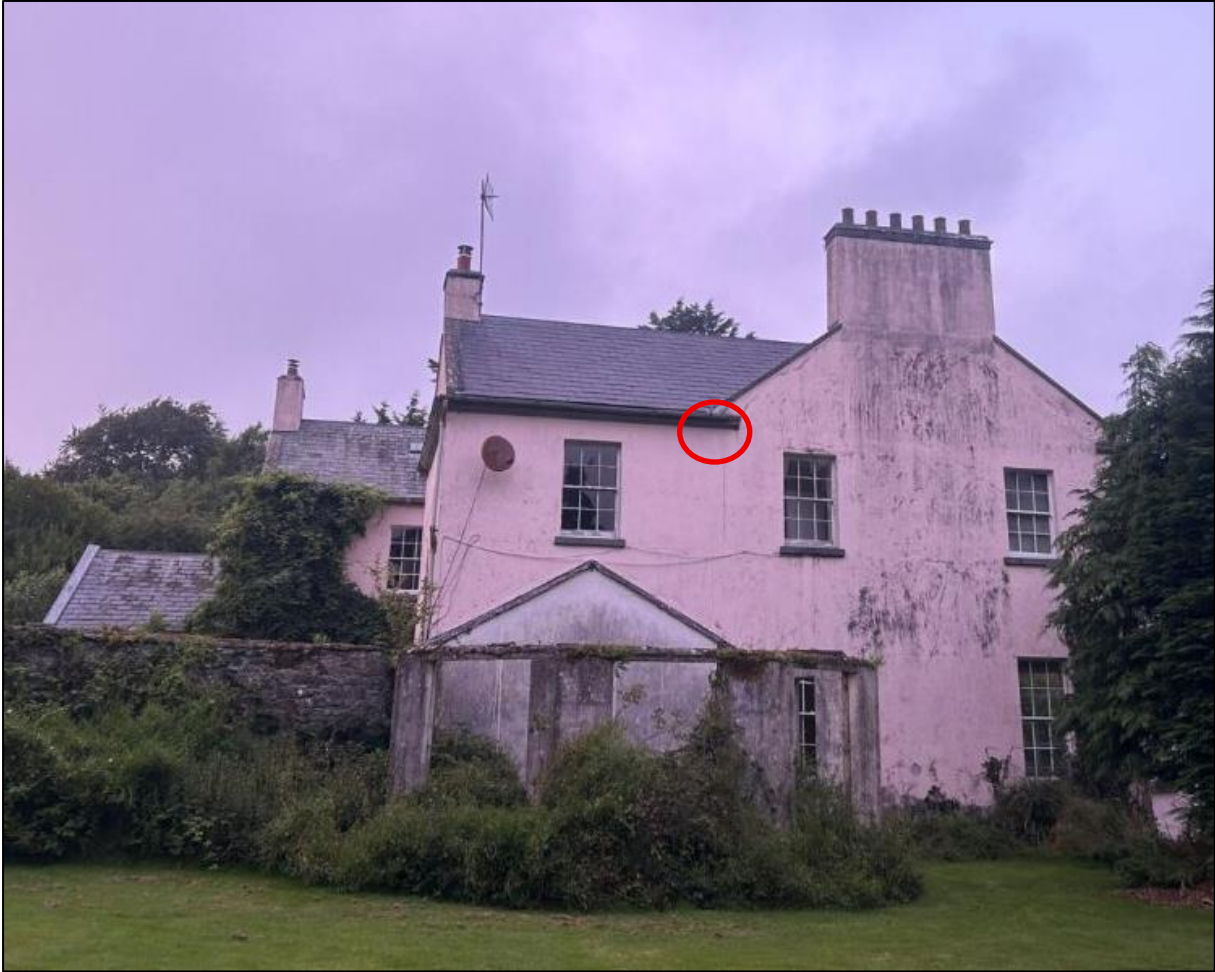
Plate 3-7: Soprano pipistrelle emergence point from VP3 at B1 on 19/08/2025

The surveyor at VP3 observed one soprano pipistrelle emerge from a roof tile of the Main House at 21:07 (see Plate 3-7 below). No other emergence was observed from B1 at VP3. A review of the NVA footage from VP3 also confirmed no other bat emergence from B1 at VP3.

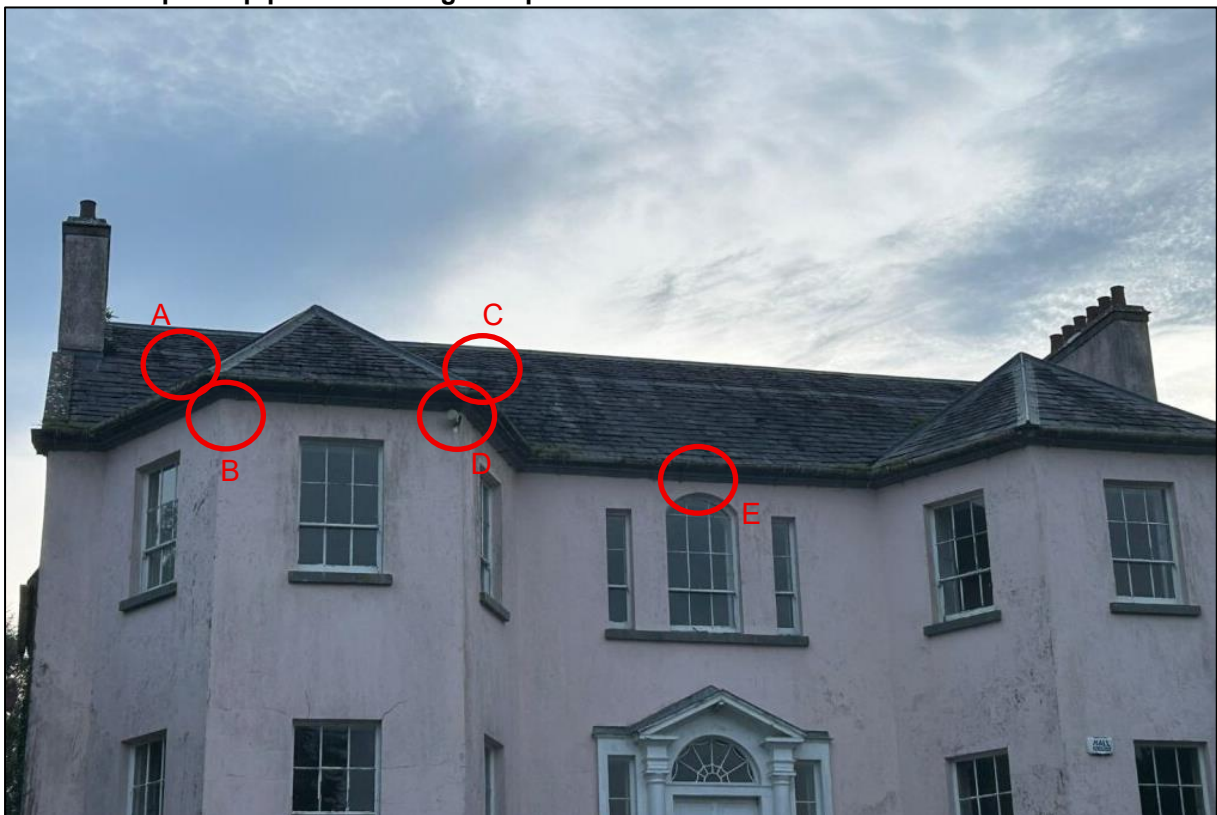
Plate 3-8: Soprano pipistrelle emergence points from VP1 at B1 on 04/09//2025

In total, 11 soprano pipistrelles were observed emerging from five different points of the roof of B1 at VP1.

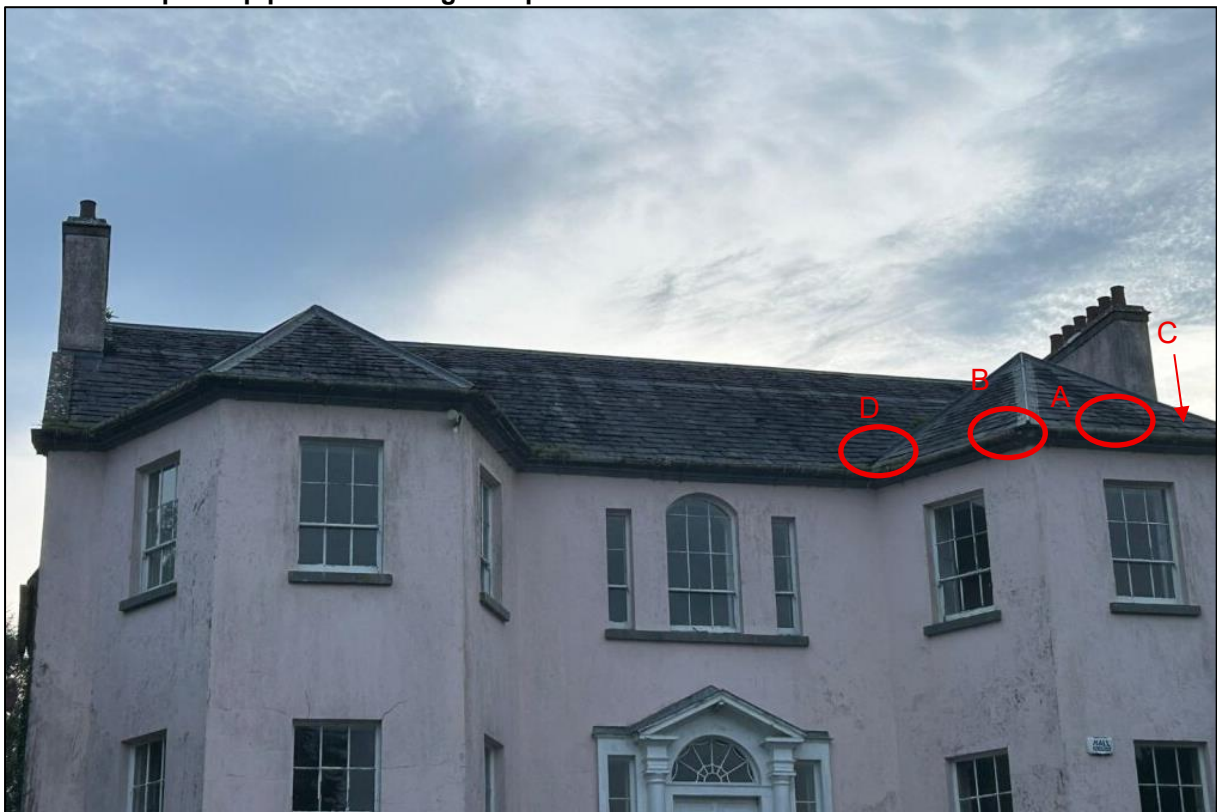
Plate 3-9: Soprano pipistrelle emergence points from VP2 at B1 on 04/09/2025

In total, 11 soprano pipistrelles were observed emerging from four different points of the roof of B1 at VP2.

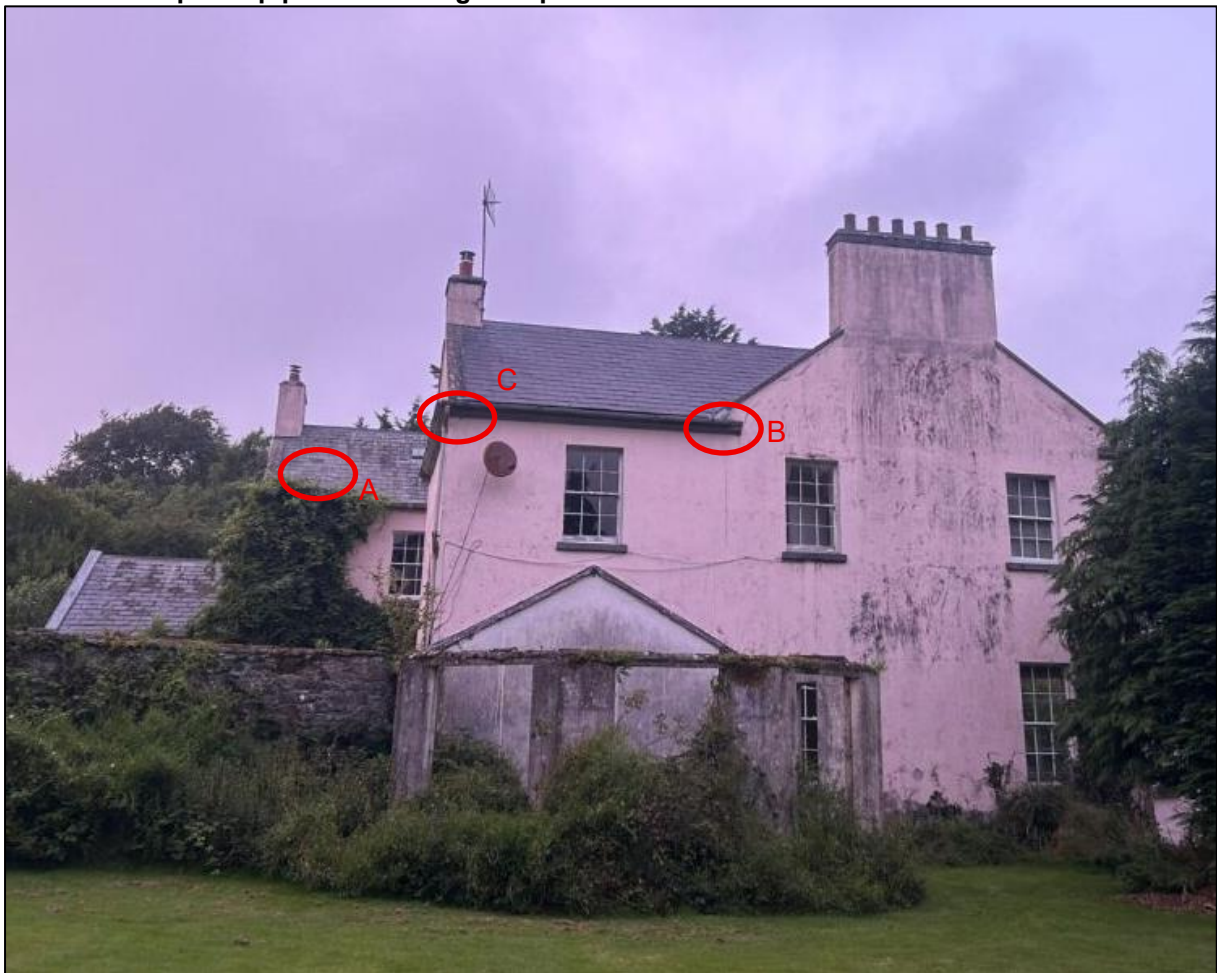
Plate 3-10: Soprano pipistrelle emergence points from VP3 at B1 on 04/09/2025

In total, five soprano pipistrelles were observed emerging from three different points of the roof of B1 at VP2.

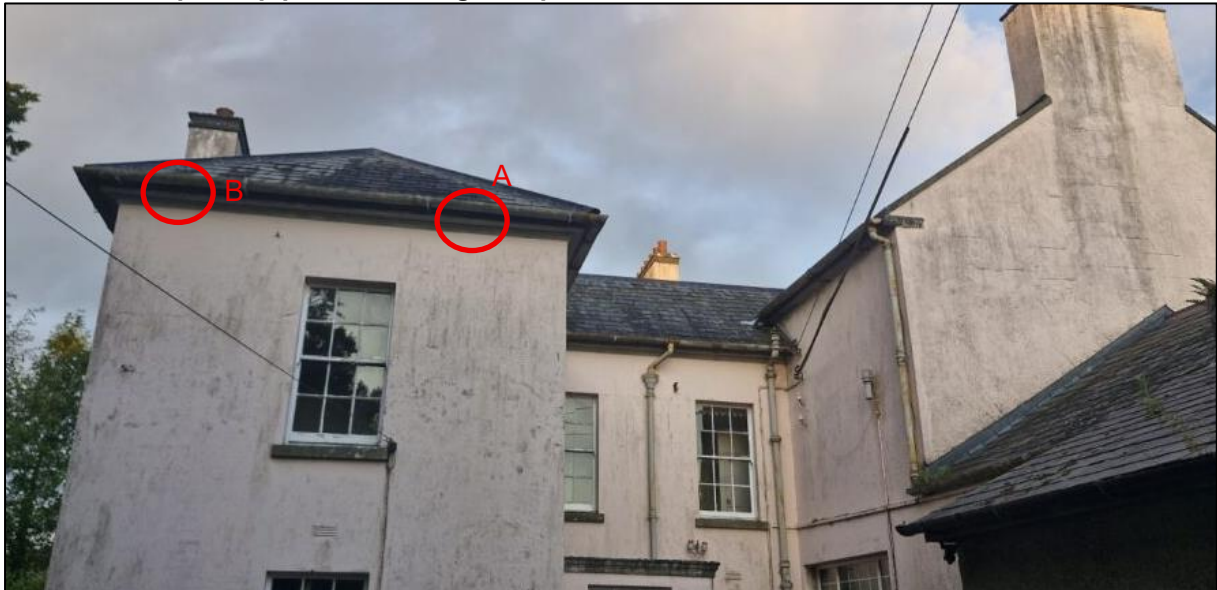
Plate 3-11: Soprano pipistrelle emergence points from VP4 at B1 on 04/09/2025

No other emergence was observed from B1 at VP4. A review of the NVA footage from VP4 also confirmed no other bat emergence from B1 at VP4.

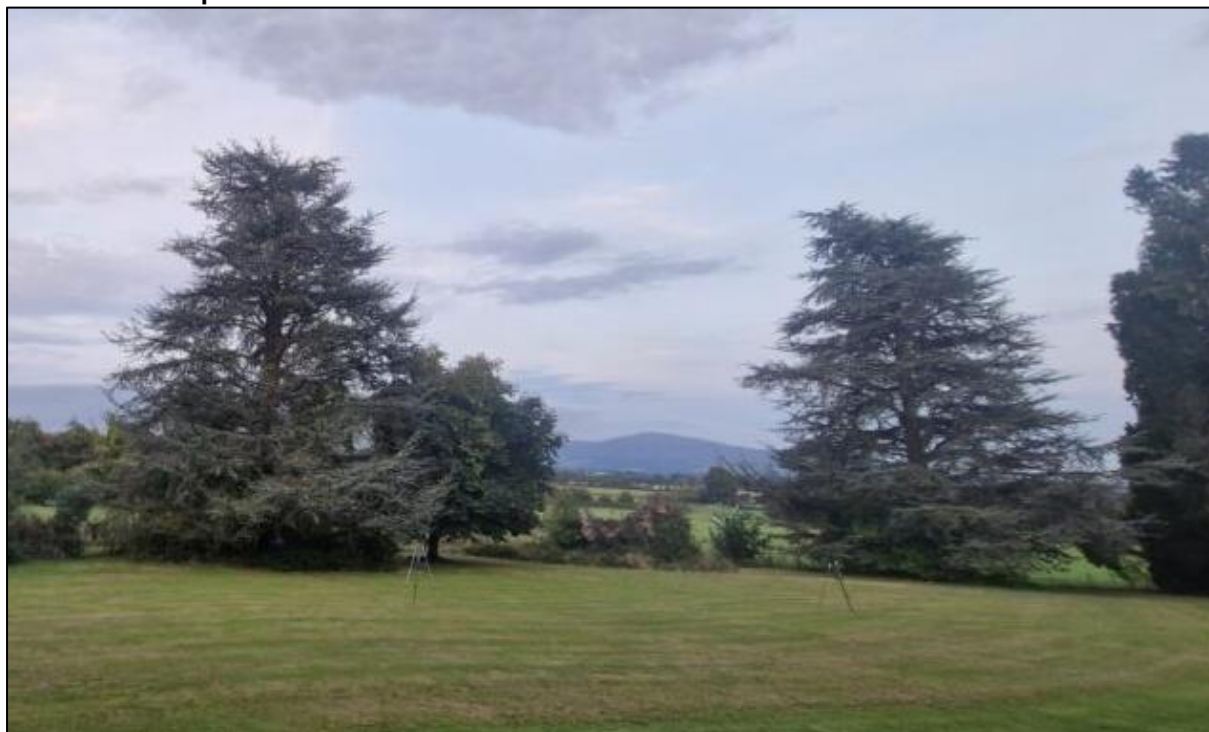
Plate 4-1: Example of Mature trees to the South of B1 where Bat Boxes will be erected

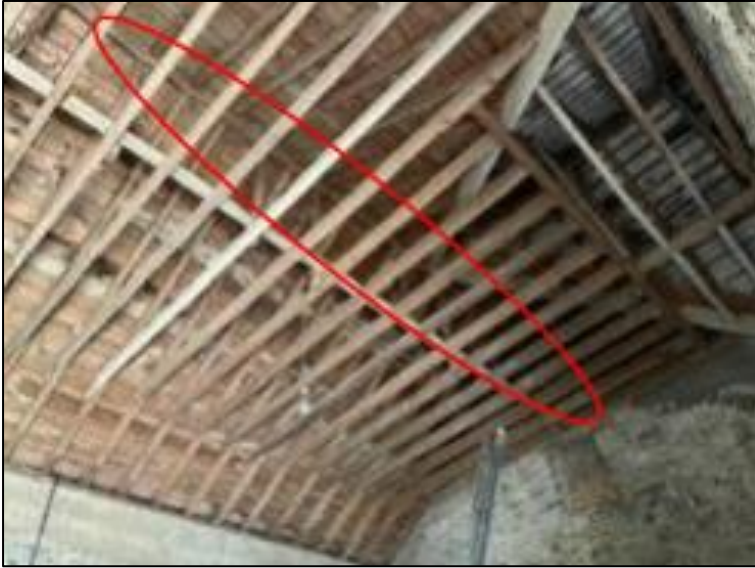
Plate 4-2: Image of Roof of B5 where a bat box will be erected

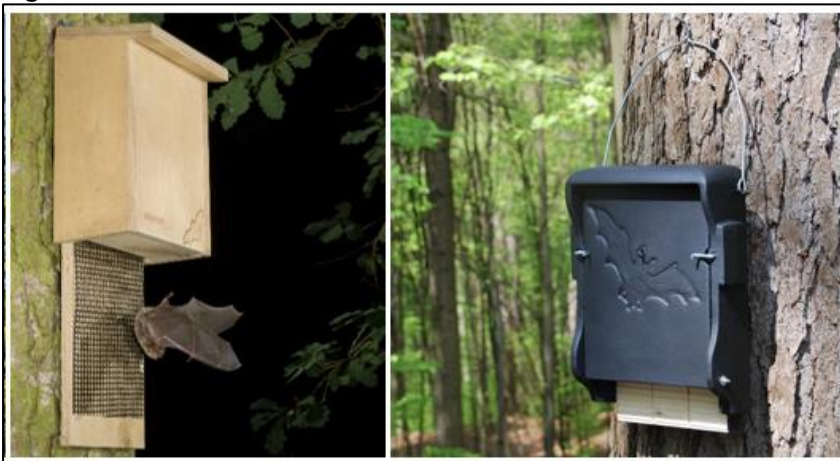
Figure 4-1: Suitable Bat Roost Boxes

Figure 4-1 below shows suitable bat roost box examples including a Bat Box Schwegler (model 1FF) and Vivara Small Bat Box.

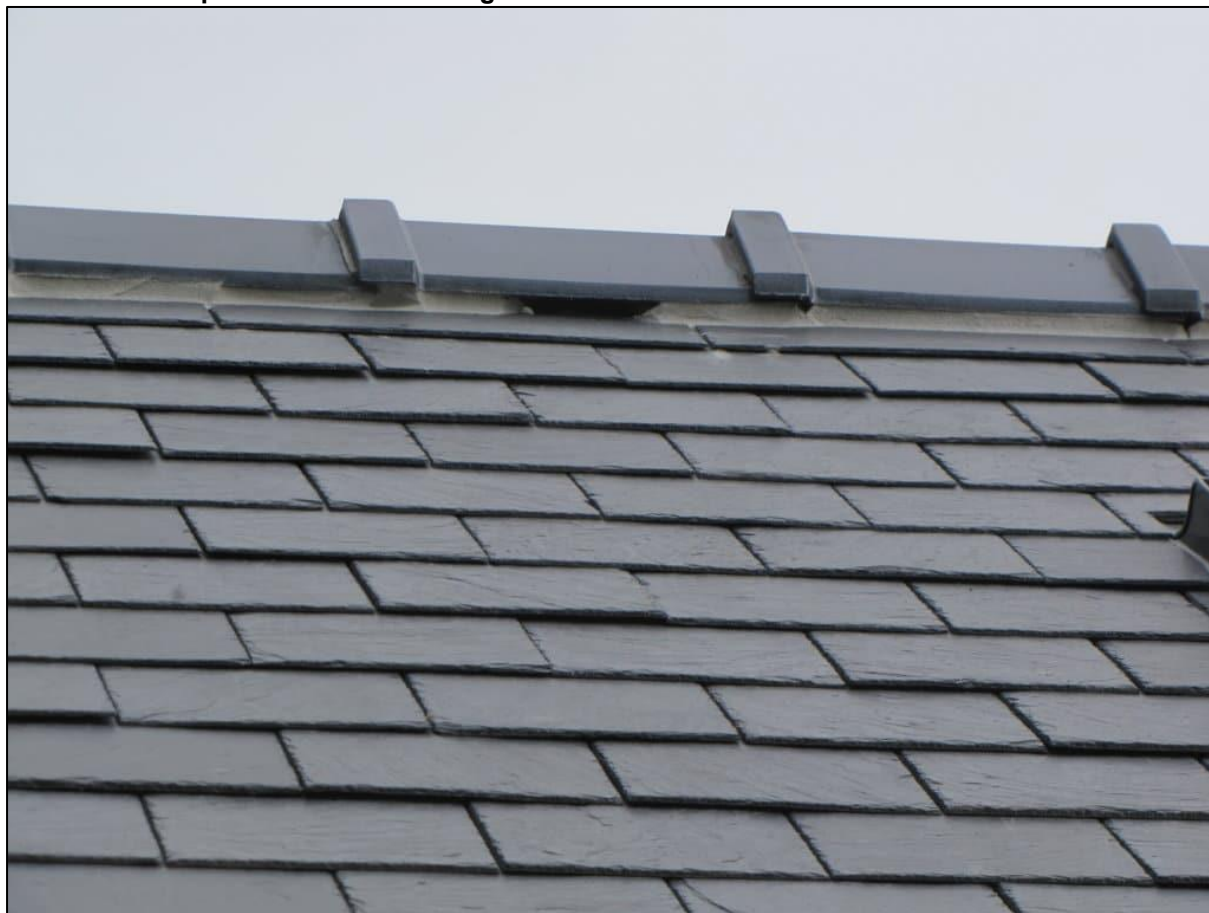
Plate 4-5: Example of a bat access ridge tile suitable for B1

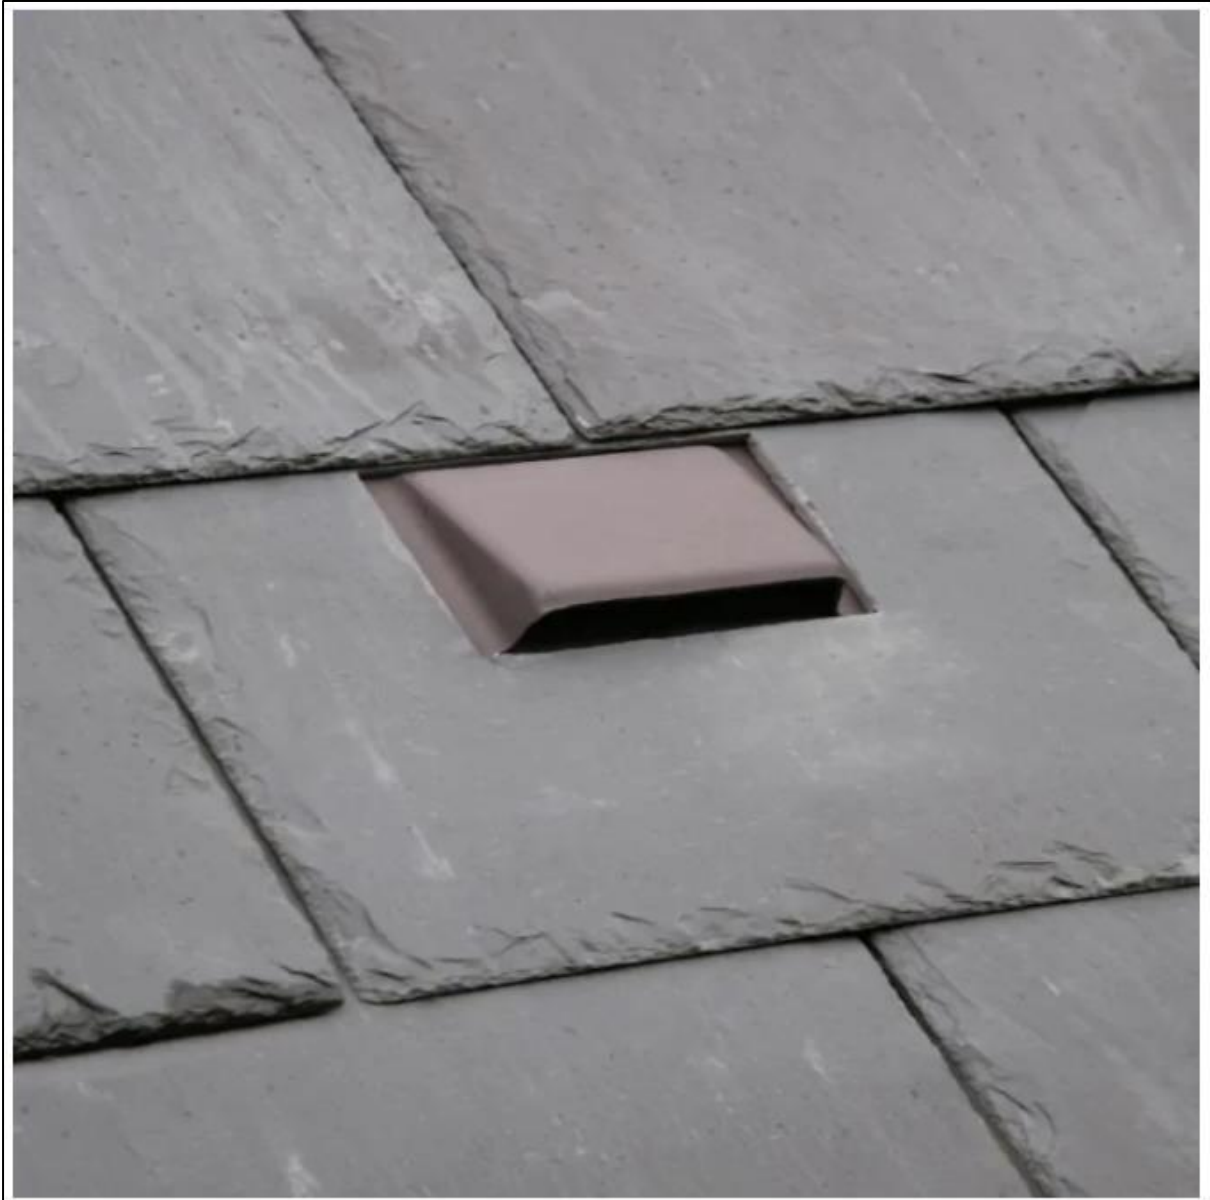
Plate 4-6: Example of a bat access tile suitable for B1

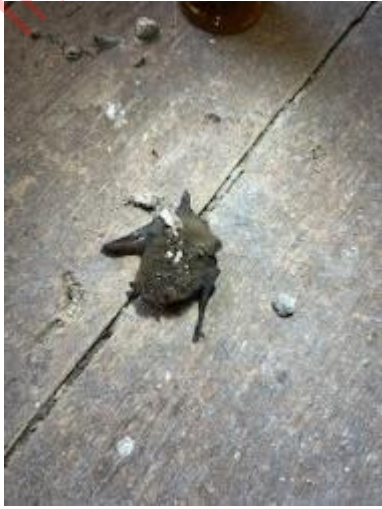
<p>Bats found</p>	<p>Four dead bats were found in the loft space of B1. These appeared to be two juveniles and two adult pipistrelle bats. It is unclear how old the specimens were, but it is suspected that these were no less than a year old due to their condition and lack of decomposition.</p>

<p>Figure i: Example of dead bat found in the loft space of B1.</p>
-------------------	---

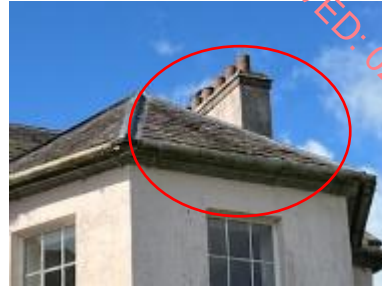
features and or entry/exit points, B1 is considered to have high roosting potential.

Figure vii: Gaps between slate roof tile at the front of B1's roof.

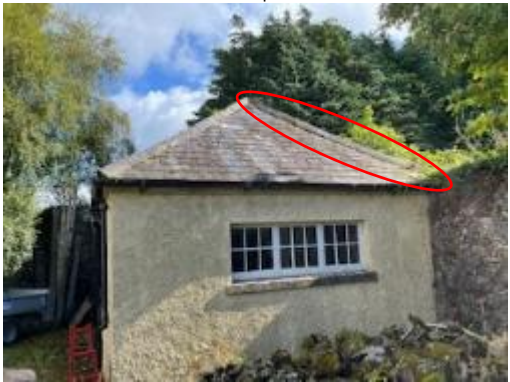
Bats found	No bats were found at the time of survey.
Evidence of bat use	No evidence of bat use was found.
Potential for bat use	<p>Level of likelihood of presence – Low</p> <p>A small number of gaps were found along ridgeline of the building's roof as well as a small amount of suitable roosting potential found along the central beam of the roof truss framework. Potential access could also be found through the open garage door as well as small gaps above the door itself. Given the buildings limited amount of roosting features it is considered to be of low potential.</p>

<p>Figure xviii: Example of gaps between roof tile along ridge.</p>

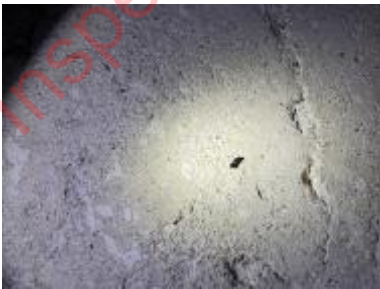
Bats found	No bats were found at the time of survey.
Evidence of bat use	<p>Two droppings were found in the internals of building B6.</p>

<p>Figure xxi: Dropping found in building B6.</p>

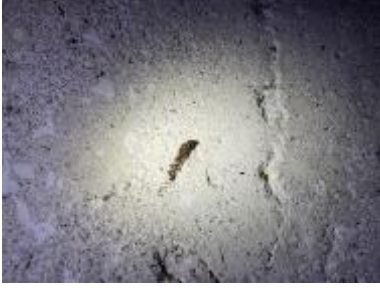
<p>Figure xxiii: Dropping found in building B6.</p>
Potential for bat use	<p>Level of likelihood of presence - Confirmed</p> <p>In addition to the dropping evidence found, open access can be found through window openings throughout the building and the large open entrance to the building. Internally, suitable roosting features included the central beam of the roof truss framework and cracks in the internal brick/stonework. Given the aforementioned features</p>

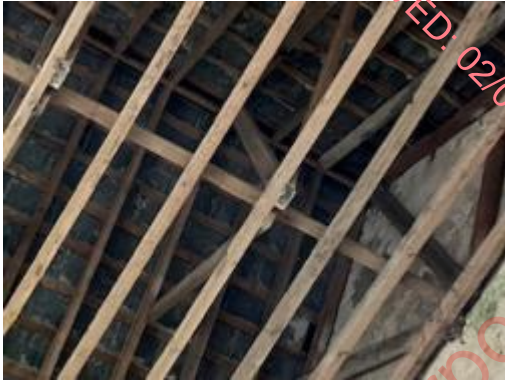
and evidence found B6 is considered to be of moderate roosting potential.

Figure xxiv: Roosting potential along central roof ridge beam.

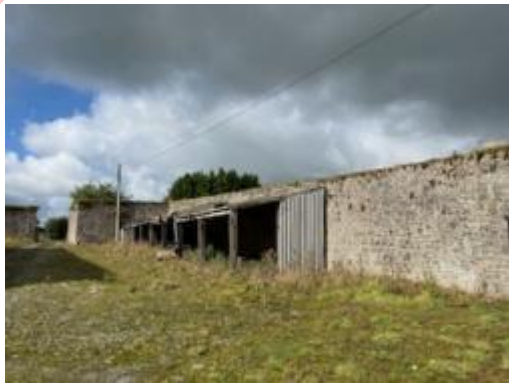
B7 has no loft spaces or roof voids, the underside of the corrugated metal roof is unlined and visible. Structurally this building was in poor condition, with timber framing and roofing material buckled in several places.

Figure 9: Eastern and southern facing aspects of B7.

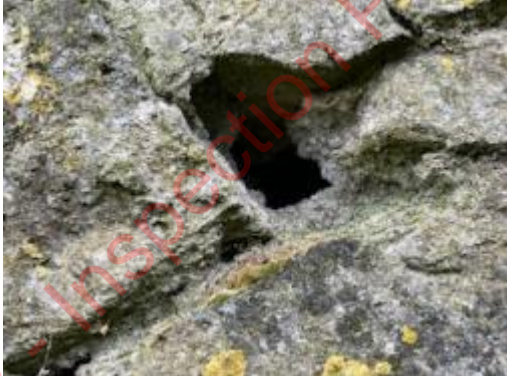
Bats found	No bats were found at the time of survey.
Evidence of bat use	No evidence of bat use was found.
Potential for bat use	<p>Level of likelihood of presence – Moderate. Stone built walls that are found across the site exhibited varying degrees of gaps and crevices in which roosting bats could utilize. In most cases it was unclear how deep some suitable crevices were, and no evidence of usage was found at any point. Given these features, the stone walls (where identified in the PRA results map found in Appendix 3) are considered to be of moderate roosting potential.</p>

<p>Figure xxviii: Example of crevice in stone wall.</p>

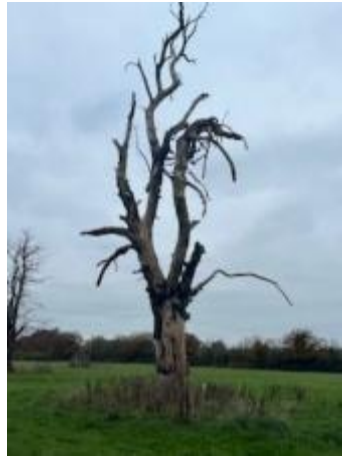
T1 is a large dead tree found at grid reference S 16779 37685. This tree was located within a large field close to hedgerow and tree line.

Figure 22: Large dead tree (T1).

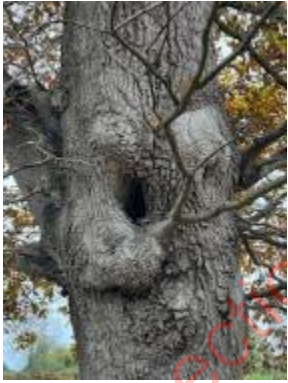
Bats found	No bats were found at the time of survey.
Evidence of bat use	No evidence of bat use was found.
Potential for bat use	<p>Level of likelihood of presence – Moderate. T2 exhibited potential roosting features in the form of knot holes and given its location in close proximity to suitable commuting and foraging habitat T2 is considered to be of moderate roosting potential.</p>

<p>Figure xxxii: Example of knot hole on T2.</p>

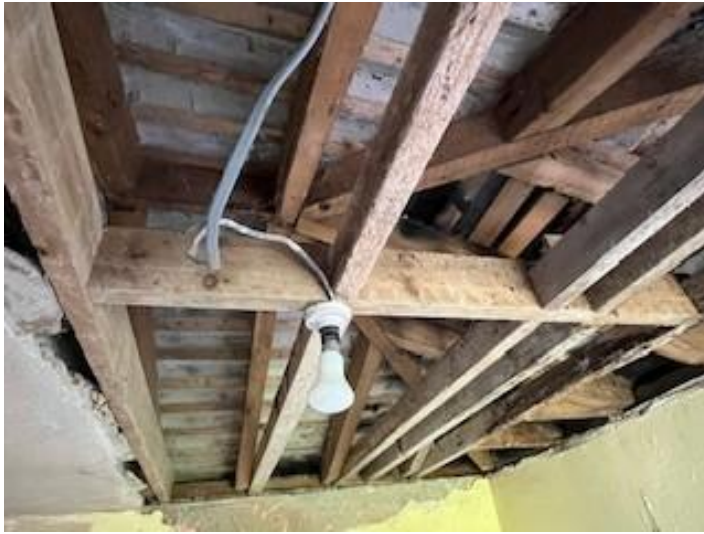
Exposed underside of B14s roof through gaps from missing ceiling material.
