National Botanic Gardens, Kilmacurragh, Kilbride, Co. Wicklow

Restoration of Kilmacurragh House

Bat Surveys and Ecological Impact Assessment

FINAL REPORT

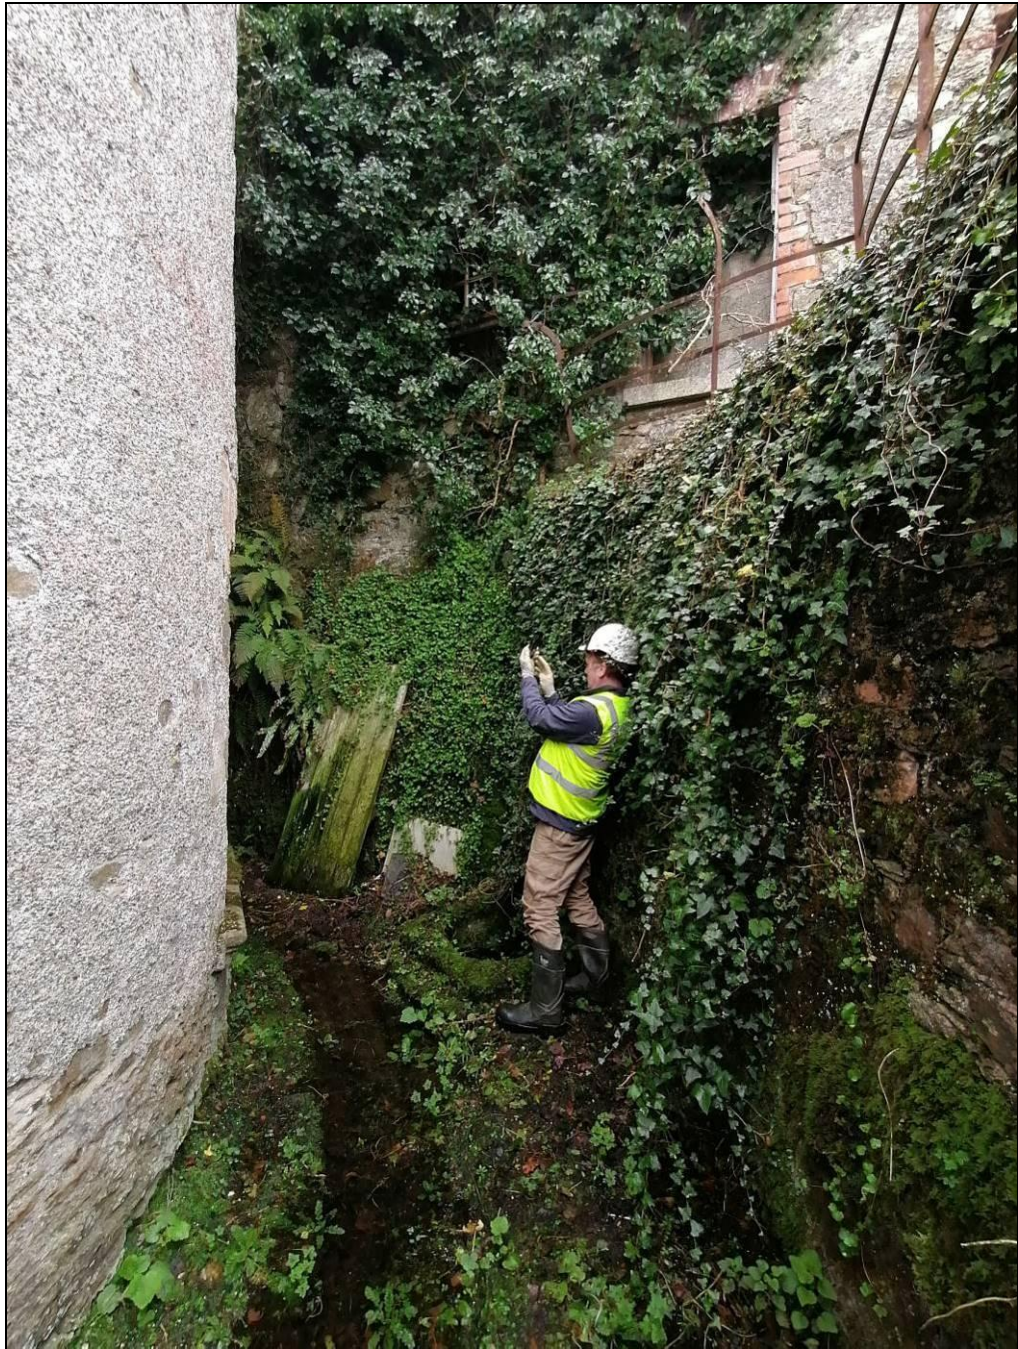
Photo 7. Fern and moss rich walls of the basement passageway.

Given the importance of the damp basement walls, disturbance and habitat changes should be avoided/ minimised. Potentially damaging operations include re-pointing and repairing of the walls here, spillage of lime onto the

It is recommended that this is kept in place during future works and the condition of the wall behind monitored to ensure that it does not dry out or become too dark for the vegetation here to grow.

As a conservation measure it is recommended that an ex-situ population of these fern and moss species are collected and cultivated by the National Botanic Gardens prior to the works commencing thereby ensuring that they can be reinstated should this area require works or be negatively impacted by works higher up on the building. Specialist advice in this regard should be sought. Populations could be established elsewhere in the gardens as well as in Glasnevin.

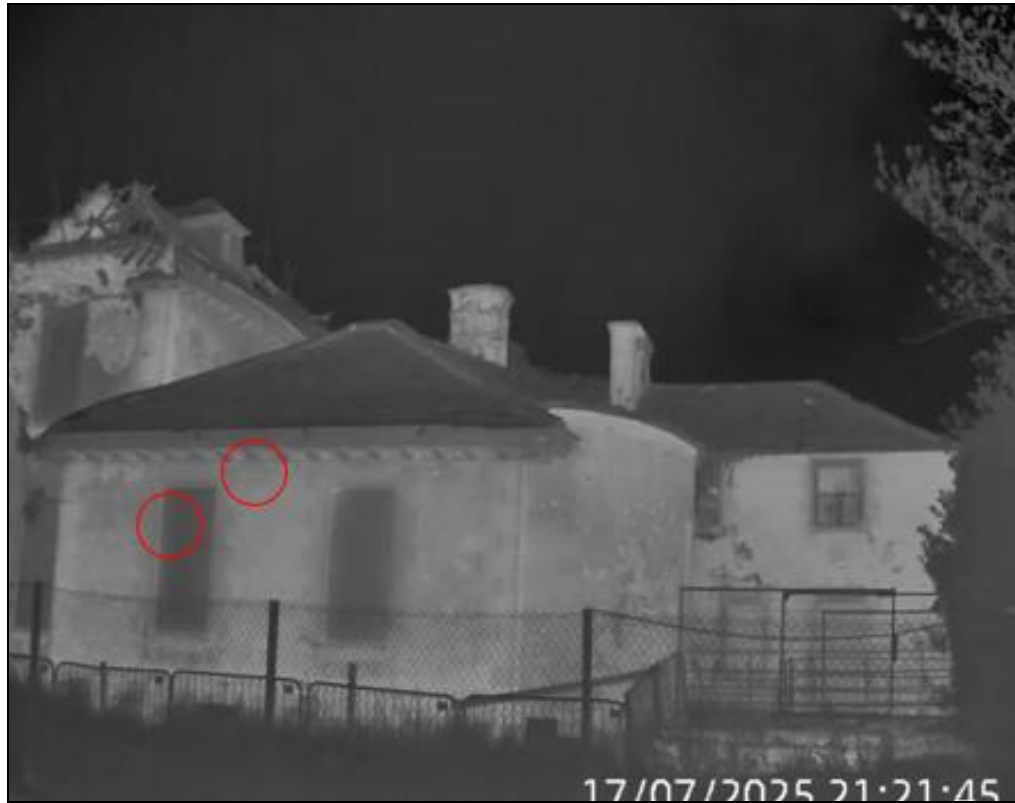
Figure 27. Emergence locations at the Bullnose - recorded by NVA 1.

Time	Species	Details
21:47	Leisler's Bat	First Bat Recorded
22:10	Soprano Pipistrelle	Bat emerges from fascia board (29mins after sunset)
22:18	Soprano Pipistrelle	Bat flies from S-N in front of Scope, begins moving back and forth along the path here
22:20	Pipistrelle	Both Pipistrelle call at the same time, one bat on scope
22:25	Common and Soprano Pipistrelle	Feeding in front of scope (video captured)
22:43	Soprano Pipistrelle	Emerges from crevice in left hand window

The static detector associated with NVA1 recorded Leisler's bat, Common pipistrelle, Soprano pipistrelle and Brown long-eared bats.

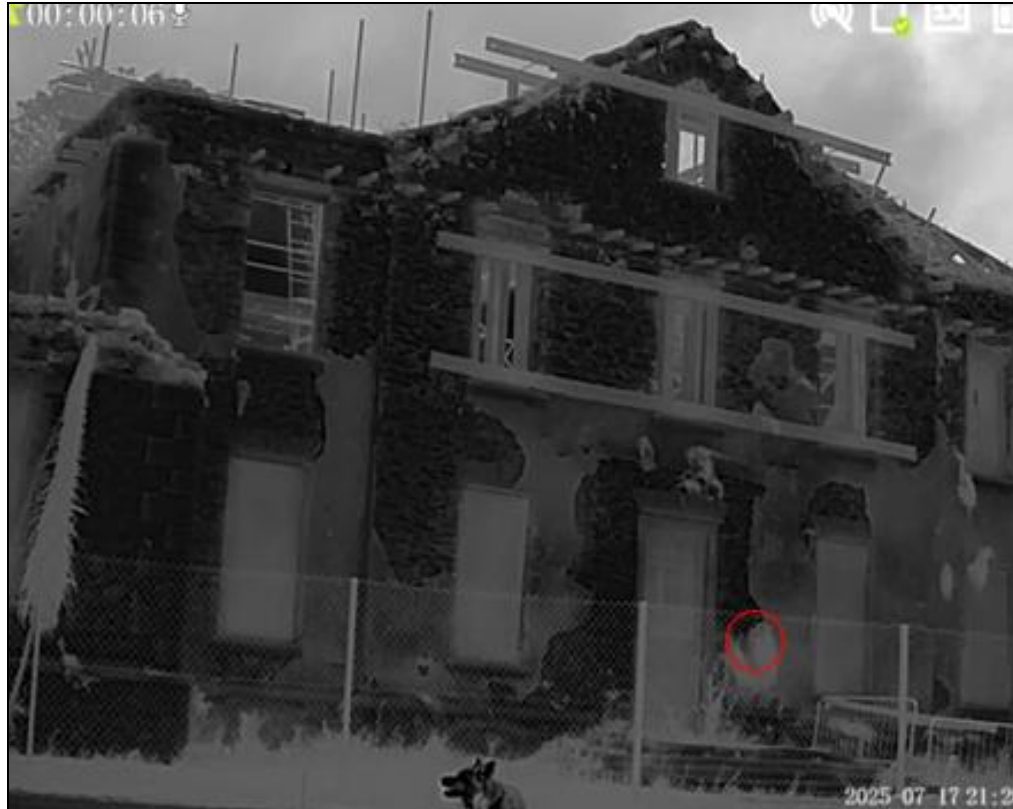
Figure 28. Emergence location from the front of the house – recorded by NVA 2.

Time	Species	Details
22:17	Unknown	First bat seen on Pixfra, passing up and down along path (36 minutes after sunset)
22:20	Unknown	Bat emerges from crevices in wall/under plaster, Right of the main door
23:17	Unknown	24 bat passes along path, no more emerging

The static detector associated with NVA2 recorded Leisler’s bat, Common pipistrelle, Soprano pipistrelle, possible Nathusius’s pipistrelle and Daubenton’s bats.

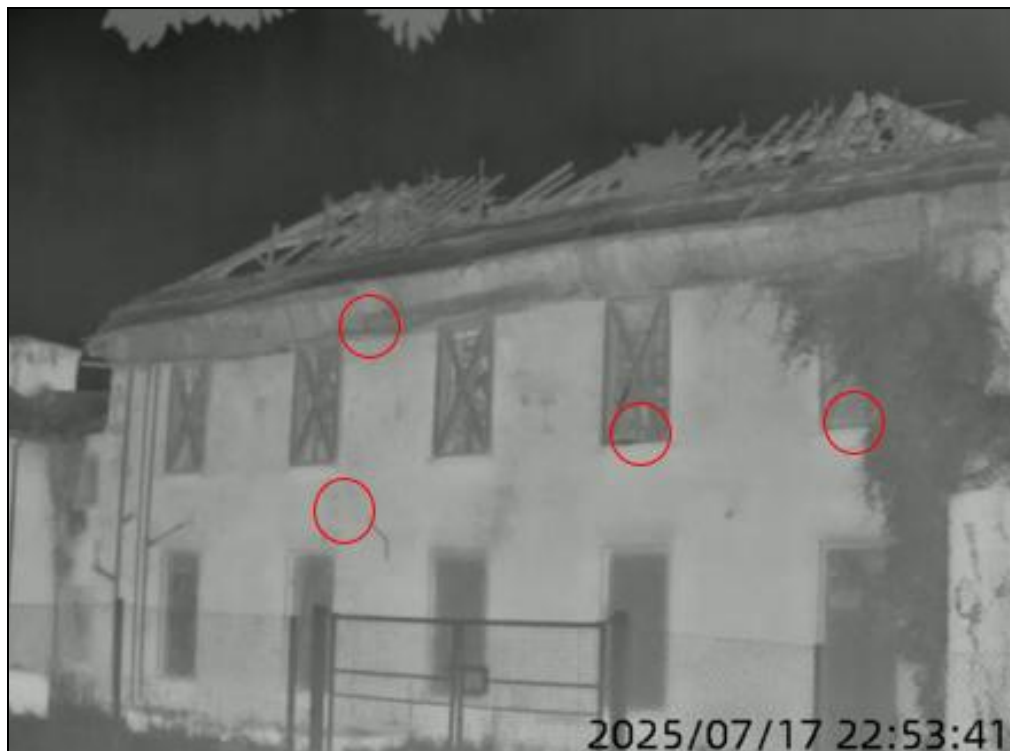
Figure 29. Emergence locations at the rear of the house - recorded by NVA 3.

Time	Species	Details
21:57	Common Pipistrelle	Emerges from roof of main derelict building
22:09	Leisler's Bat	Emerges from main building wall
22:10	Natterer's Myotis	Emerges from fascia board
22:17	Leisler's Bat	Emerges from main building window, second from the right
22:20	Brown Long eared	Emerges from window, second on the top right
22:23	Brown Long eared	Emerges from the same window
22:25	Brown Long eared	Emerges from the same window
22:35	Brown Long eared	Emerges from the same window
23:12	Brown Long eared	emerges from top right most window, second bat seen inside building

The static detector associated with NVA3 recorded Leisler's bat, Common pipistrelle, Soprano pipistrelle, Natterer's bat, and *Myotis* bat (possible Whiskered bat).

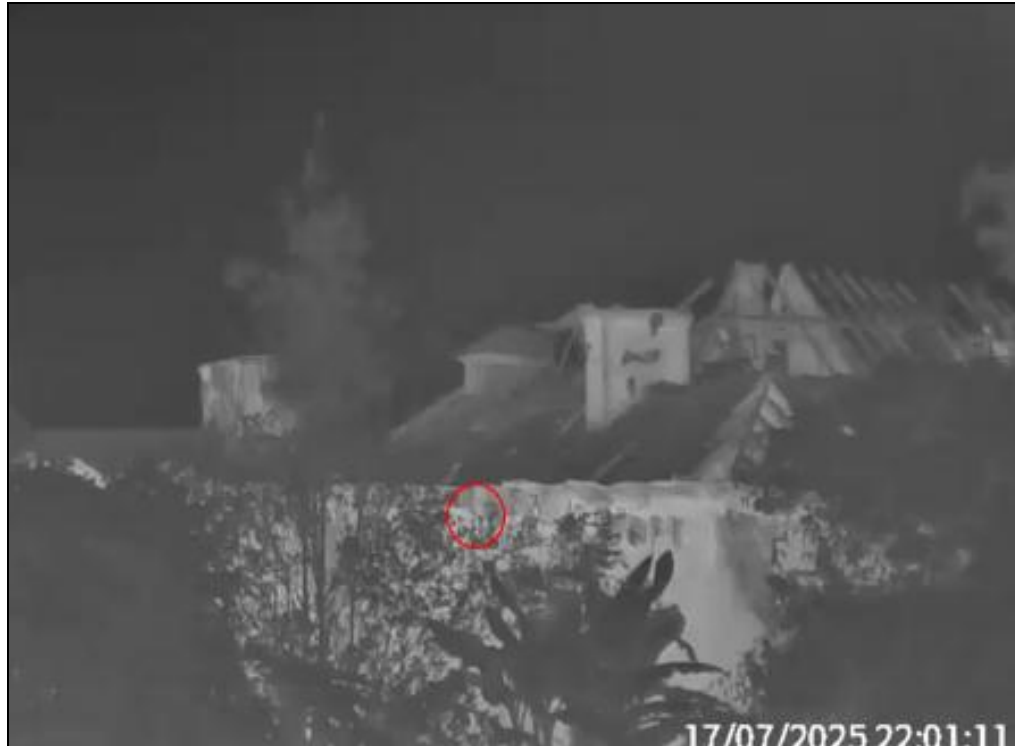
Figure 30. Emergence location from the Kitchen Wing - recorded by NVA4.

Time	Species	Details
21:53	Unknown	First bat seen on Thermal 19mm (12 minutes after sunset)
22:09	Unknown	Bat pos. emerging from rear of building
23:01	Soprano Pipistrelle	Activity over kitchen garden increases, many bats feeding over yard here

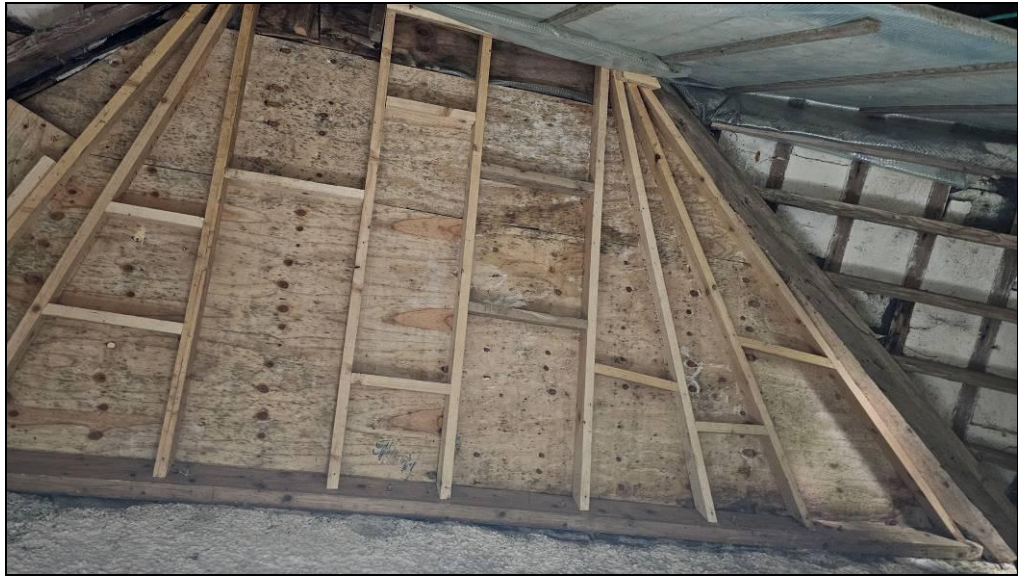
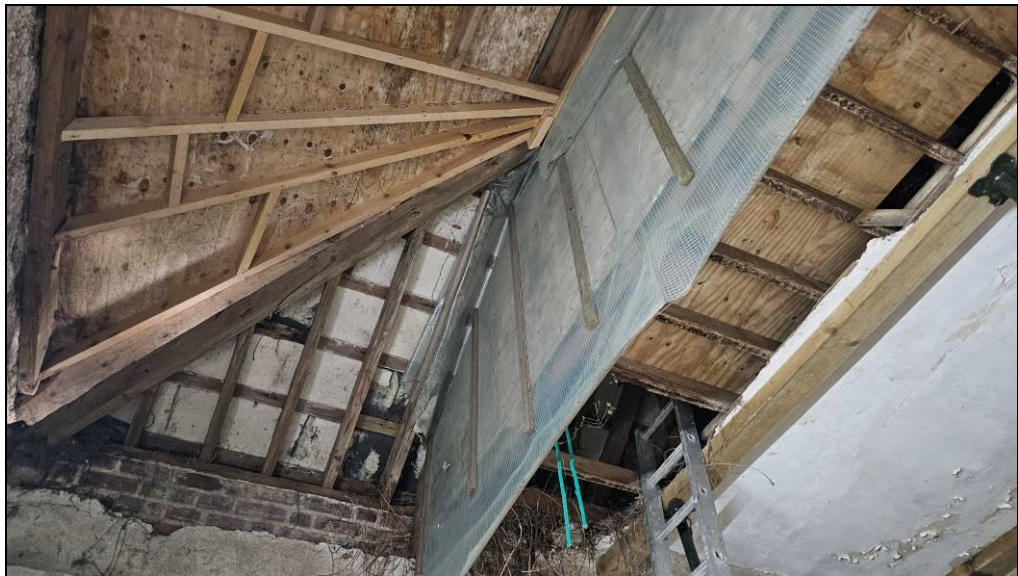
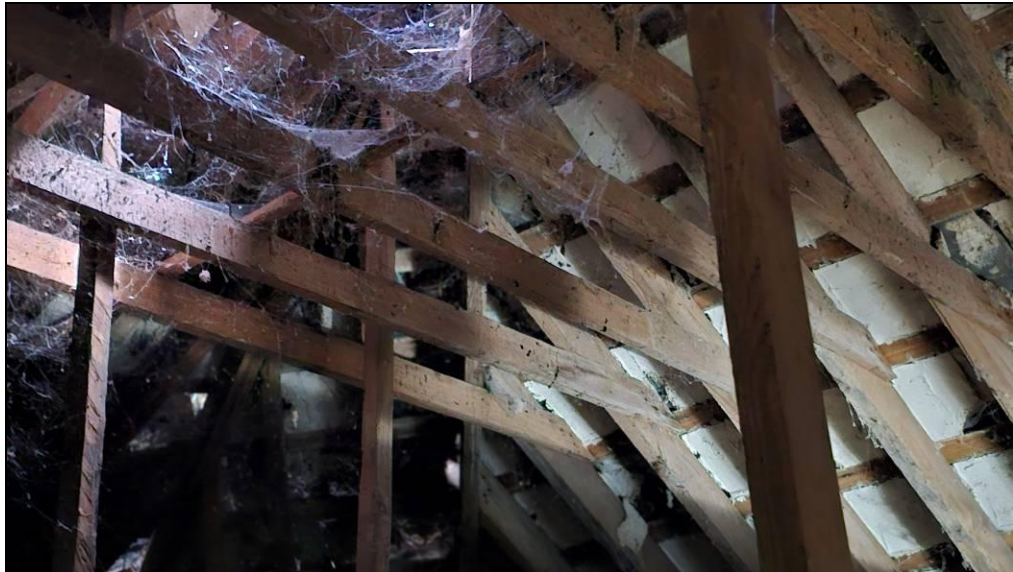
On the 7th August 2025 the interior of the house was again inspected. It was noted that there had been changes to the Bullnose with the erection of sheeting to prevent weather from entering this structure. This has allowed a darkened ‘attic’ to be created which is very attractive to bats. The slates here are fixed with traditional lime parging on battens which are very favourable to roosting bats. The attic below the Bullnose has many cobwebs present but some bat droppings were present here and on the floor below.

Photo 17. Repairs to the roof of the bullnose have created a darkened attic space.

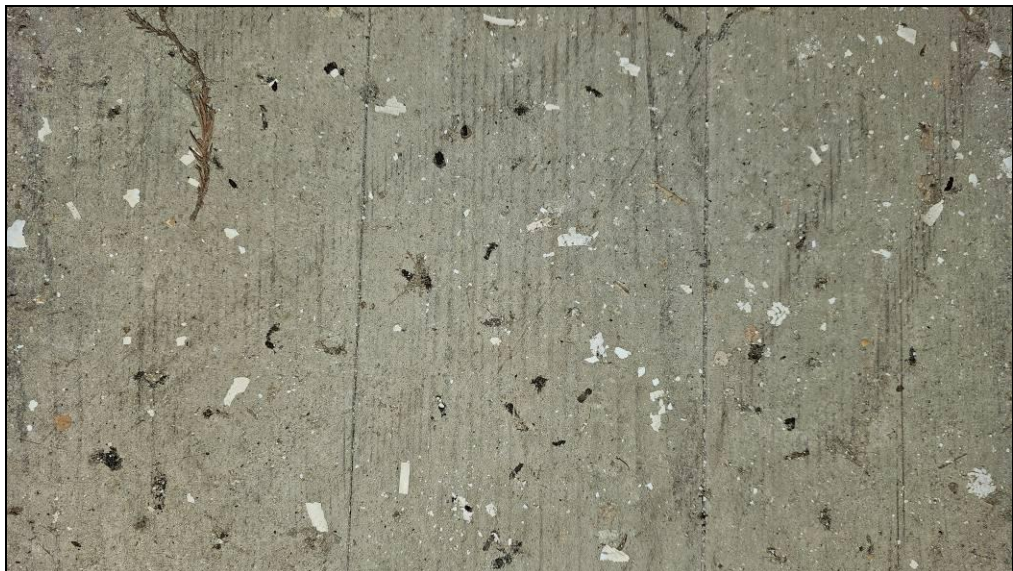
Photo 20. Bat droppings in the Bullnose.
