Bat Derogation Licence Application

Templetney Water Treatment Plant, Co. Tipperary

Project: Templetney Water Treatment Plant, Co. Tipperary.

Project Reference: 2025/24

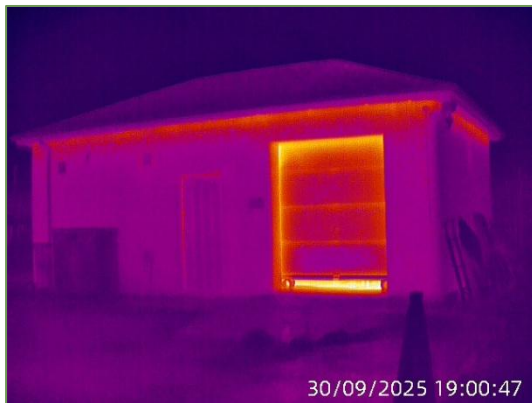
Plate 2.1 Thermal perspective overlooking the western aspect of the Pump House.

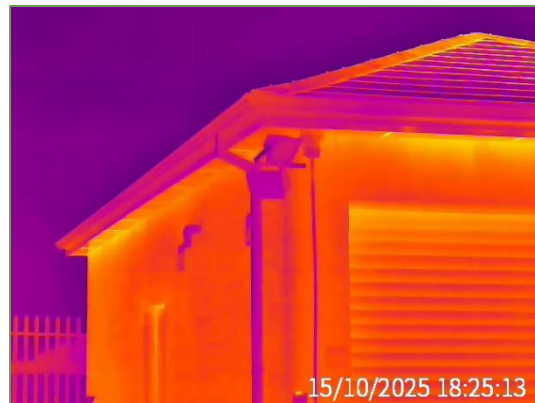
Plate 2.2 Thermal perspective overlooking the eastern aspect of the Pump House.

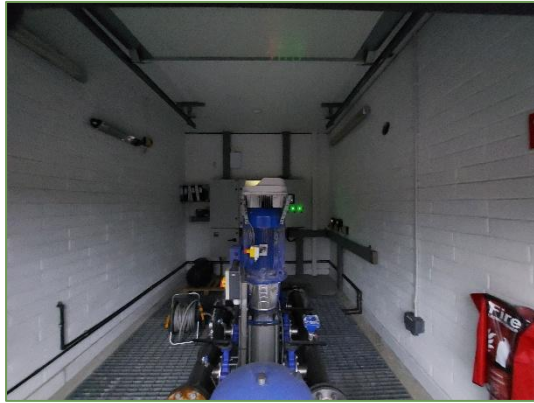
Plate 3.1 Interior of pump room.

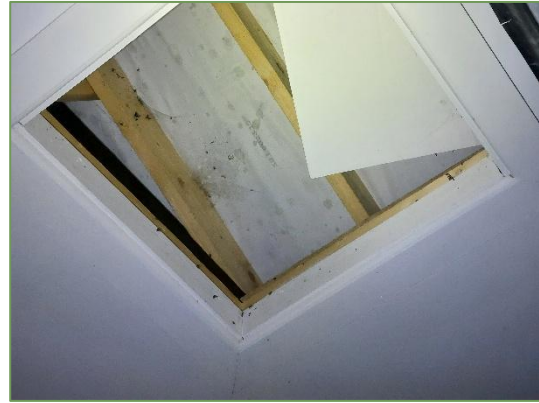
Plate 3.2 Attic hatch within pump room.

The attic hatch (see **Plate 3.2**) will be kept closed during works and fasteners installed to prevent strong winds opening the hatch once the Louvered doors are installed. Keeping the hatch closed will provide an effective measure to reduce noise and dust related disturbance on bats

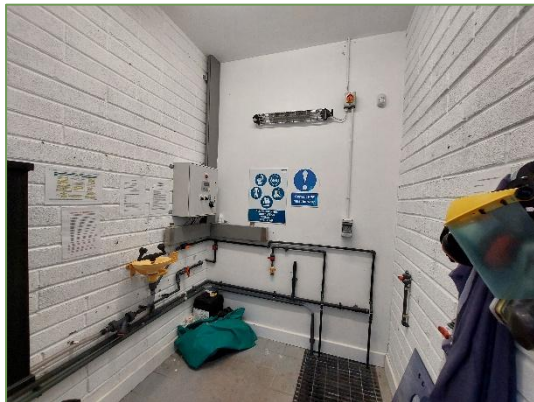
Plate 3.3 Interior of Pump House.

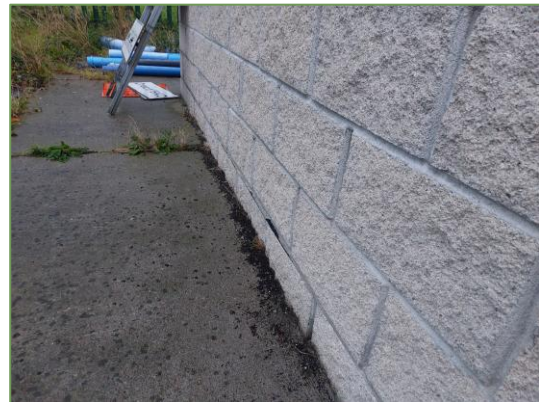
Plate 3.4 Accumulation of droppings on the exterior.

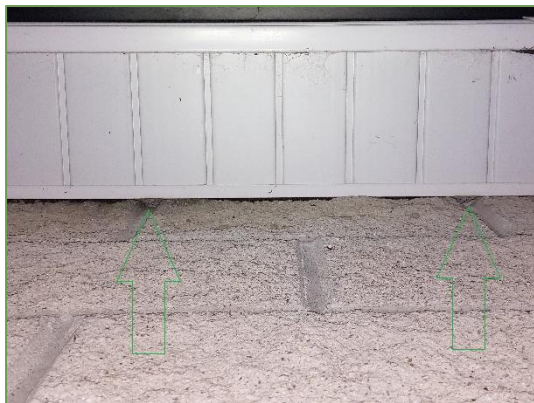
Externally, deep grout lines are present between blockwork, and these extend vertically up beyond the soffit (see **Plate 3.5**). These grout lines create a small gap which facilitates bat access and egress into the attic space and are present around the entire structure. An accumulation of droppings was noted externally on the south-western side of the Pump House externally during the September survey, indicating proximity to the roosting location within (see **Plate 3.4**). This accumulation was no longer present at the time of the October survey.

Plate 3.5 Block work walls with grout lines (green arrows) extending up last soffit, providing crawl space for bat access/egress.

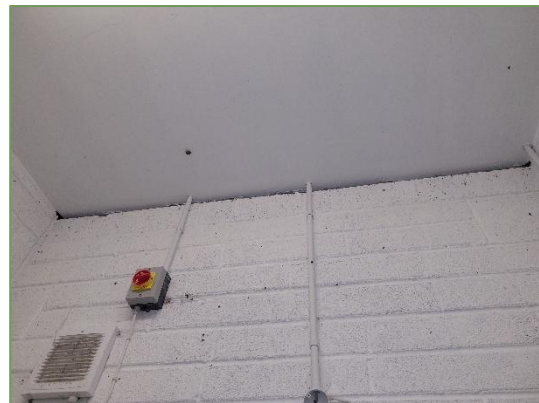
Plate 3.6 Gaps between wall and ceiling appear to provide interior access for bats.

Prior to the commencement of works, a bat licensed Ecologist will be engaged to provide a toolbox talk on-site. The bat licensed Ecologist will examine the gap between the ceiling and internal wall to ensure no bats are present, and this space will be filled using foam pipe lagging or a similar product (not expanding foam) to prevent further bat access to the ground floor

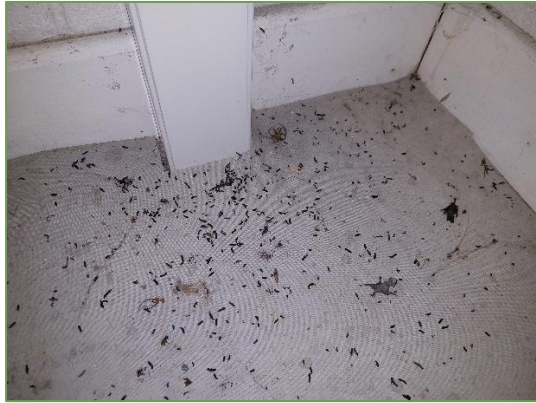
Plate 3.7 Bat droppings within Pump House.

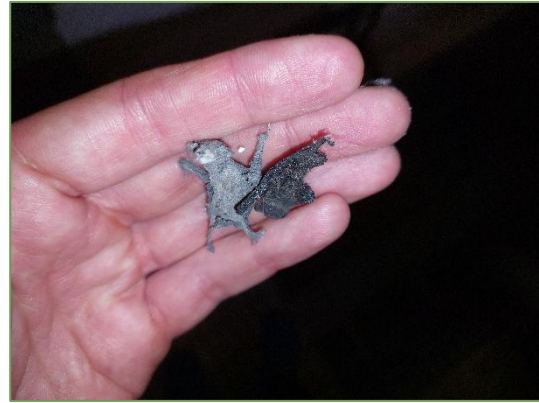
Plate 3.8 Dead juvenile bats found within the pump room - indicates maternity roosting.

rooms of the Pump House. This measure will ensure that further juvenile bats (see **Plate 3.8**) do not fall into the rooms and become trapped.

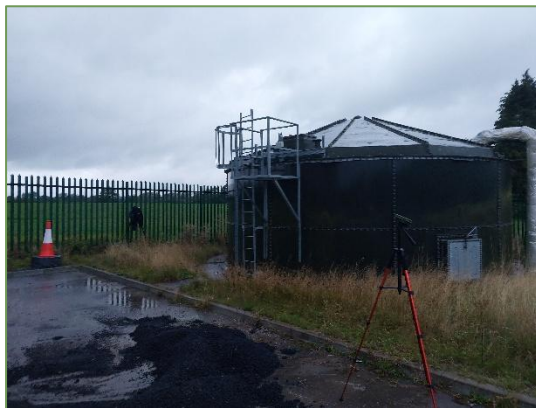
The study area contains a water tank and some small metal structures (see **Plates 3.9-3.10**), in addition to the Pump House. These metal structures are considered to have negligible suitability for roosting bats and no evidence of such was recorded during surveys. These other structures are not considered further, and the discussion below relates to the Pump House only.

Plate 3.9 Water tank within the study area.

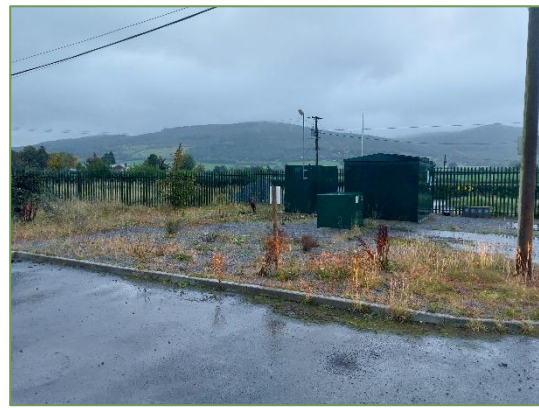
Plate 3.10 Metal structures (control room etc.) within the study area.

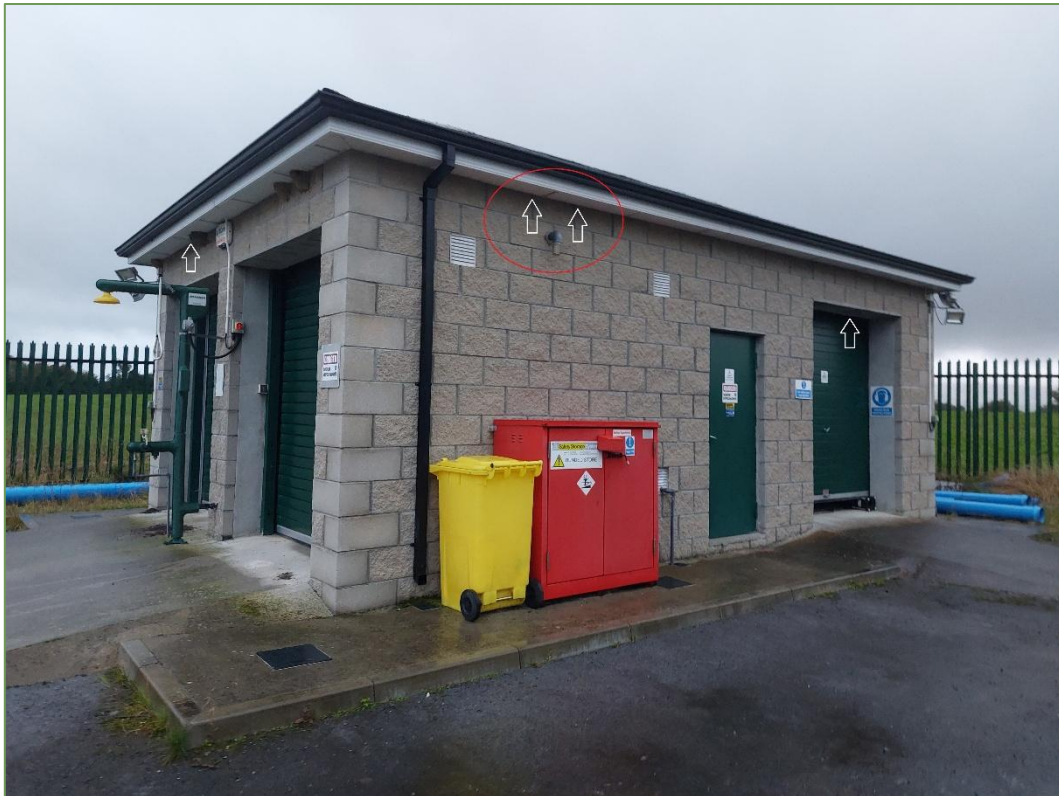
The Pump House is constructed of concrete blocks with an artificial slate roof (see **Plate 3.11**). No windows are present, and interior access is provided by way of roller doors and other pedestrian access doors. The Pump House is composed of a number of rooms that are connected by gaps above the internal walls and the ceilings (see **Plate 3.6**). Droppings were noted in several locations, with most being present in the pump room (see **Plate 3.7**). A dropping sample was collected from the pump room and sent for DNA analysis to Surescreen Scientifics. Testing results confirmed this dropping was attributed to Soprano pipistrelle (see **Appendix A**). Dead juvenile bats were found within the pump room specifically (see **Plate 3.8**), indicating the presence of maternity roosting. These individuals are presumed to have entered the interior space through the aforementioned gap between the wall and ceiling. The pumps appear to operate continuously within the structure and produce significant noise which the roosting bats appear accustomed to.

Plate 3.11 View of western side of Pump House building, arrows indicate observed access/egress points. Red circles indicate those observed to most commonly observed to be used.

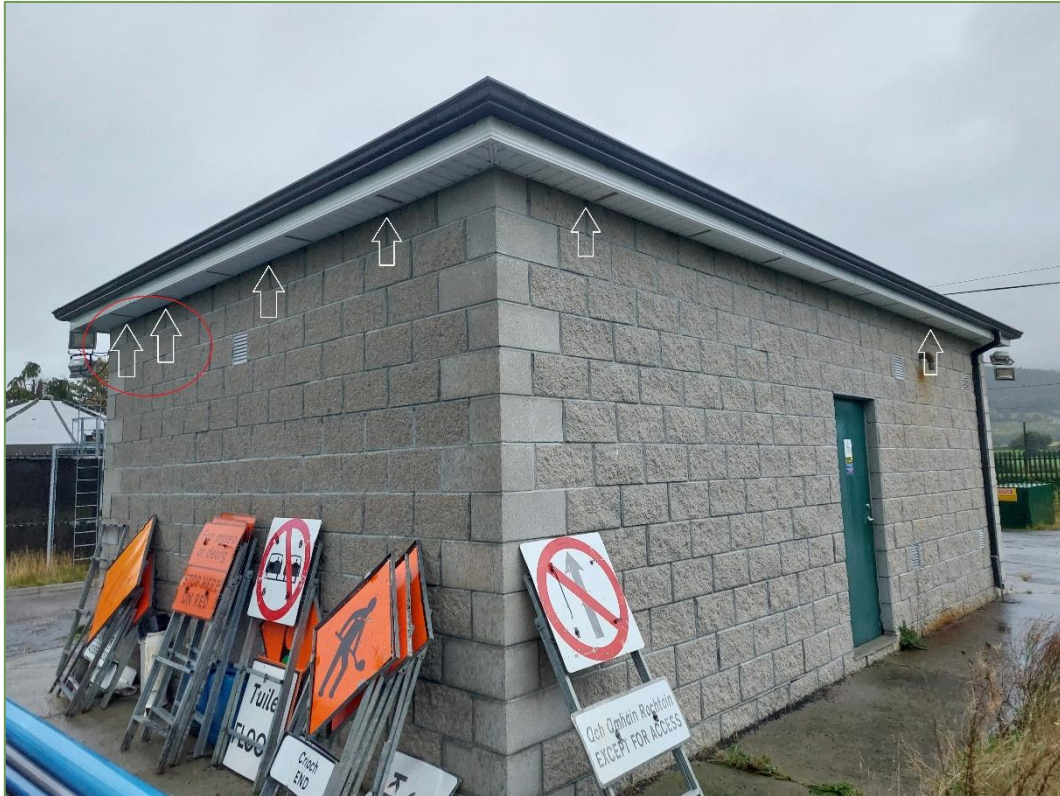
Plate 3.12 View of south eastern side of Pump House building, arrows indicate observed access/egress points. Red circles indicate those observed to most commonly observed to be used.

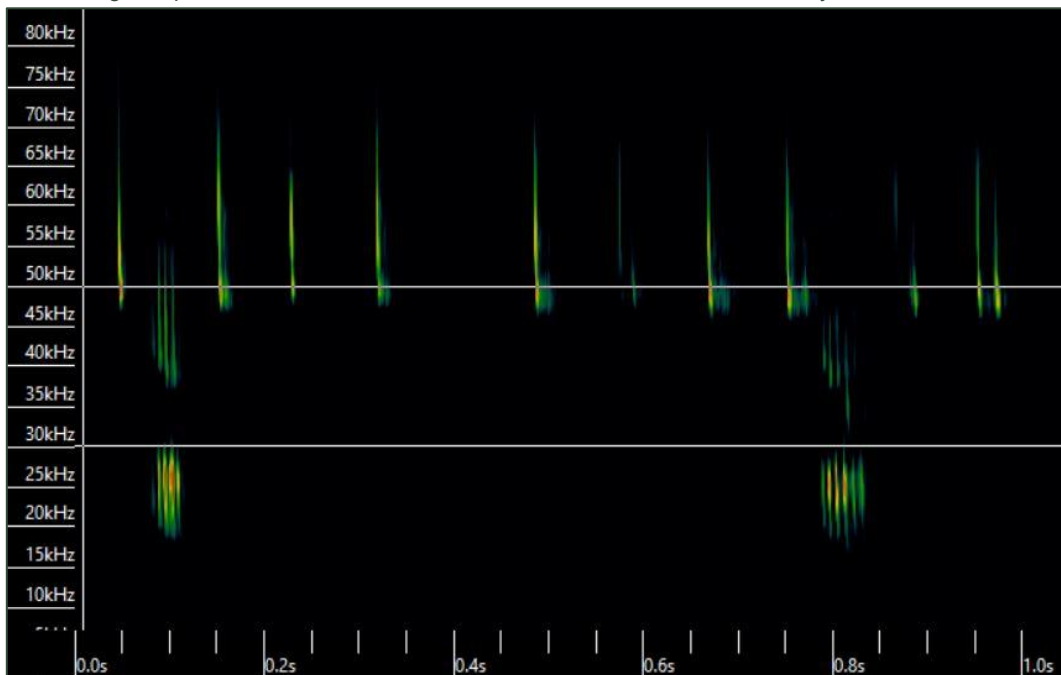
Upon egress, the majority of bats flew directly north-west, towards a nearby treeline off-site. Echolocation registrations recorded were typically associated with emerging or re-entering pipistrelles and foraging behaviour by pipistrelles was generally not observed within the study area. One Common pipistrelle was observed at 19:28 flying for a number of minutes in circles off the eastern boundary of the site while emitting loud social calls (see **Plate 3.13**), possibly associated with courtship behaviour known as 'song-flight'.

Plate 3.13 Sonogram showing example of Common pipistrelle 'Type D' social calls (following Middleton et al. (2022), possibly associated with 'song-flight' behaviour by a male.

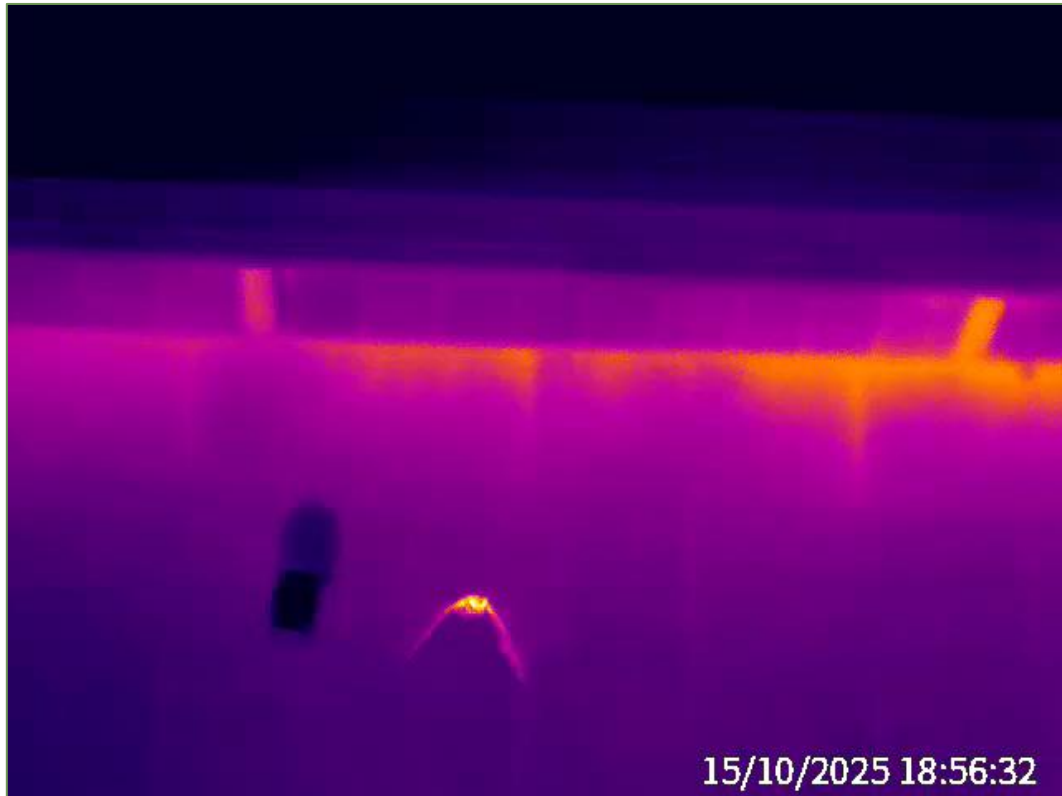
Plate 3.14 Thermal image of Common Pipistrelle immediately after emergence.

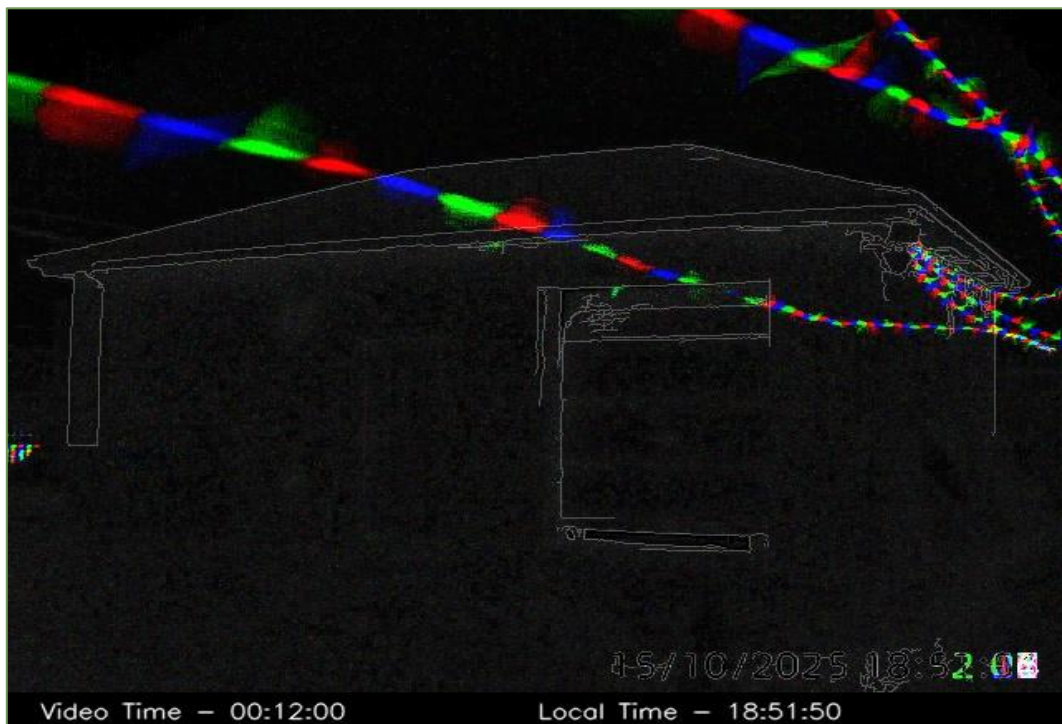
Plate 3.15 30-second summary image of bat emergence from western corner of pumphouse.

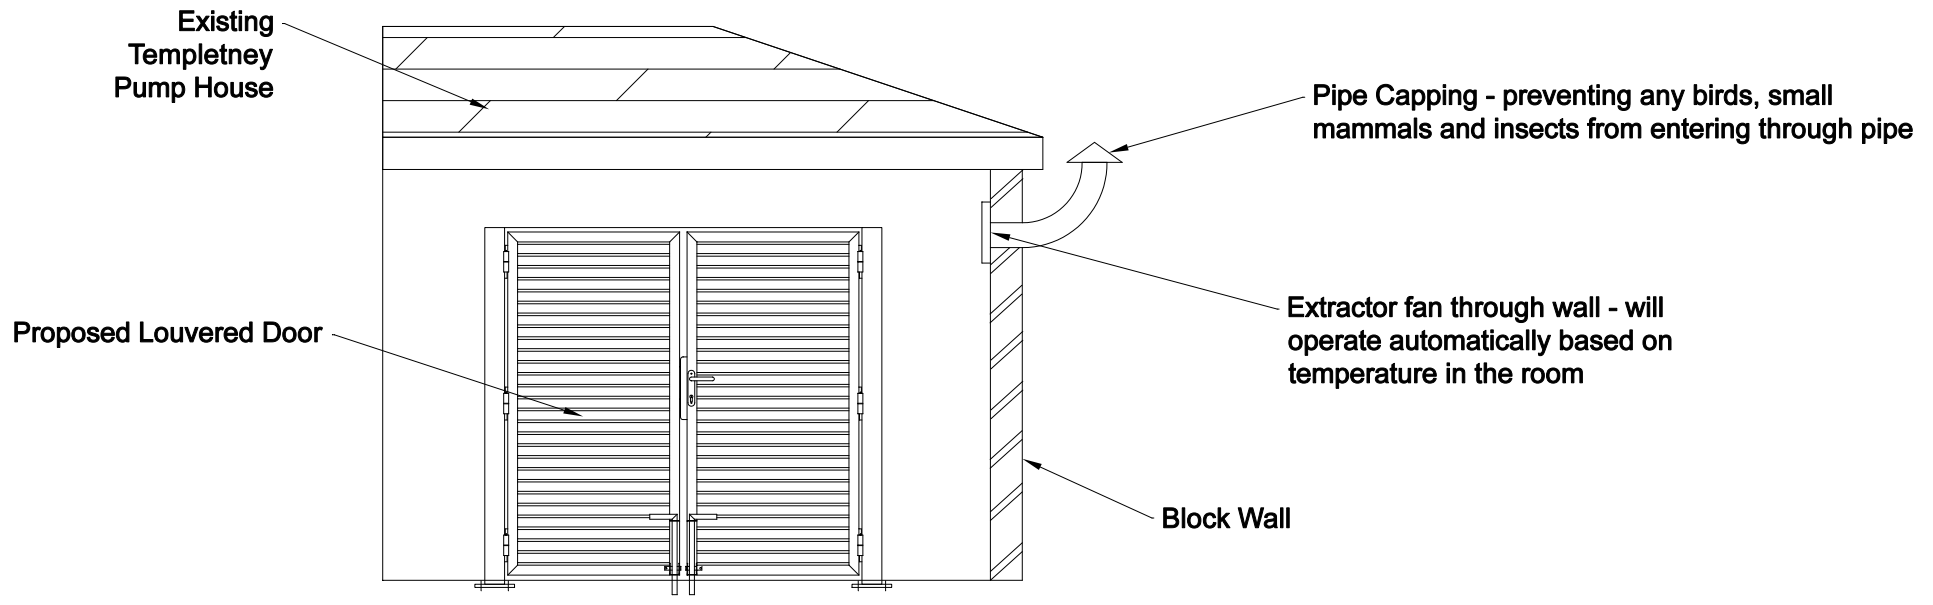
Appendix B - Project Design

- Replace the roller door with a new louvered style door.
- Installation of an extraction fan through the wall to control room temperature.
- Replacement of the three 'High Lift Pumps' within the Pump House with more powerful High Lift Pumps.
