**BAT SURVEY AND
MITIGATION PLAN
FOR PROPOSED WORKS AT
TINERANA STABLES,
OGONNOLLOE, CO. CLARE**

Applicants Gary and Michelle McNamara

1 Bat Survey and Mitigation Measures – Tinerana Stables County Clare

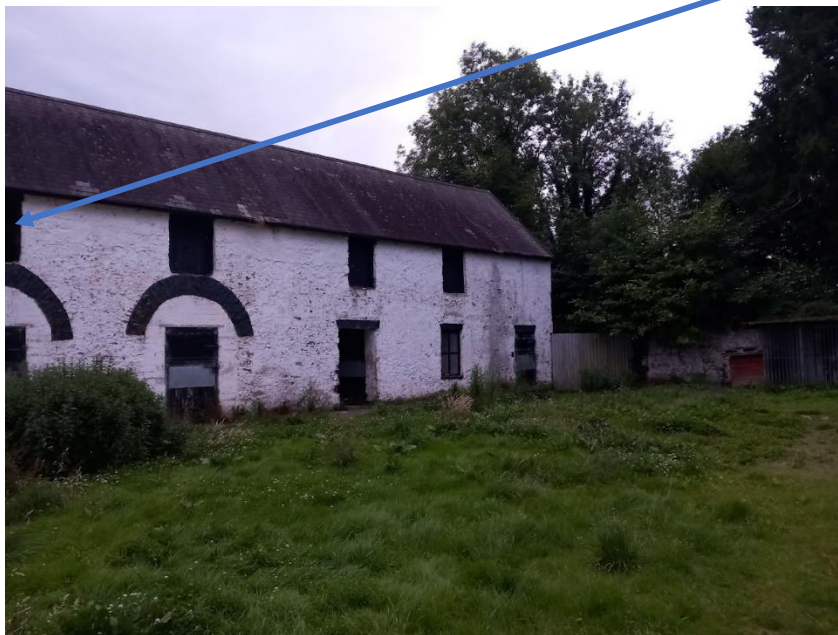
Plate 3-1 Stable A – exit by Long Brown eared bats.

Two long brown eared bats were observed flying out (dropping and flying) from Stable A at 23:06. See Plate 3.1 below. Bat species recorded during the emergence survey including foraging behaviour particularly at the scrub in the southern corner of the site.

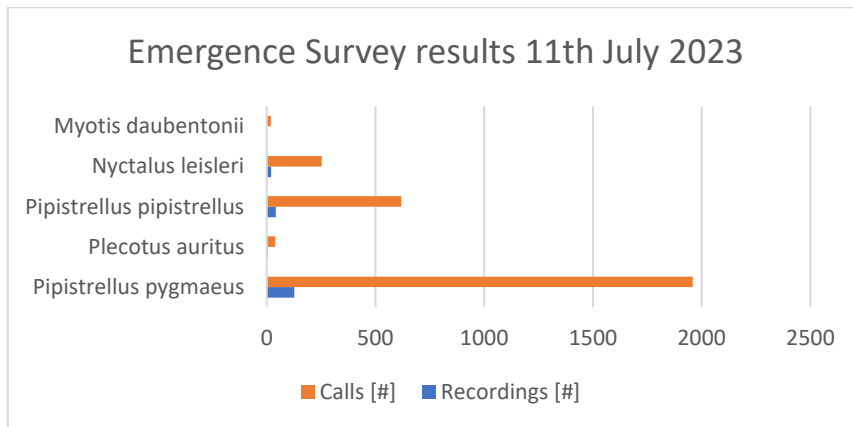
Figure 3-5 Emergence Survey Results 11th July 2023

The most frequently recorded species were soprano pipistrelles (127 calls), followed by common pipistrelles (42), and much less frequently recordings of Leisler bats(20), Long brown eared bats (4) and one recording of Daubenton bat. Figure 3.5 presents the overall results of activity over the emergence survey.

No bats were recorded emerging from the tower during the emergent survey of 11th July 2023.

No bats were observed emerging from the northwest stable but individual soprano pipistrelles were observed foraging within the north eastern open access part of this building through the evening.

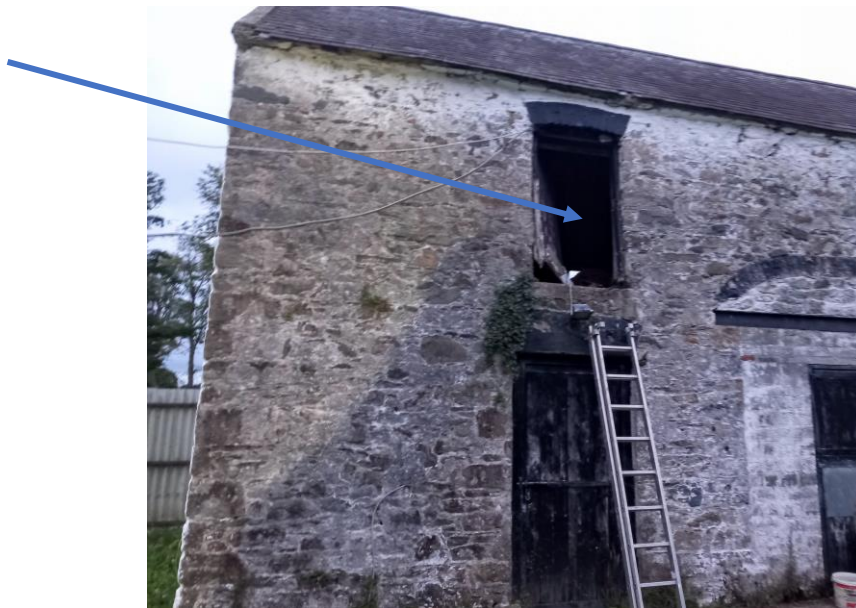
Plate 3.2 Access for Long Brown Eared Bats

During the dawn survey of 19th July, between 6 to 8 individual Long Brown eared bats were observed flying into the loft door at Stable B. See plate 3.2 below. No other species were observed returning to the stables during the dawn survey.

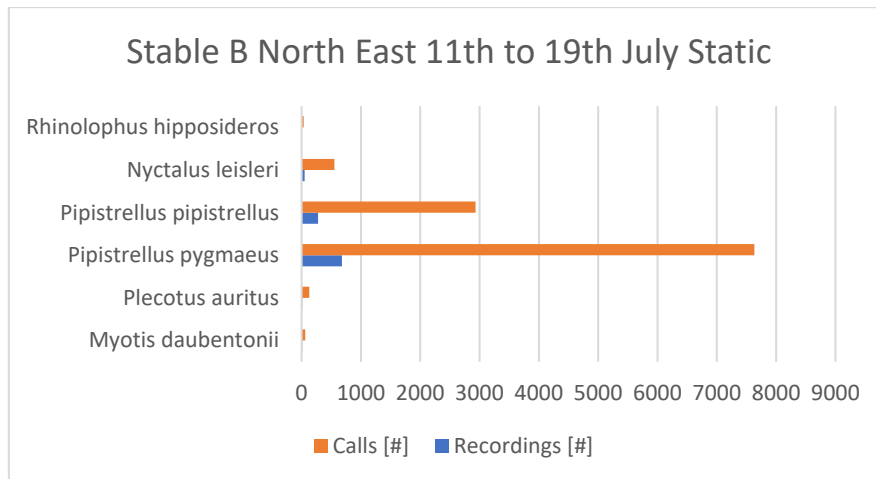
Figure 3-8 Stable B Static Detector results 11th to 19th July 2023

Over the 9 nights recorded in the loft of Stable B², the most frequently recorded species were soprano pipistrelle (679 records), followed by common pipistrelle (277 records). Again in much lower numbers,

Leisler bats (51 records), Long brown eared (10 records), and Daubenton bats (10 records). Lesser horseshoe bat activity was recorded more frequently in Stable B on the following dates

- 13th July at 00:33
- 16th July at 23:44 to 23:47
- 18th July at 22:53 to 22:57, and 03:29
- 19th July at 00:22.

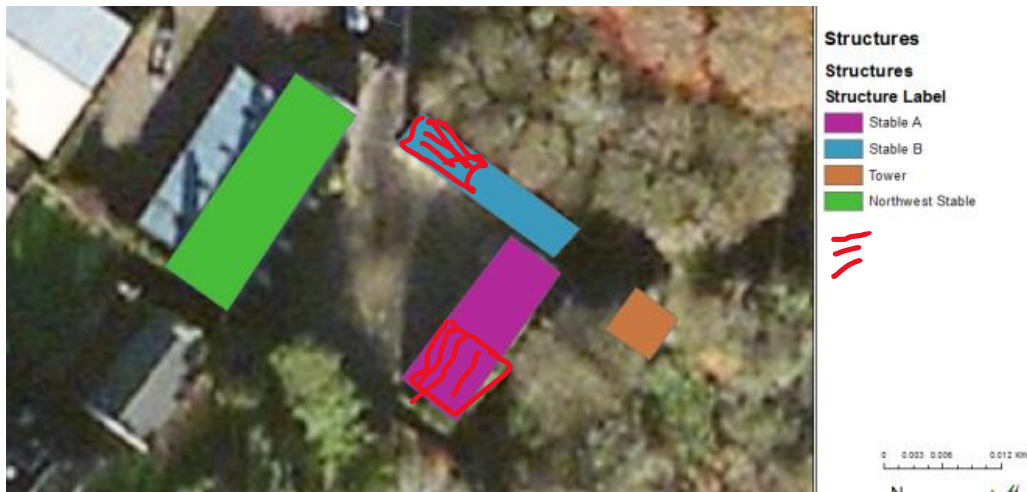
Figure 4-1 Location of dedicated roosts in Stables A and B and C – shown in red is the new locations following NPWS consultation

Dedicated roosts will be retained in the lofts of both Stables A and B and also within the tower (see Figure 4.1 for locations).

The SOUTHERN section of the Stable A and the WESTERN section of Stable B will be retained as a bat roost. A length of 9m of each loft will be retained to be used as a bat roost. The entire existing width and height of the loft space will be retained within the 9m sections for use as a bat roost. The bat loft space will be sectioned from the remainder of the loft space by a stud wall. The existing timber roost, which allows for an uncluttered and unobstructed loft space will be retained. A doorway within the stud partition will be provided for access to the bat roost.

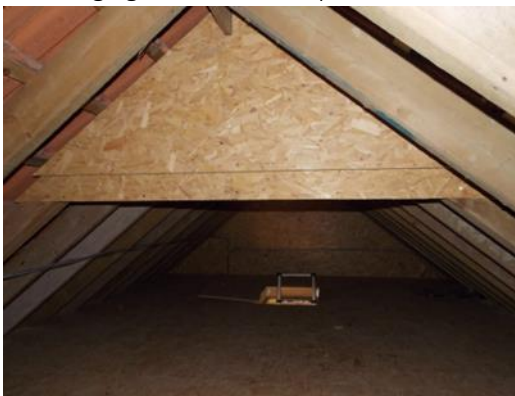
A HOTBOX WILL BE PROVIDED WITHIN STABLE A -this will be simply plywood plates over the 3 rafters with a plywood plate either side from the roof ridge, with a large rectangular access area maintained for the bats; this will enhance roosting conditions within the stable by reducing light into the this part of the building and decreasing draughts.

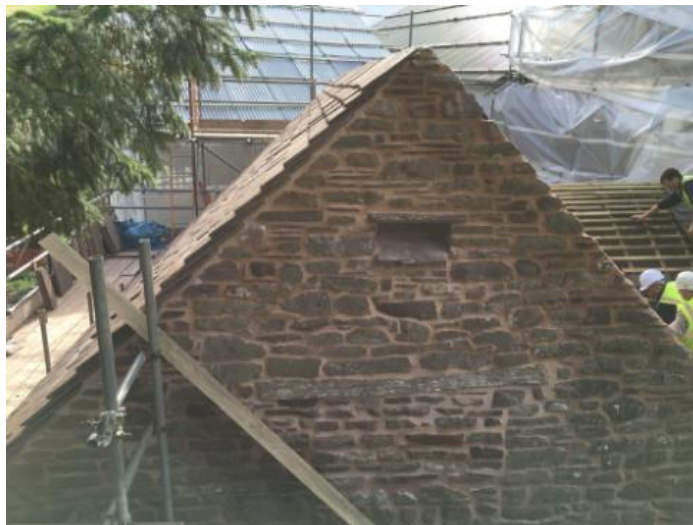
Figure 4-2 Letterbox design for roost access (Wildwood Ecology)

- A letter box access is proposed-. These are installed as low as practically possible on the gable wall but at least 0.4m above the level of the deck. The opening will be a minimum of 20cm x 30cm (600cm²) with a larger area preferable. This ensures that bats are away from clutter during access and will not be impeded by any potential bird's nests.

- The access will be open to facilitate access by Lesser Horseshoe Bats as well as Long Brown eared bats. See figure below for design of letter box access.

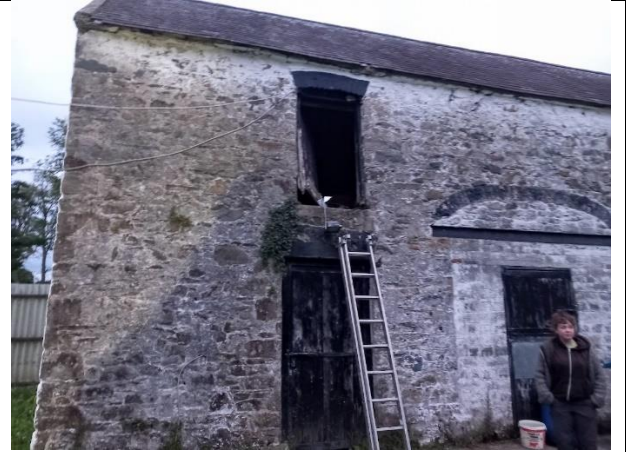
Stable B loft access used by Long Brown Eared Bats

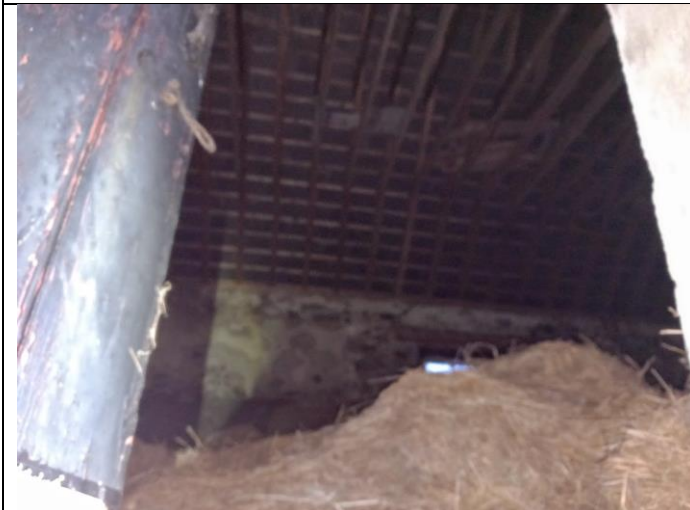
Interior of loft space Stable B

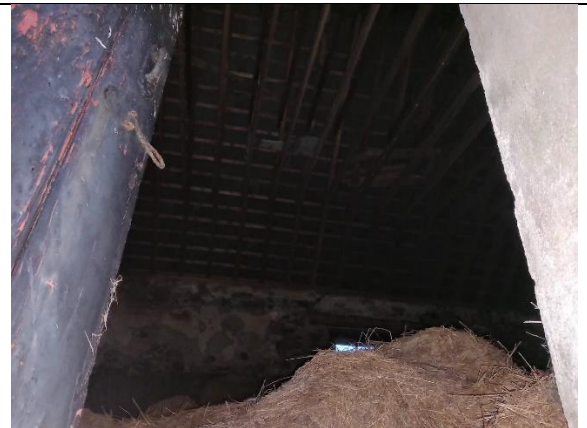
Interior of loft space Stable A
