Bat Survey Report

New Hotel Cottages

at Cahernane House Hotel,

Document Title: 2025 Bat Survey Report (Update on previous bat report)

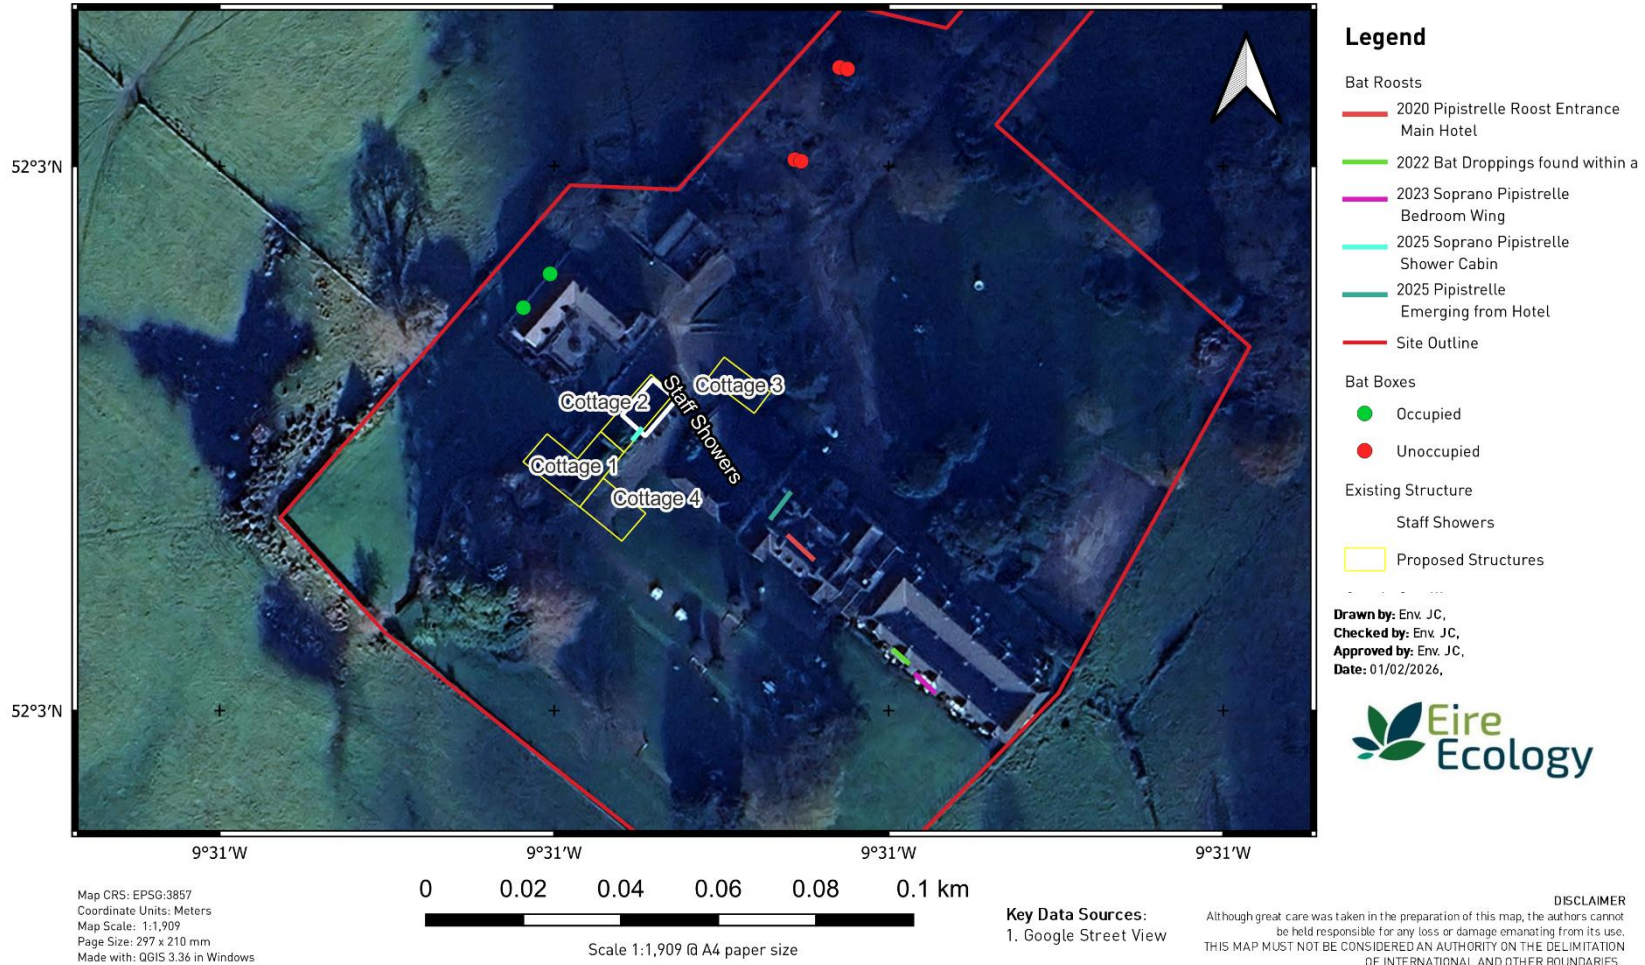
Figure 5-1: Current application with other bat related locations

Figure 5-1 shows the location of 4 proposed cottage buildings and known bat roosts.

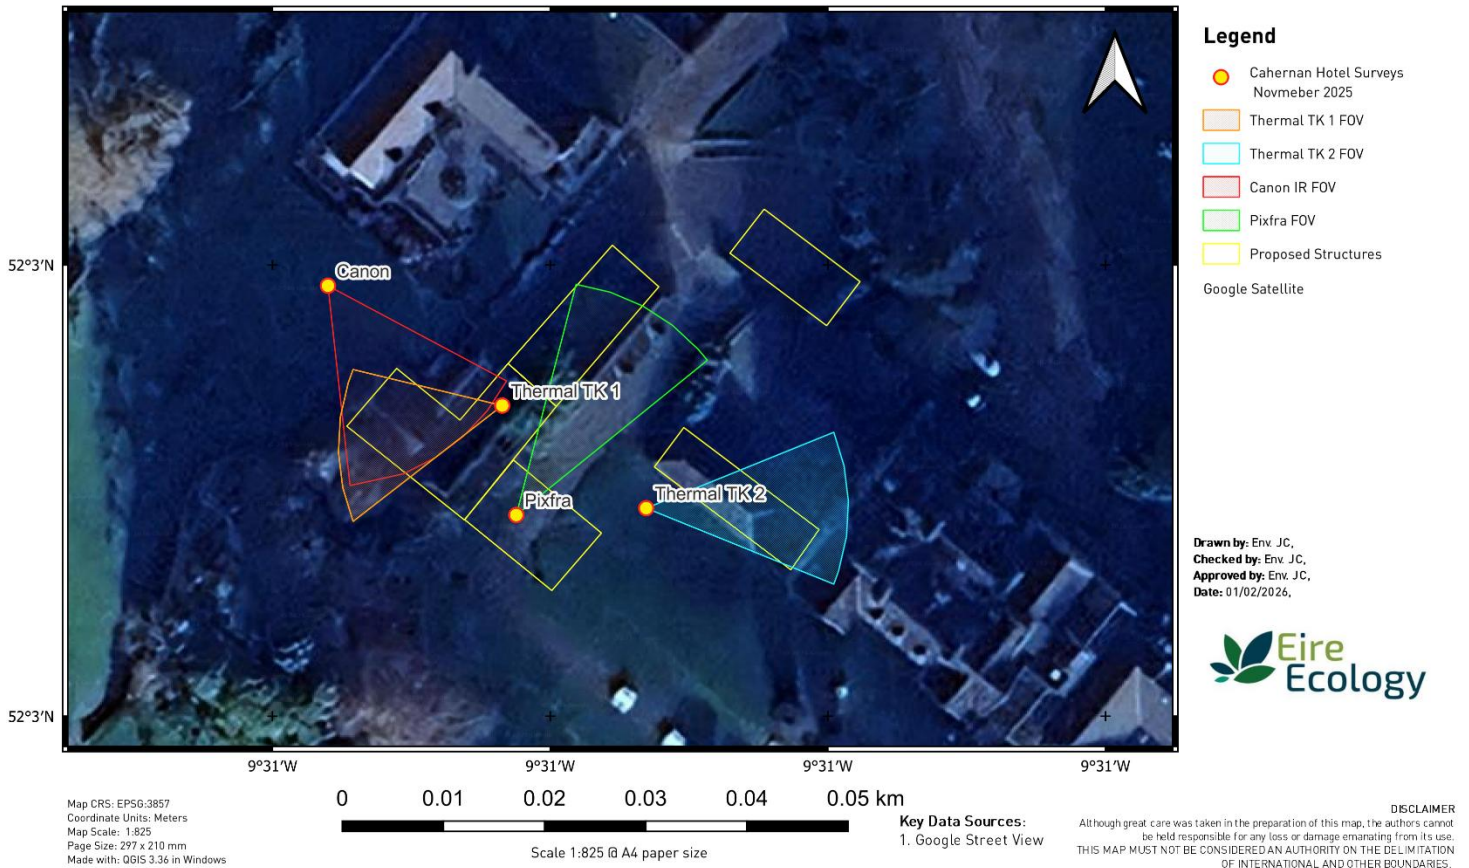
Figure 5-2: Cahernane House emergence survey 29/09/2025

Four POV's were chosen for nighttime emergence surveys in September, two facing a storage shed to the northwest (proposed cottage 1), one facing the west end of the hotel and yard (as construction of cottages could cause disturbance here) and lastly, one facing a changing room building to be removed for the construction of cottages (Figure 4-1). Audio was recorded at scope locations and were monitored by surveyors throughout the night.

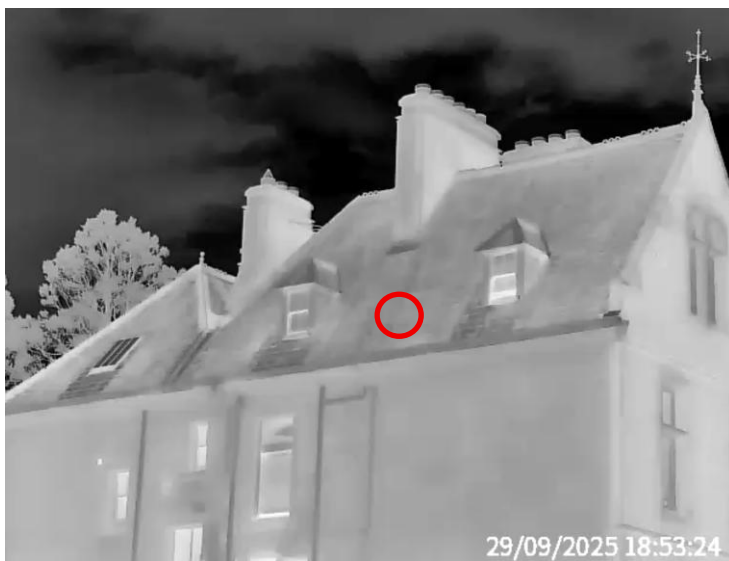
Plate 5-1: West side of Cahernane House Hotel

Two bats were seen emerging from the West end of the main hotel building, Common and Soprano Pipistrelle. Bat activity was considerable at this location, with bats passing over the courtyard for much of the night, particularly near sunset. These consisted primarily of Common and Soprano Pipistrelle.

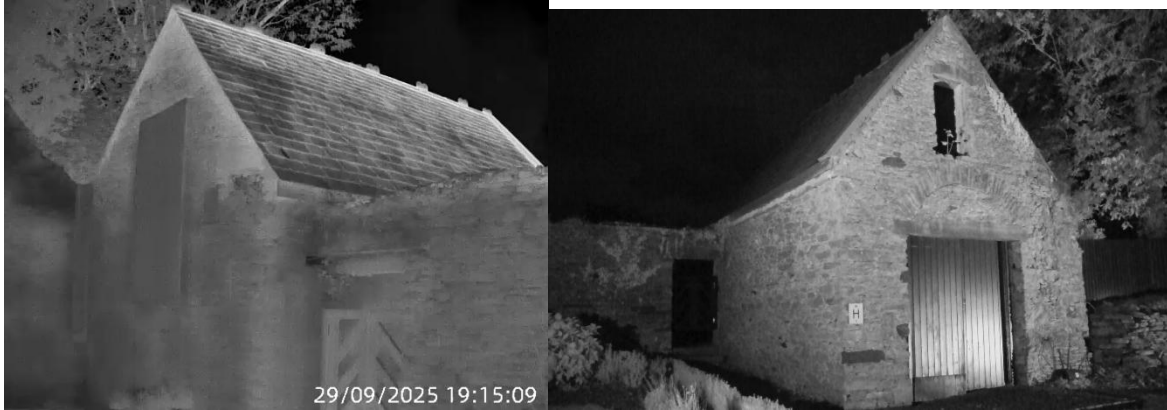
Plate 5-3: Storage Shed (Cottage 1 front)

Both the canon IR and Thermal TK were focused by cottage 1, one to the front and one to the rear. Bat activity here was low, with a number of passes recorded behind the shed and heading to the Southeast/South. The rock and tree located behind this building is a used hunting ground for bats. Thermals showed Pipistrelles circling this area.

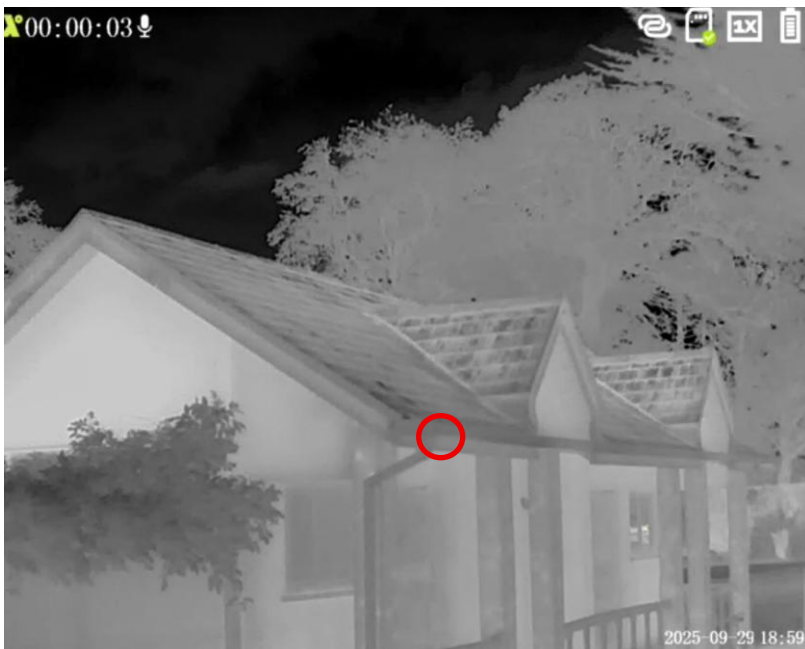
Plate 5-4: Cabin adjacent to Hotel (Cottage 2 Location)

One Soprano Pipistrelle was seen emerging from the staff changing cottage before re-entered through the same spot 30 minutes later (exiting from underneath the roof). After this, no bat was seen emerging from this building. Bat droppings were found in the building in September, but no signs of occupation were seen after this.

Mitigation measures will involve the presence of a licensed bat worker during demolition (until such time as the building is deemed unsuitable to act as a bat roost). The surveyor will come back after the integrated bat boxes have been installed, and the outdoor bollards has been installed and that it functions as stated in 6.3.1.3. and photograph evidence of compliance with a final report submitted to the NPWS at this point.

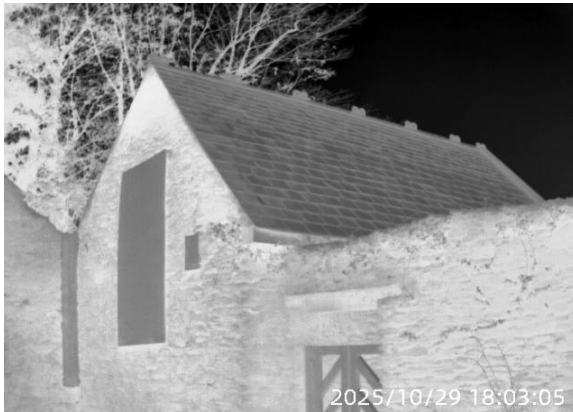
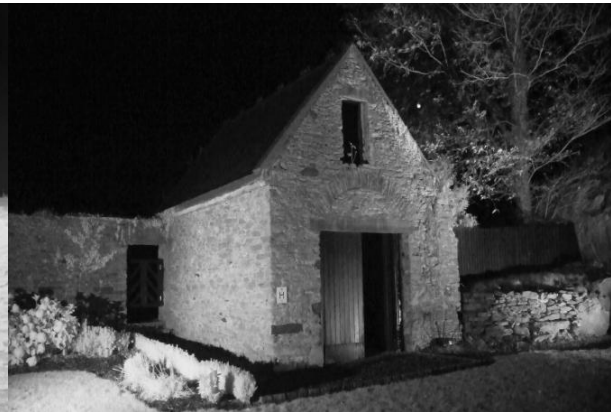
Sunset occurred at 16:57 and weather conditions were good for this survey. Five POV's were used during the October survey. The Shed at the location of cottage 1 was again surveyed from two angles with the Canon XA10 and Guide Track TK. These were in the same location as the previous survey in 2025. While bats were seen flying behind the Shed, none were seen emerging. Only Soprano Pipistrelle were recorded.

Plate 5-6: Storage Shed - Canon

Plate 5-5: Storage Shed - Thermal TK

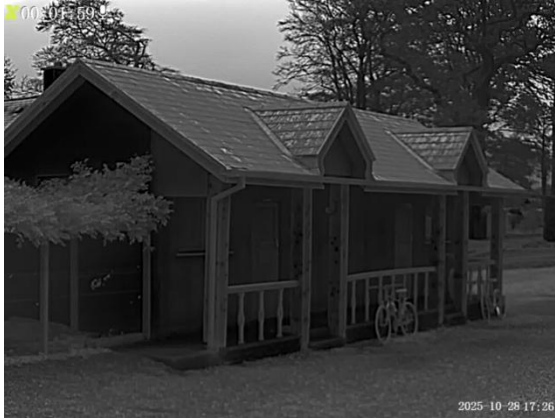
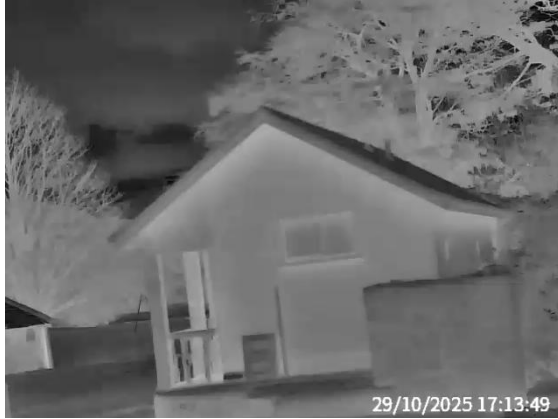
The Staff changing cottage surveyed in September (proposed Cottage 2) was surveyed again, this time with two POV's, from the Northeast and Southeast. No bats were seen emerging from this building from either viewpoint, though Common and Soprano Pipistrelle were both recorded close to sunset on both scopes.

Plate 5-7: Cabin - Pixfra

Plate 5-8: Cabin - Thermal TK 1

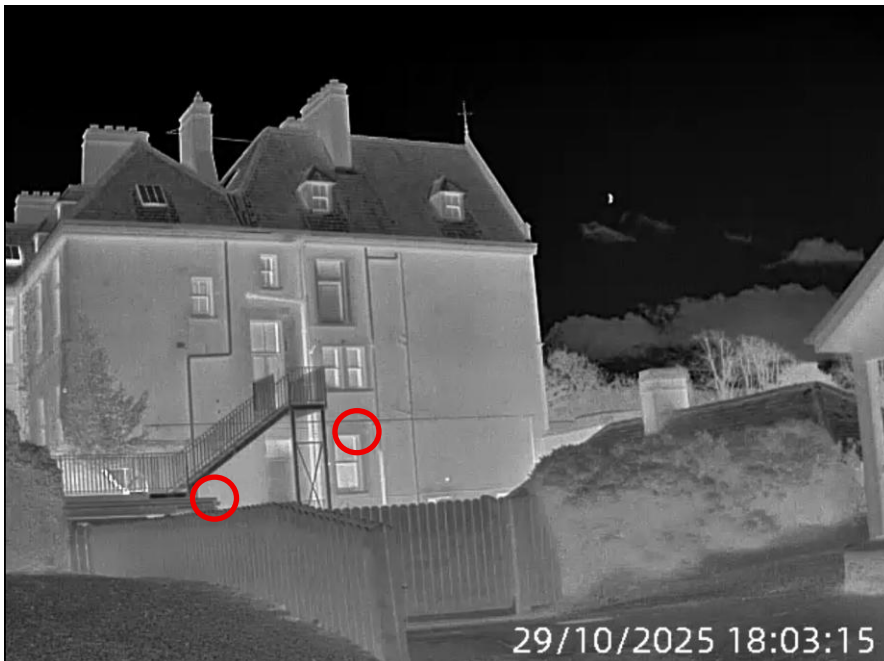
Plate 5-9: West end - Cahernane Hotel

The main Cahernane hotel building was surveyed on the western side with a Thermal Scope. The scope looks over the yard where cottage 3 will be located and covers the roof of the laundry building. Two bats were seen to emerge from different spots here, one from the pumphouse next to the fire escape and one from the window adjacent to the Air conditioning unit. Due to distance, none of these bats were recorded echolocating during emergence.

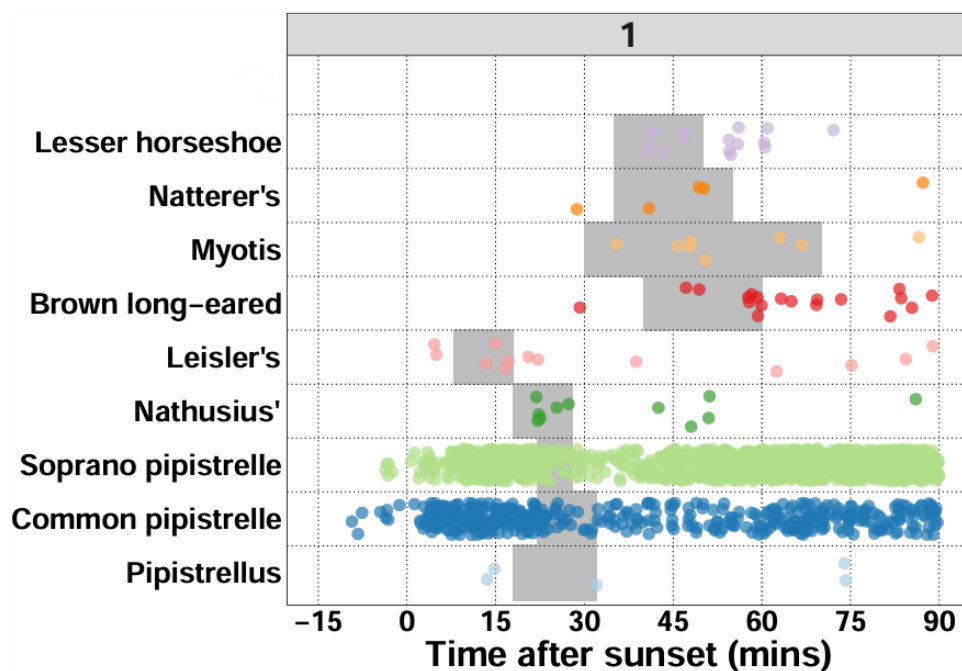
Figure 5-4: Time analysis: 29th Sep -> 29th Oct

Time Analysis of calls suggests that Soprano and Common Pipistrelle are roosting in the vicinity, with numerous calls before typical emergence. Lesser horseshoe bat, Natterer’s myotis, a brown long-eared bat, Leisler’s bat and unidentified pipistrelle were also recorded within typical emergence times at this location.

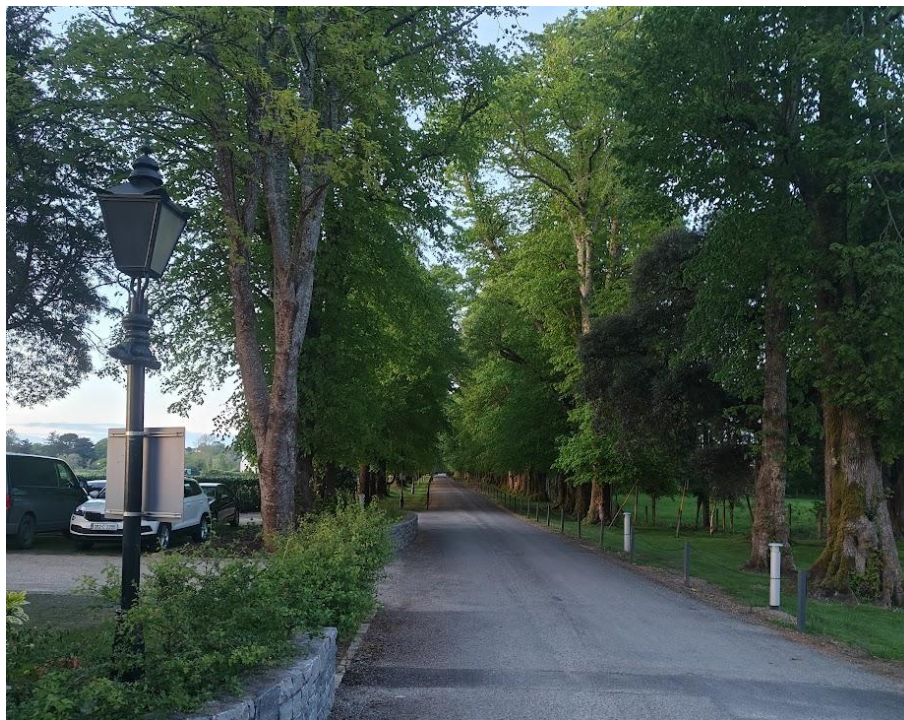
The survey conducted in May 2024 confirms these works have been completed and the lighting regime to the NW of the site has significantly improved.

Plate 6-1: Lamp post with blacked out sides and new bollards.

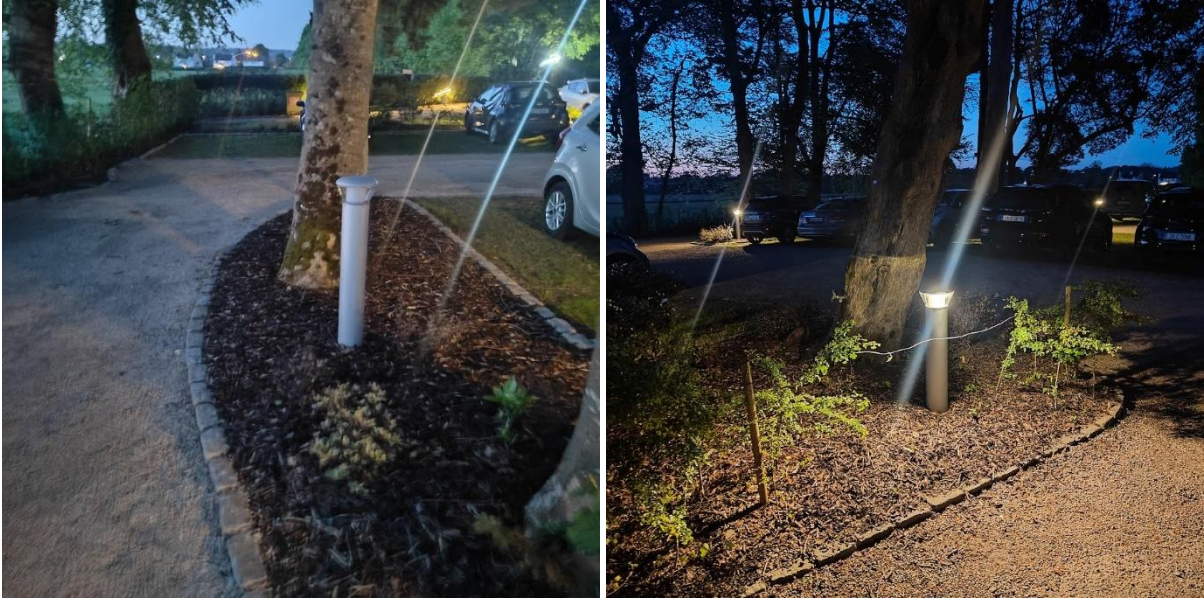
Plate 6-2 & Plate 6-3: Sensor lamps within woodland carpark

The change to the NW of the courtyard will have minimal impact on the lighting regime within the carpark woodland and represents a smaller scale development than the previously approved orangery.
