# Bat Derogation Licence Application

## Lissardagh Main House

**Project:** Lissardagh Main House Renovation, Lissardagh, County Cork.

**Project Reference: 2023/21**

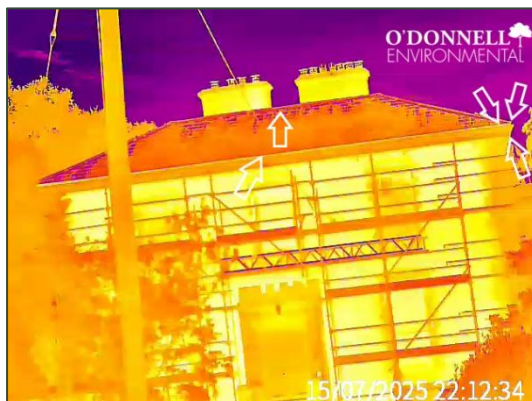
**Plate 2.1** Thermal perspective overlooking the west aspect of Lissardagh Main House. Emergence points are highlighted with white arrows.

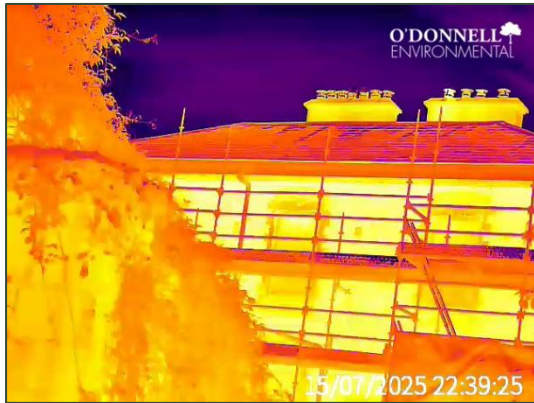
**Plate 2.3** Thermal perspective overlooking the east aspect of Lissardagh Main House.

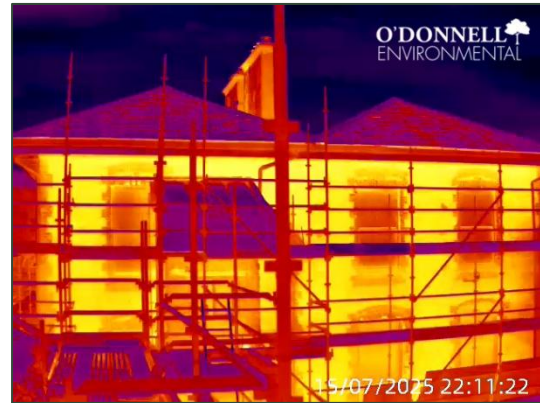
**Plate 2.4** Thermal perspective overlooking the north aspect of Lissardagh Main House.

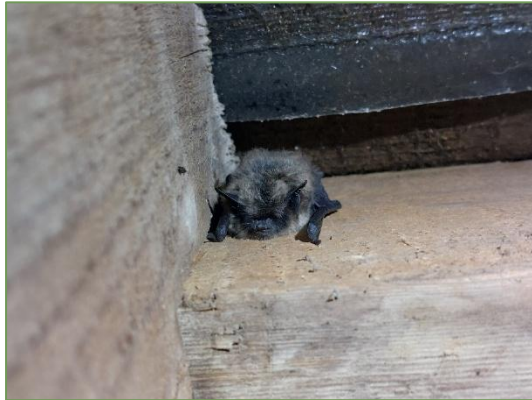
**Plate 3.1** Whiskered Bat roosting along the ridge beam within the western attic section of Lissardagh House.

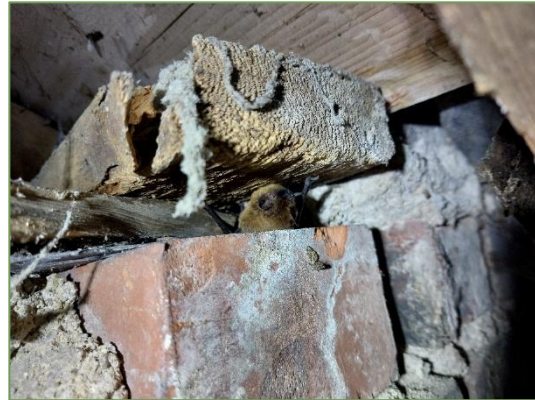
**Plate 3.2** Soprano Pipistrelle within the exposed interior brickwork of Lissardagh House attic.

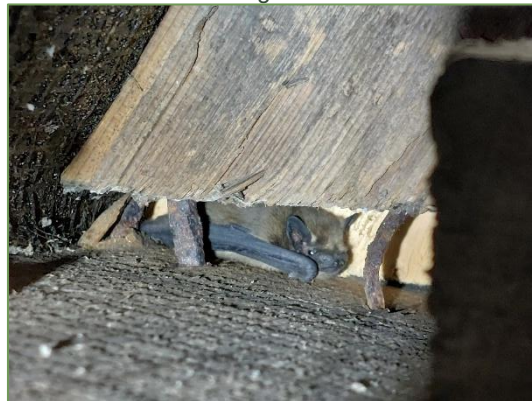
**Plate 3.3** Common Pipistrelle roosting in the ridge beam joinery within the attic of Lissardagh House.

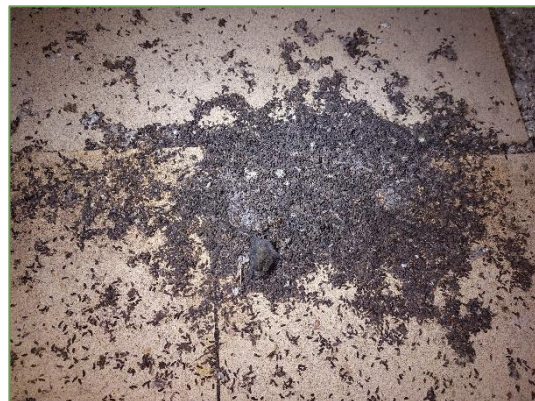
**Plate 3.4** Significant accumulation of bat droppings underneath the hip-roof apex within the western attic portion, with dead juvenile whiskered bat present also.

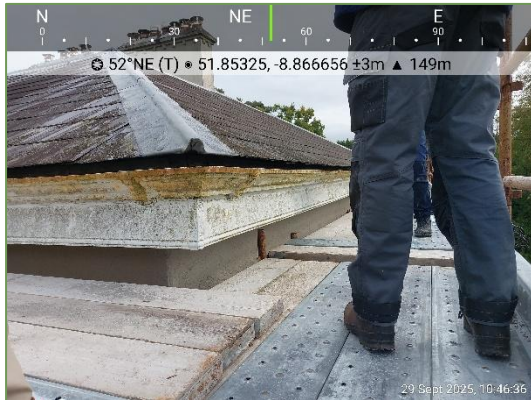
External inspection of Lissardagh Main House at height revealed a number of suitable access/egress locations throughout the roof structure. Droppings were recorded in the gap between the gutters and slates on the southwest and southeast corners (see **Plates 3.5-3.6**), presenting the likely main access/egress point. Damaged lead ridges throughout the entire exterior roof structure provides roosting voids for bat species (see **Plate 3.7**), in addition to access/egress opportunities (see **Plate 3.8**). Minor gaps were additionally present along the plastic fascia-soffit which provides additional access/egress opportunities.

**Plate 3.5** View of southwest corner of roof. Note gap between gutters and slate.

**Fascias and soffits:**  
Remove PVC fascias and soffits, taking care to retain the existing lath and plaster soffit. Review condition of cross-framing between the truss ends to detail, making good as required. Construct new hardwood fascia and soffits over the retained lath and plaster soffit.

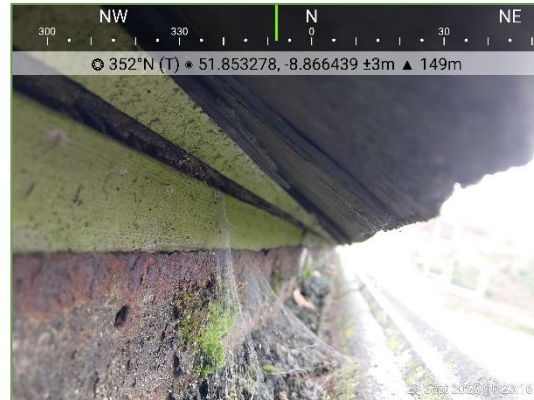
**Plate 3.6** Detailed view of gap between gutters and slate on southwest corner, droppings evident.

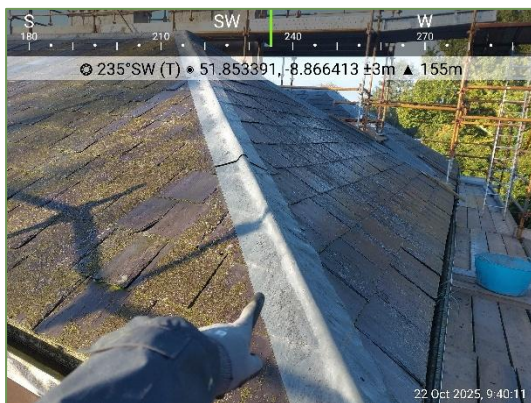
**Plate 3.7** Example view of damaged lead. Presents voids underneath and above slates, with droppings and individual bats recorded underneath.

A seasonal restriction on remaining particular roof works with potential to negatively affect the maternity colony is considered warranted. These works consist of localised slate repair, lead repair, timber splicing, timber treatment and chimney works. These works will be completed before 1<sup>st</sup> May 2026, outside of the maternity season (May-September inclusive) to avoid disturbance of the maternity colony.

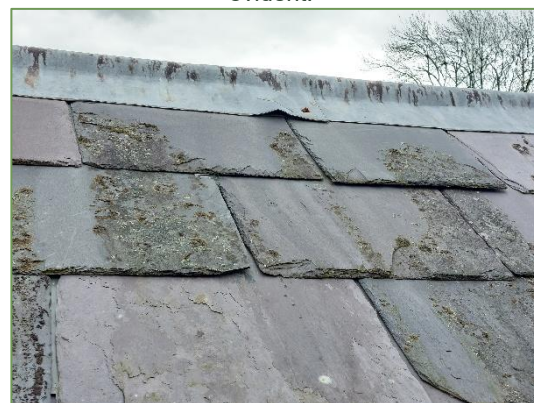
**Plate 3.8** Example of buckled lead ridges, presenting suitable access/egress throughout.

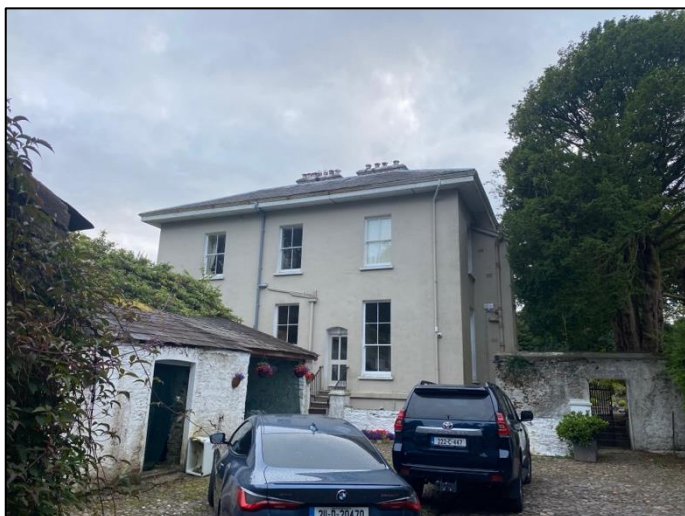
**Plate 1** Eastern face of the subject house. During the activity survey a Soprano pipistrelle was often recorded foraging here.

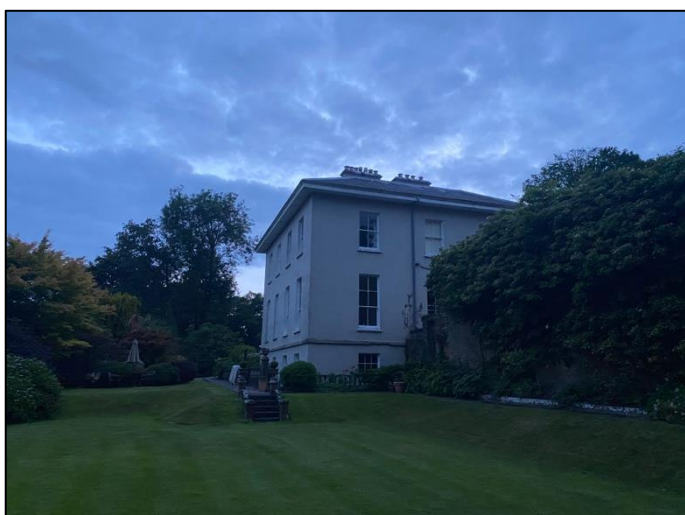
**Plate 2** The south-eastern section of the house immediately before the survey commenced. Approximately 12 bats were recorded emerging from this corner.

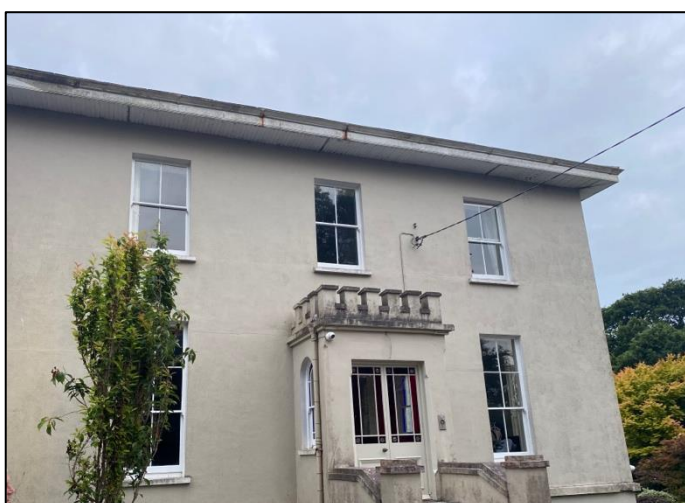
**Plate 3** Western face of the subject house. Bats were recorded emerging from the roof here.

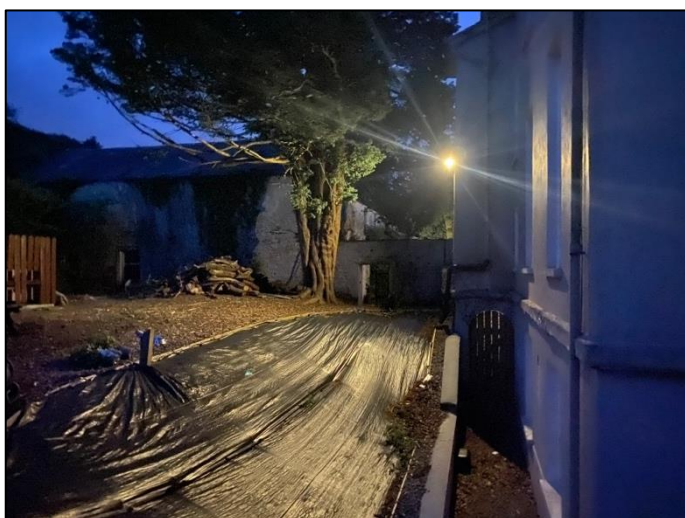
**Plate 6** Sensor lighting on the proposed development site. There were sensor lights to the north and east of the house.
