# Bat Survey Report

The Stone Yard,  
Kilshane,  
Co. Tipperary

April 2026

**Project:** The Stone Yard, Kilshane House, Co. Tipperary.

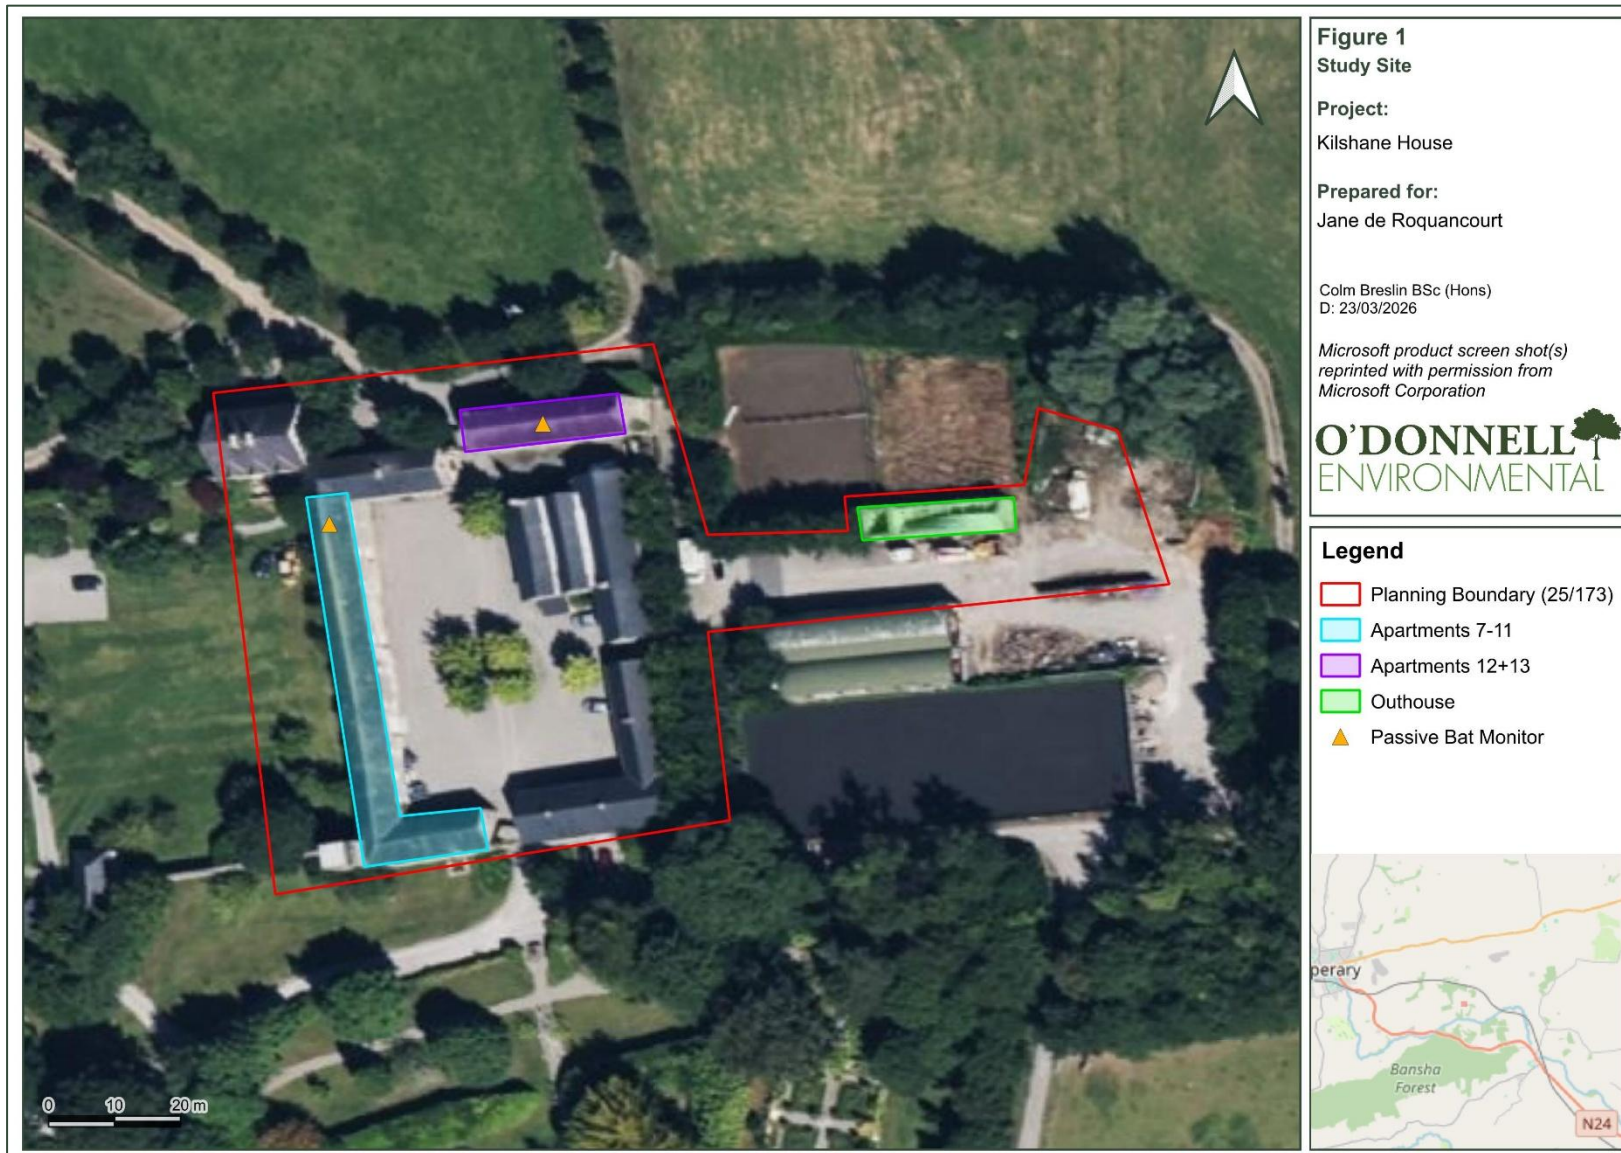
**Figure 1**  
**Study Site**

The proposed development encompasses three historic structures located within the curtilage of Kilshane House (see **Figure 1**), approximately 3.4km west of Tipperary Town. The structures are bounded by mature trees, with the surrounding landscape characterised by extensive pasture, rivers and mixed woodland (including Bansha Forest). The courtyard is subject to low levels of lighting disturbance from external light fixtures on apartments when occupied by guests.

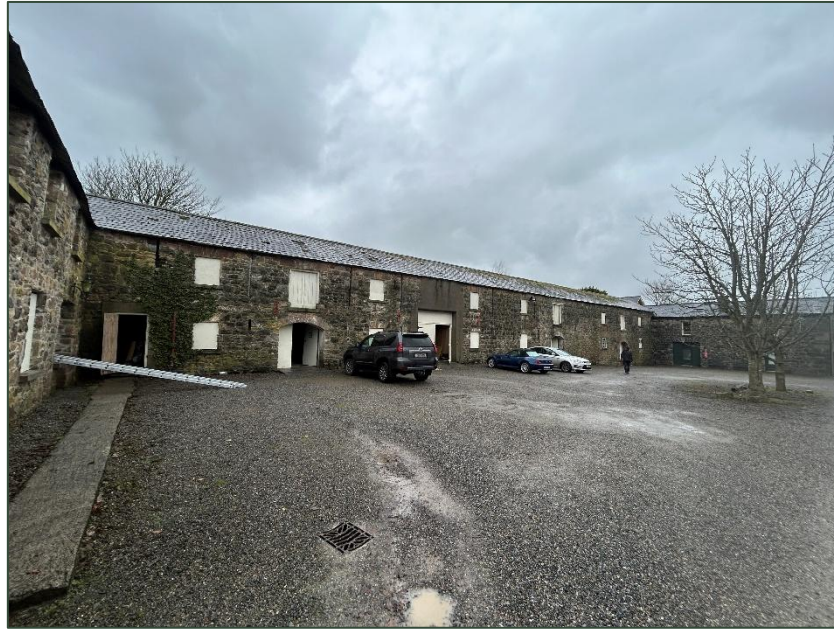
The structure proposed to accommodate Apartments 7-11 (see **Figure 1**) comprises a single contiguous L-shaped stonework structure. The roof is comprised of natural slate with no underlay, sitting directly atop the timber roof frame and held with lime mortar. There is no attic space. While generally intact, the roof structure is degraded in multiple places through missing slates and open windows which results in the interior being somewhat exposed to light as well as wind and water ingress occasionally. Corvid nests are in multiple points within the rafters. The structure generally lacks interior floors, except for Apartment 7 and 8. Interior walls were inspected at height using a ladder and endoscope (see **Plate 3.5**). Loose slates and open windows ensure the entire structure is accessible to bats. There are interior lights which are likely used occasionally and result in temporary disturbance to bats roosting within.

**Plate 3.1** Overview of Apartments 7-11.

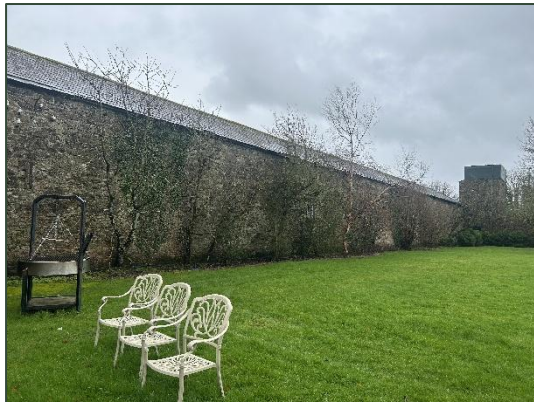
**Plate 3.2** Alternate view of Apartments 7-11.

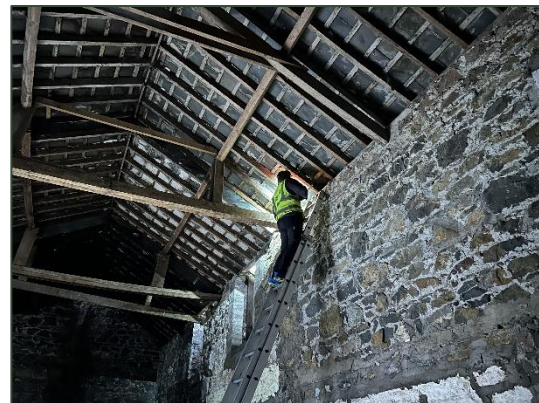
Numerous 'low' or 'moderate' suitability crevices were identified within the structure complex, primarily in the form of loose mortar between stonework, wooden joinery at the hip roof and rafter sections (see **Plate 3.7; 3.11**), where the roof sits on the wallplate, and small sections of wooden sarking above the wallplate and below the slates (see **Plate 3.6**). There were clear gaps between the ridge beam and battens that provides access to cavities underneath the ridge tiles. There are two interior walls, with crevices associated at ridge level where the roof structure adjoins. Gaps were present within the wooden lintels of the upper floor windows, and within the underside of the interior floors also.

**Plate 3.5** Surveyor at height inspecting stonework crevices and roof structure.

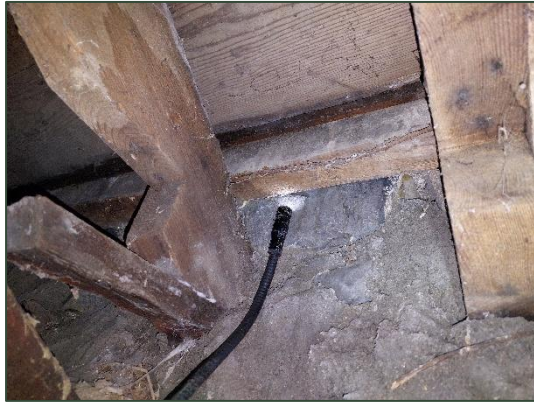
**Plate 3.6** View of example crevice between roof structure sarking and wall plate.

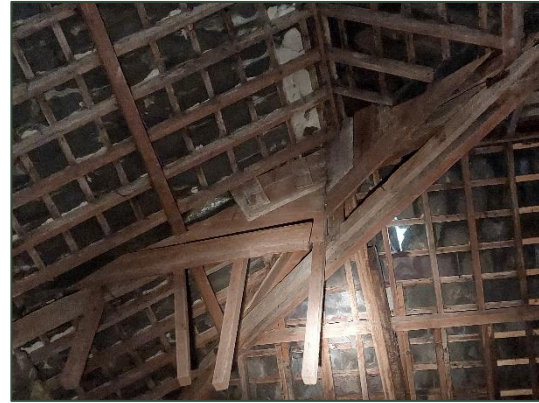
**Plate 3.7** Example of complex joinery at hip-roof sections of Apartment 11.

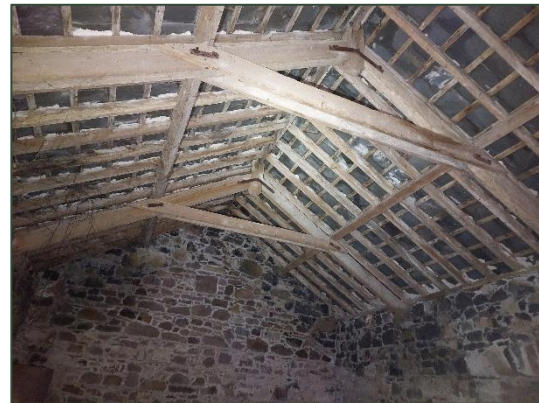
**Plate 3.11** View of Apartment 7.

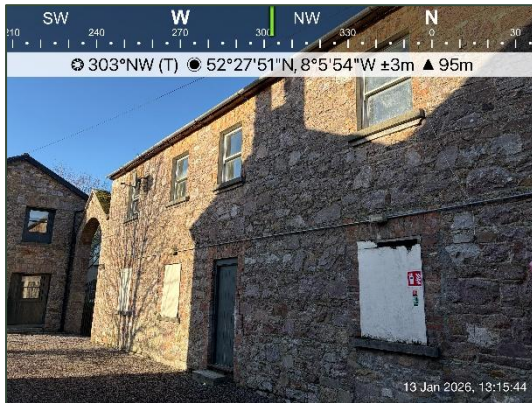
Apartments 12+13 is a standalone structure at the northeast of the site of the same construction as Apartments 7-11: stonework walls with natural slate atop timber roof. This structure was significantly degraded with a large section of the ground floor exterior wall missing and roof structure open to the elements, allowing light, wind and rain throughout (see **Plate 3.14**). The ground floor was fully accessible, with access to the upper floor not possible due to safety concerns. However, clear views were possible of the upper floor and roof (see **Plate 3.15**). Most interior floors and ceilings have been removed, and no attic void is present. A small accumulation of droppings and feeding remains were identified within the central room of the

**Plate 3.12** View of Apartment 12+13.

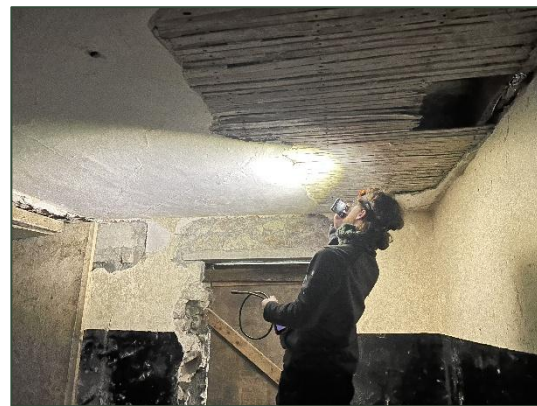
ground floor. Above this accumulation a portion of the ceiling remained, composed of lath and plaster (see **Plate 3.15**) which may contain the roosting location/feeding perch. DNA analysis was undertaken on these droppings by SureScreen Scientific on behalf of O'Donnell Environmental and were identified as Brown long-eared bat and Natterer's bat (see **Appendix A**).

**Plate 3.15** Surveyor inspecting void above small accumulation of droppings.

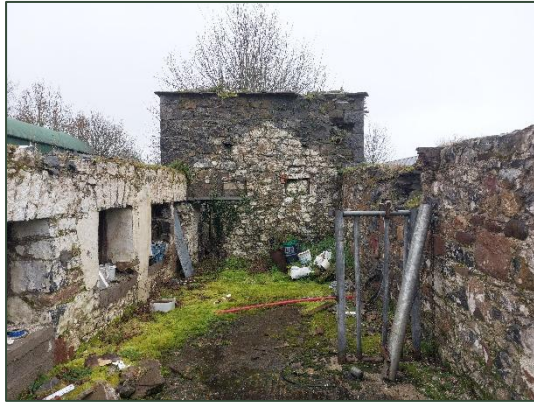
The outhouse is located at the east of the proposed development and is composed of stonework with no roof (see **Plate 3.16**). There are no interior spaces, and the structure is exposed to wind and rain. The western portion of the outhouse comprises a dovecote (see **Plate 3.17**), with some minor crevices which were inspected with endoscope at height. No evidence of bat roosting was identified within the outhouse. Overall, the outhouse is considered to be of 'low' suitability for roosting bats following Collins (2023).

**Plate 3.16** View of outhouse with dovecote.

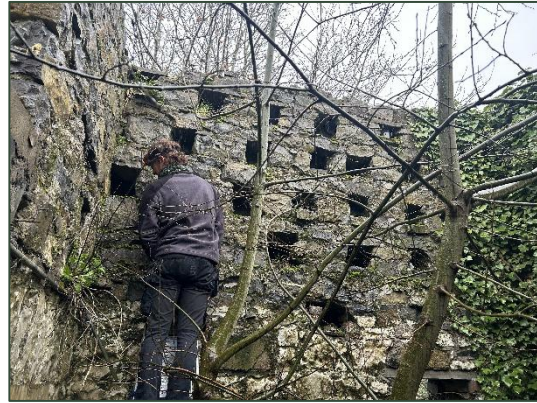
**Plate 3.17** Surveyor inspecting crevices of dovecote.

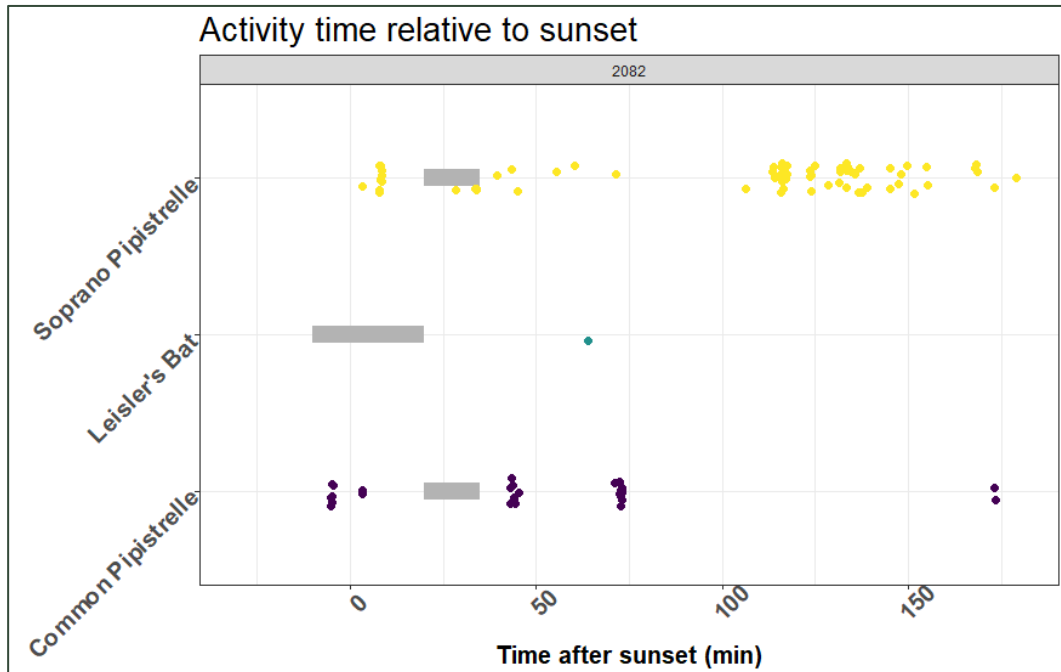
A detailed comparison between timing of registrations and relative sunset was conducted on all recordings from Apartment 7-11 (see **Figure 3.1**). Mean emergence times of species were taken from Andrews and Pearson (2022). The earliest registration of Common pipistrelle was recorded 5 minutes before sunset. The earliest registration of Soprano pipistrelle was recorded 3 minutes after sunset. The mean emergence time of both species are approximately 25 minutes and 34 minutes after sunset respectively. The timing of registrations prior to sunset relative to mean emergence times indicates that both Common pipistrelle and Soprano pipistrelle were day-roosting within Apartments 7-11.

**Figure 3.1** Graph showing registrations of each bat species recorded within Apartments 7-11 relative to sunset. Grey box indicates the average emergence window for each species, with registrations within and before this time indicative of roosting within the structure.

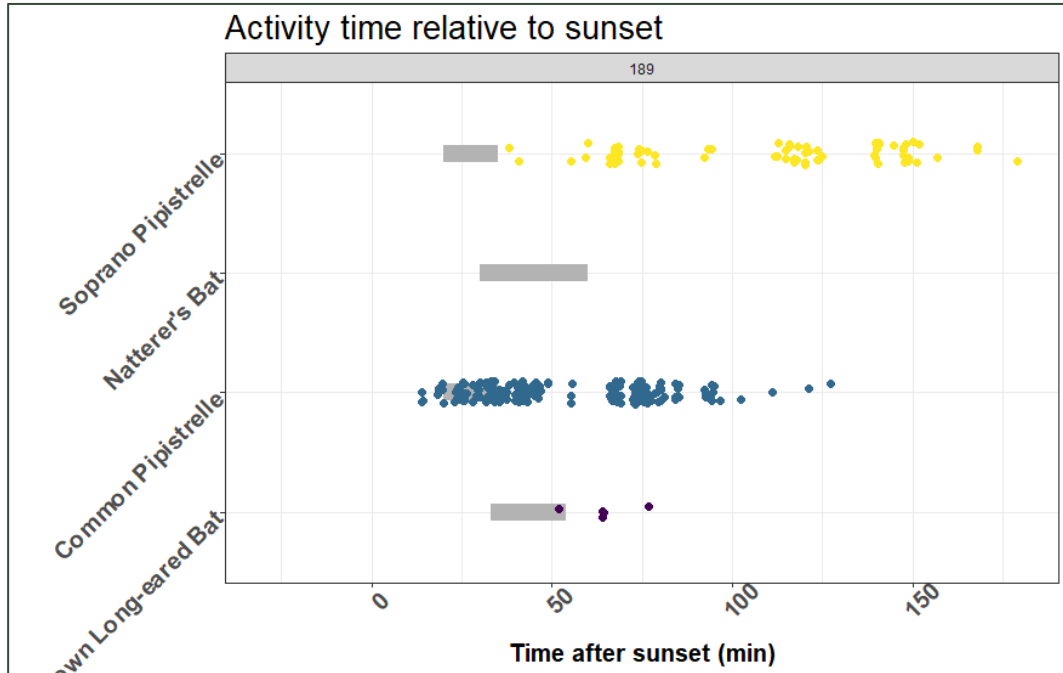
A detailed comparison between timing of registrations and relative sunset was conducted on all recordings from Apartments 12+13 (see **Figure 3.2**). Mean emergence times of species were taken from Andrews and Pearson (2022). The earliest registration of Common pipistrelle was recorded 12 minutes after sunset, prior to their mean emergence time of 25 minutes. The earliest registrations of Brown long-eared bat was 40 minutes after sunset, prior to the mean emergence time of 61 minutes after sunset. Soprano pipistrelle was first recorded 40 minutes after sunset, after their mean emergence time of 34 minutes. Natterer's bat were not recorded until 4 hours after sunset, well beyond their mean emergence time of 31 minutes. The timing of registrations relative to mean emergence times, in addition to DNA analysis of droppings (see **Section 3.2.2**) indicates that both Common pipistrelle and Brown long-eared bat were day-roosting, and Natterer's bat were night-roosting or foraging within Apartments 12+13. There is potential for Common pipistrelle and Soprano Pipistrelle emerging from Apartments 7-11 at earlier times (see **Section 3.3.1** above) utilising Apartments 12+13 immediately afterwards. Following a precautionary approach, it is considered that Soprano pipistrelle were also day roosting within Apartments 12+13.

**Figure 3.2** Graph showing registrations of each bat species recorded within Apartments 12+13 relative to sunset. Grey box indicates the average emergence window for each species, with registrations within and before this time indicative of roosting within the structure.

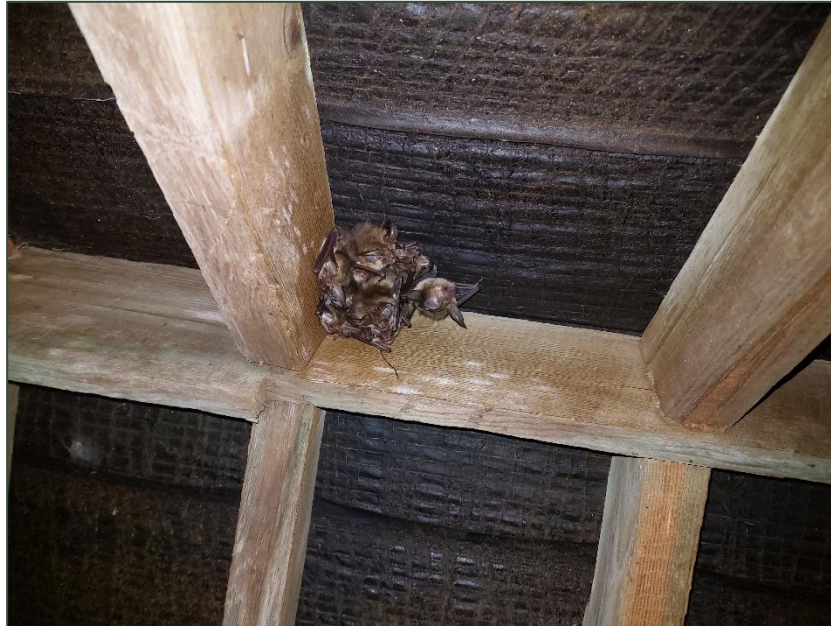
**Plate 4.1** Example of a Brown long-eared bat colony roosting at apex underneath felt where ridge board joins with rafter. (Photo: Colm Breslin under licence).

Brown long-eared bat prefer to roost within large attic spaces (Swift, 1998). Brown long-eared bat are 'fissure roosters', preferring to maintain contact with both the ridge beam and rafters at the apex (Swift, 1998). The bat compartment within Apartment 8 will have a footprint of approximately 40 square metres and an apex height of 1.3m. The bat compartment within Apartment 12 will have a footprint of approximately 30 square metres and an apex height of 2m. The ridge beam will remain exposed, and roof structure within the bat compartment follow that shown in **Plate 4.1**. Double or triple ridge boards may be used with 20-30mm gaps to increase available roosting sites (Razgour et al., 2013). Consideration should be given to increasing the number of internal roosting spaces through the use of rough timber panels, decided in consultation with a bat licensed Ecologist.

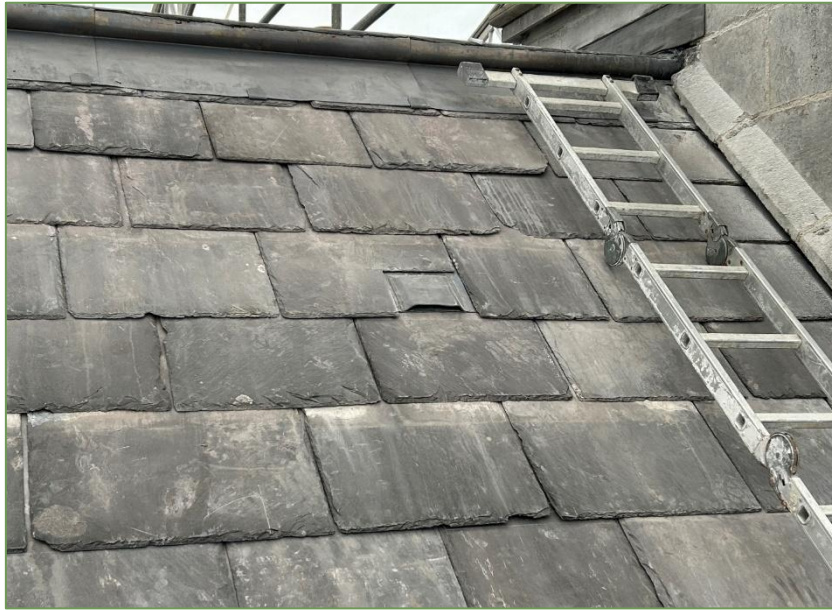
Plate 4.2 - Example of a lead bat-access tile (Photo: Tom O'Donnell).

The use of bat-safe construction materials may only be used within the bespoke bat compartments. Underlay within any areas of attic to which bats may have access at least must use only traditional bitumen felt (1F). The felt should be cut with 30x100mm slots at 2m intervals along the ridge beam to allow bats to access the void between the slates and felt, and bat-access tiles.

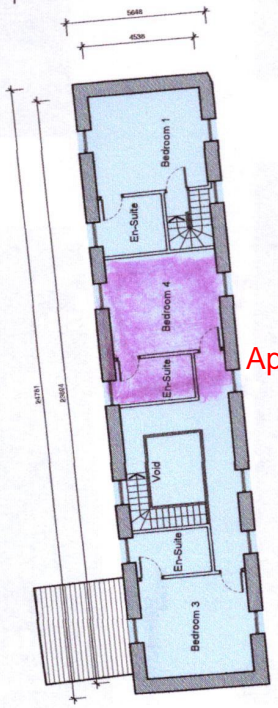
Apartment 12 Bat Roost

Proposed First Floor Plan  
Scale: 1:100

Bespoke bat compartments will be sealed off entirely from each Apartment. A locked access-hatch on the interior floor of the bat compartment will be provided to facilitate access for bat-licensed Ecologists to monitor the population within the roost. Any items that might need inspection or maintenance (ventilation units, water tanks etc.) will not be located in the bat compartment. No light fixtures will be attached to the floor of the bat compartment to avoid potential future disturbance from maintenance works. This may be achieved by creating a "double-skin" floor/ceiling where electrical services can be wired through without breaching the bat compartment. A layer of polythene may be rolled along the floor of the bat compartment to catch bat droppings/urine.
